# **North Branch and Kingsbury Branch Class Three and Four Road Erosion Assessment**

Project funded with a grant from VT DEC ERP

Central Vermont Regional Planning Commission with assistance from

December 26, 2012

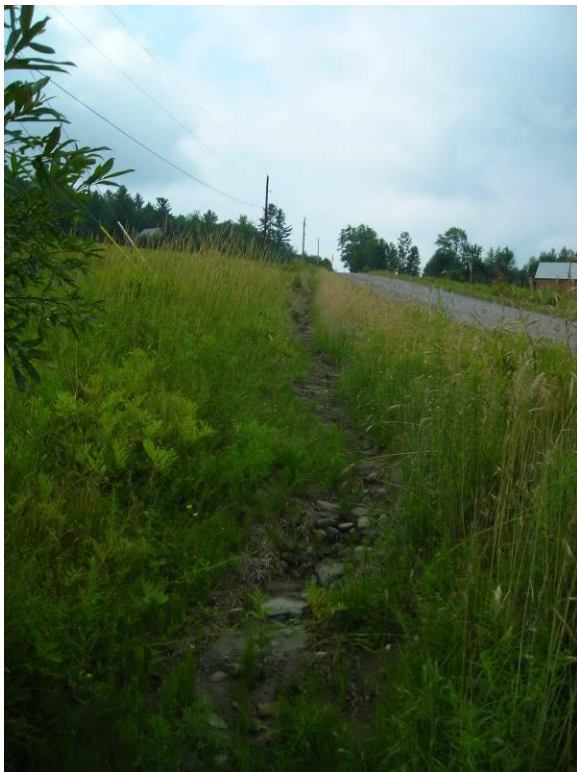
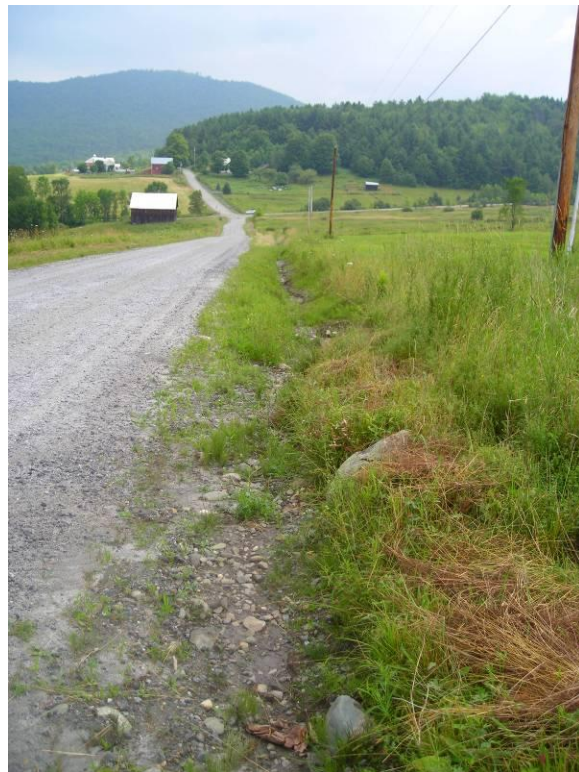
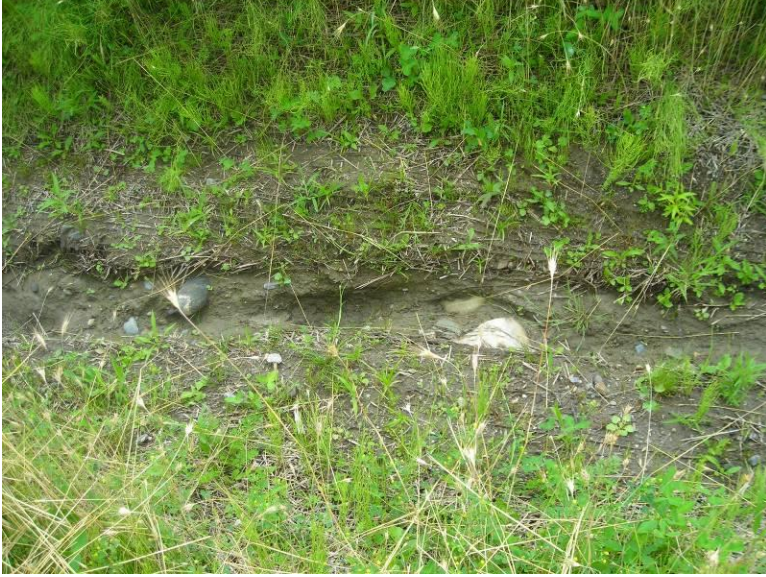
## Erosion site 2

Location – 600 feet of road shoulder erosion along Jacobs Rd 0.2 miles west of Horn of the Moon Rd in East Montpelier, VT

- Add 3-4 new cross culverts above existing culvert
- Add stone aprons at outlets of new culverts and existing culvert
- Install headers and footers on all new culverts and existing culvert
- Improve ditch moving it closer to the road
- Improve ditch by stone lining for length of erosion about 600 ft
- Replace existing culvert if undersized for location.

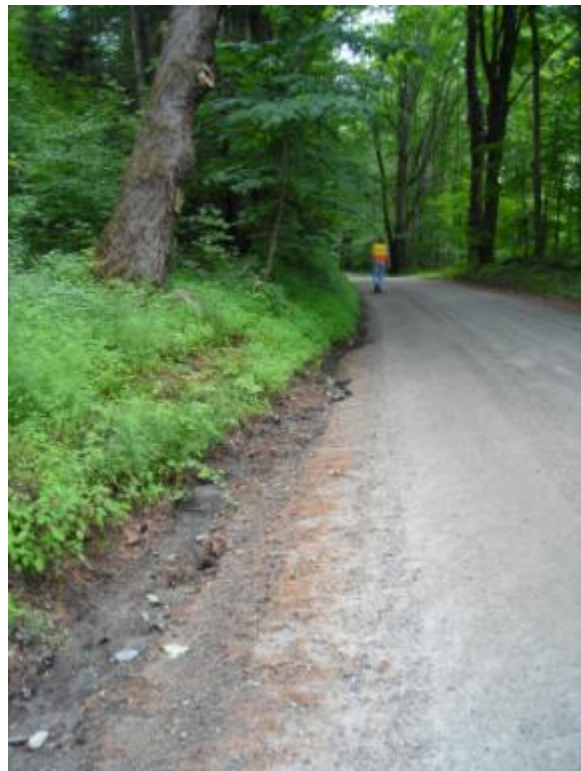
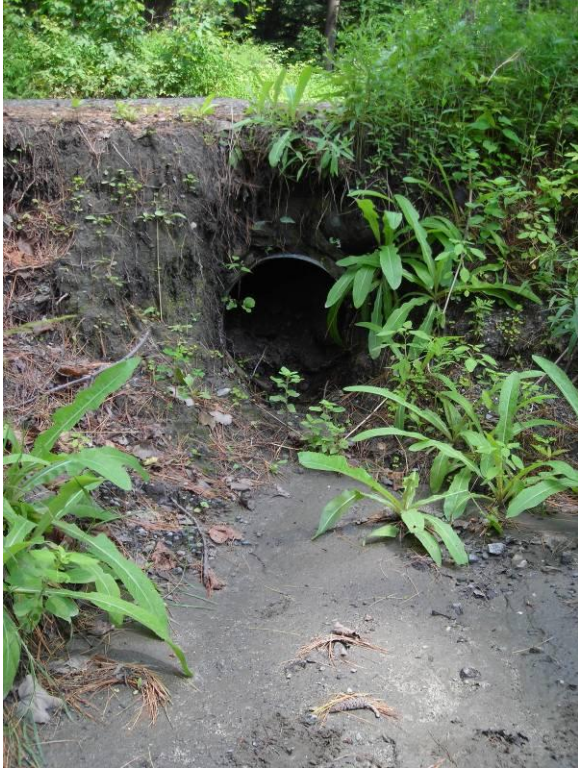
**Erosion site 3** - Good site for Better Back Roads Grant (combined with site 4)

Location – 370 feet of road shoulder erosion along Horn of the Moon Rd 0.58 miles south of Sanders Circle in East Montpelier, VT

- Add 1-2 new cross culverts above existing culvert
- Add stone aprons at outlets of new culverts and existing culvert
- Install headers and footers on all new culverts and existing culvert
- Improve ditch by stone line for length of erosion about 300 ft
- Replace existing culvert if undersized for location.

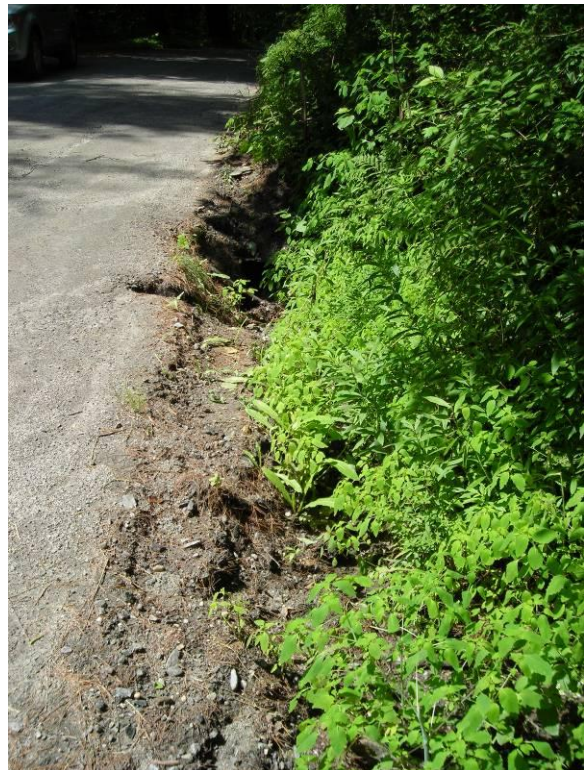
**Erosion site 4** - Good site for Better Back Roads Grant (combined with site 3)

Location – 230 feet of road shoulder and ditch erosion along Horn of the Moon Rd 0.5 miles south of Sanders Circle in East Montpelier, VT

- Add 1-2 new cross culverts above existing culvert
- Add stone aprons at outlets of new culverts and existing culvert
- Install headers and footers on all new culverts and existing culvert
- Improve ditch by stone line for length of erosion about 230 ft
- Replace existing culvert if undersized for location.

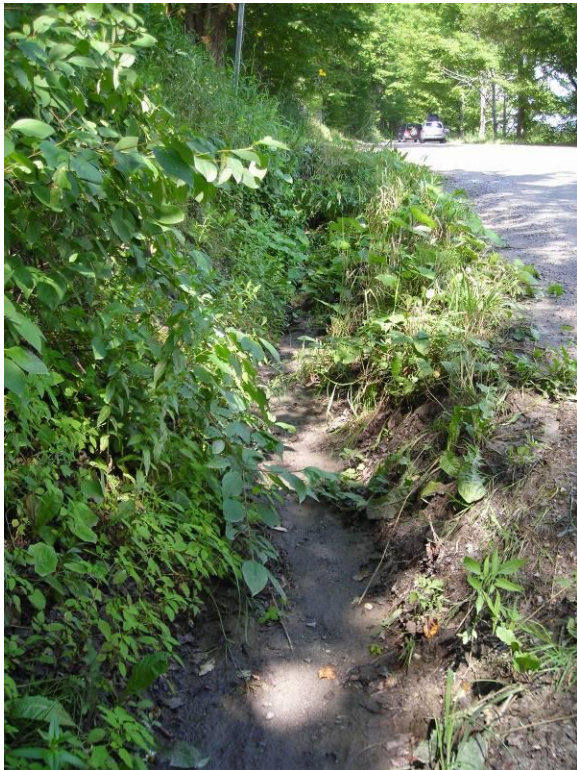
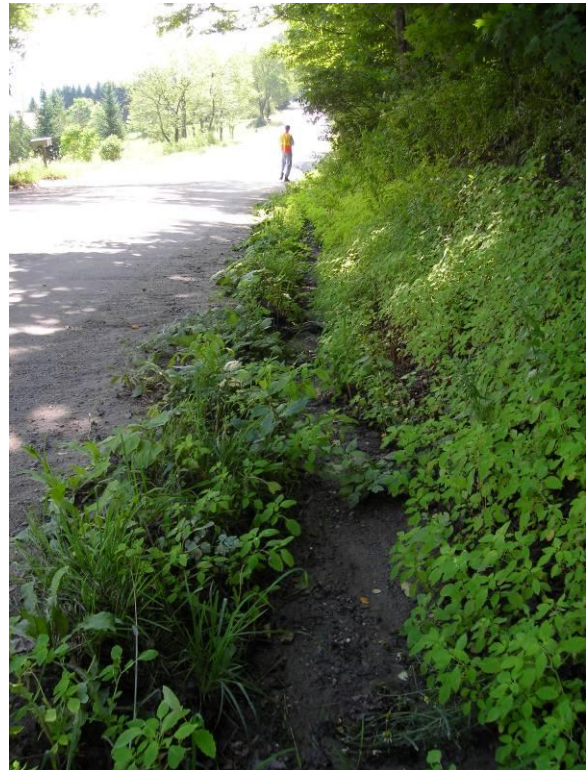
### Erosion site 5

Location – 130 feet of ditch erosion along Lyle Young Rd 0.22 miles east of Center Rd (just below Rock Rd) in East Montpelier, VT.

- Improve driveway culvert above ditch
- Improve ditch by stone line for length of erosion about 130 ft
- Replace existing culvert if undersized for location.

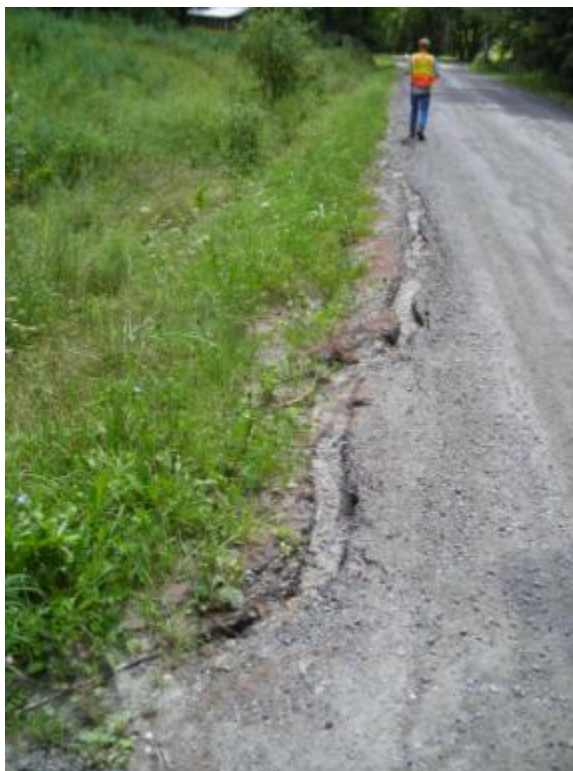
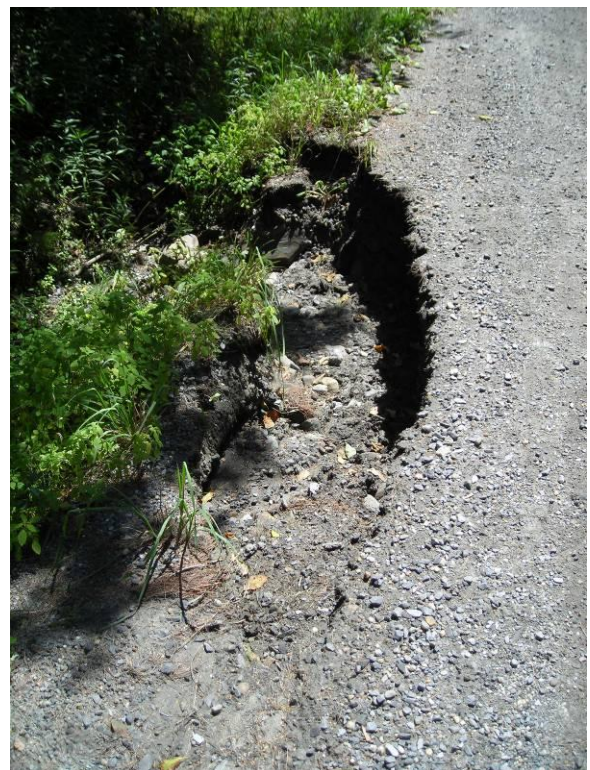
## Erosion site 5 and 6

Location – 200 feet of roadway shoulder erosion on Bolduc Rd 290 feet north of Dolan Rd in Middlesex, VT.

- Add turn outs above driveway
- Add turnout on driveway before entering road
- Improve ditch by bringing it closer to road edge
- Replace existing culvert at location.

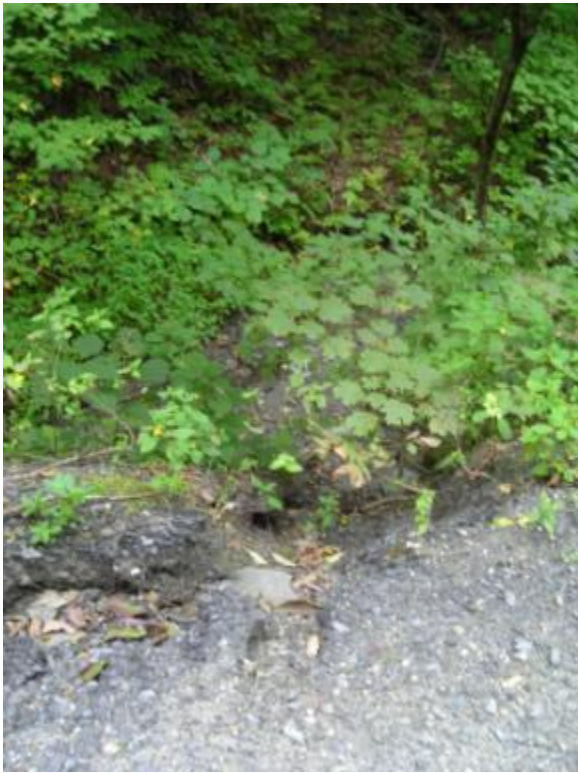
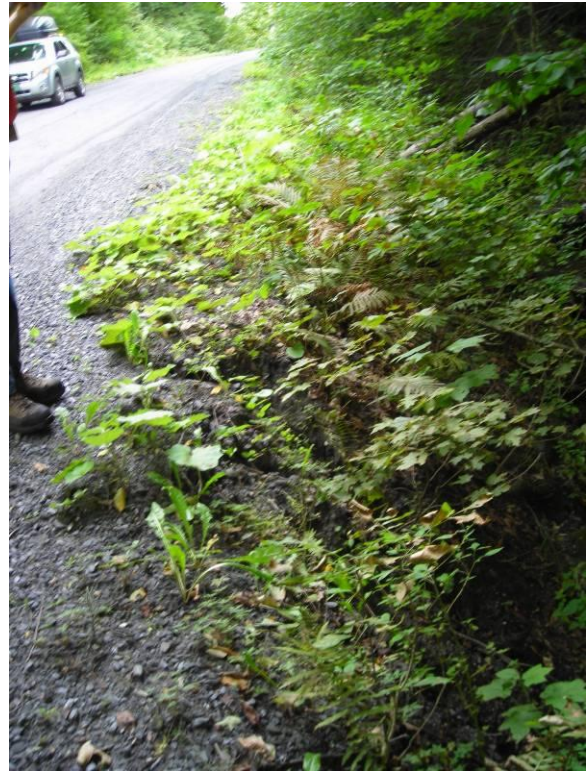
## **Erosion site 2 and 6 – Good sites for Better Back Roads grant**

Location – 5 roadway shoulder erosion sites on County Rd 300 feet north of Log Town Rd in Woodbury, VT.

- Improve ditch on opposite side of road from erosion sites and stone line for about 400 ft
- Regrade road to shed water toward new ditch
- Replace existing culverts at location

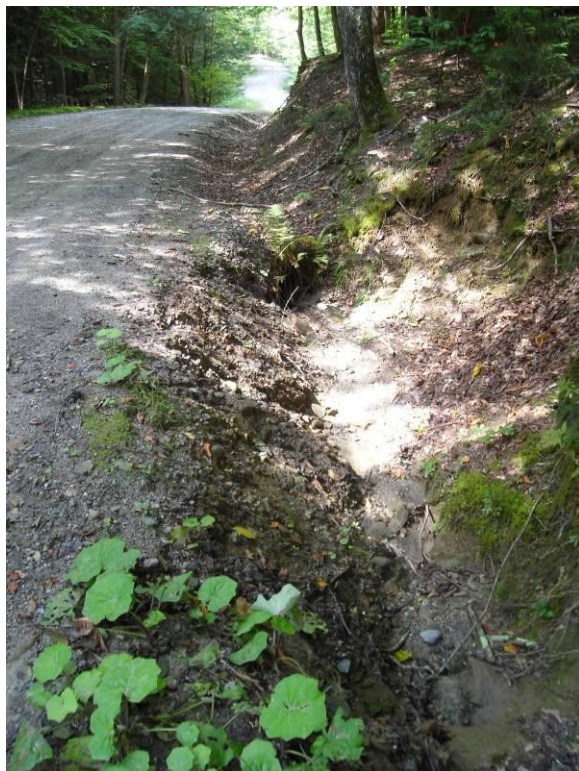
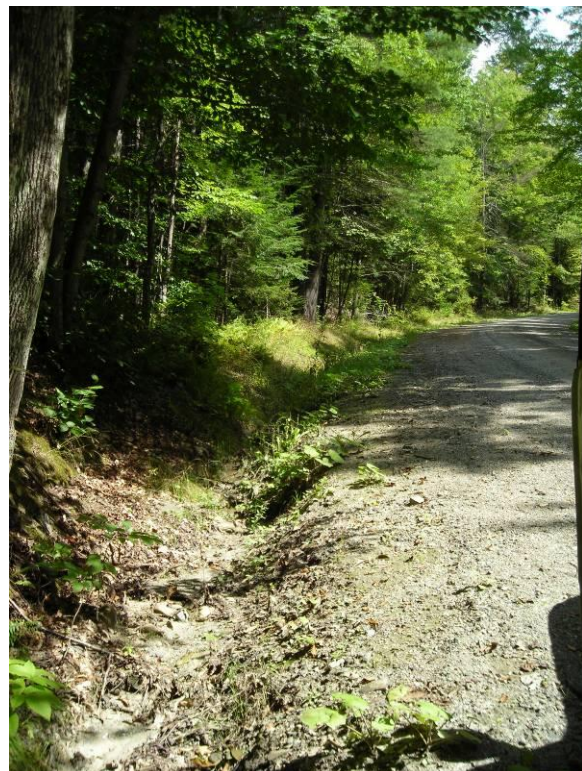
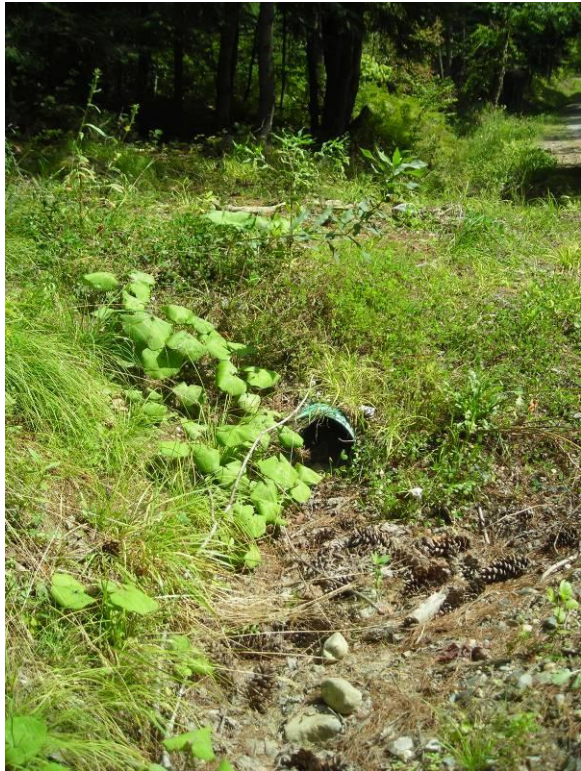
## Erosion site 2-

Location – 325 feet of ditch erosion on Harris Hill Rd 0.33 miles north of Eagle Ledge Rd in Worcester, VT.

- Add 1-2 new cross culverts above existing culvert
- Add stone aprons at outlets of new culverts and existing culvert
- Install headers and footers on all new culverts and existing culvert
- Improve ditch by stone lining for length of erosion about 325 ft
- Replace existing culvert if undersized for location.

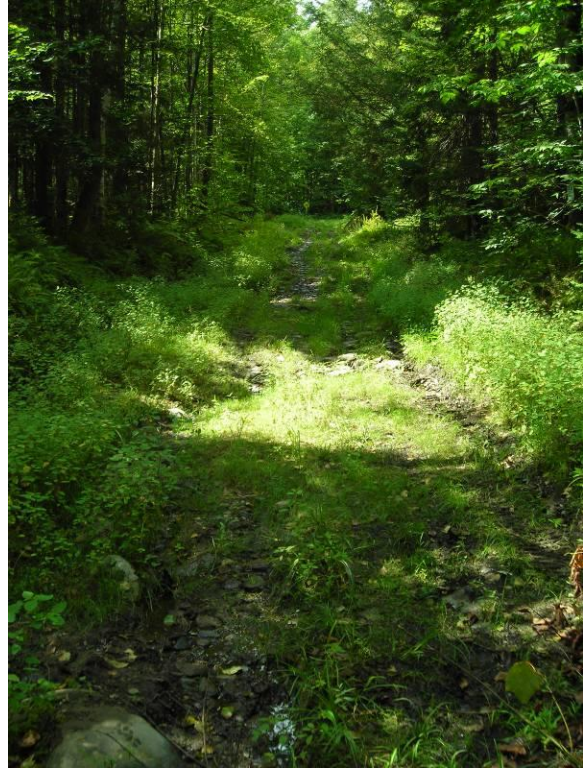
## Erosion site 5

Location – 745 feet of road ditch erosion on Downs Rd (Class 4) 1.36 miles west of Elmore Rd (Route 12) in Worcester, VT.

- Sunken road bed needs to be built back up
- Add 3-4 new culverts if possible
- Add water bars in roadway if culverts are not possible
- Add stone aprons at outlets of new culverts and existing culvert
- Install headers and footers on all new culverts and existing culvert
- Add turnouts along roadway where culverts are not possible
- Stone line turnout apron
- Improve ditch by stone lining for length of erosion about 745 ft
- Replace existing culverts if undersized for location.
