Landslide Hazard Analysis of the Great Brook Watershed, Plainfield, Vermont

George Springston and Ethan Thomas
Norwich University Department of Geology and Environmental Science
108 Harmon Drive
Northfield, VT 05663
802-485-2734
gsprings@norwich.edu

Revised, March 17, 2014

Prepared for
Central Vermont Regional Planning Commission
29 Main Street, Suite 4
Montpelier, VT 05602

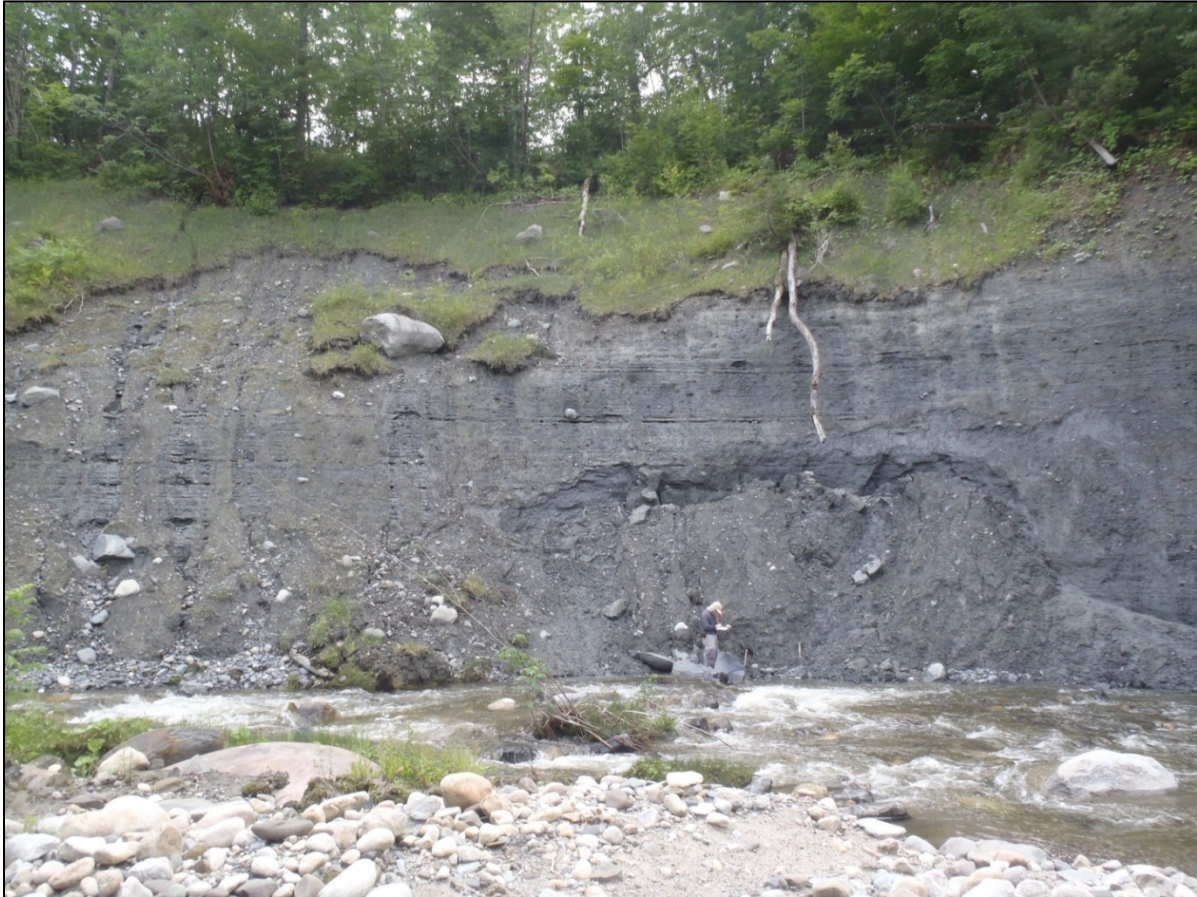
On the cover: Large landslide at Site GB-3 on Great Brook near Plainfield Village. George Springston, July 11, 2013.

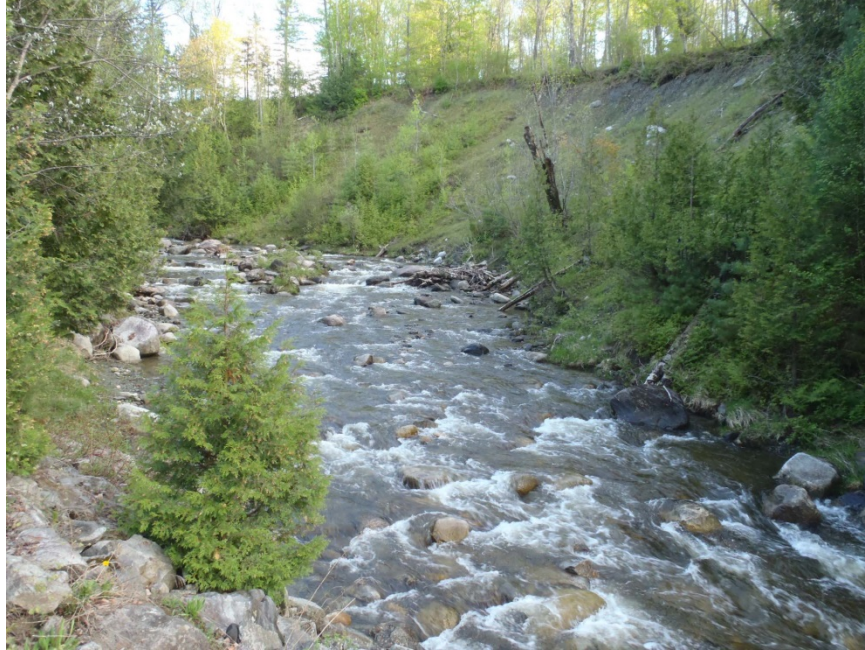
Site GB-3 is one of a pair of very large landslides near the bottom of the watershed. Both are on the outside of meander bends and both had been undergoing active slope failure in the years prior to the studies of Barg and Springston (2001a) and Springston and Barg (2001).

Before those studies, the last major erosion event was probably the flood of either 1989 or 1990. Figure 7a shows the site as it was just prior to the May, 2011 flood. In the years between 2001 and 2011, much of the 105 foot (32 meter) slope had begun to revegetate, but the May 2011 flood caused heavy erosion at the base and undercut the slope at the downstream end of the landslide. The over-steepening of the lower slopes (probably combined with high pore-water pressures in the surficial material) resulted in renewed translational sliding.

Figure 7a. Site GB-3 on May 18, 2011, prior to the May 26-27 flood. No major landslide activity had occurred at this site since the 1989 or 1990 floods and although some bare soil was visible in the upper parts of the downstream portions, the slope was beginning to revegetate.

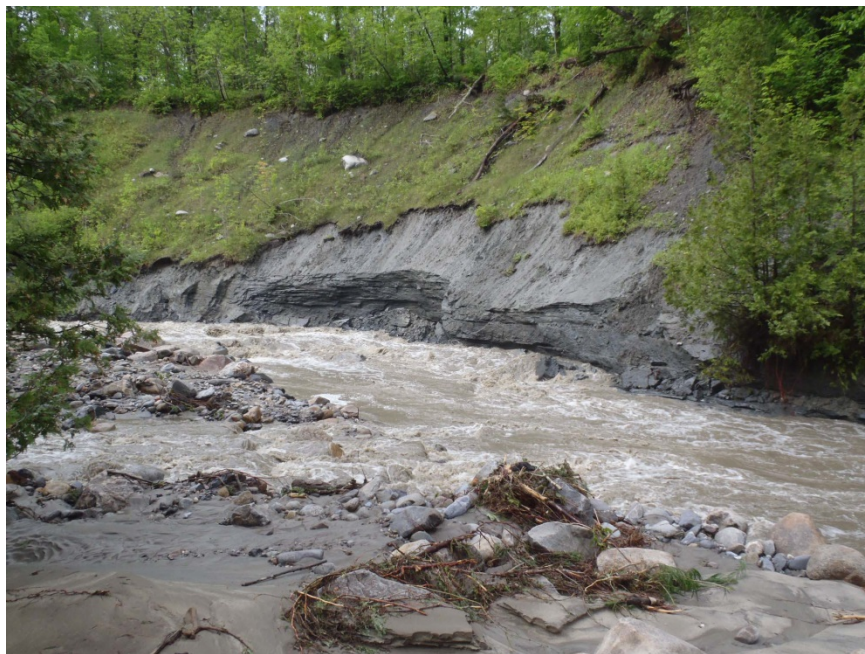
Figure 7b. Site GB-3 on May 27, 2011, the morning after the May flood. The brook is receding from the peak flow, but is still high and turbid. The base of the slide has been scoured and dramatically undercut and translational slides have removed material from the main face.

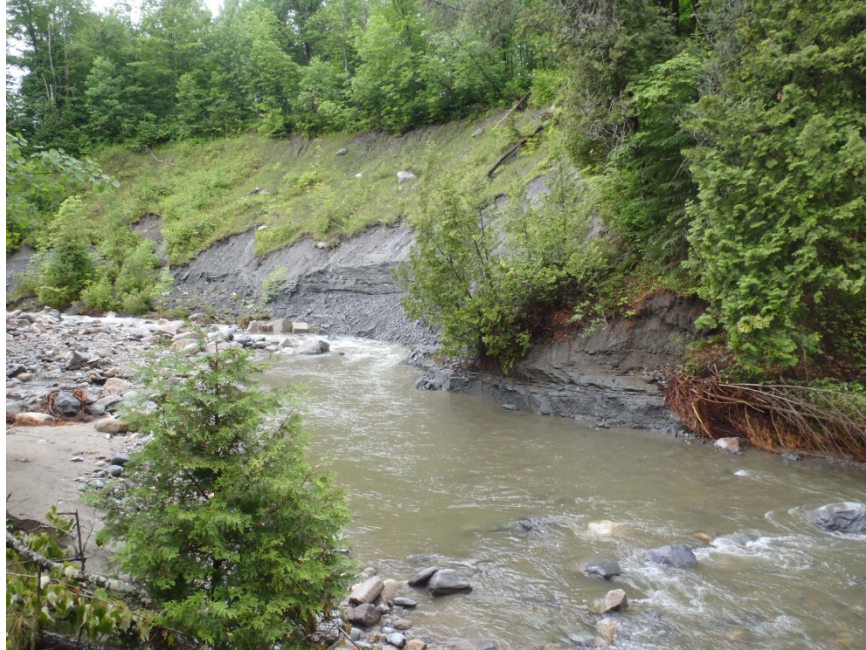
Figure 7c. Site GB-3 on June 13, 2011. The water level has receded and the scoured base is clearly visible. Additional vegetated sections have slid off of the main face and slumped material is accumulating at the base.

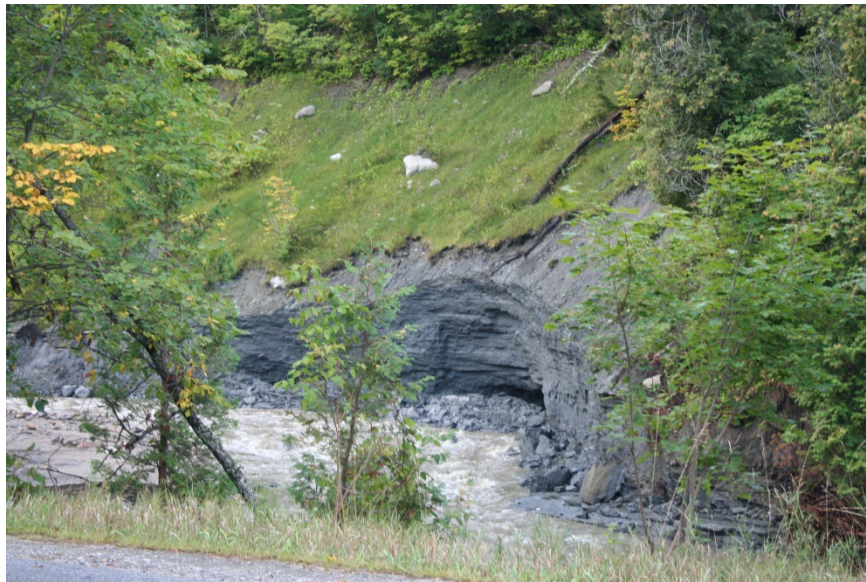
Figure 7d. Site GB-3 on August 29, 2011, one day after the peak flow from Irene. The toe deposits have been scoured away and some new scour and undercutting has occurred at the base. Photo courtesy of Bram Towbin.

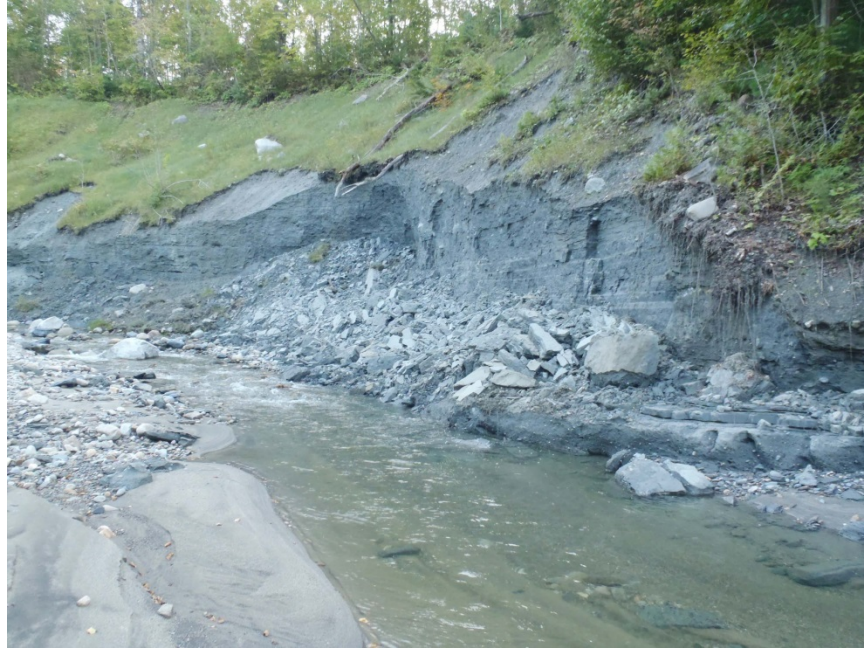
Figure 7e. Site GB-3 on September 14, 2011, two weeks after Irene. Additional collapse of the greatly over-steepened base has occurred and new material has slid off of the main slope.

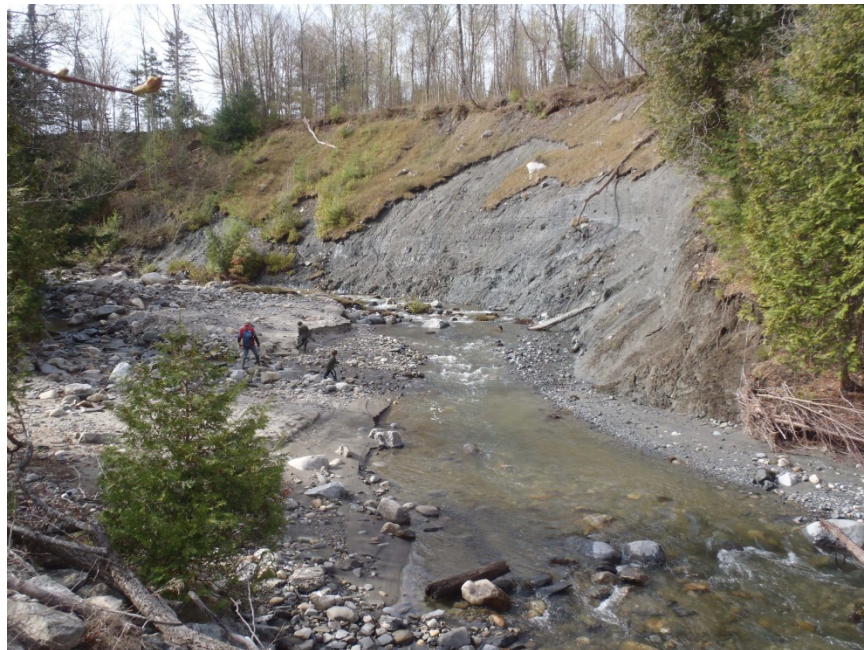
Figure 7f. Site GB-3 on April 26, 2012. Over the course of the winter and early spring the toe deposits have built up, covering over the over-steepened base and material has continued to slide off of the main face.

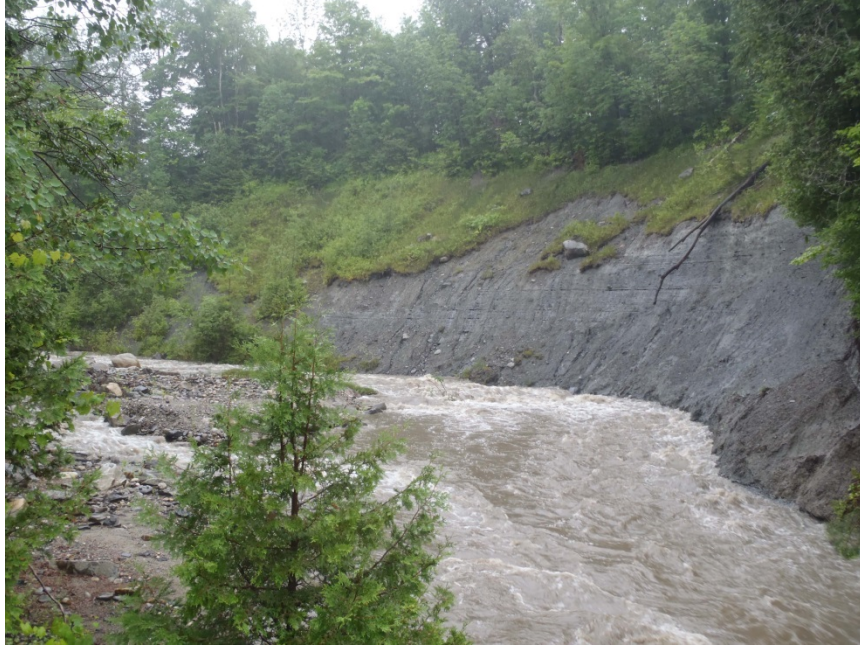
Figure 7g. Site GB-3 on July 2, 2013. High flows in June and early July led to renewed scour at the base and translational slides off of the main face.

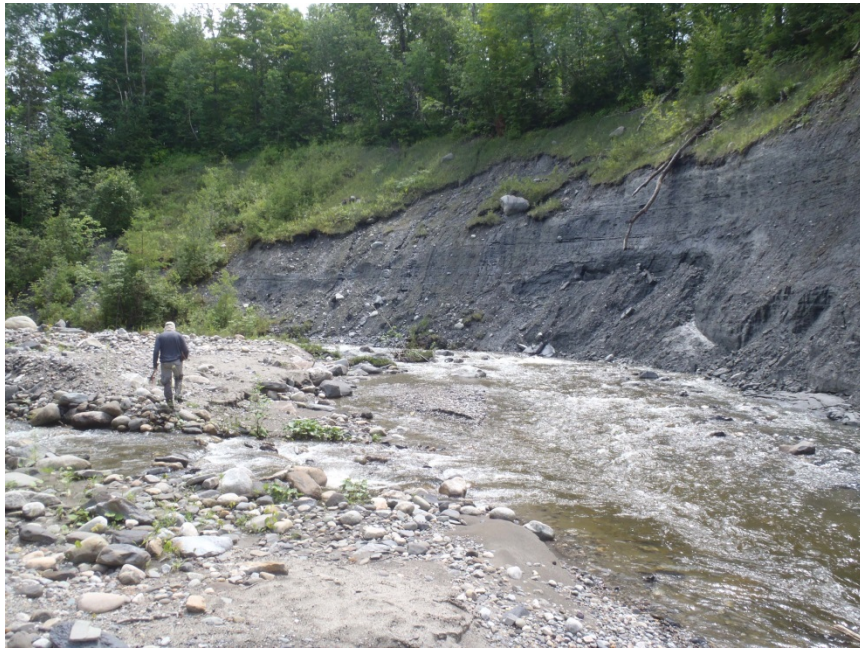
Figure 7h. Site GB-3 on July 11, 2013. The waters have receded and the fresh toe deposits have partially collapsed.

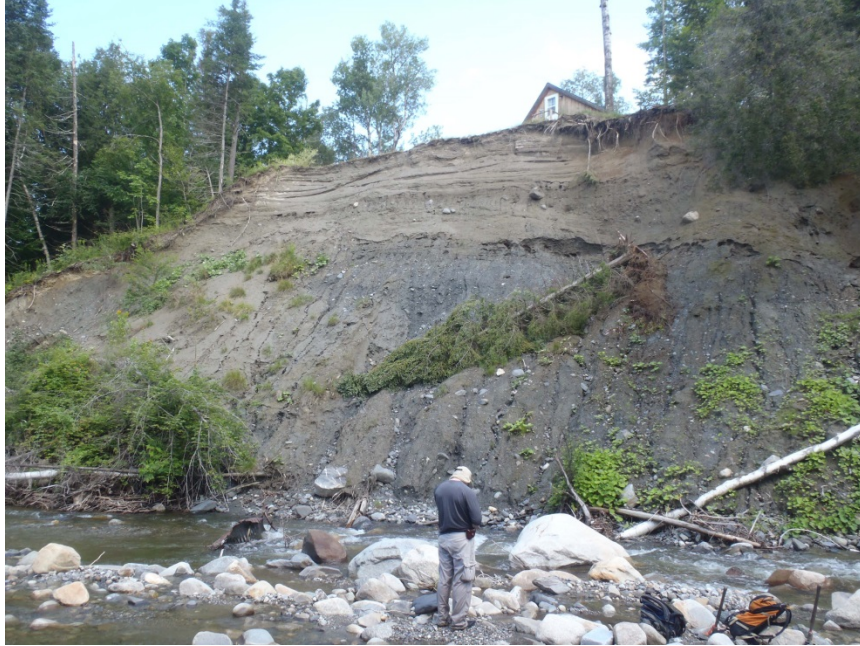
Site GB-1025 is on the outside of a meander bend and has been the site of ongoing slope instability for many years. At the time of the field work in 2000 this was an active landslide. Since that time a house and garage have been built on the terrace a short distance back from the landslide and the slope has continued to fail (Figures 8a and b). The site is underlain by 18.0 feet (5.5 meters) of lacustrine, medium to fine sand over 8.9 feet (2.7 meters) of laminated silty clay and medium to fine sand over about 29.8 feet (9.1 meters) of dense, silt-matrix till. The over-steepened condition, the erodible materials, and the position on the outside of the meander bend make it highly likely that this slope will continue to fail and thus put the house and garage at greater and greater risk.

Figure 8a. Site GB-1025. Active landslide on right bank. Lacustrine sand, silt, and silty clay over dense gray till. Note roof of garage visible just beyond top of landslide. Photo taken July 29, 2013.

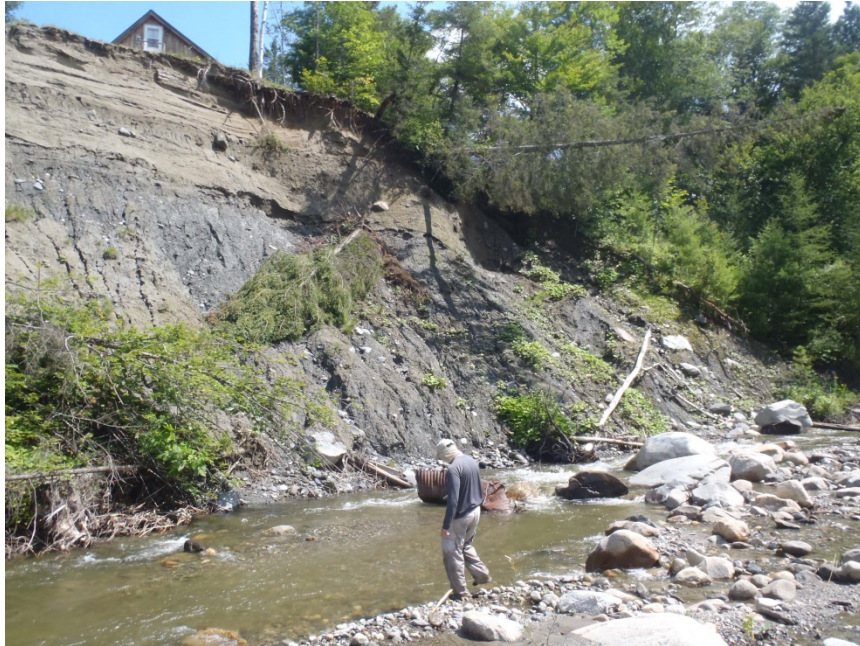
Figure 8b. Site GB-1025 looking downstream and across. Note trees toppling over at top. Photo taken July 29, 2013.

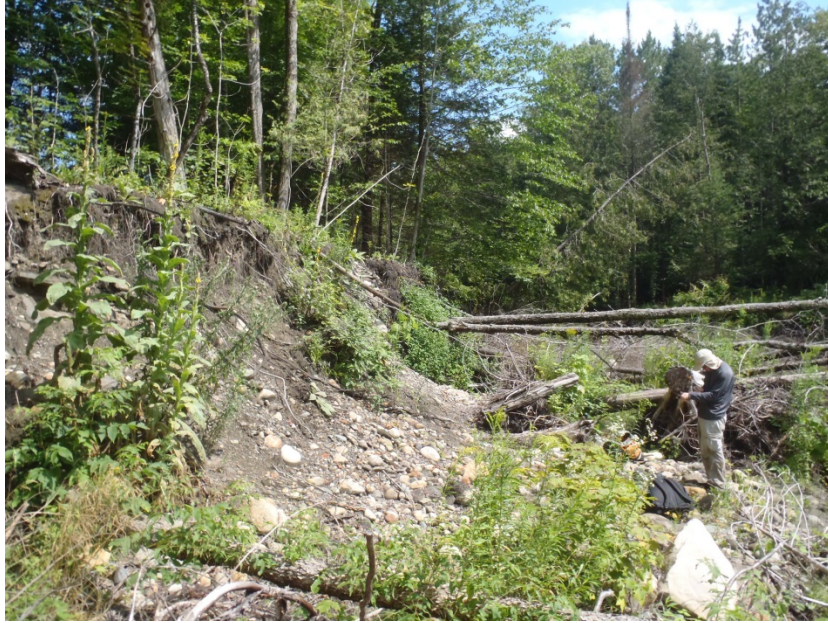
A typical slope failure in stream terrace deposits is located at Site GB-1023 (Figure 9a). The 10 foot (3.3 meter) section consists of loose boulder-cobble-pebble gravel overlain by loose, sandy pebble-cobble gravel. Figure 9b shows a similar exposure at Site GB-1027. The surficial materials at these sites were deposited by Great Brook at some time in the recent past. Given the extensive channel incision documented in this study and the earlier study by Barg and Springston (2001a), it is likely that the tops of these terraces represented the active floodplain of the brook sometime in the 20th Century (perhaps as recently as the 1960s).

Figure 9a. Site GB-1023 looking downstream. Typical exposure of coarse-grained stream terrace deposits on outside of bend. Material failed during high stream flows of 2011, primarily by singe-grain detachment. Photo taken July 29, 2013.

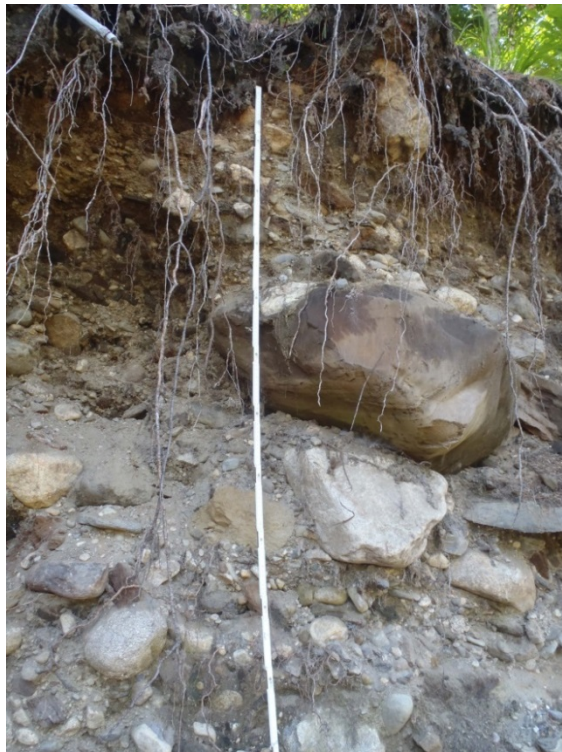
Figure 9b. Closeup of stream terrace deposits at Site GB-1027. Boulder-cobble-pebble gravel in lower part is overlain by sandy pebble-cobble gravel. Similar to material at GB-1023 but coarser-grained. Photo taken July 29, 2013.

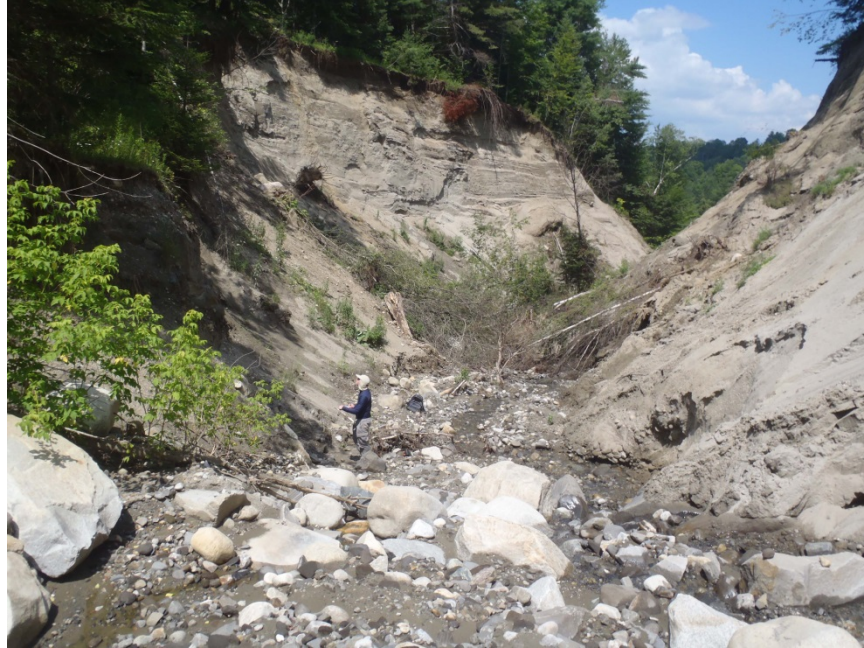
Figures 10a and b show one of the sites within the extensive MacLaren-Fowler landslide-gully complex. The stratigraphic section at Site GB-1010 consists of over 70 feet (21 meters) of ice-contact sands and possible silt with lenses of pebble gravel (Table 2). The intermittent stream that flows in the bottom of this gully is actively incising into the bed and cutting laterally into the sand deposits, resulting in ongoing slope failures. The eroded sand is easily transported downstream to Great Brook and contributes a very heavy load of fine sediment to the brook.

Figure 10a. Site GB-1010. Looking down gully on July 16, 2013. This is part of the large MacLaren-Fowler gully system, which has developed in ice-contact sands.

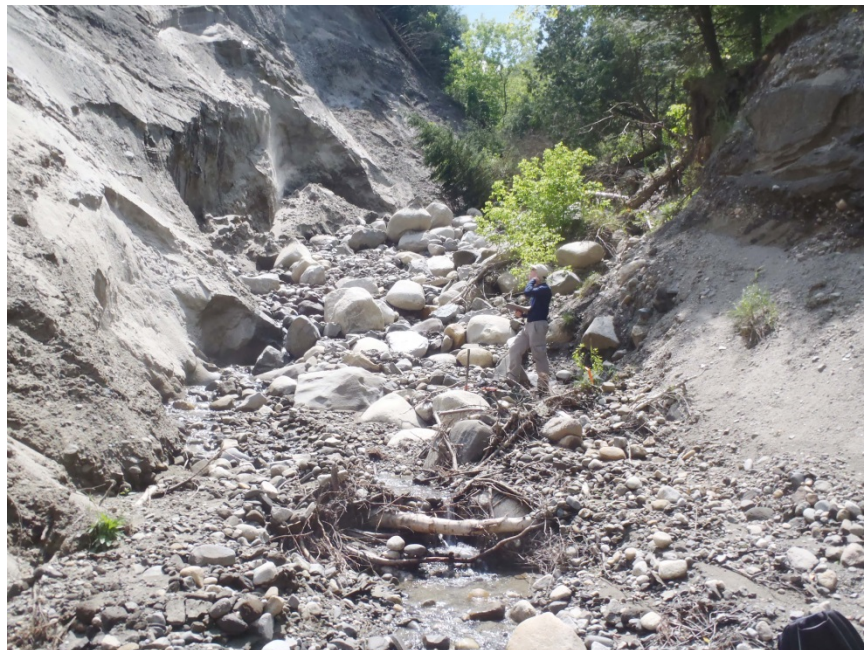
Figure 10b. Site GB-1010 looking upstream. Headcuts are actively incising the valley bottom, the bases of the slopes are being undercut, and the side walls are continuously collapsing into the gully bottom. Some of the boulders in the channel have fallen in from gravel lenses within the ice-contact deposits exposed in the side walls while others have probably washed down from till exposures near the head of the gully.

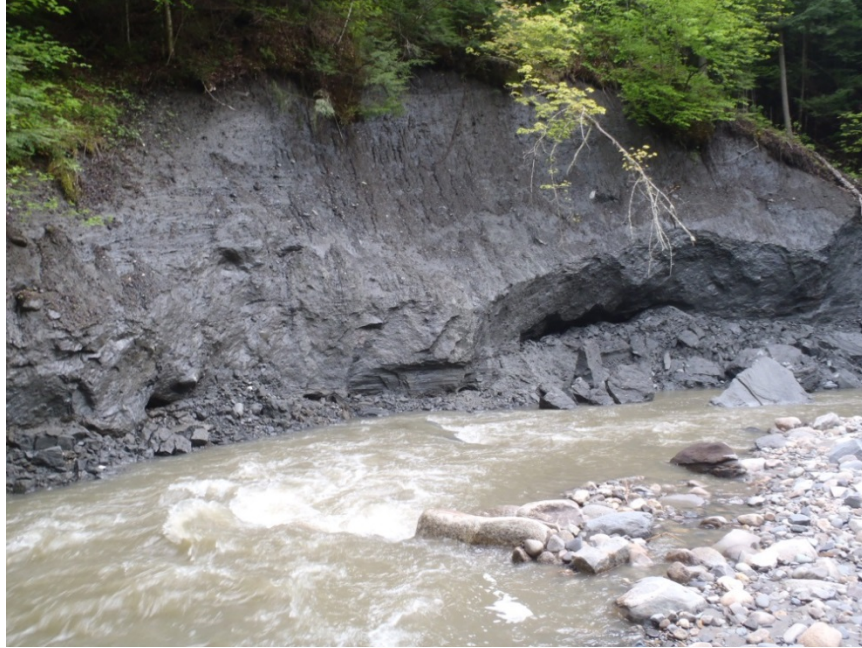
Figure 11a. Site GB-1032 on May 29, 2011, two days after the May 26-27 flood. Dense till has been heavily eroded at the base, leading to the prominent overhang seen at right. Although this has been an active landslide for many years, no overhang was present prior to this flood. Note the angular blocks of till below the overhang and the large gray block of till in the brook.

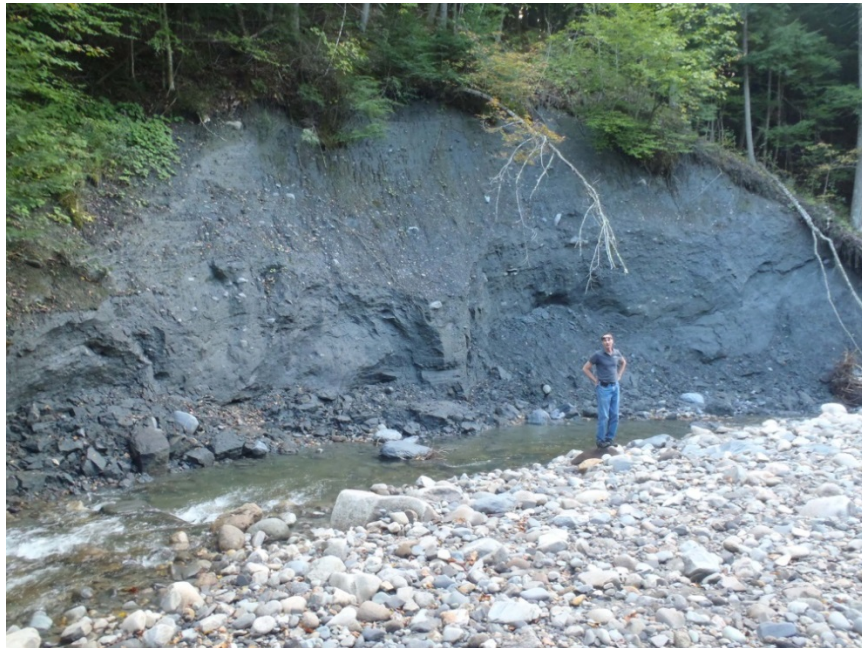
Figure 11b. Site GB-1032 on September 14, 2011, about two weeks after Irene. Additional scour has occurred at the base, leading to the breaking off of irregular blocks from the over-steepened slope. Slumped material is accumulating at the base.

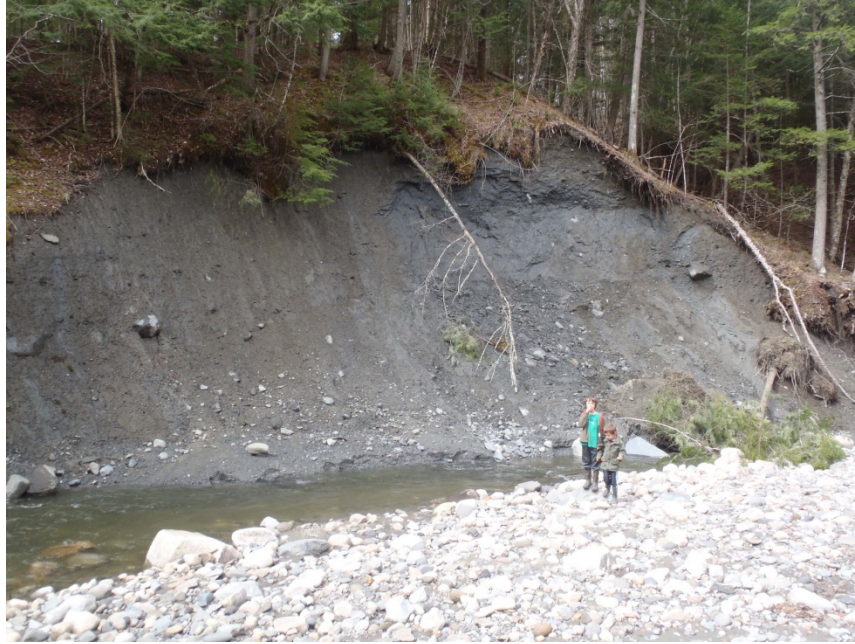
Figure 11c. Site GB-1032 on April 26, 2012. Additional material has slumped down from above.

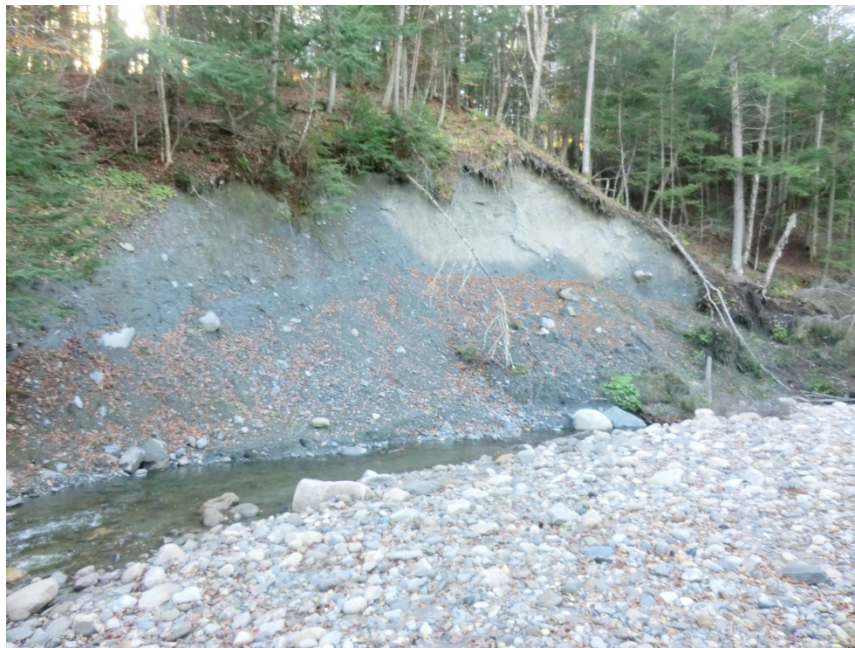
Figure 11d. Site GB-1032 on October 18, 2012. Additional slumping has occurred. Photo courtesy of Bear Creek Environmental.

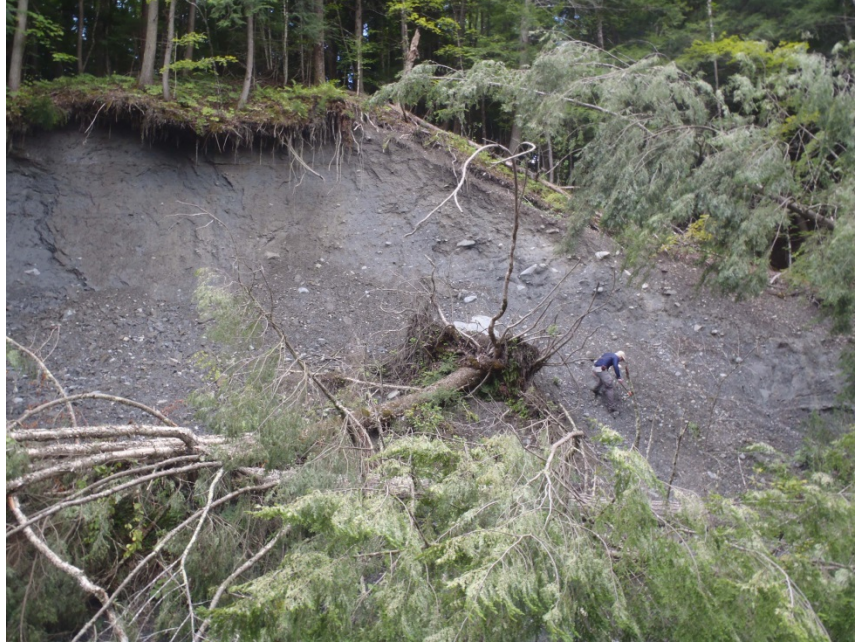
Figure 11e. Site GB-1032 on July 30, 2013. Slumping has continued and trees with roots have toppled out onto and down the slope.

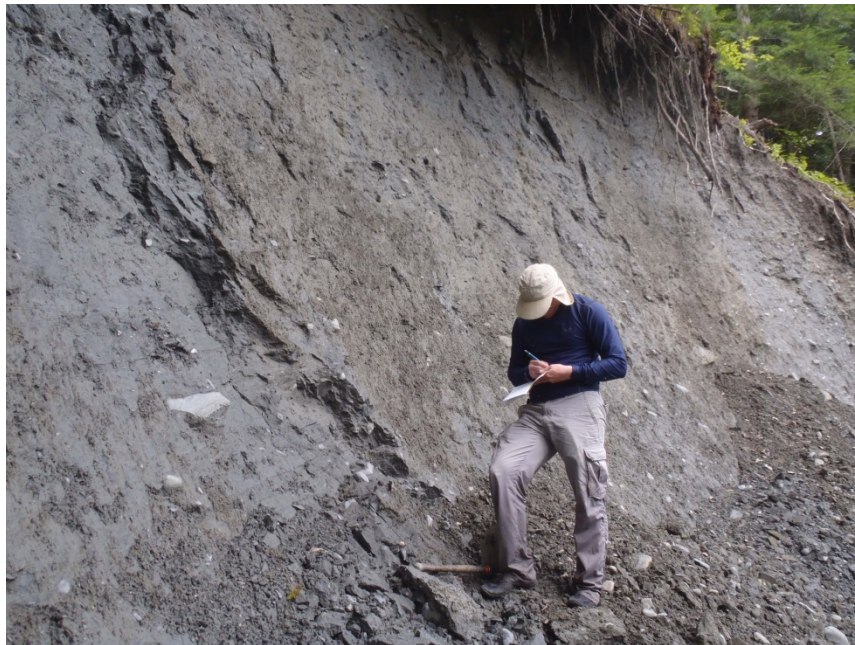
Figure 11f. Upper face at Site GB-1032 on July 30, 2013. Thin slabs of dense till are breaking off parallel to the face. This jointing parallel to the face of the landslide is apparently due to weathering.

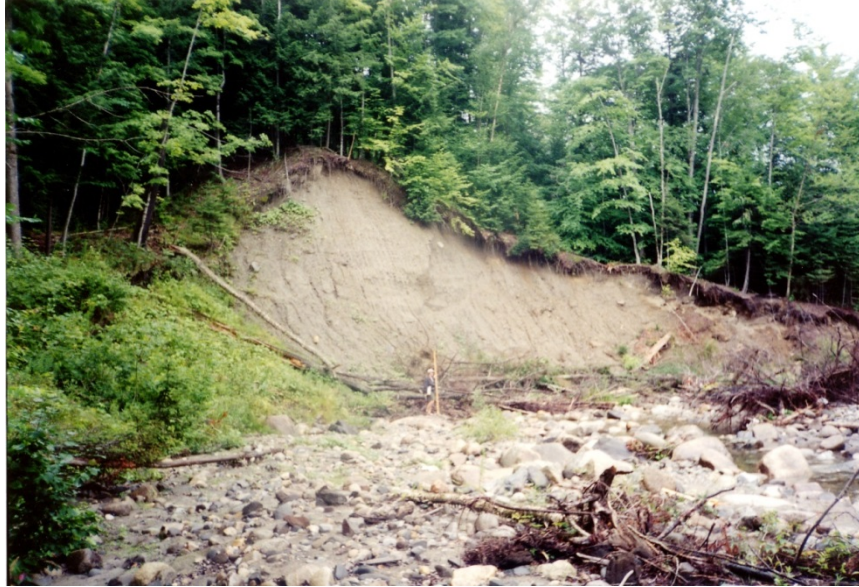
Site GB-1036, also on the outside of a meander bend, has been the site of ongoing slope instability for many years. Figures 12a through f show how the site has changed since 2000. Following a long period of little change, slope instability accelerated during the 2011 floods, with slope failure mechanisms including fluvial shear at the base, translational sliding from the upper parts, toppling of the upper soil horizons and trees out onto the slope, and growth of the toe deposits as the upper slope fails back. In the future, the relatively loose toe deposits will probably be easily swept away by moderately high stream flows.

Figure 12a. Site GB-1036, summer, 2000. Last major erosion was probably during Hurricane Floyd in 1999. Photo courtesy of Lori Barg.

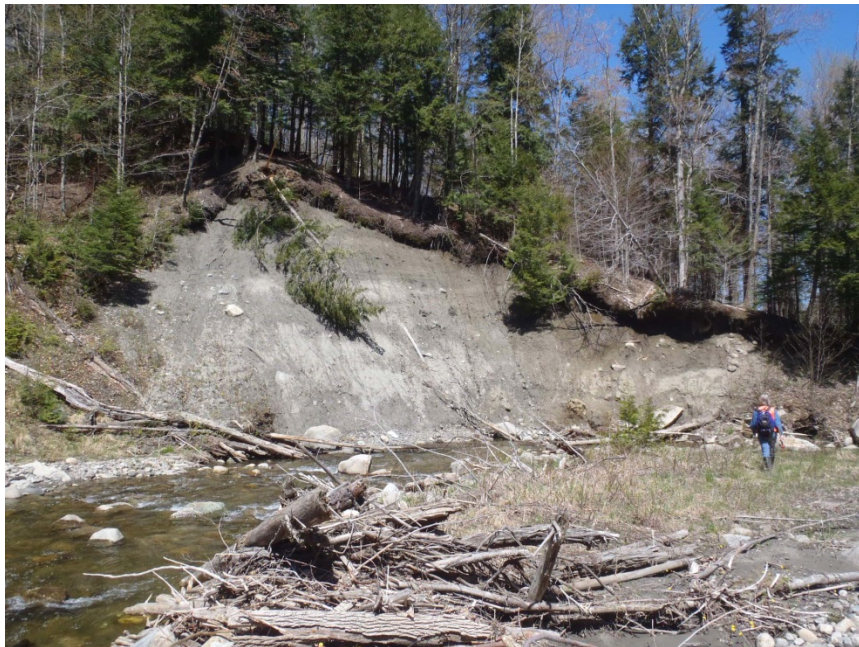
Figure 12b. Site GB-1036 on May 12, 2011, prior to the May 26-27 flood. Changes since the summer of 2000 appear to be modest.

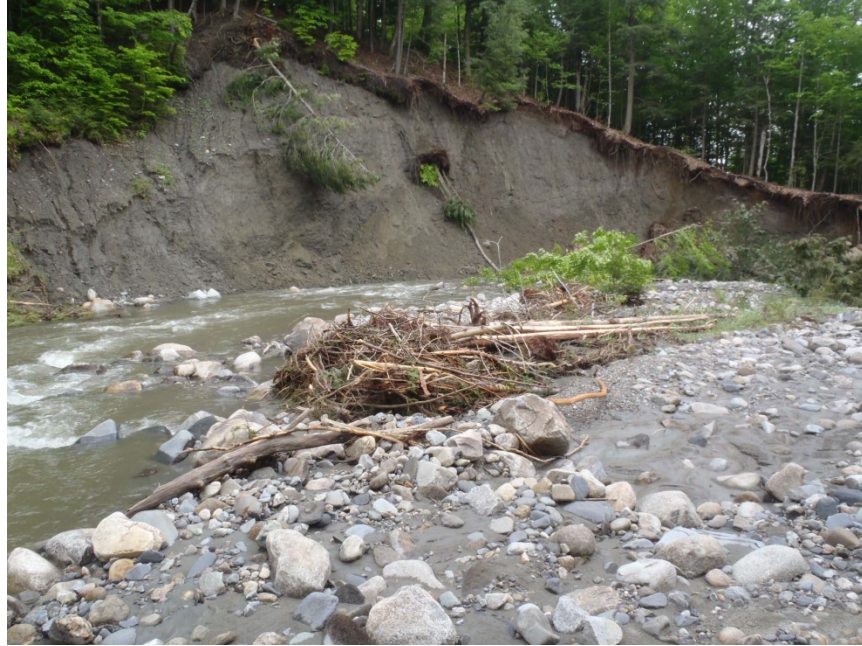
Figure 12c. Site GB-1036 on May 29, 2011, two days after the May flood. Heavy erosion at the base has resulted in translational slides and topples in the upper parts.

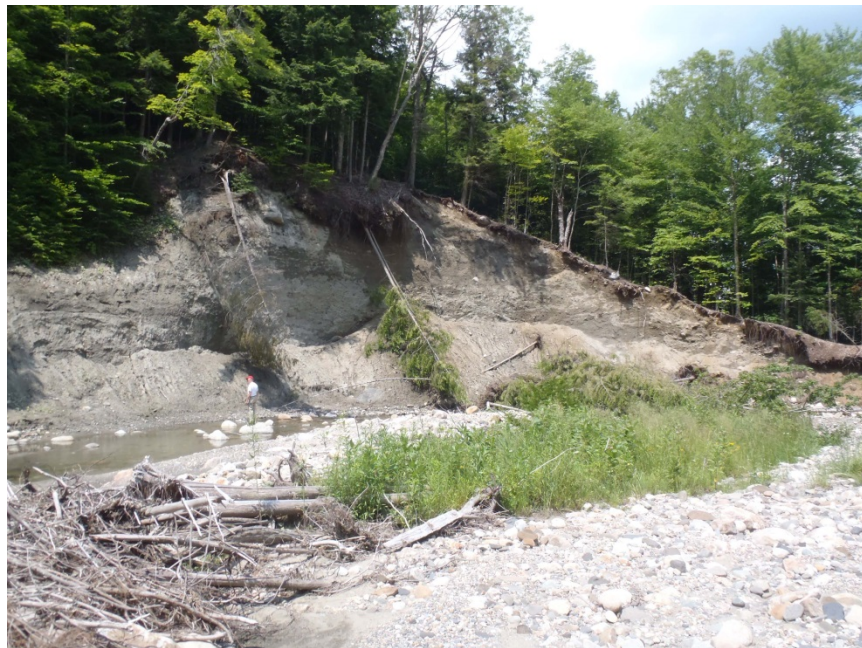
Figure 12d. Site GB-1036 on July 1, 2012. Note buildup of toe deposits at base.

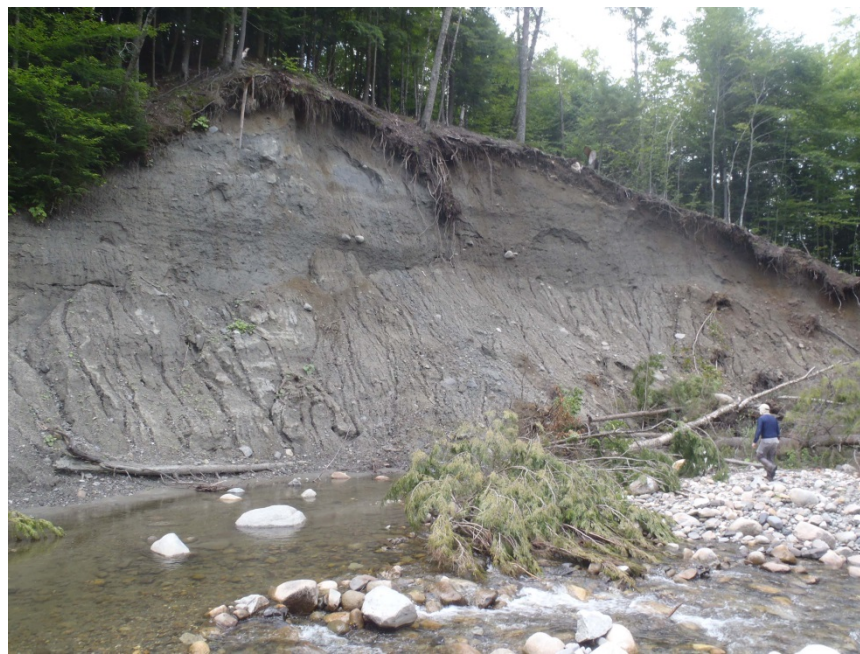
Figure 12f. Site GB-1036 on July 30, 2013. Note the continued buildup of toe deposits.

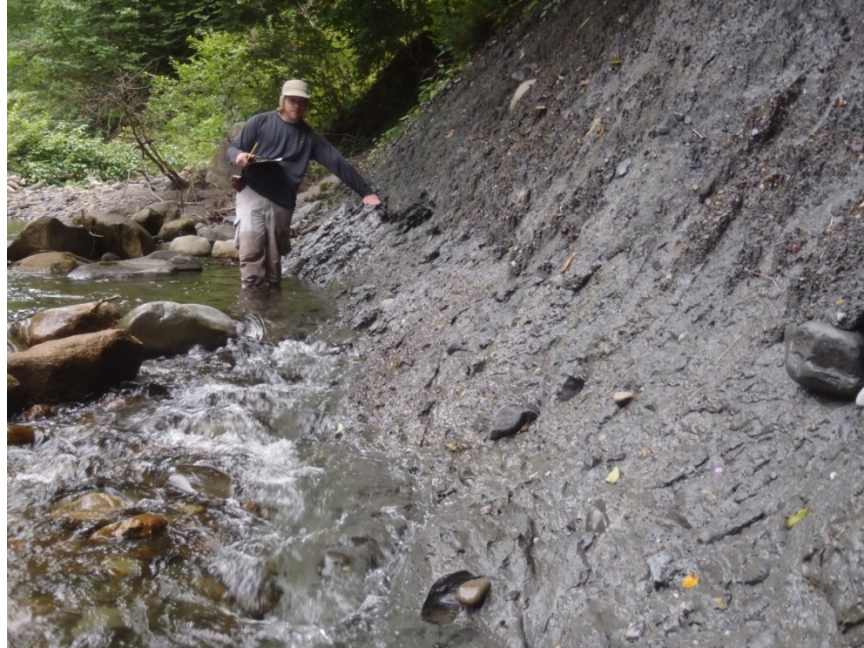
Figure 13a. Site GB-1044. Looking upstream at freshly scoured dense till (up to hand) on August 1, 2013. Although this landslide was active during the 2011 floods, the fresh scour shown in these photos appears to be from the high flows of June and early July, 2013.

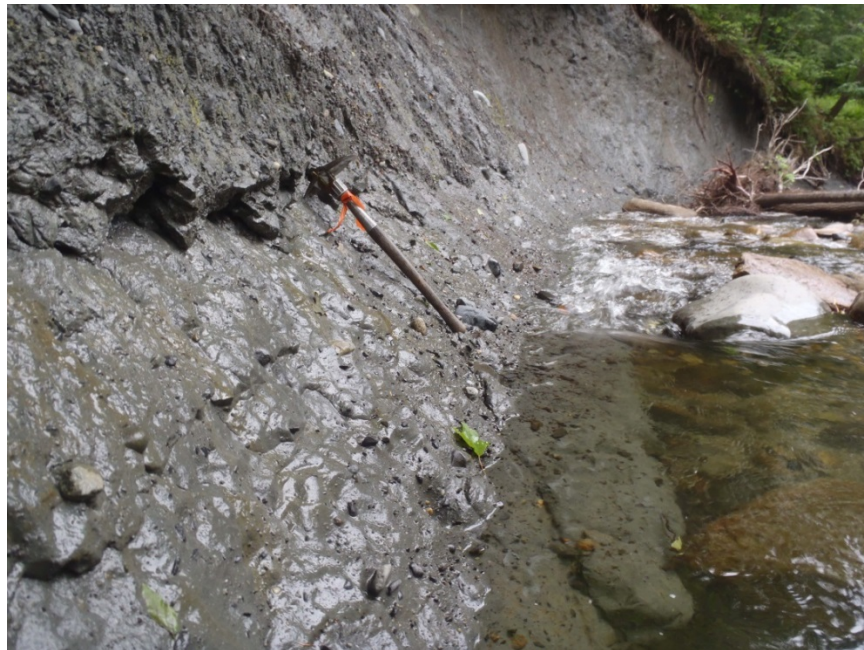
Figure 13b. Site GB-1044, looking downstream. Scour line at shovel head. Note fresh till visible below the water line. Removal of the material has occurred by irregular block detachment.
