Moretown, Vermont Phase 2 Stream Geomorphic Assessment & River Corridor Plan

April 20, 2018

Prepared by:
Bear Creek Environmental, LLC
149 State Street, Suite 3
Montpelier, Vermont 05602

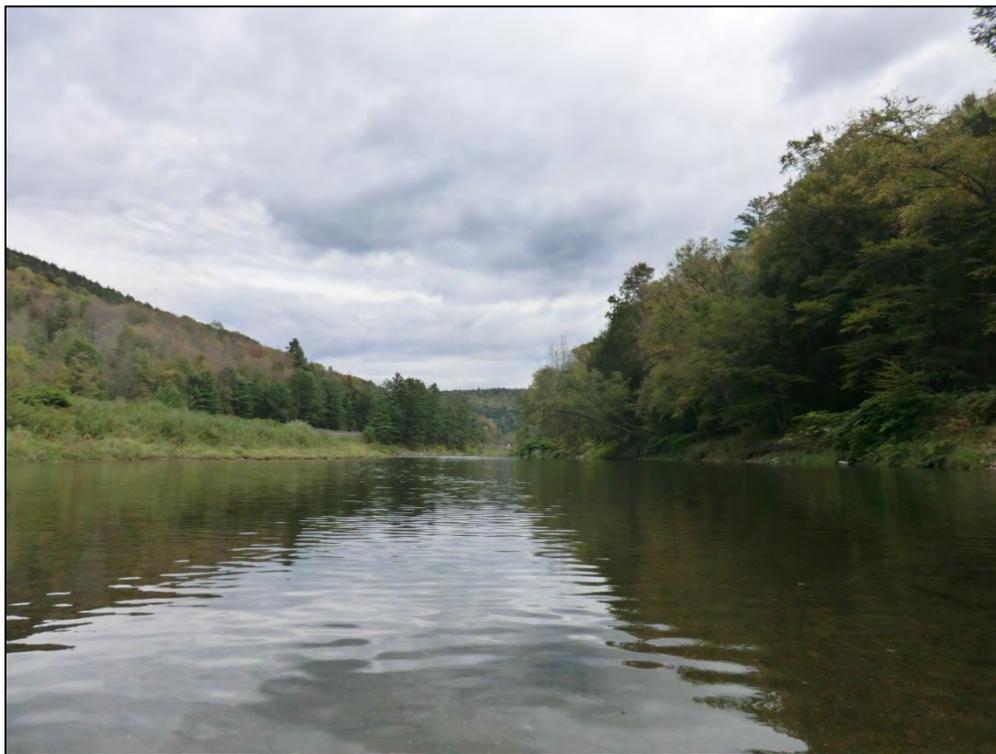
Reach 3 on the Mad River begins at the downstream end at the Moretown No. 8 hydroelectric dam and continues upstream to Kenneth Ward Park (Appendix C, Map 1). The reach is nearly 3,500 feet in length and the river flows along Vermont Route 100B. This reach was not segmented during the assessment. The Mad River in reach M03 is backwatered due to the presence of Moretown Dam No. 8 immediately downstream. For this reason, a full Phase 2 assessment could not be completed for M03. The river flows through a semi-confined valley in this reach. Impacts include a lacking riparian buffer due to the presence of RT 100B and stormwater inputs from the road. Bank armoring is present in some areas along RT 100B. Invasive Japanese knotweed is prevalent on both banks within this reach.

Figure 5.1. M03 looking downstream – impounded.

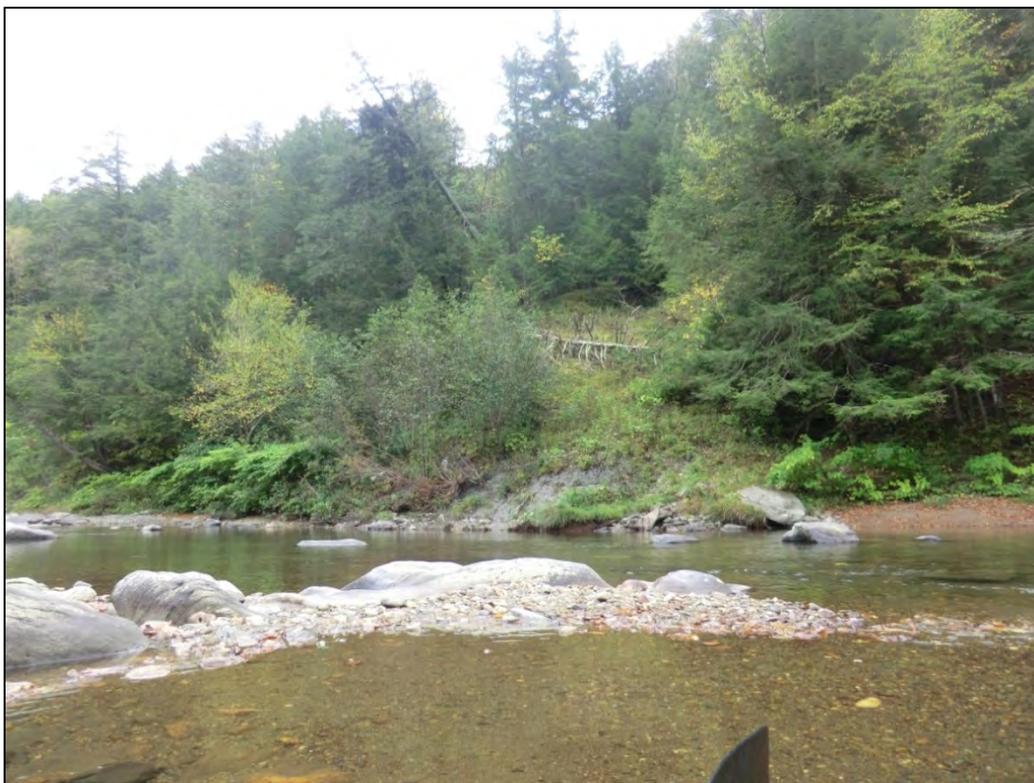
Reach 4 on the Mad River starts downstream at Kenneth Ward Park and continues upstream to just below the bridge on Bridge Road in Moretown (Appendix C, Map 2). The river flows along VT-100B, Spillway Road, as well as farms, houses, and forest for just over 9,000 feet. The river valley within M04 is semi-confined. This reach was not segmented during the Phase 2 assessment. The majority of the reach appears to have been historically straightened due to the presence of Route 100B and adjacent residential and agricultural land uses. This straightening led to minor historic incision; widening is possibly being prevented by bank armoring. Additional impacts in M04 include lacking buffer vegetation along the west side of the river due to the presence of VT-100B, houses, and farms, and several mass failures along the eastern valley wall. Bedrock is common on the bed in this reach, which may provide some vertical stability. M04 is in **good** geomorphic condition for these reasons. The reach is in **fair** habitat condition due to lacking large woody debris and bank and buffer vegetation on one bank.

Figure 5.2. Mass failures and bedrock are common in reach M04.

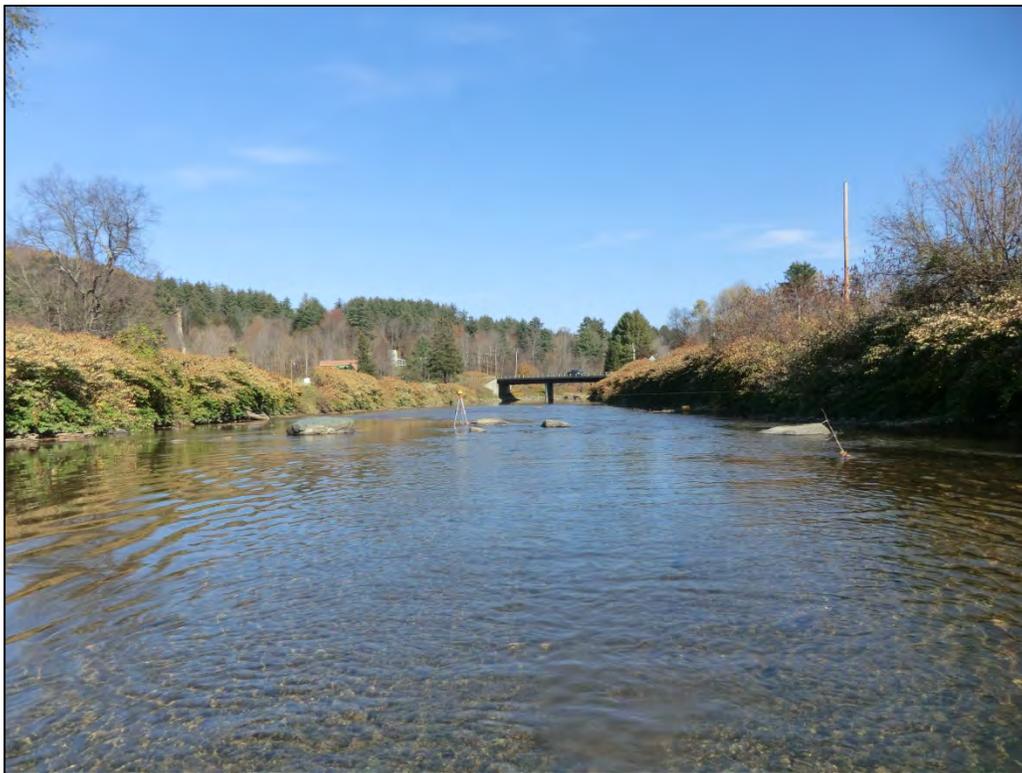
M06 is a 2,600 foot reach on the Mad River that begins roughly 600 feet downstream of the VT-100B bridge near Dickerson Road and ends 450 feet downstream of the Fletcher Road bridge (Appendix C, Map 3). This short reach flows through a broad valley, but due to the presence of 100B in the middle of the valley, the phase 2 valley type is semi-confined. The river for almost the entirety of this reach has been historically straightened due to the road and adjacent residential/agricultural land uses. Vegetation is lacking in the riparian buffers on both banks for most of the reach, and bank vegetation is dominated by invasive Japanese knotweed. Armoring is common along the east bank of the river, especially where it flows along 100B. Due to historic channel alterations, the river has undergone major incision in this reach, which has led to a stream type departure and loss of floodplain access. For this reason, M06 is in **fair** geomorphic condition. Similarly, M06 is in **fair** habitat condition, which is due to lacking large woody debris, poor instream cover for fish, and reduced/impacted bank and buffer vegetation.

Figure 5.3. M06 flows along VT-100B and was extensively historically straightened.

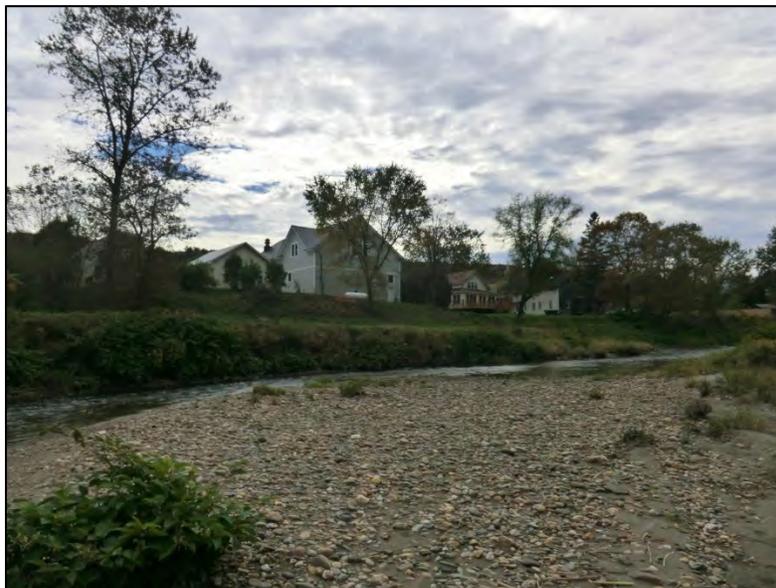
Reach 8 on the Mad River flows through the village of Moretown. It is approximately 1,500 feet long, beginning just above the Fletcher Road bridge at the confluence with Doctors Brook downstream and ending upstream approximately 1,200 feet below the Route 100B bridge near Old Gulf Road (Appendix C, Map 3). The river valley in this reach is naturally very broad, but Route 100B bisects it, creating a semi-confined phase 2 valley. Adjacent lands to the west of the river in this reach are primarily forested, while lands to the east are primarily residential, with several homes along Route 100B, as well as the Moretown library, firehouse, and elementary school. Riparian buffer vegetation is lacking for the entirety of the reach on the eastern side of the river due to several lawns. Japanese knotweed is prevalent along both banks of the river in this reach. There is a high terrace along the east side of the river. Bedrock gorges exist both immediately upstream and downstream of this reach, which provides vertical stability to M08. Further vertical adjustments of the river bed are unlikely due to these upstream and downstream grade controls. M08 is in **good** geomorphic condition as a result of this stability. The reach is in **fair** habitat condition because it is lacking large woody debris, and bank and buffer vegetation are either lacking or dominated by invasive species.

Figure 5.4. Residential land use adjacent to the river in M08 has resulted in poor riparian buffer vegetation.

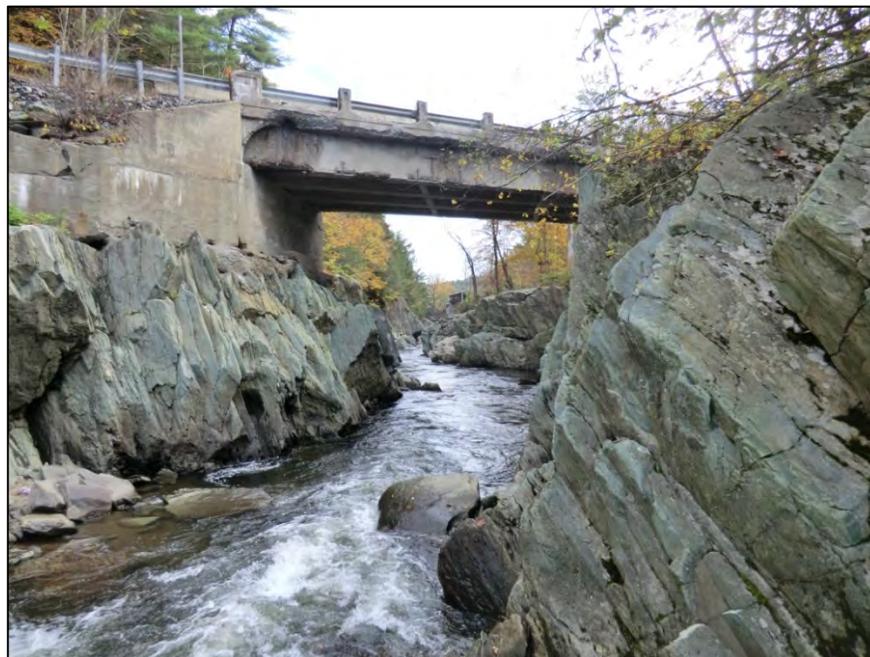
The downstream most segment on reach 9 is nearly 1,400 feet in length, and begins just upstream of the Moretown library and continues upstream to just above the Route 100B bridge near Old Gulf Road (Appendix C, Map 3). The Mad River flows through a bedrock gorge in segment A, and thus a full Phase 2 assessment could not be completed on this segment. It was unsafe to walk in the river within this segment; however, limited observations and impacts were recorded from the river bank. Bedrock is abundant both on the river bed and on the banks throughout this segment, providing both vertical and horizontal control for river adjustments. There is an old mill located on the south bank of the river within this segment. It was unsafe to assess the Route 100B bridge within this segment, but it was noted as being in poor condition. Administrative judgement data were collected for the segment, placing it in **good** geomorphic condition.

Figure 5.5. The Mad River flows through a bedrock gorge in M09-A.

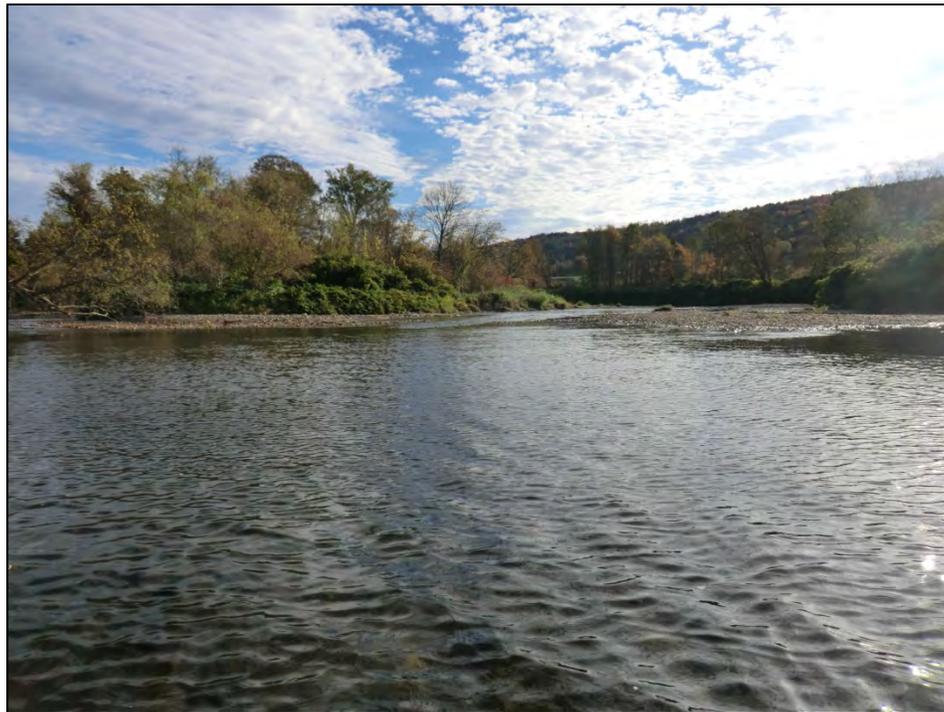
The upstream segment on reach M09 of the Mad River is roughly 1,800 feet in length, beginning just above the Route 100B bridge near Old Gulf Road and ending immediately upstream of the confluence of Dowsville Brook with the Mad River (Appendix C, Map 3). The river flows through a broad valley in this segment with adjacent agricultural and residential lands. This section of the Mad River is moderately sinuous and has several large aggradational features. Additionally, the river is exhibiting planform change in this segment via a flood chute and an impending *neck cutoff*. There is major erosion on both banks throughout the reach, especially on the outside of meander bends. Both streambanks are blanketed in Japanese knotweed. Major historic incision has occurred in this segment, which has resulted in a loss of floodplain access and a stream type departure. The river appears to be building a juvenile floodplain at a lower elevation. Due to these adjustments, M09-B was placed in **fair** geomorphic condition. The morphological characteristics of the river in this segment, as well as impacted banks and buffers, led to its placement in **fair** habitat condition.

Figure 5.6. Overly wide channel with abundant aggradation in M09-B.

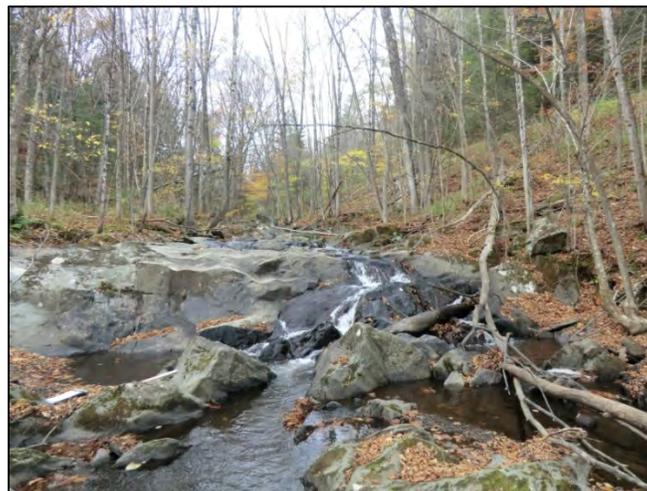
The downstream segment on reach 1 of Welder Brook begins at the confluence with the Mad River and continues upstream for roughly 2,500 feet to behind 445 Stevens Brook Road (Appendix C, Map 4). The segment is characterized by a step-pool bedform and abundant bedrock grade controls. Impacts within this segment are minimal and mostly relate to the presence of Stevens Brook Road along the north side of the stream channel. There are short sections of the brook that appear to have been straightened along the road, but for the most part, channel planform is natural. The abundant bedrock on the streambed in T1.01-A provides stability to the brook, which has not undergone incision or widening. T1.01-A is in **good** geomorphic condition for this stability and lack of impacts. Similarly, the segment is in **good** habitat condition, as it has a diversity of bed features, good instream cover, and mostly well forested buffers.

Figure 5.7. Bedrock grade controls are abundant in T1.01-A.

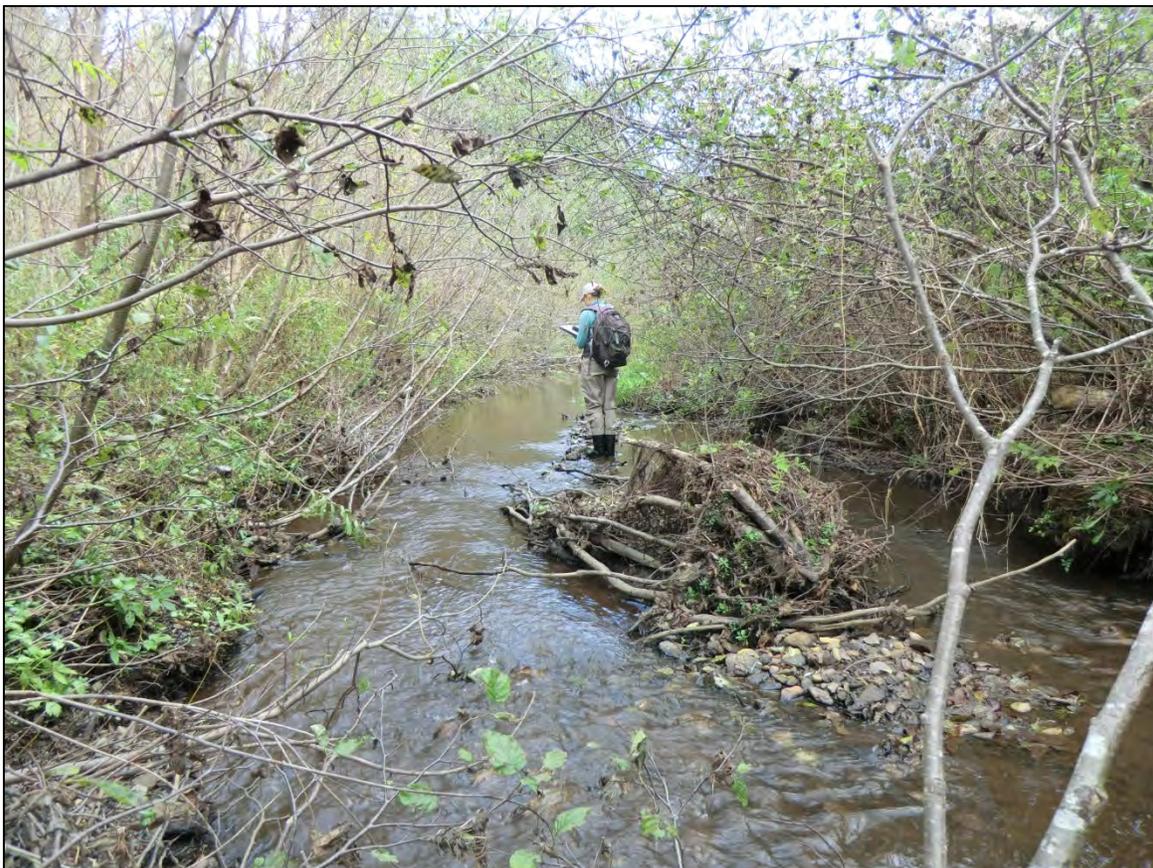
Segment B on reach one of Welder Brook is just over 1,200 feet in length and flows through a very broad valley (Appendix C, Map 4). This segment is within a large wetland complex and the brook has a low gradient, sinuous channel. The riparian buffers are well vegetated with shrub/sapling and herbaceous vegetation. There are multiple side channels and flood chutes throughout this segment where water spreads out as flows rise. Bank erosion is common, especially on outside meander bends, as are steep riffles. The brook has not incised in this segment, and human alteration is minimal. The planform is natural and floodplain connectivity is excellent. For these reasons, T1.01-B is in **good** geomorphic condition. The segment is also in **good** habitat condition, with its abundant large woody debris, diverse bed features, and well vegetated banks and buffers.

Figure 5.8. T1.01-B has a narrow, sinuous wetland channel.

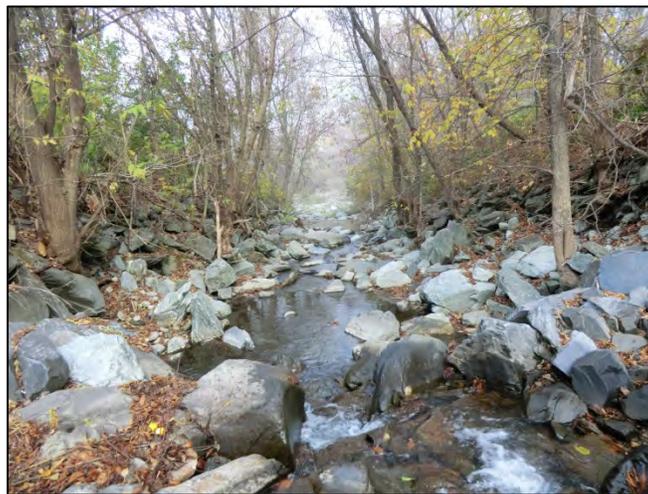
The lower segment on reach one of Doctors Brook is roughly 1,200 feet in length, ending just upstream of a private bridge (Appendix C, Map 3). The entirety of this segment appears to have been historically straightened due to the presence of houses and roads along its banks. This extensive straightening has led to major historic channel incision, a stream type departure, and a loss of floodplain access. Abundant bank armoring is preventing channel widening for much of this segment; however, areas that are not armored have severely eroding banks. Riparian buffers are lacking on both banks for most of the segment. For the aforementioned reasons, T1.01-A was placed in **poor** geomorphic condition. The segment is in **fair** habitat condition as a result of lacking large woody debris, altered channel planform, and impacted banks and buffers.

Figure 5.9. T2.01-A has been extensively straightened and riprapped.

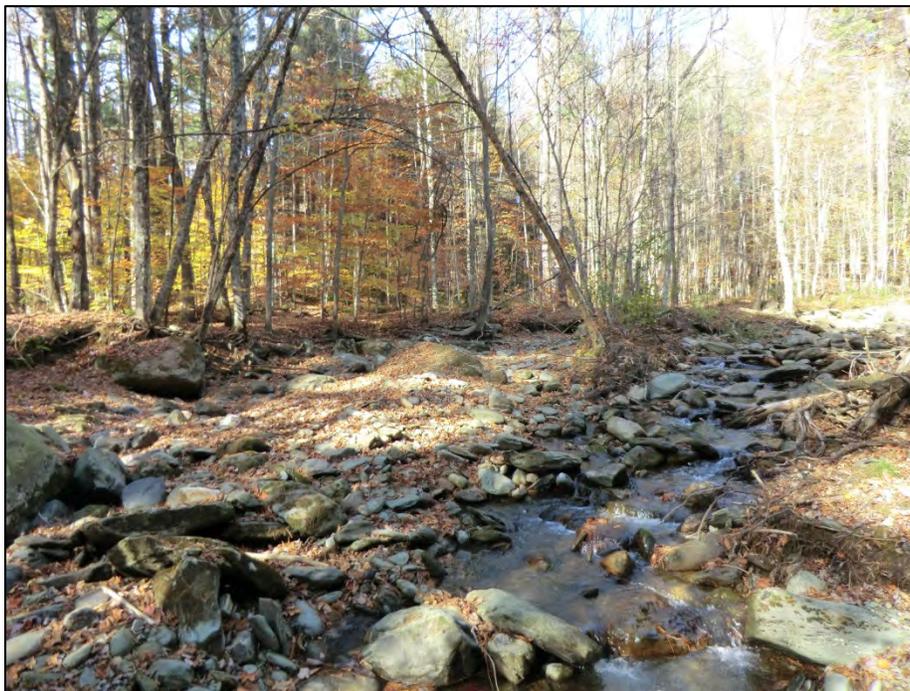
The upper segment on reach one of Doctors Brook is nearly 1,400 feet in length and flows through a forested, very broad valley (Appendix C, Map 3). The brook has a natural planform in this segment and minimal human alteration. A small section of historic channel straightening was observed at the downstream end of the segment, and another small area of channel alteration exists in the vicinity of a stream ford. Severe bank erosion was noted in this segment, especially on outside meander bends. Three mass failures were documented, the largest of which is located on the western bank of the brook toward the downstream end of the segment and is underlain by clay and sand. BCE observed one channel avulsion toward the upstream end of the segment where the brook appears to have formed a new primary flow path fairly recently. Severe historic incision was noted in this segment, which likely stems from the extensive historic channel alteration downstream in segment A. A stream type departure has occurred in T2.01-B, along with some loss of floodplain access. For these reasons, T2.01-B was placed in **fair** geomorphic condition. Despite channel adjustments and instability, there is abundant large woody debris and abundant pool features in this segment, as well as well forested banks and buffers. T2.01-B received a ranking of **good** for habitat condition.

Figure 5.10. Channel avulsion in T2.01-B.

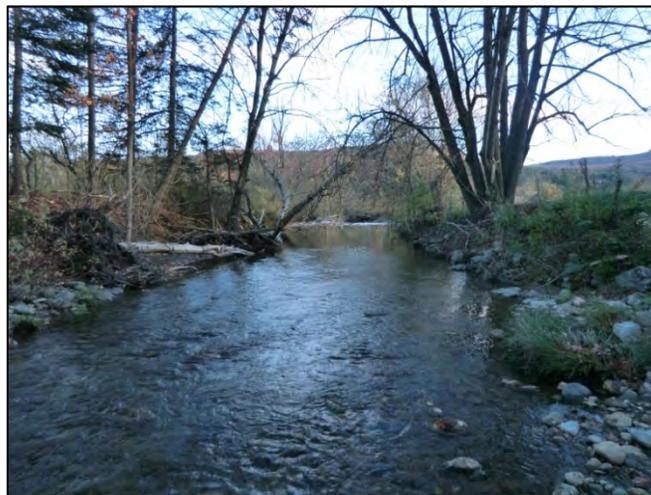
The downstream-most segment on reach one of Dowsville Brook is nearly 1,400 feet in length, extending from roughly 500 feet upstream of the Route 100B bridge downstream to the confluence with the Mad River (Appendix C, Map 5). Adjacent lands to this segment of the brook are primarily agricultural. Because of this, riparian buffer vegetation is lacking on both sides of the brook for much of the segment. The majority of T3.01-A appears to have been historically straightened due to the presence of the Route 100B crossing and surrounding agricultural lands. This historic straightening has led to channel incision, widening, and a departure from reference stream type. Due to these impacts and adjustments, T3.01-A is in **fair** geomorphic condition. Channel alterations and reduced bank and buffer vegetation led to the placement of T3.01-A in in **fair** habitat condition.

Figure 5.11. Straightened channel in T3.01-A.

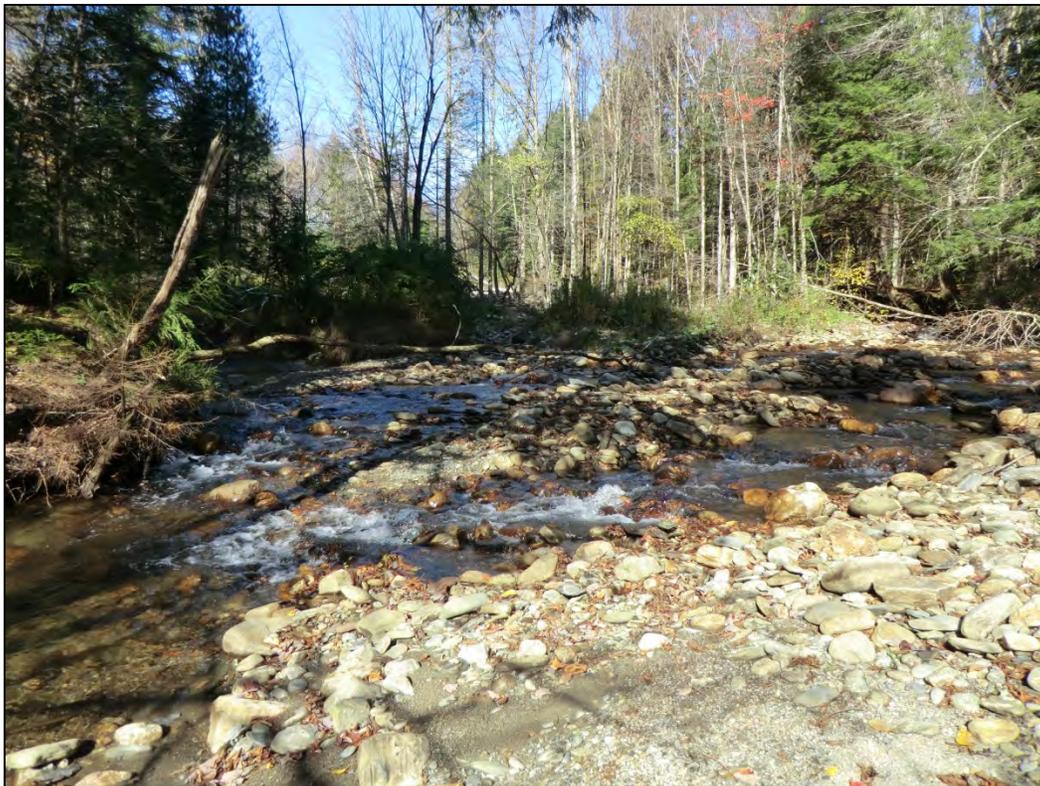
Segment B on reach one of Dowsville Brook is nearly 3,600 feet in length, beginning about 500 feet above the Route 100B bridge and ending upstream about 500 feet below the Route 100 bridge (Appendix C, Map 5). The brook flows through forested land in this segment and has minimal channel alteration. T3.01-B has undergone major aggradation and channel widening, leading to planform change. The channel is braided at low flows at some locations in this segment, but there are side channels and flood chutes throughout the segment, creating braiding at higher flows as well. Bank erosion is common on the outside of meander bends. Debris jams are abundant and are also contributing to planform change within T3.01-B. This segment is in **fair** geomorphic condition due to the major adjustments it is undergoing. The brook has abundant large woody debris and pools, as well as well forested banks and buffers. T3.01-B is in **good** habitat condition.

Figure 5.12. Aggradation and low flow braiding in T3.01-B.

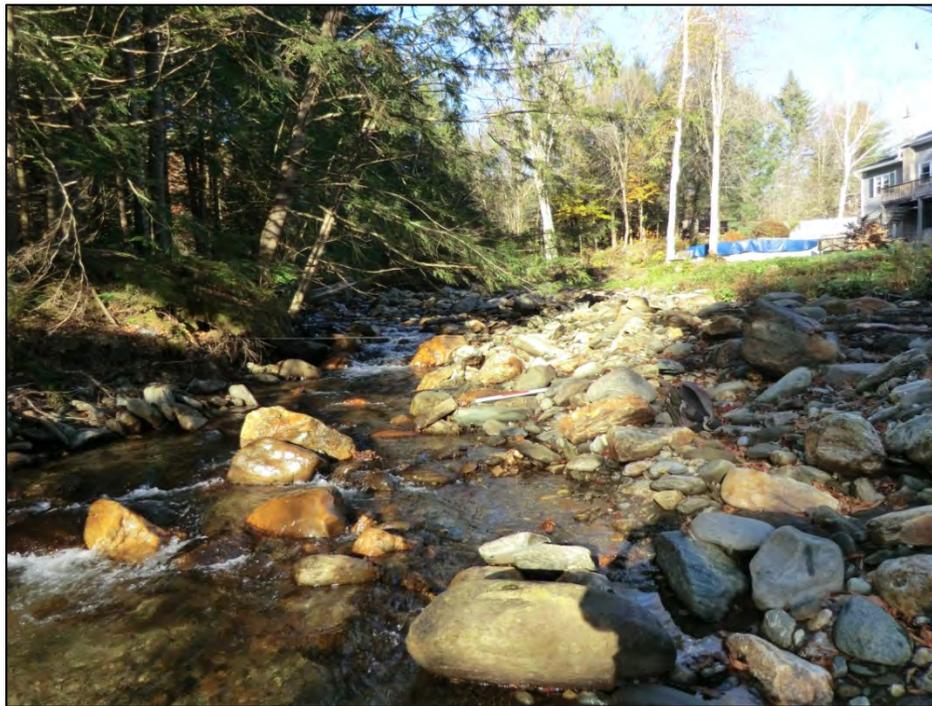
The upstream most segment on reach one of Dowsville Brook is characterized as having a higher slope than the downstream segments. This nearly 2,500 foot segment is located in Duxbury and flows through forested and residential land from just downstream of the Route 100 bridge upstream to near the cul-de-sac on Clark Road (Appendix C, Map 5). Historic and recent channel alterations were observed during the Phase 2 assessment, including channel straightening, dredging, windrowing, and berms. The uppermost portion of this segment has a higher slope than the rest of the segment, which is flatter and has large depositional features. Large flood chutes are present throughout the segment, contributing to planform adjustment. Sections of the brook appear to have been historically straightened behind several of the homes on Clark Road. Historic and recent berms, windrowing, and dredging were observed in the lower half of the segment above the Route 100 bridge. Major incision has occurred in this segment, though it has not led to a stream type departure. T3.01-C is in **fair** geomorphic condition and **fair** habitat condition due to the aforementioned alterations and adjustments, as well as impacted riparian buffers.

Figure 5.13. T3.01-C at cross section location.

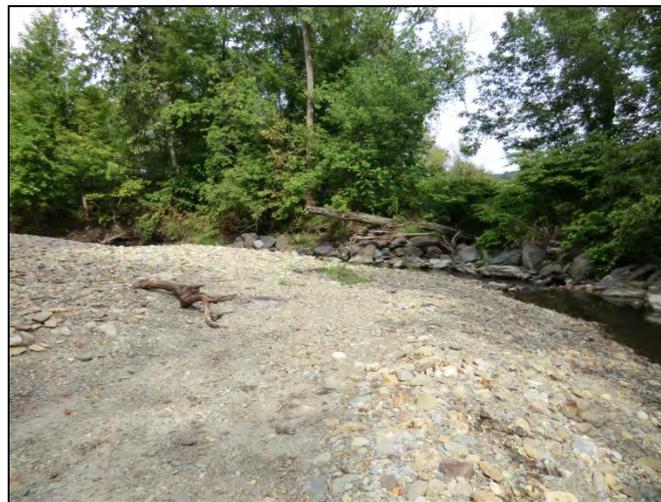
The downstream most segment on reach one of Jones Brook is approximately 2,300 feet in length, beginning roughly 700 feet above the Three Mile Bridge Road bridge at the upstream end and flowing downstream to the confluence with the Winooski River (Appendix C, Map 6). R16.S2.01-A flows through a very broad valley along several corn fields. Most of the segment appears to have been historically straightened due to the surrounding land use. Historic incision occurred within this segment and channel widening is actively occurring. Riprap is abundant along both banks, but bank erosion is occurring where riprap is not present. Some planform change was noted in the form of flood chutes. Lateral adjustments are being limited by bank armoring. R16.S2.01-A is in **fair** geomorphic condition for these reasons. The brook is also in **fair** habitat condition in this segment due to its altered planform, as well as lacking bank and buffer vegetation. Japanese knotweed is prevalent along both banks.

Figure 5.14. Large bar and riprapped bank in R16.S2.01-A.

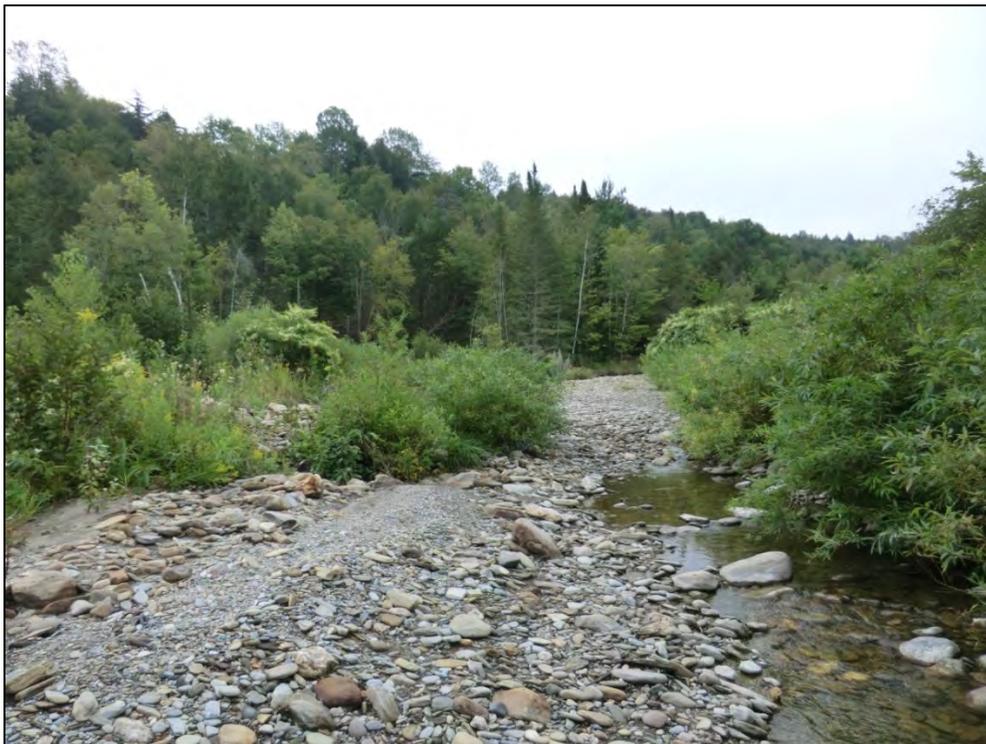
Segment B on reach one of Jones Brook is roughly 1,200 feet in length (Appendix C, Map 6). This segment differs from segments A and C primarily in channel planform and dimensions. R16.S2.01-B is characterized by abundant large depositional features, creating an extremely wide channel and low flow braiding conditions. There are several flood chutes and side channels that appear to be wetted at various flow conditions (including low flow). There are few human impacts to the brook within this segment, which include one stream ford and a very short section of minor windrowing just upstream of the ford. There is a major gully coming off of the east valley wall within this segment that may contribute large amounts of fine sediment to the brook. The source of the gully is unknown though it appears to originate in a clearing upslope and may be related to logging activities. The brook is part of a naturally very dynamic system. R16.S2.01-B is in **fair** geomorphic condition as a result of its abundant adjustments. Similarly, the brook is in **fair** habitat condition within this segment due to lacking instream cover and its hydrologic conditions that create a shallow channel without a diversity of bed features.

Figure 5.15. There is major aggradation and braiding in R16.S2.01-B.

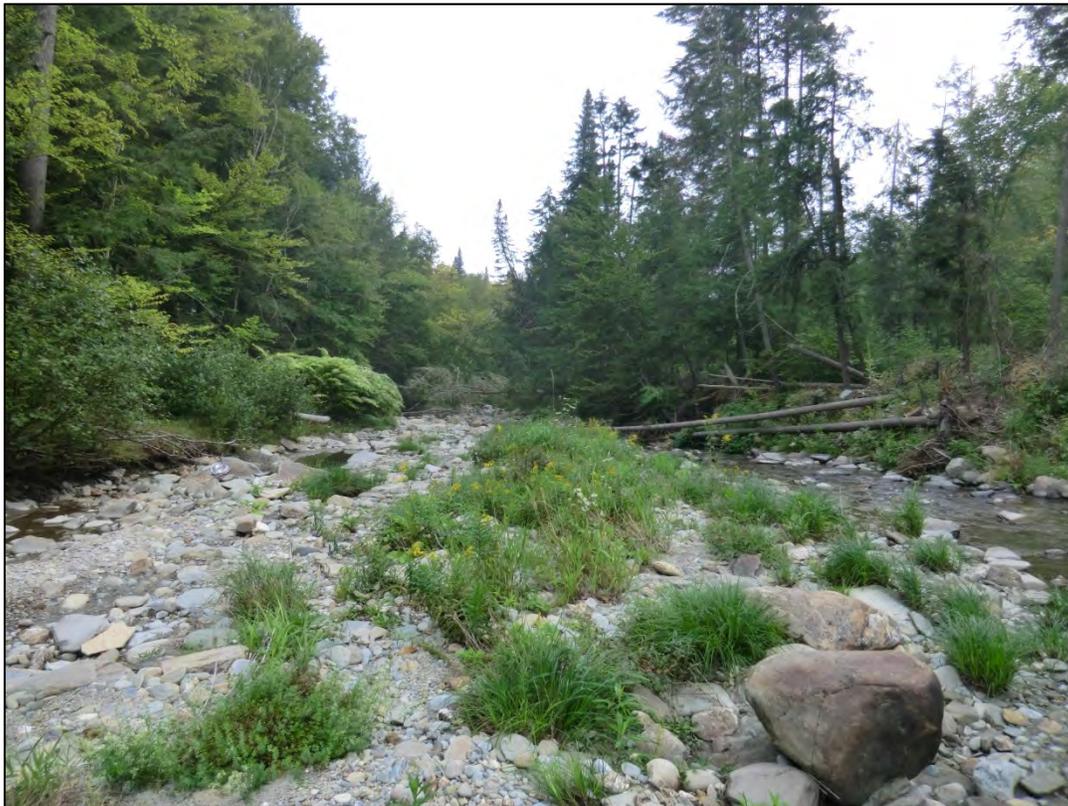
The upstream most segment on reach one of Jones Brook is just over 900 feet in length and flows through a narrower, steeper valley than the two downstream segments (Appendix C, Map 6). The brook is characterized by a naturally straight channel with large substrate. The brook has undergone historic incision and recent channel widening, which has led to a stream type departure. Large bars are present at the downstream end of the segment. It appears that the brook has been minimally altered, as it flows through the woods away from development along Jones Brook Road. R16.S2.01-C is in **fair** geomorphic condition as a result of historic and recent channel adjustments. The brook is also in **fair** habitat condition for many reasons, including lacking pool features, unstable banks, and a wide channel with mostly shallow water.

Figure 5.16. Wide, straight channel in R16.S2.01-C.

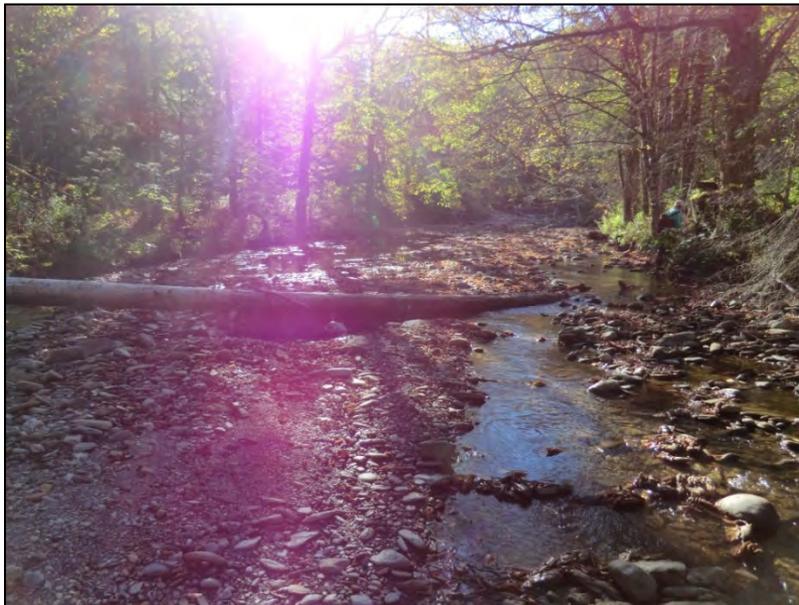
The downstream most segment on reach two of Jones Brook flows through a narrow valley in the Town of Berlin. The downstream half of the segment flows through the woods, while the upstream half flows through a residential area along the west bank of the brook (Appendix C, Map 6). Aggradation is a major process that is currently occurring within R16.S2.02-A. Numerous large bars are present throughout the segment causing the formation of steep riffles and channel widening. Although moderate historic incision has occurred within this segment, floodplain access is still mostly intact. Riparian buffers are lacking in the vicinity of two houses along the western bank of Jones Brook. Bank erosion is common along both banks within this segment, which provides further evidence that channel widening is occurring, and four mass failures are present. R16.S2.02-A is in **fair** geomorphic condition as a result of historic and active channel adjustments. This segment is also in **fair** habitat condition due to such factors as lacking instream cover, reduced bank and buffer vegetation, and lacking pool features.

Figure 5.17. Aggradation is a major process currently occurring within R16.S2.02-A.

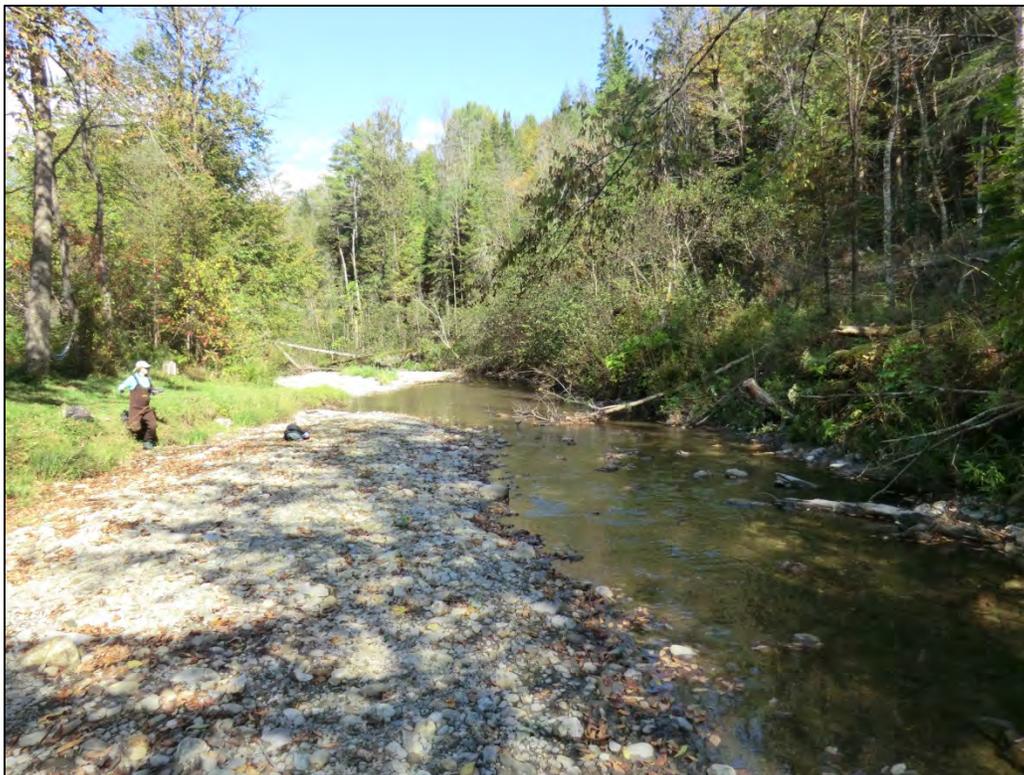
Segment B on reach two of Jones Brook is a short segment – only roughly 900 feet in length and is located in Berlin. The brook flows through a slightly wider valley in this segment than downstream and has more channel alteration due to the presence of residences on both sides of the brook (Appendix C, Map 6). Much of the segment appears to have been historically straightened up against the eastern valley wall due to residential land use on the west. Buffer vegetation is lacking for most of the segment on the western side of the brook, but also for a small section on the eastern side. The historic straightening in this segment appears to have led to major historic incision, resulting in a stream type departure and loss of floodplain access. Major aggradation has also occurred within this segment, as evidenced by several large bar features. For these reasons, R16.S2.02-B is in **fair** geomorphic condition. The segment is also in **fair** habitat condition as a result of lacking instream cover and pool habitat, channel adjustments that have created a wide, shallow channel, and lacking bank and buffer vegetation.

Figure 5.18. Wide, depositional channel in R16.S2.02-B.

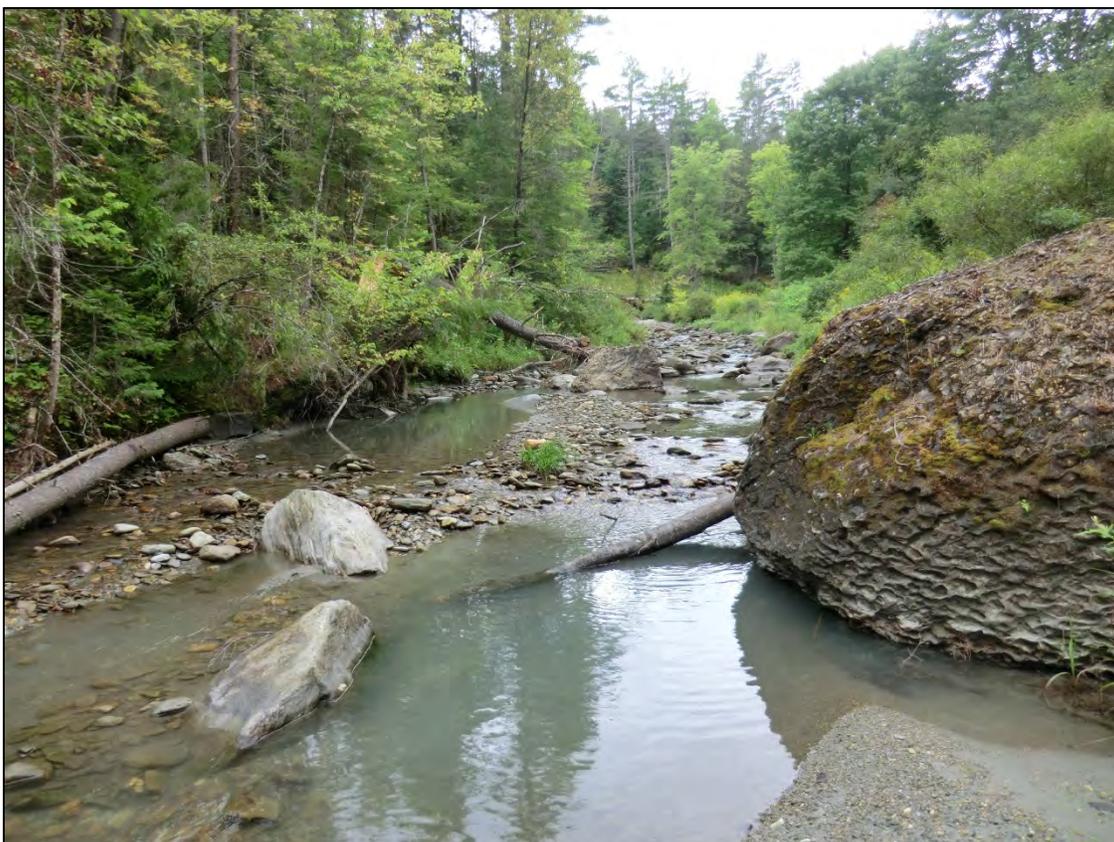
Segment C on reach two of Jones Brook flows through a narrower valley than the adjacent segments. It is roughly 1,200 feet in length and flows mostly through the woods along Jones Brook Road (Appendix C, Map 7). The lower end of the segment is in Berlin, while the upstream end is in Moretown. Very few channel alterations were observed within this segment, which has a mostly natural planform. Moderate historic incision was noted at the cross section for R16. S2.02-C, as well as minor widening. A few areas of bank erosion were noted in this segment, particularly on the eastern bank. Due to historic and recent channel adjustments, this segment was placed in **fair** geomorphic condition. R16.S2.02-C lacked large woody debris at the time of the assessment. Hydrologic characteristics and impacted bank and buffer vegetation on one side of the channel also contributed to the segment being placed in **fair** habitat condition.

Figure 5.19. R16.S2.02-C has a narrower valley and is naturally more entrenched than downstream segments.

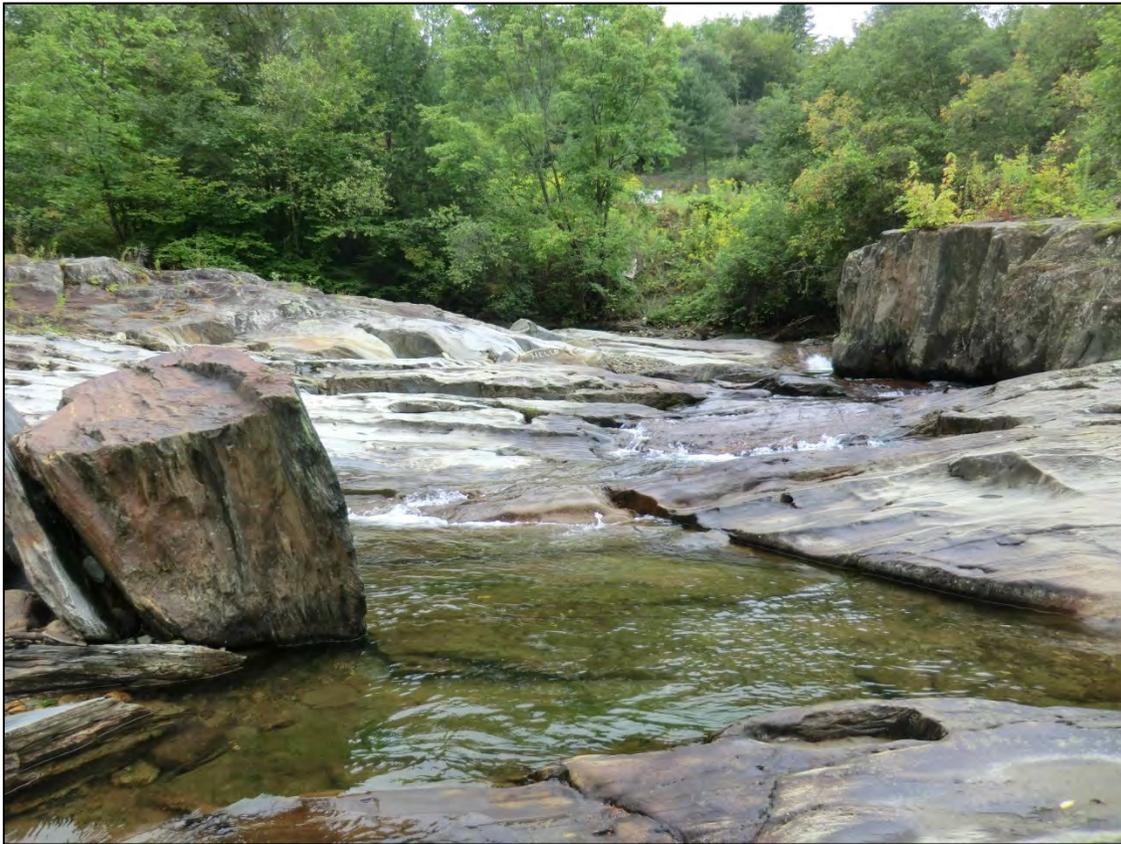
Segment D on R16.S2.02 is very short, only 584 feet in length. This segment flows through the woods and has a large bedrock grade control at its downstream end (Appendix C, Map 7). This grade control provides vertical stability to the channel within R16.S2.02-D, which has prevented major channel incision. Jones Brook upstream of the bedrock grade control appears to be undergoing minor channel widening with extensive bank erosion along the west bank. Overall, R16.S2.02-D was reported to be in **good** geomorphic condition due to only minor channel adjustments. Similarly, segment D was placed in **good** habitat condition, as it has good instream cover, a diversity of bed features, and mostly well vegetated banks and buffers.

Figure 5.20. Large bedrock grade control at the downstream end of R16.S2.02-D.

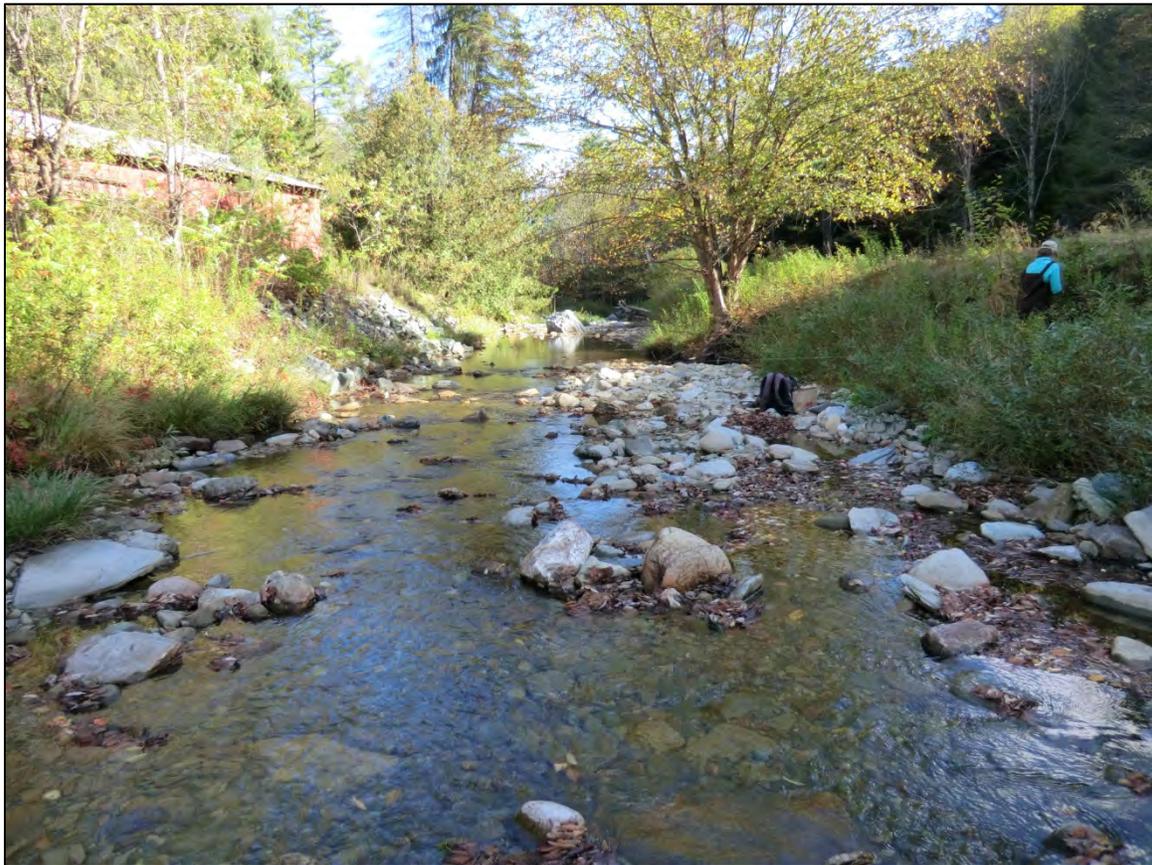
The upstream most segment on reach two of Jones Brook is nearly 700 feet in length, and flows through primarily residential land along Jones Brook Road (Appendix C, Map 7). This land use appears to have resulted in historic straightening for the entirety of this segment. Severe historic incision has occurred within R16.S2.02-E, causing a stream type departure and loss of floodplain access. Some channel widening is occurring, though it is limited in some locations due to riprap. Riparian buffer vegetation is lacking along the western side of Jones Brook for the whole segment. R16.S2.02-E is in **fair** geomorphic condition due to extensive historic channel alteration and severe historic incision. Large woody debris, bed features, and bank and buffer vegetation are lacking, which resulted in the placement of the segment in **fair** habitat condition.

Figure 5.21. Jones Brook has a straight and severely incised channel in R16.S2.02-E.

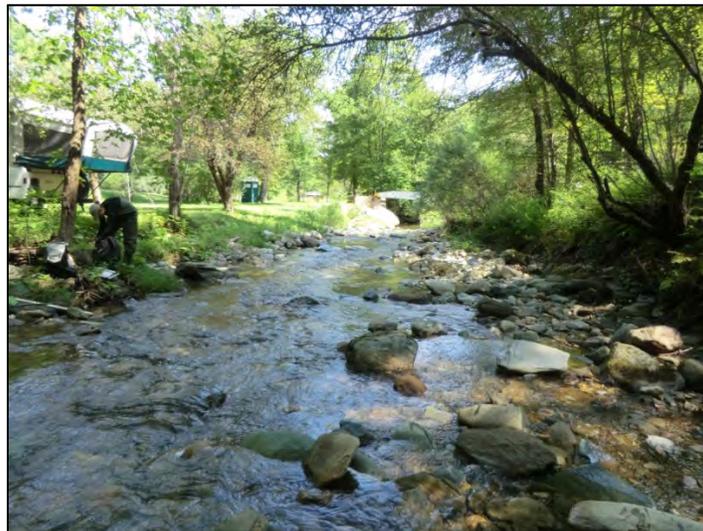
The downstream most segment on reach three of Jones Brook is just over 800 feet in length, beginning at the confluence with Kelley Brook downstream and ending upstream where the brook flows away from Jones Brook Road (Appendix C, Map 7). This segment has a very broad valley by reference; however, the valley is bisected by Jones Brook Road, which functionally narrows the valley. All of segment A appears to have been historically straightened due to the placement of Jones Brook Road in the western corridor and a house on the east of the brook. Despite this historic straightening, minimal channel incision has occurred within R16.S2.03-A. Bedrock grade controls exist both upstream and downstream of this segment, which may contribute to the vertical stability within the segment. Similarly, aggradation, widening, and planform change are minimal in this segment. A geomorphic condition of **good** was given to this segment for this lack of channel adjustments and the segment’s relative stability. R16.S2.03-A ranked **fair** for habitat condition for the brook’s lack of large woody debris, its altered planform, and lacking bank and buffer vegetation.

Figure 5.22. R16.S2.02-A looking downstream at the cross section location.

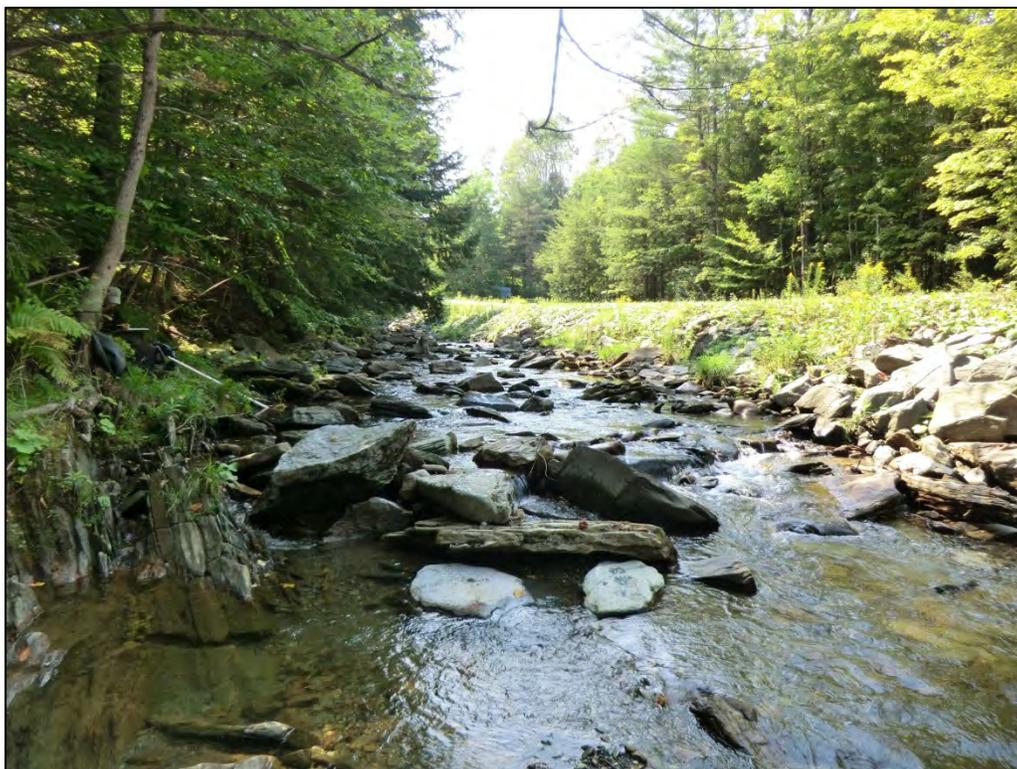
The second segment on reach three of Jones Brook is characterized by major channel encroachment by Jones Brook Road. This very short segment (just over 400 feet in length) flows directly along the road (Appendix C, Map 7). The brook has been straightened along the eastern valley wall for nearly the entire segment and is currently trapped between the road and valley wall. There is a major human caused change in valley width in this segment due to the presence of Jones Brook Road. Extensive bank armoring is present along the road. The road encroachment creates a human elevated floodplain and a high incision ratio, and has resulted in loss of floodplain access and a stream type departure. Lateral channel adjustments are being prevented by the bank armoring present on the west side of the channel and the valley wall immediately on the east. R16.S2.03-B is in **fair** geomorphic condition for these reasons. The straightened channel in this segment lacks large woody debris, pool features, and bank and buffer vegetation on one side. For these reasons, R16.S2.03-B is also in **fair** habitat condition.

Figure 5.23. R16.S2.03-B has been extensively straightened along Jones Brook Road.
