Moretown, Vermont Phase 2 Stream Geomorphic Assessment & River Corridor Plan

April 20, 2018

Prepared by:
Bear Creek Environmental, LLC
149 State Street, Suite 3
Montpelier, Vermont 05602

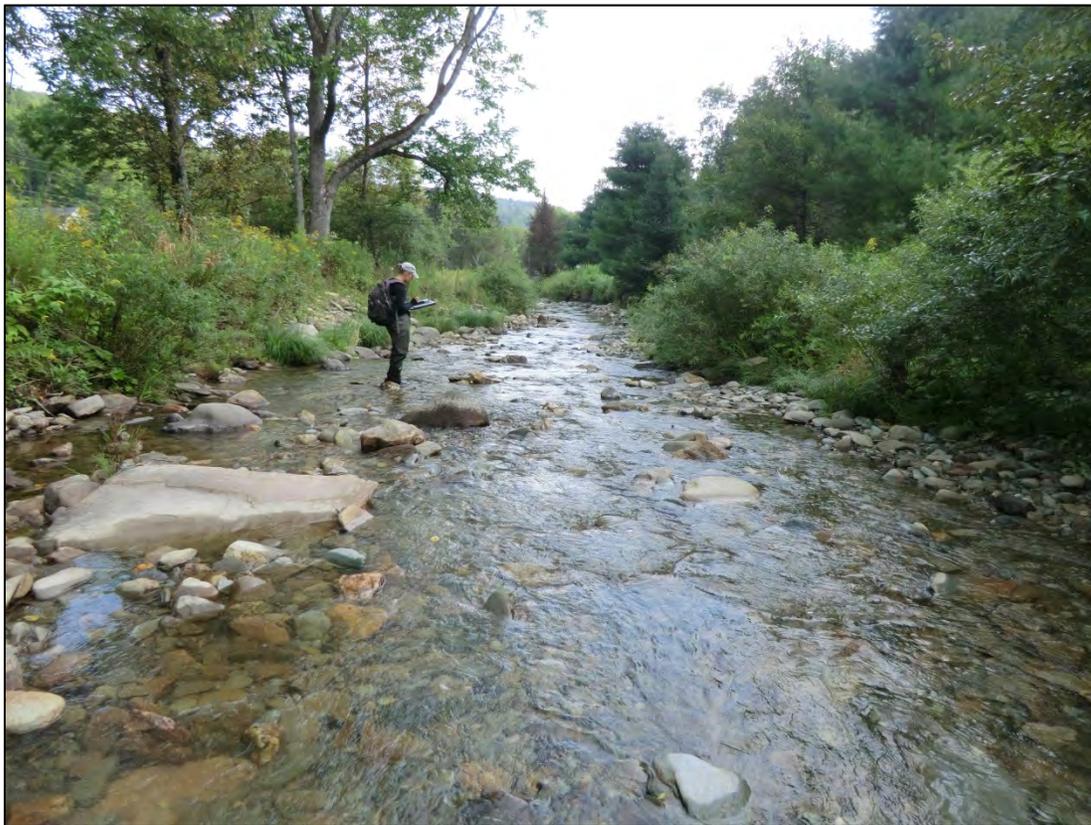
The upstream most segment on reach three of Jones Brook is the longest, at 2,100 feet. Jones Brook appears to have been historically straightened for the entire length of this segment due to several houses along Jones Brook Road (Appendix C, Map 7). Five ledge grade controls are present in the middle and at the downstream end of this segment, which afford the channel some vertical stability. Moderate historic incision has occurred within R16.S2.03-C likely as a result of channel alteration. Widening is currently occurring as evidenced through abundant bank erosion. Riparian buffer vegetation is lacking for about half of the segment. R16.S2.03-C is in **fair** geomorphic condition and **fair** habitat condition.

Figure 5.24. Straight channel in R16.S2.03-C.

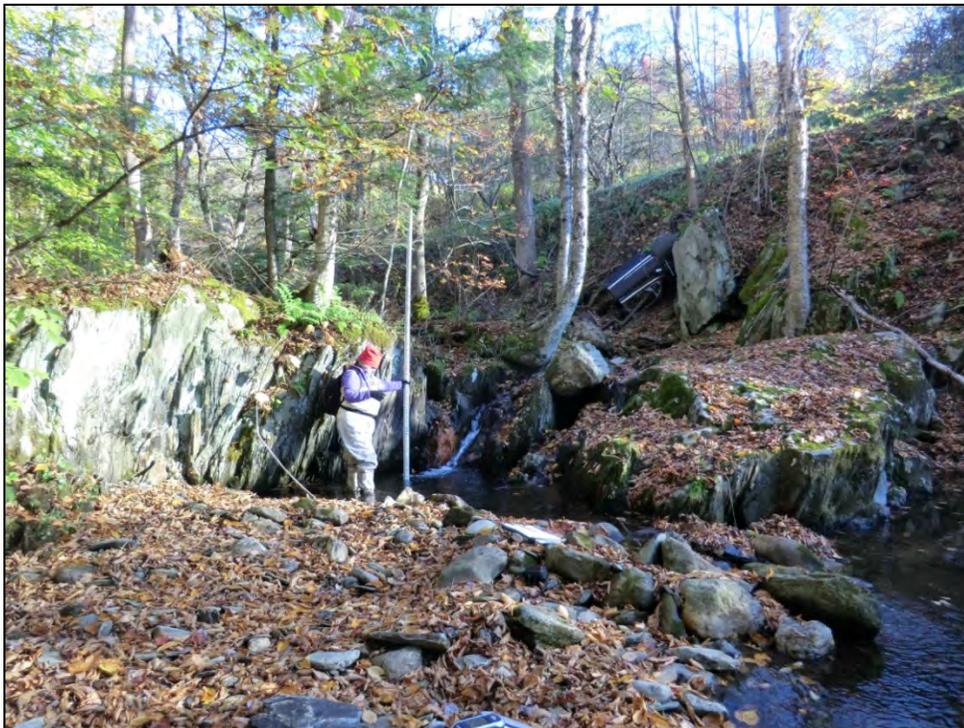
Figure 5.26. Bedrock grade controls are abundant in this segment.

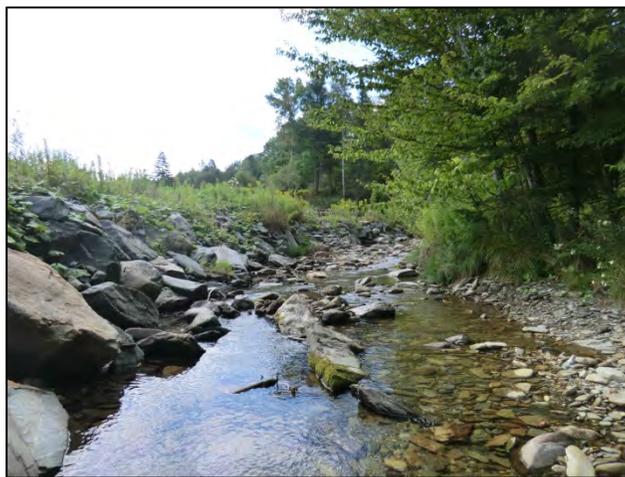
Figure 5.27. Extensive riprap and straightening in R16.S2.03-S1.01-A.

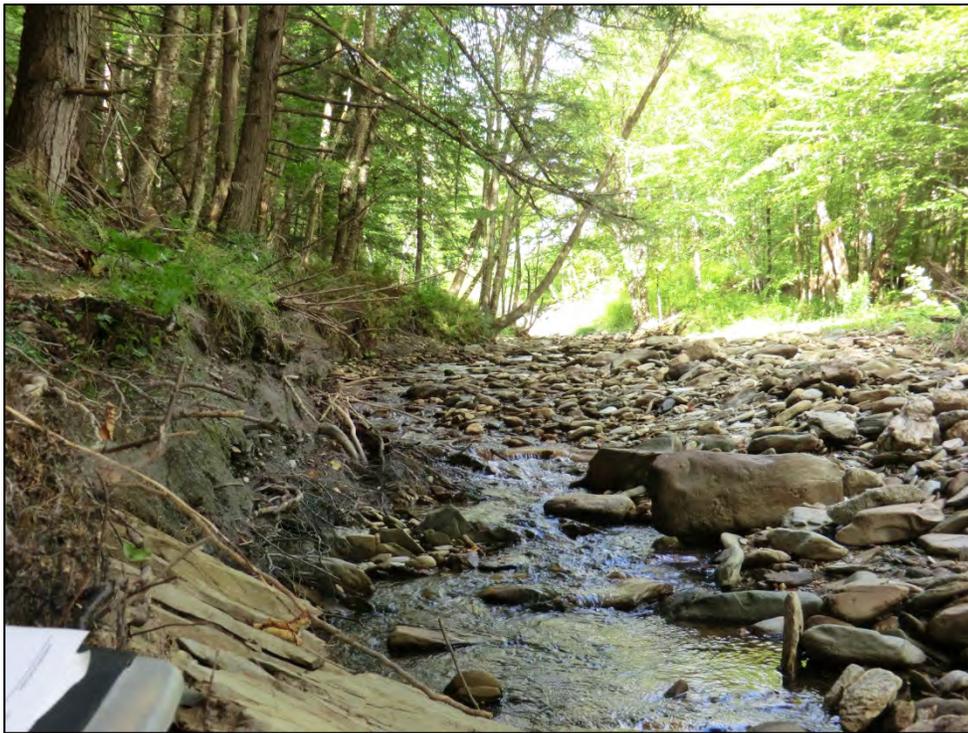
Figure 5.28. Headcut in R16.S2.03-S1.01-B.

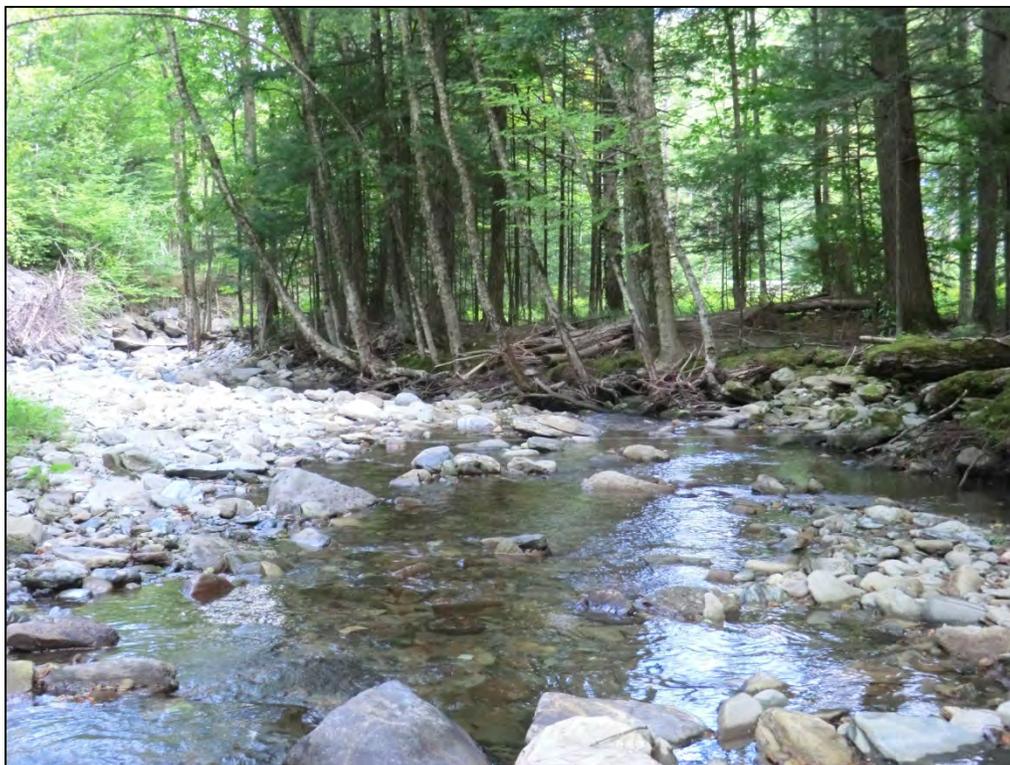
Figure 5.28. Downstream view at cross section in R16.S2.03-S1.01-C.
