Municipal Class 4 Road Erosion Remediation and Demonstration Project Report

Central Vermont Regional Planning Commission

29 Main St, Suite 4
Montpelier, VT 05602
802-229-0389
September 15, 2018

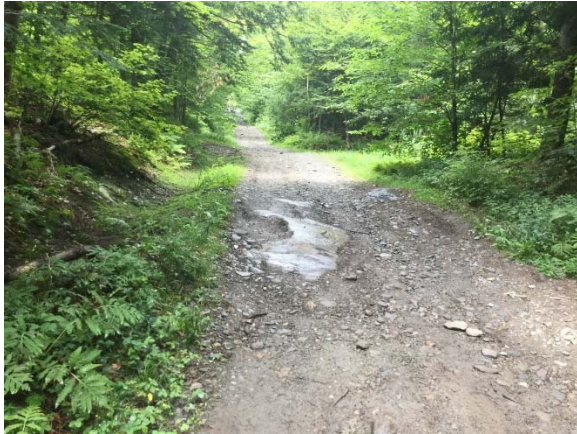
Lynch Hill Road (before BMP)

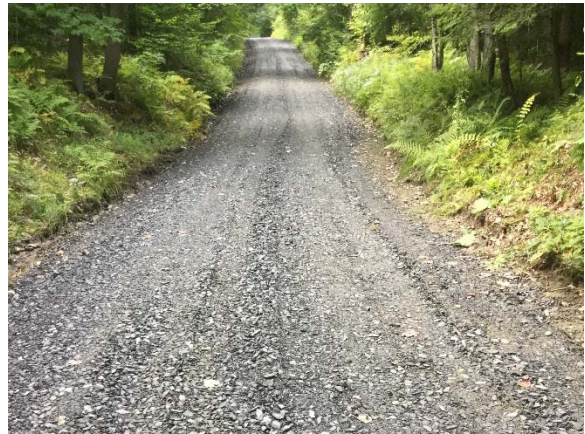
Lynch Hill Road (after BMP)

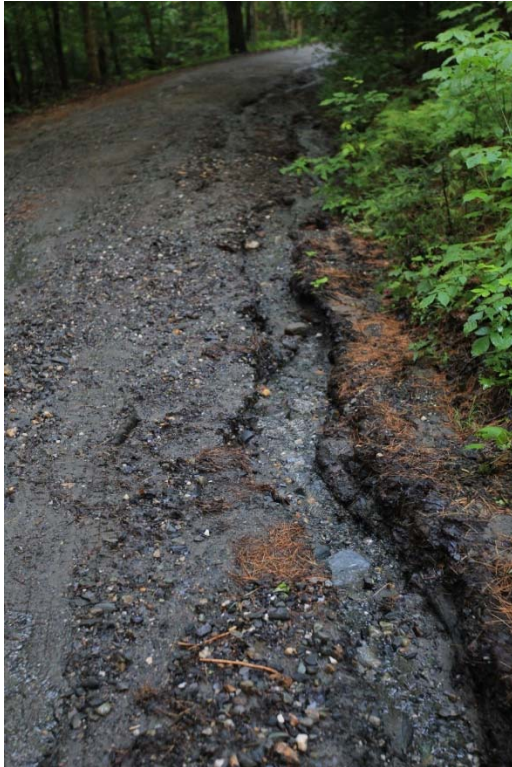
Before

The first three segments are on the south end of Apple Hill. Apple Hill is a steep road that is sunken and experiences severe erosion. As you can see in the before photo, the road had no ditch, with berms along both sides, and an undersized culvert in the middle. The work done to fix this road included berm removal, resurfacing with new gravel on the roadway, installing a stone lined ditch and a new culvert with stone headers and outlets.

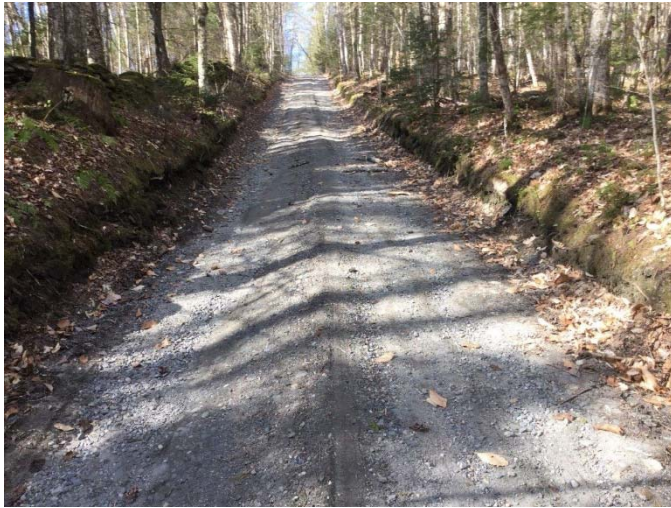
Before

The next three segments in Calais are on the north end of Apple Hill. Apple Hill at this end is a steep road that is sunken and experiences severe erosion. As pictured in the before photo, the road had no ditch and there were high berms along both sides. The work done to fix this road included berm removal, resurfacing with new gravel on the roadway, installing a stone lined ditch, installing stone lined turnouts, and installing a new culvert at the bottom of the road.

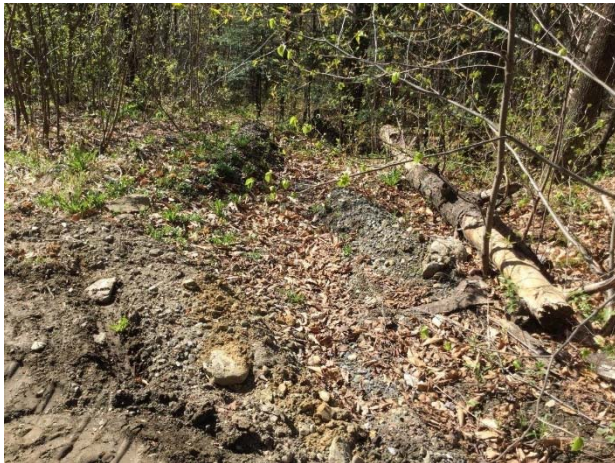
Before

The last two segments in Calais are on Woodbury Mountain Road. Woodbury Mountain Road is a steep road that is sunken and experiences severe erosion. The before photo shows an eroding turn out that was cut in with a grader. There is also no ditch along the road and berms exist along both sides. The work done to fix this road included berm removal, resurfacing with new gravel on the roadway, installing a stone lined ditch and stone lined turnouts.

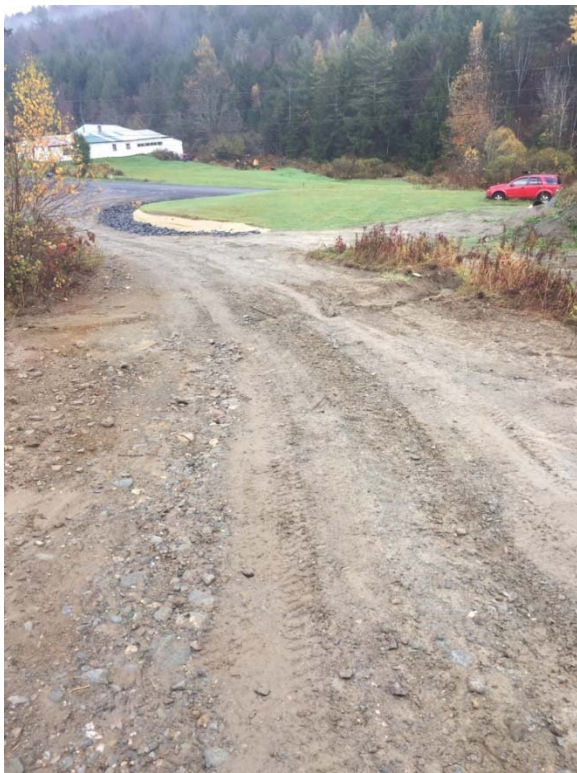
Before

Moretown worked on a total of eight segments. The first seven segments are on Lynch Hill Road, which is a steep road that is sunken and experiences severe erosion. The before photo shows how water would run down the middle of the road because of berms and no ditch. The work done to fix this road included berm removal, resurfacing with new gravel on the roadway, installation of stone and grass lined ditches, stone lined turnout, and water bars.

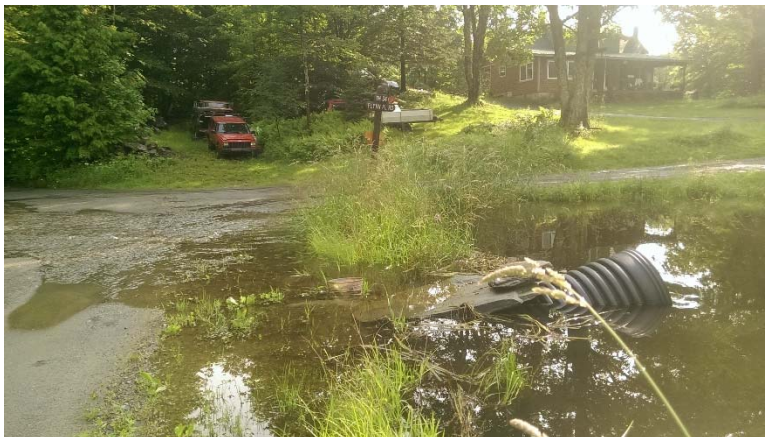
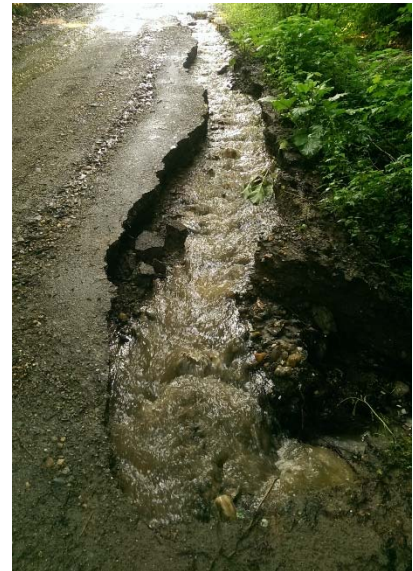
Before

The eighth segment in Moretown is on Bathenes Road, which is a well maintained Class 4 road except for a culvert at the top of the road. The culvert had been poorly installed causing water to top over it each year and cause severe erosion. The work done to fix this issue included installing a new culvert with elbow and stone headers.

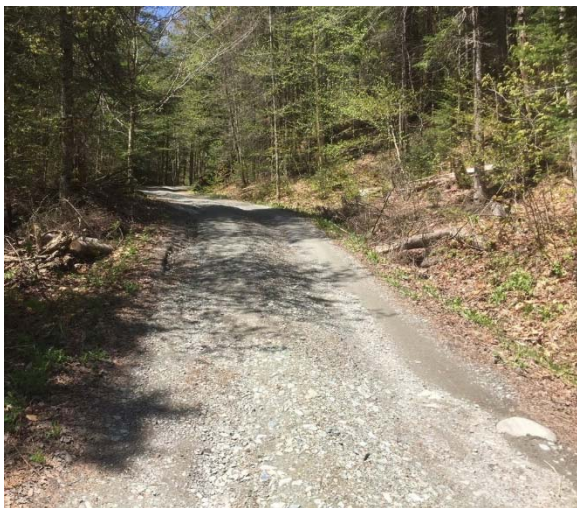
Before

Worcester worked on a total of seven segments, all on Hancock Brook Road. Although Hancock Brook Road has a number of steep sections, it is really quite flat. This road became sunken and experienced severe erosion. The before photo shows how water would run down the middle of the road because of berms and no ditch. The work done to fix this road included berm removal, resurfacing with new gravel on the roadway, installation of stone and grass lined ditches, and new culverts with stone headers.

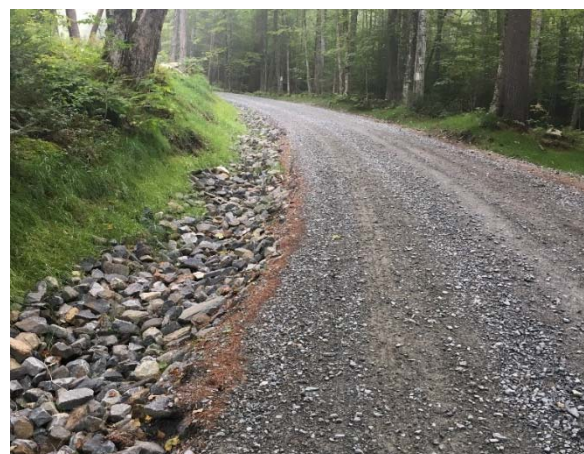
The resiliency of the BMPs installed on Apple Hill Roads south end in 2017 to withstand numerous heavy rain events and a Vermont winter are a testament to project success. The picture on the right showcases this. As you can see, both the stone lined ditch and roadway show very little evidence of erosion and sediment transport. The project team expects to see similar resiliency with all the BMPs installed for years to come.

Calais - Apple Hill Road south end one year after BMP installation
