Kingsbury Branch of the Winooski River Watershed River Corridor Plan October 2008

Kingsbury Branch of the Winooski River Watershed River Corridor Plan

October 24, 2008

Bear Creek Environmental, LLC

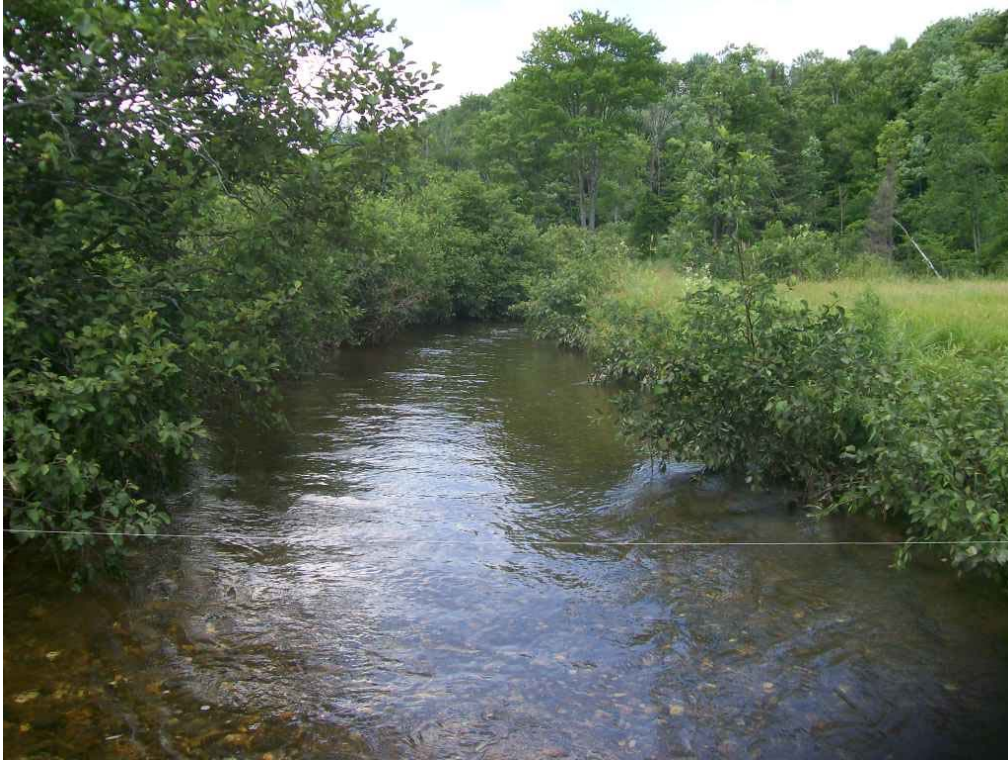
A variety of habitat quality was often found within a reach. For example, reach 15 had fair habitat at the lower end where it lacks a high quality buffer and had been historically straightened (Figure 9). The mid section of reach 15, which is located away from roads and development, had good habitat and contained large wood debris, high quality pools, and large trees along the banks (Figure 10).

Figure 9. Segment M15-A rated “fair” for habitat. The segment lacked large woody debris, riparian vegetation and a diversity of pools where the channel had been historically straightened

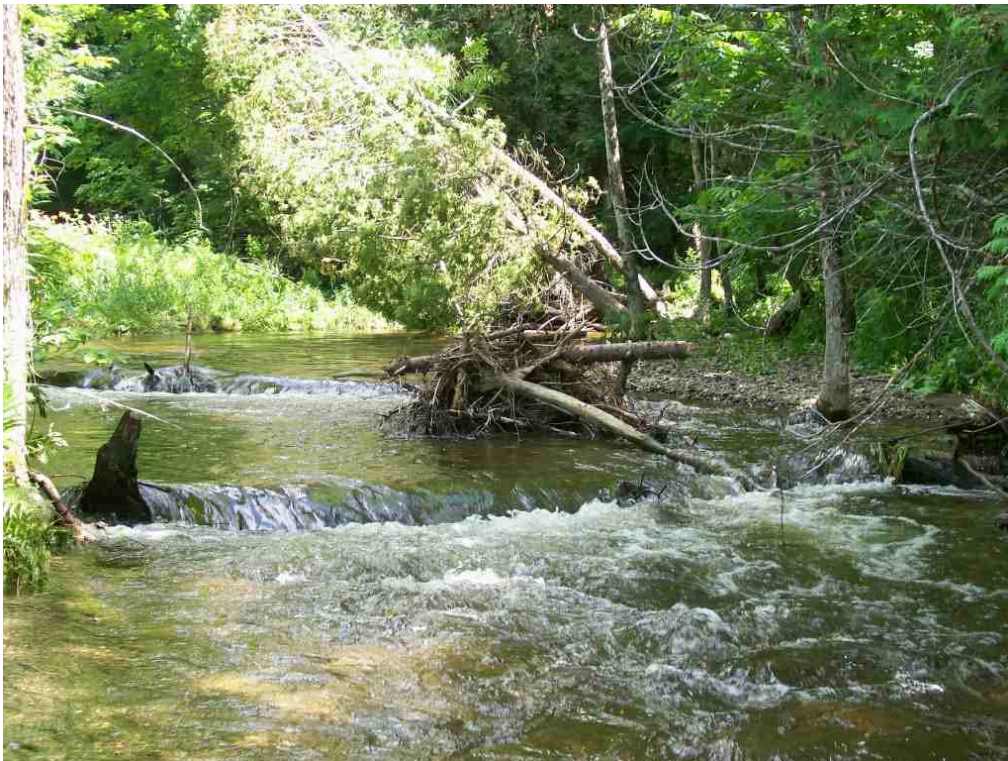
Figure 10. This short section of M15-B had high quality habitat including excellent instream cover, deep pools, stable banks, and a high quality riparian zone.

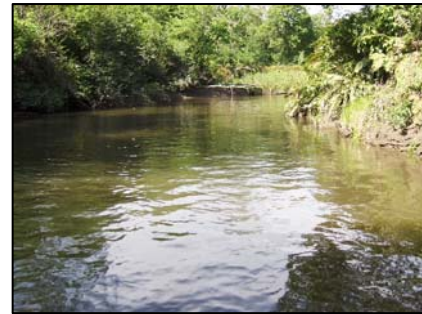
Reach M02 begins about 1200 feet upstream of the bridge at Cate Farm Road. This reach is highly sinuous and is also highly influenced by North Montpelier Pond. The lack of sediment below the pond has likely contributed to historic incision within this reach. This reach has undergone a stream type departure from an “E” to a “C” channel due to widening or planform migration and is currently undergoing a major aggradation process. M02 has an excellent riparian buffer and has abundant wetlands adjacent to the channel.

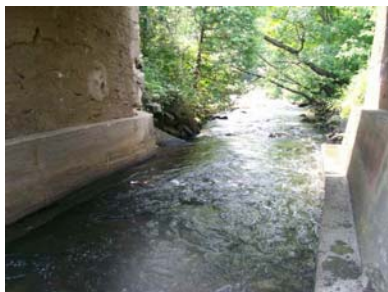
The upper portion of Segment M12-B contains an undersized bridge over Moscow Woods Road. Below the bridge is a 20 foot wide penstock. Both the bridge and the penstock are major channel constrictions within this segment.

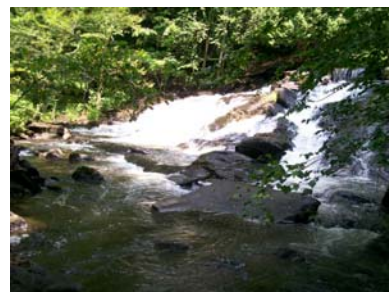
Below the penstock is bedrock controlled falls.

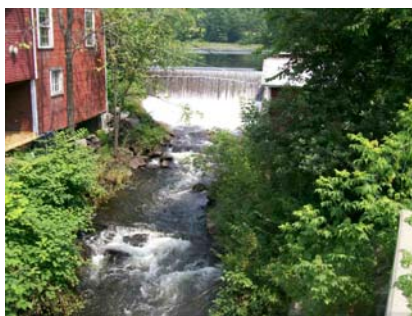
Reach M13 – Old Mill Dam

An old Mill Dam is located at the lower end of the reach, resulting in an impoundment.

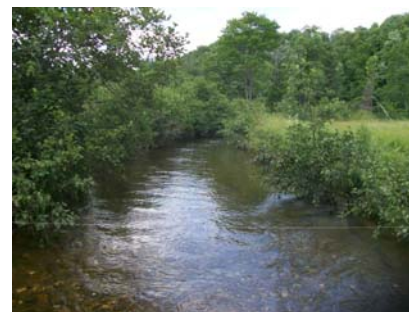
Segment M15-A begins just downstream of the Route 14 bridge near the intersection of Route 14 and Sand Hill Road. This “C” channel has little to no riparian buffers and it is not incised, making it a good candidate for buffer restoration. This segment is experiencing minor planform adjustment.

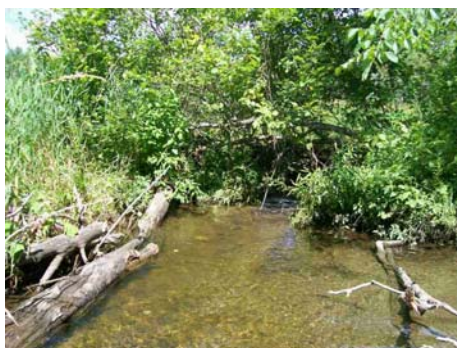
Segment M15-B begins where buffer becomes more forested than downstream. This “C” channel has been historically straightened and likely pushed up against the valley wall. This has resulted in extreme planform adjustment within the segment and many mass failures are contributing abundant sediment resulting in major aggradation. The riparian buffer is generally good.

I. Protect River Corridor

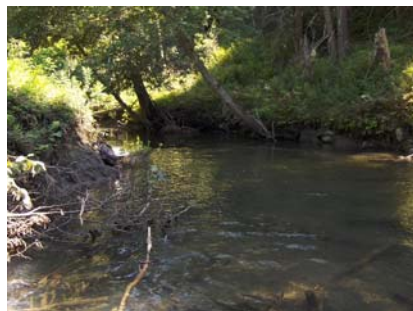
Reach T3.02 begins about 550 feet upstream of the Route 14 Bridge near Pekin Brook Road. This “E” channel has been historically straightened and has considerable bank erosion along both banks along with evidence of failed rip rap. Two remnant beaver dams were noted within the reach. Major widening and planform adjustment is occurring within this reach. Riparian buffers are generally good.

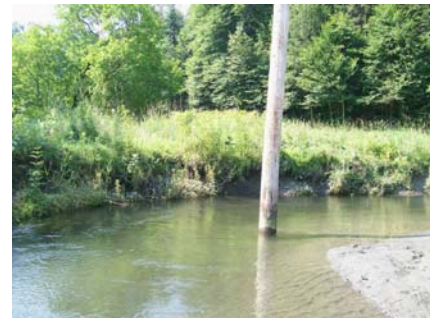
Segment T3.04-A begins at the culvert on Peck Hill Road near the intersection of Peck Hill Road and Pekin Brook Road. This “E” channel runs through agricultural fields that are hayed and used as cow pastures and now lacks a healthy riparian buffer. This segment was likely all straightened and is now readjusting. This segment is experiencing extreme planform adjustment and erosion is significant along this segment. The bridge at the upstream end of the segment may be causing problems in T3.04-B as flood waters have crossed the road during flood events.

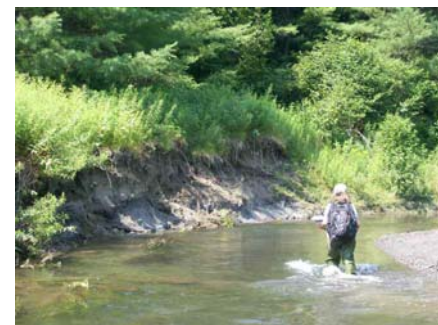
Segment T3.04-B

Segment T3.04 begins just upstream of the bridge near the intersection of Jack Hill Road and Pekin Brook Road. This “C” channel has a well developed floodplain and runs along a field on the left bank that is mowed for hay regularly leading to buffer widths <25 feet. Mass failures and erosion are present on the outside of meander bends and major planform adjustment is evident.

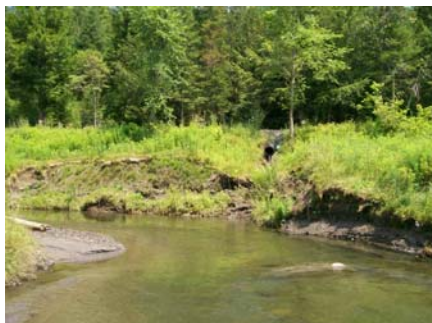
Segment T3.04-C begins at the driveway bridge off Pekin Brook Road. This “C” channel has significant erosion on the outside of meander bends, and some locations with little to no riparian buffer. This segment is experiencing major planform adjustment

in response to a corridor encroachment and historic grazing within the corridor.

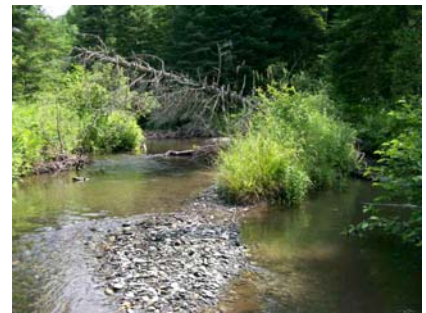
Segment T3.05-B begins where vegetation changes to densely forested, and thus it has a very healthy riparian buffer. This “C” segment is experiencing major planform adjustment but has good vegetation holding the banks in place.

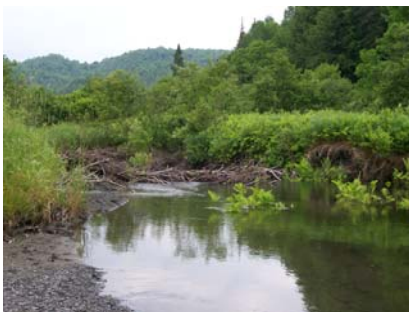
Segment T3.06-A begins just downstream of the intersection of Singleton Road and Pekin Brook Road where a major tributary enters Pekin Brook. This “C” segment has incised historically and is now experiencing major planform adjustment as it works to rebuild new floodplain. This segment generally has a healthy riparian buffer.

I. Protect River Corridor
