# Moretown, Vermont Phase 2 Stream Geomorphic Assessment & River Corridor Plan

April 20, 2018

Prepared by:  
Bear Creek Environmental, LLC  
149 State Street, Suite 3  
Montpelier, Vermont 05602

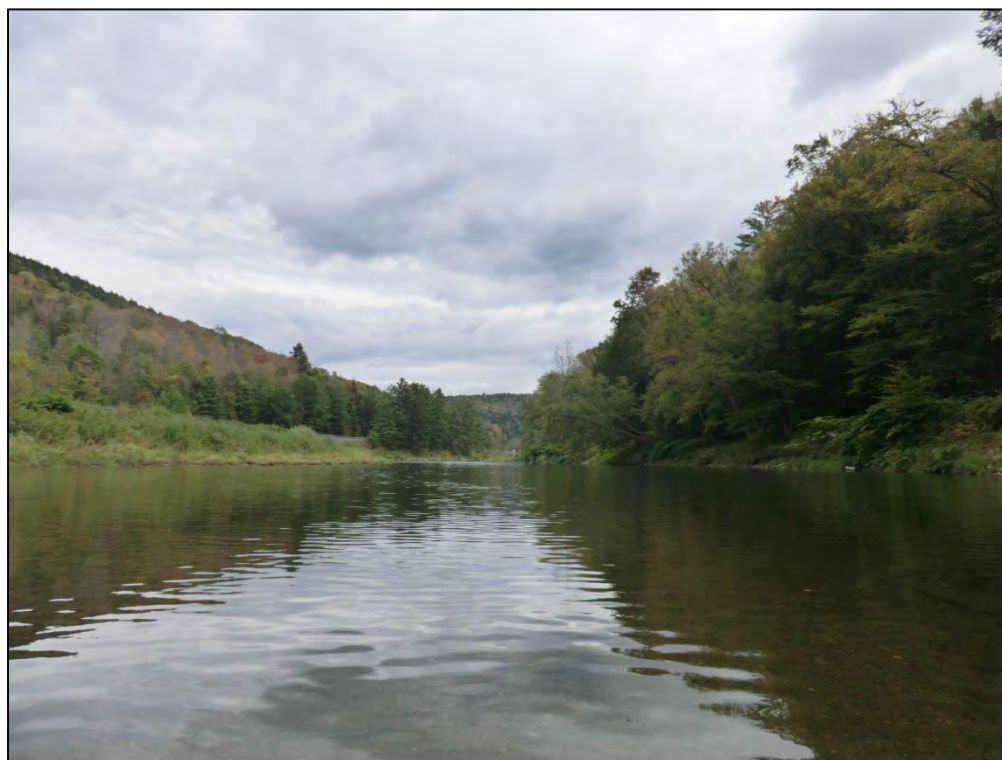
Reach 3 on the Mad River begins at the downstream end at the Moretown No. 8 hydroelectric dam and continues upstream to Kenneth Ward Park (Appendix C, Map 1). The reach is nearly 3,500 feet in length and the river flows along Vermont Route 100B. This reach was not segmented during the assessment. The Mad River in reach M03 is backwatered due to the presence of Moretown Dam No. 8 immediately downstream. For this reason, a full Phase 2 assessment could not be completed for M03. The river flows through a semi-confined valley in this reach. Impacts include a lacking riparian buffer due to the presence of RT 100B and stormwater inputs from the road. Bank armoring is present in some areas along RT 100B. Invasive Japanese knotweed is prevalent on both banks within this reach.

**Figure 5.1.** M03 looking downstream – impounded.

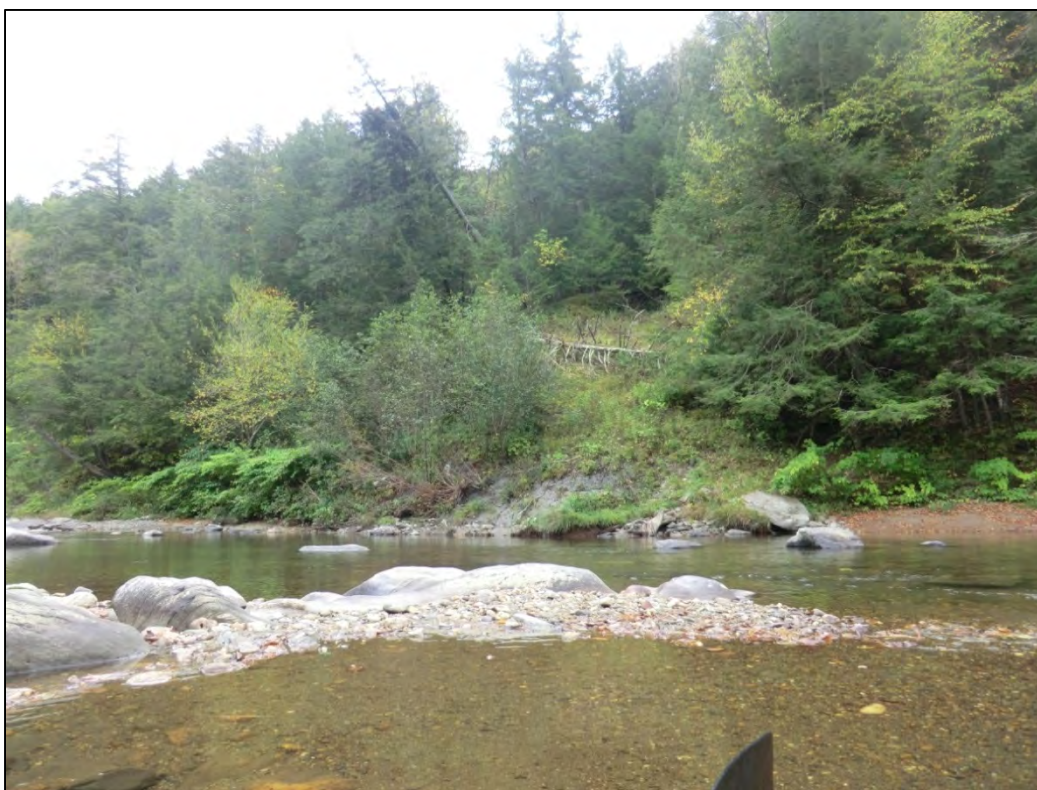
Reach 4 on the Mad River starts downstream at Kenneth Ward Park and continues upstream to just below the bridge on Bridge Road in Moretown (Appendix C, Map 2). The river flows along VT-100B, Spillway Road, as well as farms, houses, and forest for just over 9,000 feet. The river valley within M04 is semi-confined. This reach was not segmented during the Phase 2 assessment. The majority of the reach appears to have been historically straightened due to the presence of Route 100B and adjacent residential and agricultural land uses. This straightening led to minor historic incision; widening is possibly being prevented by bank armoring. Additional impacts in M04 include lacking buffer vegetation along the west side of the river due to the presence of VT-100B, houses, and farms, and several mass failures along the eastern valley wall. Bedrock is common on the bed in this reach, which may provide some vertical stability. M04 is in **good** geomorphic condition for these reasons. The reach is in **fair** habitat condition due to lacking large woody debris and bank and buffer vegetation on one bank.

**Figure 5.2.** Mass failures and bedrock are common in reach M04.

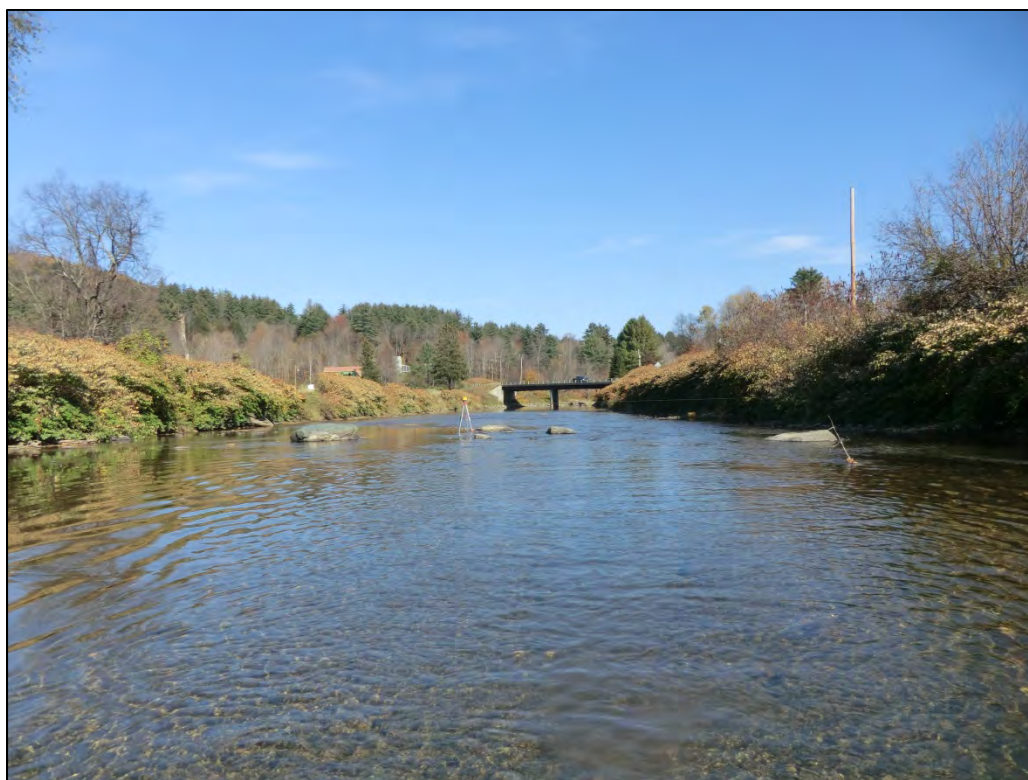
M06 is a 2,600 foot reach on the Mad River that begins roughly 600 feet downstream of the VT-100B bridge near Dickerson Road and ends 450 feet downstream of the Fletcher Road bridge (Appendix C, Map 3). This short reach flows through a broad valley, but due to the presence of 100B in the middle of the valley, the phase 2 valley type is semi-confined. The river for almost the entirety of this reach has been historically straightened due to the road and adjacent residential/agricultural land uses. Vegetation is lacking in the riparian buffers on both banks for most of the reach, and bank vegetation is dominated by invasive Japanese knotweed. Armoring is common along the east bank of the river, especially where it flows along 100B. Due to historic channel alterations, the river has undergone major incision in this reach, which has led to a stream type departure and loss of floodplain access. For this reason, M06 is in **fair** geomorphic condition. Similarly, M06 is in **fair** habitat condition, which is due to lacking large woody debris, poor instream cover for fish, and reduced/impacted bank and buffer vegetation.

**Figure 5.3.** M06 flows along VT-100B and was extensively historically straightened.

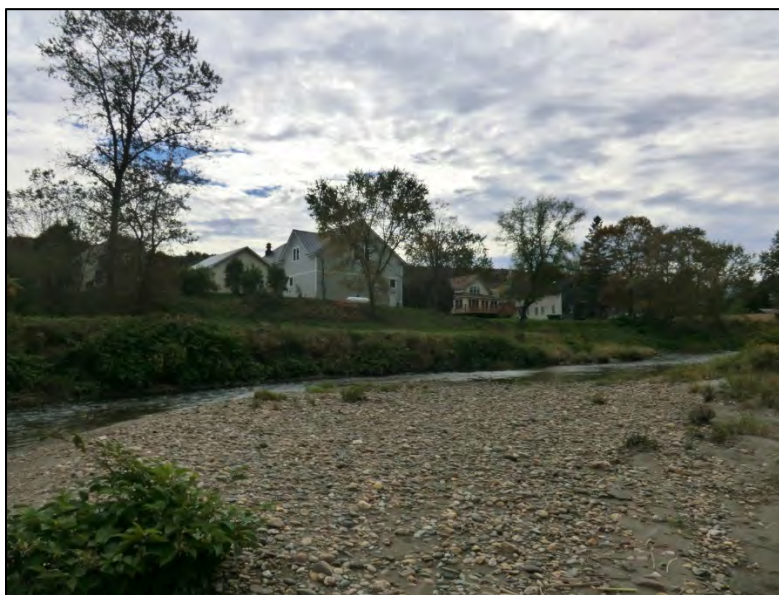
Reach 8 on the Mad River flows through the village of Moretown. It is approximately 1,500 feet long, beginning just above the Fletcher Road bridge at the confluence with Doctors Brook downstream and ending upstream approximately 1,200 feet below the Route 100B bridge near Old Gulf Road (Appendix C, Map 3). The river valley in this reach is naturally very broad, but Route 100B bisects it, creating a semi-confined phase 2 valley. Adjacent lands to the west of the river in this reach are primarily forested, while lands to the east are primarily residential, with several homes along Route 100B, as well as the Moretown library, firehouse, and elementary school. Riparian buffer vegetation is lacking for the entirety of the reach on the eastern side of the river due to several lawns. Japanese knotweed is prevalent along both banks of the river in this reach. There is a high terrace along the east side of the river. Bedrock gorges exist both immediately upstream and downstream of this reach, which provides vertical stability to M08. Further vertical adjustments of the river bed are unlikely due to these upstream and downstream grade controls. M08 is in **good** geomorphic condition as a result of this stability. The reach is in **fair** habitat condition because it is lacking large woody debris, and bank and buffer vegetation are either lacking or dominated by invasive species.

**Figure 5.4.** Residential land use adjacent to the river in M08 has resulted in poor riparian buffer vegetation.

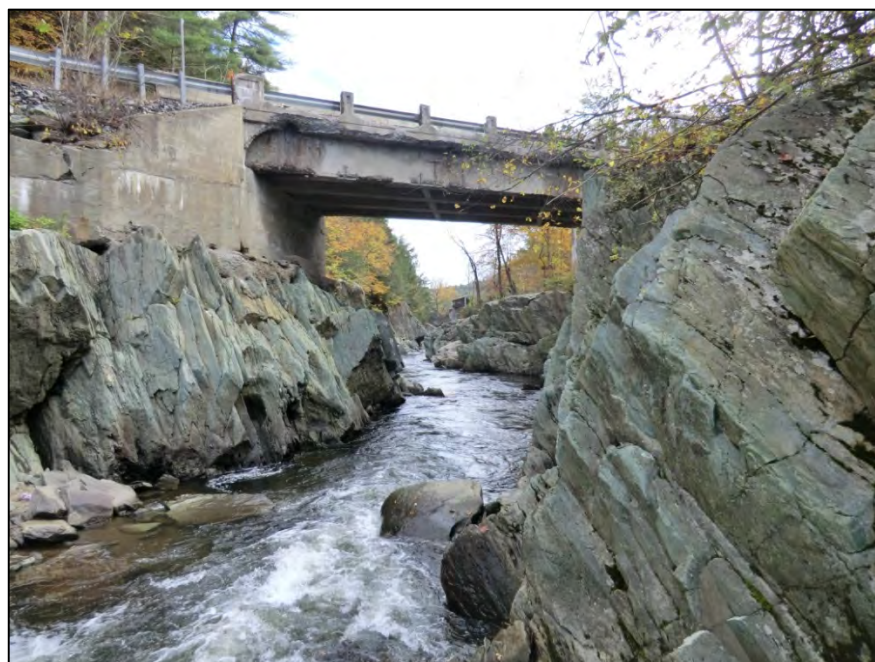
The downstream most segment on reach 9 is nearly 1,400 feet in length, and begins just upstream of the Moretown library and continues upstream to just above the Route 100B bridge near Old Gulf Road (Appendix C, Map 3). The Mad River flows through a bedrock gorge in segment A, and thus a full Phase 2 assessment could not be completed on this segment. It was unsafe to walk in the river within this segment; however, limited observations and impacts were recorded from the river bank. Bedrock is abundant both on the river bed and on the banks throughout this segment, providing both vertical and horizontal control for river adjustments. There is an old mill located on the south bank of the river within this segment. It was unsafe to assess the Route 100B bridge within this segment, but it was noted as being in poor condition. Administrative judgement data were collected for the segment, placing it in **good** geomorphic condition.

**Figure 5.5.** The Mad River flows through a bedrock gorge in M09-A.

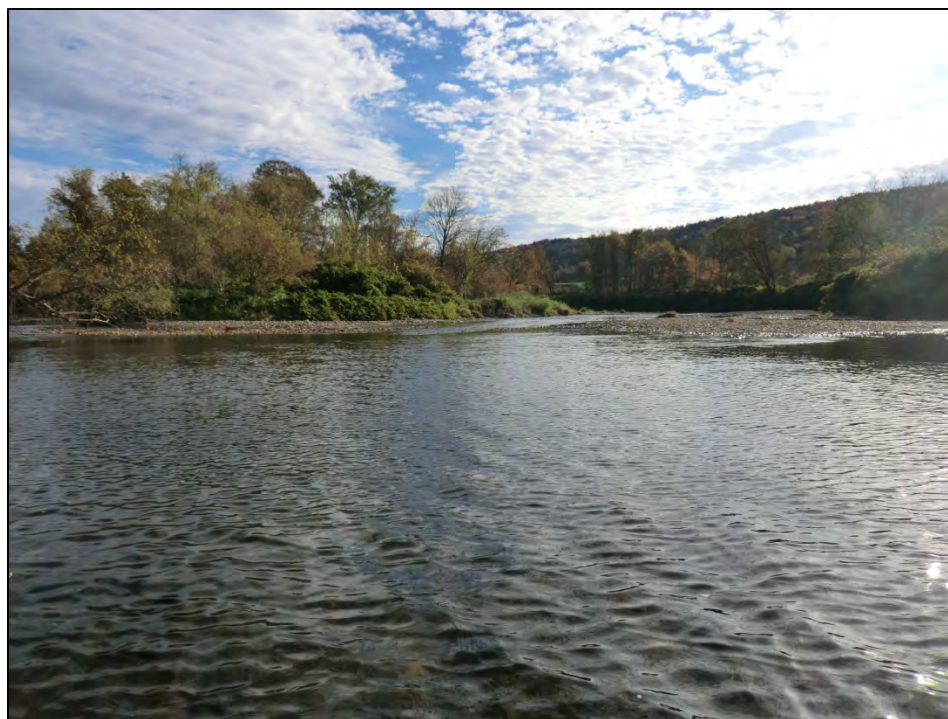
The upstream segment on reach M09 of the Mad River is roughly 1,800 feet in length, beginning just above the Route 100B bridge near Old Gulf Road and ending immediately upstream of the confluence of Dowsville Brook with the Mad River (Appendix C, Map 3). The river flows through a broad valley in this segment with adjacent agricultural and residential lands. This section of the Mad River is moderately sinuous and has several large aggradational features. Additionally, the river is exhibiting planform change in this segment via a flood chute and an impending *neck cutoff*. There is major erosion on both banks throughout the reach, especially on the outside of meander bends. Both streambanks are blanketed in Japanese knotweed. Major historic incision has occurred in this segment, which has resulted in a loss of floodplain access and a stream type departure. The river appears to be building a juvenile floodplain at a lower elevation. Due to these adjustments, M09-B was placed in **fair** geomorphic condition. The morphological characteristics of the river in this segment, as well as impacted banks and buffers, led to its placement in **fair** habitat condition.

**Figure 5.6.** Overly wide channel with abundant aggradation in M09-B.

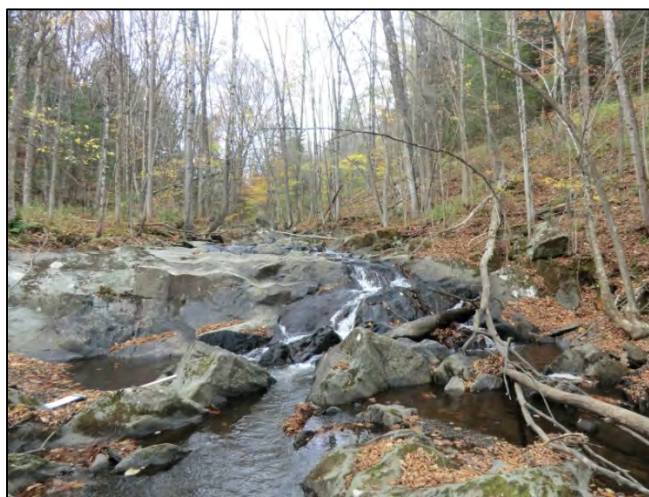
The downstream segment on reach 1 of Welder Brook begins at the confluence with the Mad River and continues upstream for roughly 2,500 feet to behind 445 Stevens Brook Road (Appendix C, Map 4). The segment is characterized by a step-pool bedform and abundant bedrock grade controls. Impacts within this segment are minimal and mostly relate to the presence of Stevens Brook Road along the north side of the stream channel. There are short sections of the brook that appear to have been straightened along the road, but for the most part, channel planform is natural. The abundant bedrock on the streambed in T1.01-A provides stability to the brook, which has not undergone incision or widening. T1.01-A is in **good** geomorphic condition for this stability and lack of impacts. Similarly, the segment is in **good** habitat condition, as it has a diversity of bed features, good instream cover, and mostly well forested buffers.

**Figure 5.7.** Bedrock grade controls are abundant in T1.01-A.

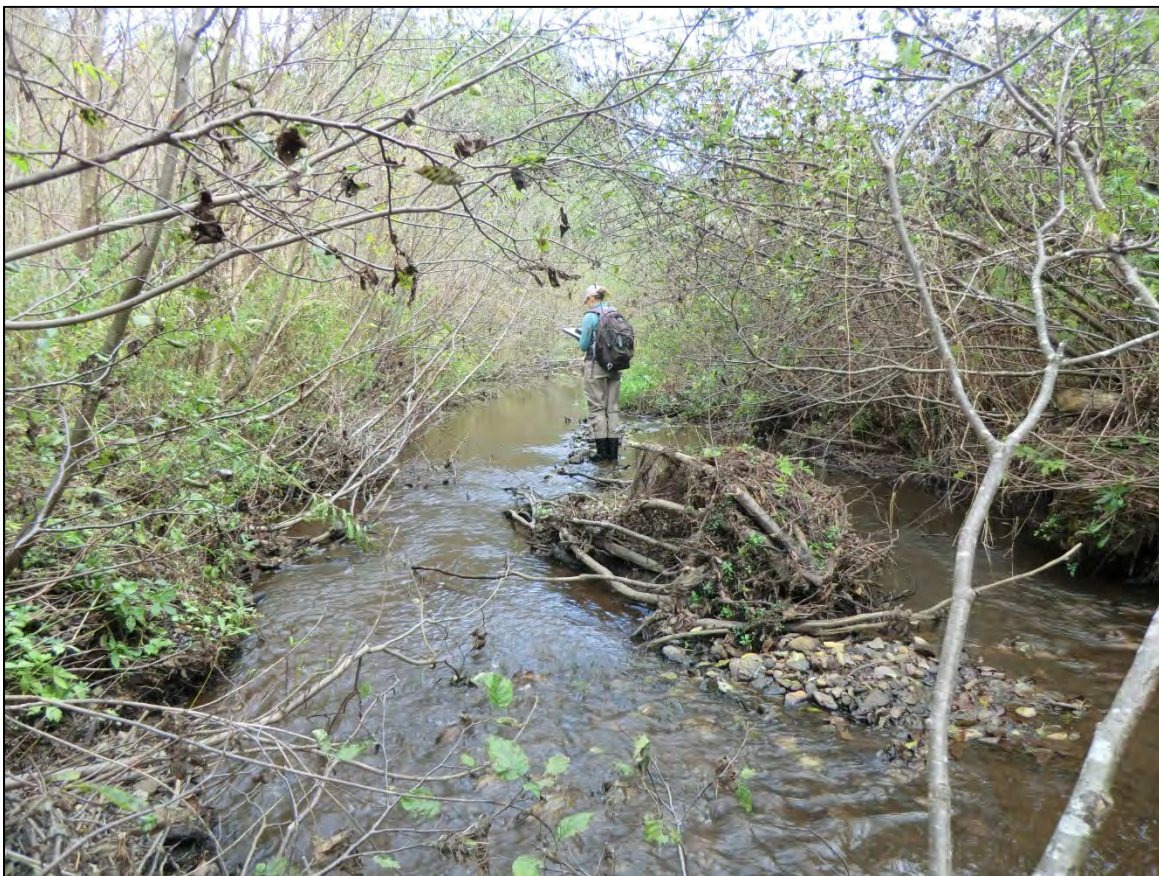
Segment B on reach one of Welder Brook is just over 1,200 feet in length and flows through a very broad valley (Appendix C, Map 4). This segment is within a large wetland complex and the brook has a low gradient, sinuous channel. The riparian buffers are well vegetated with shrub/sapling and herbaceous vegetation. There are multiple side channels and flood chutes throughout this segment where water spreads out as flows rise. Bank erosion is common, especially on outside meander bends, as are steep riffles. The brook has not incised in this segment, and human alteration is minimal. The planform is natural and floodplain connectivity is excellent. For these reasons, T1.01-B is in **good** geomorphic condition. The segment is also in **good** habitat condition, with its abundant large woody debris, diverse bed features, and well vegetated banks and buffers.

**Figure 5.8.** T1.01-B has a narrow, sinuous wetland channel.

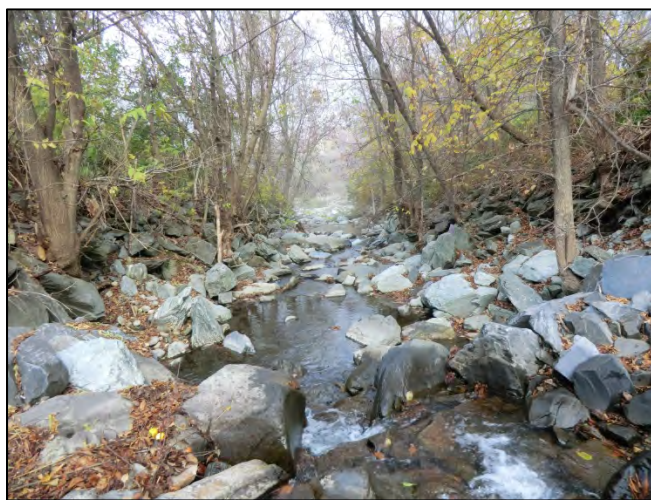
The lower segment on reach one of Doctors Brook is roughly 1,200 feet in length, ending just upstream of a private bridge (Appendix C, Map 3). The entirety of this segment appears to have been historically straightened due to the presence of houses and roads along its banks. This extensive straightening has led to major historic channel incision, a stream type departure, and a loss of floodplain access. Abundant bank armoring is preventing channel widening for much of this segment; however, areas that are not armored have severely eroding banks. Riparian buffers are lacking on both banks for most of the segment. For the aforementioned reasons, T2.01-A was placed in **poor** geomorphic condition. The segment is in **fair** habitat condition as a result of lacking large woody debris, altered channel planform, and impacted banks and buffers.

**Figure 5.9.** T2.01-A has been extensively straightened and riprapped.

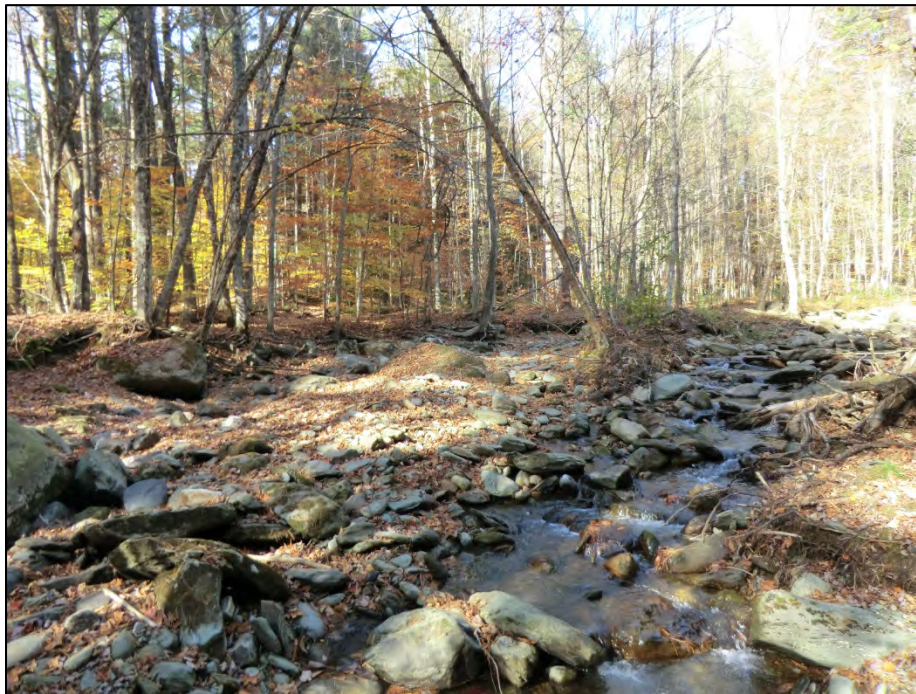
The upper segment on reach one of Doctors Brook is nearly 1,400 feet in length and flows through a forested, very broad valley (Appendix C, Map 3). The brook has a natural planform in this segment and minimal human alteration. A small section of historic channel straightening was observed at the downstream end of the segment, and another small area of channel alteration exists in the vicinity of a stream ford. Severe bank erosion was noted in this segment, especially on outside meander bends. Three mass failures were documented, the largest of which is located on the western bank of the brook toward the downstream end of the segment and is underlain by clay and sand. BCE observed one channel avulsion toward the upstream end of the segment where the brook appears to have formed a new primary flow path fairly recently. Severe historic incision was noted in this segment, which likely stems from the extensive historic channel alteration downstream in segment A. A stream type departure has occurred in T2.01-B, along with some loss of floodplain access. For these reasons, T2.01-B was placed in **fair** geomorphic condition. Despite channel adjustments and instability, there is abundant large woody debris and abundant pool features in this segment, as well as well forested banks and buffers. T2.01-B received a ranking of **good** for habitat condition.

**Figure 5.10.** Channel avulsion in T2.01-B.

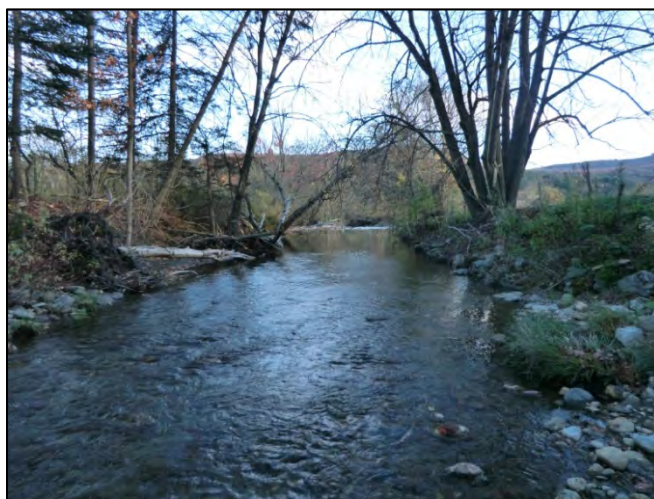
The downstream-most segment on reach one of Dowsville Brook is nearly 1,400 feet in length, extending from roughly 500 feet upstream of the Route 100B bridge downstream to the confluence with the Mad River (Appendix C, Map 5). Adjacent lands to this segment of the brook are primarily agricultural. Because of this, riparian buffer vegetation is lacking on both sides of the brook for much of the segment. The majority of T3.01-A appears to have been historically straightened due to the presence of the Route 100B crossing and surrounding agricultural lands. This historic straightening has led to channel incision, widening, and a departure from reference stream type. Due to these impacts and adjustments, T3.01-A is in **fair** geomorphic condition. Channel alterations and reduced bank and buffer vegetation led to the placement of T3.01-A in in **fair** habitat condition.

**Figure 5.11.** Straightened channel in T3.01-A.

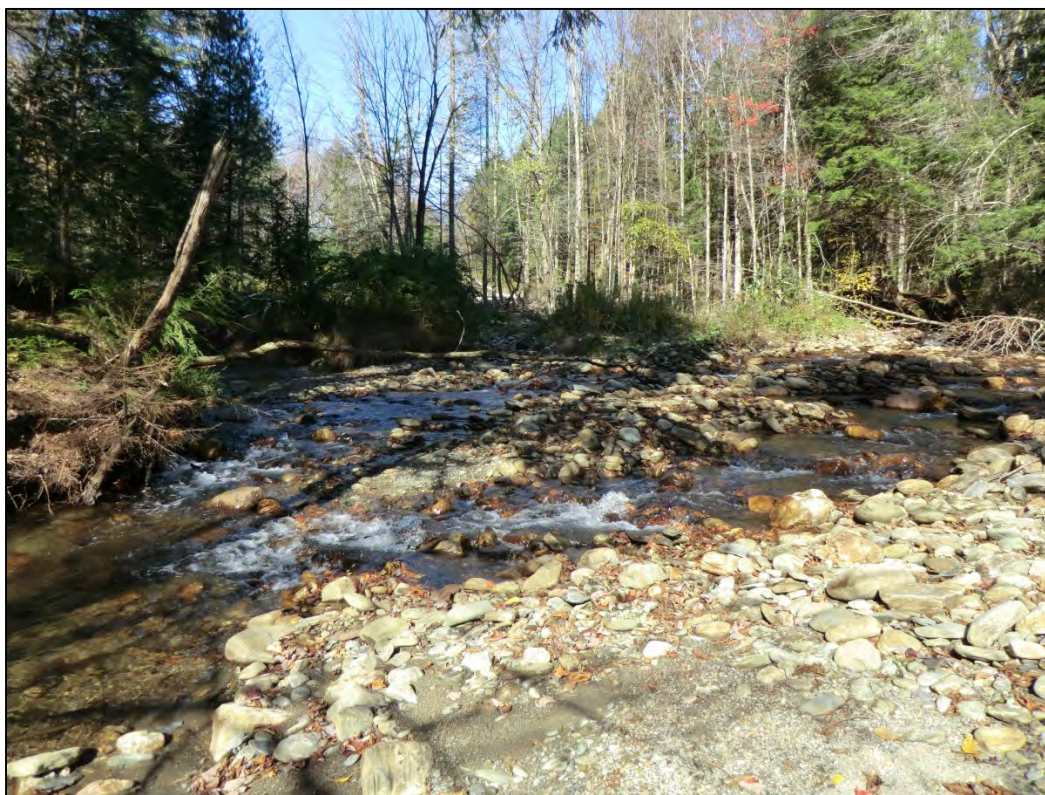
Segment B on reach one of Dowsville Brook is nearly 3,600 feet in length, beginning about 500 feet above the Route 100B bridge and ending upstream about 500 feet below the Route 100 bridge (Appendix C, Map 5). The brook flows through forested land in this segment and has minimal channel alteration. T3.01-B has undergone major aggradation and channel widening, leading to planform change. The channel is braided at low flows at some locations in this segment, but there are side channels and flood chutes throughout the segment, creating braiding at higher flows as well. Bank erosion is common on the outside of meander bends. Debris jams are abundant and are also contributing to planform change within T3.01-B. This segment is in **fair** geomorphic condition due to the major adjustments it is undergoing. The brook has abundant large woody debris and pools, as well as well forested banks and buffers. T3.01-B is in **good** habitat condition.

**Figure 5.12.** Aggradation and low flow braiding in T3.01-B.

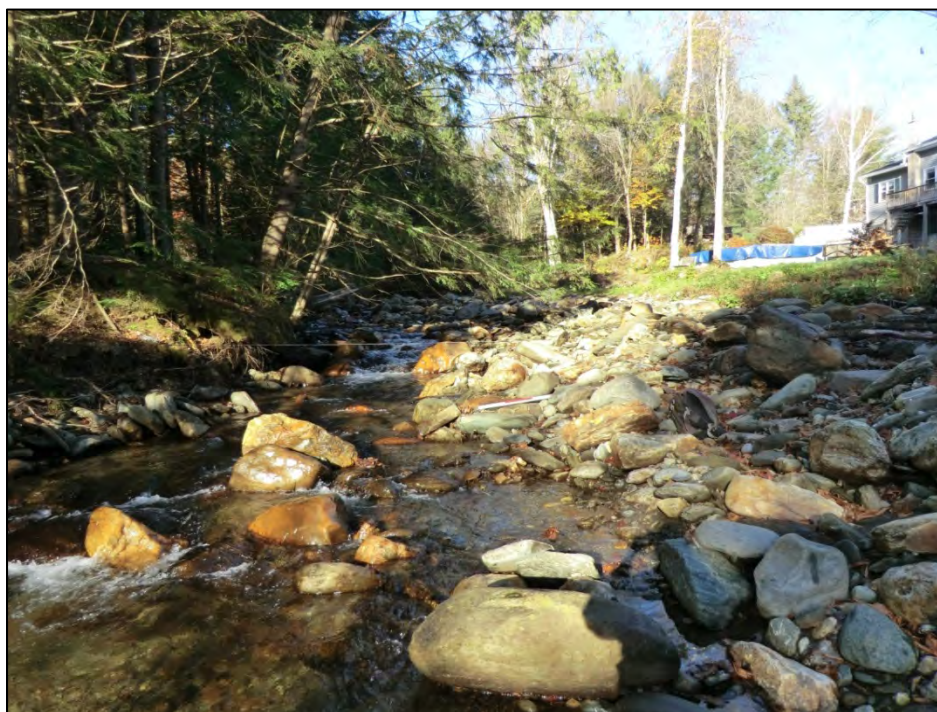
The upstream most segment on reach one of Dowsville Brook is characterized as having a higher slope than the downstream segments. This nearly 2,500 foot segment is located in Duxbury and flows through forested and residential land from just downstream of the Route 100 bridge upstream to near the cul-de-sac on Clark Road (Appendix C, Map 5). Historic and recent channel alterations were observed during the Phase 2 assessment, including channel straightening, dredging, windrowing, and berms. The uppermost portion of this segment has a higher slope than the rest of the segment, which is flatter and has large depositional features. Large flood chutes are present throughout the segment, contributing to planform adjustment. Sections of the brook appear to have been historically straightened behind several of the homes on Clark Road. Historic and recent berms, windrowing, and dredging were observed in the lower half of the segment above the Route 100 bridge. Major incision has occurred in this segment, though it has not led to a stream type departure. T3.01-C is in **fair** geomorphic condition and **fair** habitat condition due to the aforementioned alterations and adjustments, as well as impacted riparian buffers.

**Figure 5.13.** T3.01-C at cross section location.

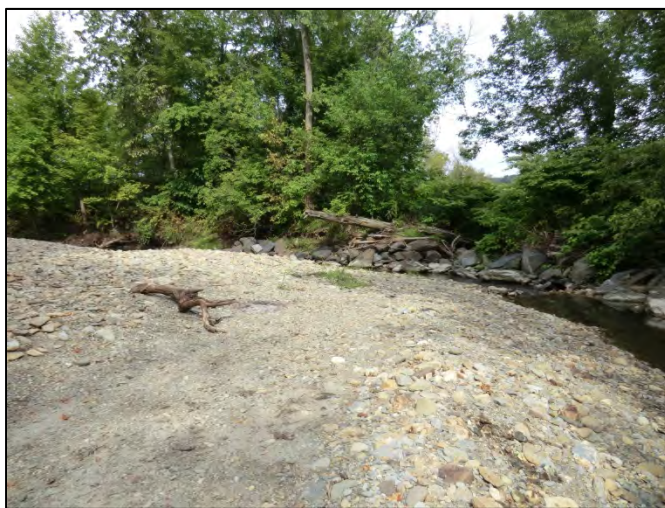
The downstream most segment on reach one of Jones Brook is approximately 2,300 feet in length, beginning roughly 700 feet above the Three Mile Bridge Road bridge at the upstream end and flowing downstream to the confluence with the Winooski River (Appendix C, Map 6). R16.S2.01-A flows through a very broad valley along several corn fields. Most of the segment appears to have been historically straightened due to the surrounding land use. Historic incision occurred within this segment and channel widening is actively occurring. Riprap is abundant along both banks, but bank erosion is occurring where riprap is not present. Some planform change was noted in the form of flood chutes. Lateral adjustments are being limited by bank armoring. R16.S2.01-A is in **fair** geomorphic condition for these reasons. The brook is also in **fair** habitat condition in this segment due to its altered planform, as well as lacking bank and buffer vegetation. Japanese knotweed is prevalent along both banks.

**Figure 5.14.** Large bar and riprapped bank in R16.S2.01-A.

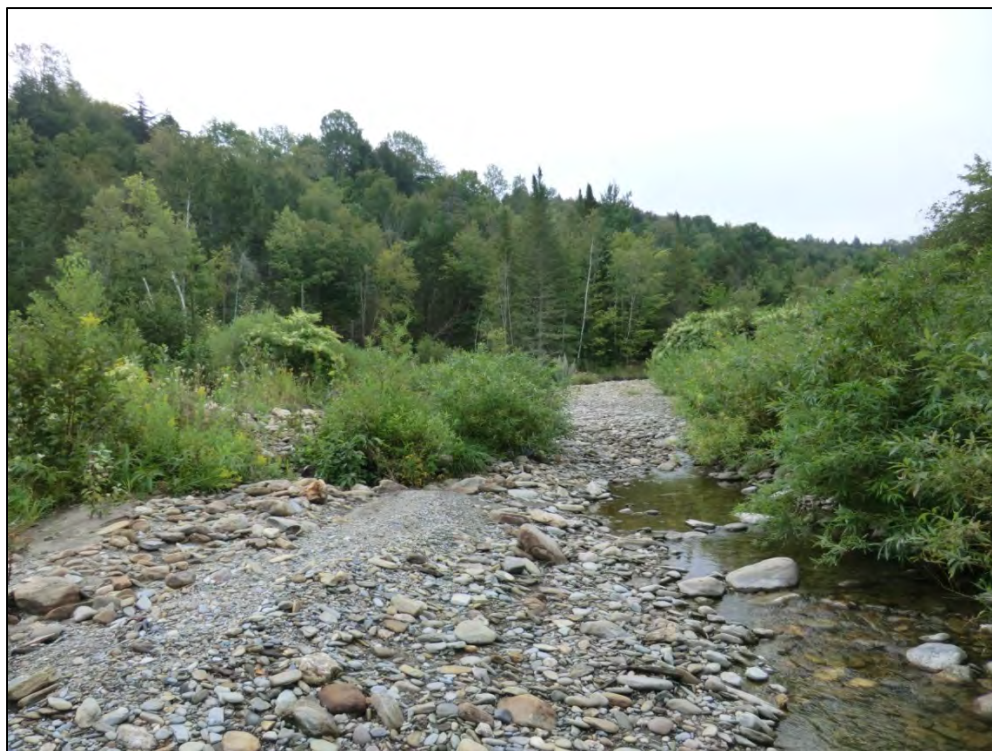
Segment B on reach one of Jones Brook is roughly 1,200 feet in length (Appendix C, Map 6). This segment differs from segments A and C primarily in channel planform and dimensions. R16.S2.01-B is characterized by abundant large depositional features, creating an extremely wide channel and low flow braiding conditions. There are several flood chutes and side channels that appear to be wetted at various flow conditions (including low flow). There are few human impacts to the brook within this segment, which include one stream ford and a very short section of minor windrowing just upstream of the ford. There is a major gully coming off of the east valley wall within this segment that may contribute large amounts of fine sediment to the brook. The source of the gully is unknown though it appears to originate in a clearing upslope and may be related to logging activities. The brook is part of a naturally very dynamic system. R16.S2.01-B is in **fair** geomorphic condition as a result of its abundant adjustments. Similarly, the brook is in **fair** habitat condition within this segment due to lacking instream cover and its hydrologic conditions that create a shallow channel without a diversity of bed features.

**Figure 5.15.** There is major aggradation and braiding in R16.S2.01-B.

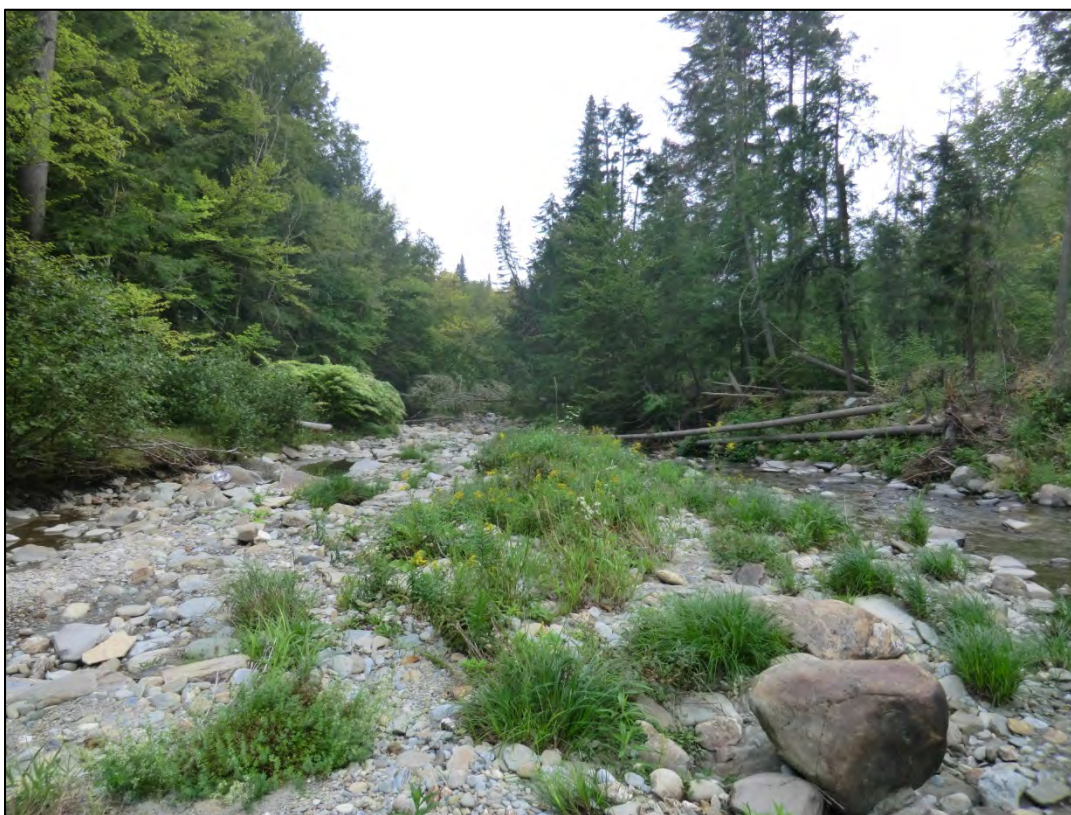
The upstream most segment on reach one of Jones Brook is just over 900 feet in length and flows through a narrower, steeper valley than the two downstream segments (Appendix C, Map 6). The brook is characterized by a naturally straight channel with large substrate. The brook has undergone historic incision and recent channel widening, which has led to a stream type departure. Large bars are present at the downstream end of the segment. It appears that the brook has been minimally altered, as it flows through the woods away from development along Jones Brook Road. R16.S2.01-C is in **fair** geomorphic condition as a result of historic and recent channel adjustments. The brook is also in **fair** habitat condition for many reasons, including lacking pool features, unstable banks, and a wide channel with mostly shallow water.

**Figure 5.16.** Wide, straight channel in R16.S2.01-C.

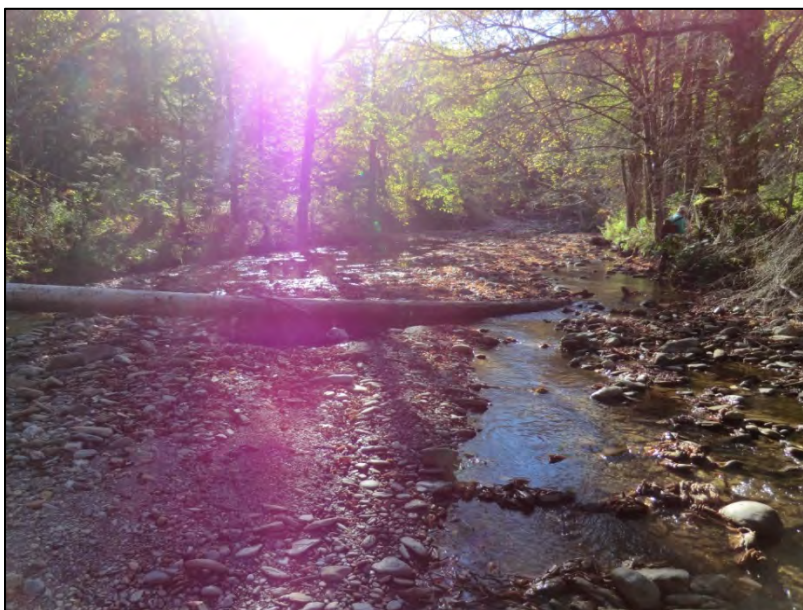
The downstream most segment on reach two of Jones Brook flows through a narrow valley in the Town of Berlin. The downstream half of the segment flows through the woods, while the upstream half flows through a residential area along the west bank of the brook (Appendix C, Map 6). Aggradation is a major process that is currently occurring within R16.S2.02-A. Numerous large bars are present throughout the segment causing the formation of steep riffles and channel widening. Although moderate historic incision has occurred within this segment, floodplain access is still mostly intact. Riparian buffers are lacking in the vicinity of two houses along the western bank of Jones Brook. Bank erosion is common along both banks within this segment, which provides further evidence that channel widening is occurring, and four mass failures are present. R16.S2.02-A is in **fair** geomorphic condition as a result of historic and active channel adjustments. This segment is also in **fair** habitat condition due to such factors as lacking instream cover, reduced bank and buffer vegetation, and lacking pool features.

**Figure 5.17.** Aggradation is a major process currently occurring within R16.S2.02-A.

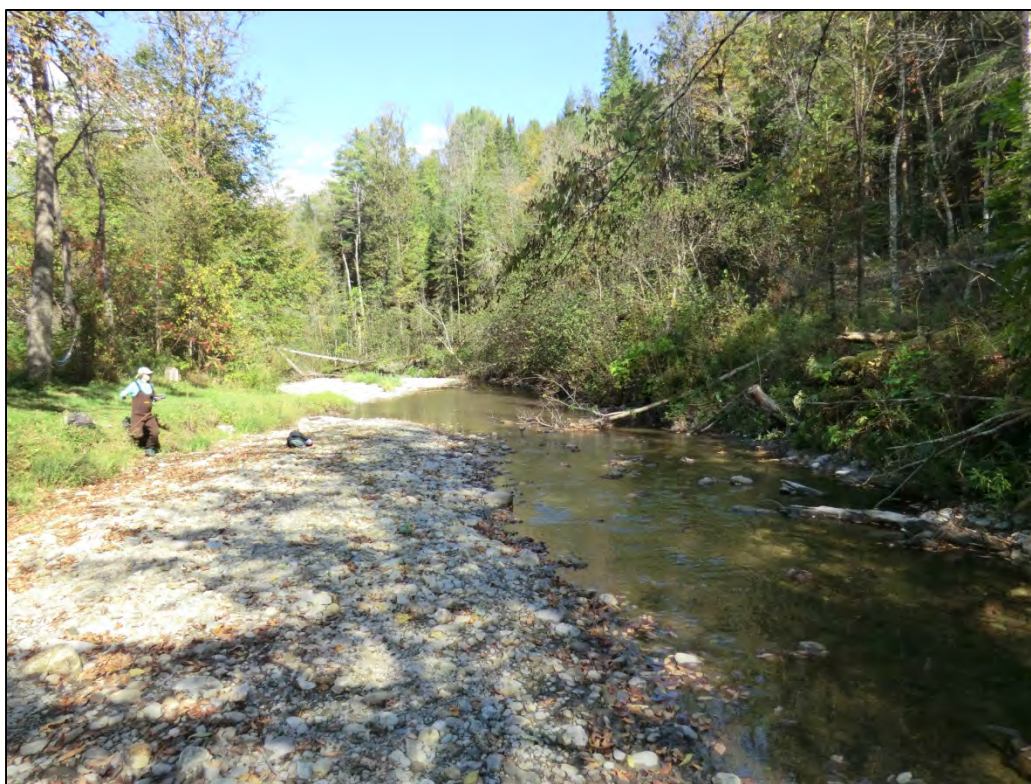
Segment B on reach two of Jones Brook is a short segment – only roughly 900 feet in length and is located in Berlin. The brook flows through a slightly wider valley in this segment than downstream and has more channel alteration due to the presence of residences on both sides of the brook (Appendix C, Map 6). Much of the segment appears to have been historically straightened up against the eastern valley wall due to residential land use on the west. Buffer vegetation is lacking for most of the segment on the western side of the brook, but also for a small section on the eastern side. The historic straightening in this segment appears to have led to major historic incision, resulting in a stream type departure and loss of floodplain access. Major aggradation has also occurred within this segment, as evidenced by several large bar features. For these reasons, R16.S2.02-B is in **fair** geomorphic condition. The segment is also in **fair** habitat condition as a result of lacking instream cover and pool habitat, channel adjustments that have created a wide, shallow channel, and lacking bank and buffer vegetation.

**Figure 5.18.** Wide, depositional channel in R16.S2.02-B.

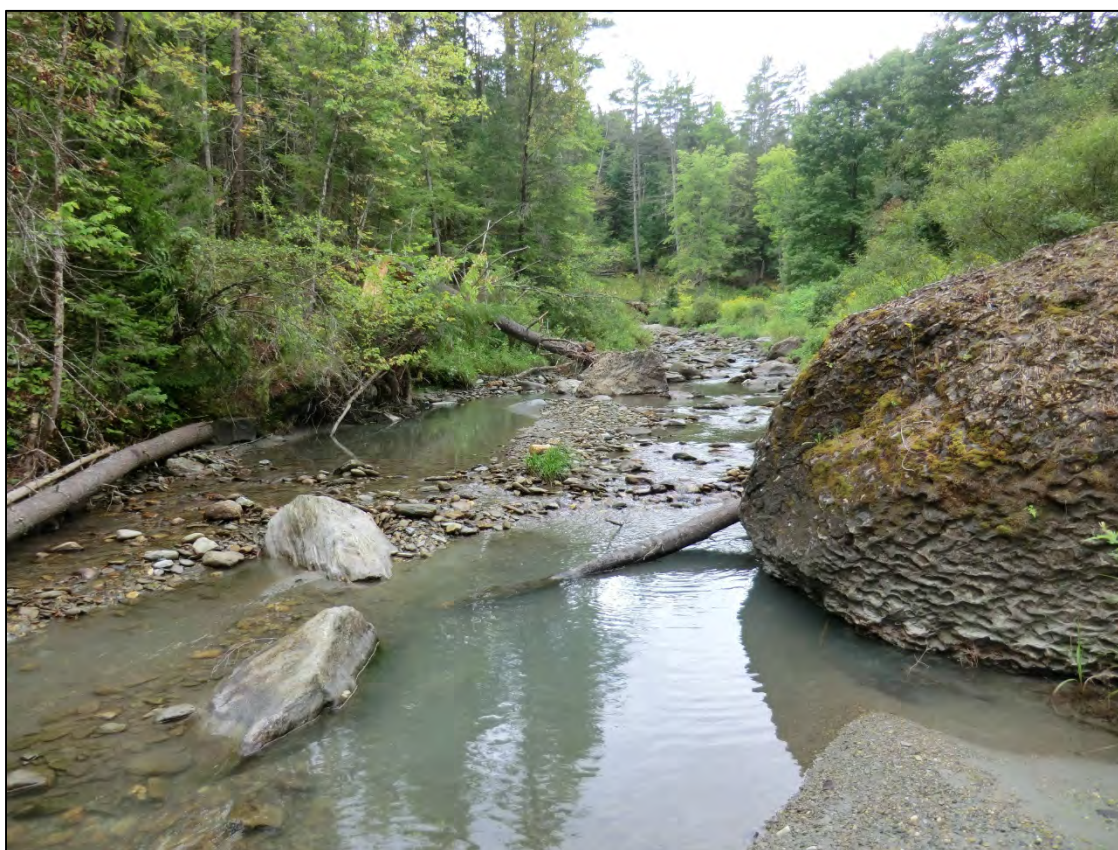
Segment C on reach two of Jones Brook flows through a narrower valley than the adjacent segments. It is roughly 1,200 feet in length and flows mostly through the woods along Jones Brook Road (Appendix C, Map 7). The lower end of the segment is in Berlin, while the upstream end is in Moretown. Very few channel alterations were observed within this segment, which has a mostly natural planform. Moderate historic incision was noted at the cross section for R16.S2.02-C, as well as minor widening. A few areas of bank erosion were noted in this segment, particularly on the eastern bank. Due to historic and recent channel adjustments, this segment was placed in **fair** geomorphic condition. R16.S2.02-C lacked large woody debris at the time of the assessment. Hydrologic characteristics and impacted bank and buffer vegetation on one side of the channel also contributed to the segment being placed in **fair** habitat condition.

**Figure 5.19.** R16.S2.02-C has a narrower valley and is naturally more entrenched than downstream segments.

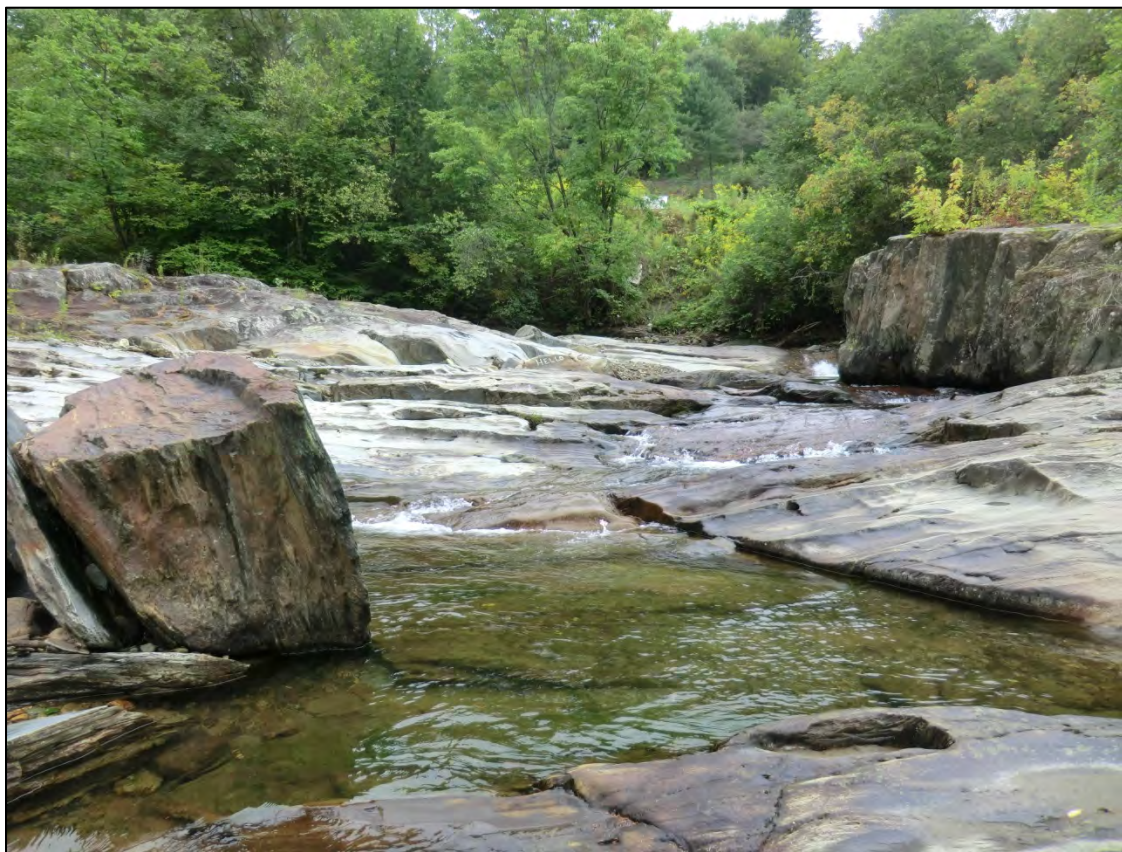
Segment D on R16.S2.02 is very short, only 584 feet in length. This segment flows through the woods and has a large bedrock grade control at its downstream end (Appendix C, Map 7). This grade control provides vertical stability to the channel within R16.S2.02-D, which has prevented major channel incision. Jones Brook upstream of the bedrock grade control appears to be undergoing minor channel widening with extensive bank erosion along the west bank. Overall, R16.S2.02-D was reported to be in **good** geomorphic condition due to only minor channel adjustments. Similarly, segment D was placed in **good** habitat condition, as it has good instream cover, a diversity of bed features, and mostly well vegetated banks and buffers.

**Figure 5.20.** Large bedrock grade control at the downstream end of R16.S2.02-D.

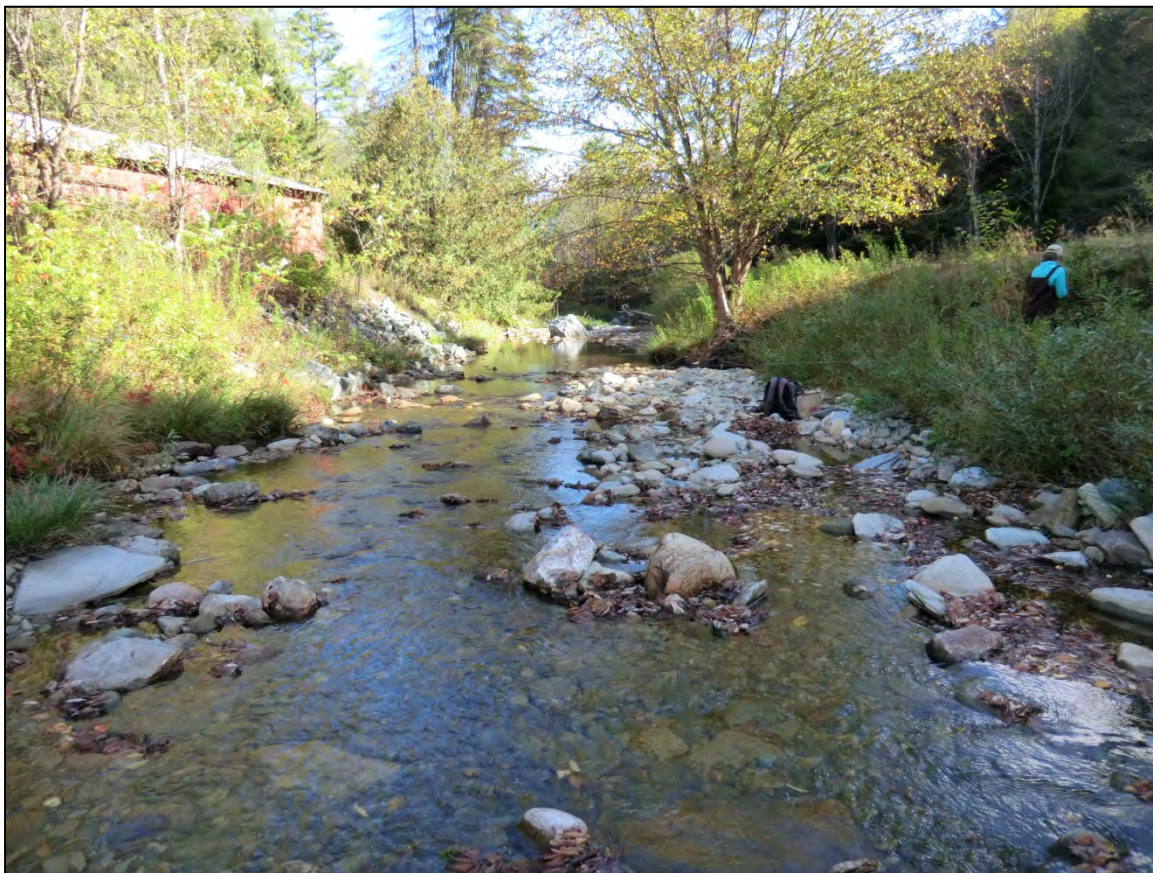
The upstream most segment on reach two of Jones Brook is nearly 700 feet in length, and flows through primarily residential land along Jones Brook Road (Appendix C, Map 7). This land use appears to have resulted in historic straightening for the entirety of this segment. Severe historic incision has occurred within R16.S2.02-E, causing a stream type departure and loss of floodplain access. Some channel widening is occurring, though it is limited in some locations due to riprap. Riparian buffer vegetation is lacking along the western side of Jones Brook for the whole segment. R16.S2.02-E is in **fair** geomorphic condition due to extensive historic channel alteration and severe historic incision. Large woody debris, bed features, and bank and buffer vegetation are lacking, which resulted in the placement of the segment in **fair** habitat condition.

**Figure 5.21.** Jones Brook has a straight and severely incised channel in R16.S2.02-E.

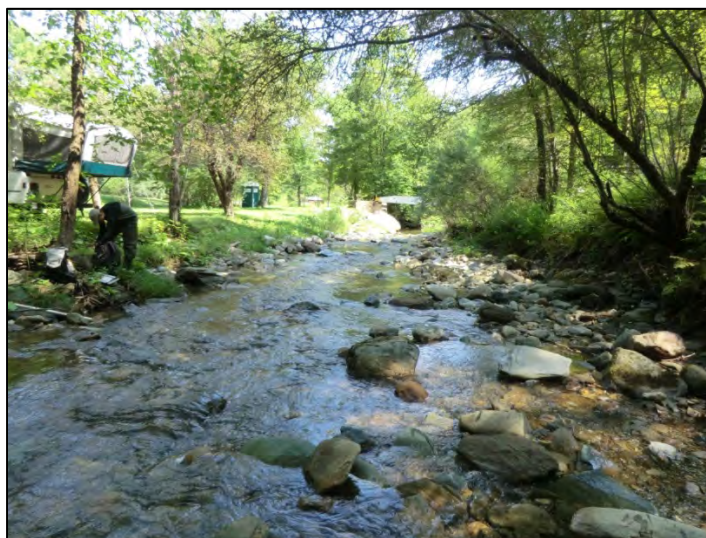
The downstream most segment on reach three of Jones Brook is just over 800 feet in length, beginning at the confluence with Kelley Brook downstream and ending upstream where the brook flows away from Jones Brook Road (Appendix C, Map 7). This segment has a very broad valley by reference; however, the valley is bisected by Jones Brook Road, which functionally narrows the valley. All of segment A appears to have been historically straightened due to the placement of Jones Brook Road in the western corridor and a house on the east of the brook. Despite this historic straightening, minimal channel incision has occurred within R16.S2.03-A. Bedrock grade controls exist both upstream and downstream of this segment, which may contribute to the vertical stability within the segment. Similarly, aggradation, widening, and planform change are minimal in this segment. A geomorphic condition of **good** was given to this segment for this lack of channel adjustments and the segment's relative stability. R16.S2.03-A ranked **fair** for habitat condition for the brook's lack of large woody debris, its altered planform, and lacking bank and buffer vegetation.

**Figure 5.22.** R16.S2.02-A looking downstream at the cross section location.
