# Moretown, Vermont Phase 2 Stream Geomorphic Assessment & River Corridor Plan

April 20, 2018

Prepared by:  
Bear Creek Environmental, LLC  
149 State Street, Suite 3  
Montpelier, Vermont 05602

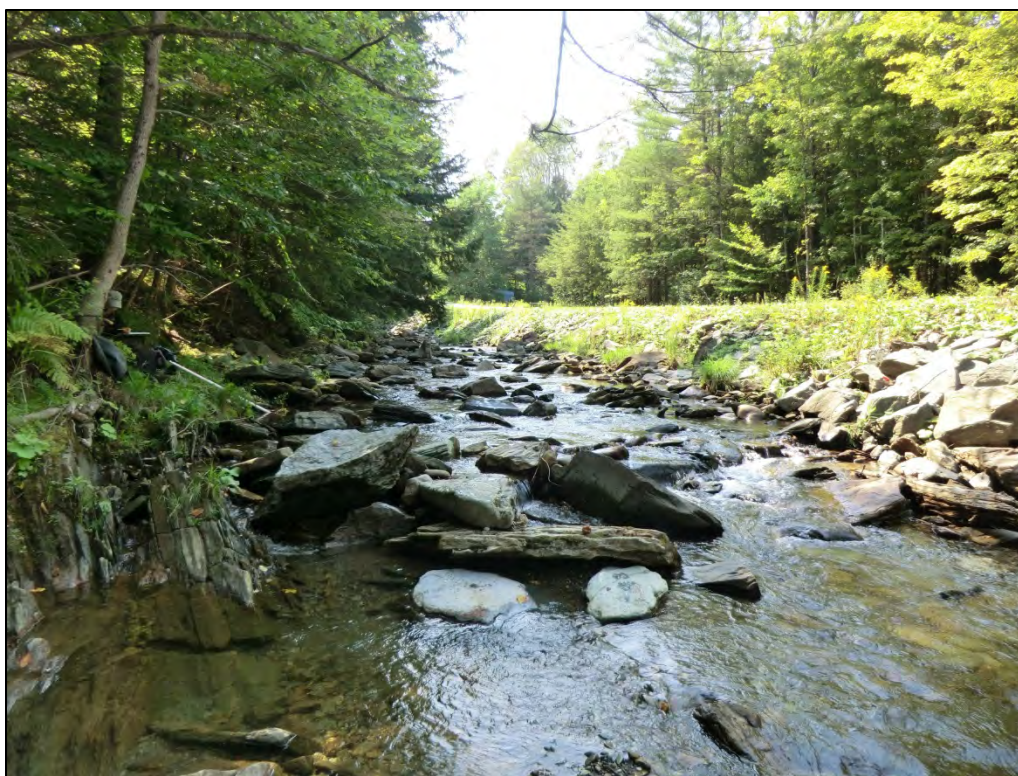
The second segment on reach three of Jones Brook is characterized by major channel encroachment by Jones Brook Road. This very short segment (just over 400 feet in length) flows directly along the road (Appendix C, Map 7). The brook has been straightened along the eastern valley wall for nearly the entire segment and is currently trapped between the road and valley wall. There is a major human caused change in valley width in this segment due to the presence of Jones Brook Road. Extensive bank armoring is present along the road. The road encroachment creates a human elevated floodplain and a high incision ratio, and has resulted in loss of floodplain access and a stream type departure. Lateral channel adjustments are being prevented by the bank armoring present on the west side of the channel and the valley wall immediately on the east. R16.S2.03-B is in **fair** geomorphic condition for these reasons. The straightened channel in this segment lacks large woody debris, pool features, and bank and buffer vegetation on one side. For these reasons, R16.S2.03-B is also in **fair** habitat condition.

**Figure 5.23.** R16.S2.03-B has been extensively straightened along Jones Brook Road.

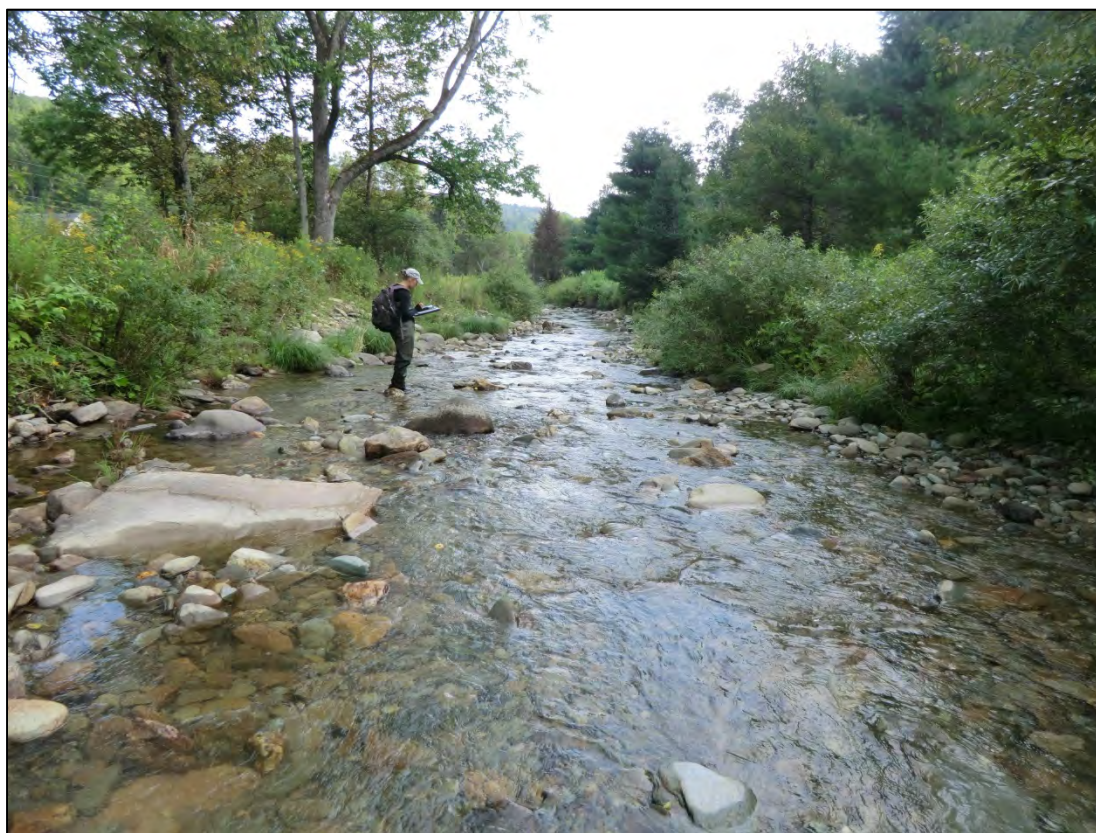
The upstream most segment on reach three of Jones Brook is the longest, at 2,100 feet. Jones Brook appears to have been historically straightened for the entire length of this segment due to several houses along Jones Brook Road (Appendix C, Map 7). Five ledge grade controls are present in the middle and at the downstream end of this segment, which afford the channel some vertical stability. Moderate historic incision has occurred within R16.S2.03-C likely as a result of channel alteration. Widening is currently occurring as evidenced through abundant bank erosion. Riparian buffer vegetation is lacking for about half of the segment. R16.S2.03-C is in **fair** geomorphic condition and **fair** habitat condition.

**Figure 5.24.** Straight channel in R16.S2.03-C.

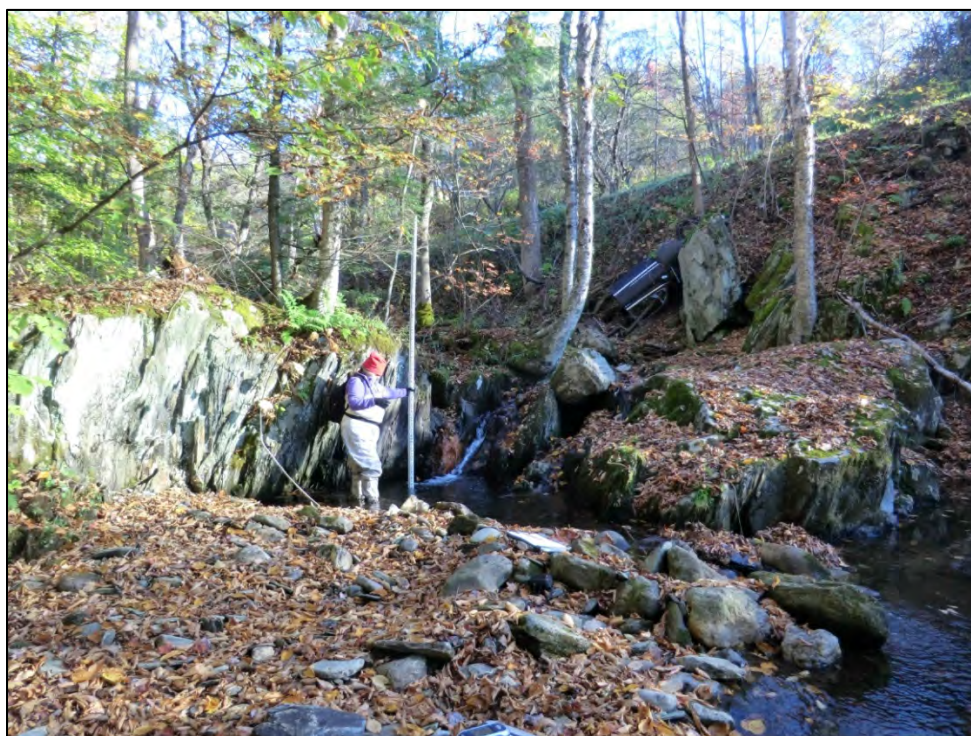
The upstream segment on reach one of Kelley Brook is similar to segment A but has a narrower valley and is less incised. This segment is just over 3,600 feet in length beginning downstream about 1,400 feet above the culvert at 360 Ward Brook Road and ending upstream near 1309 Ward Brook Road (Appendix C, Map 8). More than half of this segment has been historically straightened due to the placement of Ward Brook Road and houses along it. Bank armoring and lacking buffers are common along this stretch of the brook, especially where it flows adjacent to the road. Bedrock grade controls are abundant within this segment (fifteen in total), which offer the brook vertical stability. Despite extensive straightening, R16.S2.02-S1.01-B has overall not undergone incision, likely due to the abundance of bedrock grade controls. The segment scored **reference** for geomorphic condition as a result of its lack of adjustments. R16.S2.02-S1.01-B is in **good** habitat condition and has a diversity of bed features including large woody debris and pools.

**Figure 5.26.** Bedrock grade controls are abundant in this segment.

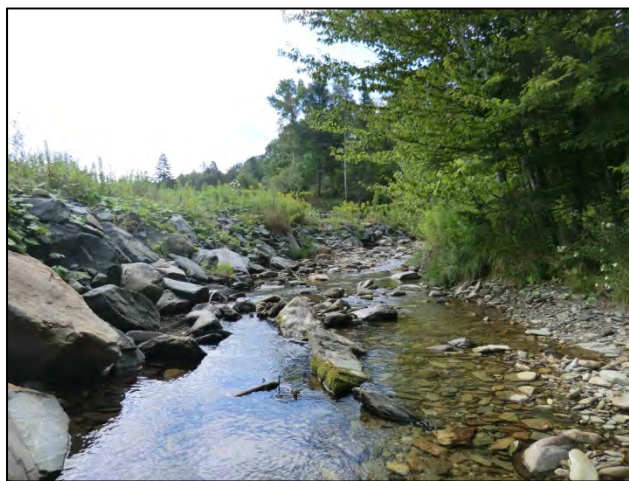
Segment A is the downstream most segment on reach one of Herring Brook. The segment begins at the confluence with Jones Brook and extends upstream for just over 800 feet to where the brook enters the woods (Appendix C, Map 9). This segment is characterized by extensive historic channel straightening due to the presence of a house and Jones Brook Road within the river valley. This channel straightening has led to major historic incision. Bank armoring is also extensive in R16.S2.03-S1.01-A and is preventing the channel from widening, creating a deep and narrow channel. A stream type departure has occurred in segment A due to the historic incision and boundary conditions preventing channel evolution. R16.S2.03-S1.01-A is in **fair** geomorphic condition for the aforementioned reasons. Similarly, this segment is in **fair** habitat condition due to a lack of bed features caused by extensive straightening, lacking large woody debris, altered channel planform, and poorly vegetated banks and buffers.

**Figure 5.27.** Extensive riprap and straightening in R16.S2.03-S1.01-A.

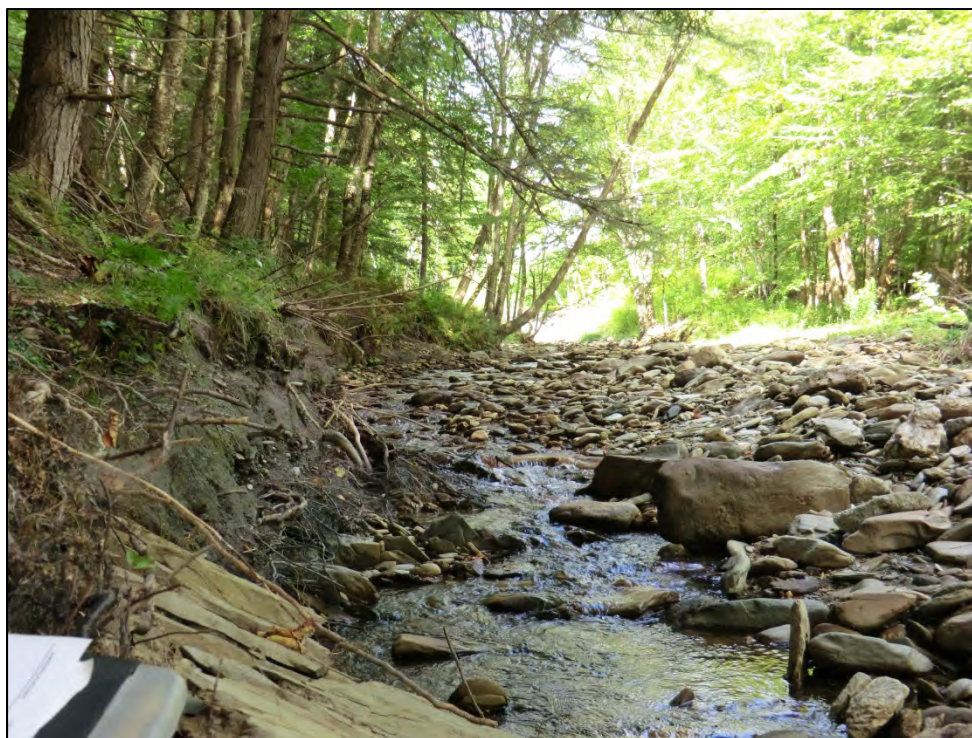
**Figure 5.28.** Headcut in R16.S2.03-S1.01-B.

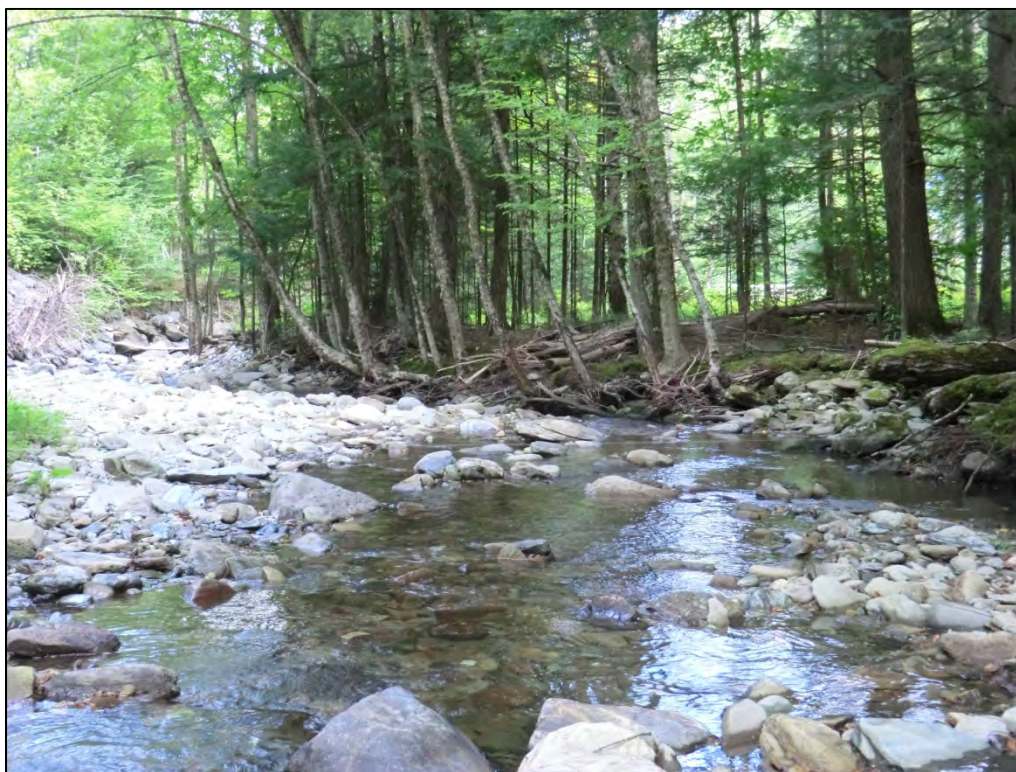
**Figure 5.28.** Downstream view at cross section in R16.S2.03-S1.01-C.
