# **Fluvial Geomorphology Assessment of the Mad River Watershed, Vermont**

Prepared for

Friends of the Mad River  
Waitsfield, VT

Field Geology Services  
Farmington, ME

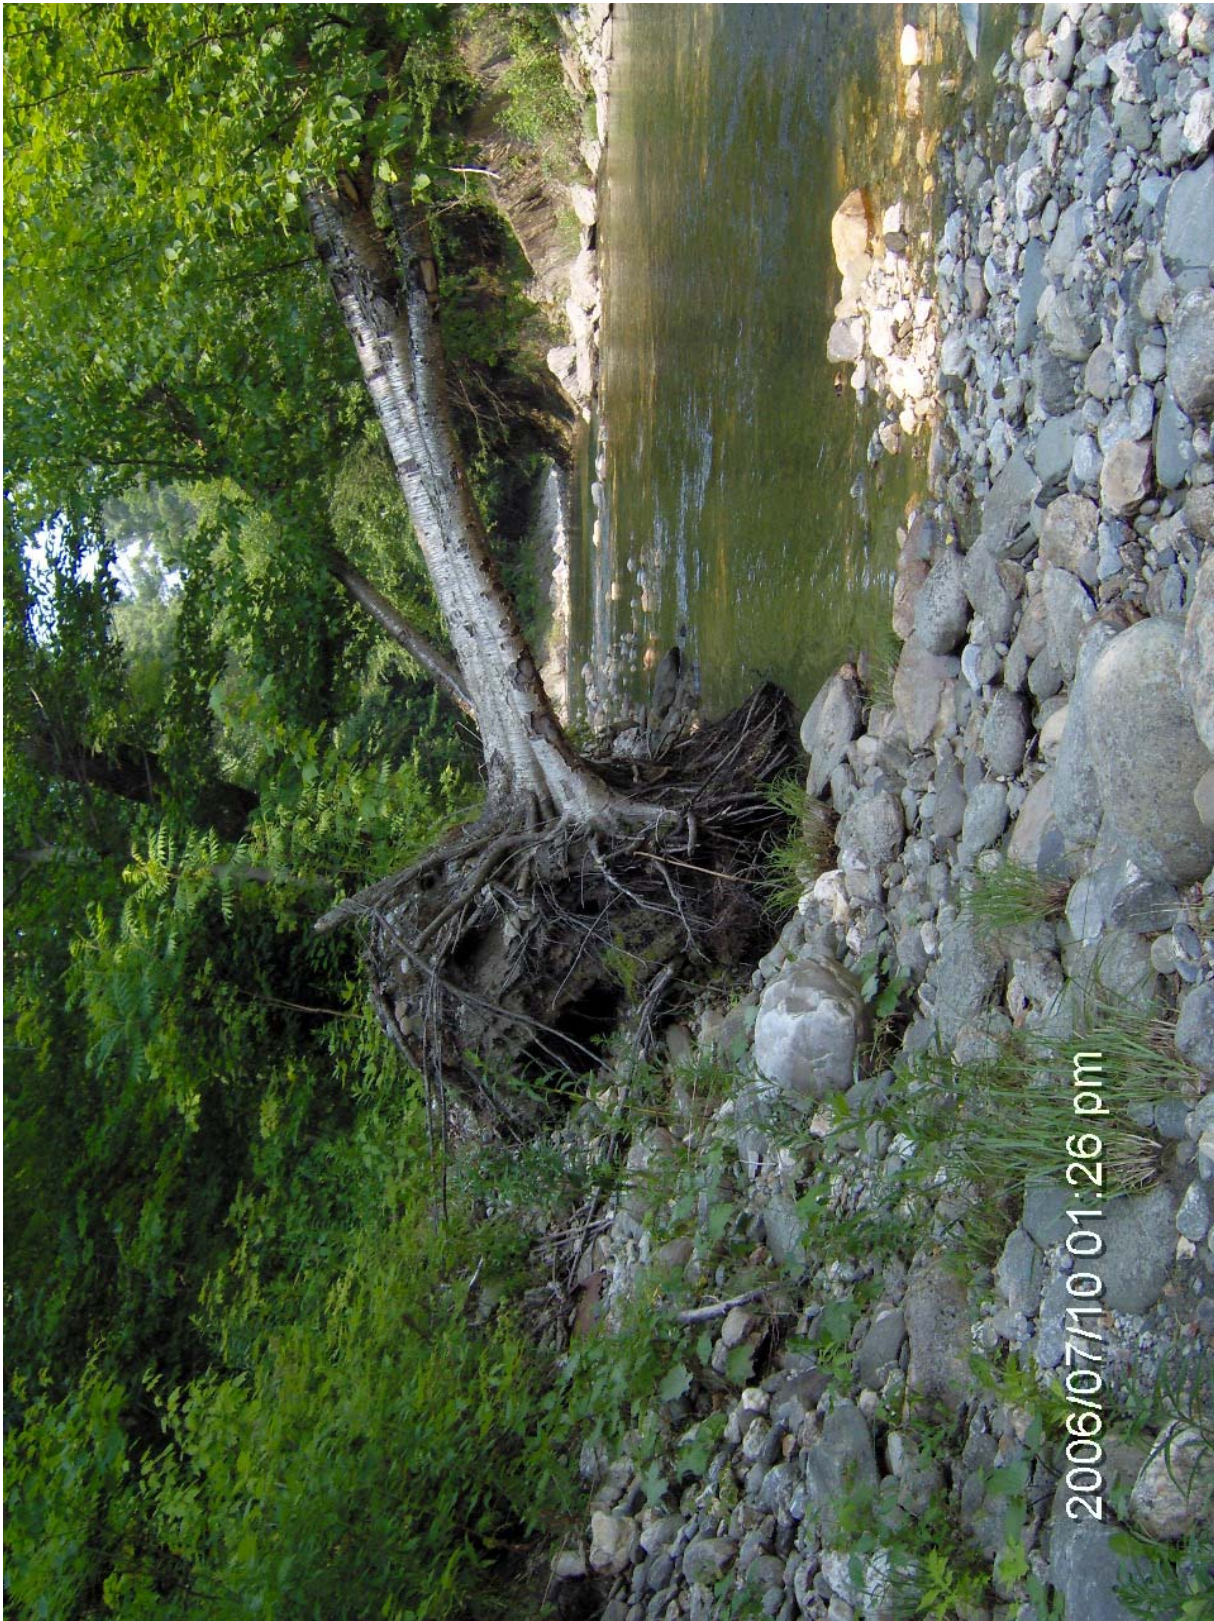
Figure 4: Erosion along the left bank of segment M19-B

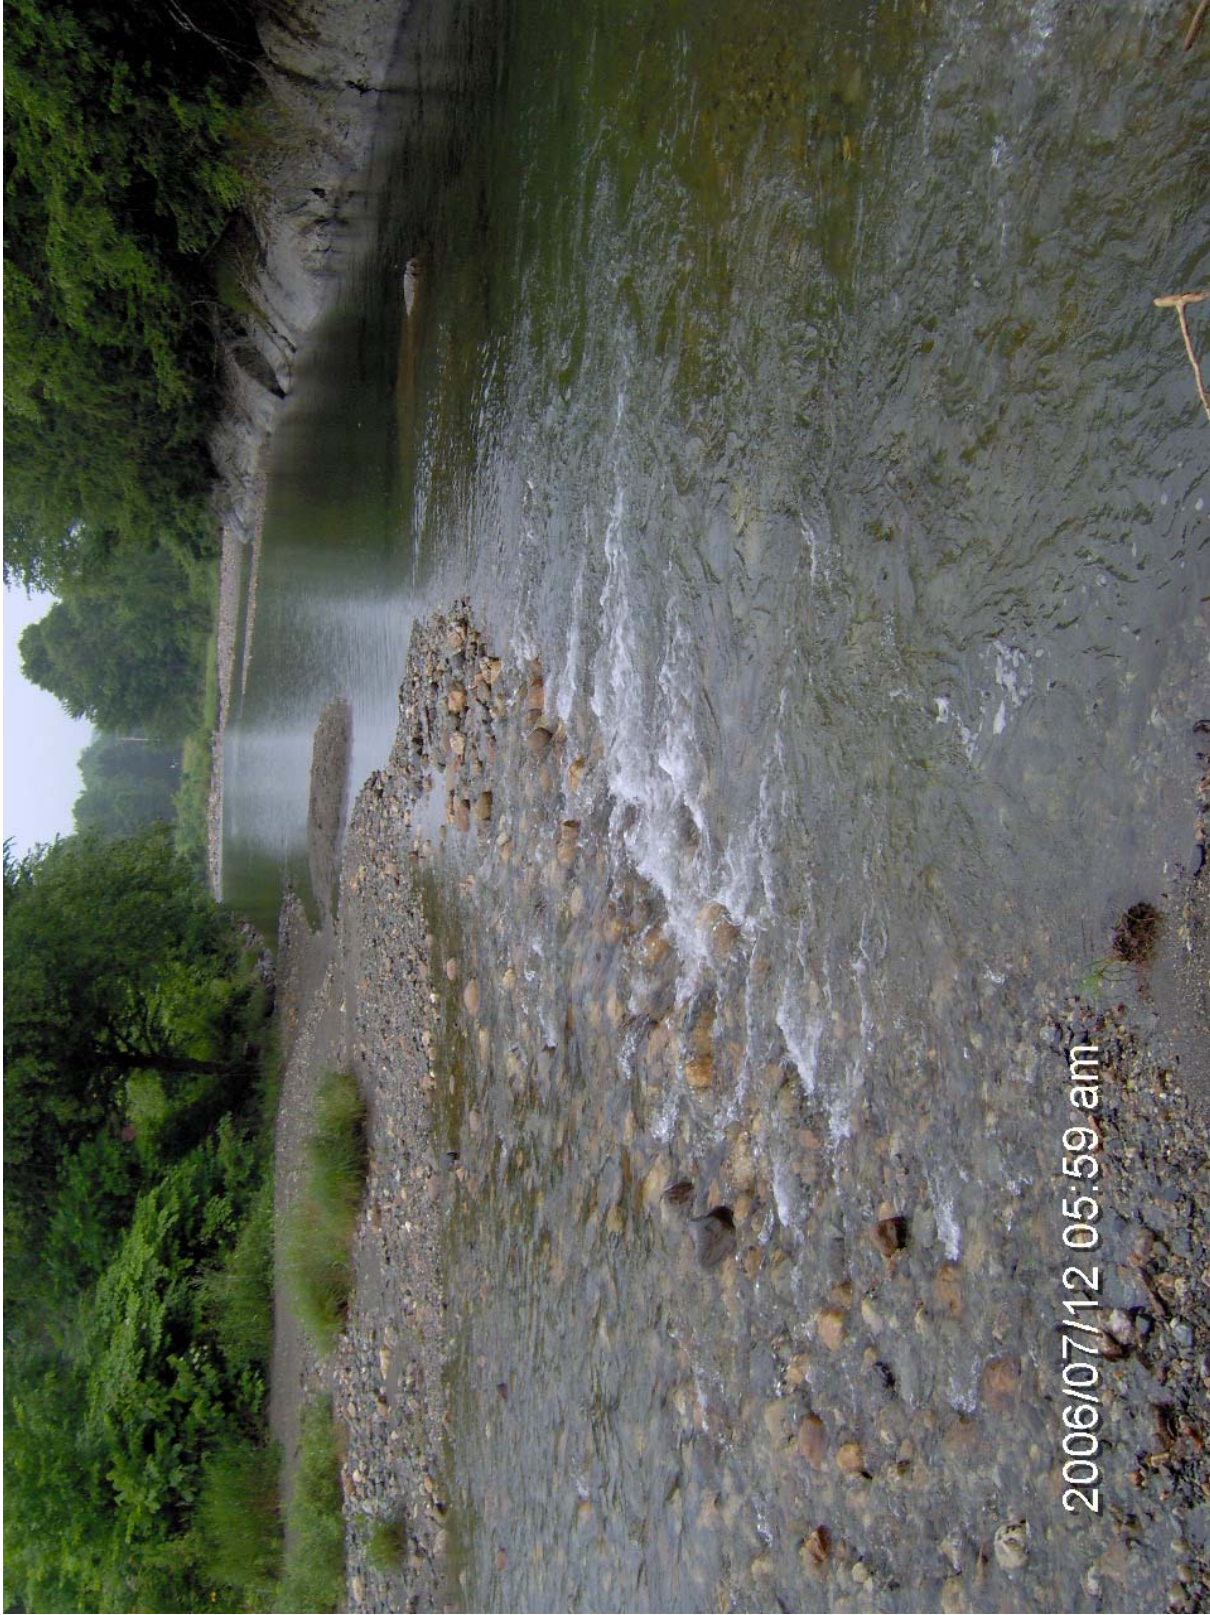
Reach M16 displays sediment buildups at bedrock-controlled channel constrictions. These constrictions lead to backwatering during high flow events and the resulting reduction in flow velocity causes the sediment deposition (Figure 6). These enlarged gravel bars have been dredged in the past with one landowner recalling extensive removal in this reach following the 1998 flood. Sediment deposition in Reach M16 is also promoted by the drop in slope and flow expansion that occurs as the river leaves the confines of the bedrock gorge upstream (Reach M18 and M17). The slope decreases from 1.04 percent in Warren Gorge to 0.44 percent downstream (Appendix 2). Further deposition also occurs at the mouth of Clay Brook, but a significant delta bar has not been formed; the naturally straight bedrock-constrained reach in this area maintains a high rate of sediment transport sufficient to remove sediment emanating from Clay Brook. These naturally straight and constricted areas are controlling the location of sediment aggradation currently observed within the reach. Gravel bar formation is enhanced by large sources of sediment made available from land clearance over a century ago and still periodically transferred to the mainstem during large flood events as in 1998.

Figure 6: Large diagonal bar deposited upstream of bedrock constriction in Reach M16

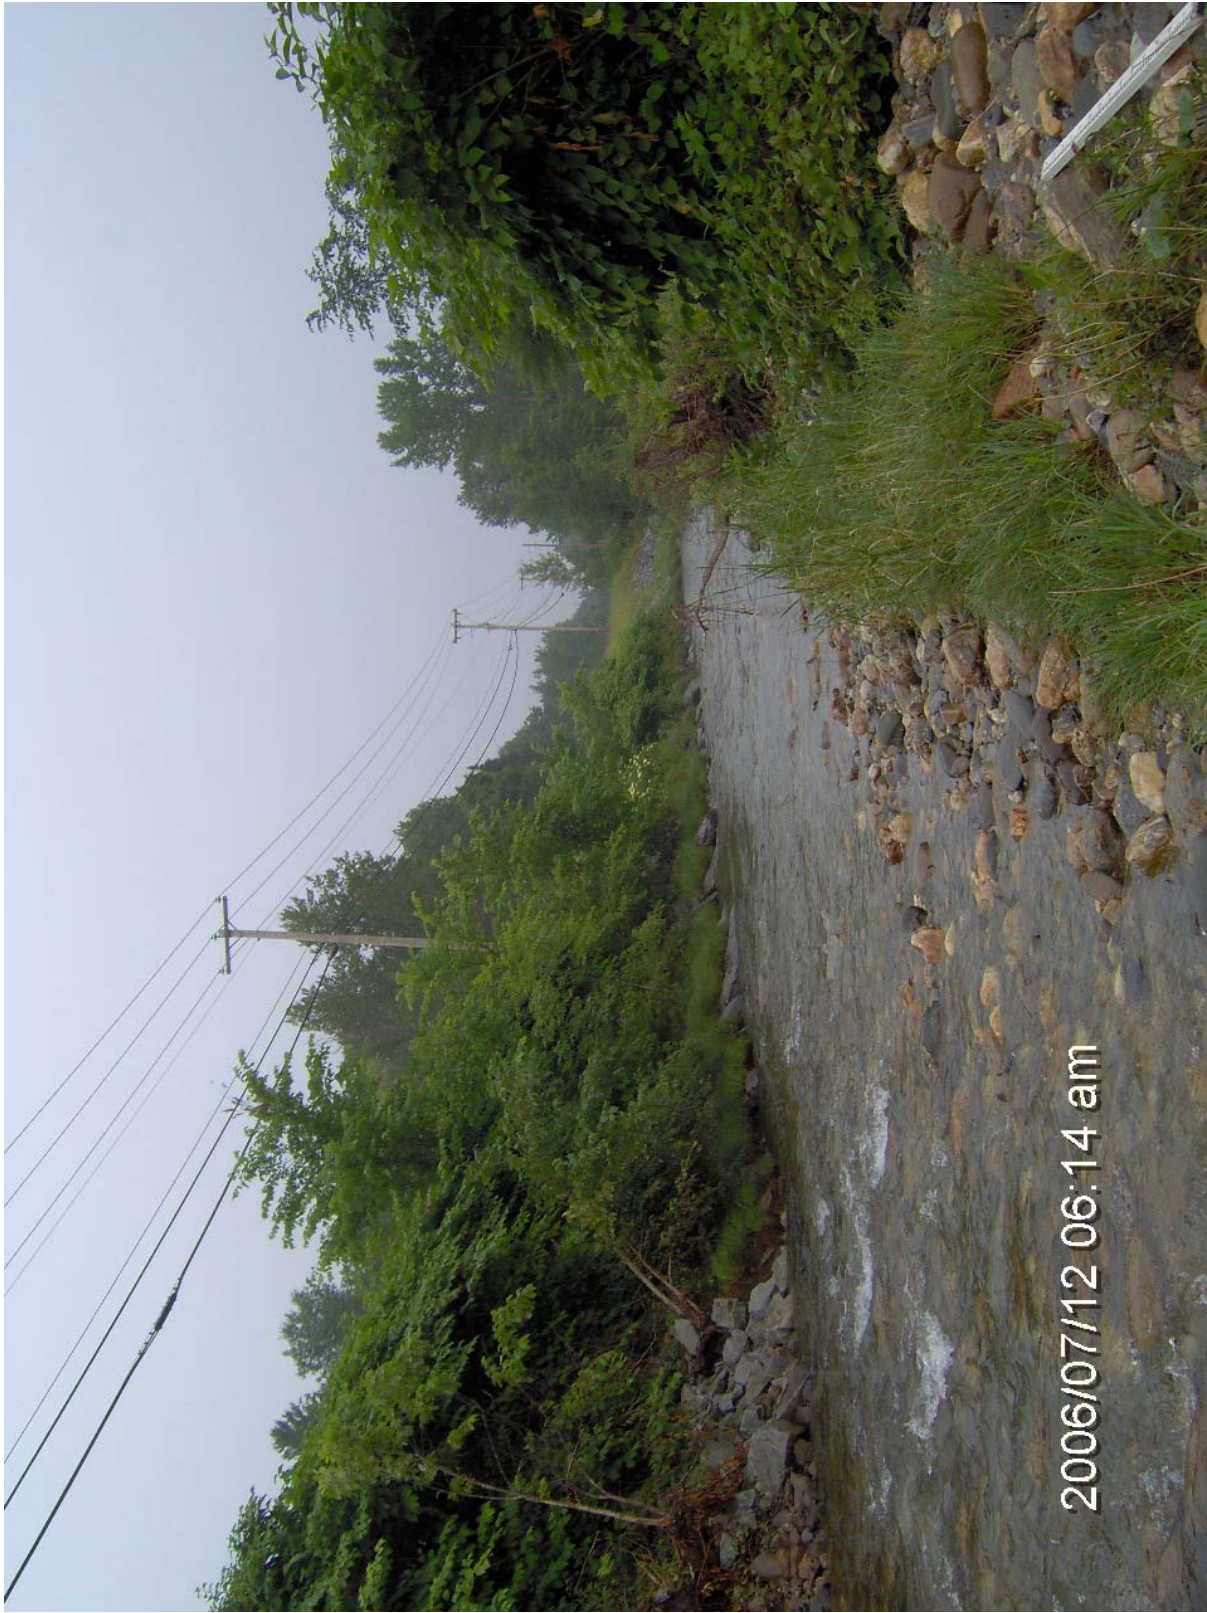
Excessive aggradation at the bedrock constrictions is enhanced by the straightening and channelization along sections of the reach (Figure 7). Sediment is transported through the channelized areas, which have an increased slope, armored banks, and lack of floodplain connectivity, and deposited above the channel constrictions where sediment transport capacity decreases rapidly during high flow events. Under natural conditions, sediment deposition would be more evenly distributed throughout the reach.

Figure 7: Straightening and bank armoring in Reach M16

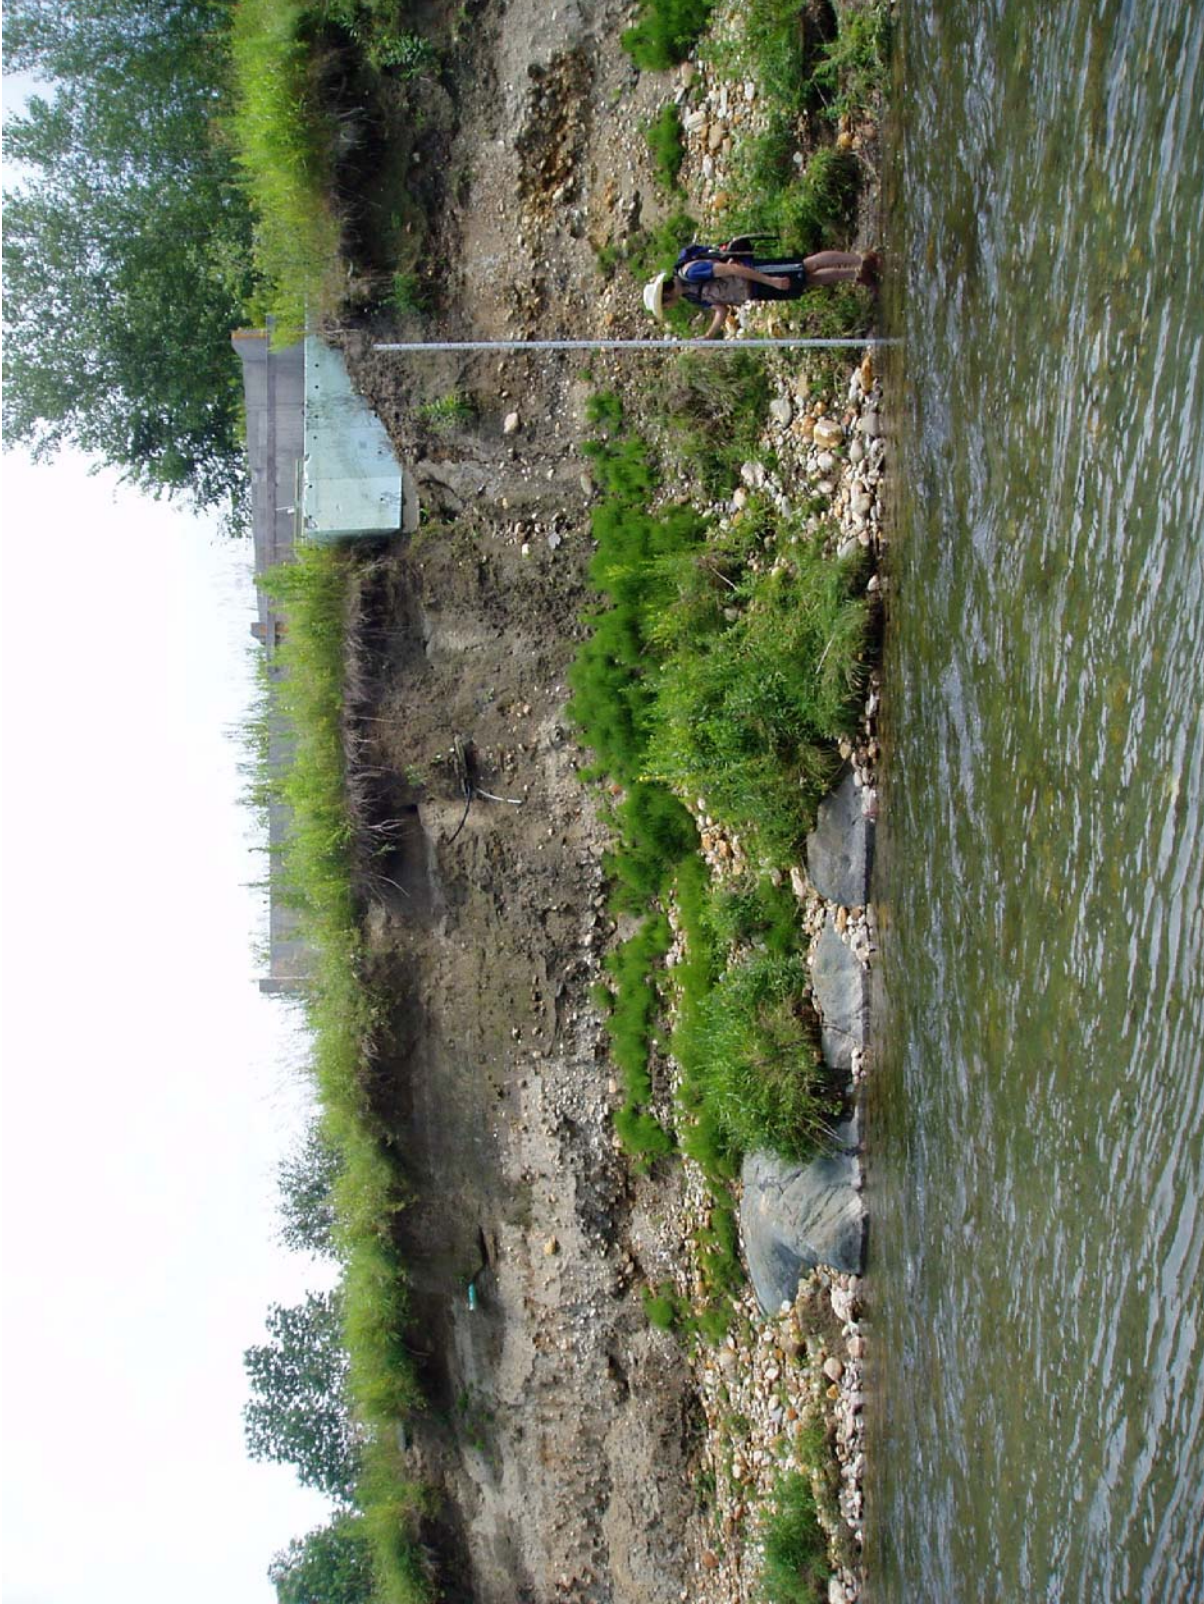
Finally, the river impinges upon a bank of unconsolidated sediments over 15 feet high on the right bank near the confluence with Folsom Brook. This bank of stratified sand and cobbles is actively eroding and has already compromised the foundation of one

building (Figure 8). While this is an area of concern, the conditions at this location are not representative of the reach as a whole.

Figure 8: High eroding bank undermining building foundation in Reach M15

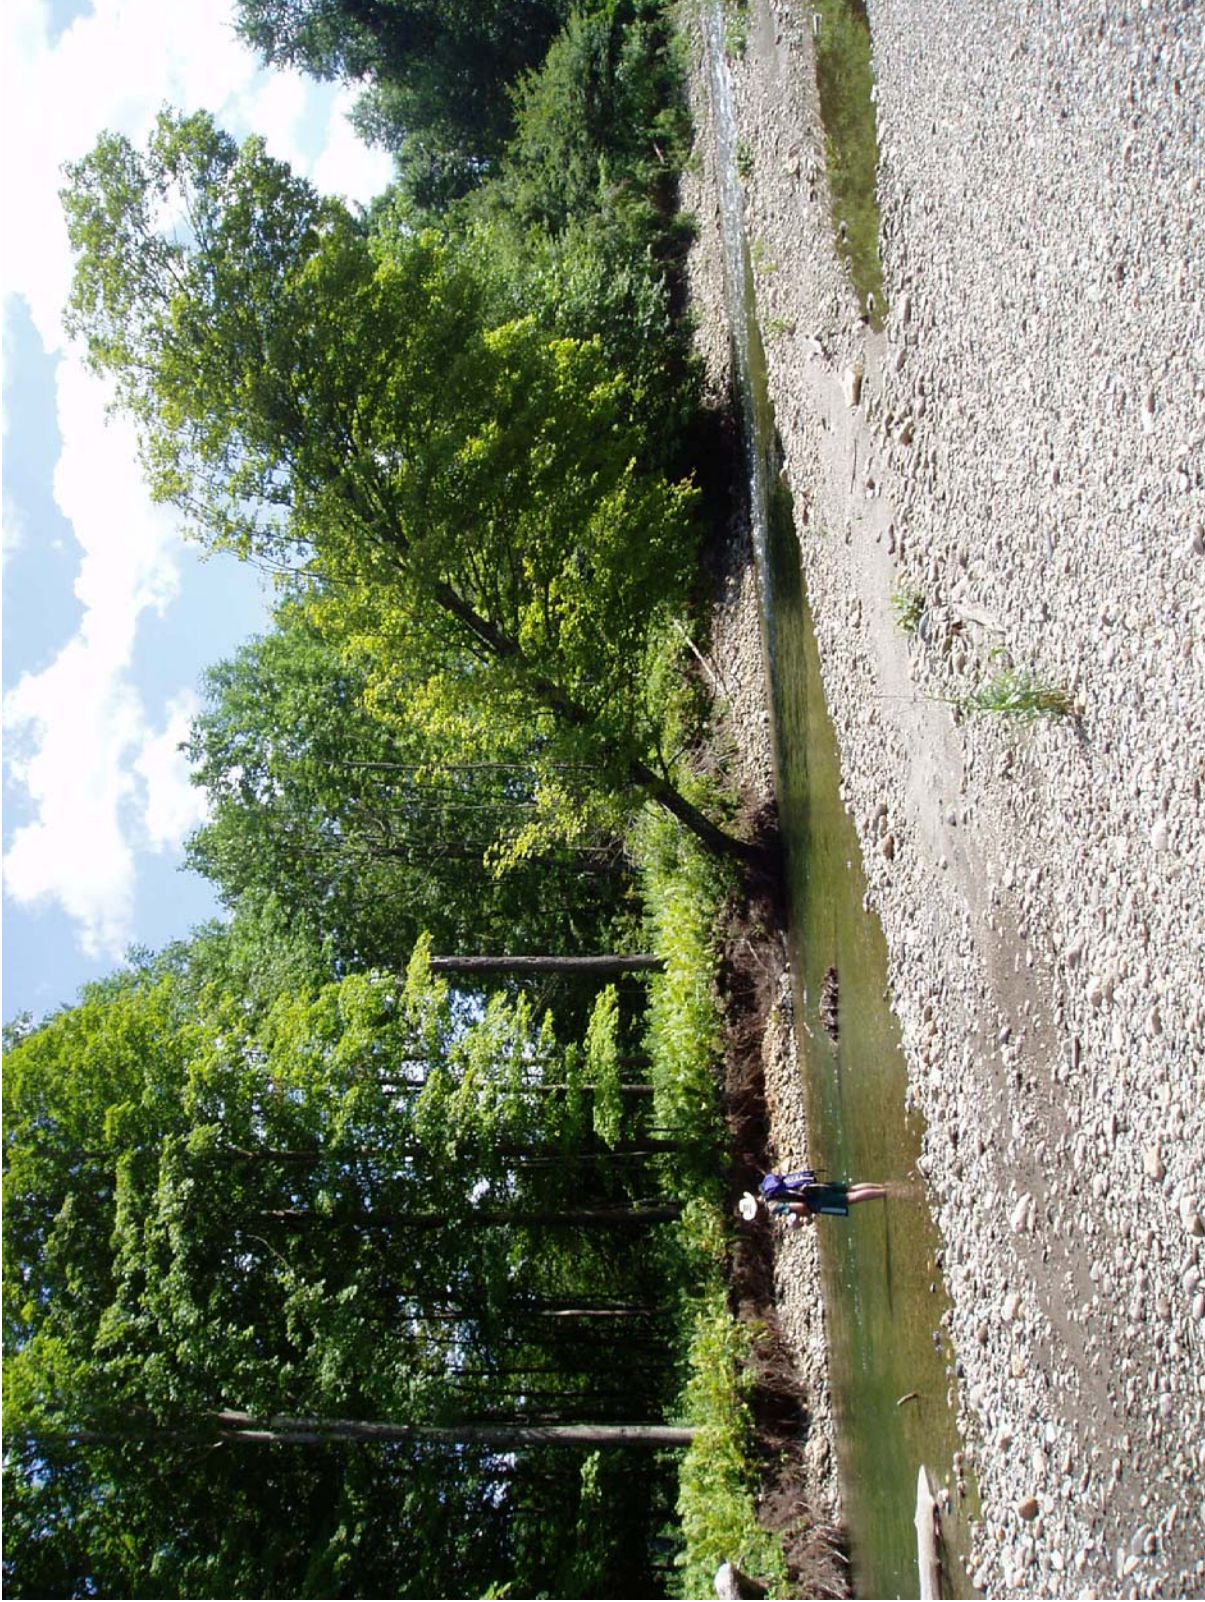
Figure 10: Eroding bank with narrow or absent riparian buffer located across actively growing point bar in Reach M13

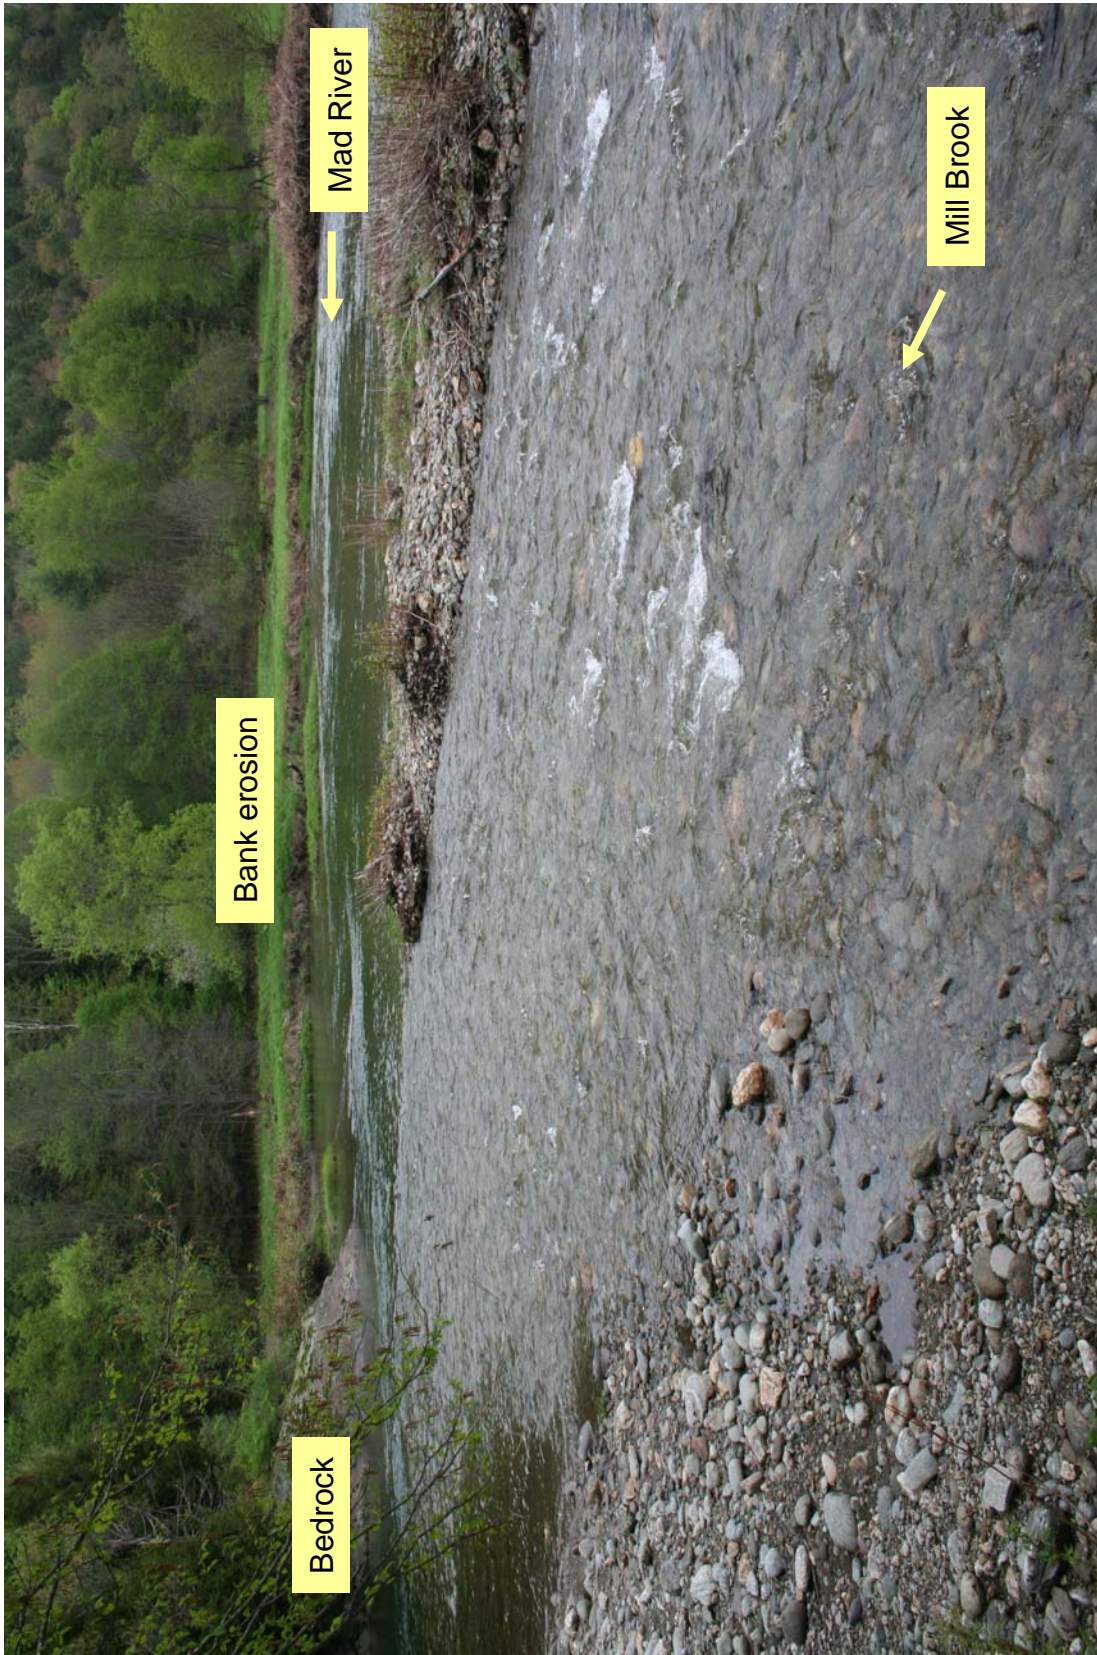
Figure 11: Bank erosion and meander development upstream of constriction between bedrock bank and deposits at Mill Brook confluence

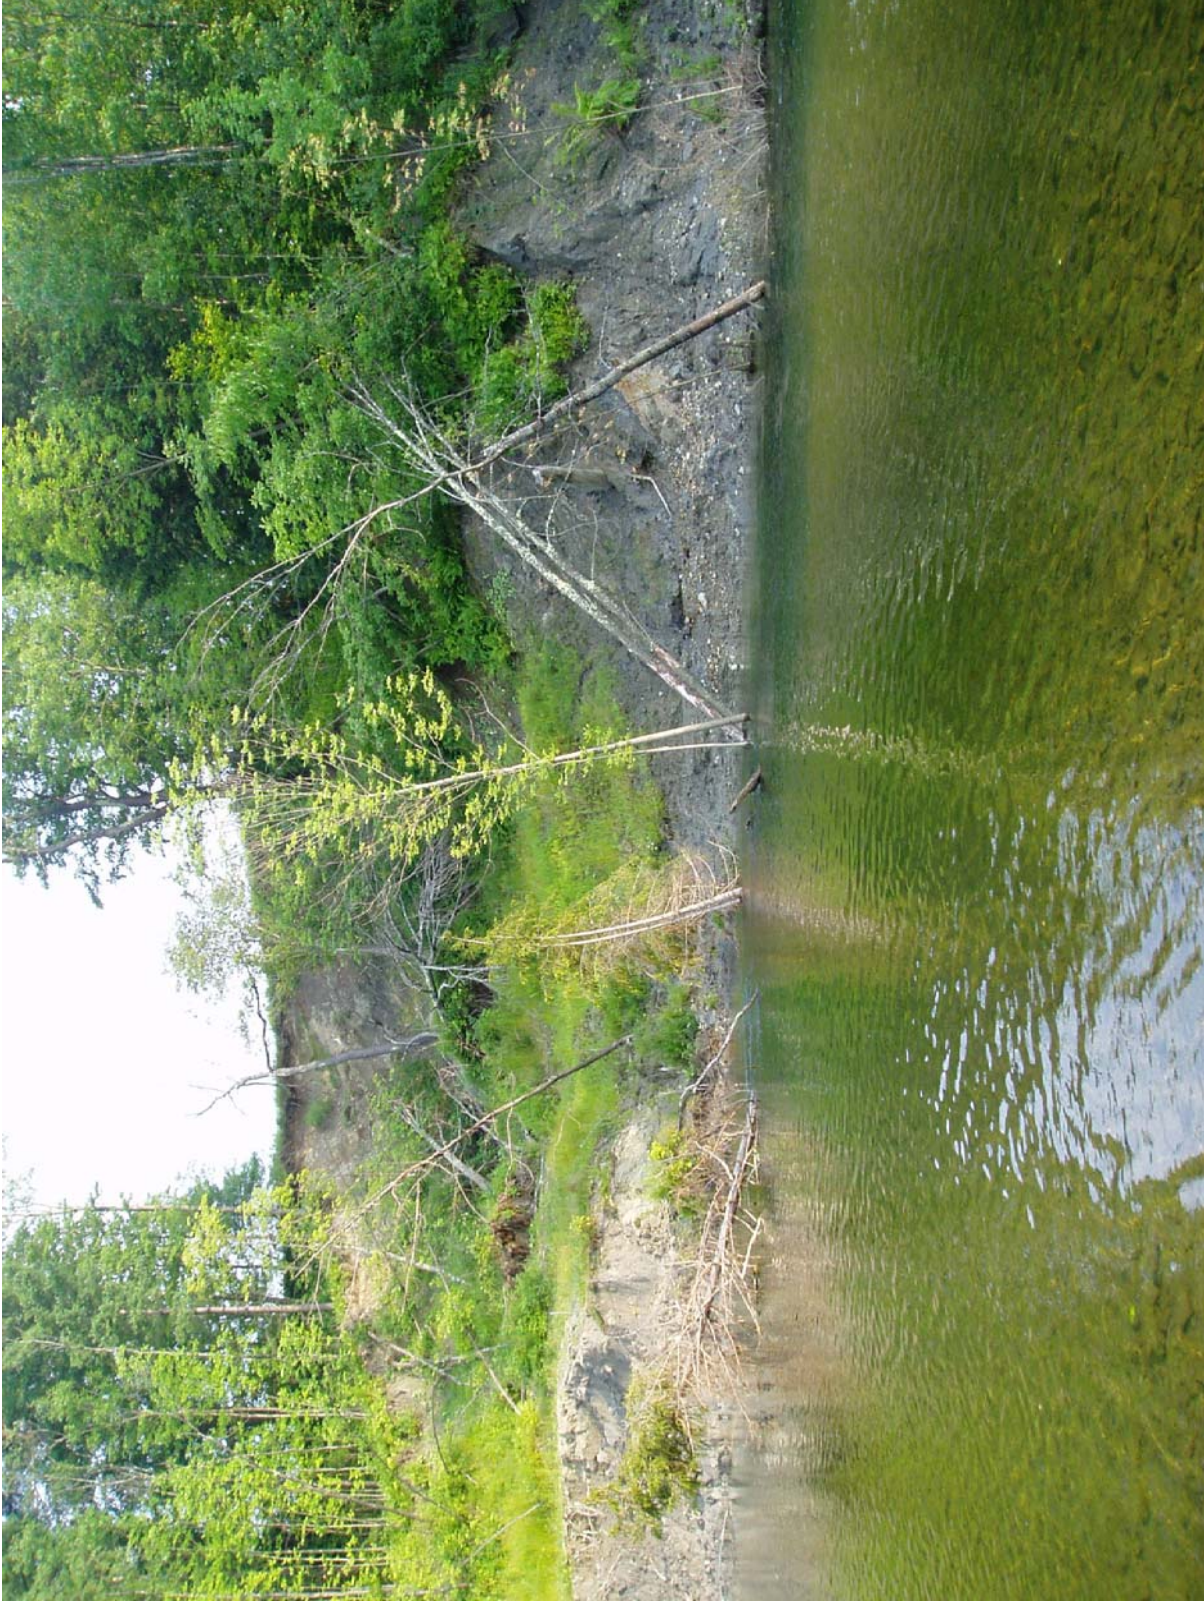
Figure 13: Large slump at downstream end of Reach M12

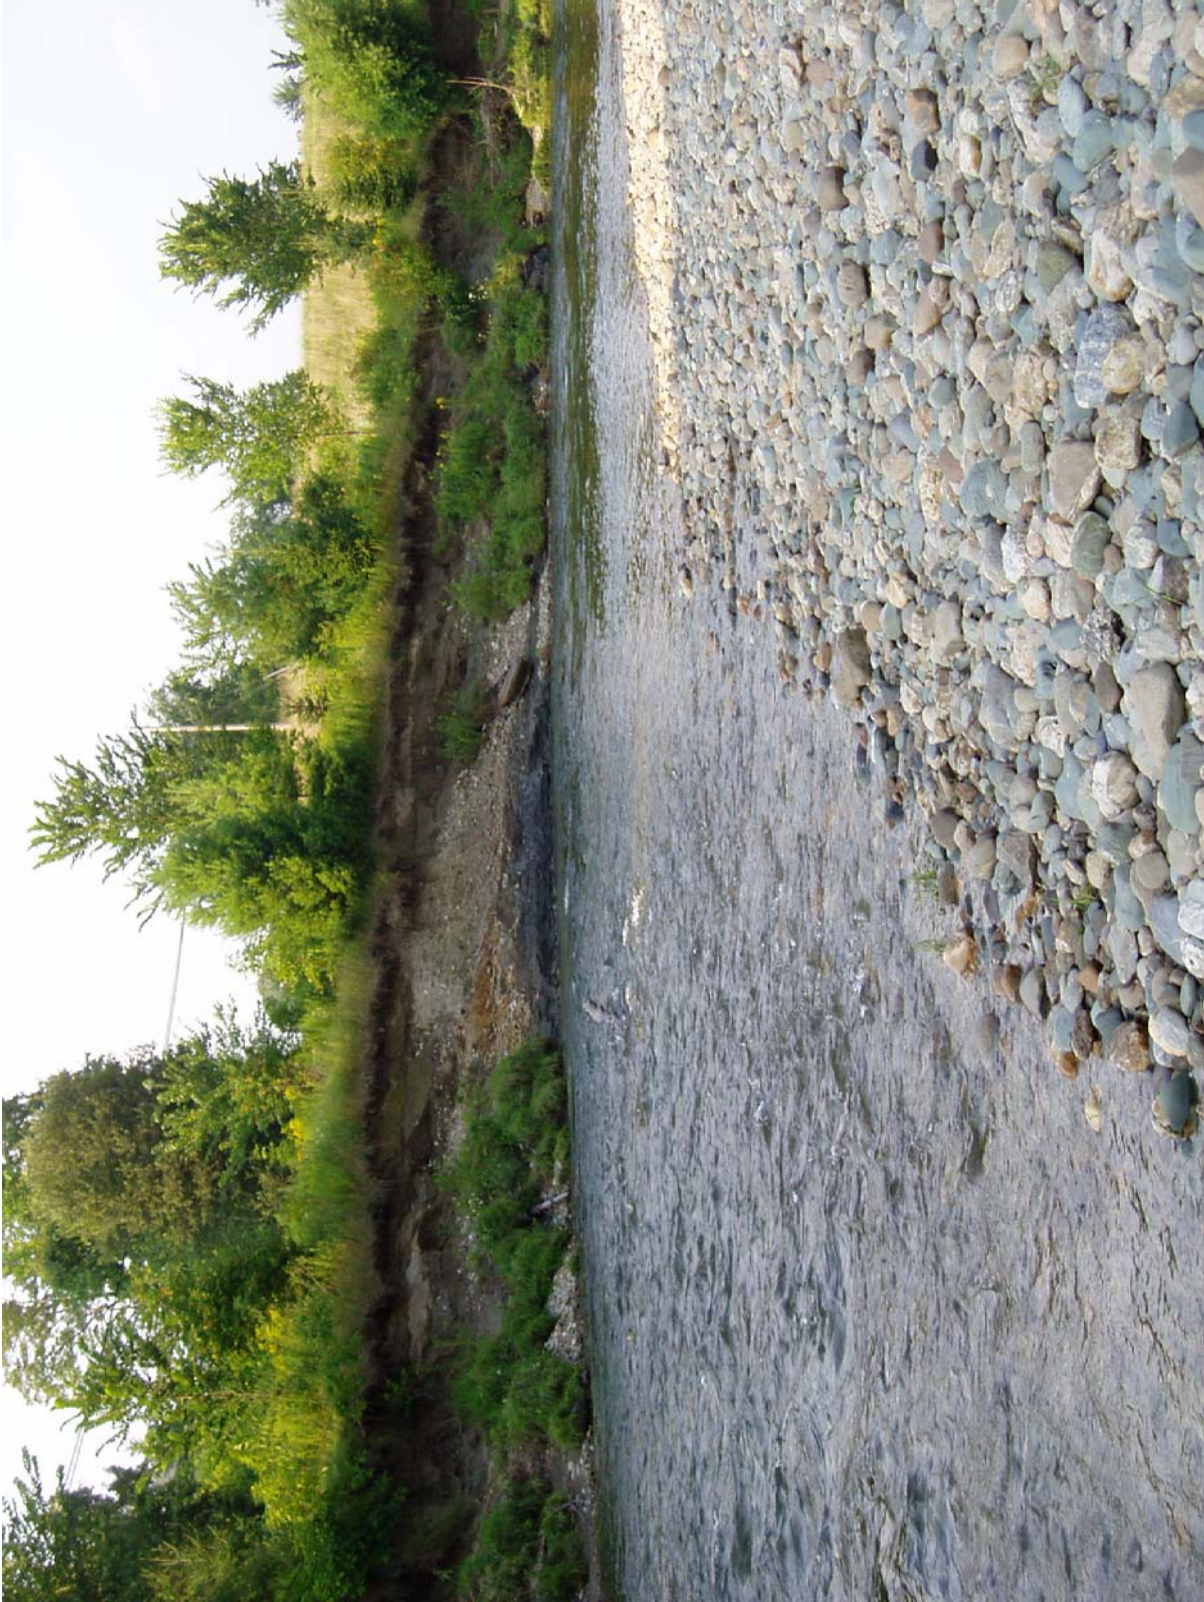
Figure 14: Deposition of gravel bar has led to continued erosion of the opposite bank near the 1824 House where earlier bioengineering efforts are barely visible today.

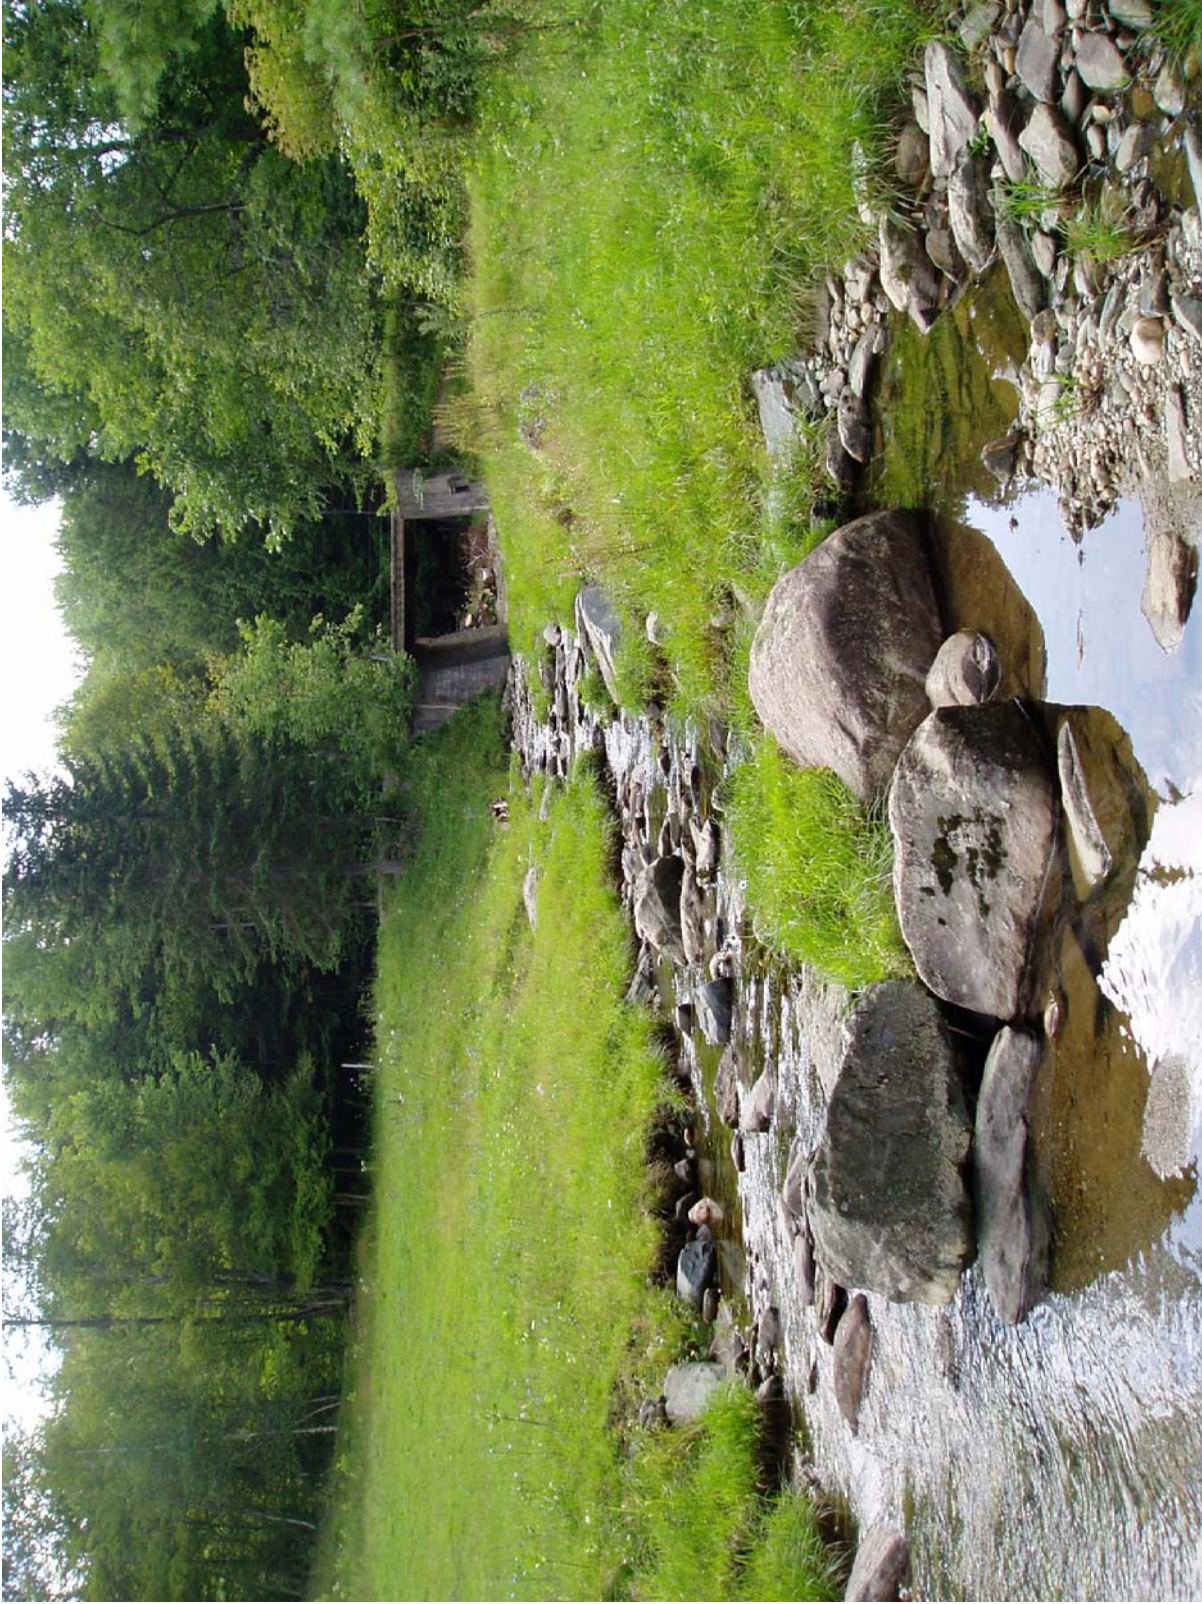
Figure 16: Lack of riparian buffer and cattle access are exacerbating bank erosion on Pine Brook (Segment T5.02-B)

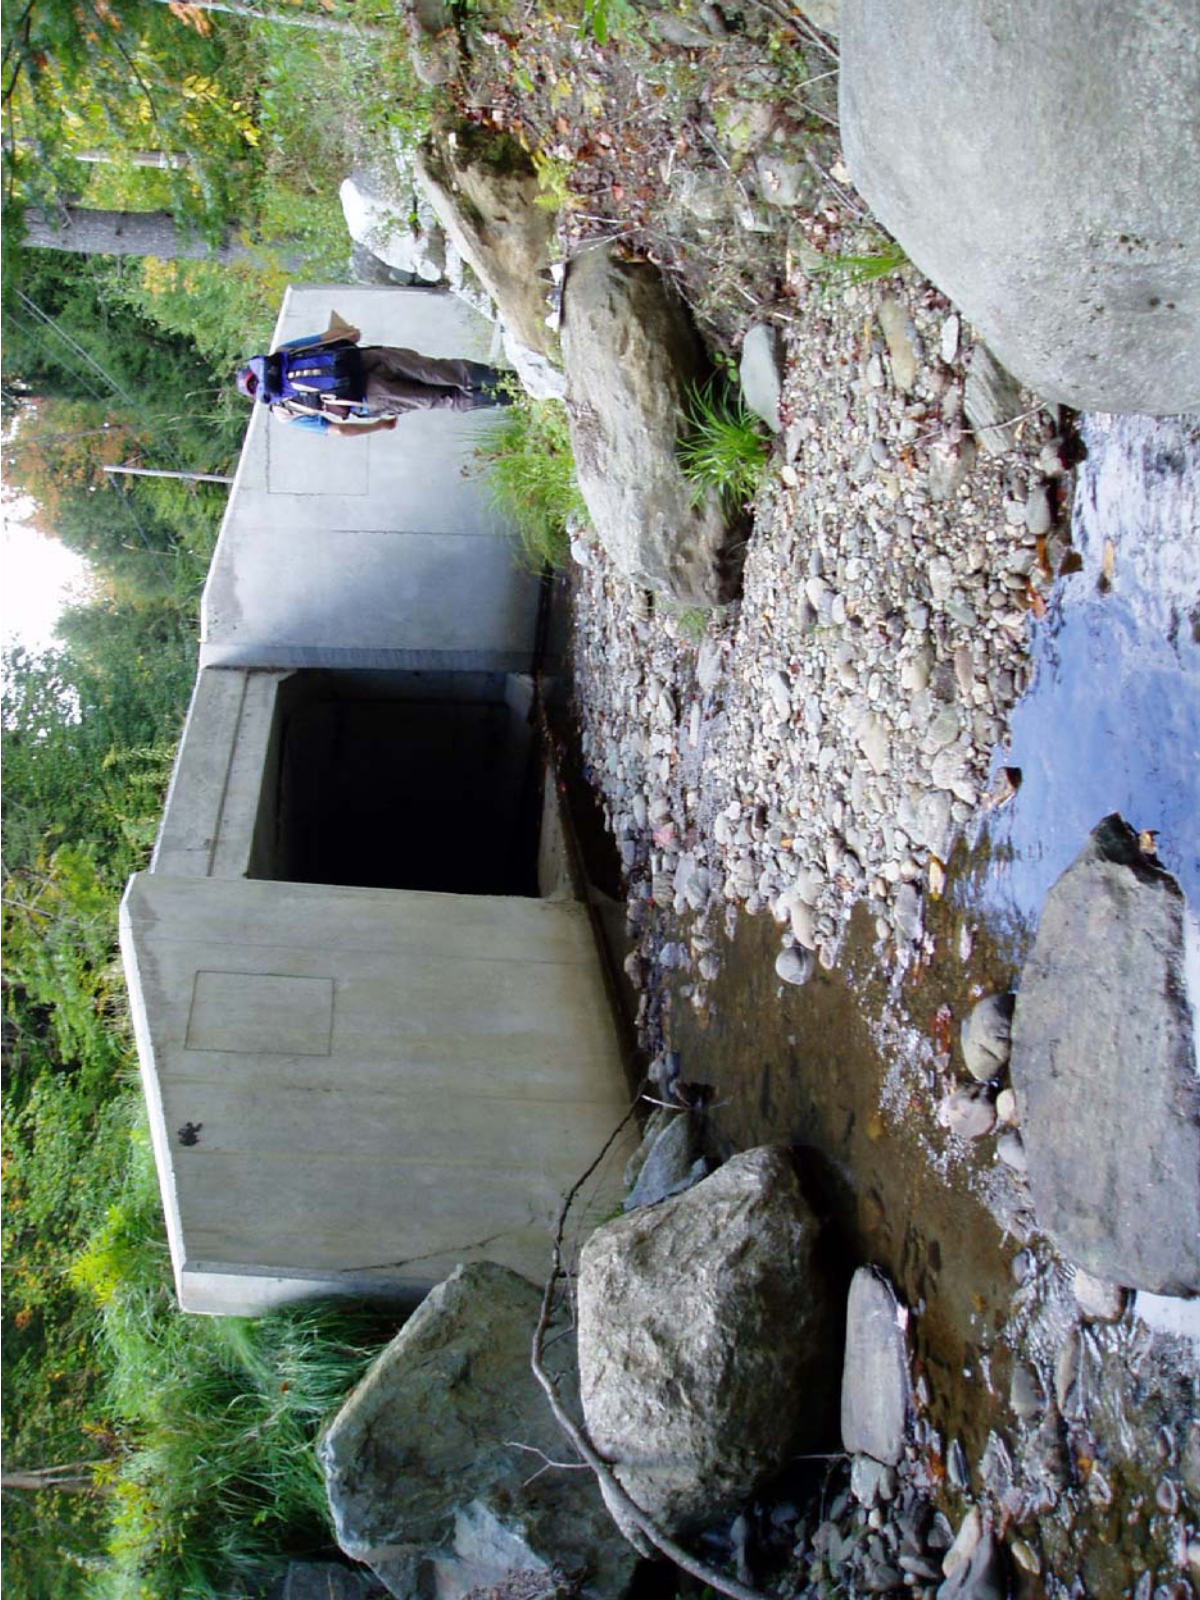
Figure 17a: Aggradation of gravel bar upstream of undersized box culvert on High Bridge Brook tributary (Reach T6.1-S1.01)

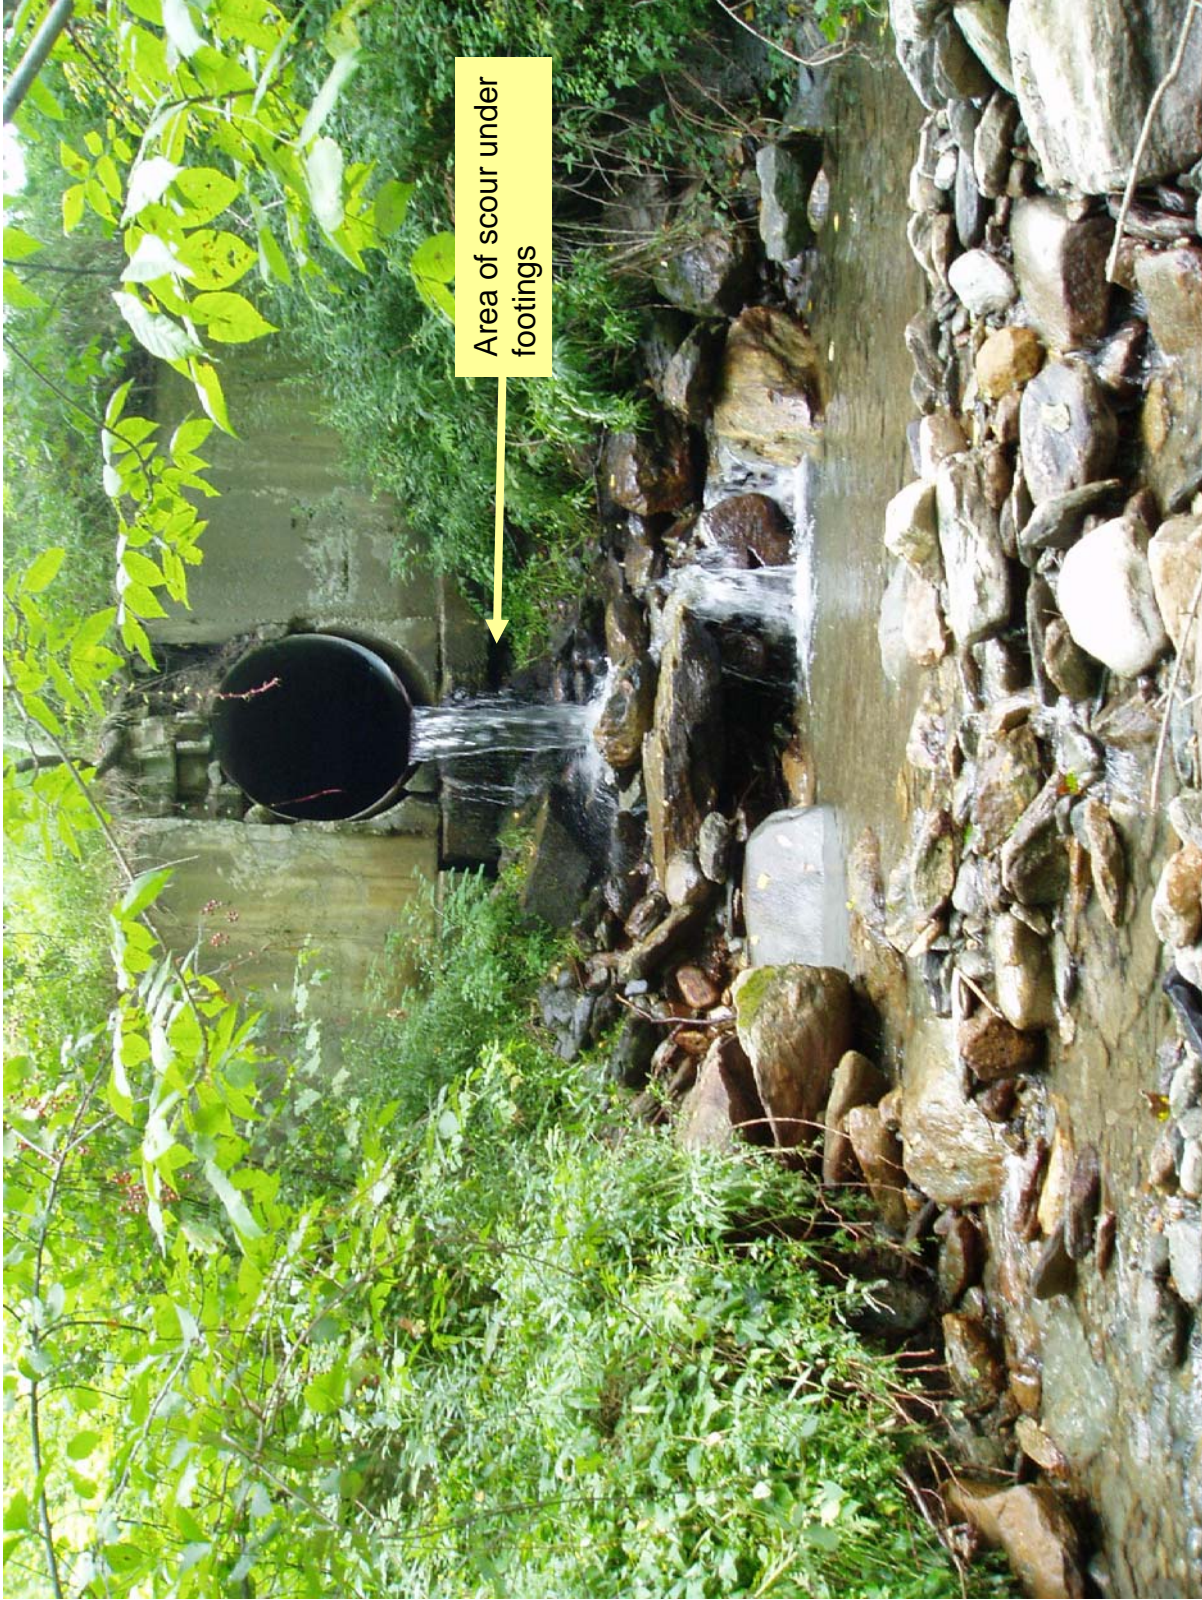
Figure 17b: Culvert passing under North Fayston Road on unnamed tributary of Shepard Brook is perched 5 feet above water surface with footings being undermined by downstream scour
