# **Fluvial Geomorphology Assessment of the Mad River Watershed, Vermont**

Prepared for

Friends of the Mad River  
Waitsfield, VT

Field Geology Services  
Farmington, ME

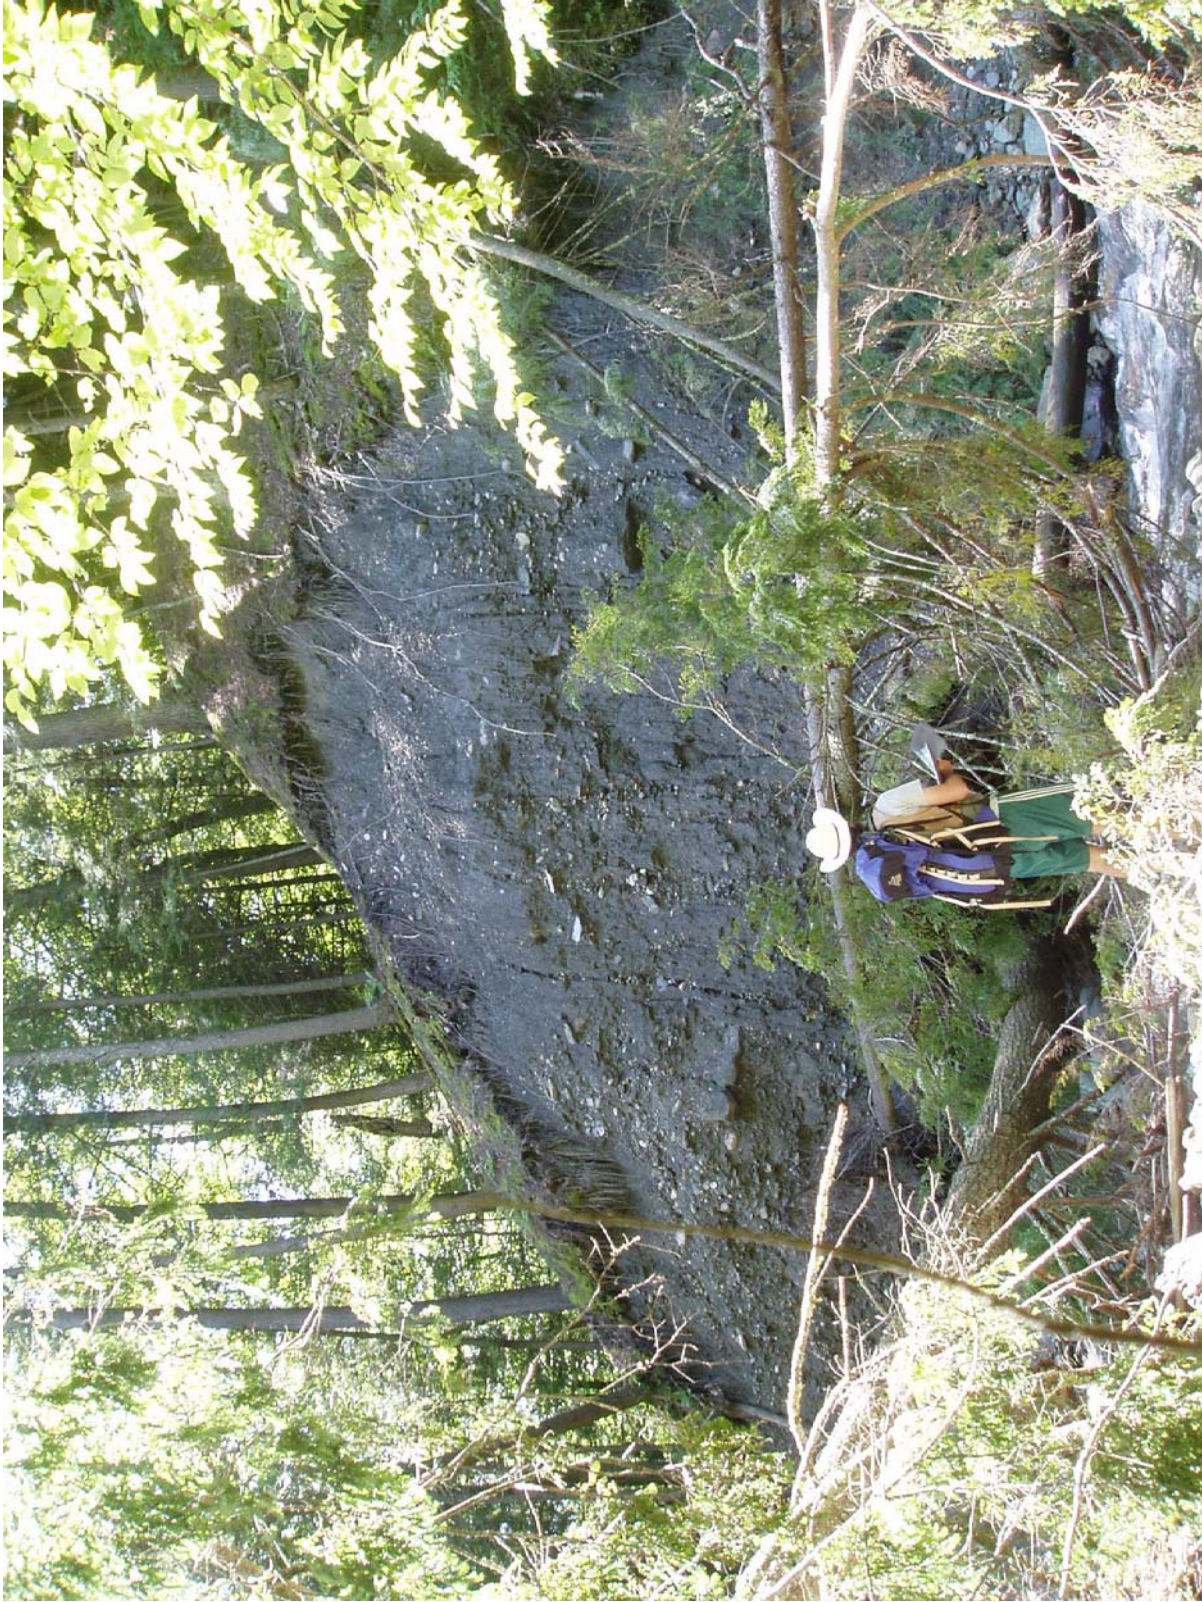
Figure 18: Mass failure on Clay Brook (Segment T9.03-A)

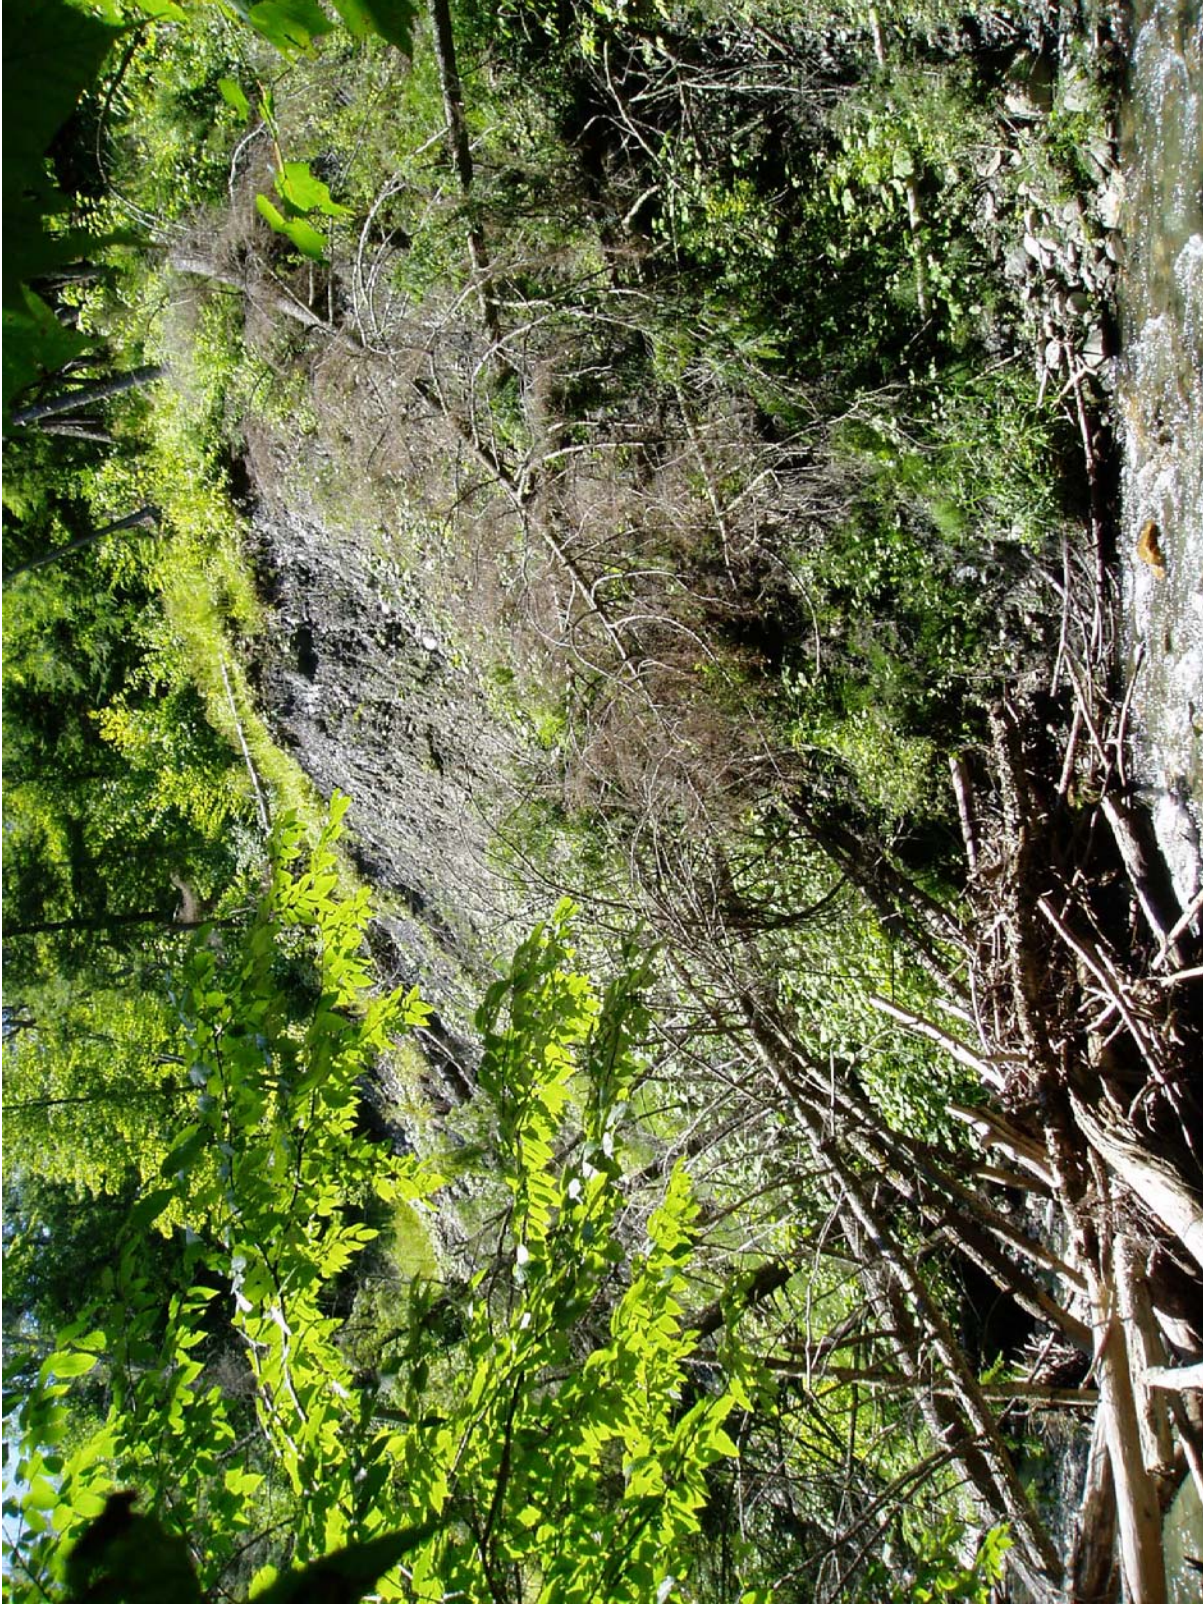
Figure 19: Debris jam associated with mass failure on Clay Brook (Reach T9.02)

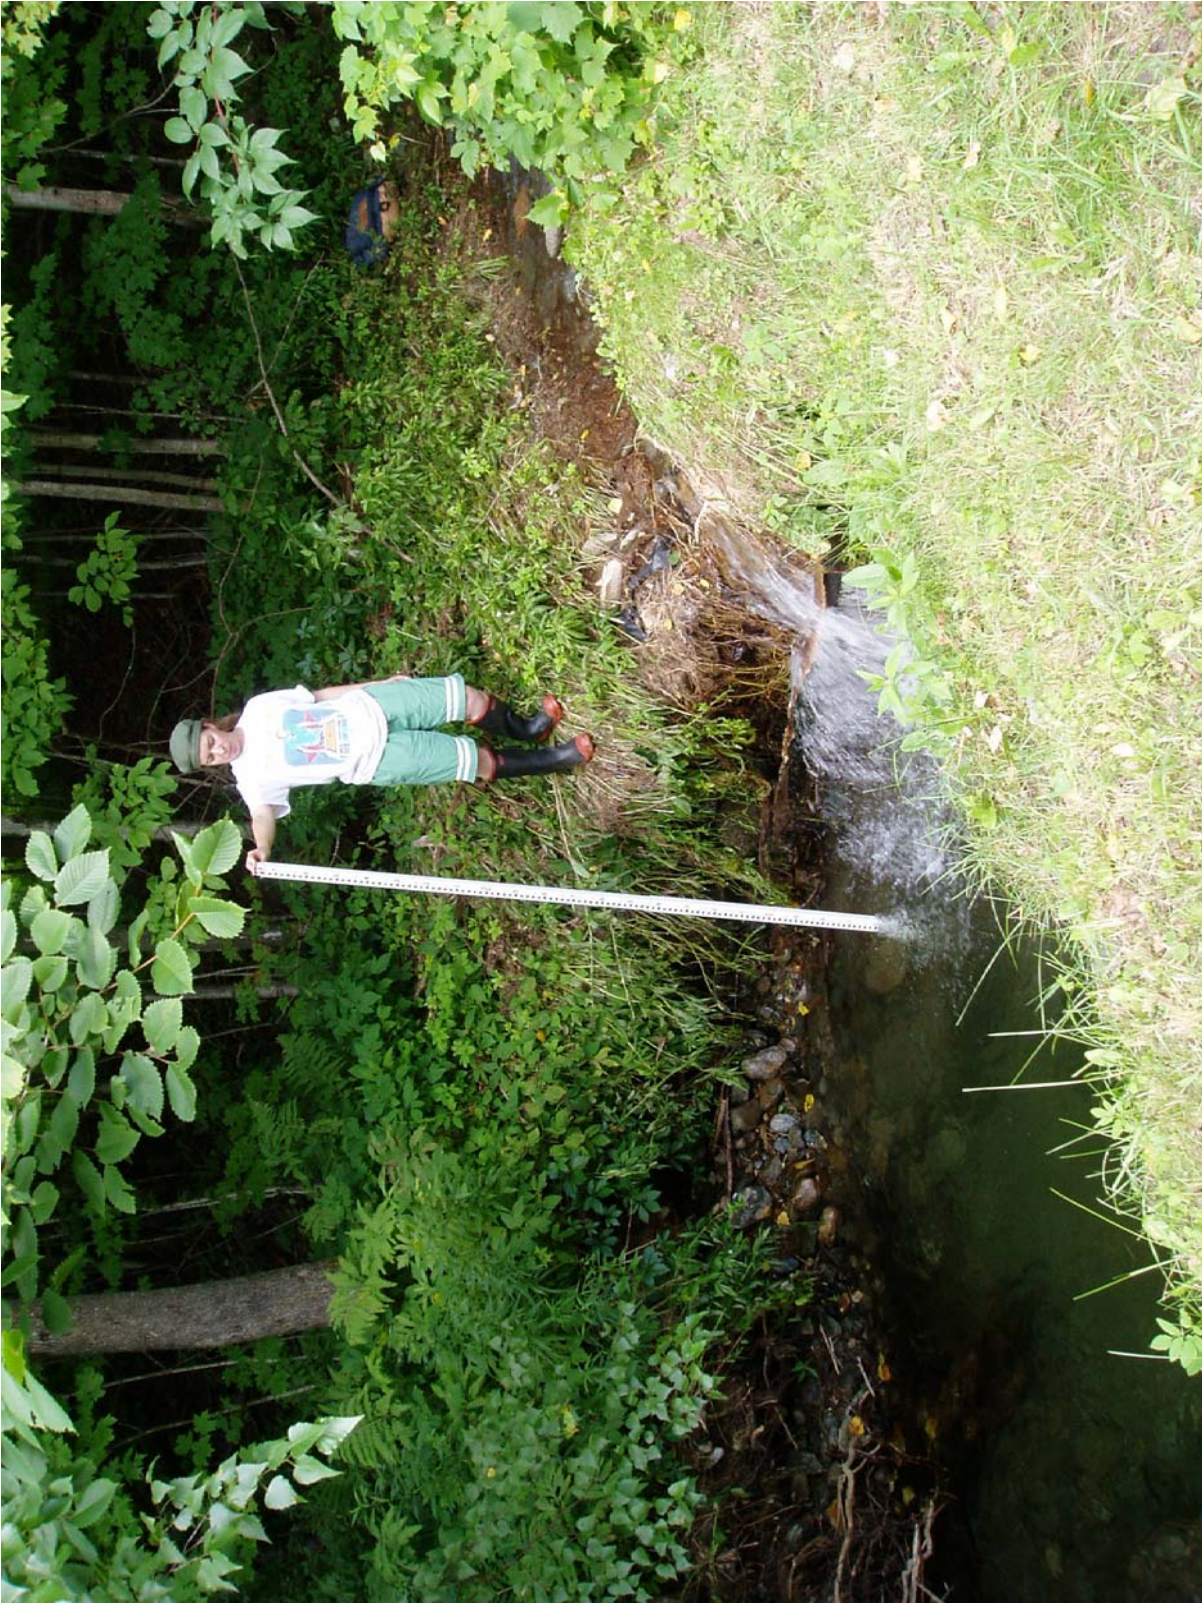
Figure 21: Headcut just upstream of North Fayston Road on unnamed tributary to Shepard Brook. Headcut is less than 50 feet from house damaged during a flood in 1986. Note flattened vegetation from recent high flows.

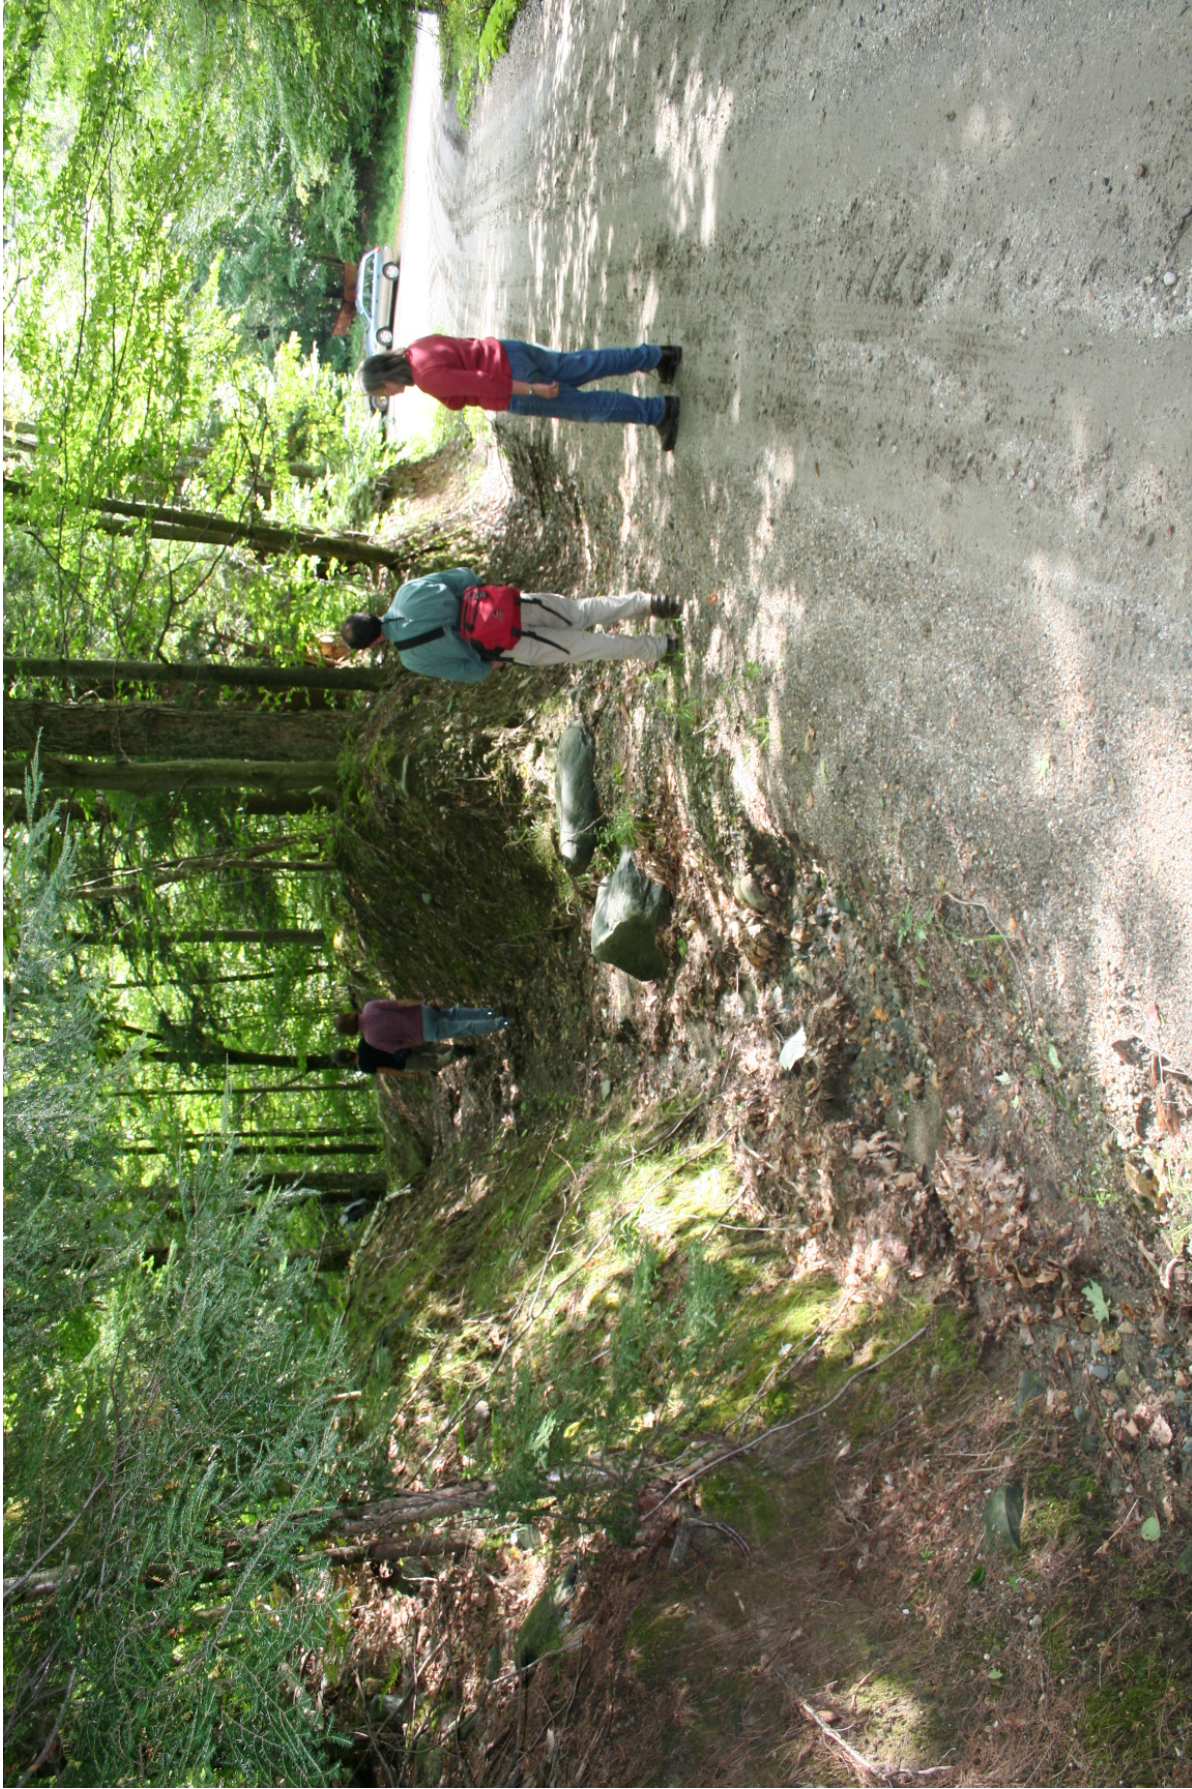
Figure 22: Area of runoff diversion from roadside ditch on Floodwoods Road on Pine Brook valley side slope.

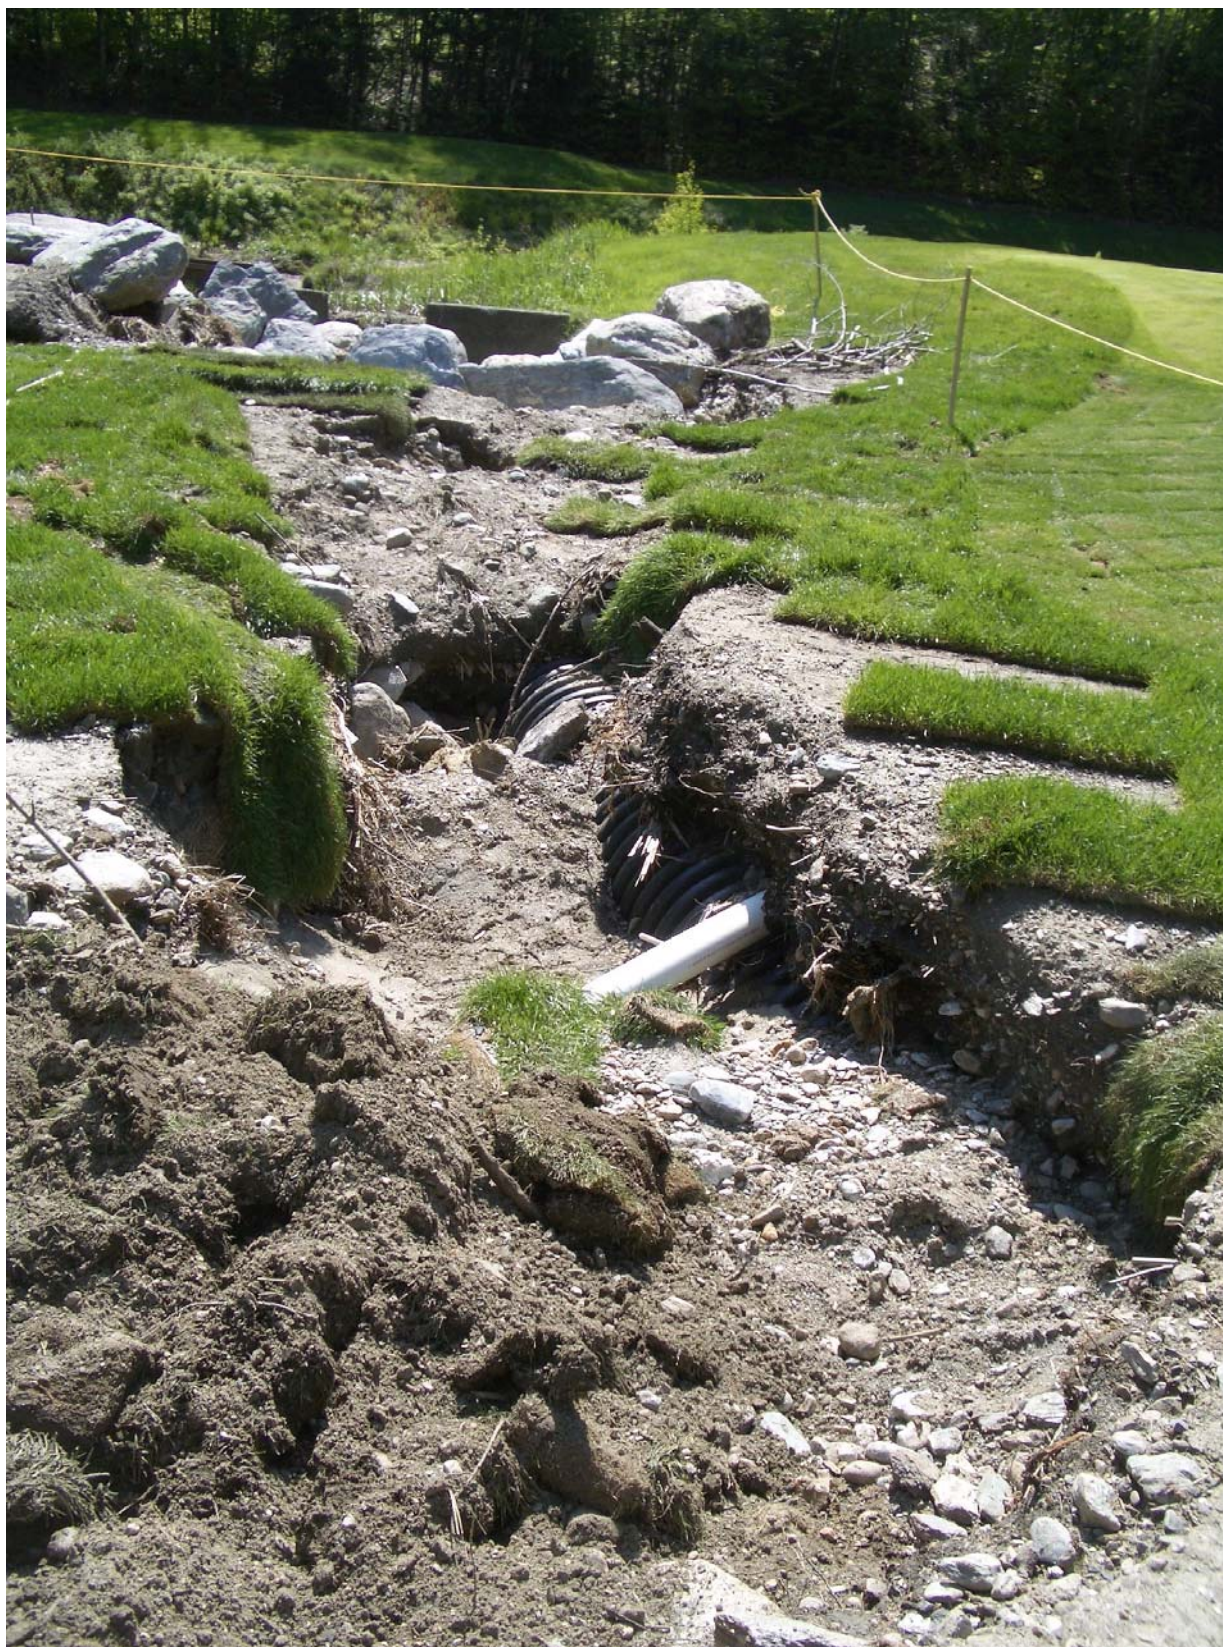
Figure 25: Channel scoured over top of undersized culvert at the Sugarbush Golf Course in the Clay Brook Watershed

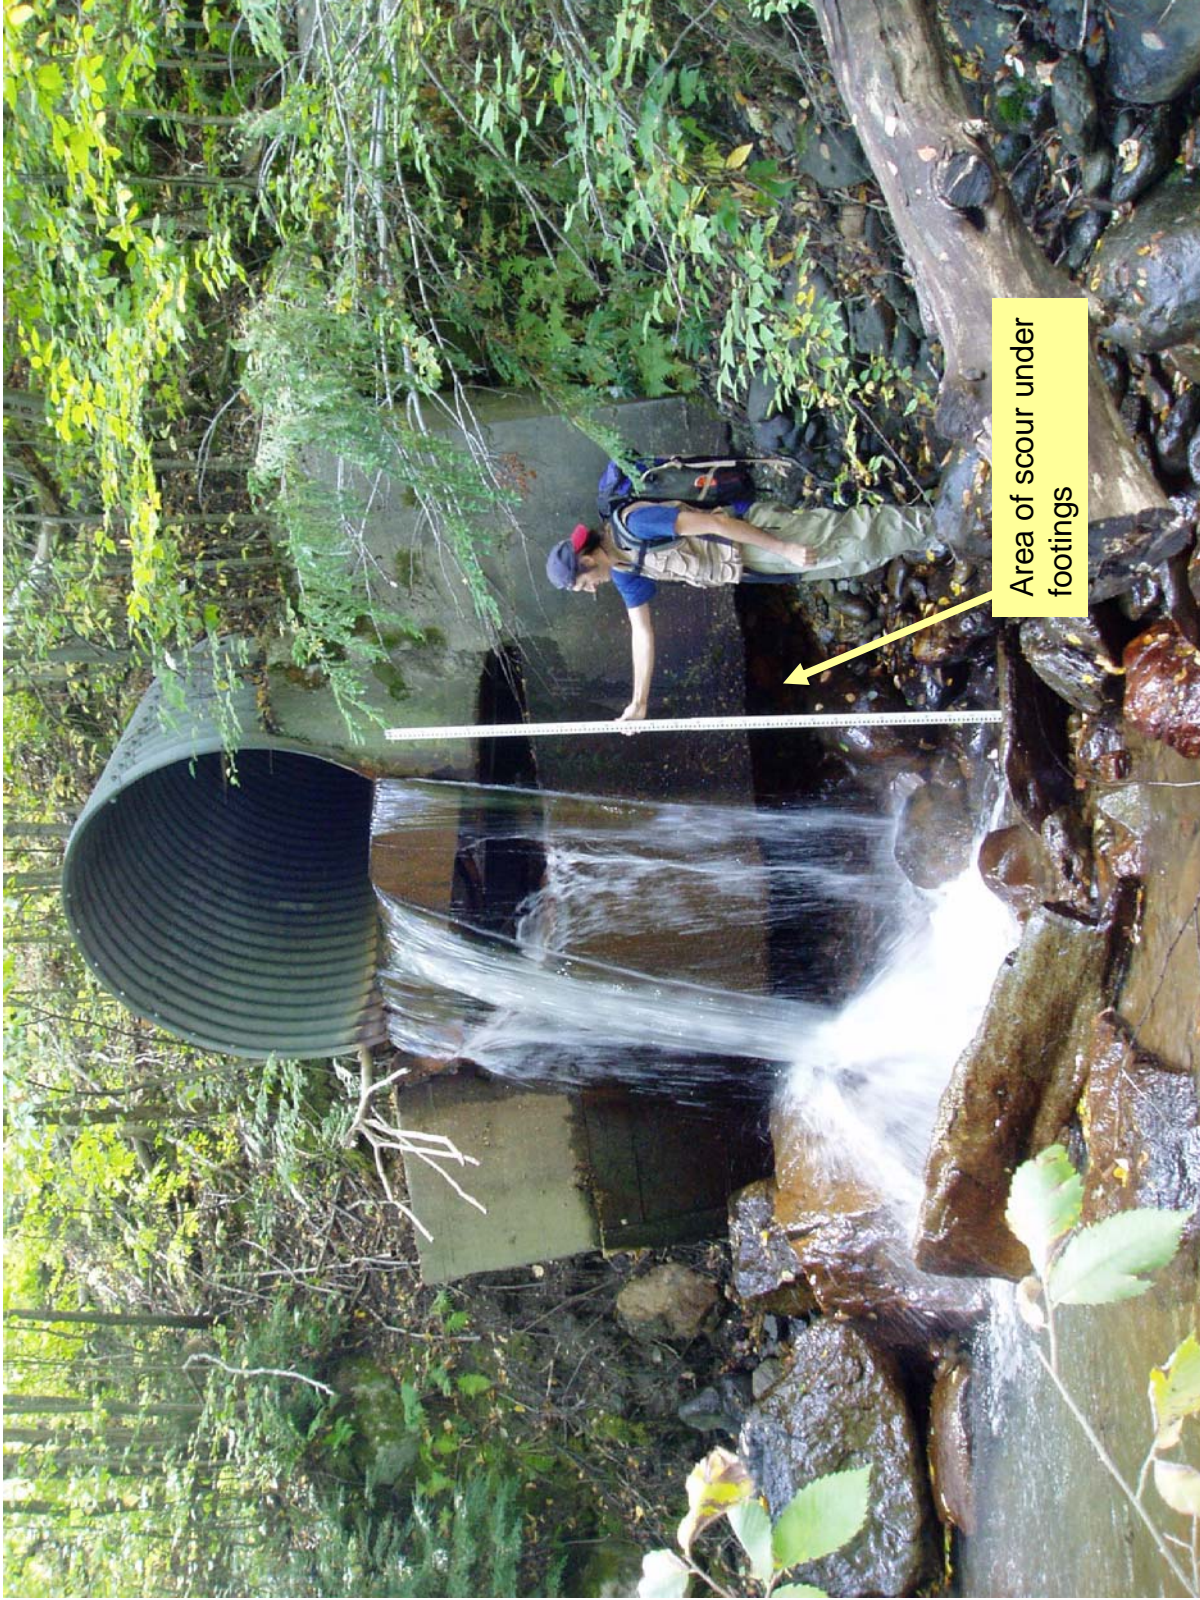
Figure 26: Outlet of culvert passing under Inferno Road on Clay Brook showing scour under culvert footings and boulders placed on channel bed to prevent further scour

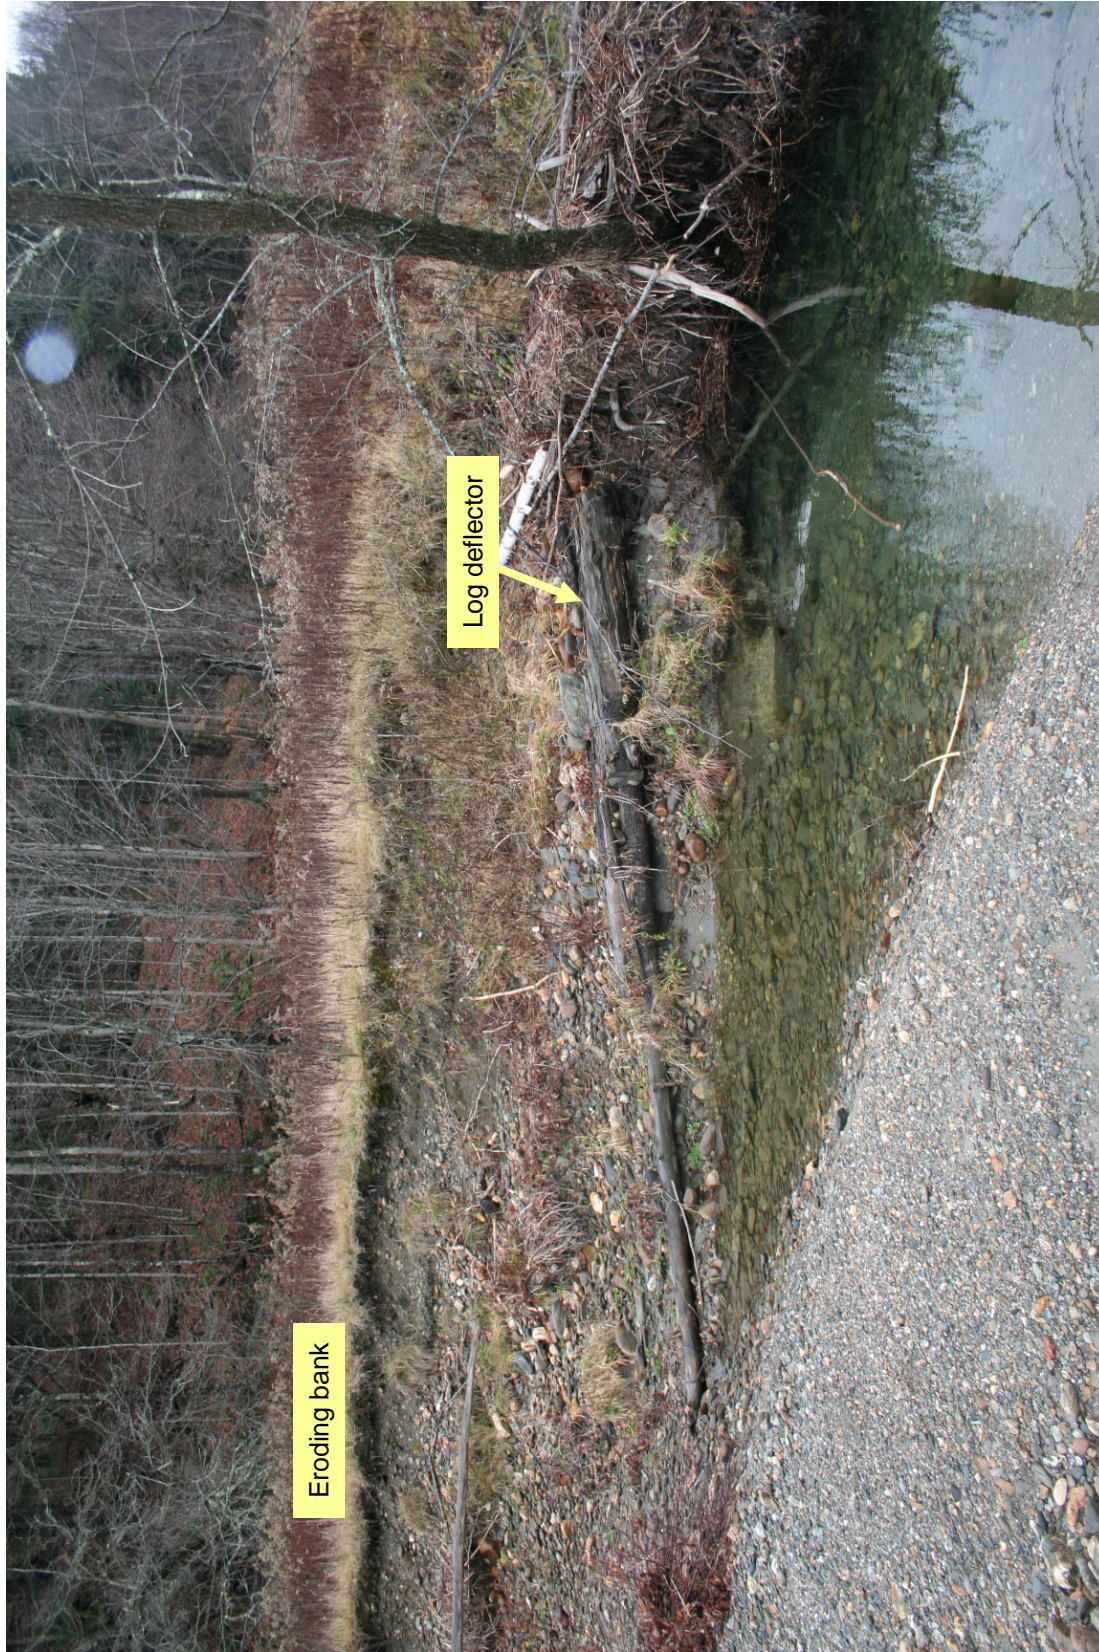
Figure 31. Remaining log deflector along eroding bank of meander and still active side channel created during 1998 flood.

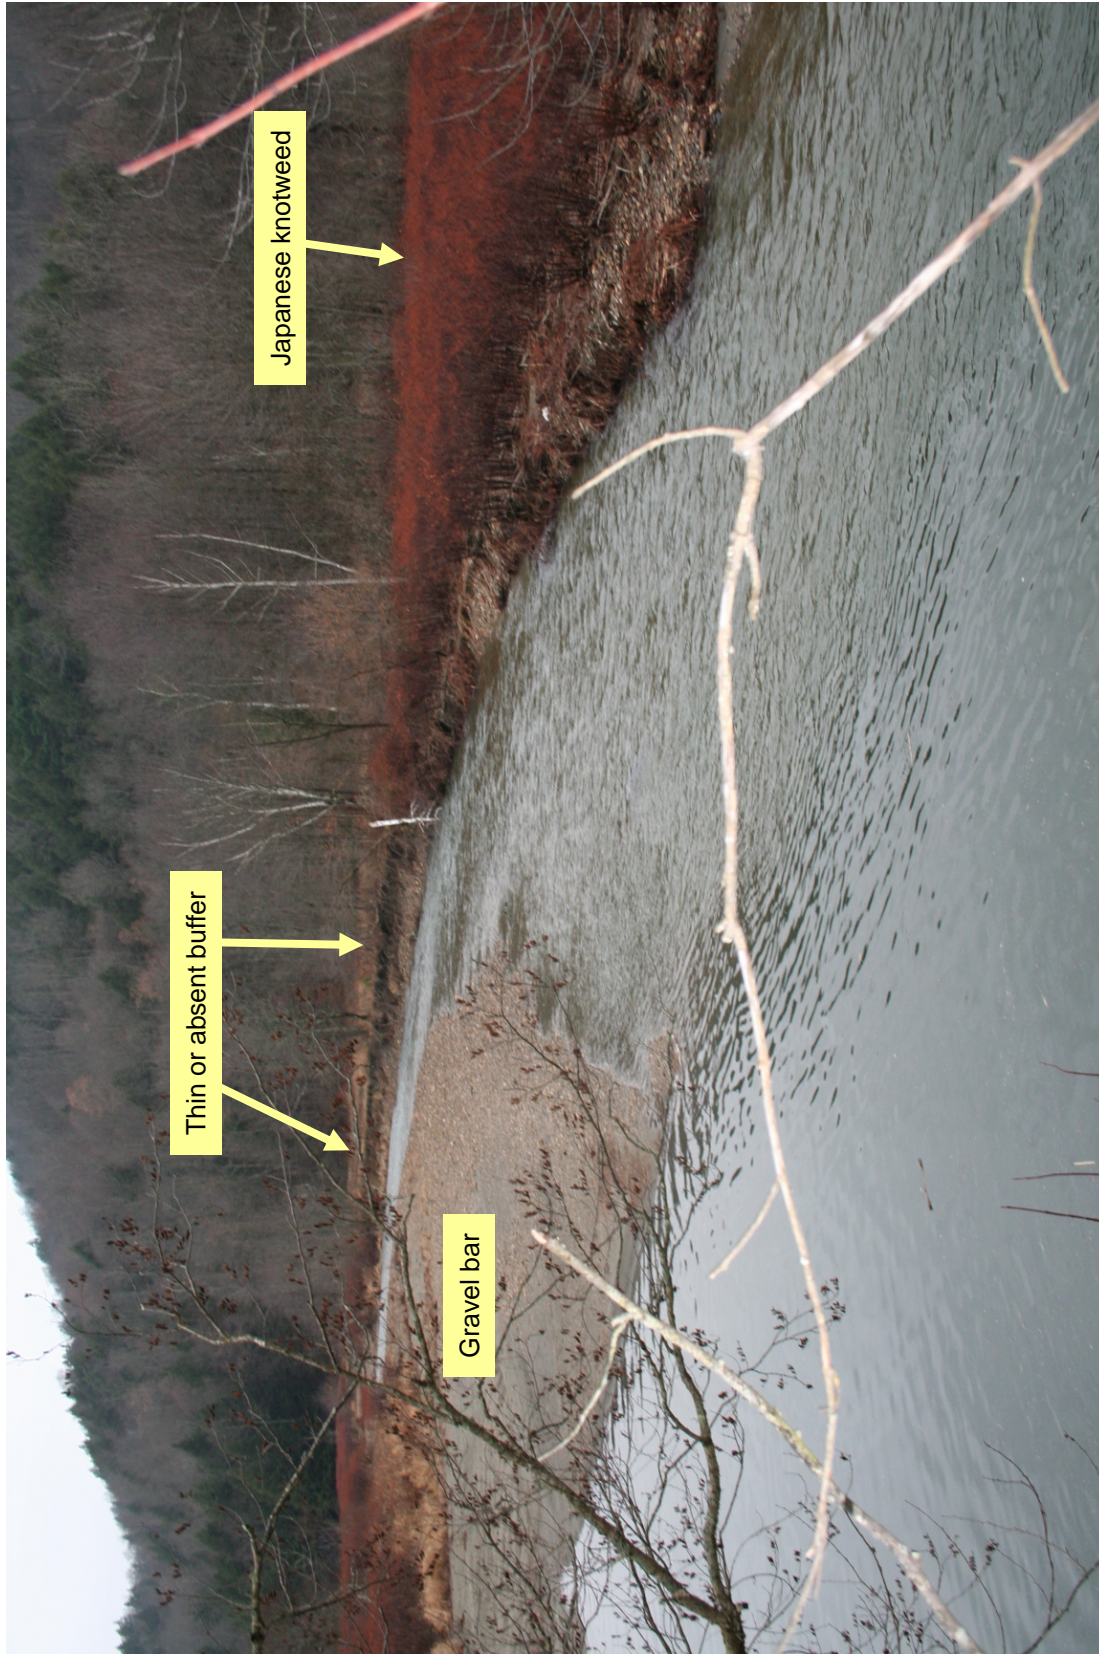
Figure 32. Large gravel bars forming where channel widens along area with thin or absent buffer. Japanese knotweed (red color) is predominate vegetation colonizing gravel bars. Looking upstream from area of riprap shown on Figure 28.

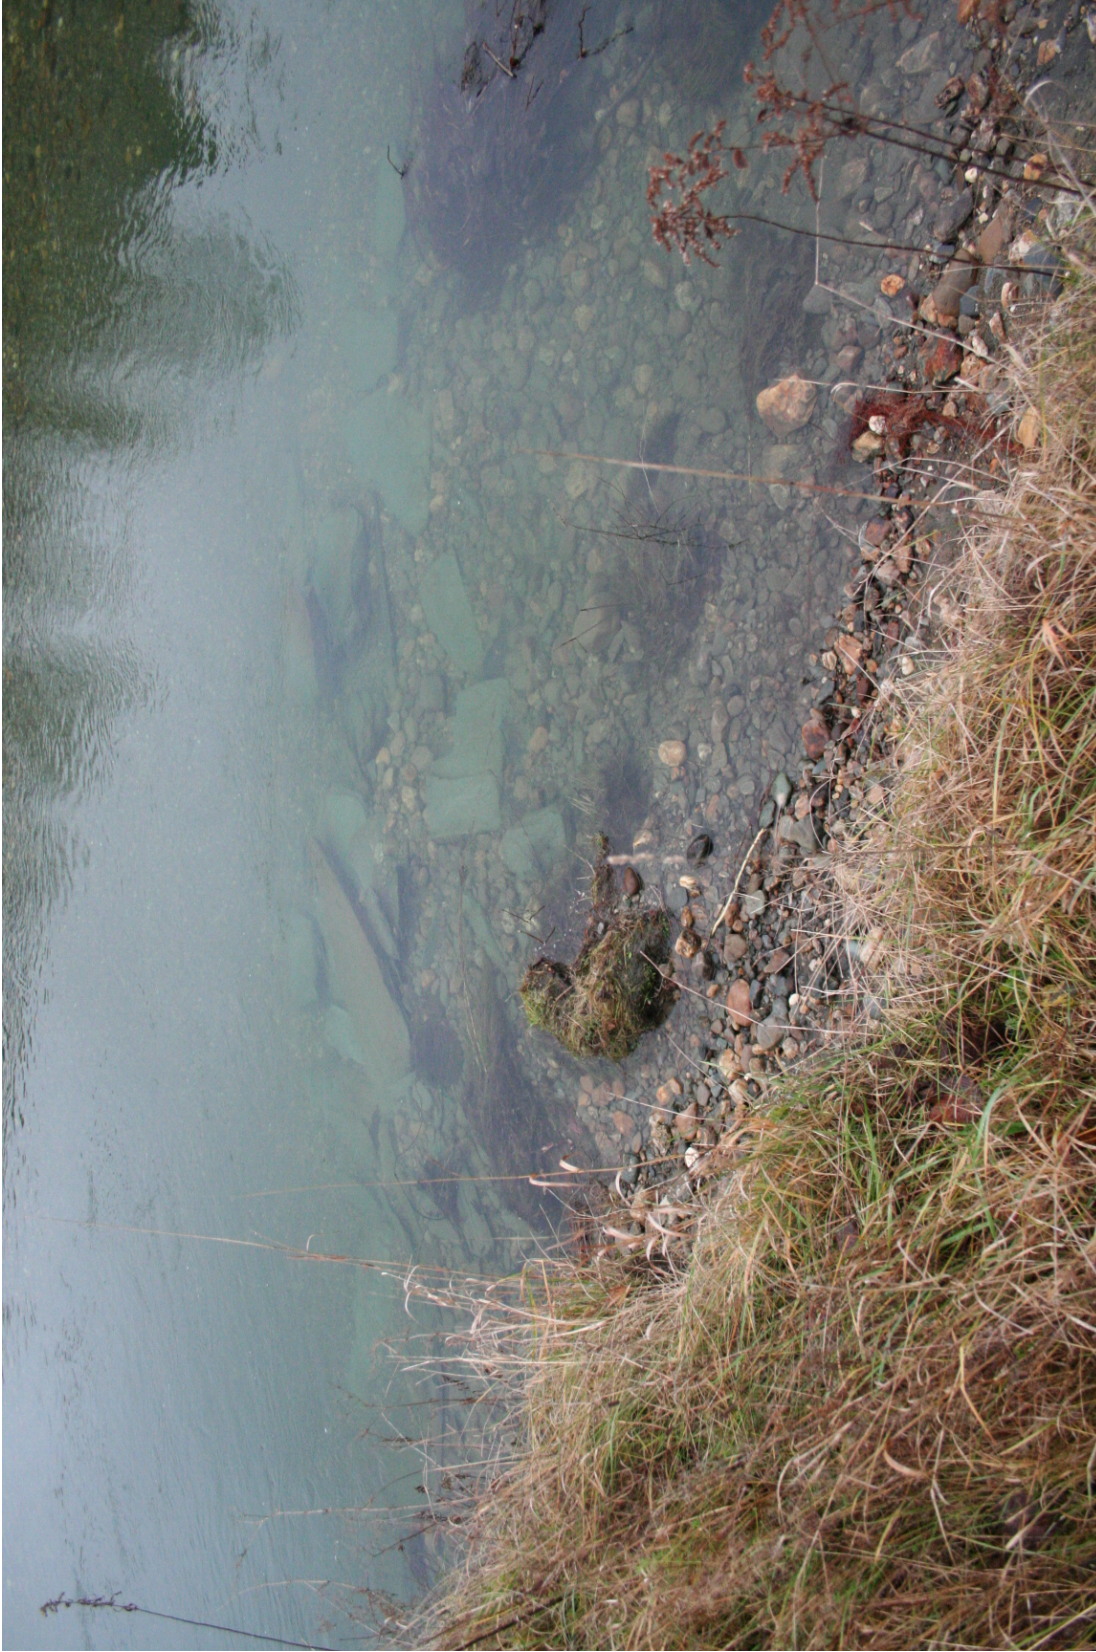
Figure 34. Failed riprap that was previously lining the bank but is now in the river as the bank continued to recede behind it. Location of riprap shown in Figure 28.
