# **Pekin Brook Corridor Plan**

## **Calais, Vermont**

**June 2, 2010**

**Bear Creek Environmental, LLC**  
297 East Bear Swamp Road  
Middlesex, Vermont 05602

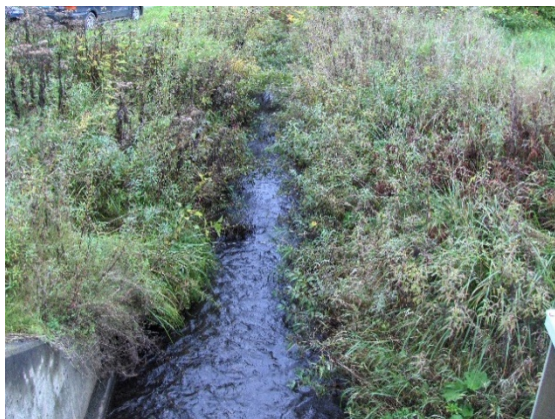
T3.03SI.01-A is a 430 foot long segment, which begins at the confluence of Pekin Brook and continues until the George Road crossing. Segment T3.03SI.01-A is an “E” channel with a poor riparian zone that has experienced major historic degradation and whose planform has been completely altered due to the straightening. Adequate buffers are lacking due to the encroachment of Peck Hill Road and George Road; hay fields line the eastern bank. The riffle-pool bedform is weak and is plane bed in places. The upper part of the segment, just downstream from George Road crossing contains a mass failure.

**Figure 7.2. Straightened section and plane bed features in T3.03SI.01-A**

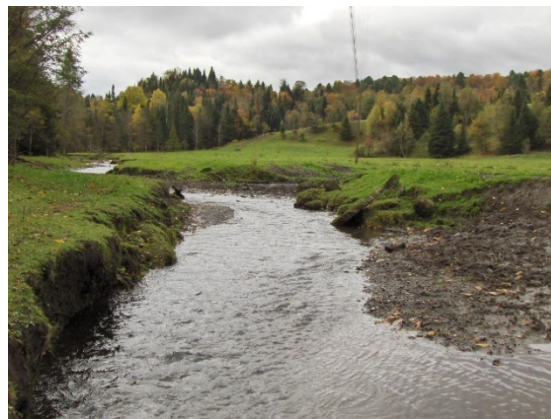
**Figure 7.3. Agricultural land use within the corridor of T3.03SI.01-B**

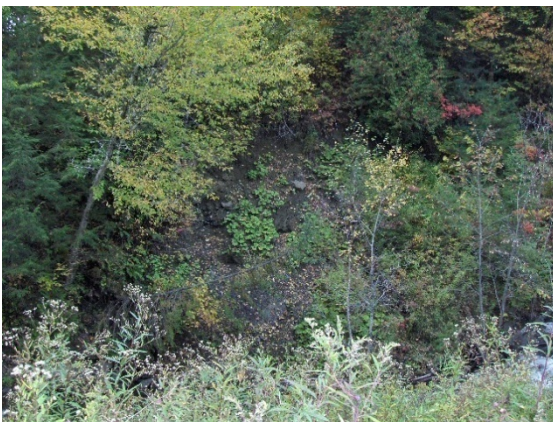
T3.07 begins just upstream of the Kent Hill Road crossing. Due to lack of landowner permission, Reach T3.07 did not receive a full Phase 2 assessment. Based on administrative judgment, this is a “B” channel. There is a mass failure approximately 20 feet high by 20 feet wide on the downstream end of the reach just below a waterfall (Figure 7.4). The downstream end of the reach has been straightened and armored with rip-rap where it is close to North Calais Road (Figure 7.5).

**Figure 7.4. Mass failure in reach T3.07**

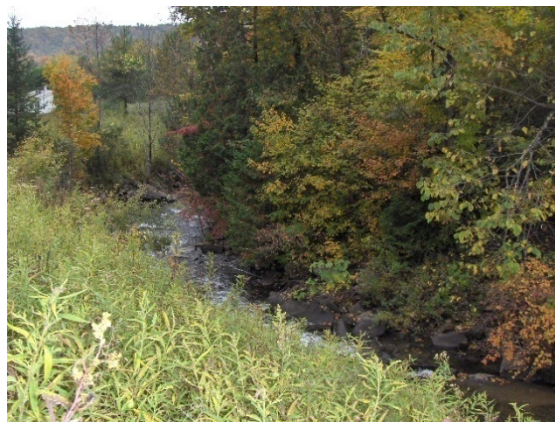
**Figure 7.5. Straightened section of reach T3.07**

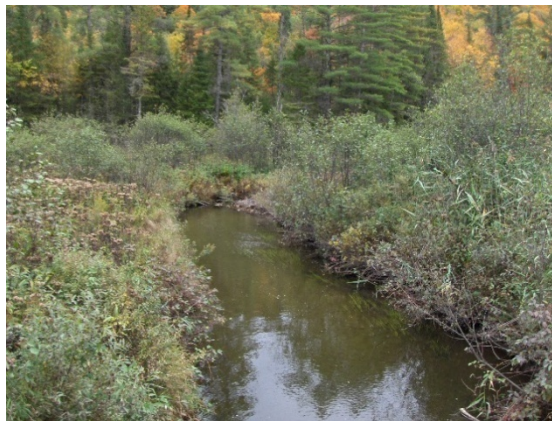
Reach T3.08 begins just upstream from the next crossing (North Calais Road) on Pekin Brook and continues until the confluence with Dugar Brook. Similar to T3.07, Reach T3.08 did not receive a full Phase 2 assessment due to lack of landowner permission. Observations were made from two crossings along North Calais Road and from one point along the road. From all three locations, the reach appears to be a sand dominated, “E” type stream (Figure 7.6) with high sinuosity. The buffers are well vegetated with shrub/saplings except for road crossings and areas where North Calais Road encroaches the river corridor.

**Figure 7.6. Sand dominated “E” channel in reach T3.08**

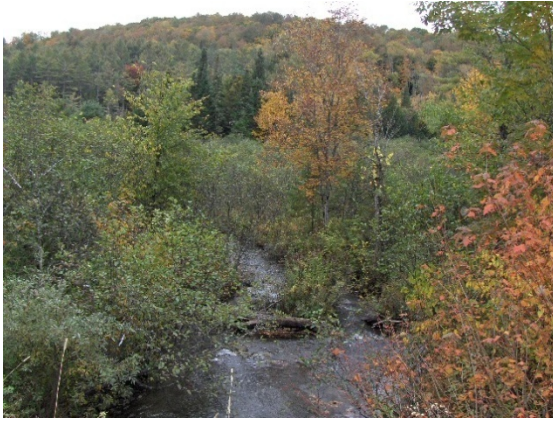
**Figure 7.7. Gravel dominated "E" channel in reach T3.09**

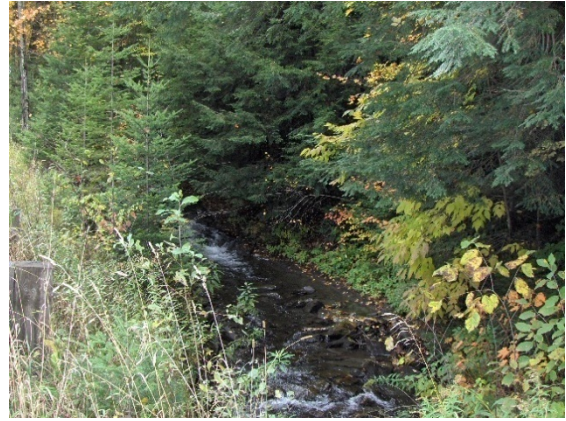
**Figure 7.8. Short "B" channel section in reach T3.09**

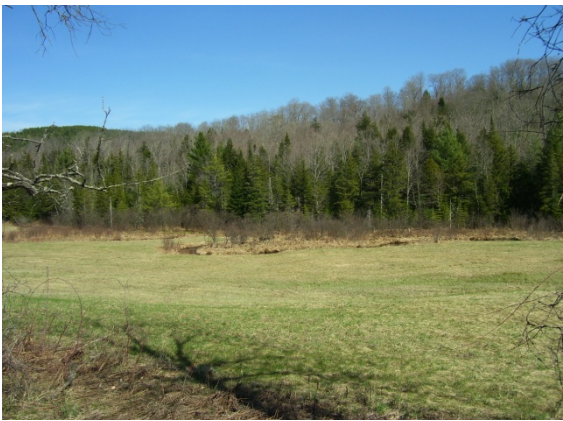
**Figure 7.9. Lack of buffer in reach T3.09**

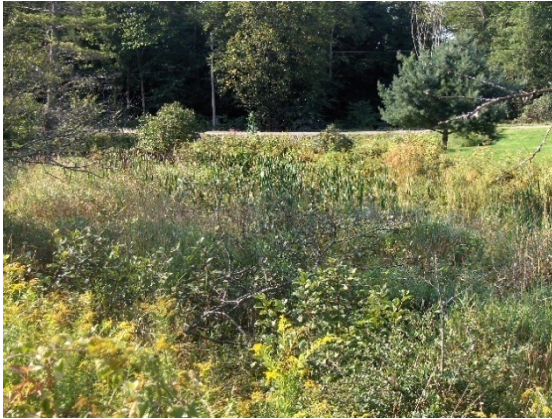
**Figure 7.11. Wetland in downstream end of T3.10-A**

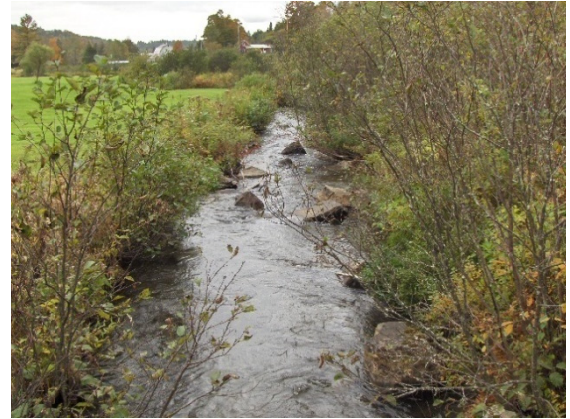
**Figure 7.12. Lack of buffer in Segment T3.10-A**

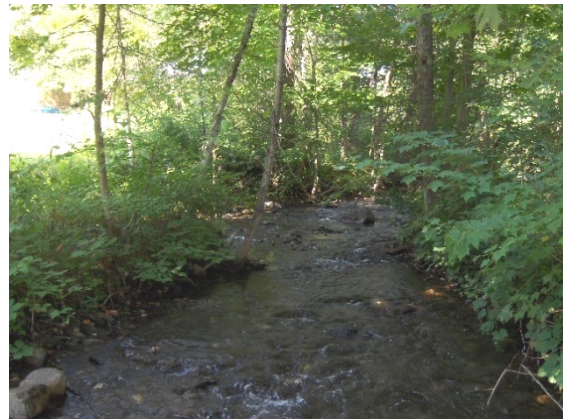
Segment T3.10-B begins where the reach becomes more entrenched and forested along the east side (Figure 7.13). It has a greater slope than downstream and is therefore a “Cb” channel with step-pool features as its dominant bedform. The west side of the corridor is residential with a valley wall continuous with the stream bank in some places. There are four bedrock grade controls (Figure 7.14) with a cascade section at the top of the segment with no buffer along the west bank (Figure 7.15). Similar to its downstream segment (T3.10-A), T3.10-B has experienced major historic incision (1.51 incision ratio), but aggradation, widening and planform adjustment is minor.

**Figure 7.13. Forested east bank and residential west bank in Segment T3.10-B**

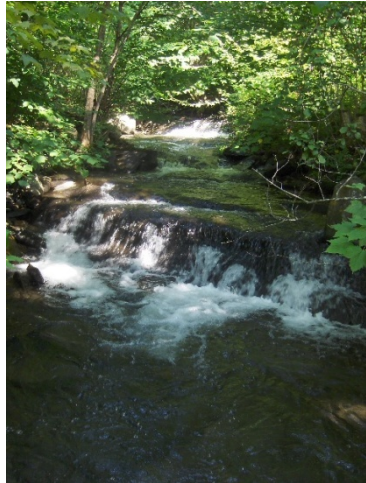
**Figure 7.14 Grade control in Segment T3.10-B**

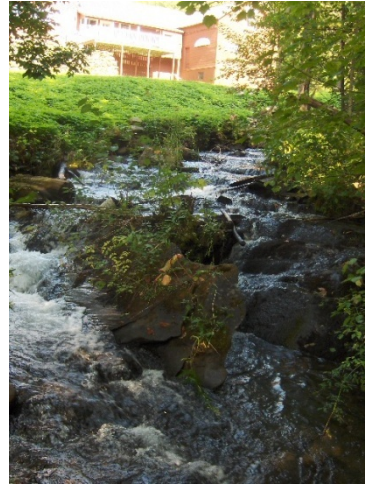
**Figure 7.15. Lack of buffer in upstream section of T3.10-B**

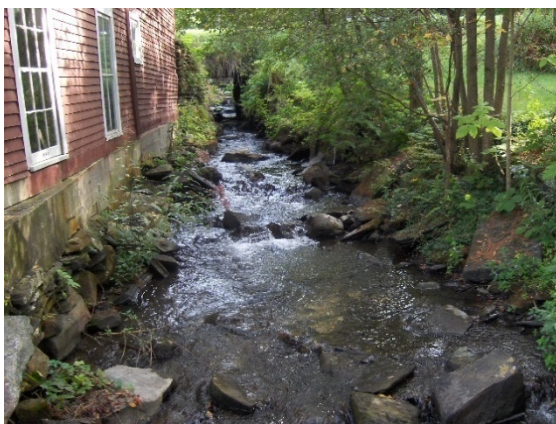
**Figure 7.16. House right along west bank on Reach T3.11 of Pekin Brook**

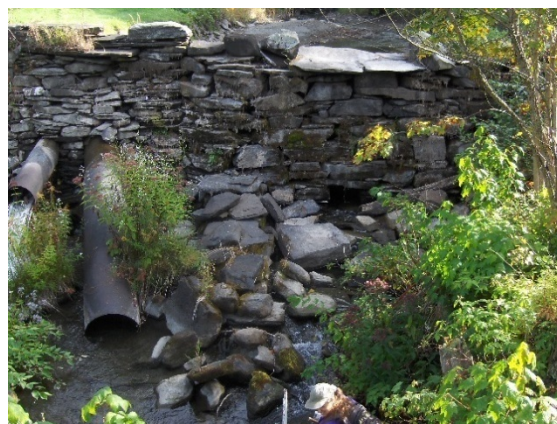
**Figure 7.17. Rock dam in Reach T3.11**

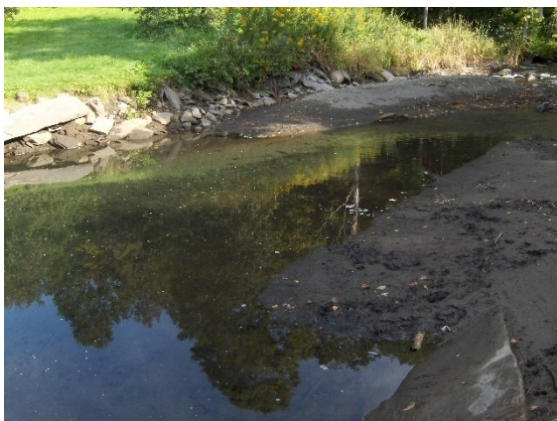
**Figure 7.18. Sediment deposition upstream of dam on T3.11**

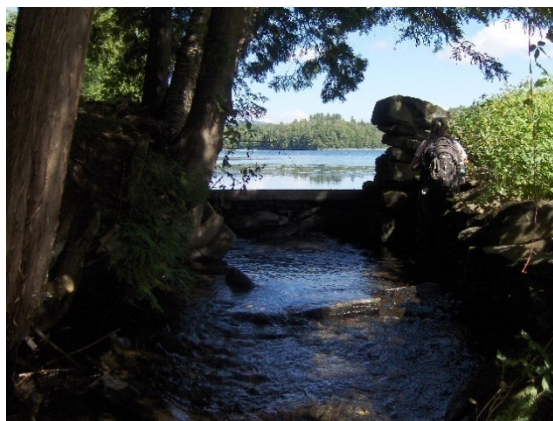
Reach T3.11 begins at the top of a large grade control near a house along the west side of the channel and continues until the dam at No. 10 Pond (Mirror Lake). A house is located right on the bank and is acting as the valley wall (Figure 7.16). The reach continues under a bridge at TH16 and then meets another on-stream dam (Figure 7.17). There is a large pool behind the dam and considerable amounts of sediment are being held back by the dam, thereby starving the downstream segment of sediment (Figure 7.18). Large trout were observed in this pool during the Phase 2 assessment. There is another dam at the upstream end of the section at the outlet of No. 10 Pond (Figure 7.19).

**Figure 7.19. Dam at No. 10 Pond at upstream end of T3.11**

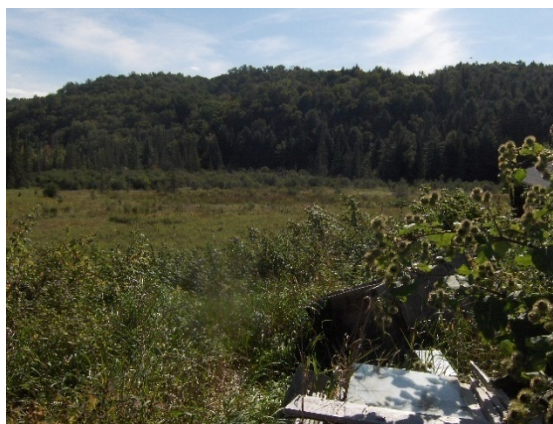
**Figure 7.20. Wetland at downstream end of Dugar Brook**

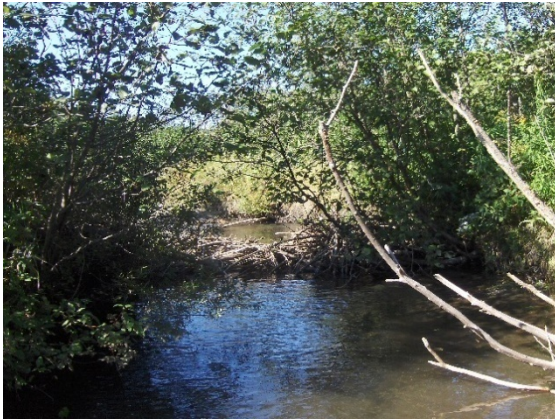
**Figure 7.21. Beaver dam in T3.08SI.01-B**

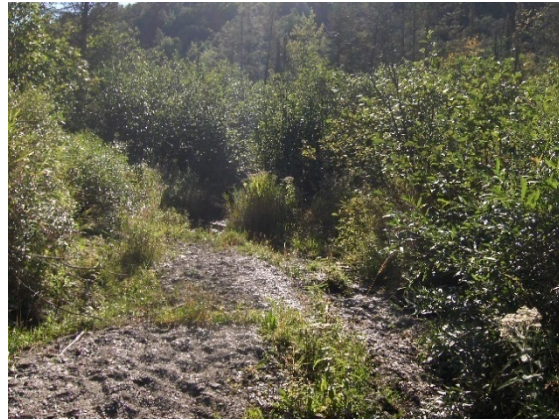
**Figure 7.22. Upstream deposition from beaver dam in T3.08SI.01-B**

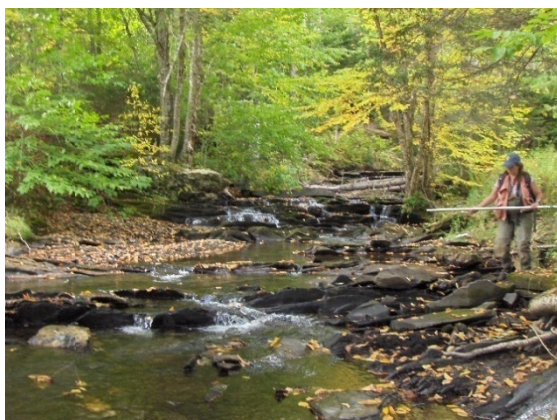
T8.08SI.01-C has not incised like the downstream segments most likely due to the presence of the grade control. However, there are many large depositional features, some of which are higher than half the bankfull elevation (Figure 7.24), indicating aggradation as a major process. The sediment transport capacity has therefore been exceeded. Since Segment T8.08SI.01-C is mostly aggradational, the channel evolution model is D-IIId. All other geomorphic processes are minor. Aside from the road encroachment, Segment T8.08SI.01-C has a riparian buffer in good condition.

**Figure 7.23. Bedrock grade control in upper part of T3.08SI.01-C**

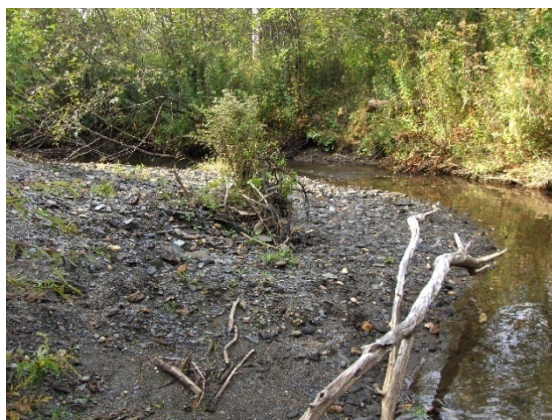
**Figure 7.24. Large side bar indicating major aggradation in Segment T3.08SI.01-C**

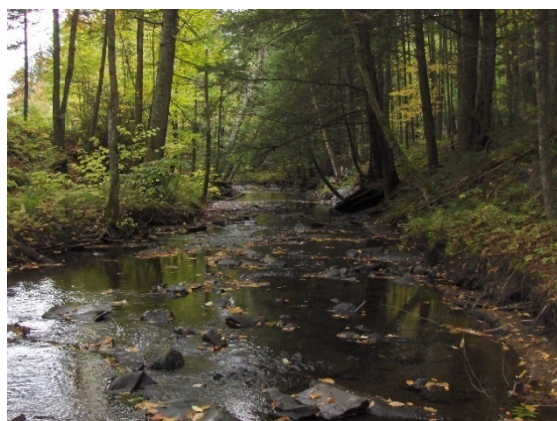
**Figure 7.25. Typical “B” channel in Reach T3.08SI.02 most likely naturally straight**

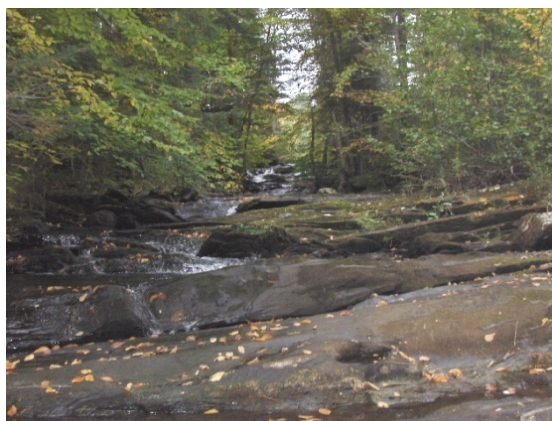
Bedrock grade controls have prevented the reach from incising (Figure 7.26). The top of the reach contains a cascade with series of bedrock grade controls that is holding back sediment. At the upstream end of the cascade there used to be an old mill dam, which is no longer present. The reach is in “good” condition and all adjustment processes are minor. Since the river corridor is well forested except for the road, protecting the river corridor is important to maintain the high quality riparian corridor.

**Figure 7.26. Series of bedrock grade controls in T3.08SI.02**

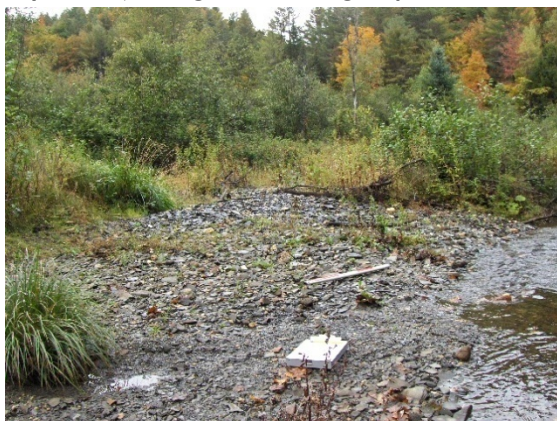
Reach T3.08SI.03 begins at the top of the bedrock grade controls where the valley becomes much wider and continues until a small bedrock gorge. The bedrock grade control in the downstream reach is holding back sediment. According to local residents, the channel was impounded by a dam at bottom of the reach. The dam is now removed, but is likely the cause of the considerable sediment retention (Figure 7.27). The channel is most likely re-adjusting from being impounded and is now seeking equilibrium.

**Figure 7.27. Deposition in T3.08SI.03 upstream from bedrock grade controls and former dam**

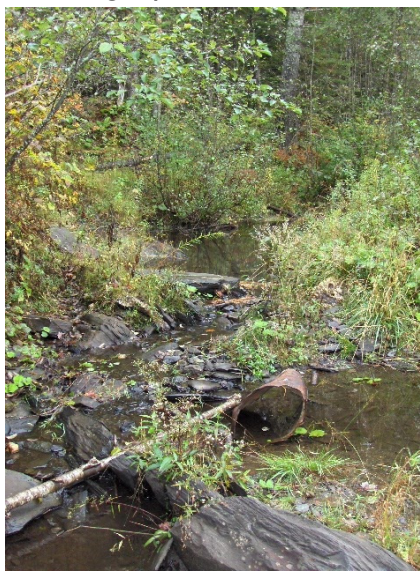
**Figure 7.28. Flood chute in reach T3.08SI.03**

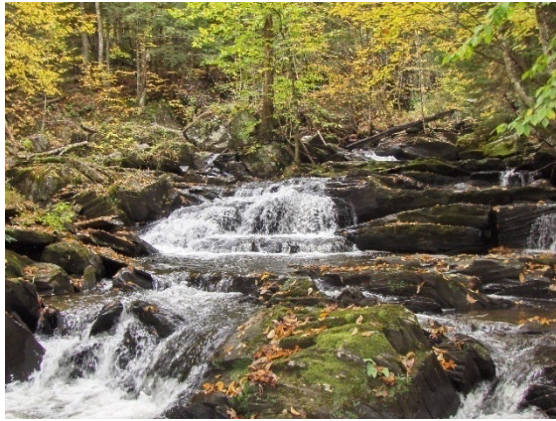
The fourth reach on Dugar Brook was divided into two segments due to a bedrock gorge in the first 200 feet (Figure 7.29). Segment T3.08SI.04-A is a bedrock gorge and, therefore, was not assessed. The segment begins at the start of the bedrock and continues until the Apple Hill Road Bridge. There is one small mass failure associated with rip-rap falling in at the bridge crossing at Apple Hill Road (Figure 7.30).

**Figure 7.29. Bedrock grade controls in T3.08SI.04-A**

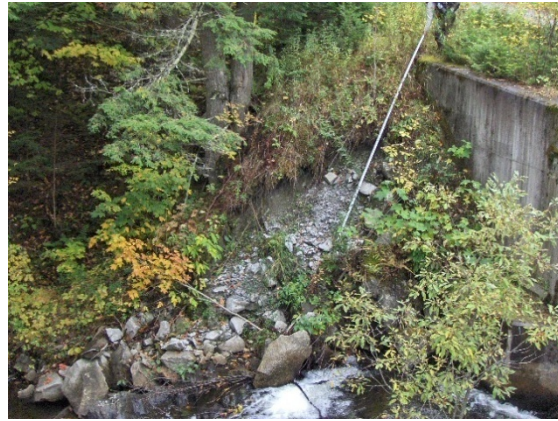
On Dugar Brook, the bridge at Apple Hill Road is undersized and has a small mass failure associated with some fallen rip-rap armoring on the downstream end. In 1973, a culvert at the Apple Hill Road crossing was washed downstream from a flood event. The culvert was replaced, but in 1984 another flood event caused the culvert to be blocked with debris and floodwaters were diverted onto Dugar Brook Road. The road was washed out for approximately 1,000 feet. According to local residents, the bridge was installed after the culvert at the crossing washed out the second time. The Apple Hill Road Bridge is low priority for replacement due to the abundant bedrock below the structure and the relatively good condition of the bridge.

**Figure 7.30. Mass failure at Apple Hill Road crossing in T3.08SI.04-A**

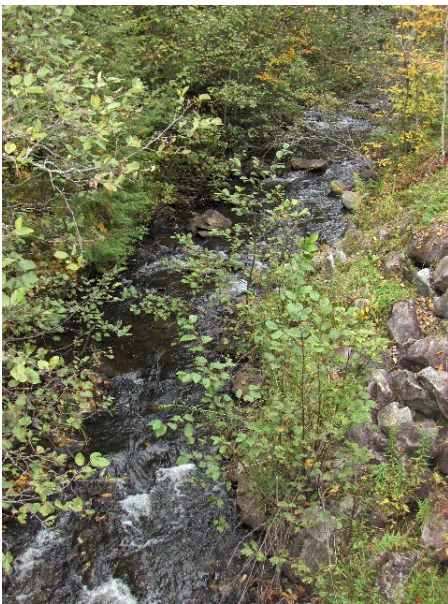
**Figure 7.31. Straightened section of Dugar Brook just upstream of Apple Hill Road crossing with armoring on left bank**

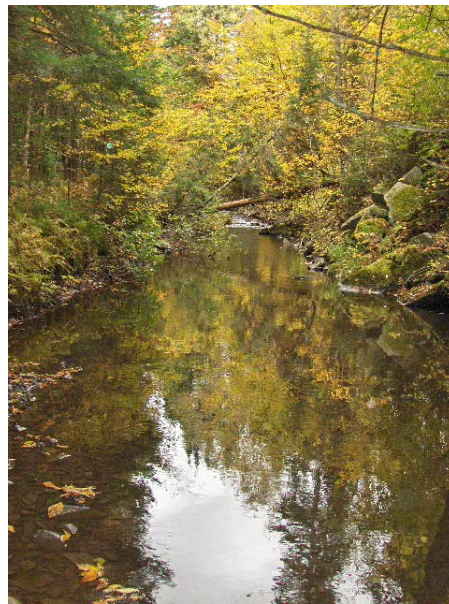
The next segment, T3.08SI.04-B, begins at Apple Hill Road and continues until the stream reaches a beaver dam at a wetland. The channel alternates between a “B” and a “Cb” morphology in stage II-III of the F channel evolution model. In some places along the segment the channel is naturally a “B”, but at other times the entrenchment has changed due to the placement of Dugar Brook Road and there is a stream type departure from a “C” to a “B” channel. This departure mostly occurs at the downstream and upstream ends of the segment.

**Figure 7.32. Plane bed section of Dugar Brook in segment T3.08SI.04-B**
