**STREAM GEOMORPHIC ASSESSMENT
of the
STEVENS BRANCH
WILLIAMSTOWN AND BARRE CITY UPSTREAM
OF THE CONFLUENCE WITH THE JAIL
BRANCH**

Prepared for: Central Vermont Regional Planning Commission

FINAL DRAFT, DECEMBER 15, 2004

**Prepared by:
Lori Barg
Step by Step Community Environmental
113 Bartlett Road
Plainfield, Vermont 05667
802-454-1874
loribarg@together.net**

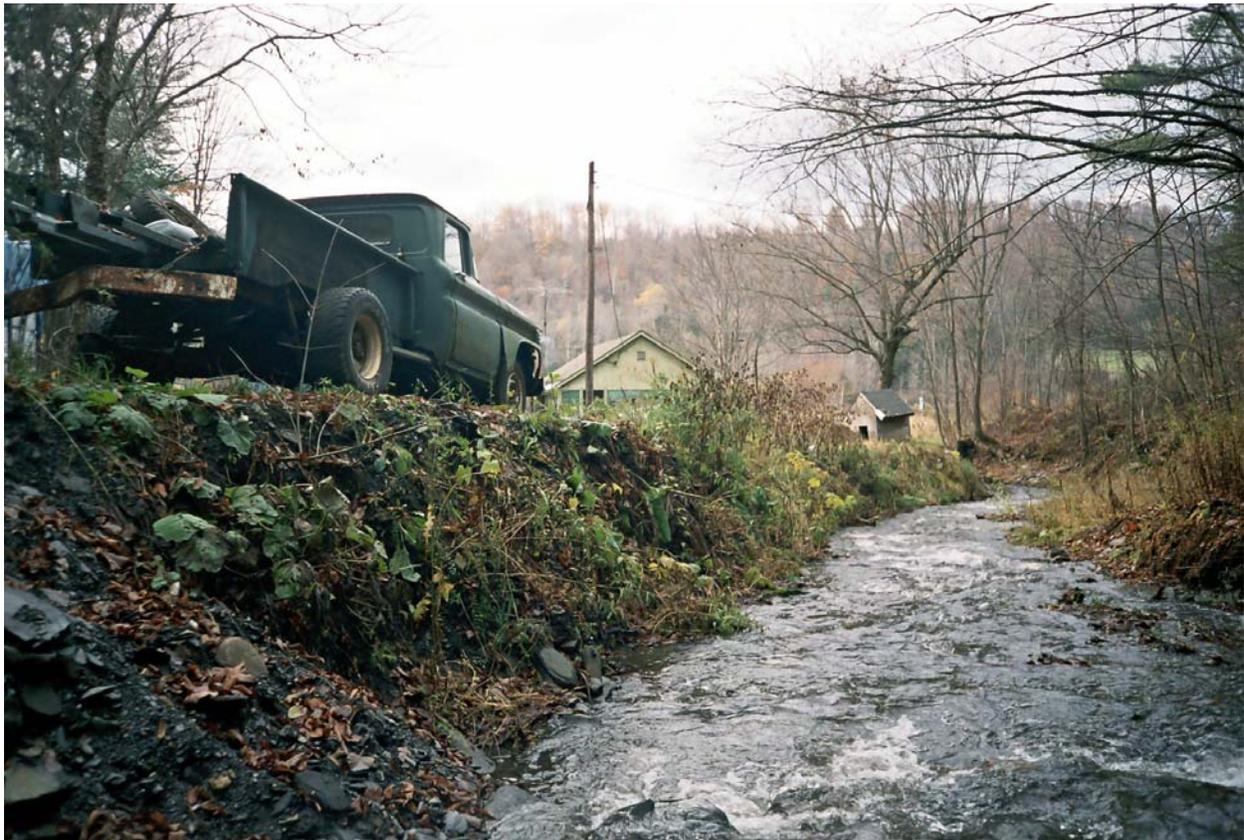
Channelized Alluvial Fan at T6.5, near the Chelsea Road in Williamstown.

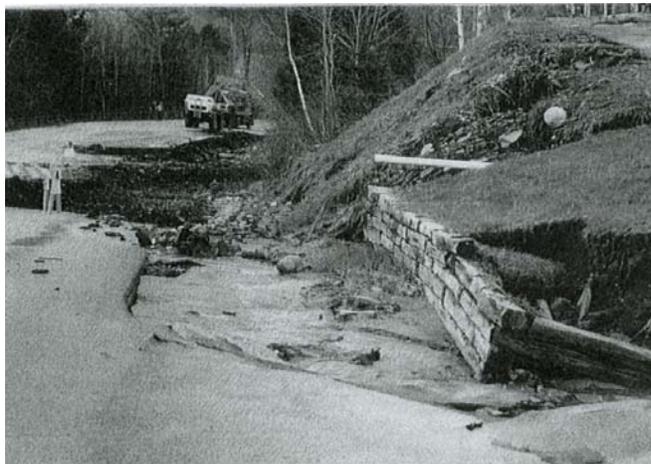
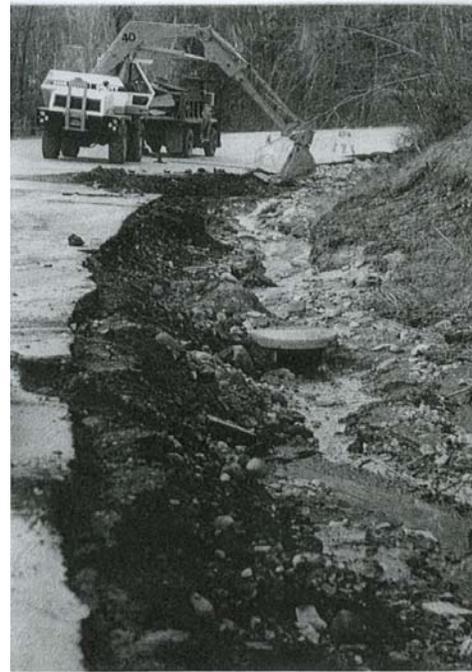
A single culvert blocked by debris on Quarry Hill in Barre in 1983 washed out a “lengthy stretch of Quarry Hill Road” (Figure 3). The Nov. 8, 1927 Rutland Herald states that Barre had “property loss \$2,000,000”.

Figure 3: Quarry Hill Road, May 1983. A four-foot culvert blocked by debris washed out Quarry Hill from Johnson Paving to within several hundred feet of the Barre City line. Tributary not assessed during study. Times Argus Photo.

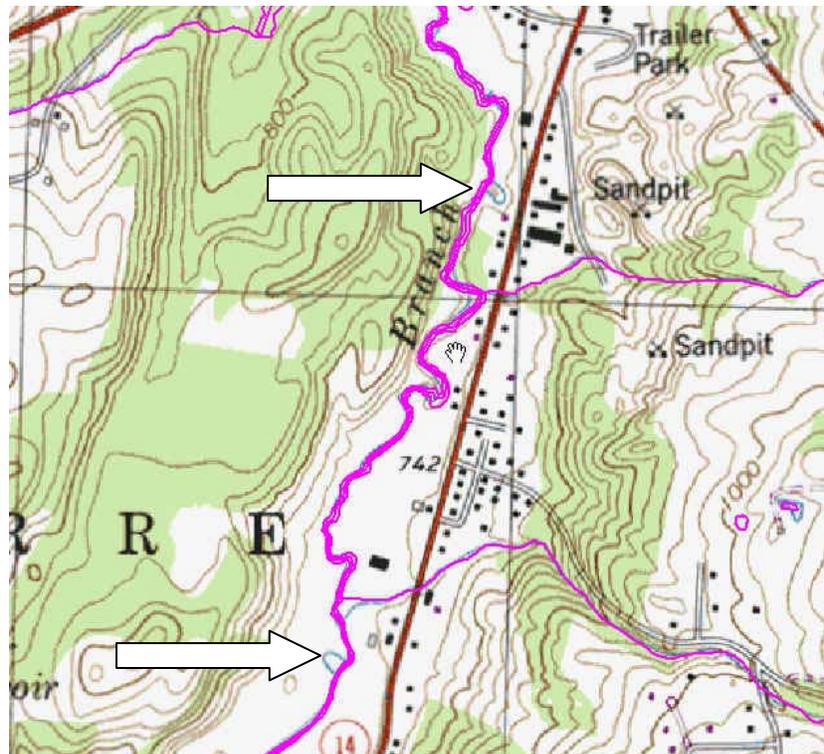
Figure 5: Channel Avulsions and flood plain encroachment. Note the two areas (arrows) where channel avulsions have occurred, or the stream has been straightened. The area to the north (west of the sandpit) has been filled in and construction has occurred.

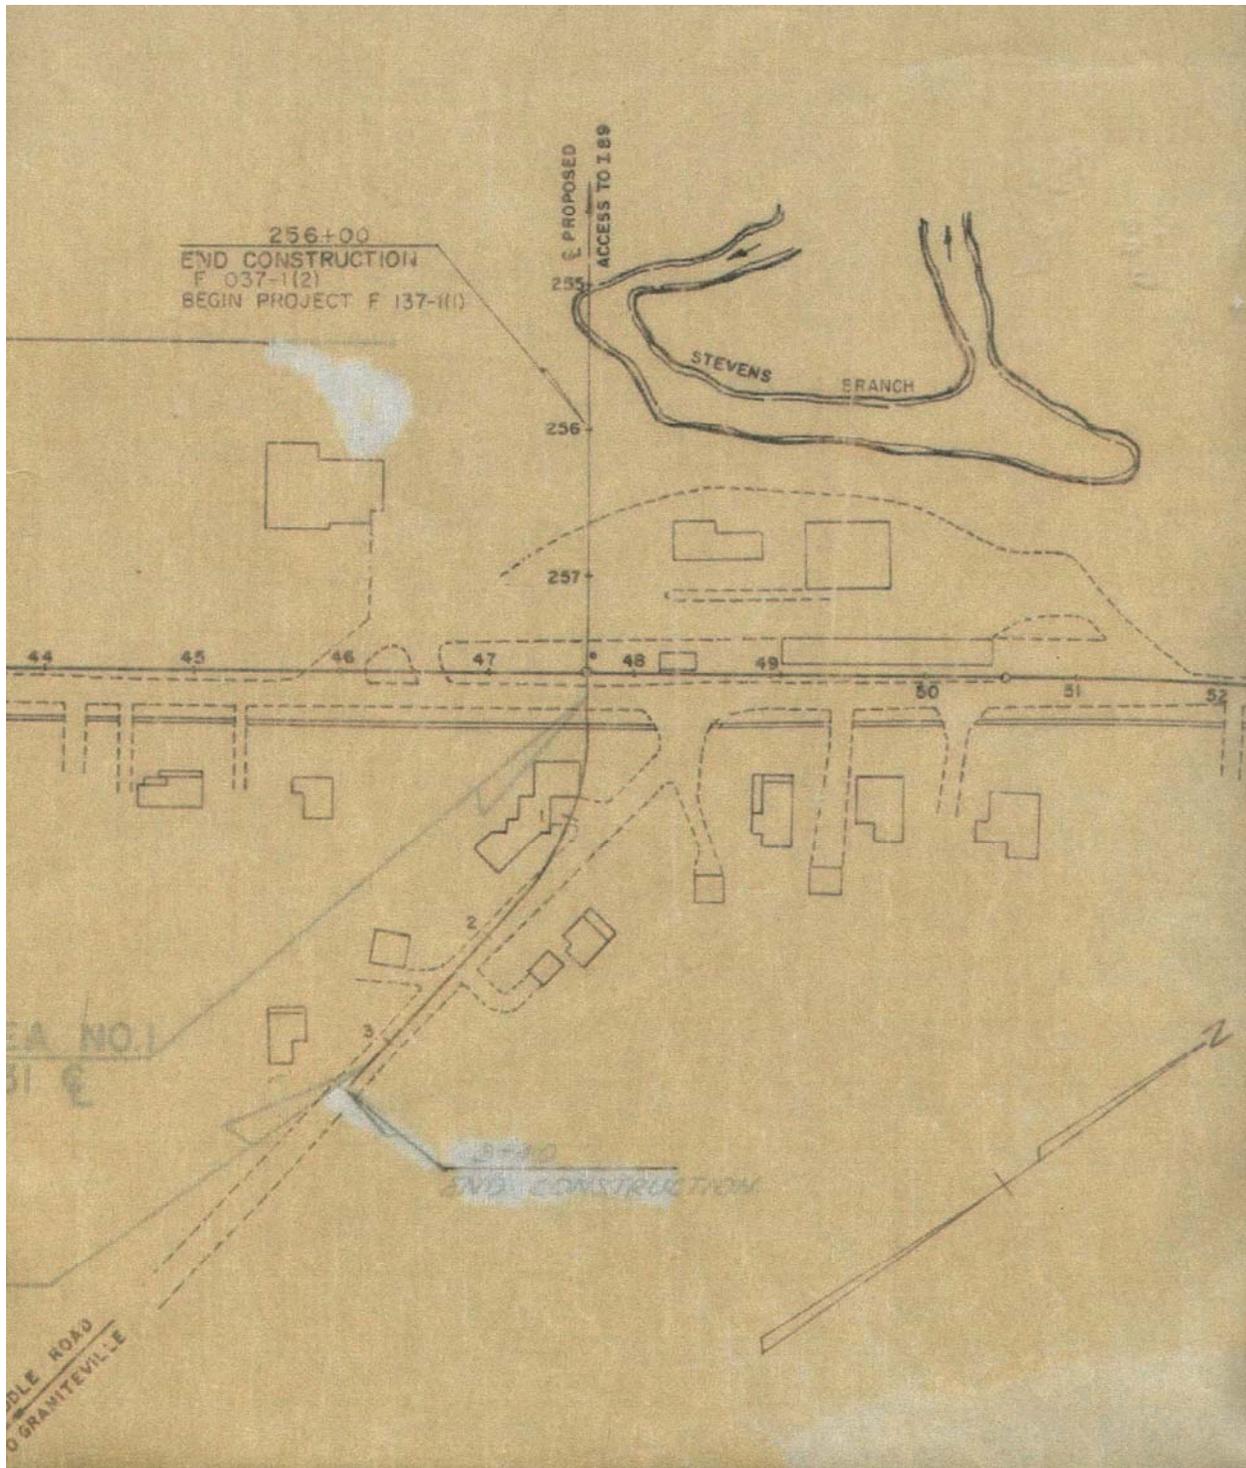
Figure 6: Channel Straightening. This Vermont Agency of Transportation survey shows a big bend in the Stevens Branch in 1965 prior to the construction of the Route 63 access road to Interstate-89 from Route 14 in Barre. The present channel has been straightened. The steeper channel slopes that resulted from channel straightening lead to increased stream velocity and increased flood damage downstream of the straightened area. Reach M3.

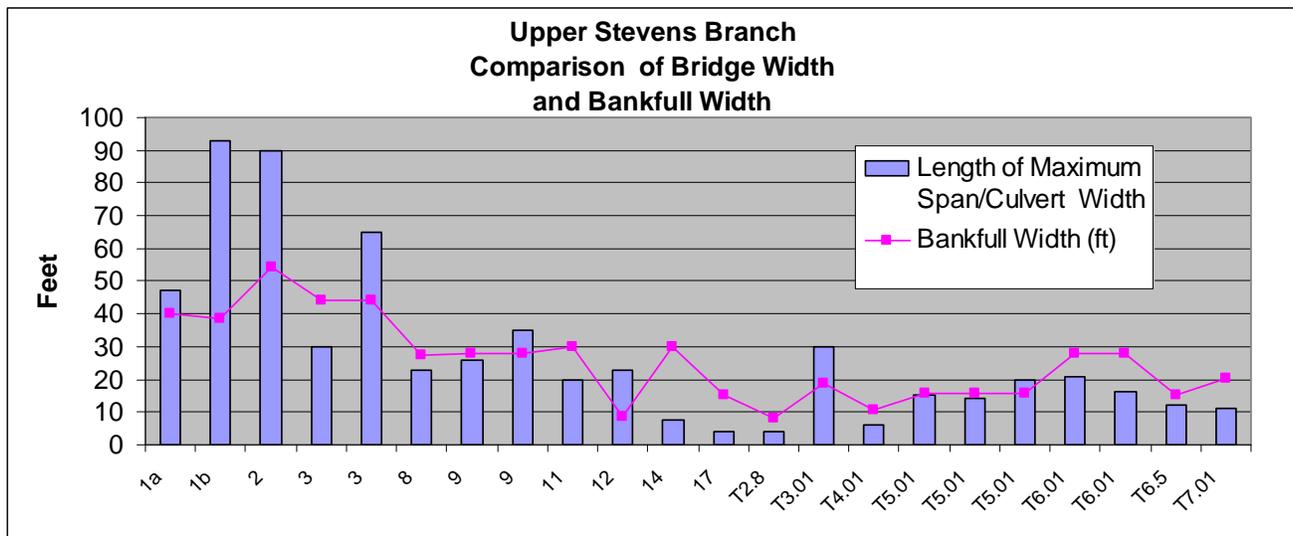
Figure 7: Comparison of Bridge/Culvert and Bankfull Width. Where line is above the vertical bars, the structures constrict the channel. Ideally all reaches would have a bridge/culvert width that is greater than bankfull width. The * indicate bridges with piers in the middle of the channel. Piers can catch debris and restrict flood flows.

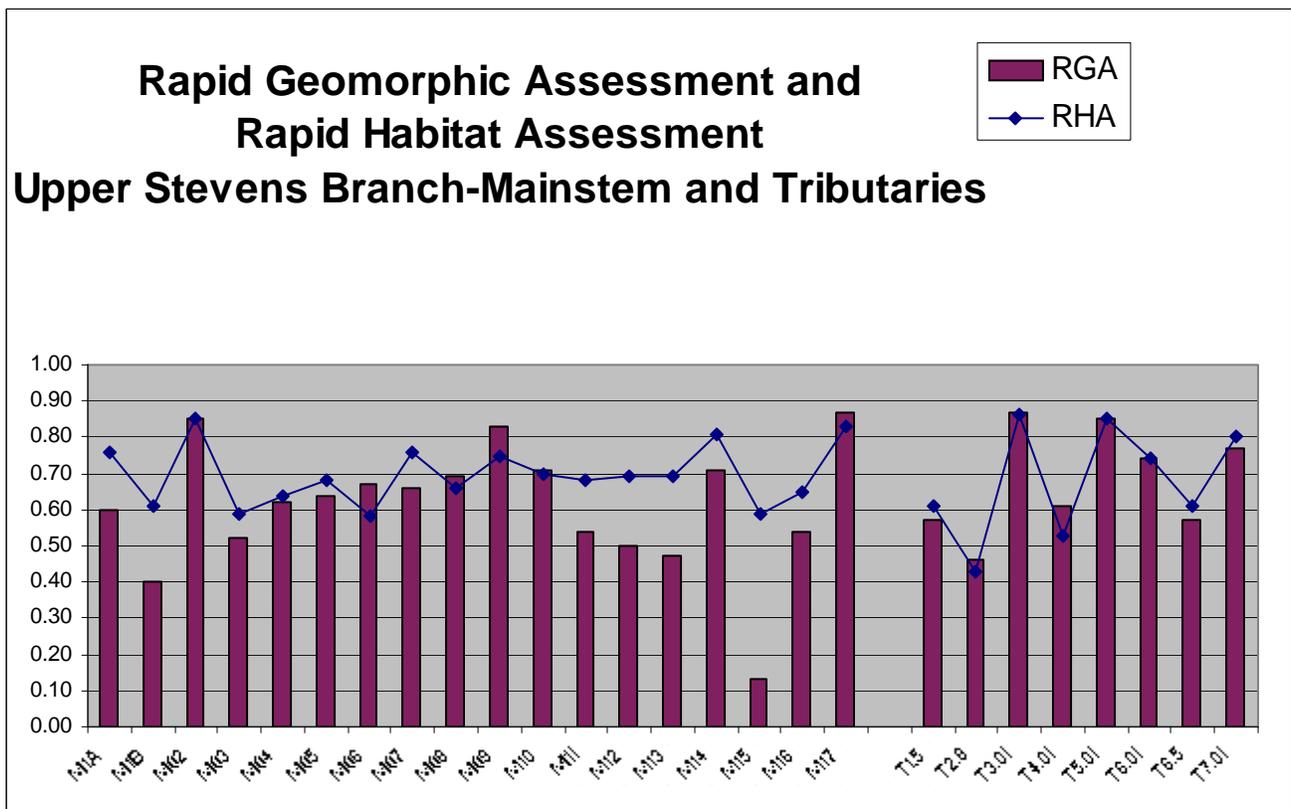
Figure 8: Rapid Geomorphic and Rapid Habitat Assessment Results

The six channelized reaches (M1B, M11, 12, 13, 15 and 16) scored the lowest on the Rapid Geomorphic Assessment. M15 was dredged in the fall of 2003. These reaches have been dredged and straightened or hard-armored. They act more like conduits for water than rivers. If these reaches had not been channelized, then most of the mainstem would fall in the fair/good category. Tributaries have often been channelized near their mouths. T6.5 on the Chelsea Road was recently dredged immediately downstream of a bedrock falls.
