# Town of Waterbury Tropical Storm Irene Inundation Area

In late August of 2011, Vermont was hit hard by Tropical Storm Irene (TSI). Heavy rain totaled over seven inches in areas over the course of one day. The immense downpours caused raging floodwaters to tear through Vermont's streams, devastating people and infrastructure throughout central and southern Vermont. In some areas, TSI flooding approached historic flood levels, while in other areas, the storm greatly exceeded them. Over 500 miles of state roads were damaged as a result of TSI, in addition to over 2000 segments of municipal roads. In total, approximately 500 bridges were damaged or destroyed, as well as almost 1,000 culverts. Approximately 1,500 residences were significantly damaged or destroyed as a result of flooding, as well as state, municipal, and commercial buildings (VANR 2012). Flooding associated with Tropical Storm Irene (TSI) in late August 2011 greatly impacted Waterbury, Vermont. Due to very high stream flows from TSI, the channels of Graves and Thatcher Brook may have experienced major changes. In order to observe any changes in channel geometry, Bear Creek Environmental (BCE) looked at pre-TSI geomorp

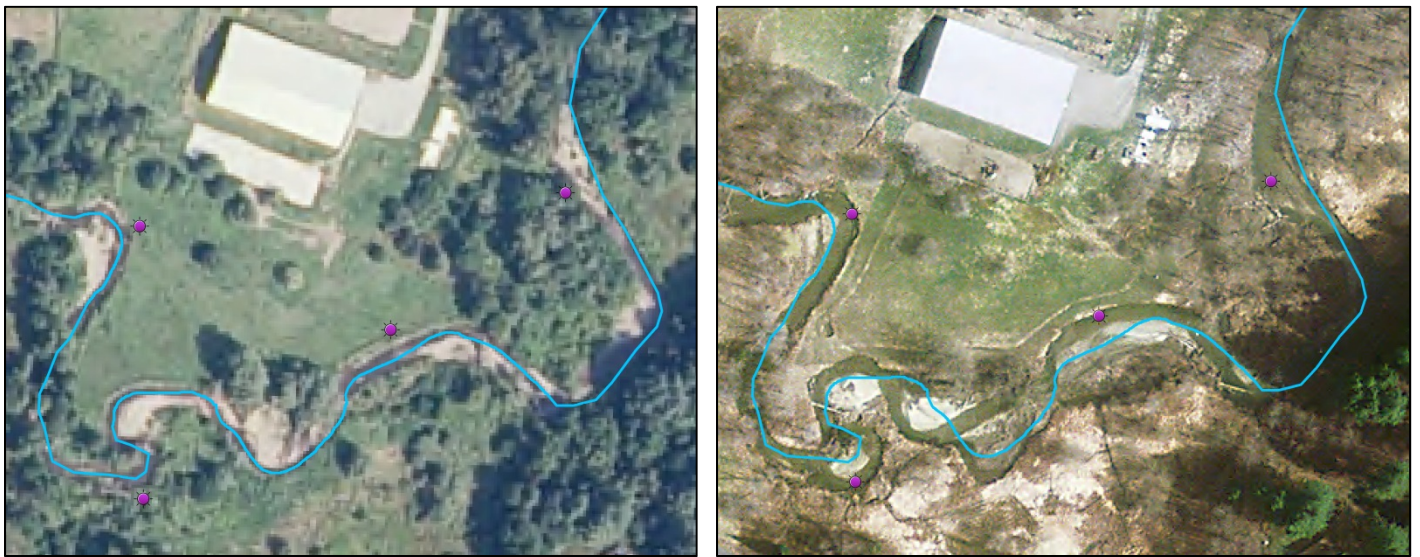
**Figure 1.** Side by side comparison of a location along Thatcher Brook where meander migration (purple dots) occurred likely as a result of TSI (2009 imagery on left, 2013 on right).

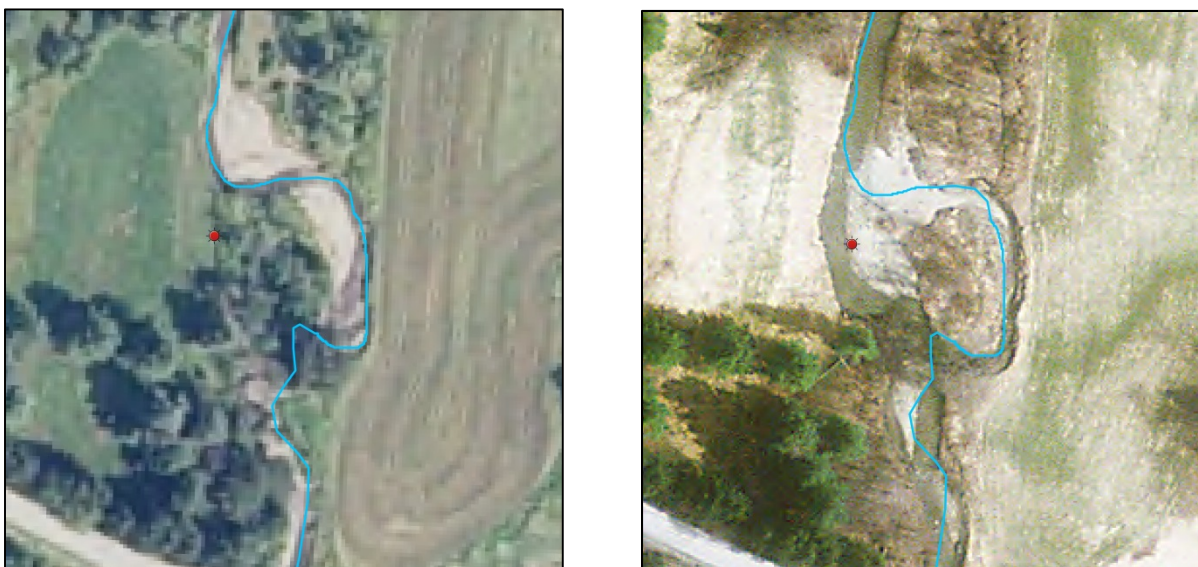
**Figure 2.** Side by side comparison of a location along Thatcher Brook where channel avulsion occurred as a result of TSI (2009 imagery on left, 2013 on right).

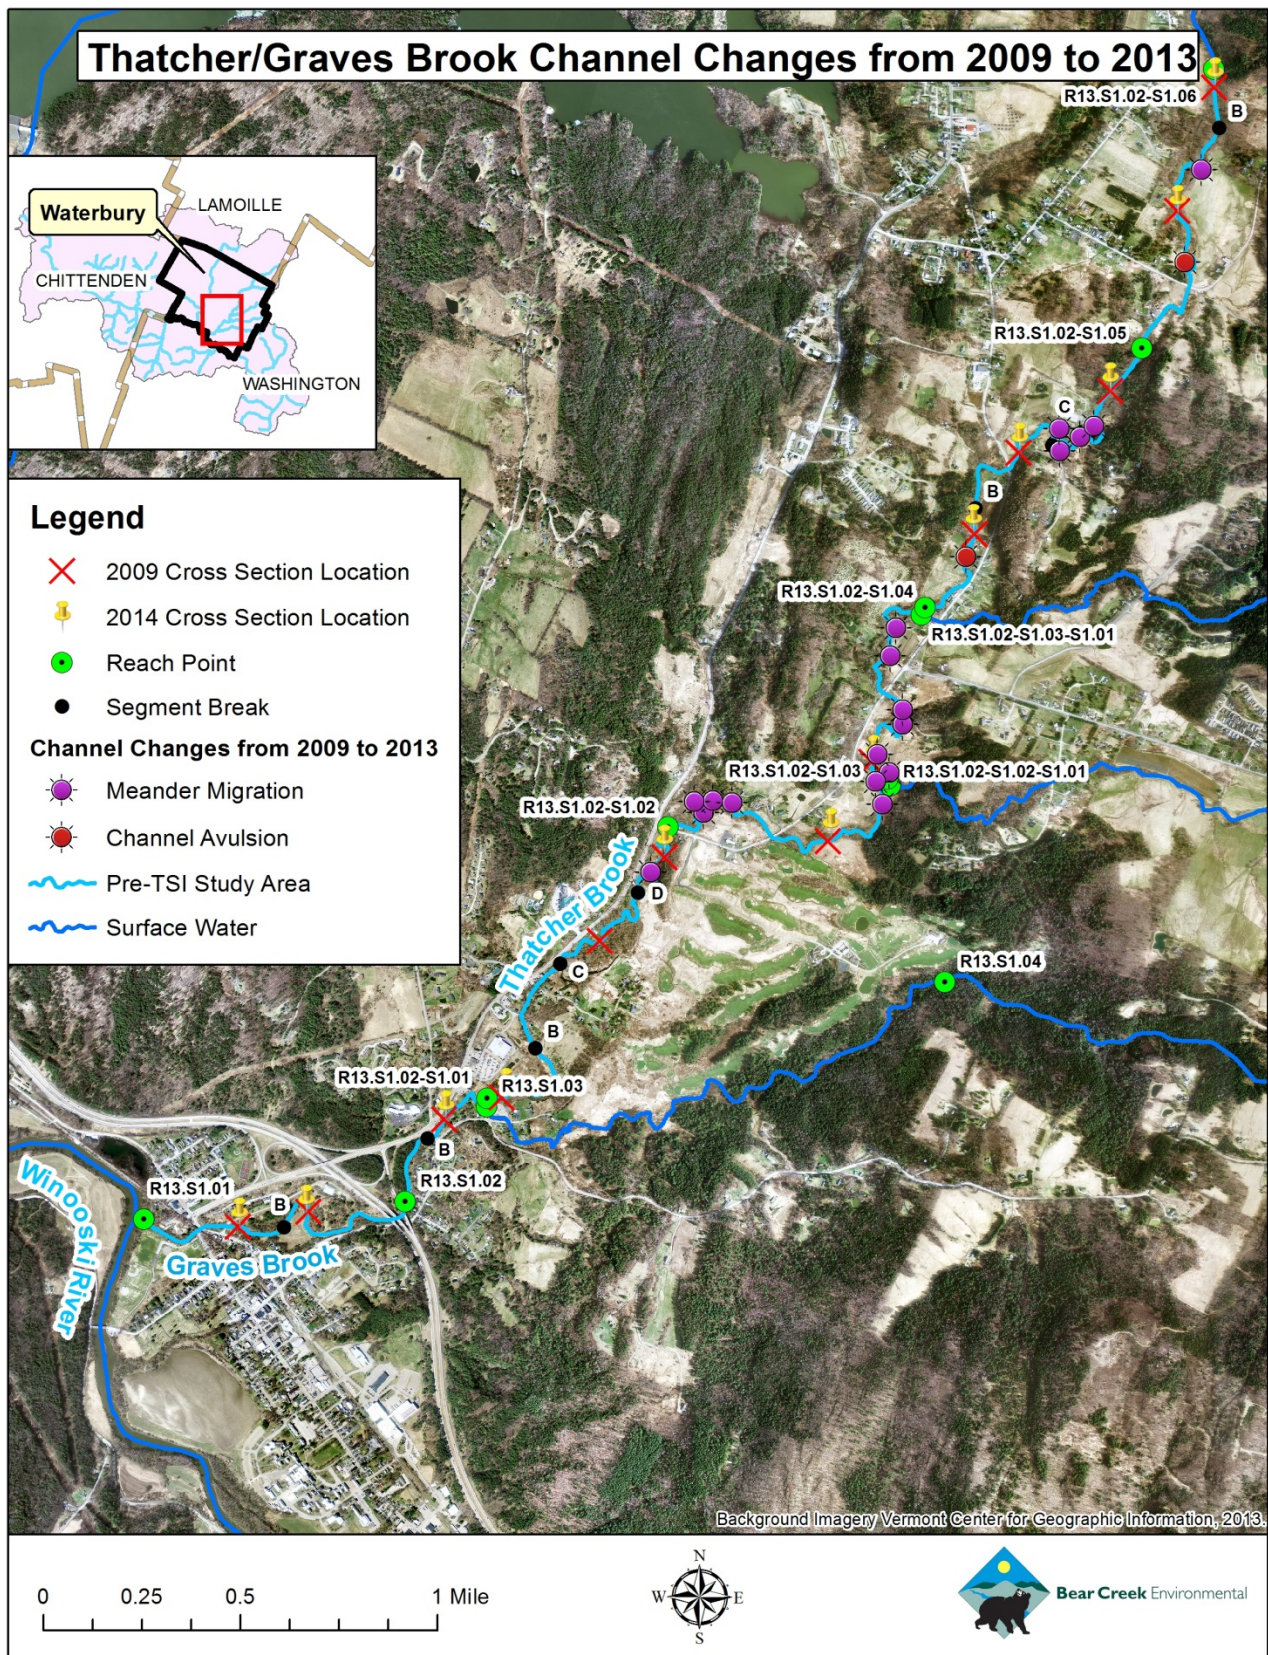
**Figure 3.** Channel changes in Thatcher and Graves Brook from 2009 to 2013.

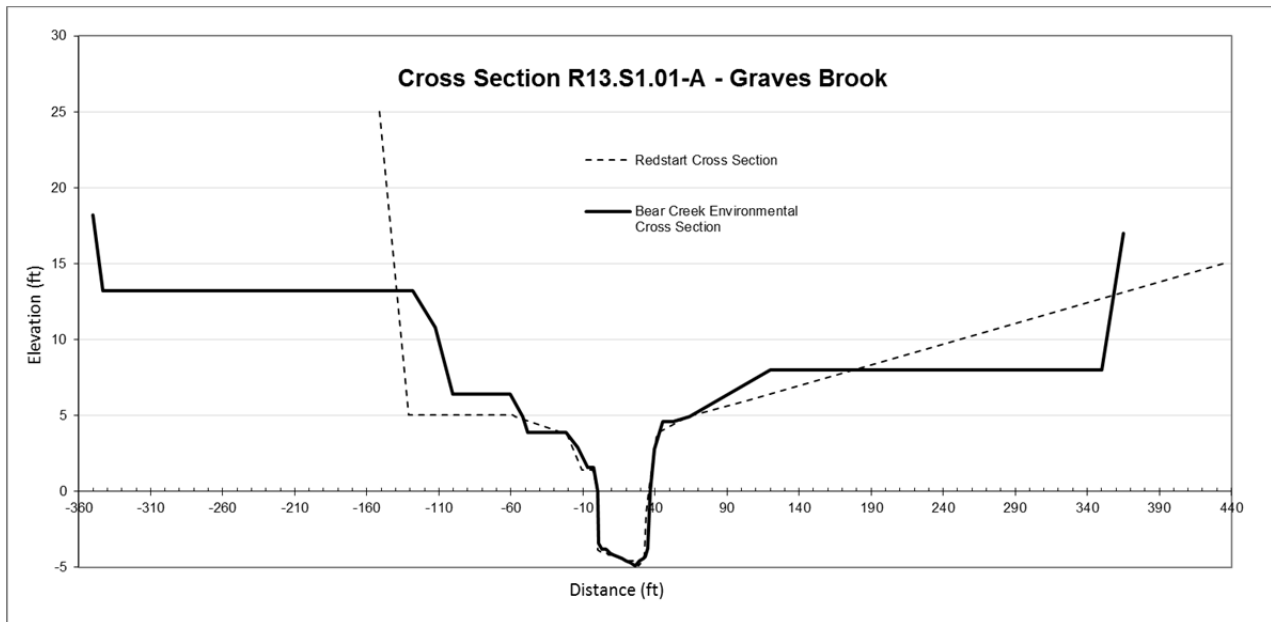
### R13.S1.01-A

**Figure 6.** 2009 and 2014 Cross sections done by Redstart and BCE, respectively in Segment R13.S1.01-A.

Table 1: Comparison of 2009 and 2014 Cross Sections at R13.S1.01-A					
River Scientist Team	Cross Sectional Area	Bankfull Width	W/D Ratio	Entrenchment Ratio	Incision Ratio
Redstart (2009)	146.8	35.3	8.5	3.39	1.8
BCE (2014)	151.4	36.6	8.8	3.17	1.8
Percent change	3.1%	3.7%	3.5%	-6.5%	0%
Comments: Cross sections very similar. No significant change due to TSI. Left valley wall differs due to 2014 cross section extending to railroad bed. 2009 cross section ended at road. Bedform in 2014 was more of a run and not a riffle.

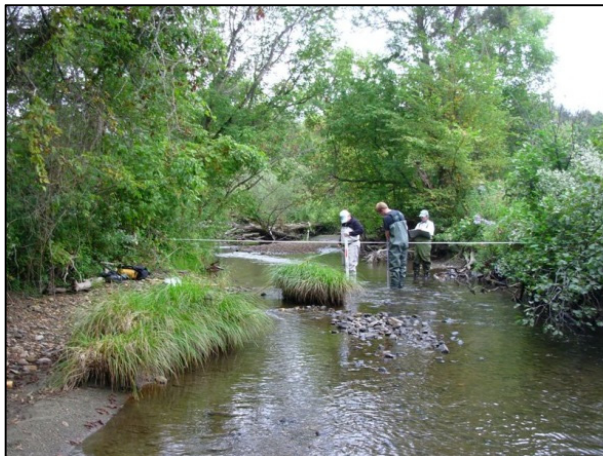
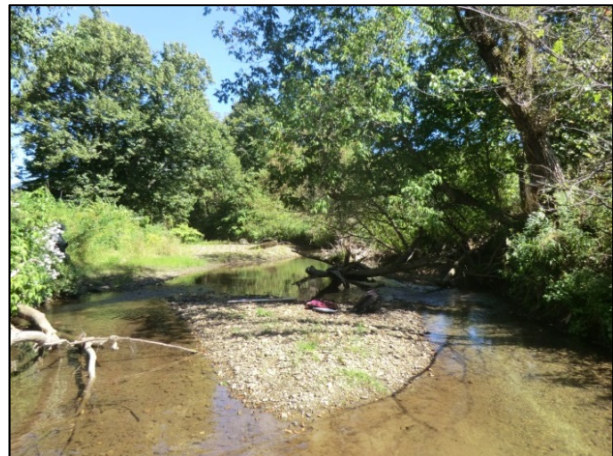
Table 6: Comparison of 2009 and 2014 Cross Sections at R13.S1.02-S1.02					
River Scientist Team	Cross Sectional Area	Bankfull Width	W/D Ratio	Entrenchment Ratio	Incision Ratio
Redstart (2009)	81.2	36	15.9	18.1	1.3
BCE (2014)	125.5	41.4	13.7	12.8	1.4
Percent change	54.6%	15.0%	-13.8%	-29.3%	7.7%
Comments: Cross sectional area for 2014 was higher than 2009. Depositional features in 2014 were larger than in 2009, and new debris noted in channel in 2014; both most likely due to TSI (See Figure 17). Both teams noted that bankfull was hard to find in the field. Redstart used a “low new bench” for determining the bankfull elevation, while Bear Creek used the tree line. This likely accounts for differences in the bankfull cross sectional areas measured.

**Figure 17.** Cross section R13.S1.02-S1.02 in 2009 (left) and 2014 (right).

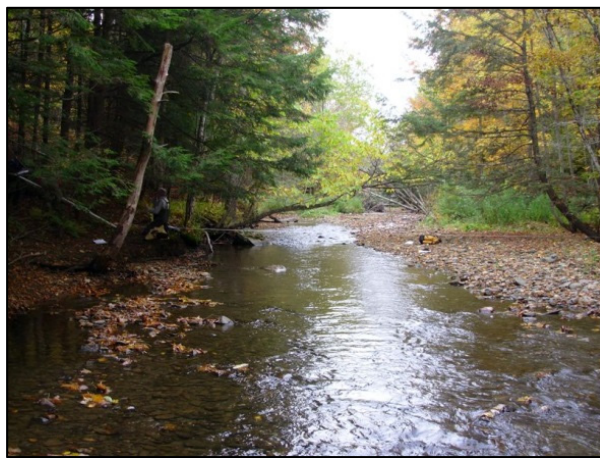
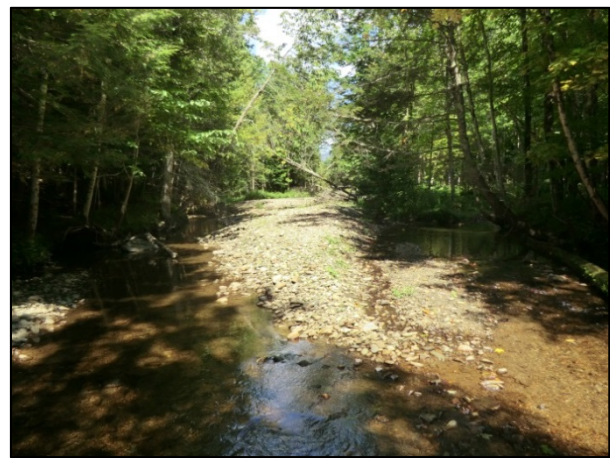
<b>Table 10: Comparison of 2009 and 2014 Cross Sections at R13.S1.02-S1.04-C</b>					
<b>River Scientist Team</b>	<b>Cross Sectional Area</b>	<b>Bankfull Width</b>	<b>W/D Ratio</b>	<b>Entrenchment Ratio</b>	<b>Incision Ratio</b>
Redstart (2009)	79.0	49.4	30.9	4.1	1.5
BCE (2014)	71.5	52.3	38.3	3.6	1.7
Percent change	-9.5%	5.9%	23.9%	-12.2%	13.3%
Comments: Left side of channel deeper in 2014. Flood chute observed in left floodplain in 2014. Bar shifted from left to right in channel.

**Figure 25.** Cross section R13.S1.02-S1.04-C in 2009 (left) and 2014 (right).

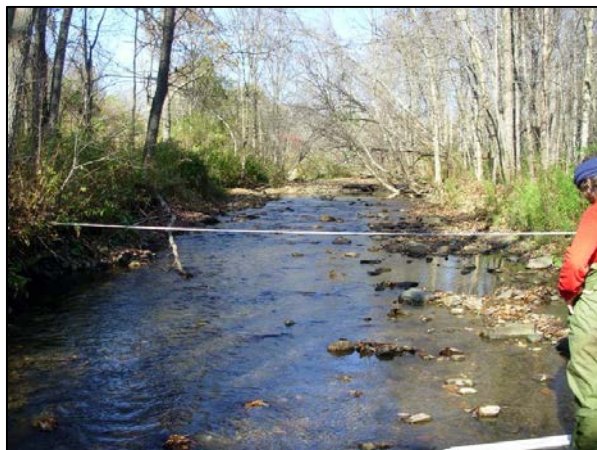
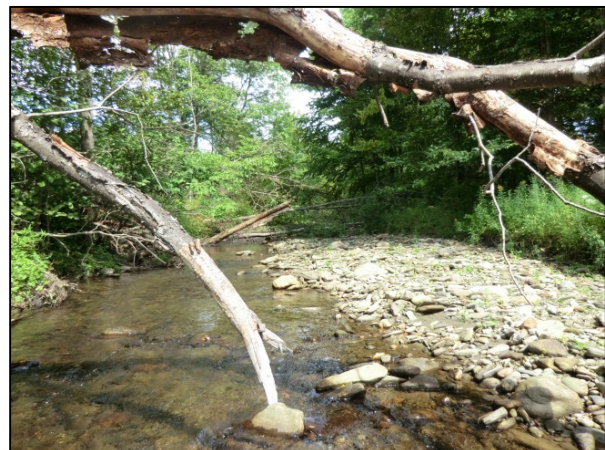
Table 11: Comparison of 2009 and 2014 Cross Sections at R13.S1.02-S1.05-A					
River Scientist Team	Cross Sectional Area	Bankfull Width	W/D Ratio	Entrenchment Ratio	Incision Ratio
Redstart (2009)	79.3	36.8	17.1	3.8	1.7
BCE (2014)	77.1	40.8	21.6	3.5	2.0
Percent change	-2.8%	10.9%	26.3%	-7.9%	15%
Comments: Cross sections were similar in 2009 and 2014. Flood chute observed in 2014 in left floodplain. 2014 cross section measured slightly downstream of 2009 cross section affecting the valley width. More aggradational and slightly wider in 2014 than 2009.

**Figure 27.** Cross section R13.S1.02-S1.05-A in 2009 (left) and 2014 (right)-more aggradational.

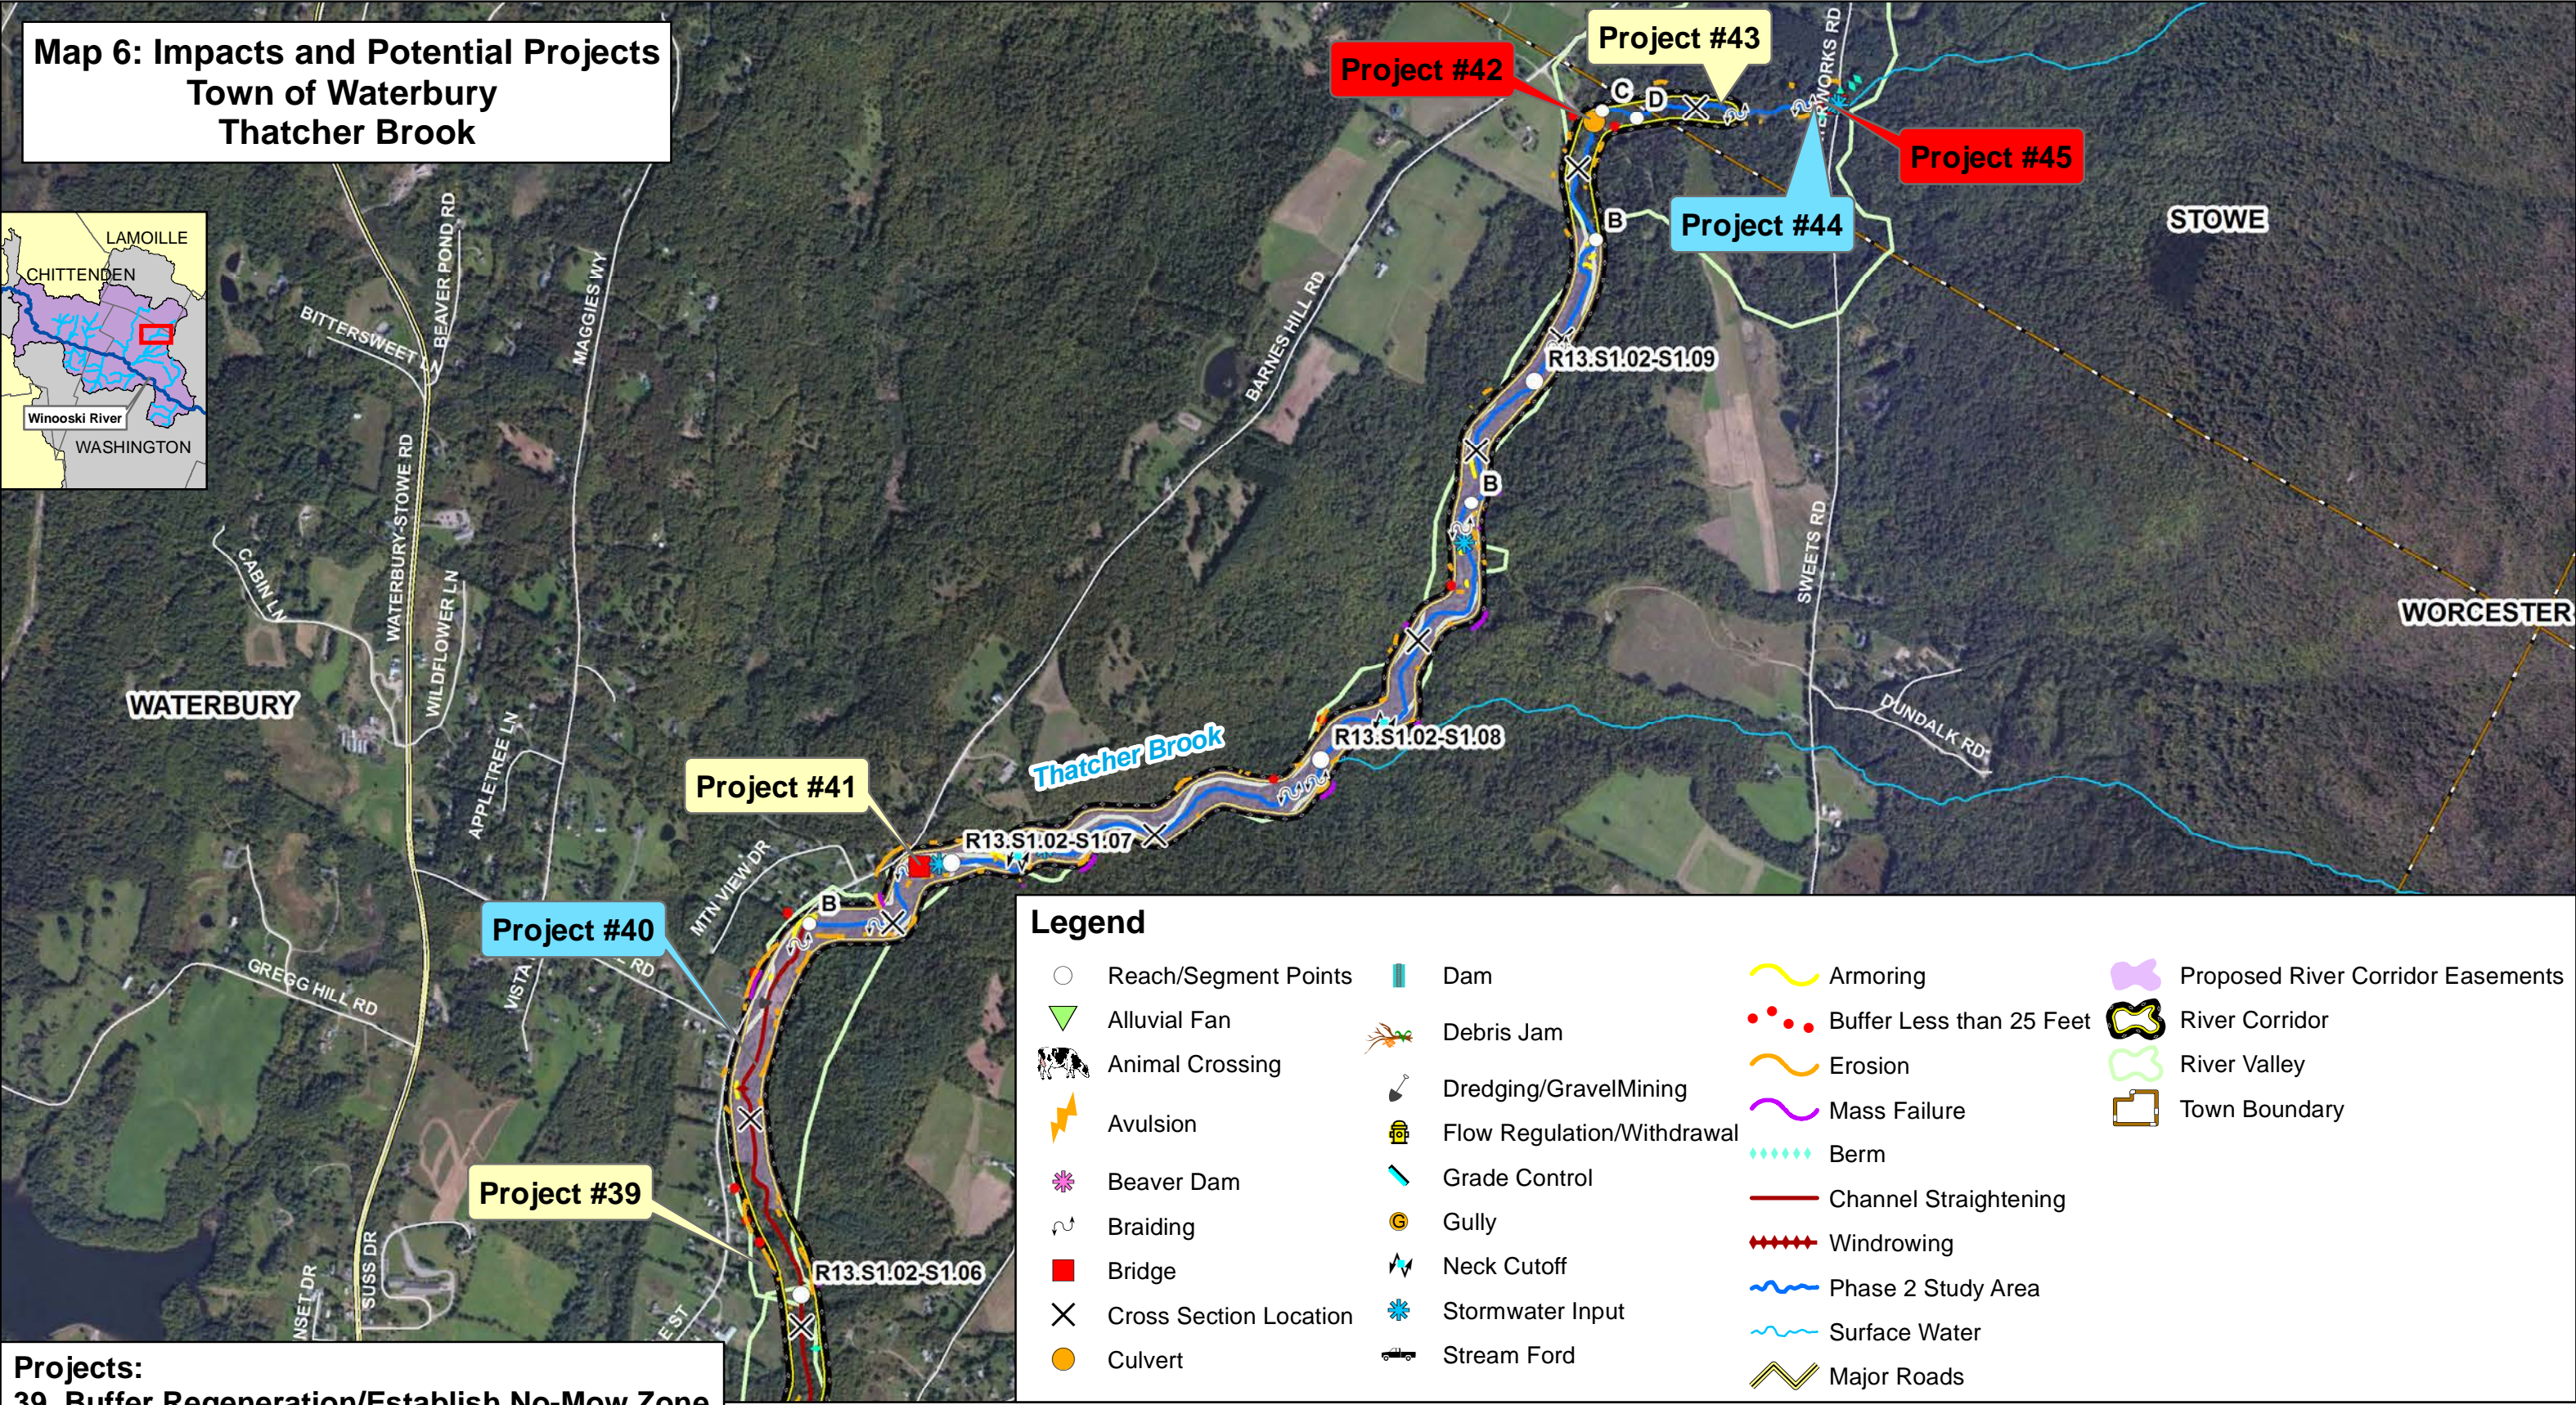
**Map 6: Impacts and Potential Projects  
Town of Waterbury  
Thatcher Brook**

Old wooden trail bridge with no abutments. Low clearance and in unstable condition.
Project #42 R13.S1.02-S1.09-B (Refer to Map 6)	Structure Replacement/ Removal	Replace Culvert	Thatcher Brook	Waterbury	At private drive crossing near 1930 Barnes Hill Road	High

Flow downstream of wetland is split into two channels that go through three culverts. Culverts are very undersized and there is no aquatic organism passage. Beaver dam upstream. Replace with adequately sized structure with no freefall drop.
Project #43 R13.S1.02-S1.09-D (Refer to Map 6)	Structure Replacement/ Removal	Remove Bridge	Thatcher Brook	Waterbury	Approximately 900 feet downstream of Waterworks Road crossing	Low

- Projects:**
- 39. Buffer Regeneration/Establish No-Mow Zone
  - 40. Riparian Corridor or Conservation Easement
  - 41. Remove Old Wooden Bridge
  - 42. Replace Culvert
  - 43. Remove Old Wooden Bridge
  - 44. Return or Remove Windrowed Material
  - 45. Restore Streamflow

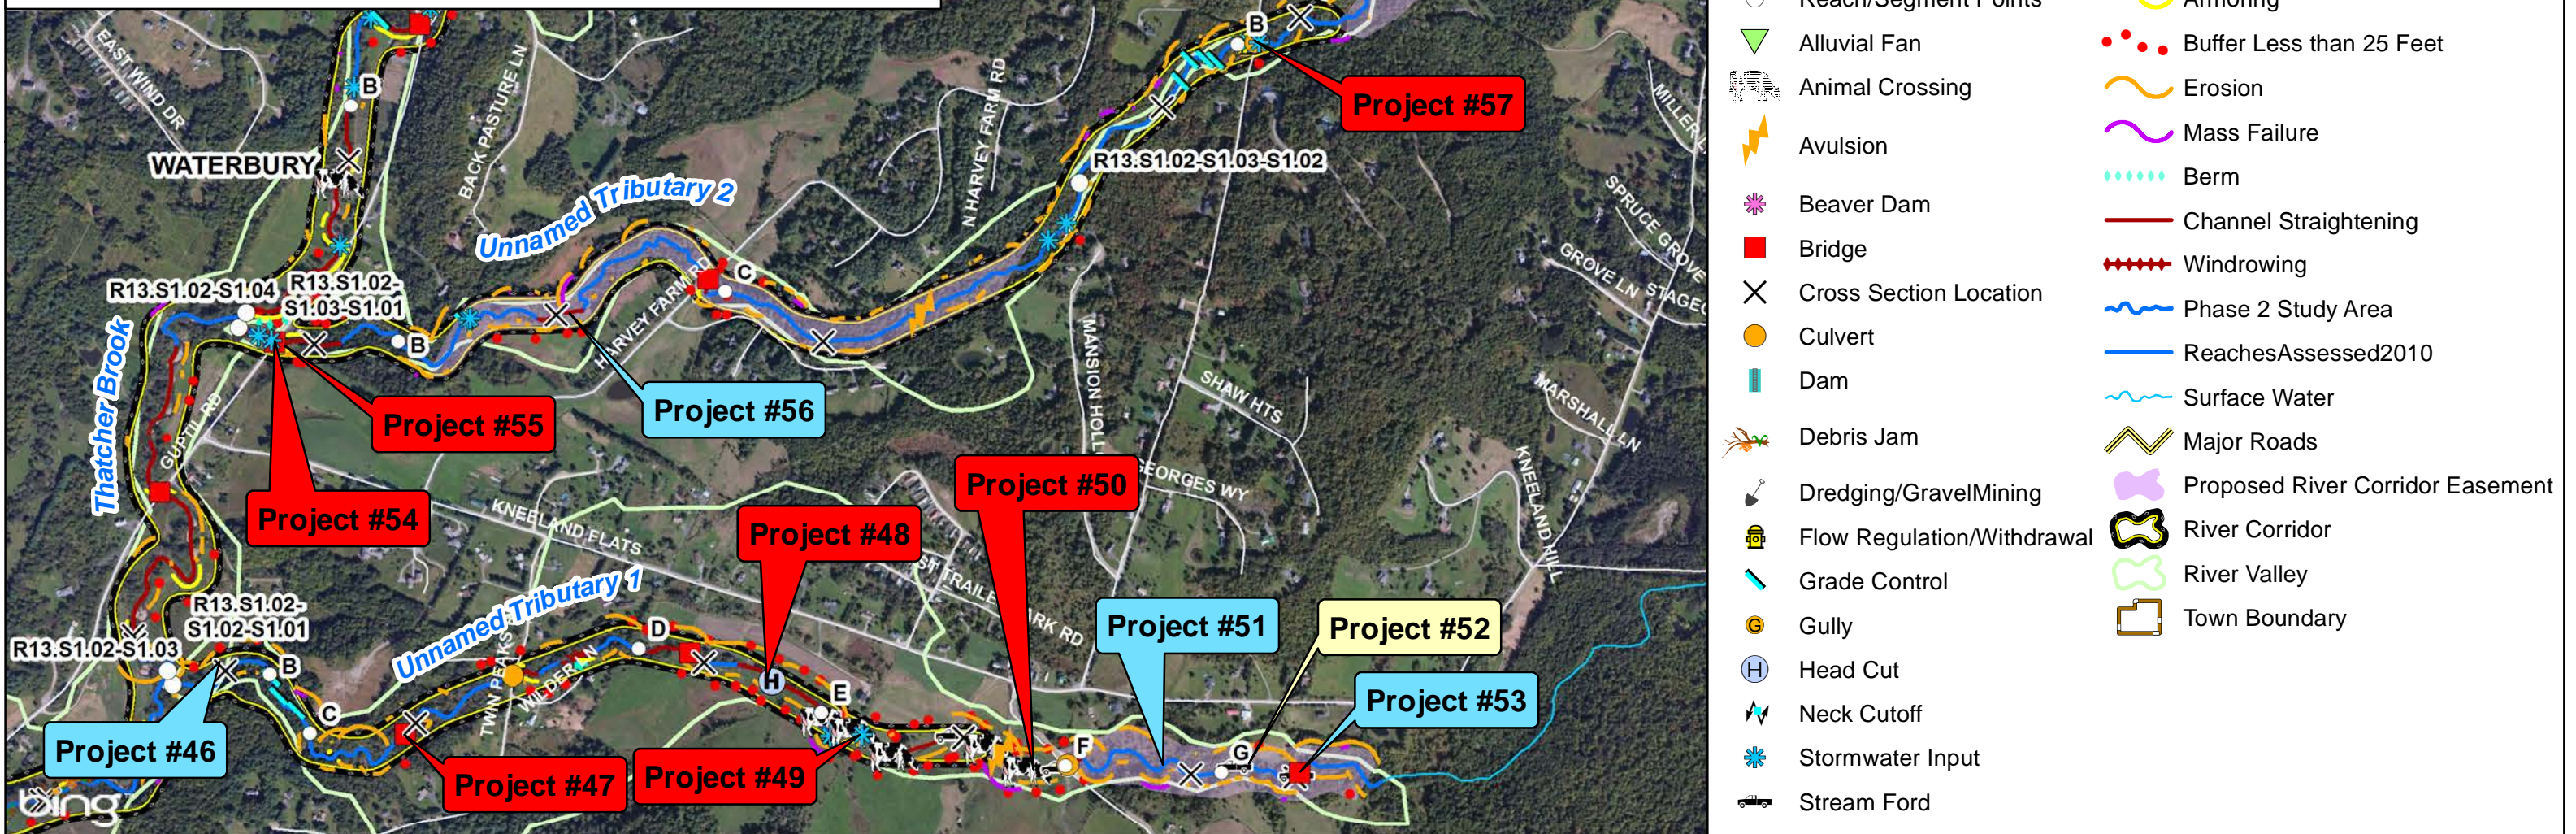
**Map 7: Impacts and Potential Projects**  
**Town of Waterbury**  
**Unnamed Tributaries 1 and 2**

There is a destroyed snowmobile bridge (iron and wood) causing sediment and debris accumulation in the stream channel. The bridge could affect water quality and channel stability, and could wash downstream and cause damage to infrastructure/property if not removed.

A snowmobile bridge on the VAST trail is in poor condition and is partially collapsing. The bridge is a safety issue if it is currently in use, and if it is not in use, it should be removed as it is undersized and failing.
Project #54 R13.S1.02-S1.03-S1.01-A (Refer to Map 7)	Structure Replacement/ Removal	Replace Bridge	Unnamed Tributary 2 to Thatcher Brook	Waterbury	Bridge on Guptil Road almost 800 feet northeast of intersection with Kneeland Flats Road	High

- Projects:**
- 46. Riparian Buffer Planting
  - 47. Remove Destroyed Bridge
  - 48. Build up Streambed with Boulder Wiers and Arrest Headcut
  - 49. Riparian Buffer Planting
  - 50. Livestock Exclusion
  - 51. River Corridor or Conservation Easement
  - 52. Riparian Buffer Planting
  - 53. Remove or Replace BRidge
  - 54. Replace Bridge
  - 55. Livestock Exclusion
  - 56. Riparian Buffer Planting & River Corridor Easement
  - 57. Culvert Replacement
  - 58. River Corridor or Conservation Easement
  - 59. Culvert Replacement
