APPENDIX A

In late August of 2011, Vermont was hit hard by Tropical Storm Irene (TSI). Heavy rain totaled over seven inches in areas over the course of one day. The immense downpours caused raging floodwaters to tear through Vermont's streams, devastating people and infrastructure throughout central and southern Vermont. In some areas, TSI flooding approached historic flood levels, while in other areas, the storm greatly exceeded them. Over 500 miles of state roads were damaged as a result of TSI, in addition to over 2000 segments of municipal roads. In total, approximately 500 bridges were damaged or destroyed, as well as almost 1,000 culverts. Approximately 1,500 residences were significantly damaged or destroyed as a result of flooding, as well as state, municipal, and commercial buildings (VANR 2012). Flooding associated with Tropical Storm Irene (TSI) in late August 2011 greatly impacted Waterbury, Vermont. Due to very high stream flows from TSI, the channels of Graves and Thatcher Brook may have experienced major changes. In order to observe any changes in channel geometry, Bear Creek Environmental (BCE) looked at pre-TSI geomorphic data and aerial imagery and compared it to

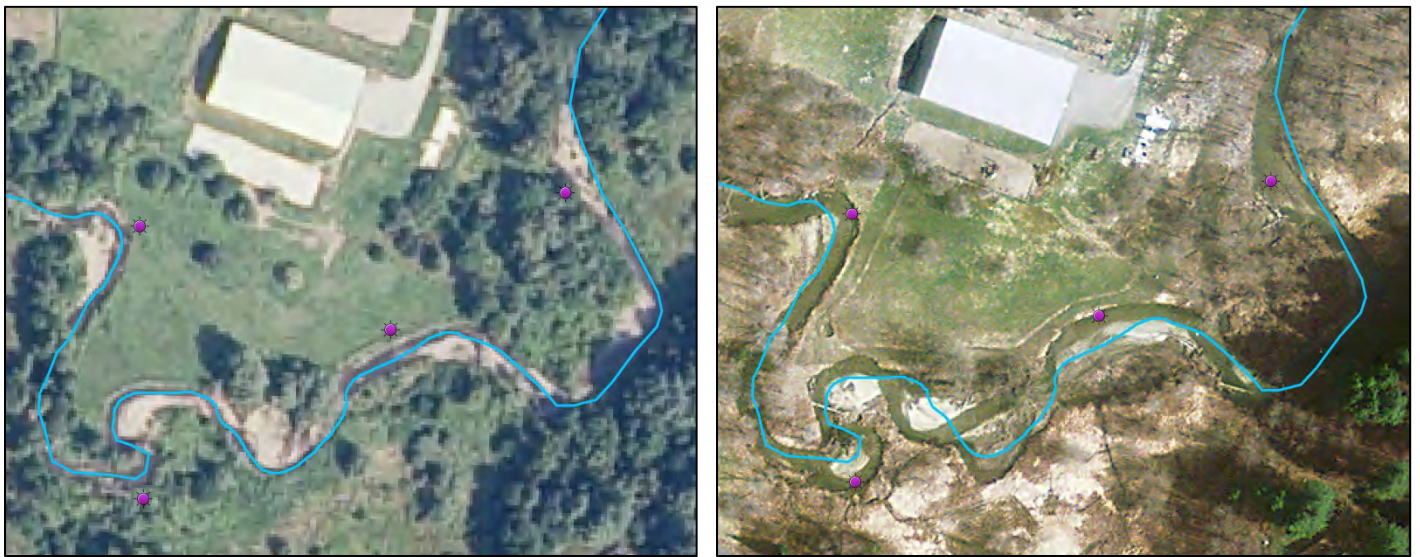
Figure 1. Side by side comparison of a location along Thatcher Brook where meander migration (purple dots) occurred likely as a result of TSI (2009 imagery on left, 2013 on right).

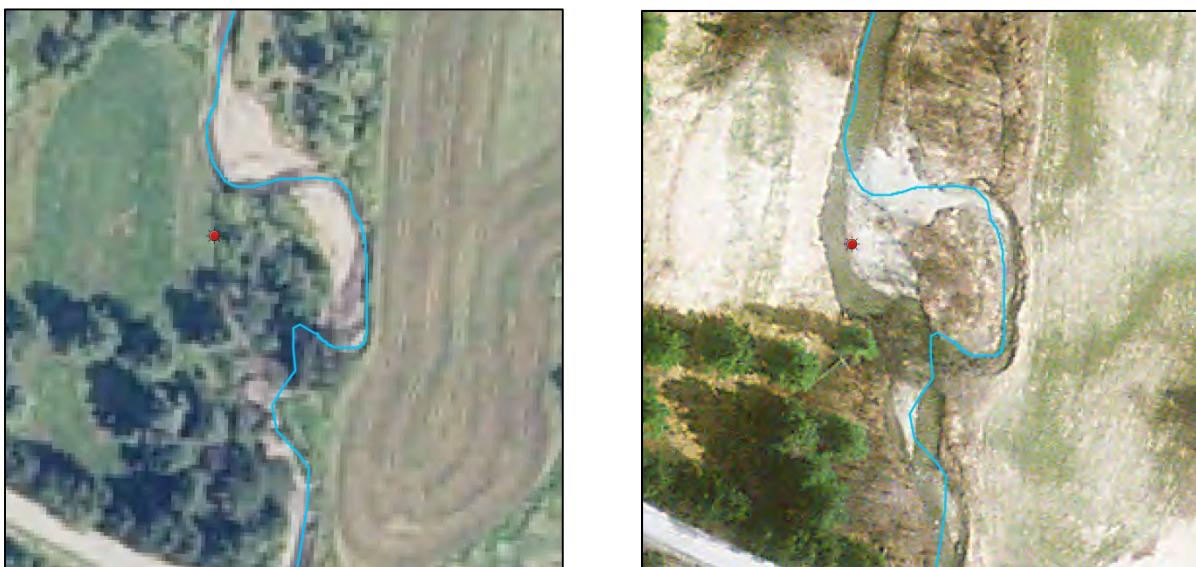
Figure 2. Side by side comparison of a location along Thatcher Brook where channel avulsion occurred as a result of TSI (2009 imagery on left, 2013 on right).

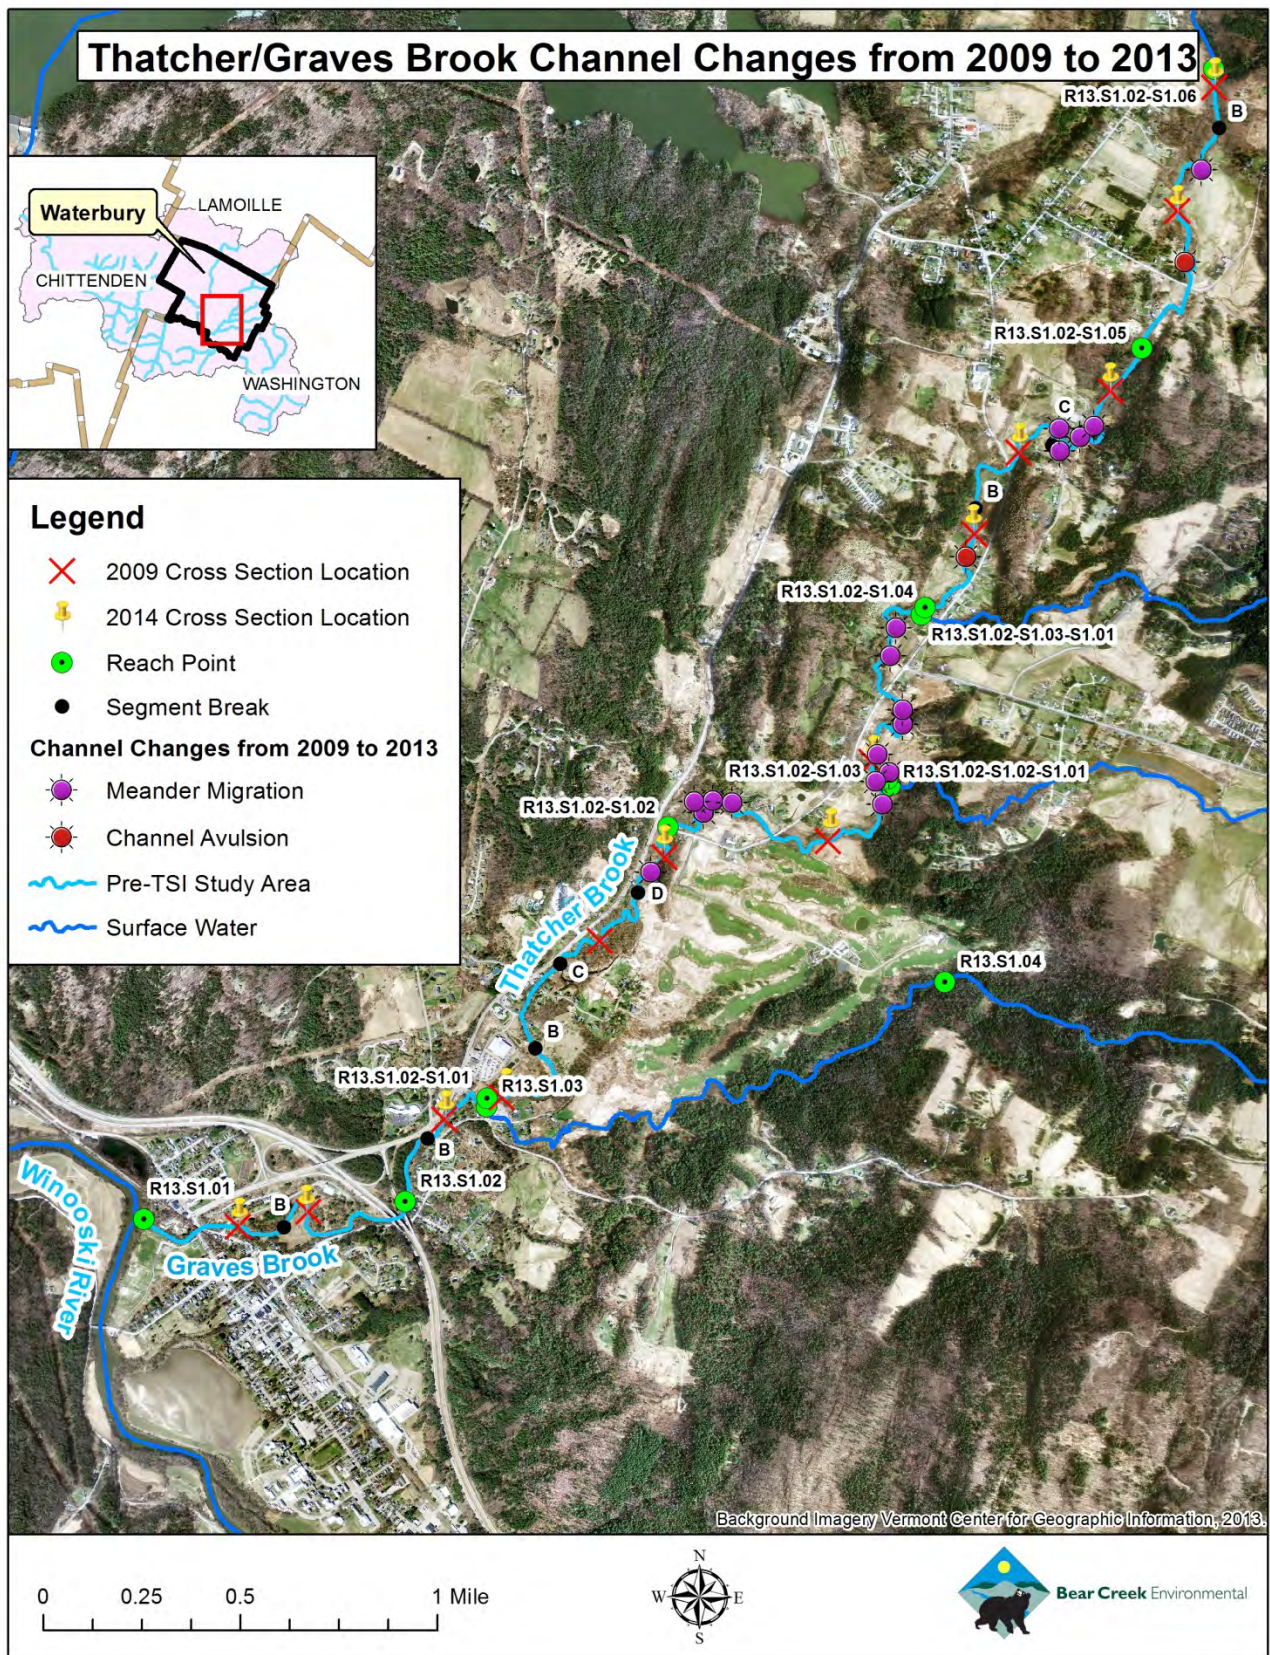
Figure 3. Channel changes in Thatcher and Graves Brook from 2009 to 2013.

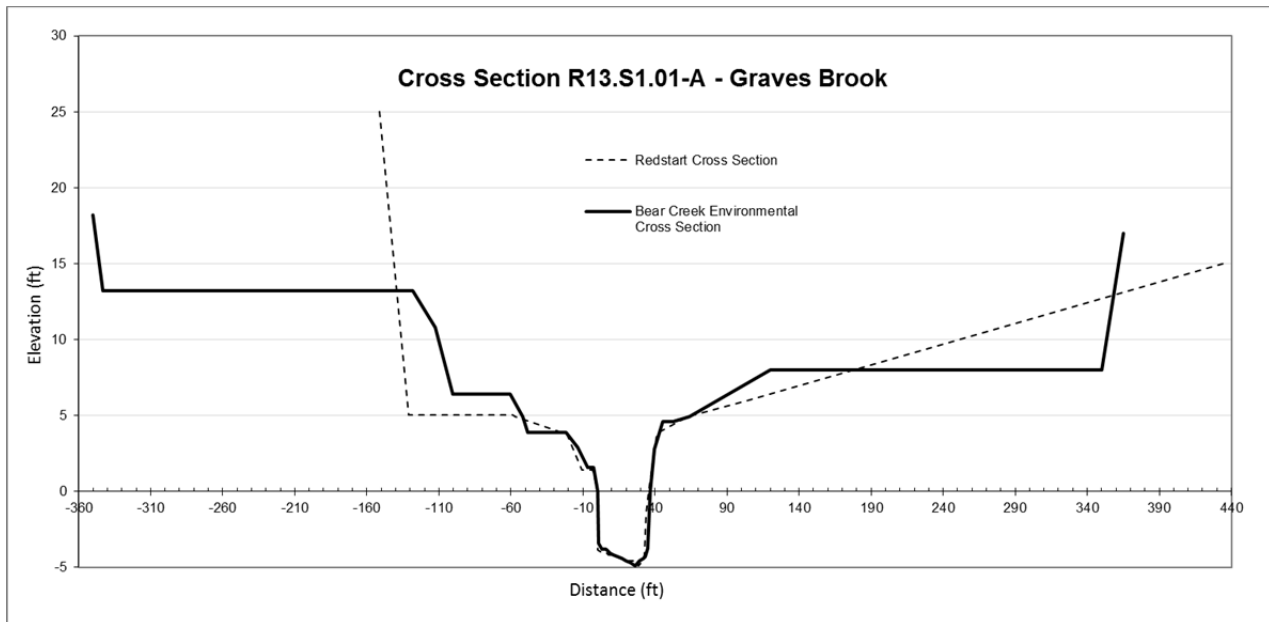
Figure 6. 2009 and 2014 Cross sections done by Redstart and BCE, respectively in Segment R13.S1.01-A.

Table 1: Comparison of 2009 and 2014 Cross Sections at R13.S1.01-A					
River Scientist Team	Cross Sectional Area	Bankfull Width	W/D Ratio	Entrenchment Ratio	Incision Ratio
Redstart (2009)	146.8	35.3	8.5	3.39	1.8
BCE (2014)	151.4	36.6	8.8	3.17	1.8
Percent change	3.1%	3.7%	3.5%	-6.5%	0%
Comments: Cross sections very similar. No significant change due to TSI. Left valley wall differs due to 2014 cross section extending to railroad bed. 2009 cross section ended at road. Bedform in 2014 was more of a run and not a riffle.

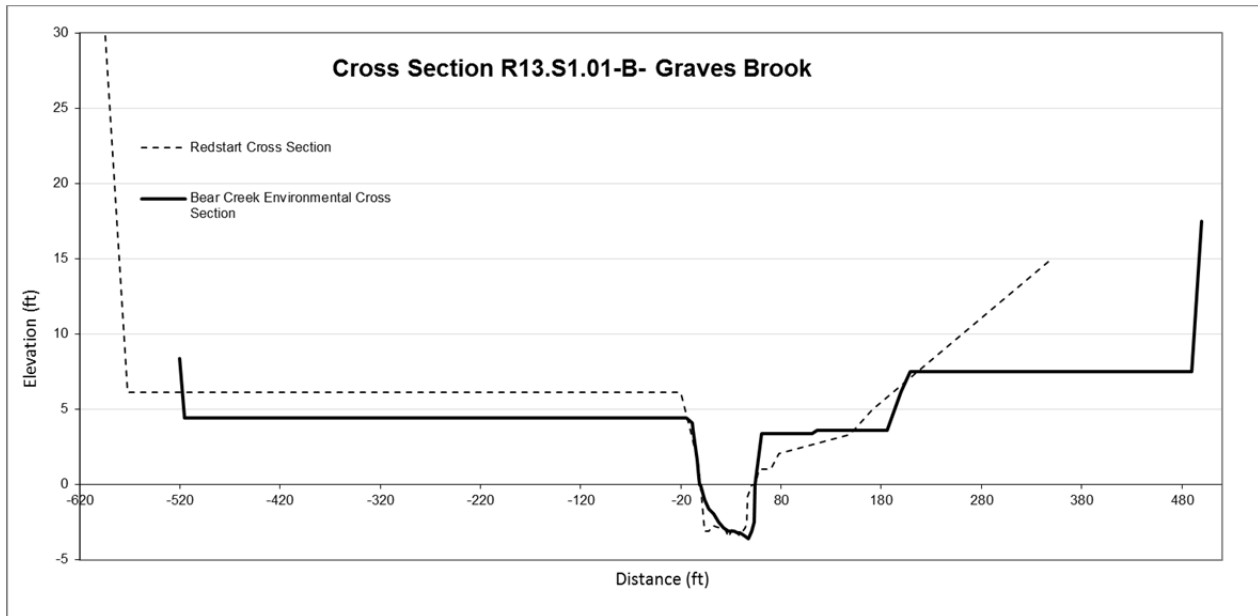
Figure 8. 2009 and 2014 Cross sections done by Redstart and BCE, respectively in Segment R13.S1.01-B.

Table 2: Comparison of 2009 and 2014 Cross Sections at R13.S1.01-B					
River Scientist Team	Cross Sectional Area	Bankfull Width	W/D Ratio	Entrenchment Ratio	Incision Ratio
Redstart (2009)	135	50.8	19.1	2.96	1.6
BCE (2014)	138	54.3	21.4	2.27	1.9
Percent change	2.2%	6.9%	12.0%	-23.3%	18.8%
Comments: 2009 cross section location is now a pool. 2014 cross section was surveyed just upstream (about 35 feet) of 2009 cross section location, which may account for the difference in left terrace elevation. Channel has slightly widened. No more undercut on left bank and left bank has slumped. More aggradational in 2014 possibly due to TSI (See Figure 9).

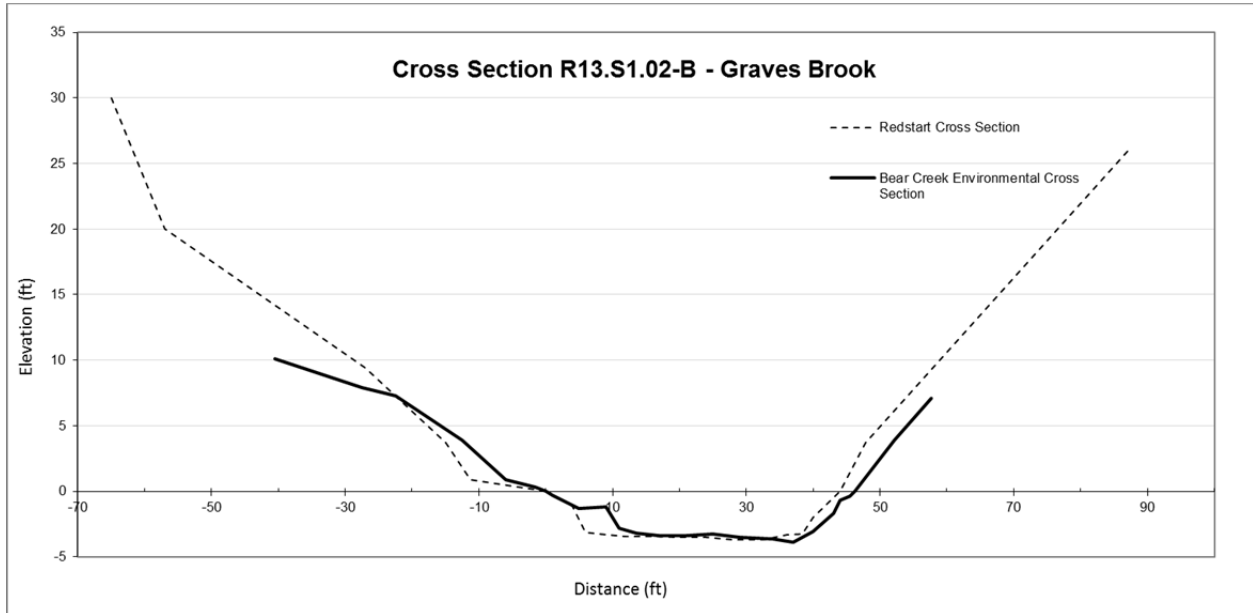
Figure 10. 2009 & 2014 Cross sections done by Redstart and BCE, respectively in Segment R13.S1.02-B.

Table 3: Comparison of 2009 and 2014 Cross Sections at R13.S1.02-B					
River Scientist Team	Cross Sectional Area	Bankfull Width	W/D Ratio	Entrenchment Ratio	Incision Ratio
Redstart (2009)	127.6	44.0	15.2	1.43	3.5
BCE (2014)	120.9	46.2	17.7	1.40	3.0
Percent change	-5.3%	5.0%	16.4%	-2.1%	-14.3%
Comments: Cross sections very similar from 2009 to 2014. Channel may have widened based on increased w/d ratio.

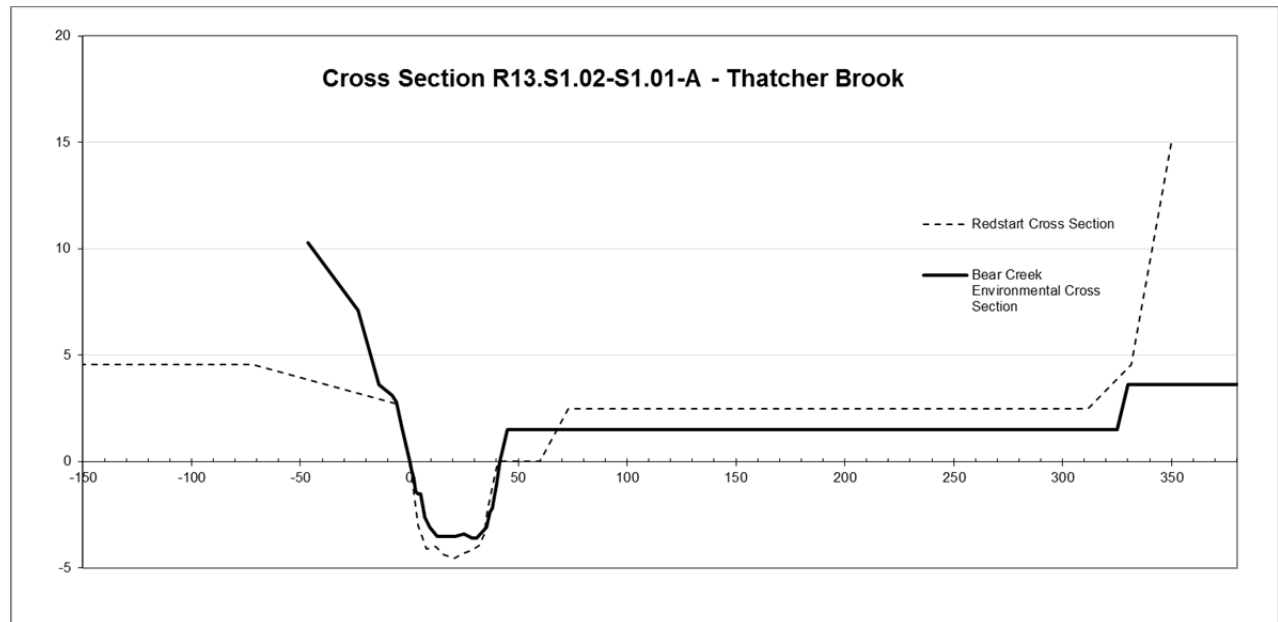
R13.S1.02-S1.01-A

Figure 12. 2009 and 2014 Cross sections done by Redstart and BCE in Segment R13.S1.02-S1.01-A.

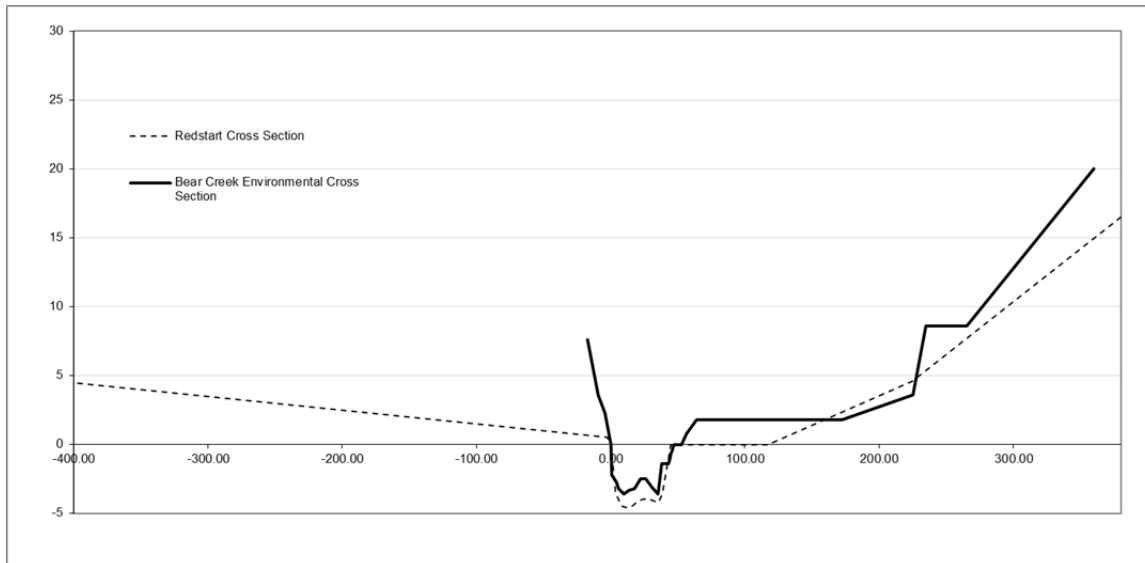
Figure 14. 2009 and 2014 Cross sections done by Redstart and BCE, respectively in Segment R13.S1.02-S1.01-D.

Table 5: Comparison of 2009 and 2014 Cross Sections at R13.S1.02-S1.01-D					
River Scientist Team	Cross Sectional Area	Bankfull Width	W/D Ratio	Entrenchment Ratio	Incision Ratio
Redstart (2009)	95.9	37.4	14.6	6.9	1.5
BCE (2014)	121.7	47.1	18.3	5.0	1.5
Percent change	26.9%	25.9%	25.3%	-27.5%	0%
Comments: Cross sectional area was higher in 2014 than 2009. The 2014 cross section was measured just upstream (about 20 feet) of the 2009 cross section due to channel changes. The fallen tree and large pool were present in the 2009 location (Figure 15). Channel may have experienced widening based on increased w/d ratio.

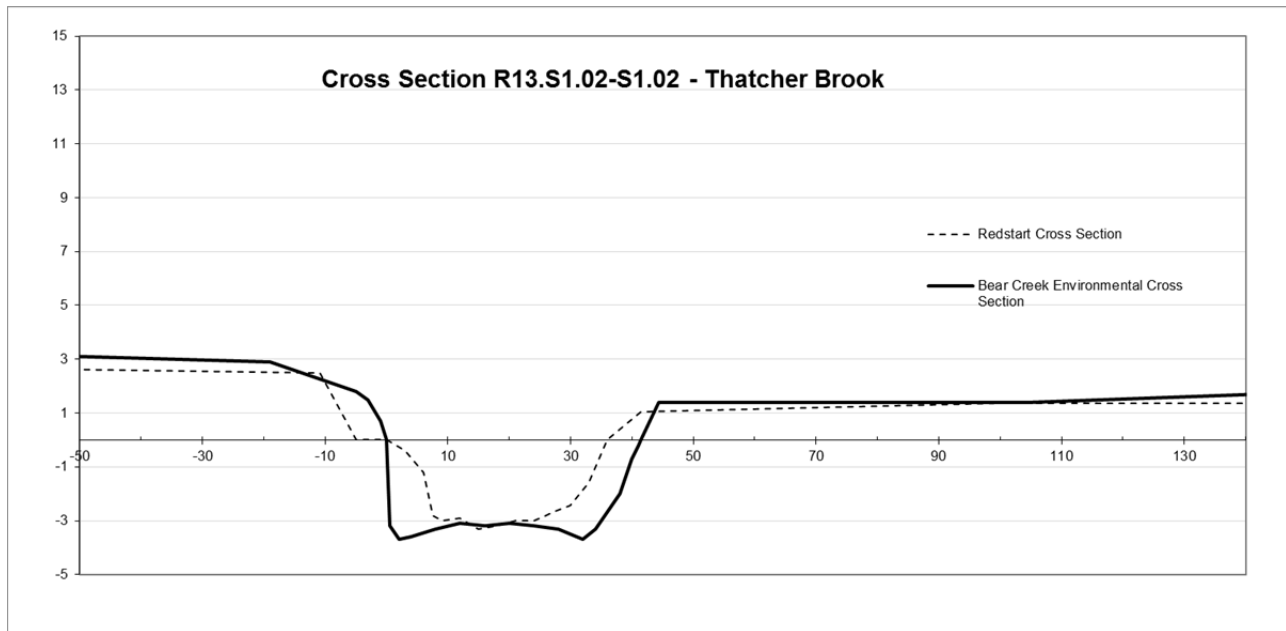
Figure 16. 2009 & 2014 Cross sections done by Redstart and BCE, respectively in Segment R13.S1.02-S1.02.

Table 6: Comparison of 2009 and 2014 Cross Sections at R13.S1.02-S1.02					
River Scientist Team	Cross Sectional Area	Bankfull Width	W/D Ratio	Entrenchment Ratio	Incision Ratio
Redstart (2009)	81.2	36	15.9	18.1	1.3
BCE (2014)	125.5	41.4	13.7	12.8	1.4
Percent change	54.6%	15.0%	-13.8%	-29.3%	7.7%
Comments: Cross sectional area for 2014 was higher than 2009. Depositional features in 2014 were larger than in 2009, and new debris noted in channel in 2014; both most likely due to TSI (See Figure 17). Both teams noted that bankfull was hard to find in the field. Redstart used a “low new bench” for determining the bankfull elevation, while Bear Creek used the tree line. This likely accounts for differences in the bankfull cross sectional areas measured.

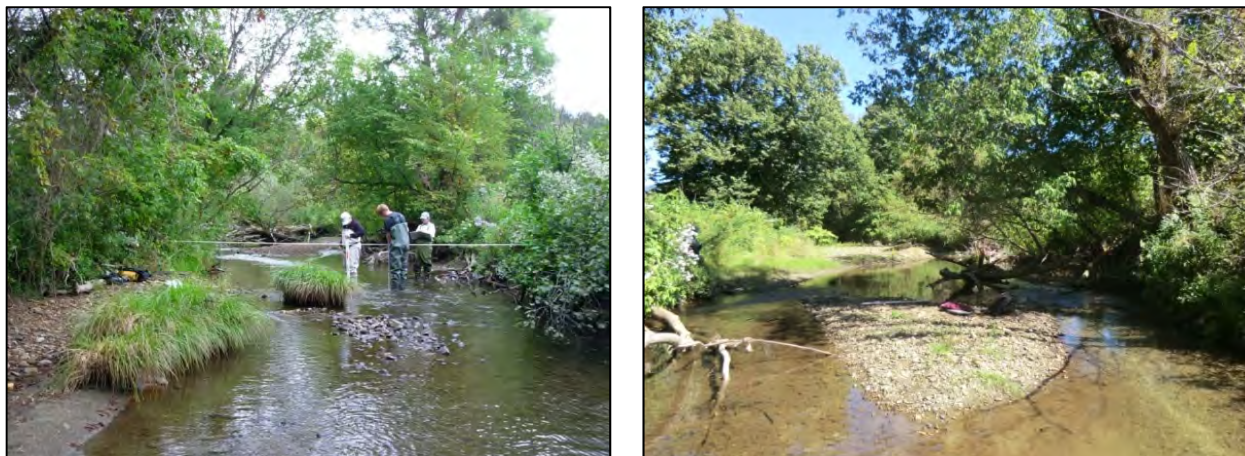
Figure 17. Cross section R13.S1.02-S1.02 in 2009 (left) and 2014 (right).

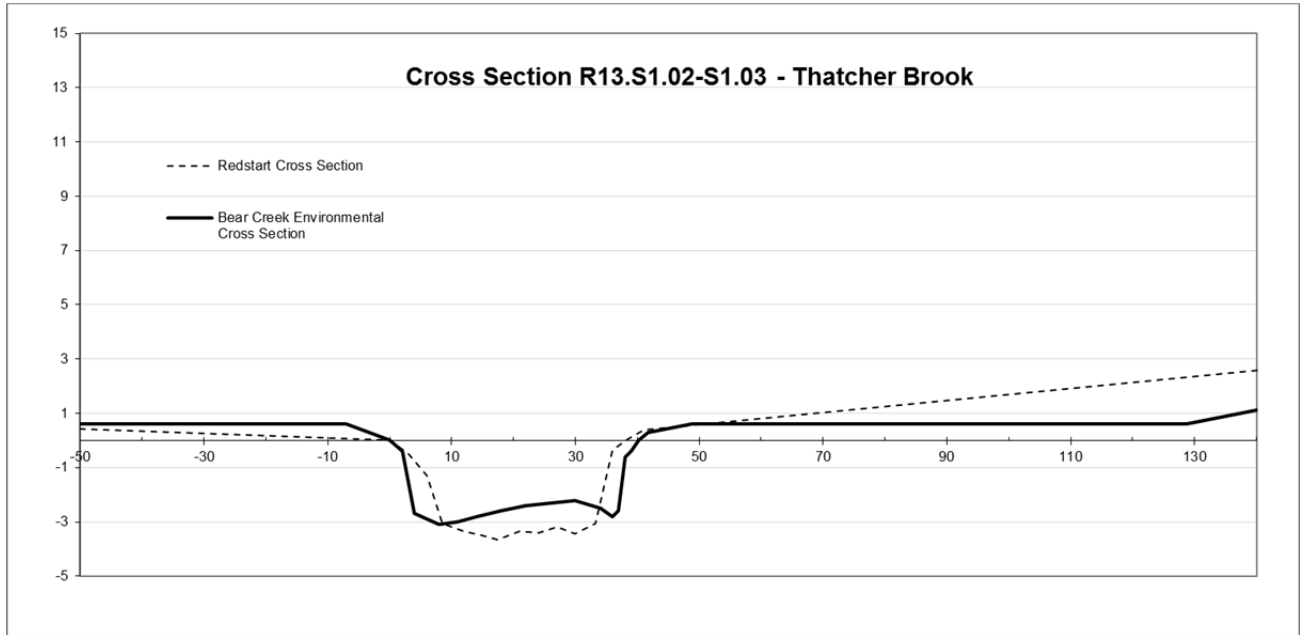
Figure 18. 2009 and 2014 Cross sections done by Redstart and BCE, respectively in Segment R13.S1.02-S1.03.

Table 7: Comparison of 2009 and 2014 Cross Sections at R13.S1.02-S1.03					
River Scientist Team	Cross Sectional Area	Bankfull Width	W/D Ratio	Entrenchment Ratio	Incision Ratio
Redstart (2009)	97.1	38.2	15.0	16.5	1.0
BCE (2014)	91.9	40.2	17.6	14.3	1.1
Percent change	-5.4%	5.2%	17.3%	-13.3%	10%
Comments: 2014 cross section was surveyed just downstream (about 40 feet) of 2009 cross section due to new beaver dam. Channel still has good floodplain access. More aggradational than in 2009 (Figure 19).

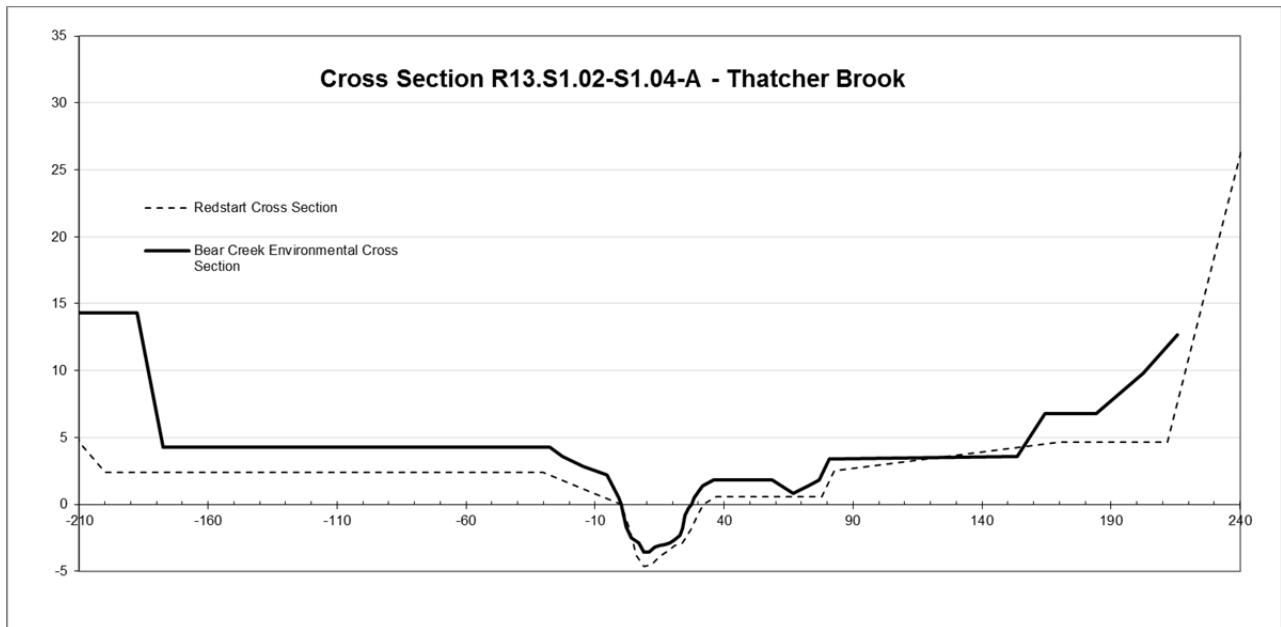
Figure 20. 2009 and 2014 Cross sections measured by Redstart and BCE, respectively in Segment R13.S1.02-S1.04-A.

Table 8: Comparison of 2009 and 2014 Cross Sections at R13.S1.02-S1.04-A					
River Scientist Team	Cross Sectional Area	Bankfull Width	W/D Ratio	Entrenchment Ratio	Incision Ratio
Redstart (2009)	91.4	31.9	11.1	11.9	1.5
BCE (2014)	67.4	27.3	11.1	6.5	1.9
Percent change	-26.3%	-14.4%	0%	-45.4%	21.1%
Comments: Cross sectional area lower in 2014 than 2009, but consistent with upstream cross sectional areas measured in 2014.

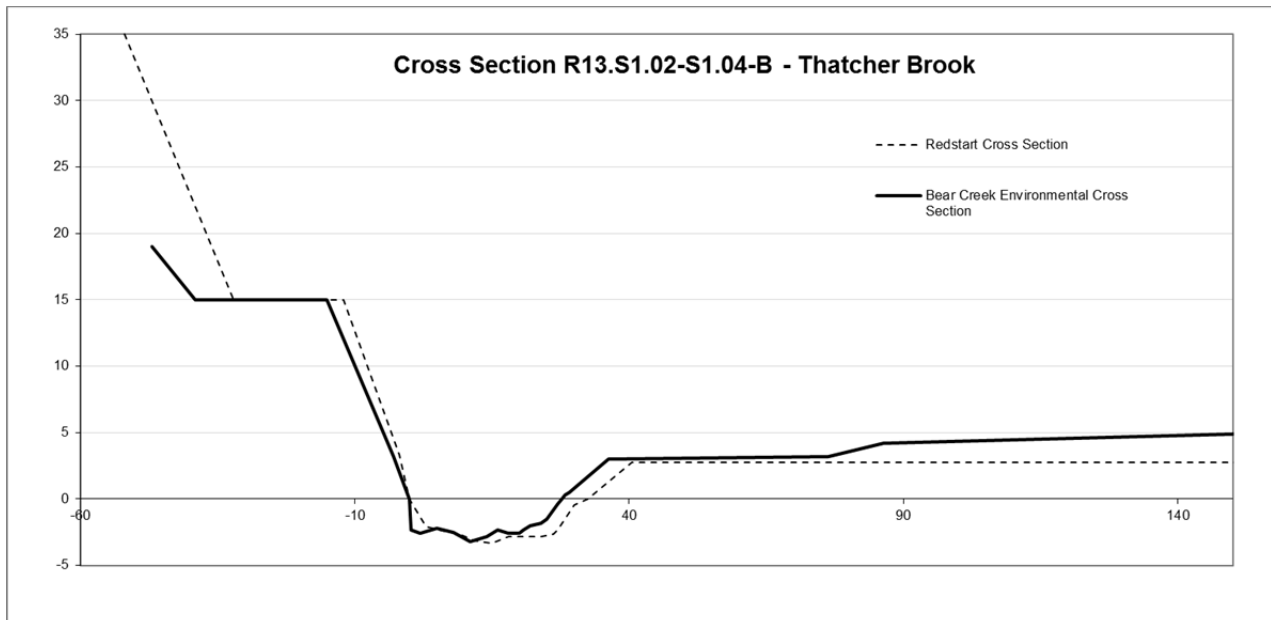
Figure 22. 2009 and 2014 Cross sections done by Redstart and BCE, respectively in Segment R13.S1.02-S1.04-B.

Table 9: Comparison of 2009 and 2014 Cross Sections at R13.S1.02-S1.04-B					
River Scientist Team	Cross Sectional Area	Bankfull Width	W/D Ratio	Entrenchment Ratio	Incision Ratio
Redstart (2009)	74.8	32.5	14.1	8.5	1.8
BCE (2014)	63.7	27.8	12.1	2.9	1.9
Percent change	-14.8%	-14.5%	-14.2%	-65.9%	5.6%
Comments: Cross sections similar. No significant changes from TSI except for some fallen debris from left bank.

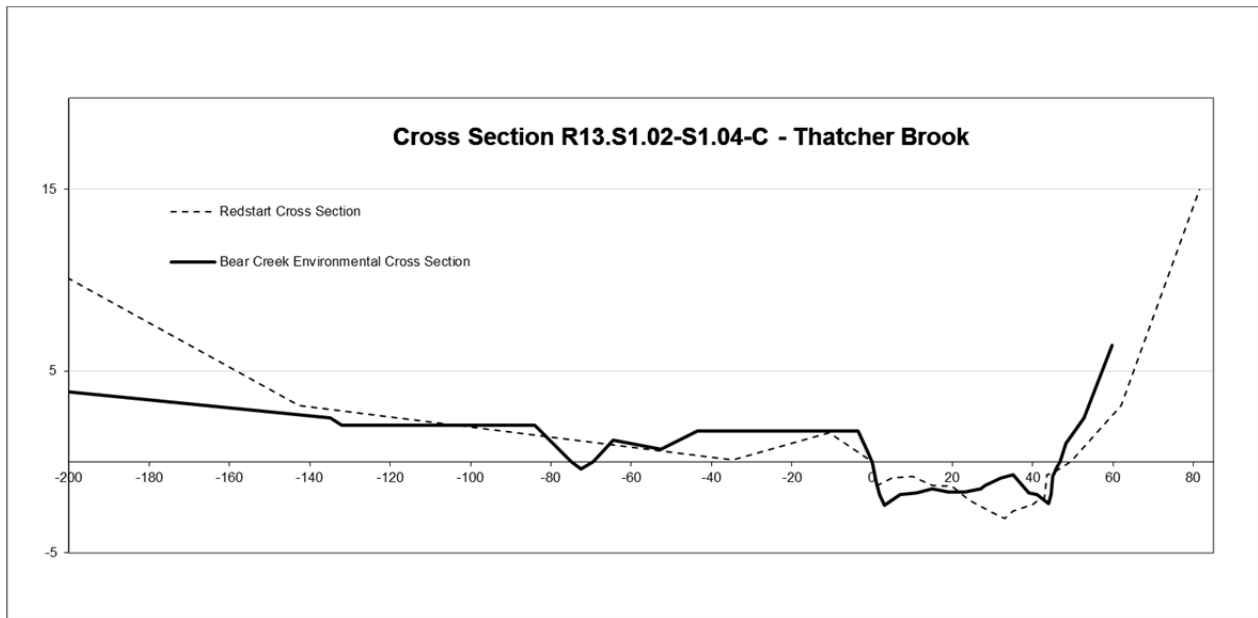
Figure 24. 2009 and 2014 Cross sections done by Redstart and BCE, respectively in Segment R13.S1.02-S1.04-C.

Table 10: Comparison of 2009 and 2014 Cross Sections at R13.S1.02-S1.04-C					
River Scientist Team	Cross Sectional Area	Bankfull Width	W/D Ratio	Entrenchment Ratio	Incision Ratio
Redstart (2009)	79.0	49.4	30.9	4.1	1.5
BCE (2014)	71.5	52.3	38.3	3.6	1.7
Percent change	-9.5%	5.9%	23.9%	-12.2%	13.3%
Comments: Left side of channel deeper in 2014. Flood chute observed in left floodplain in 2014. Bar shifted from left to right in channel.

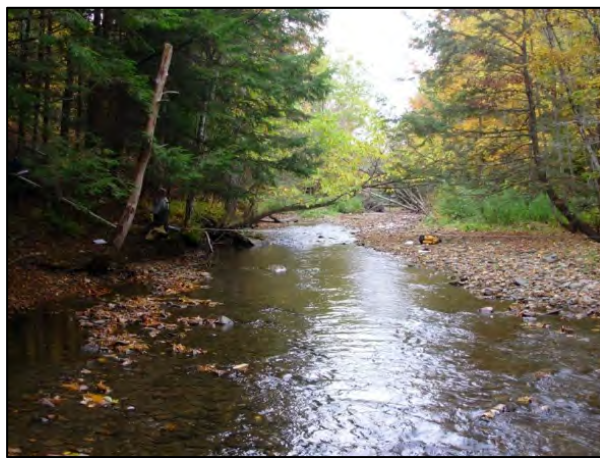
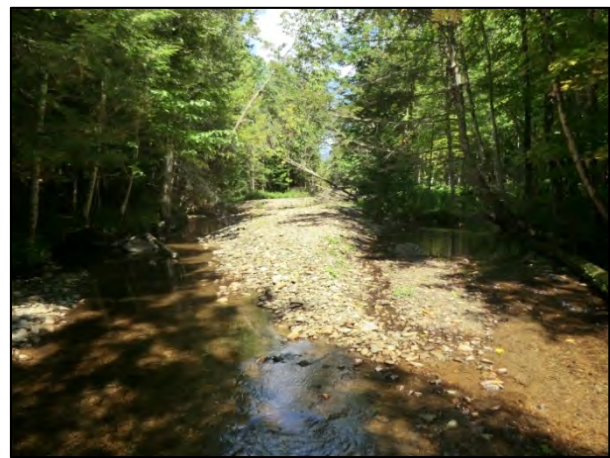
Figure 25. Cross section R13.S1.02-S1.04-C in 2009 (left) and 2014 (right).

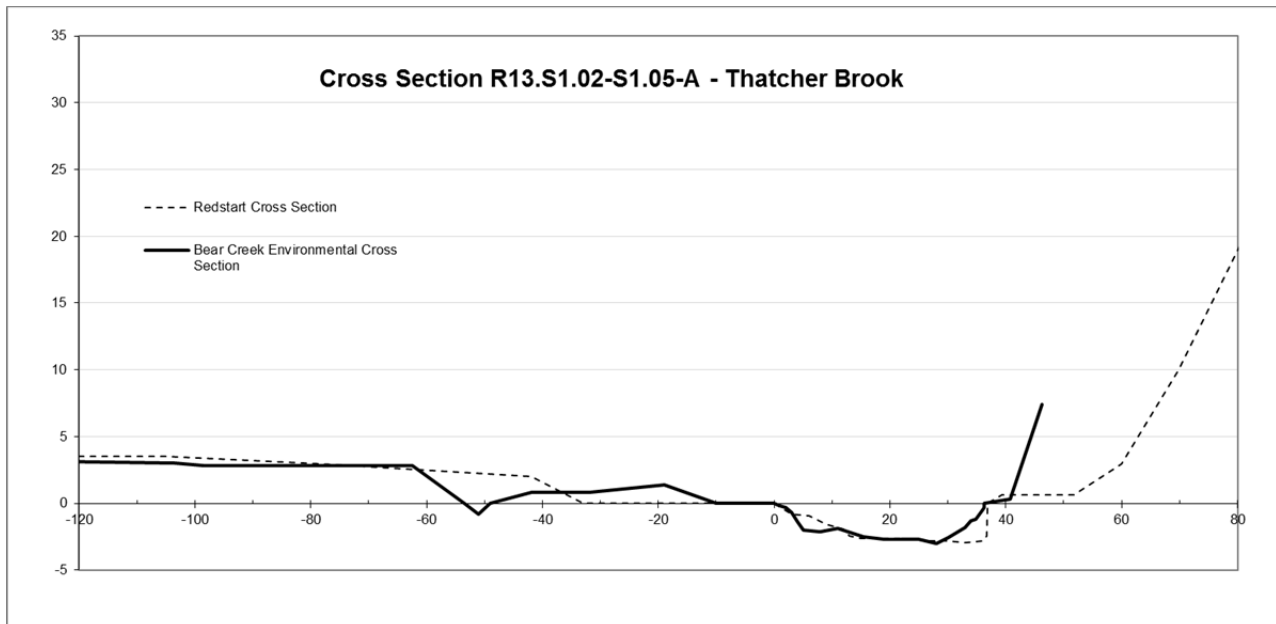
Figure 26. 2009 and 2014 Cross sections done by Redstart and BCE, respectively in Segment R13.S1.02-S1.05-A.

Table 11: Comparison of 2009 and 2014 Cross Sections at R13.S1.02-S1.05-A					
River Scientist Team	Cross Sectional Area	Bankfull Width	W/D Ratio	Entrenchment Ratio	Incision Ratio
Redstart (2009)	79.3	36.8	17.1	3.8	1.7
BCE (2014)	77.1	40.8	21.6	3.5	2.0
Percent change	-2.8%	10.9%	26.3%	-7.9%	15%
Comments: Cross sections were similar in 2009 and 2014. Flood chute observed in 2014 in left floodplain. 2014 cross section measured slightly downstream of 2009 cross section affecting the valley width. More aggradational and slightly wider in 2014 than 2009.

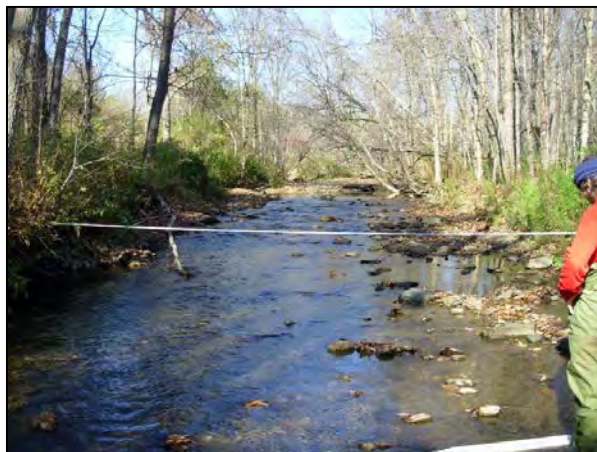
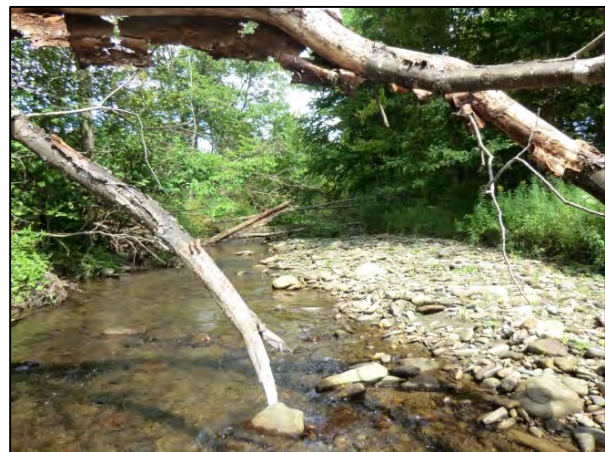
Figure 27. Cross section R13.S1.02-S1.05-A in 2009 (left) and 2014 (right)-more aggradational.

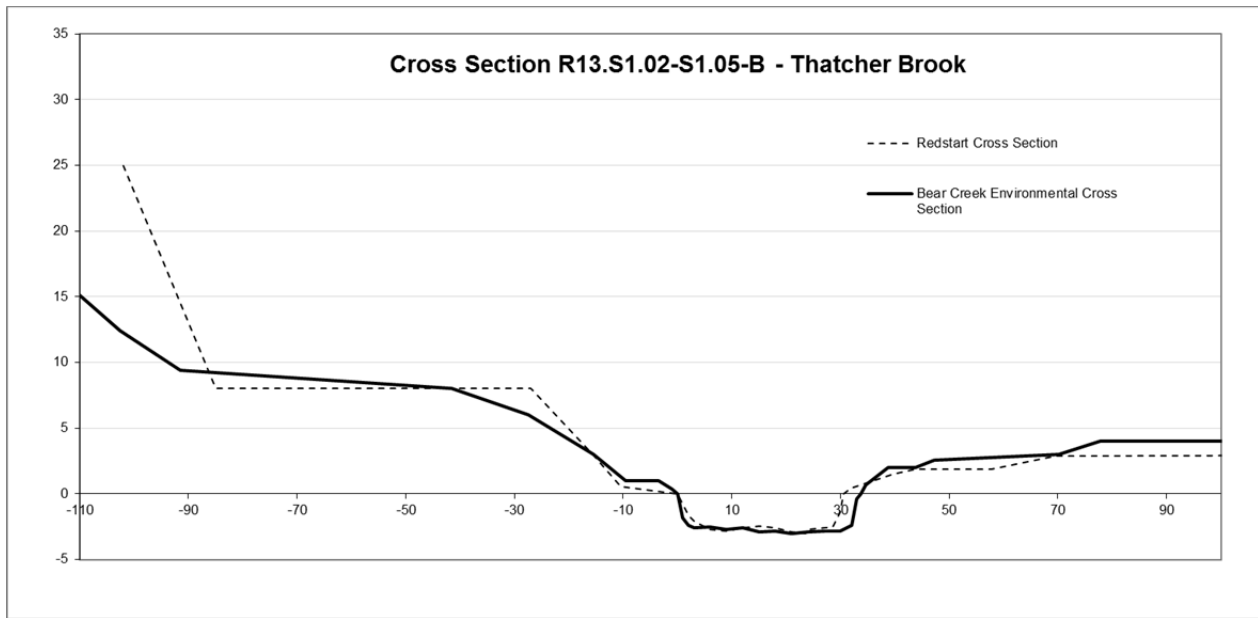
Figure 28. 2009 and 2014 Cross sections done by Redstart and BCE, respectively in Segment R13.S1.02-S1.05-B.

Table 12: Comparison of 2009 and 2014 Cross Sections at R13.S1.02-S1.05-B					
River Scientist Team	Cross Sectional Area	Bankfull Width	W/D Ratio	Entrenchment Ratio	Incision Ratio
Redstart (2009)	74.3	30.5	12.5	6.7	1.6
BCE (2014)	86.9	33.7	13.1	2.5	1.9
Percent change	17%	10.5%	4.8%	-62.7%	15.8%
Comments: Cross sections were similar in 2009 and 2014. More aggradational in 2014 than in 2009 most likely due to TSI (See Figure 29).

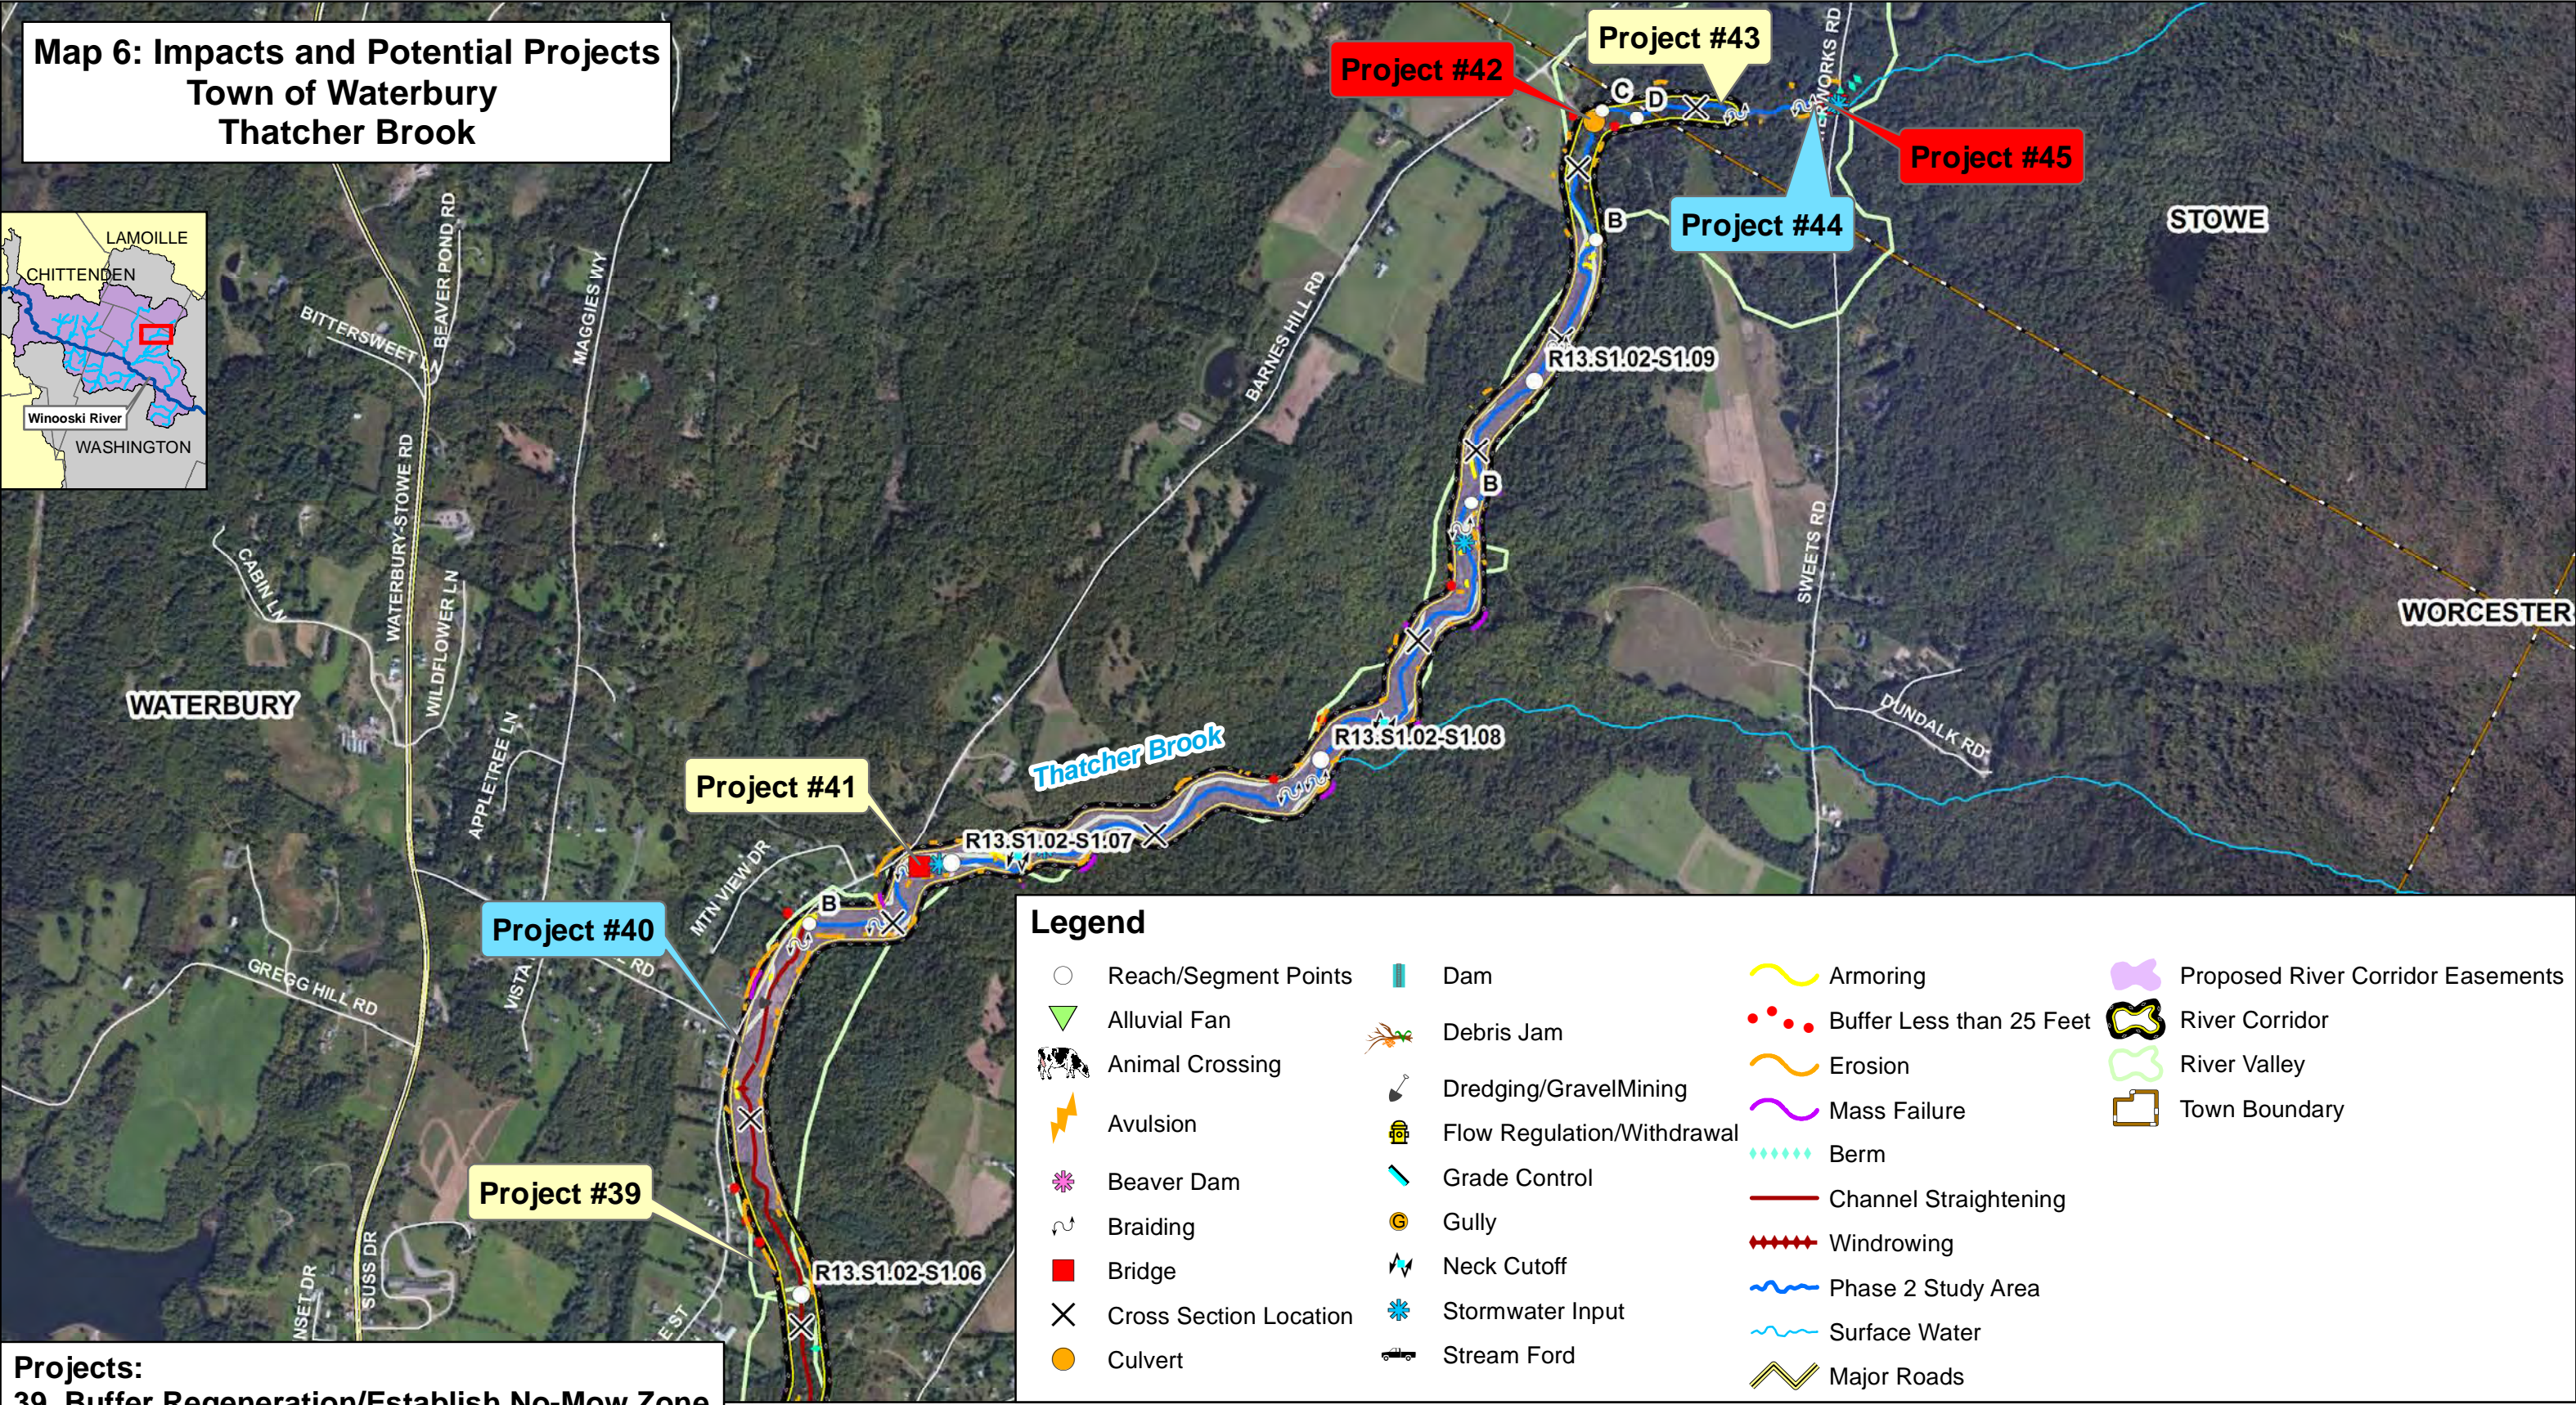
**Map 6: Impacts and Potential Projects
Town of Waterbury
Thatcher Brook**

Old wooden trail bridge with no abutments. Low clearance and in unstable condition.
Project #42 R13.S1.02-S1.09-B (Refer to Map 6)	Structure Replacement/ Removal	Replace Culvert	Thatcher Brook	Waterbury	At private drive crossing near 1930 Barnes Hill Road	High

Flow downstream of wetland is split into two channels that go through three culverts. Culverts are very undersized and there is no aquatic organism passage. Beaver dam upstream. Replace with adequately sized structure with no freefall drop.
Project #43 R13.S1.02-S1.09-D (Refer to Map 6)	Structure Replacement/ Removal	Remove Bridge	Thatcher Brook	Waterbury	Approximately 900 feet downstream of Waterworks Road crossing	Low

- Projects:**
- 39. Buffer Regeneration/Establish No-Mow Zone
 - 40. Riparian Corridor or Conservation Easement
 - 41. Remove Old Wooden Bridge
 - 42. Replace Culvert
 - 43. Remove Old Wooden Bridge
 - 44. Return or Remove Windrowed Material
 - 45. Restore Streamflow
