APPENDIX A

In late August of 2011, Vermont was hit hard by Tropical Storm Irene (TSI). Heavy rain totaled over seven inches in areas over the course of one day. The immense downpours caused raging floodwaters to tear through Vermont's streams, devastating people and infrastructure throughout central and southern Vermont. In some areas, TSI flooding approached historic flood levels, while in other areas, the storm greatly exceeded them. Over 500 miles of state roads were damaged as a result of TSI, in addition to over 2000 segments of municipal roads. In total, approximately 500 bridges were damaged or destroyed, as well as almost 1,000 culverts. Approximately 1,500 residences were significantly damaged or destroyed as a result of flooding, as well as state, municipal, and commercial buildings (VANR 2012). Flooding associated with Tropical Storm Irene (TSI) in late August 2011 greatly impacted Waterbury, Vermont. Due to very high stream flows from TSI, the channels of Graves and Thatcher Brook may have experienced major changes. In order to observe any changes in channel geometry, Bear Creek Environmental (BCE) looked at pre-TSI geomorphic data and aerial imagery and compared it to

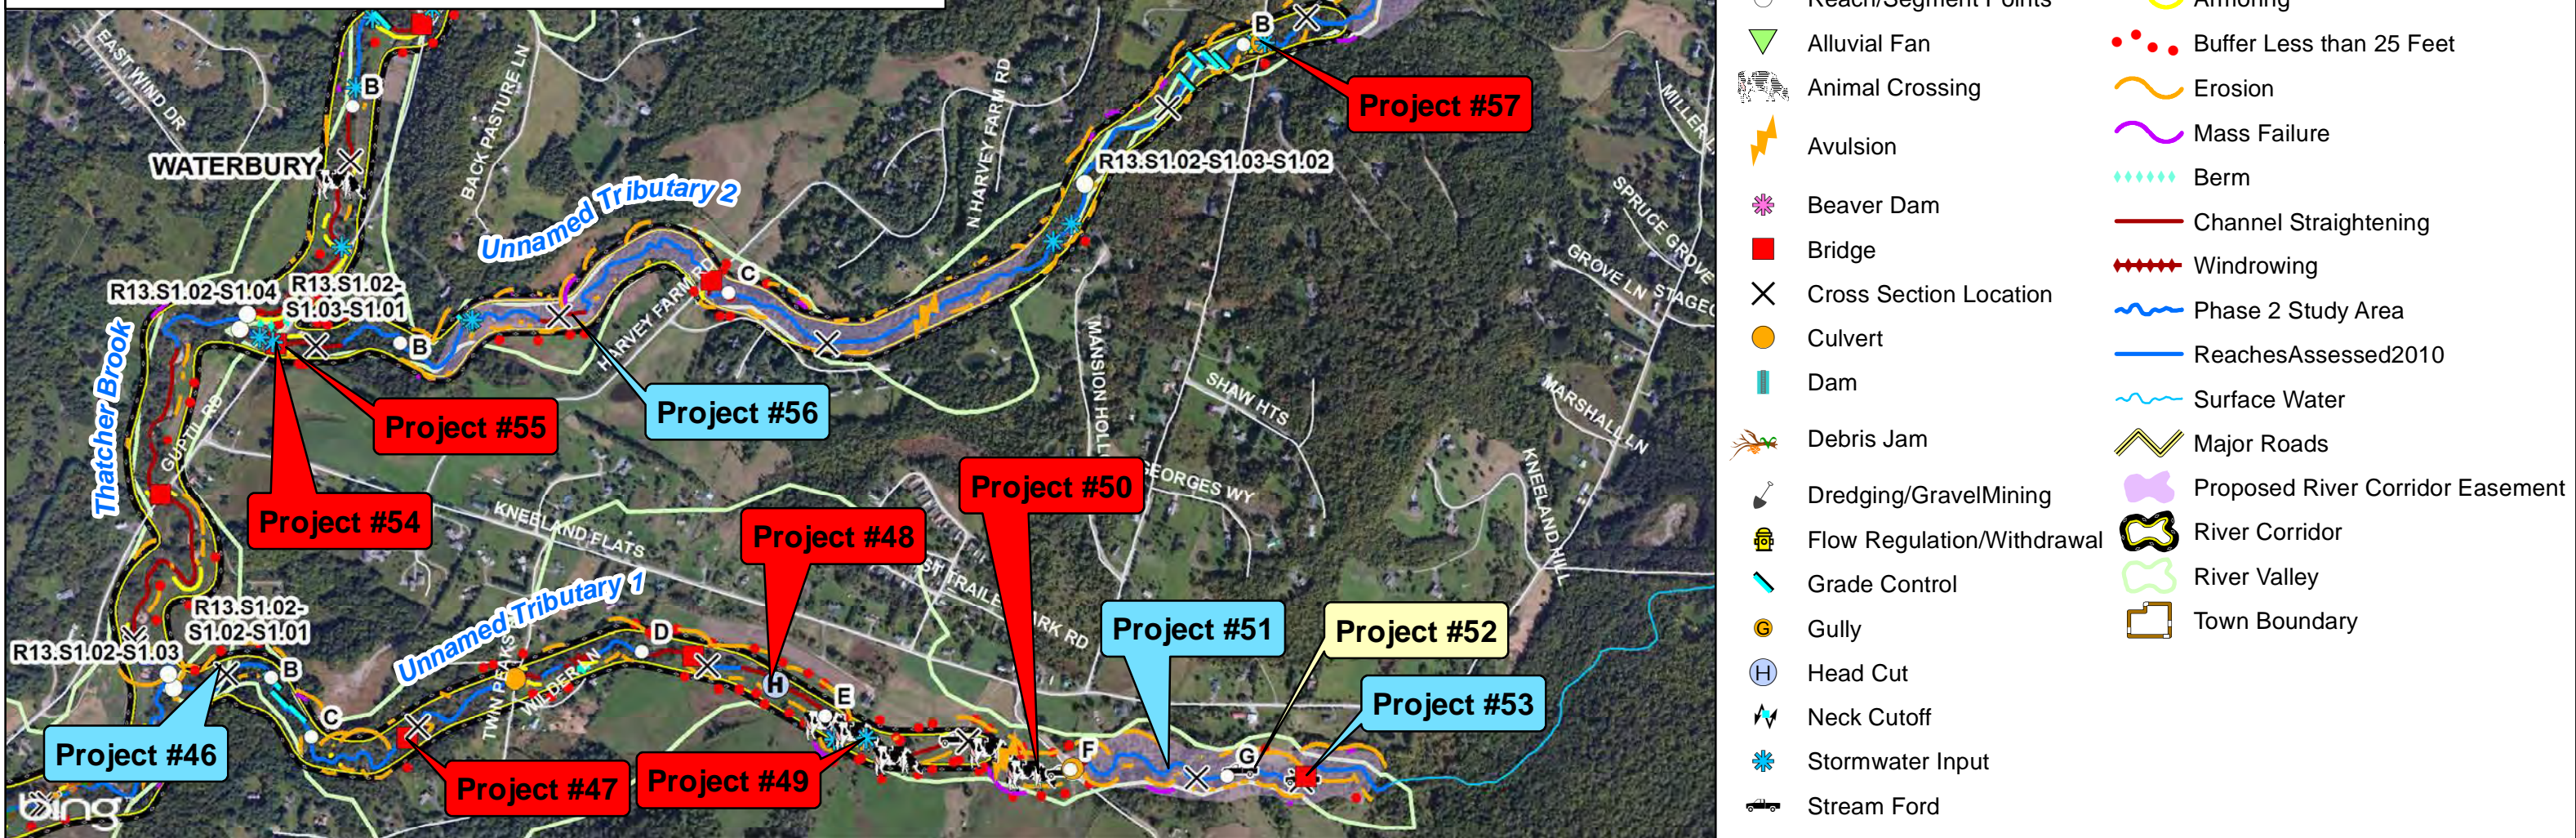
Map 7: Impacts and Potential Projects
Town of Waterbury
Unnamed Tributaries 1 and 2

There is a destroyed snowmobile bridge (iron and wood) causing sediment and debris accumulation in the stream channel. The bridge could affect water quality and channel stability, and could wash downstream and cause damage to infrastructure/property if not removed.

A snowmobile bridge on the VAST trail is in poor condition and is partially collapsing. The bridge is a safety issue if it is currently in use, and if it is not in use, it should be removed as it is undersized and failing.
Project #54 R13.S1.02-S1.03-S1.01-A (Refer to Map 7)	Structure Replacement/ Removal	Replace Bridge	Unnamed Tributary 2 to Thatcher Brook	Waterbury	Bridge on Guptil Road almost 800 feet northeast of intersection with Kneeland Flats Road	High

Bridge is slightly undersized and is in poor condition. Riprap around the bridge has all fallen into the stream and a large amount of sediment has accumulated beneath the bridge, causing it to have a very low clearance. It could be easily overtopped and damaged during high flows.

- Projects:**
46. Riparian Buffer Planting
 47. Remove Destroyed Bridge
 48. Build up Streambed with Boulder Wiers and Arrest Headcut
 49. Riparian Buffer Planting
 50. Livestock Exclusion
 51. River Corridor or Conservation Easement
 52. Riparian Buffer Planting
 53. Remove or Replace BRidge
 54. Replace Bridge
 55. Livestock Exclusion
 56. Riparian Buffer Planting & River Corridor Easement
 57. Culvert Replacement
 58. River Corridor or Conservation Easement
 59. Culvert Replacement
