Great Brook Watershed River Corridor Plan

Plainfield and Groton, Vermont
March 19, 2014

Prepared by:
Bear Creek Environmental, LLC
149 State Street, Suite 3
Montpelier, Vermont 05602

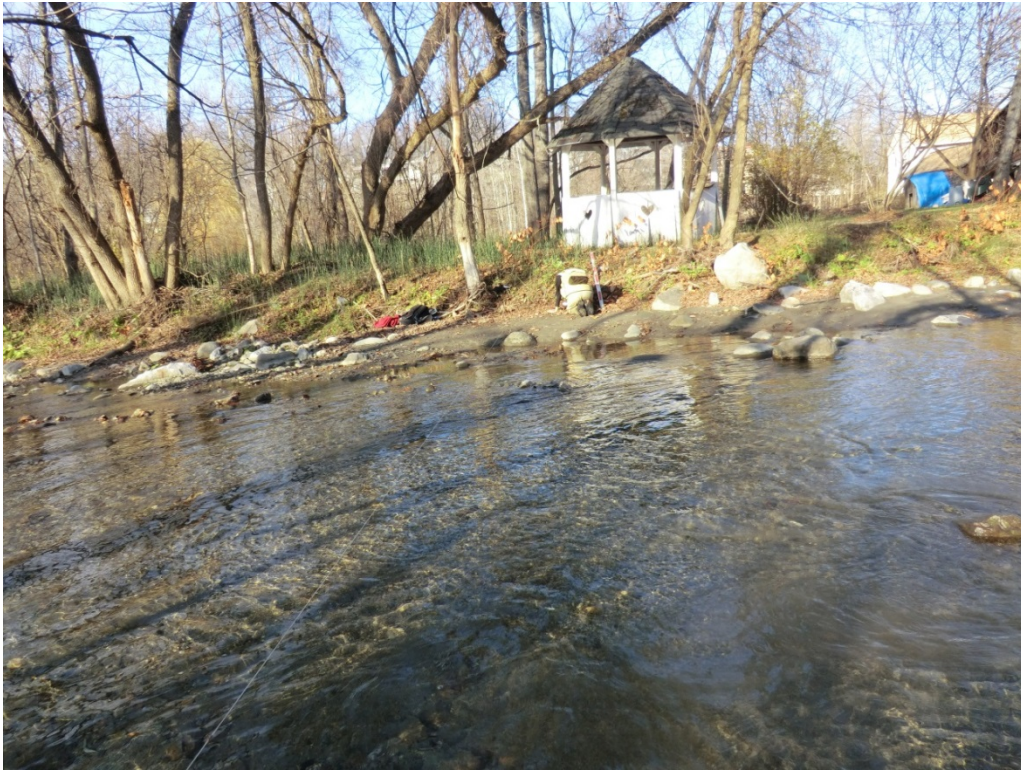
Figure 5.2. Low eastern bank provides good floodplain access in M3.01-A.

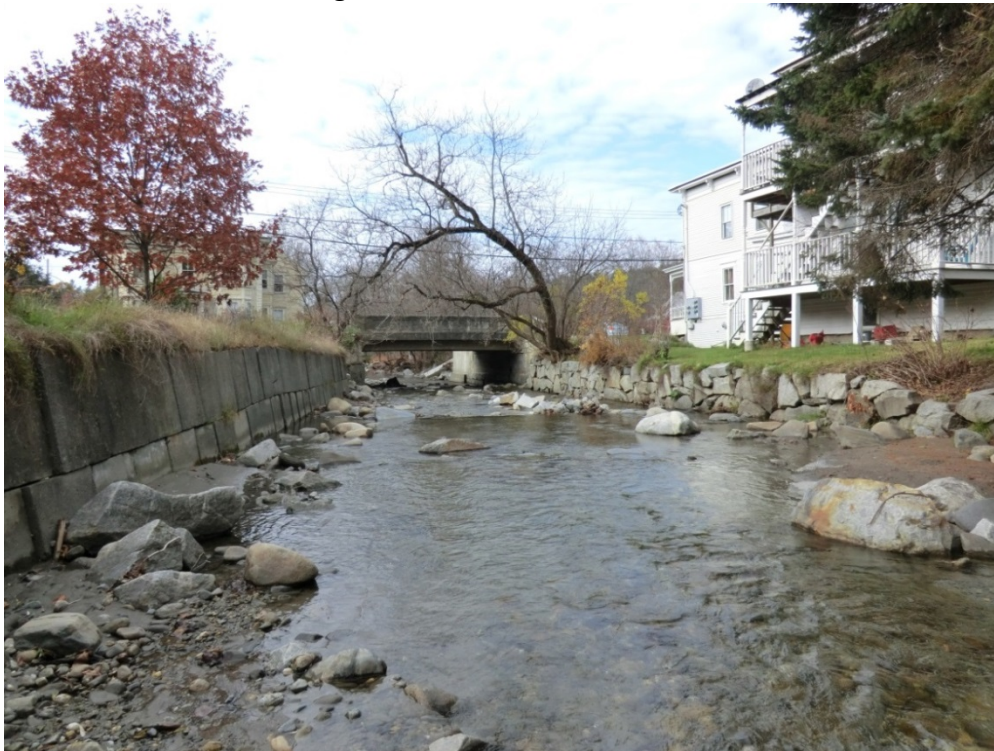
Figure 5.4. Extensive bank armoring upstream of the Mill Street bridge in Plainfield.

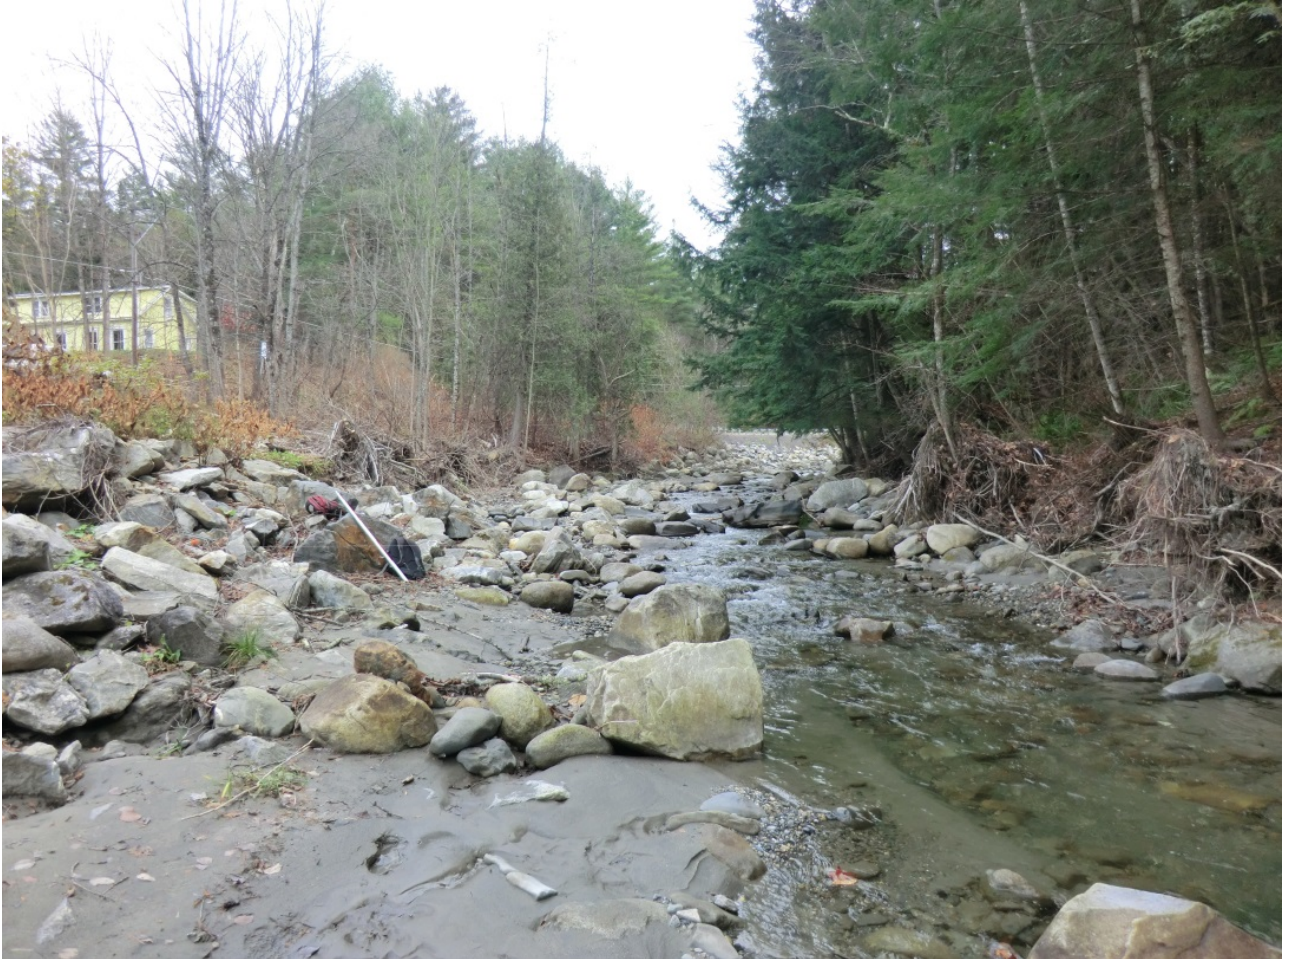
Figure 5.6. Valley wall continuous on the southern bank (right) and Brook Road close by to the north (left) in M3.01-C.

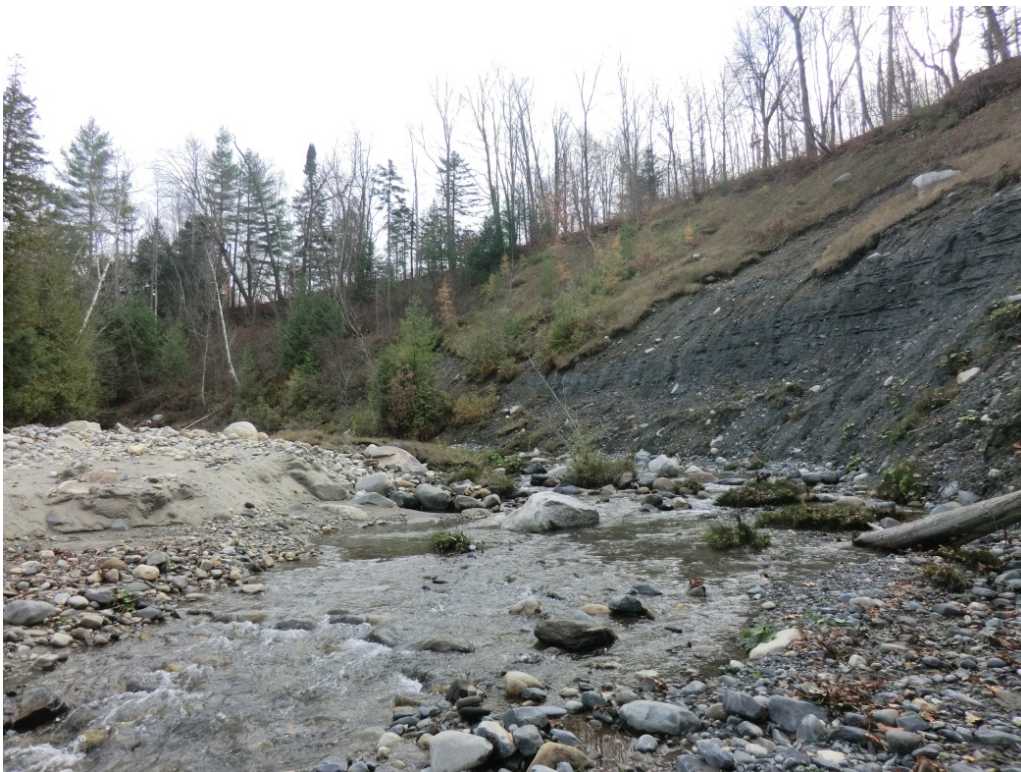
Figur5.8. Large mass failure in M3.02-A.

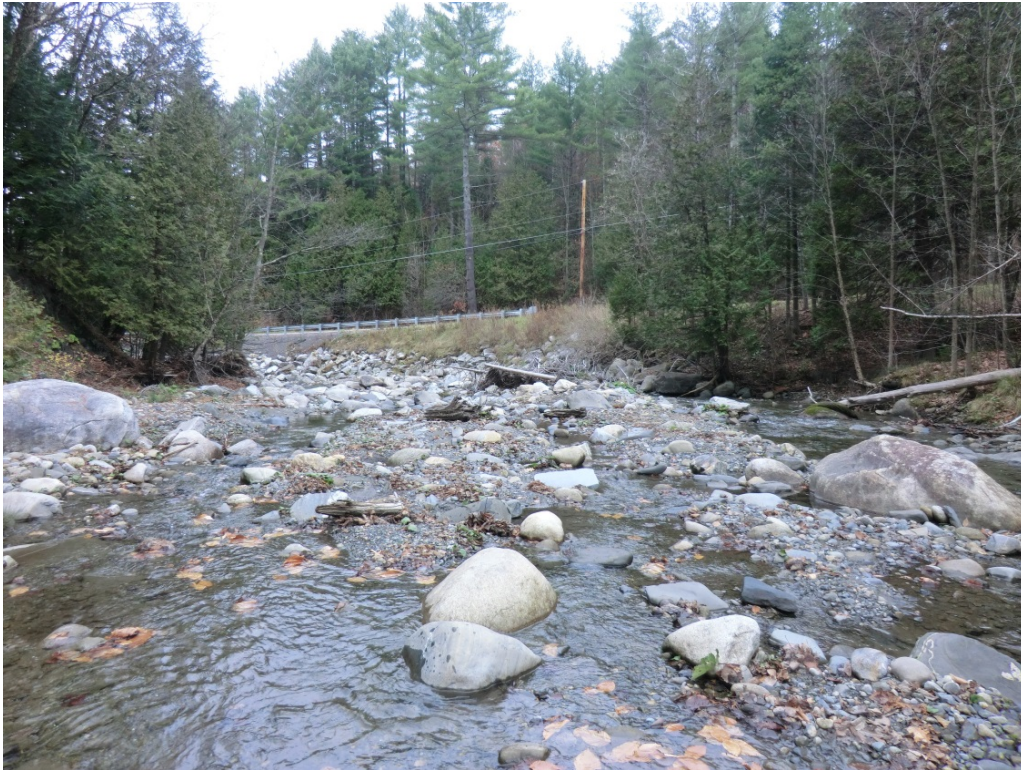
Figure 5.9. M3.02-A is braided even under low flow conditions.

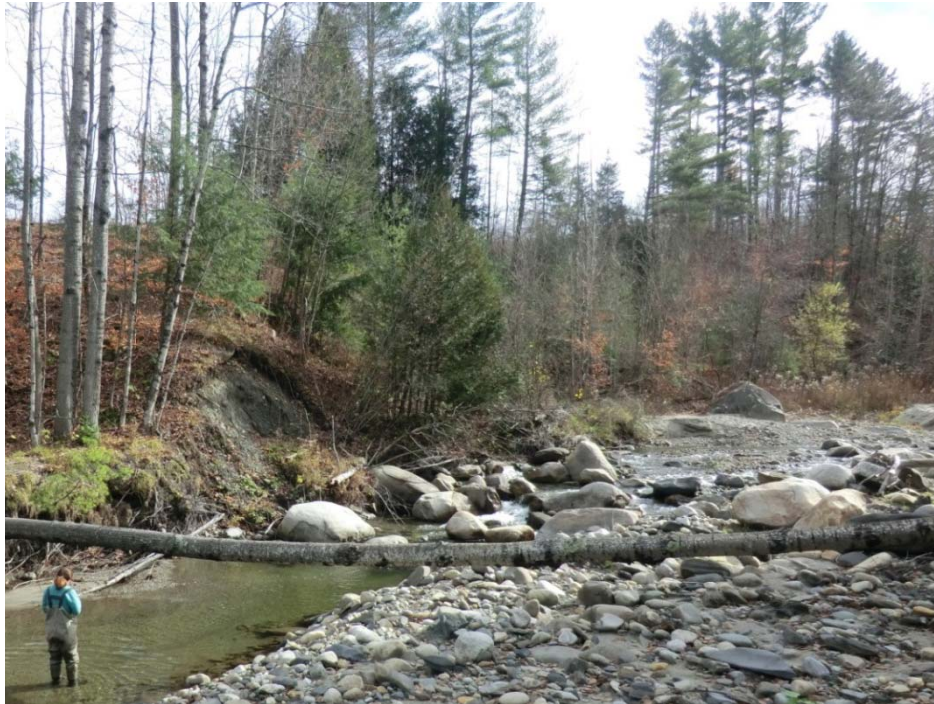
Figure 5.10. Headcut in M3.02-C is evidence of the active incision process.

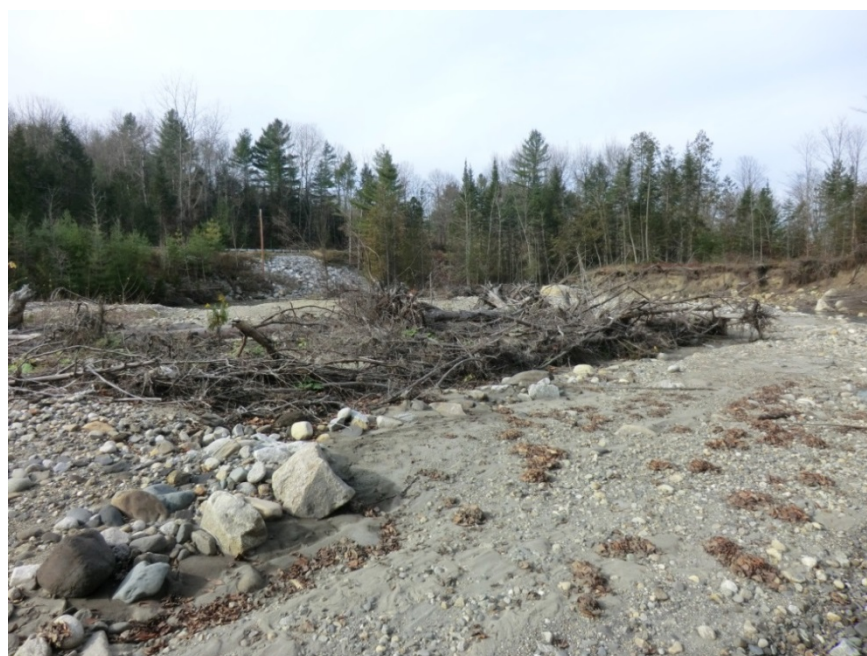
Figure 5.12. Excessive aggradation in M3.02-C dominates the streambed.

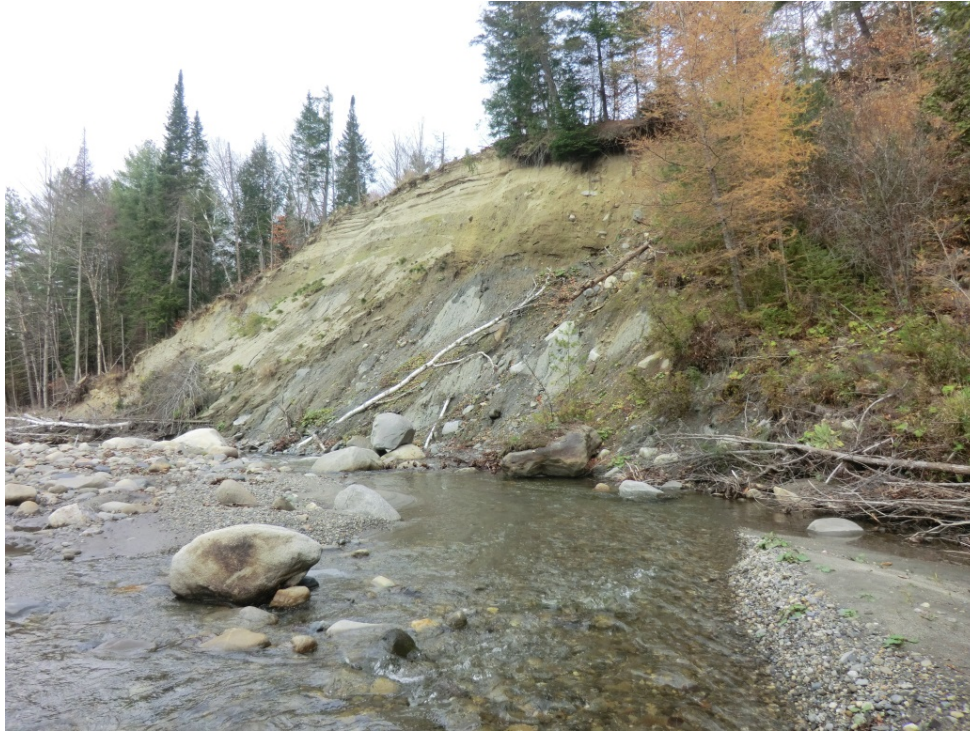
Figure 5.13. Multiple mass failures are present in M3.02-C.

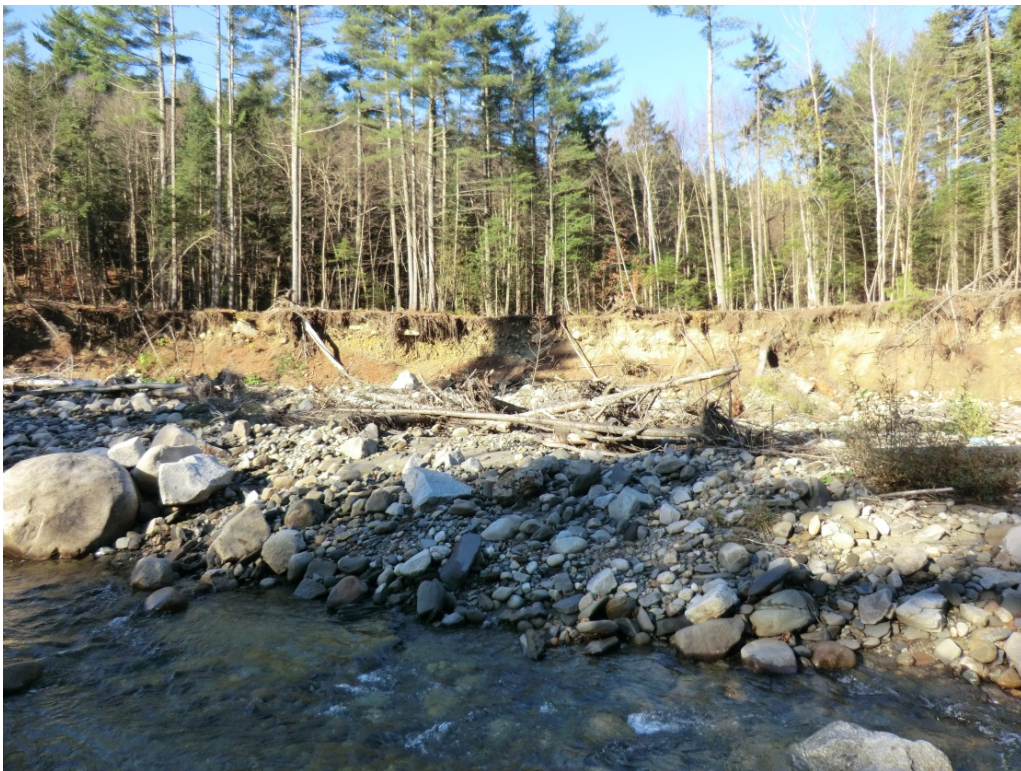
Figure 5.14. High freshly eroded banks in M3.03-A.

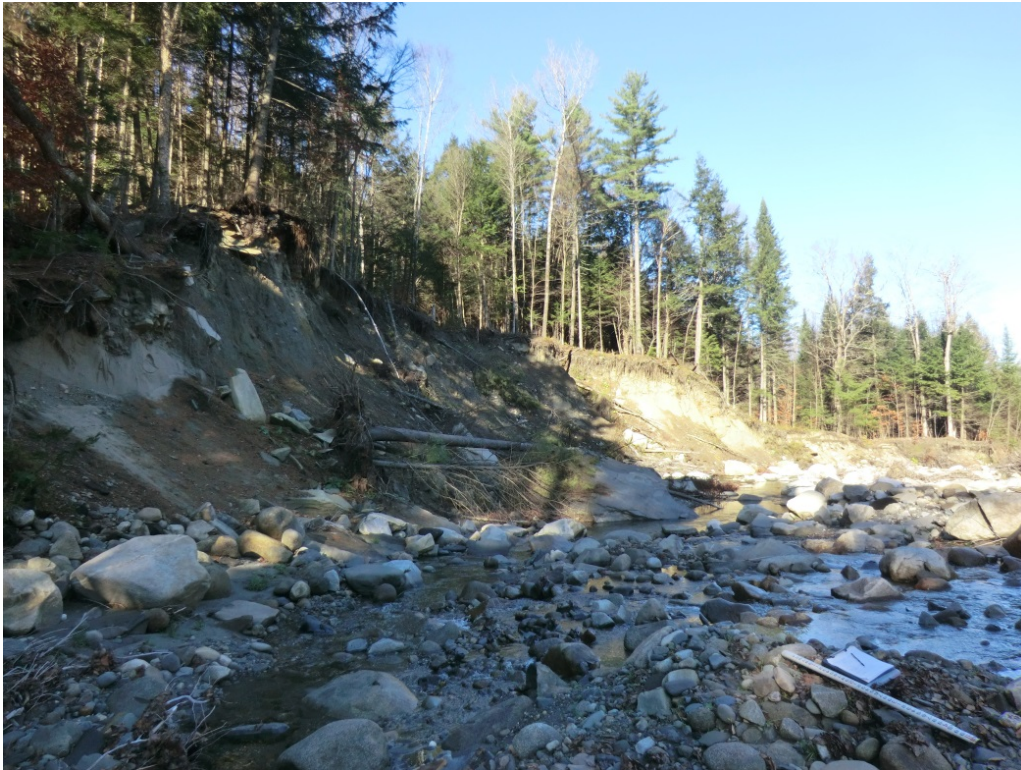
Figure 5.15. Mass failure along the western bank in M3.03-A.

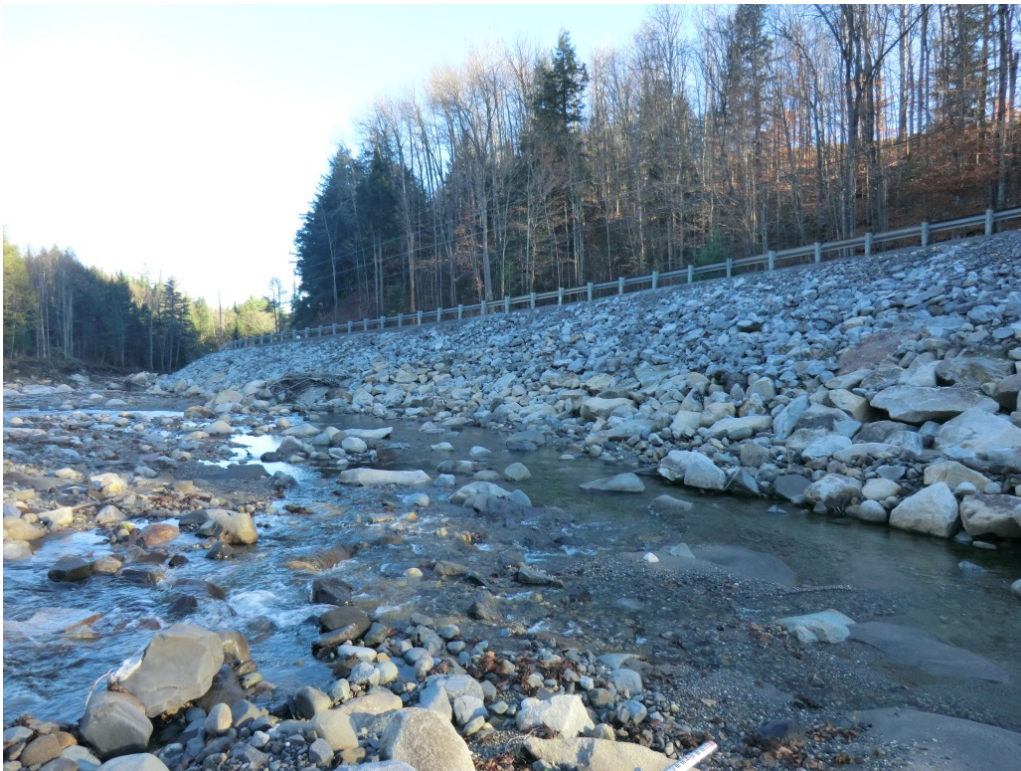
Figure 5.16. Rip rap along Brook Road in M3.03-A.

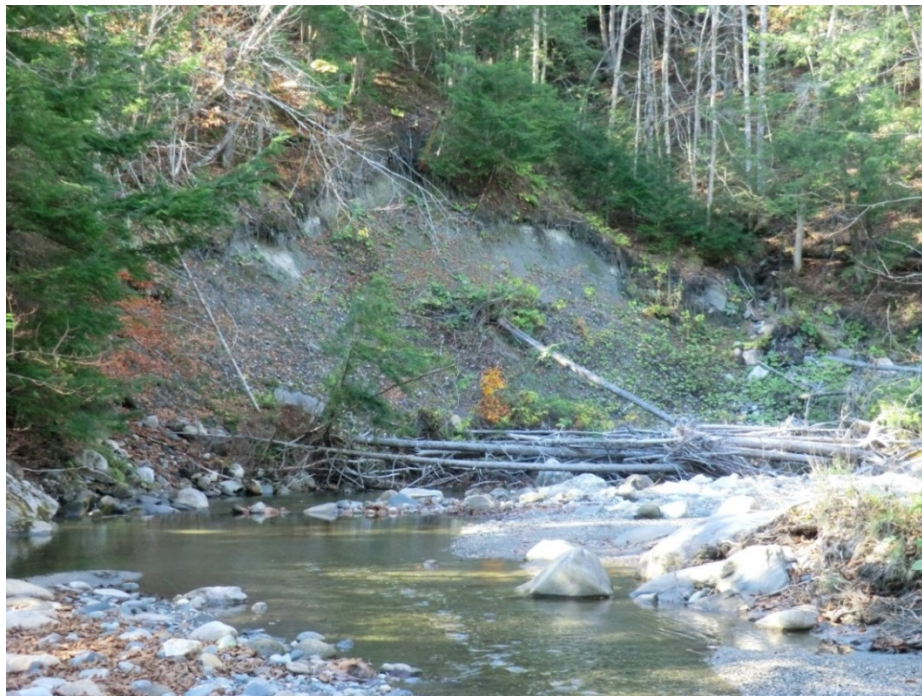
Figure 5.17. Mass failure and debris jam seen in M3.03-B.

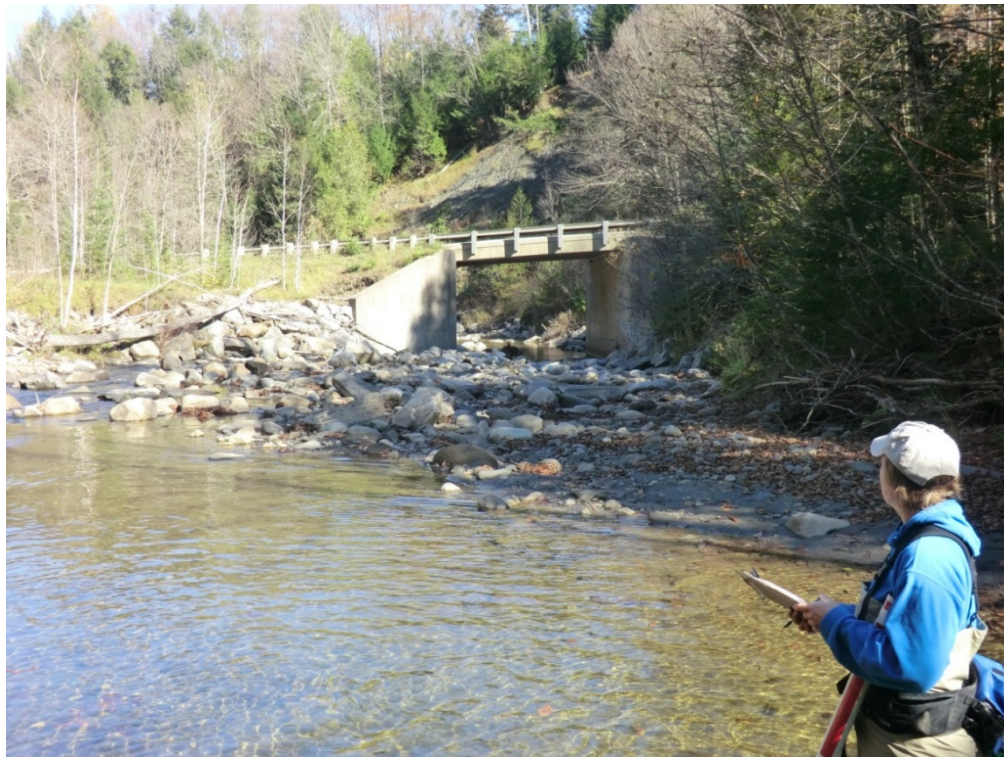
Figure 5.18. Looking downstream at undersized bridge along Brook Road in M3.03-B.

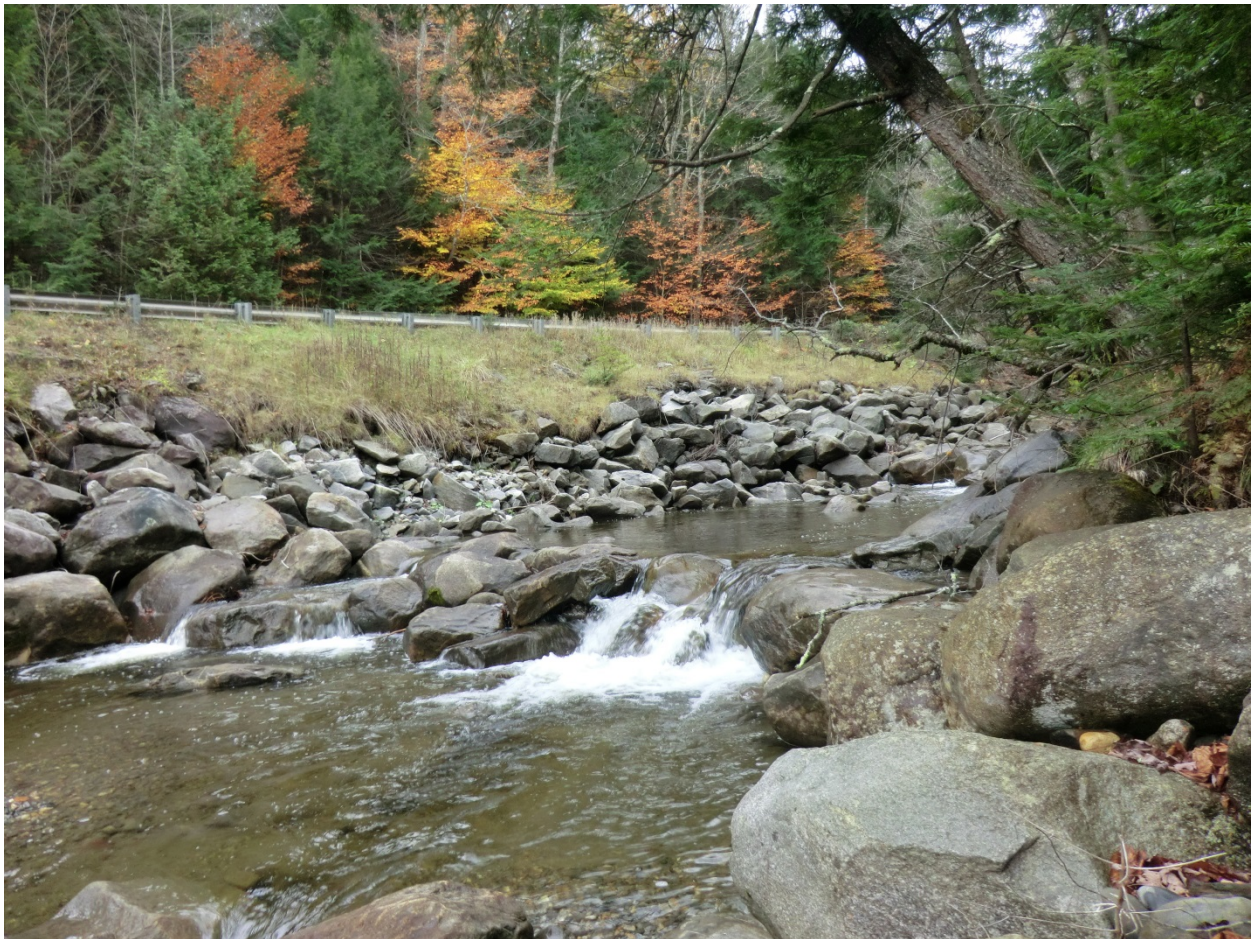
Figure 19. Intact boulder weir in M3.04-A installed to prevent incision.

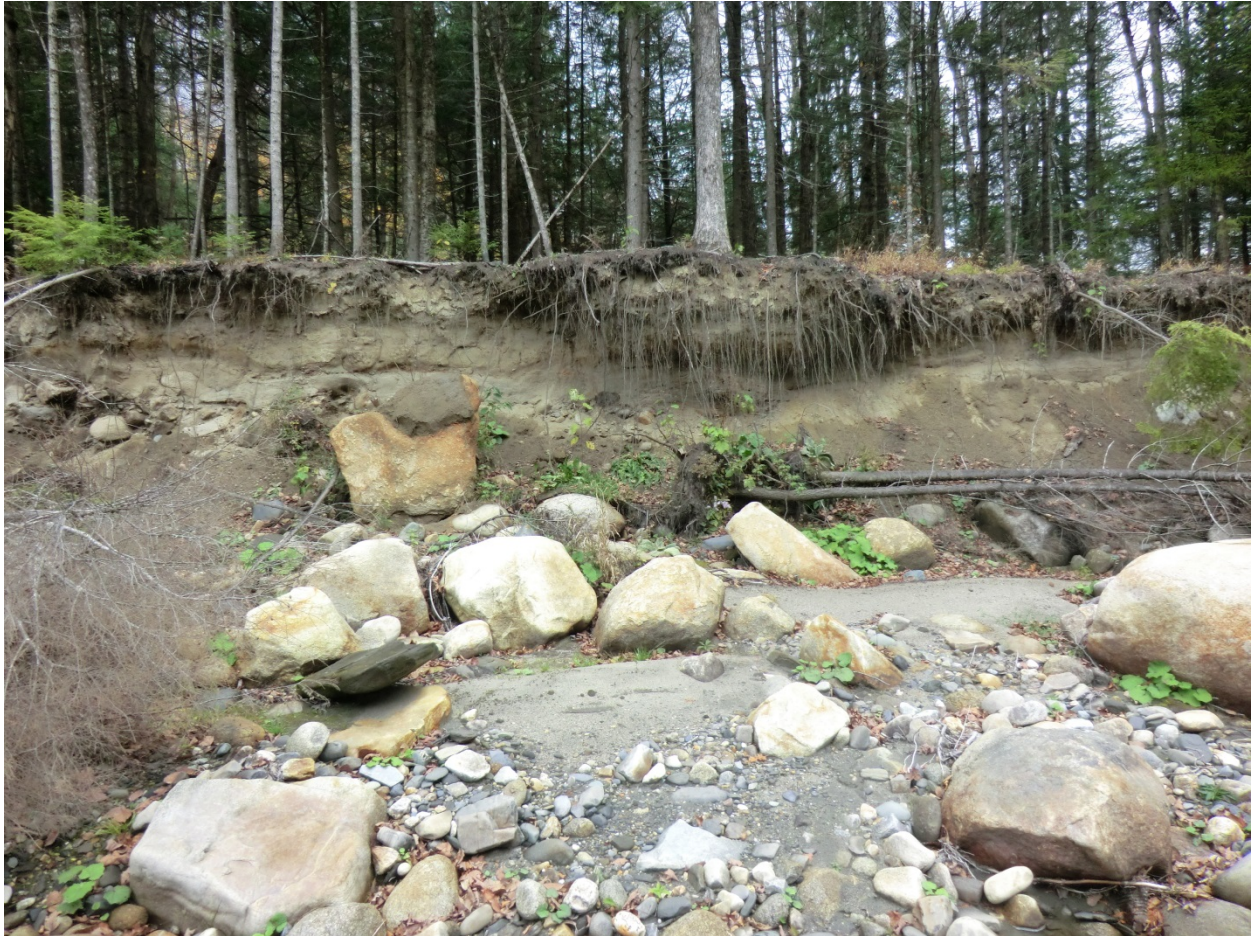
Figure 5.20. Fresh eroded banks are contributing to the large amount of sediment in the channel in M3.04-A.

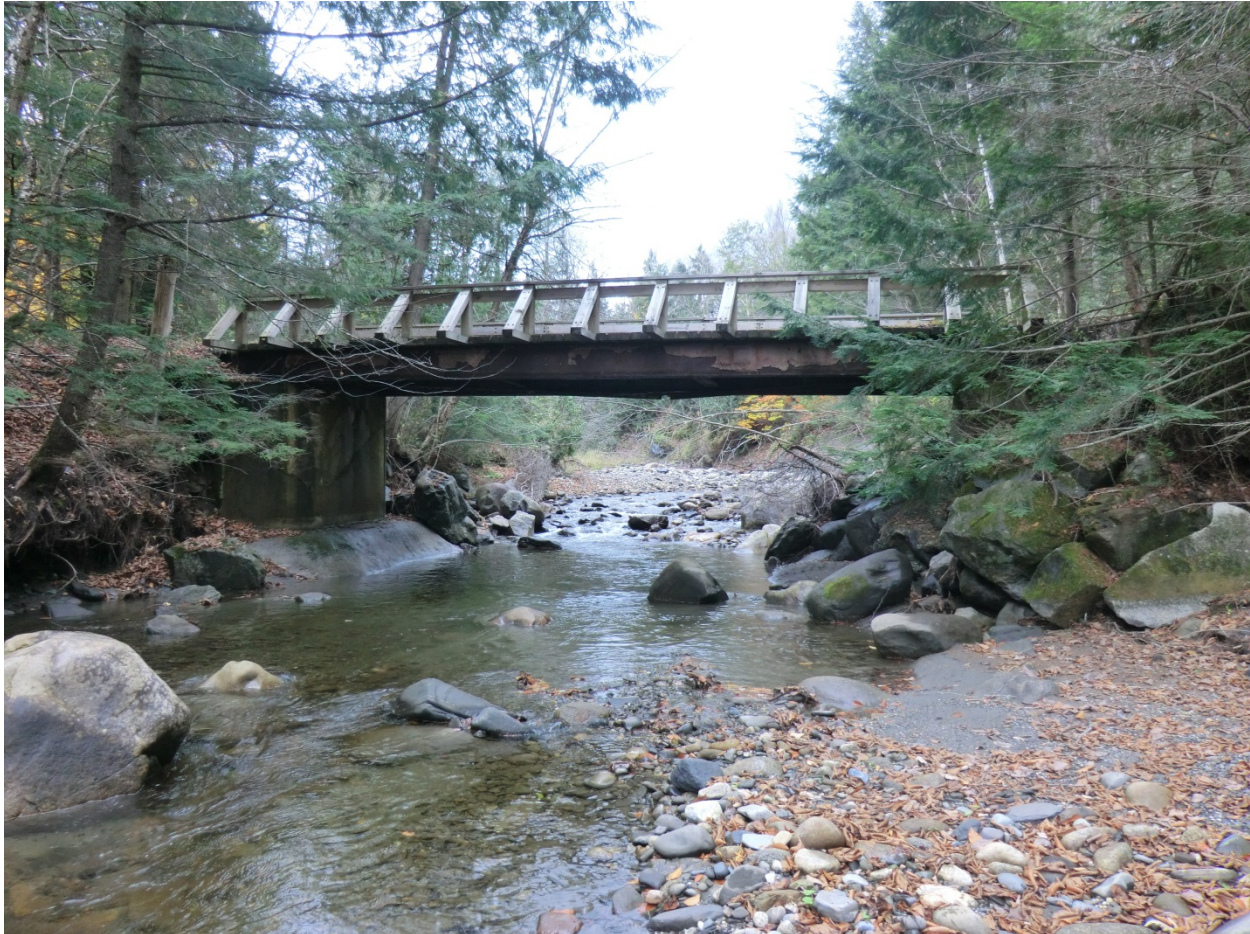
Figure 5.21. Private driveway bridge is causing upstream deposition in M3.04-B.

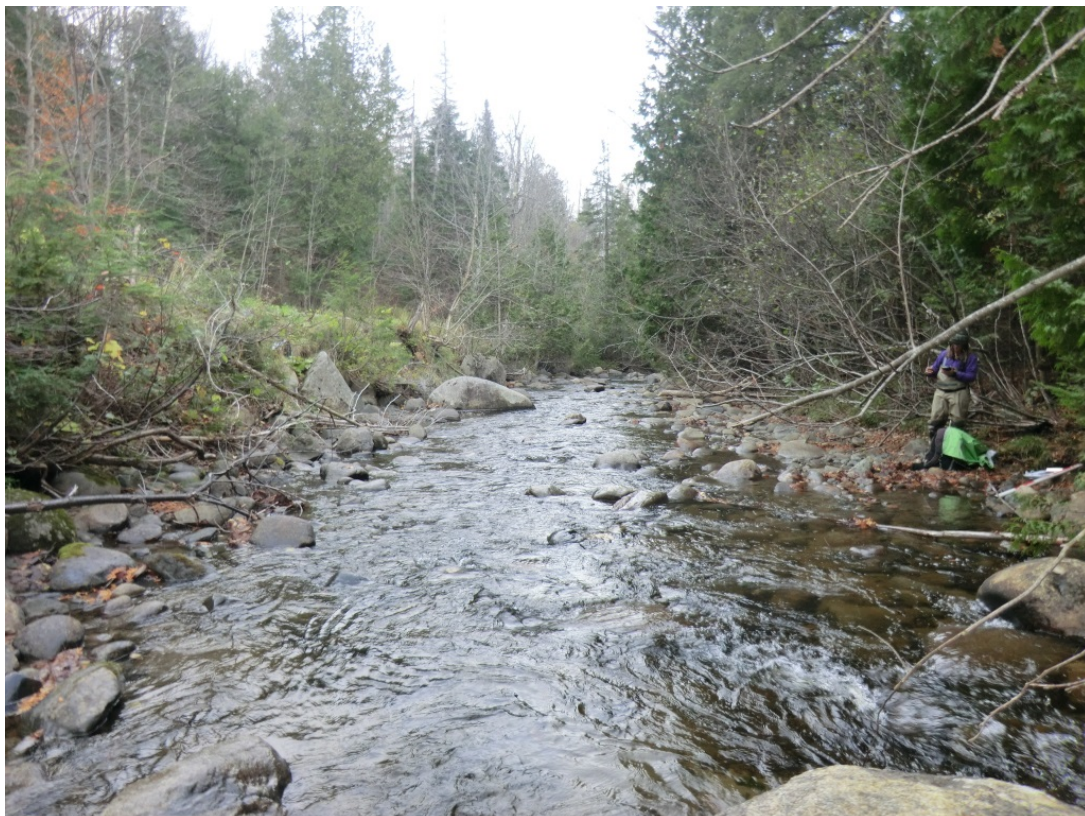
Figure 5.30. Brook Road is directly adjacent to stream channel (left) in M3.06-B resulting in poor buffer widths and reduced bank vegetation.

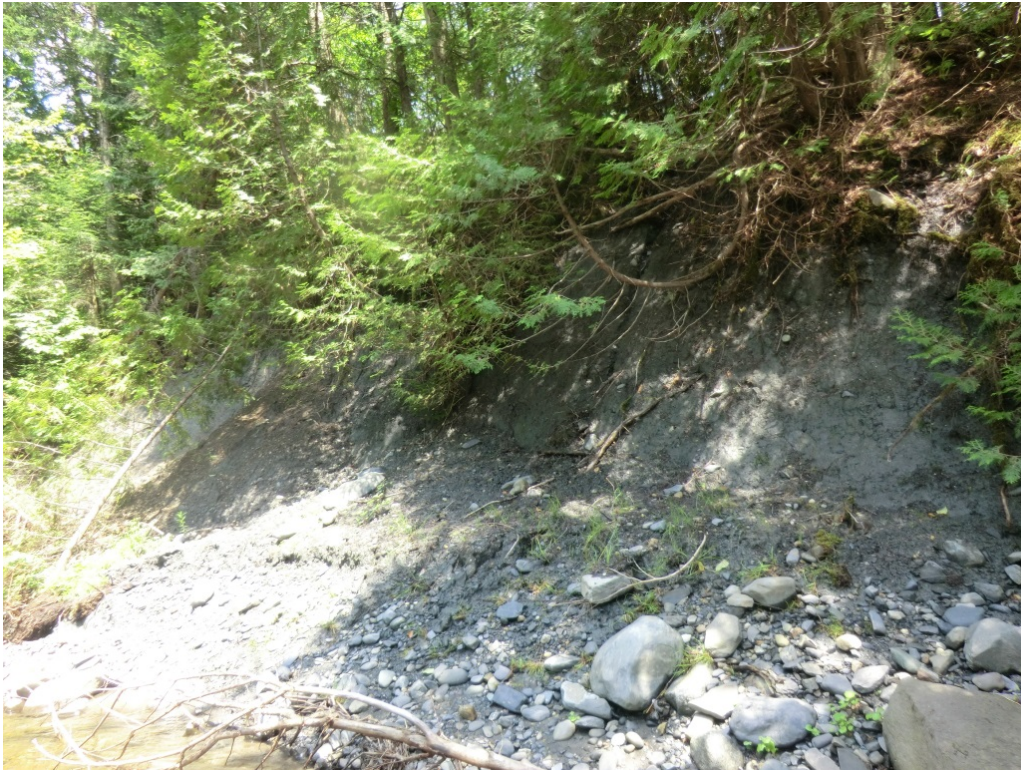
Figure 5.34. Mass failure in M3.07-A contributing sediment to the stream channel.

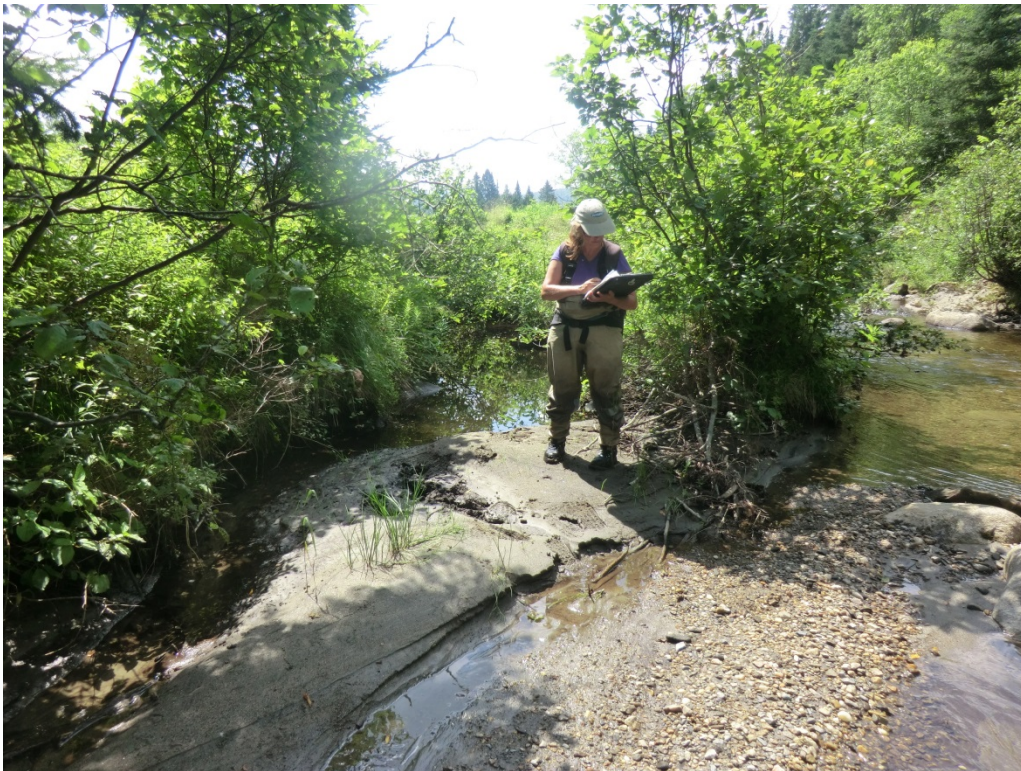
Figure 5.35. Aggradation in channel due to sediment inputs from gully across field.

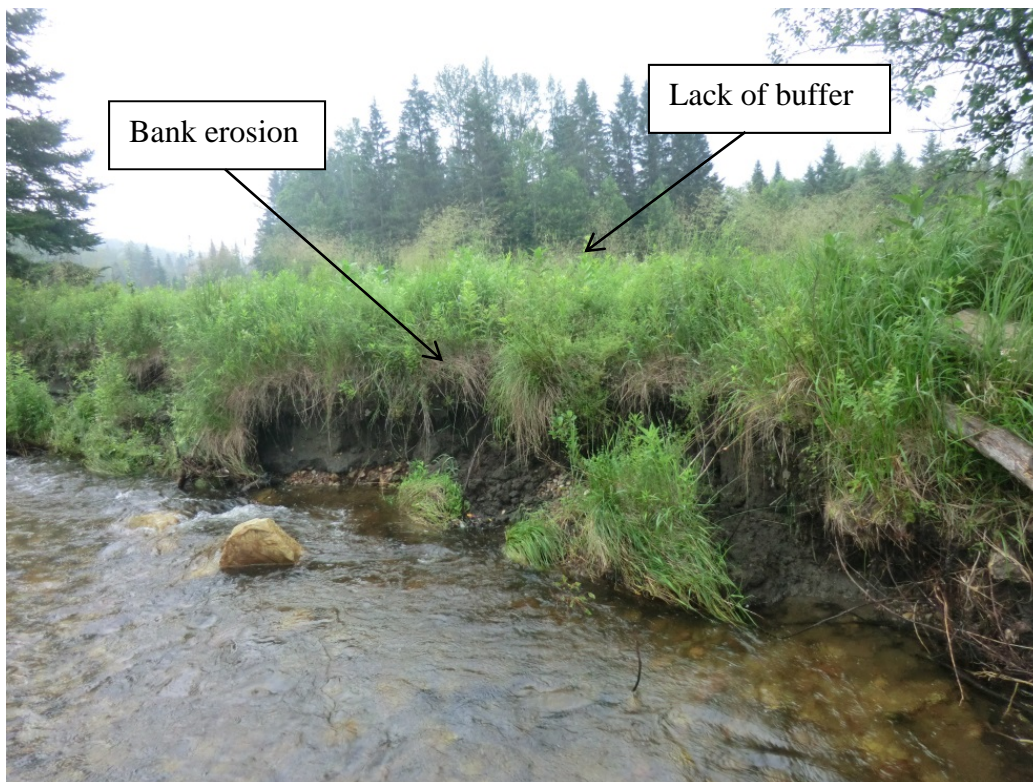
Figure 5.36. Lack of buffer on eastern bank of M3.07-B has led to extensive erosion as channel widens.

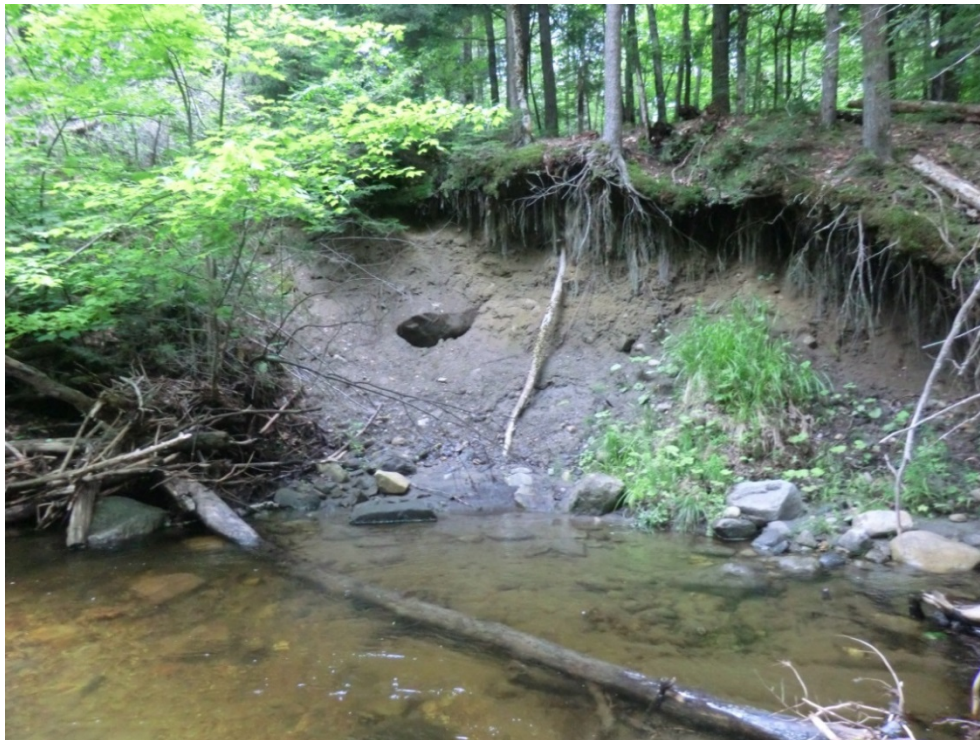
Figure 5.39. Mass failure in M3.07-C contributing sediment to Great Brook.

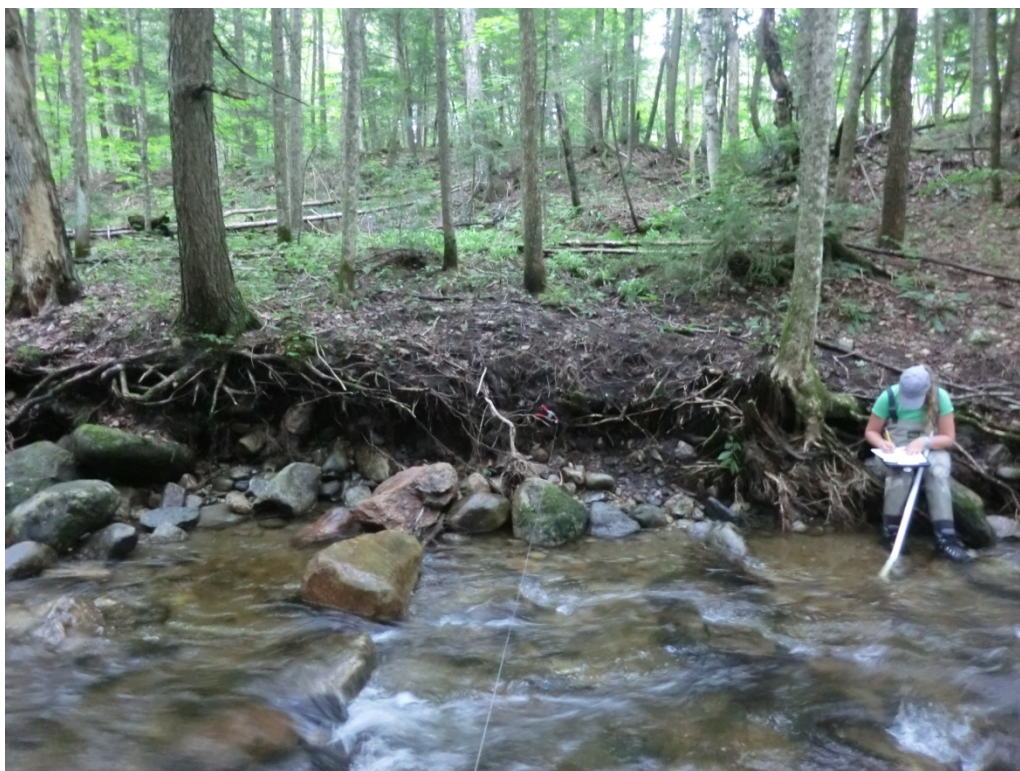
Figure 5.40. Incised channel in M3.08-A preventing floodplain access.

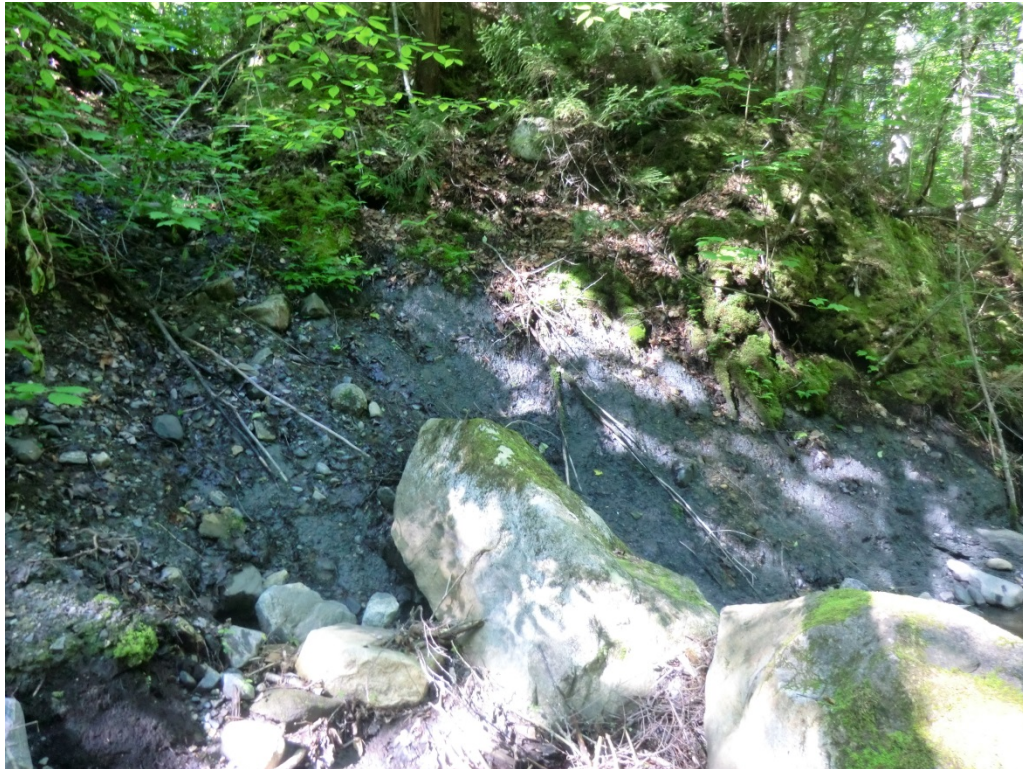
Figure 5.42. Mass failure in M3.08-B causing instability in stream bank.

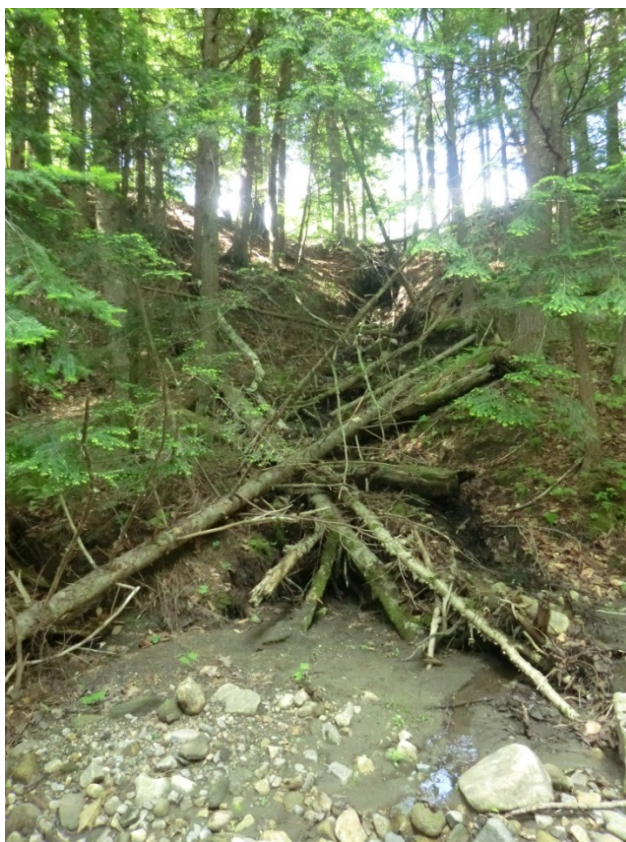
Figure 5.43. Gully in M3.08-B contributing sediment to Great Brook.

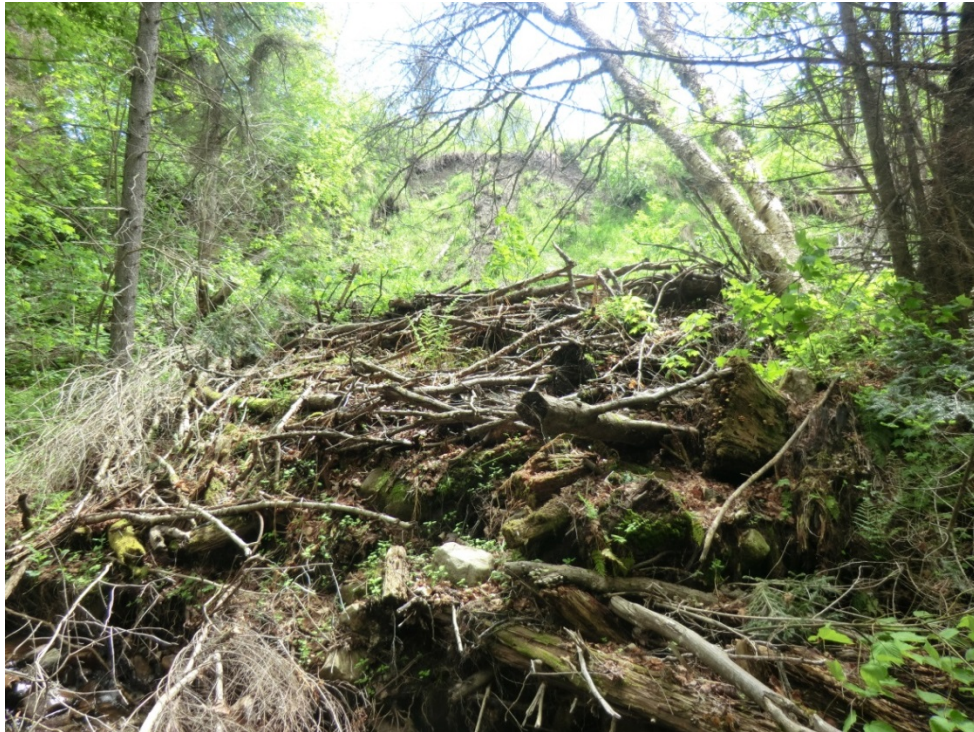
Figure 5.46. Mass failure in M3.08-C at log landing and accumulated debris.

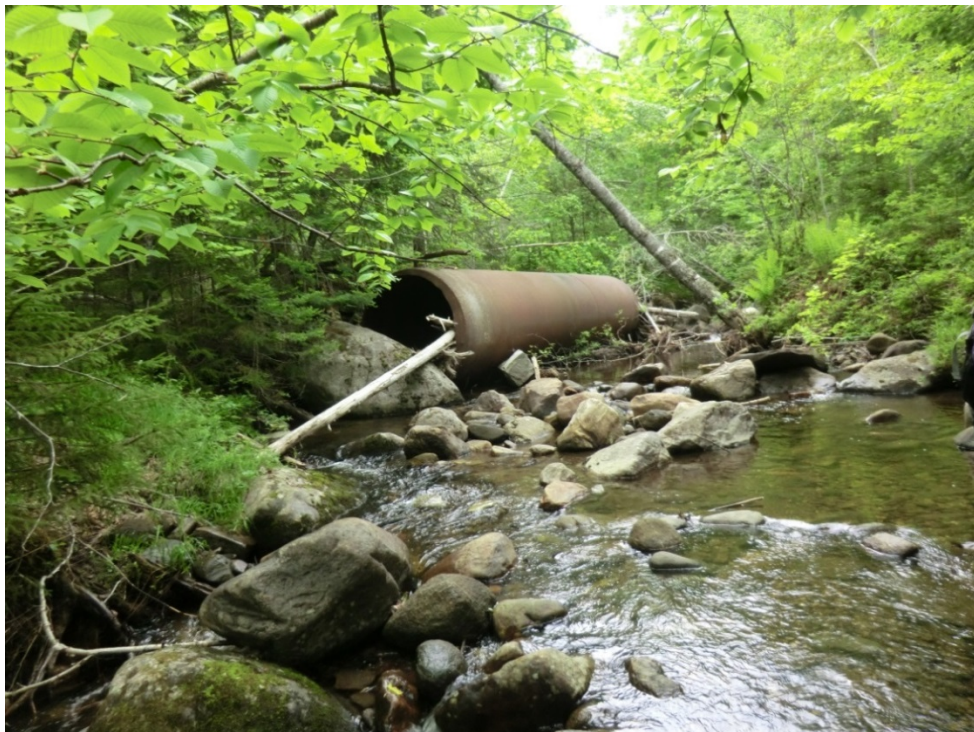
Figure 5.47. Old washed out culvert in M3.08-C causing geomorphic instability.

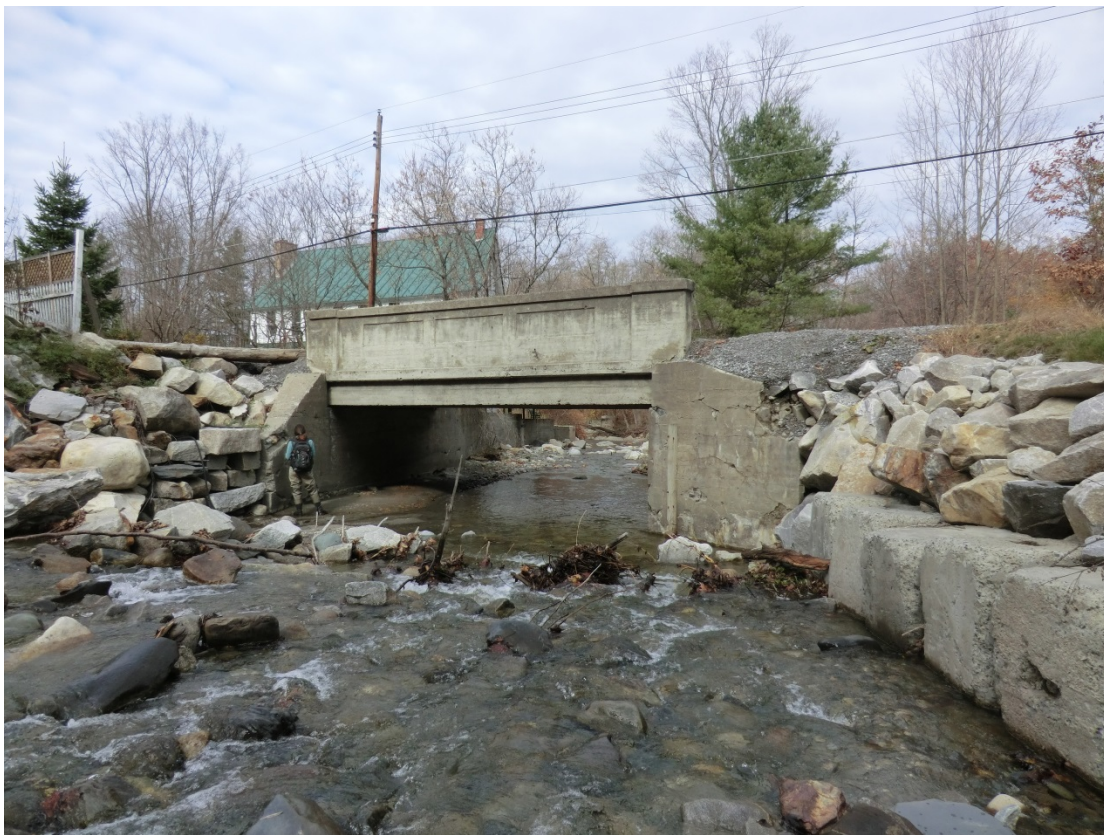
Figure 5.53. Box culvert crossing at Brook Road in segment M3.01-C recommended for replacement.
