Great Brook Watershed River Corridor Plan

Plainfield and Groton, Vermont
March 19, 2014

Prepared by:
Bear Creek Environmental, LLC
149 State Street, Suite 3
Montpelier, Vermont 05602

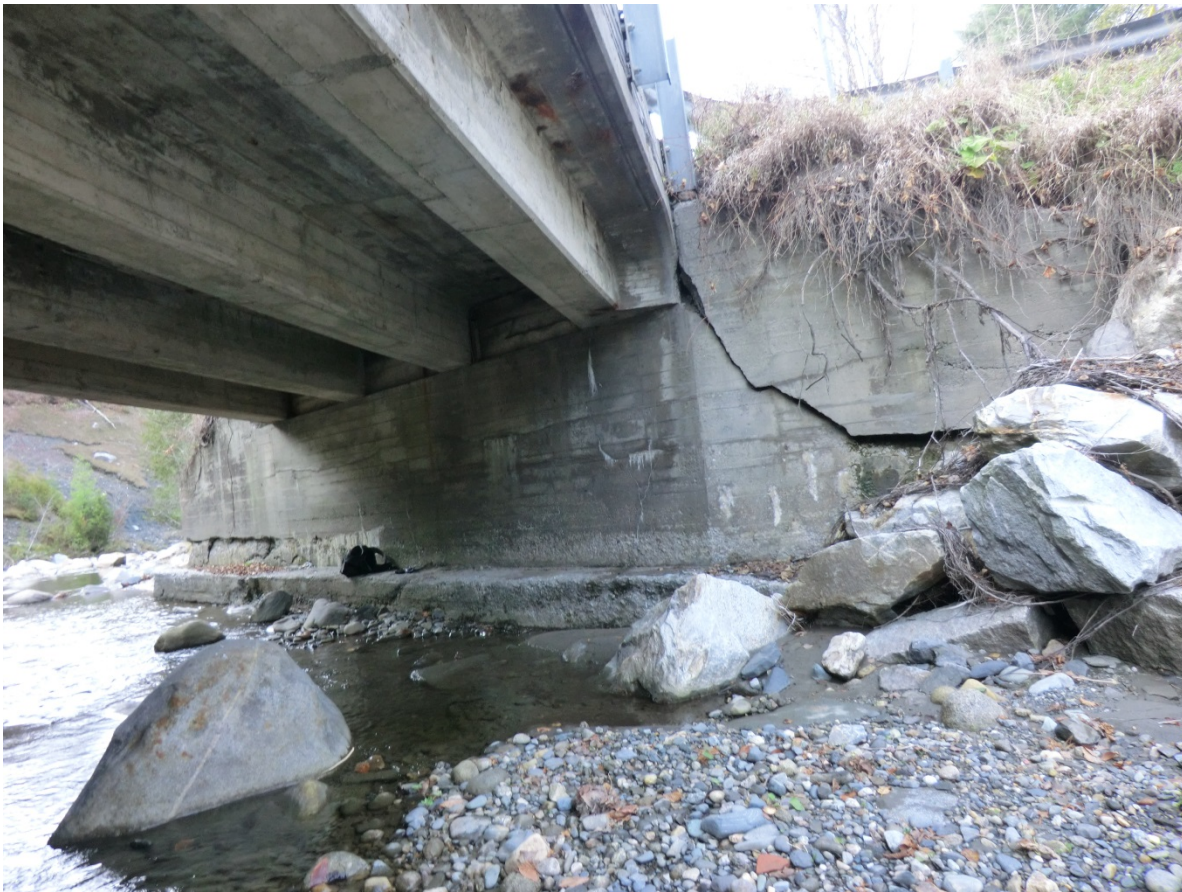
Figure 5.54. Cracked wing wall on bridge at Brook Road in segment M3.02-B recommended for replacement.

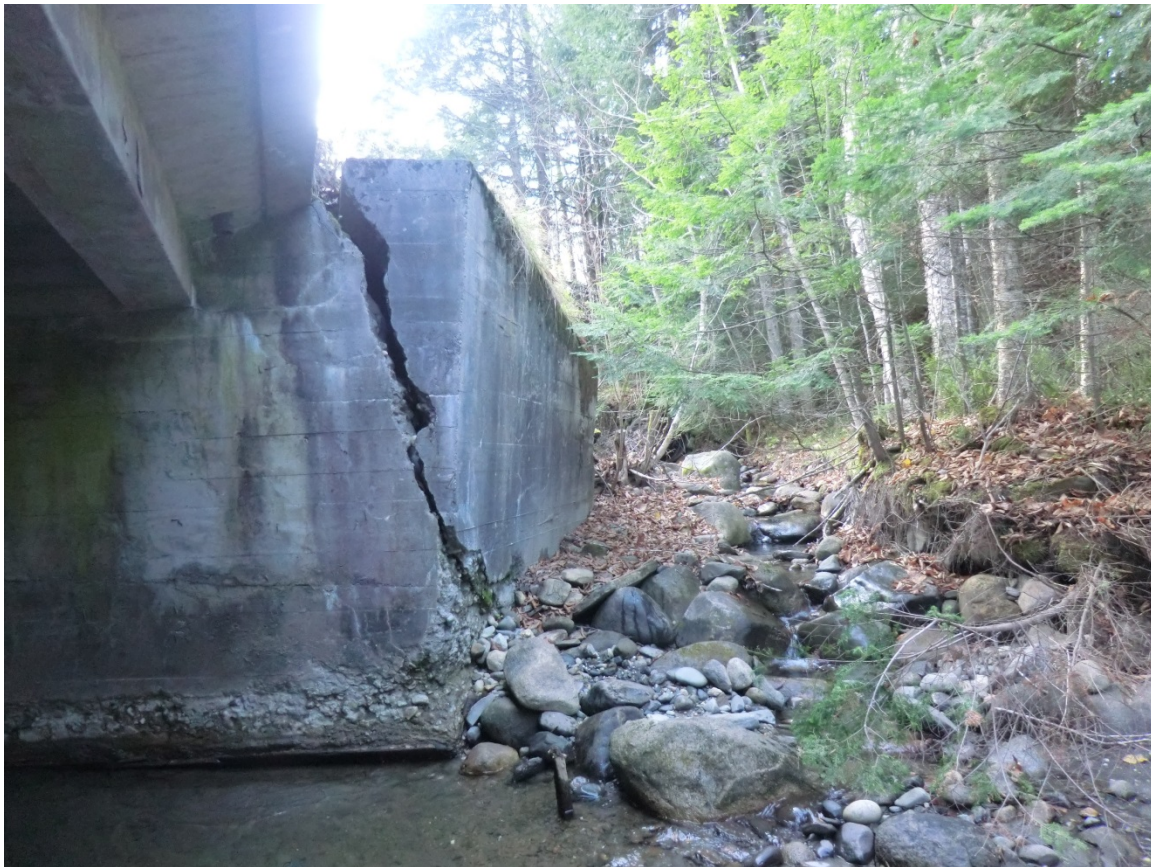
Figure 5.57. Box culvert at upstream Brook Road crossing in segment M3.05-C with cracked wing wall.
