Waterbury, Vermont Middle Winooski River Corridor Plan

December 15, 2015

Middle Winooski River Corridor Plan

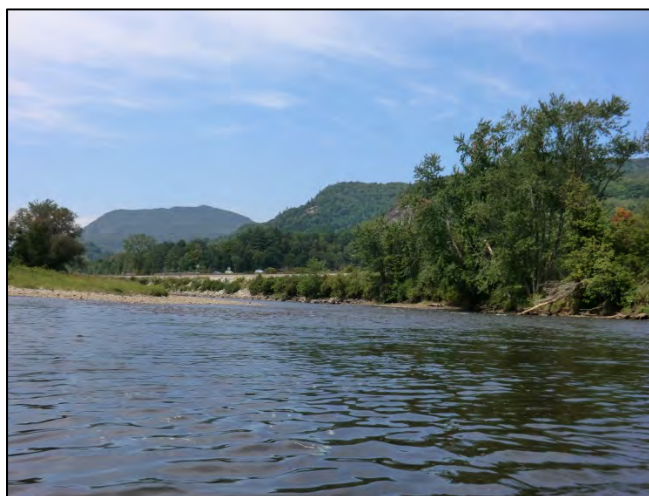
The downstream segment on R11 is characterized by an unnaturally straight channel due to historic straightening along the railroad/I-89 and River Road/Duxbury Road. The encroachment of I-89/the New England Central Railroad, one of the most important travel corridors in Vermont, has caused significant narrowing of the river valley. This, as well as the presence of a major dam just upstream, has led to channel incision, stream type departure, and loss of floodplain access. Riprap is prevalent along both banks of the river within R11-A, especially in areas where it flows directly along a road or railroad. Bank erosion is scattered between the riprap. The Winooski River is in the process of widening in R11-A, but lateral planform adjustment is restricted by the aforementioned encroachments. For these reasons, R11-A is in **fair** geomorphic condition. This segment is also in **fair** habitat condition due to altered channel planform, impacted banks and buffers, and lacking instream cover.

Figure 5.7. M2.01 impacted by valley width changes by placement of I 89 and Route 2 bridges.

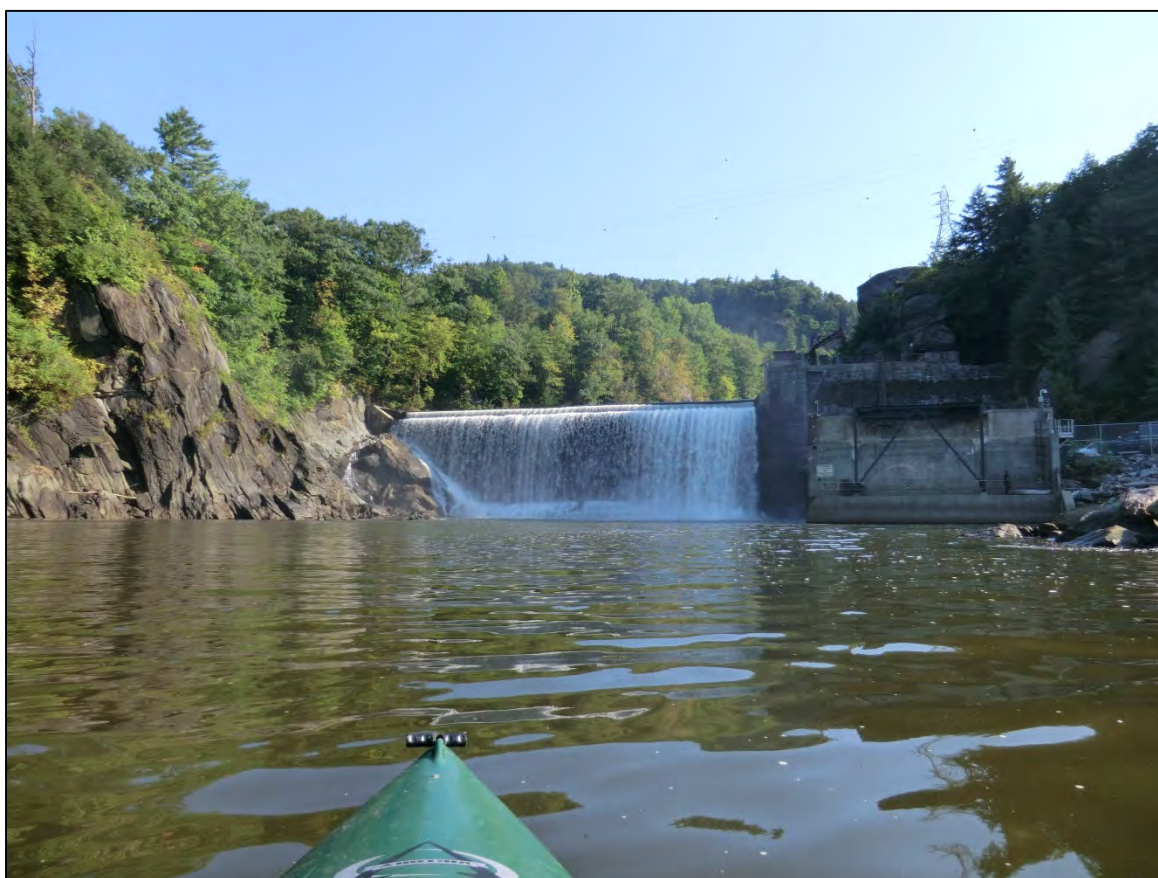
The upstream segment on reach 11 of the Winooski River is nearly 5,000 feet in length and contains the Bolton Falls Dam. The large, run-of-river dam was built in 1898 in a short bedrock gorge to generate hydroelectricity. The dam is approximately 70 feet tall. Despite the presence of the dam, the river does not appear to have incised in R11-B. The river valley is naturally confined and the channel slope is steeper than the surrounding reaches. The New England Central Railroad crosses the river in this segment and creates an encroachment on the southern bank. The channel has widened substantially in R11-B, which could be attributable to the upstream flow regulation. Overall, the segment is in **fair** geomorphic condition due to its over-widened state. It is also in **fair** habitat condition as a result of poor bank and buffer vegetation, morphology, and hydrologic characteristics.

Figure 5.8. M2.01 impacted by valley width changes by placement of I 89 and Route 2 bridges.

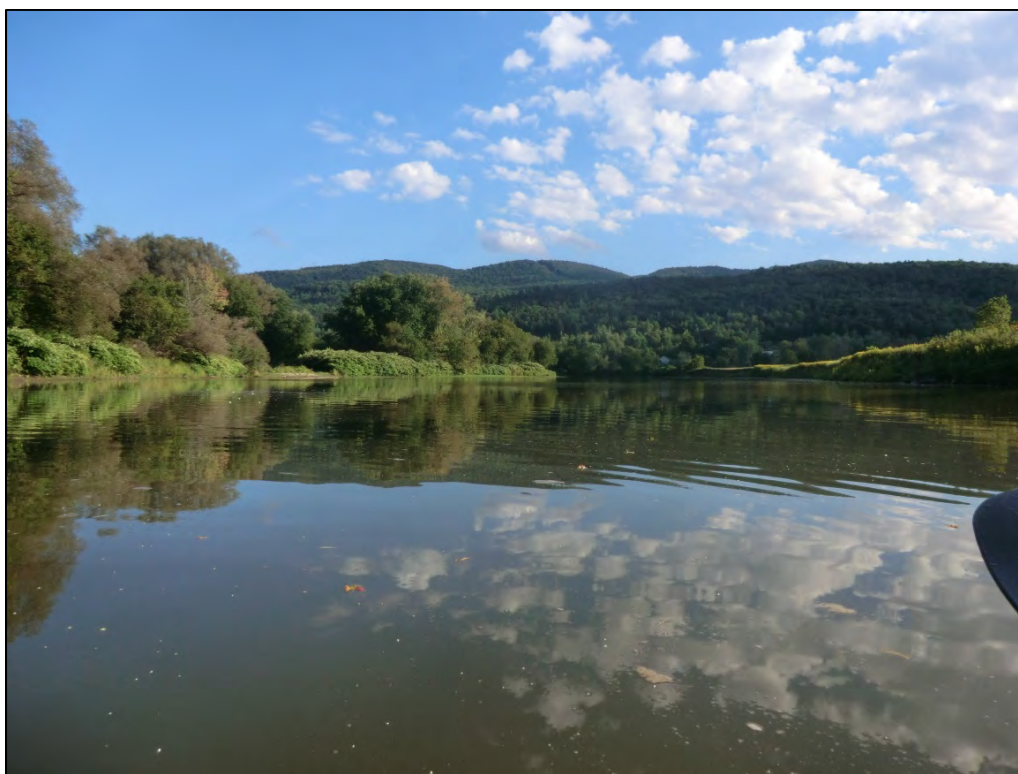
This reach was not divided into segments during assessment. It begins just above the Bolton Falls Dam and continues upstream for 2.3 miles to above the confluence of the Little River. This entire reach is affected by the large dam at Bolton Falls, which impounds the river and has a backwatering effect of over two miles. At the time of assessment, there were no riffles present in R12 due to the flow regulation at the dam. Impacts and habitat features were recorded during field work, but a full assessment was not done on this reach due to its impounded nature. Based on qualitative field observations, the Winooski River in R12 appears to have good access to its floodplain. The New England Central Railroad cuts across the southern floodplain, while US Route 2 encroaches upon the northern side of the river. Riparian buffers are lacking along nearly the entire reach due to the presence of agricultural fields. Most of this reach appears to have been historically straightened due to the placement of I-89, Route 2, and the railroad. Bank erosion and armoring are scattered along both banks in R12.

Figure 5.9. R12 is impounded and lacks bed features due to the presence of the Bolton Falls Dam.

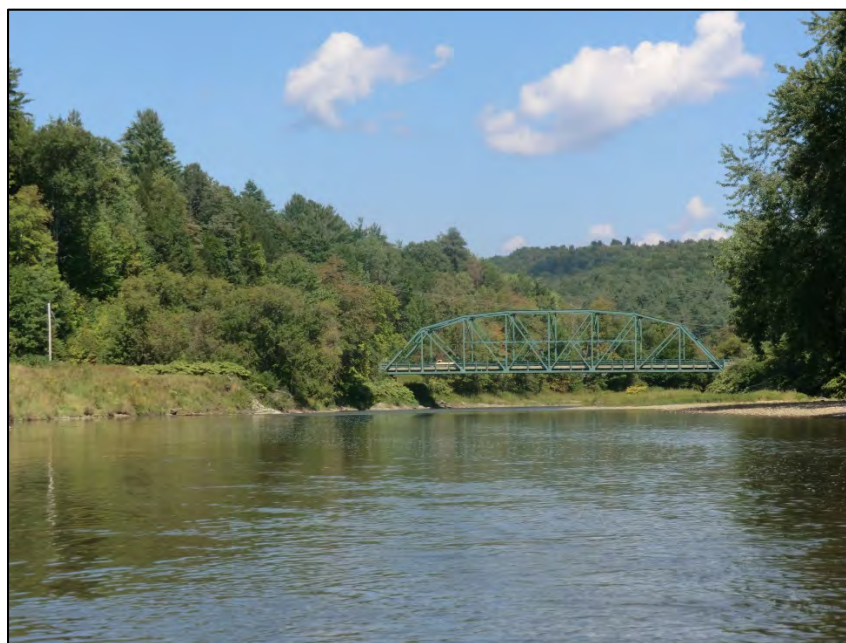
Reach 13 on the Winooski River begins just above the Little River and continues upstream for nearly four miles to above Waterbury Village near the Waterbury Ice Center. The reach was not divided into any segments during assessment. The Winooski River is extensively encroached upon by development in R13. Waterbury Village is located on the northeastern bank of the river, River Road in Duxbury is on the south western bank, and US Route 2 is on both banks. The river appears to have been historically straightened to accommodate this development for most of the length of R13. This straightening likely caused moderate channel incision, which has led to a loss of some floodplain access and a stream type departure. In response, the channel has widened and will likely continue to widen before building a juvenile floodplain. The banks of the river are frequently eroding in R13, but have been armored in areas of infrastructure. Several large flood chutes in this reach indicate that the river is moving laterally, however surrounding development limits that movement. Stormwater inputs are common in R13 due to its urbanized surroundings. The river is in **fair** geomorphic condition due to historic incision, active widening, and limitations to planform adjustment due to surrounding developed land. It is also in **fair** habitat condition as a result of poor bank and buffer vegetation, lacking woody debris, and altered channel morphology.

Figure 5.10. Development is prevalent along the Winooski River in R13 (Winooski Street Bridge pictured).

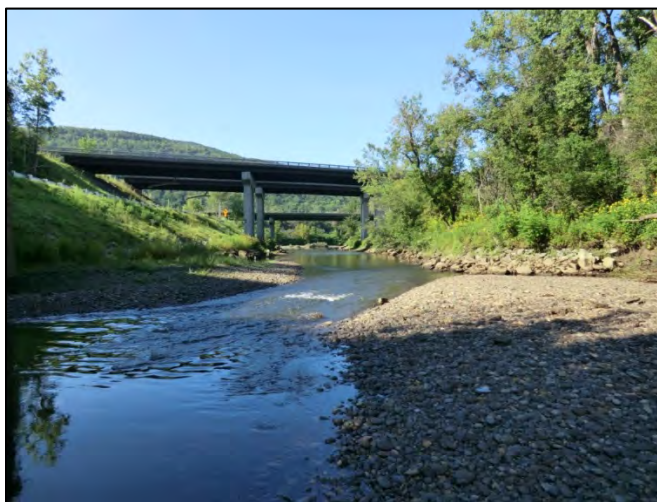
The most downstream reach on the Little River is 3,000 feet in length and was not segmented during assessment. Extreme channel incision has resulted in M2.01 from historic channel straightening and the upstream dam. This channel degradation has led to a stream type departure and loss of floodplain access. The natural valley in M2.01 has been altered from broad to narrow due to I-89 and Route 2 crossing the Little River just upstream of the confluence with the Winooski River. Incision has led to extreme widening and major aggradation and planform change. One mass failure is present in the reach and is contributing sediment to the channel. This reach's riffle-pool bedform is not well defined, and a featureless, plane bed system is subdominant. It is also lacking in large woody debris and has poor bed substrate cover. M2.01 is in **poor** geomorphic condition due to extreme historic incision and widening. The segment is also in **fair** habitat condition due to the lack of diverse bed features and flow alteration.

Figure 5.12. M2.01 impacted by valley width changes by placement of I 89 and Route 2 bridges.

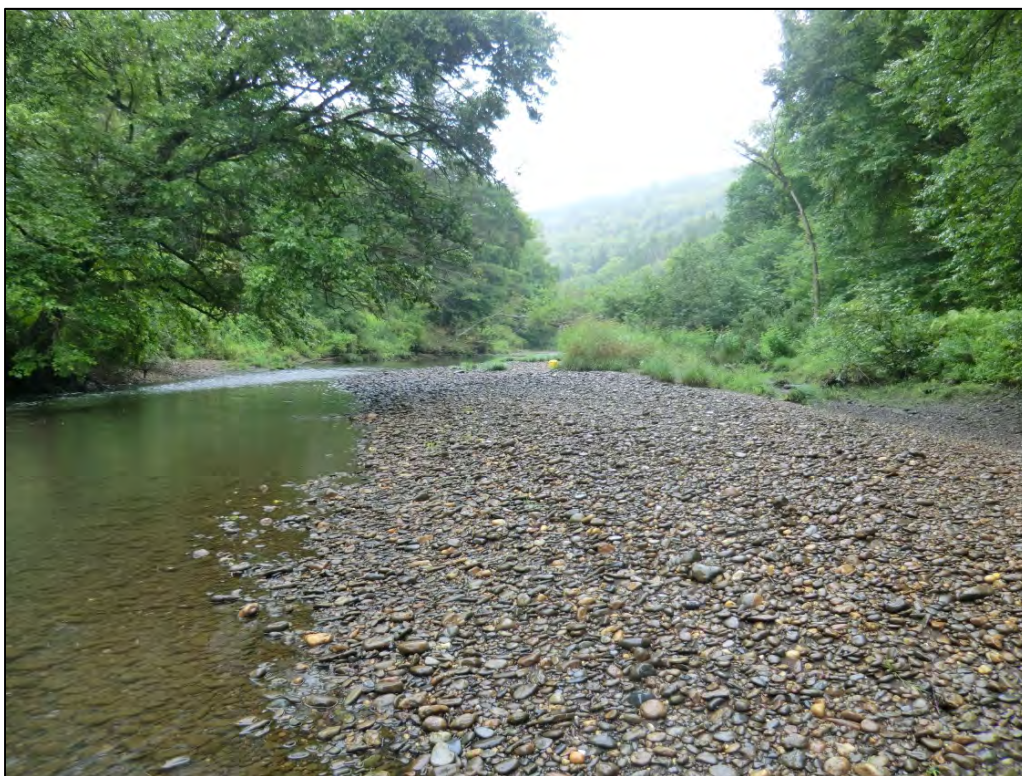
This reach was not segmented and begins just upstream of the start of the Little River State Park. It continues upstream for approximately 3,750 feet to just above a large meander where the valley narrows naturally. Extensive channel straightening and the presence of a major dam upstream have led to the geomorphic instability observed in this reach. The channel has incised, causing a stream type departure and loss of floodplain access. Major aggradation, widening and planform change have followed the incision process. Like M2.01, plane bed is the subdominant bedform in this reach due to a poorly-defined riffle-pool pattern. Bed cover has also been compromised with increased fining and algae growth. This reach is in **fair** geomorphic condition due to the aforementioned adjustments and processes. M2.02 is in **fair** habitat condition due to its channel morphology, lack of diverse bed features, abundant aggradation and flow alteration.

Figure 5.13. Cross section of M2.02 showing major aggradation and widening.

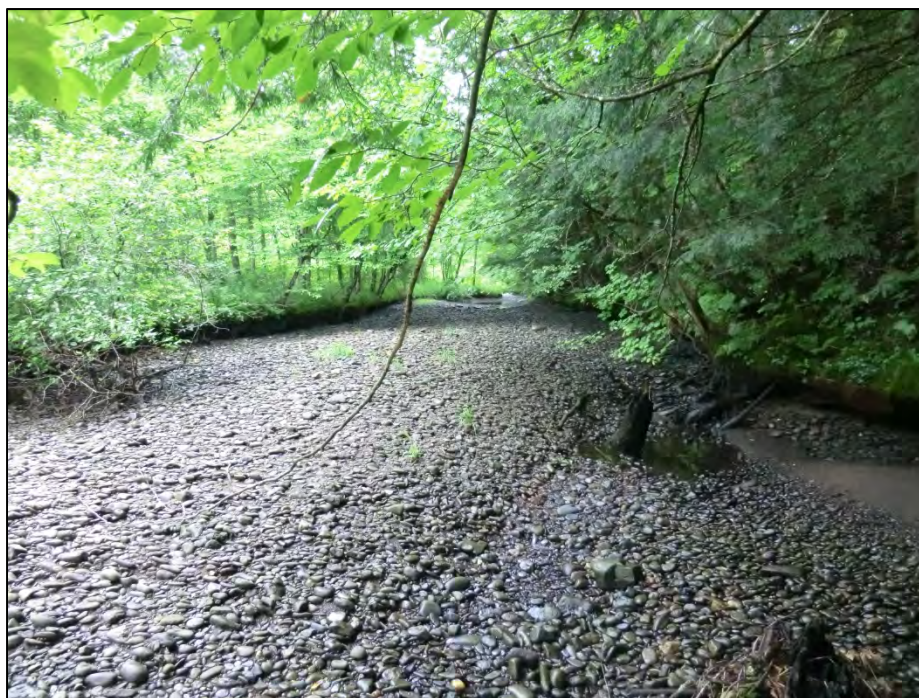
Segment M2.03-A begins where the valley becomes more confined and continues upstream for approximately 900 feet until the bedrock gorge. M2.02-A was similar to M2.02 with major channel incision. Flow alteration from the dam upstream at Waterbury Reservoir has most likely led to a series of events beginning with the channel incision due to the dam “starving” the channel of sediment by holding it back. The stream flow is regulated from this dam with scheduled releases daily to every other day. The decrease in sediment in the channel from the dam has historically caused the channel to cut into the bed followed by minor channel widening and major planform change as seen through islands and large flood chutes. M3.02-A is in **fair** geomorphic condition as a result of the flow alteration and processes that have followed. The segment is in **fair** habitat condition due to the presence of algae on the substrate, a lack of large woody debris, and channel morphology.

Figure 5.14. Large flood chute in cross section of M2.03-A.

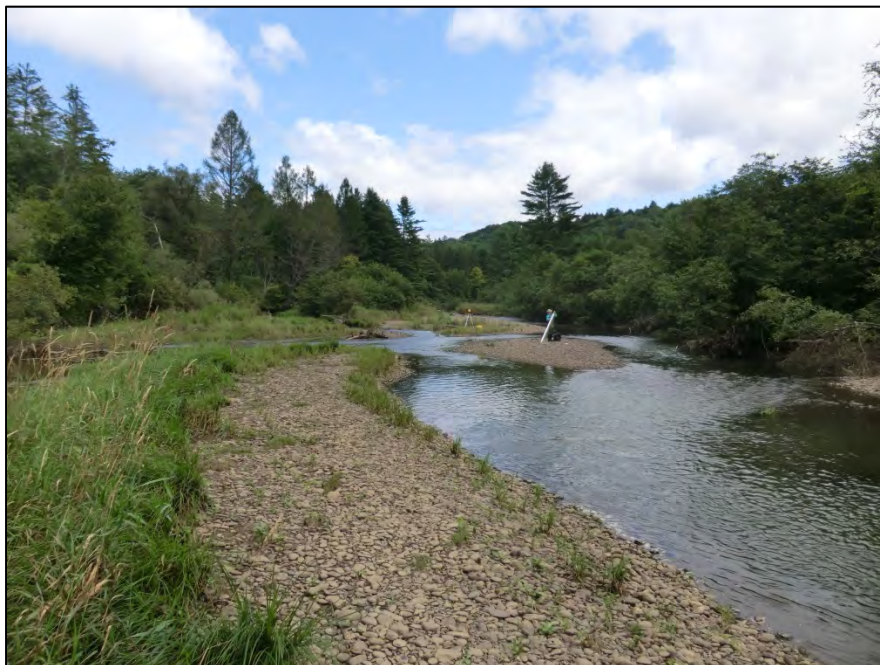
This segment begins just above the bedrock gorge where there is an old concrete dam and continues upstream for approximately 900 feet. The channel flows through a broad valley and there has been a stream habitat type departure from riffle-pool to braided due to extreme channel aggradation and planform change. Flow alteration from the Waterbury Dam has resulted in major historic incision and subsequent severe widening. The incision caused a stream type departure. Major planform adjustment is also occurring in this segment as water flows around depositional features and islands. The old dam and constriction at the bedrock gorge downstream in M2.03-B have likely exacerbated aggradation in M2.04-A. Due to extreme geomorphic processes occurring in M2.04-A, it is in **poor** geomorphic condition. The flow alteration, channel morphology, and lack of large woody debris have resulted in **fair** habitat condition.

Figure 5.16. Extreme aggradation and braided condition in M2.04-A.

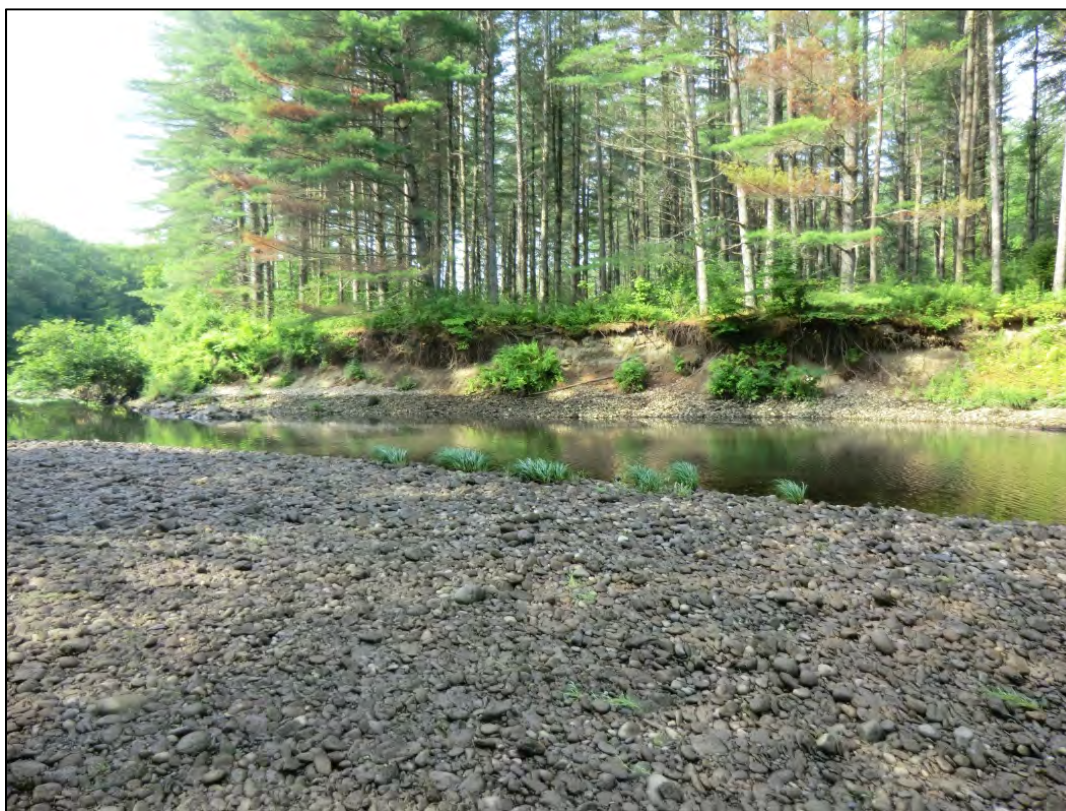
The upstream-most segment assessed on the Little River begins about 275 feet downstream of the Vermont Association of Snowmobile Trails (VAST) bridge crossing and continues to approximately 900 feet below the Waterbury Reservoir Dam. As in the downstream segment, M2.04-B has adjusted vertically and horizontally. The channel degradation is a result of the Waterbury Dam holding back sediment, although in this segment the incision is more severe than downstream (incision ratio = 4.2). The channel is also extremely wide and has abundant bank erosion, resulting in minor planform adjustment and aggradation. Frequent releases from the dam (daily or every other day) have formed the channel and are likely responsible for the over-widening. M2.04-B is in **fair** geomorphic condition due to the extreme incision and widening. Habitat condition is **fair** due to changes in channel morphology, flow alteration, unstable river banks, and lack of large woody debris.

Figure 5.17. Bank erosion along western bank in M2.04-B.

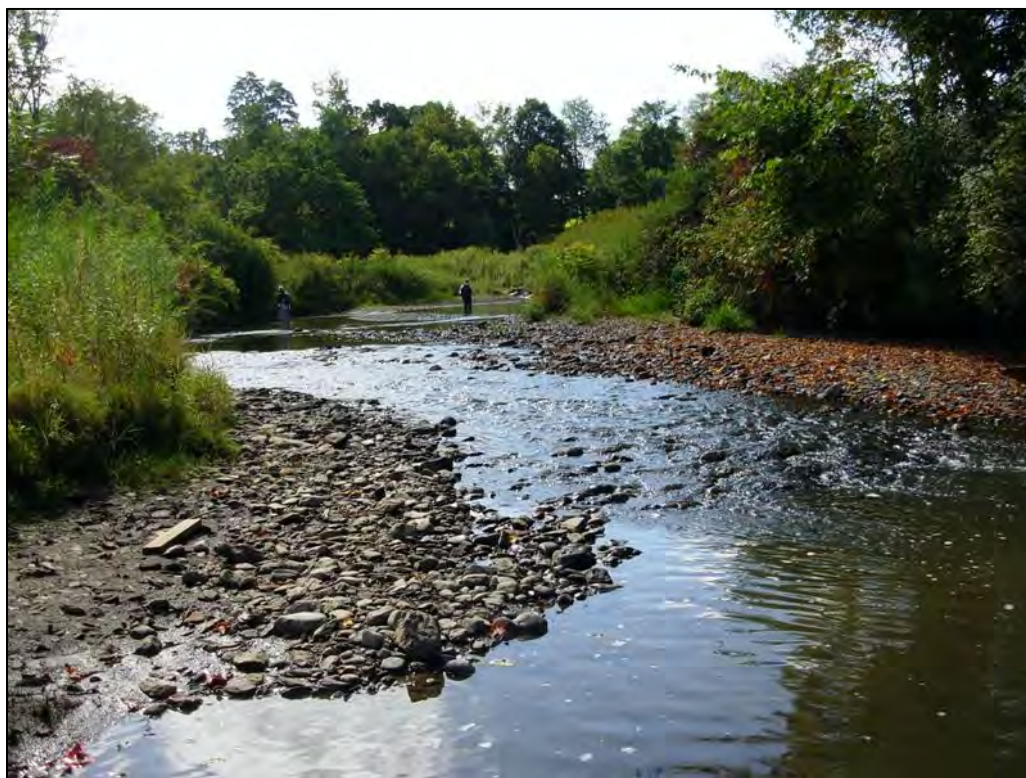
The second segment on Graves Brook assessed in 2010 begins between the Armory Drive and I-89 bridges and continues upstream for 2,700 feet to just above the bridge on the I-89 Waterbury exit. It appears that all of R13.S1.01-B was historically straightened due to the placement of roads and development. The brook has undergone moderate incision here and is aggradational. Some areas are widening and changing planform via flood chutes. Bank revetments are abundant in R13.S.01-B, preventing widening in several locations. The brook flows under the interstate through three bridges in this segment. Despite some incision, floodplain access remains intact. Due to historic channel management around development and the brook's geomorphic responses, R13.S1.01-B is in **fair** geomorphic condition. It is also in **fair** habitat condition because woody debris is lacking and bank and buffer vegetation are frequently impacted.

Figure 5.19. R13.S1.01-B is more aggradational and wider than surrounding segments.

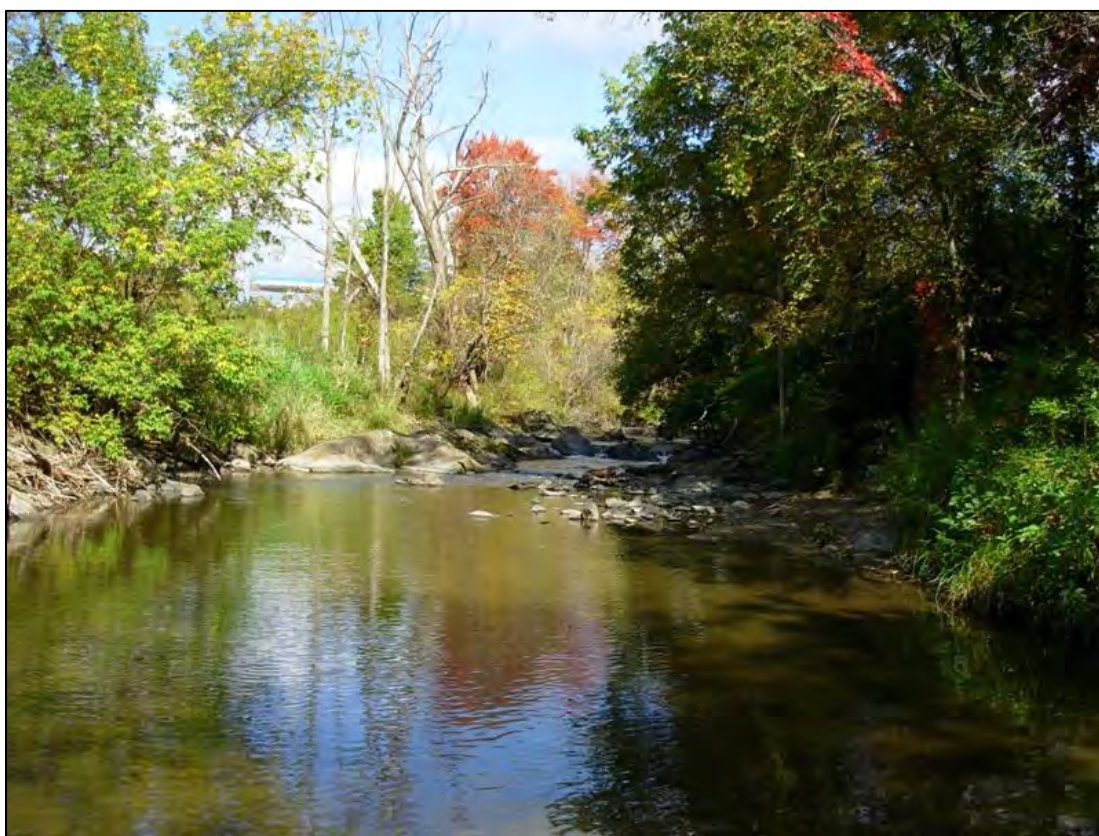
The second segment on reach two of Graves Brook flows through a confined valley for 1,200 feet from the Stowe Street Bridge to just upstream of where Thatcher Brook flows into Graves Brook. Much of this segment was historically straightened due to surrounding development. The floodplain was filled in to construct roads, which has obscured the degree of channel downcutting in this segment. R13.S1.02-B is afforded some vertical stability due to the presence of abundant bedrock just downstream and one bedrock grade control within the segment. Riprap is common along both banks, which may be preventing widening in areas. R13.S1.02-B is in **fair** geomorphic condition as a result of historic channel alteration. It is also in **fair** habitat condition because woody debris is lacking, floodplain connectivity has been altered, and banks and buffers are not consistently vegetated.

Figure 5.21. Graves Brook is entrenched in R13.S1.02-B due to historic floodplain filling.

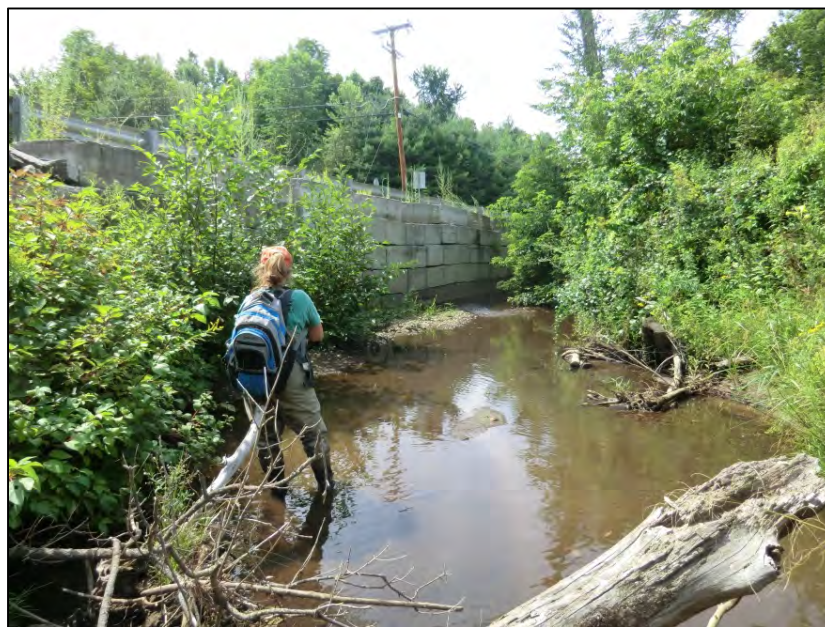
The most downstream segment assessed on Graves Brook is approximately 900 feet in length, beginning at the confluence with Thatcher Brook and continuing upstream where Perry Hill Road exits the river corridor. This section of the reach has been extensively straightened and armored for development. The channel alteration has resulted in degradation and a stream type departure due to the channel becoming deeper but not wider. Abundant bank armoring is preventing widening throughout R13.S1.03-A; however, where armoring is lacking the banks are eroding. The downstream portion of the segment is more incised and entrenched than the upstream end. The stream bed substrate feels soft underfoot from fine sediments, and the channel has lost its riffle-pool bedform, which is now dominated by plane bed. Major channel incision and increased fine sediment coupled with extensive channel alteration have caused R13-S1.03-A to be in **fair** geomorphic condition. Due to unstable river banks, a featureless bed, poor riparian buffers, and channel alterations, habitat conditions in this segment are **fair**.

Figure 5.22. Concrete block wall against Lincoln Street armoring the stream bank along Graves Brook.

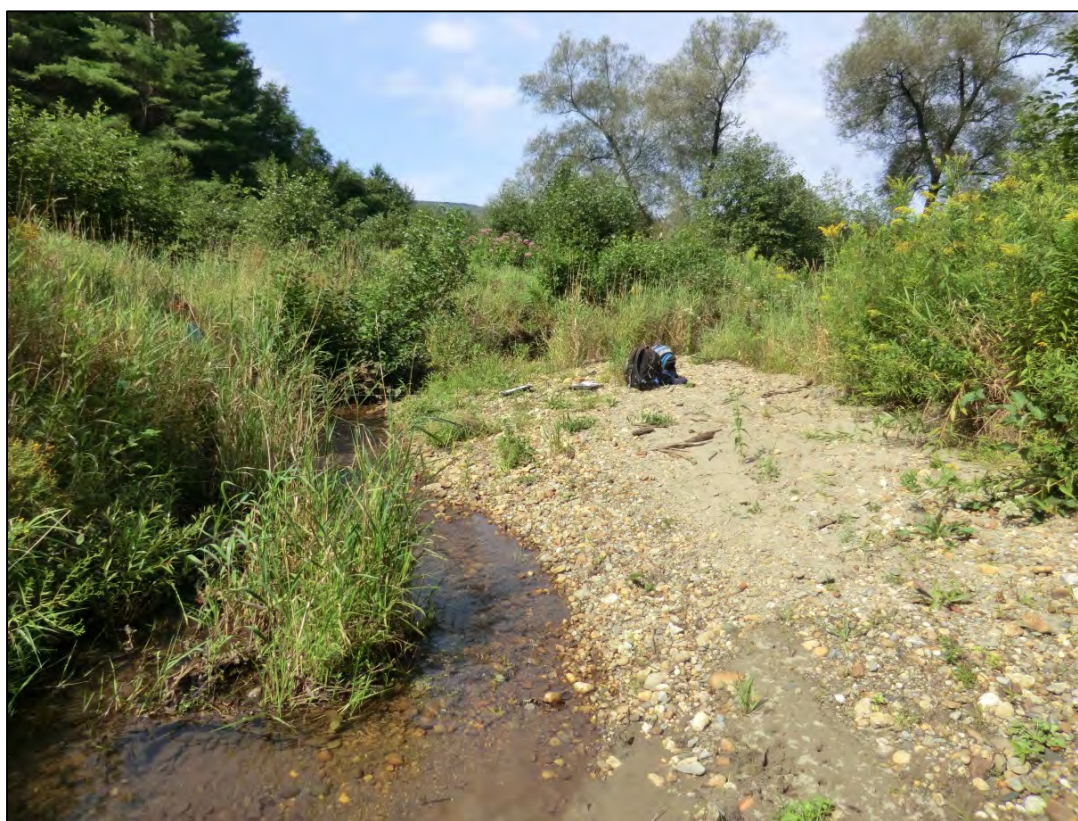
Figure 5.23. Abundant aggradation and juvenile floodplain being built on large bar in R13.S1.03-B

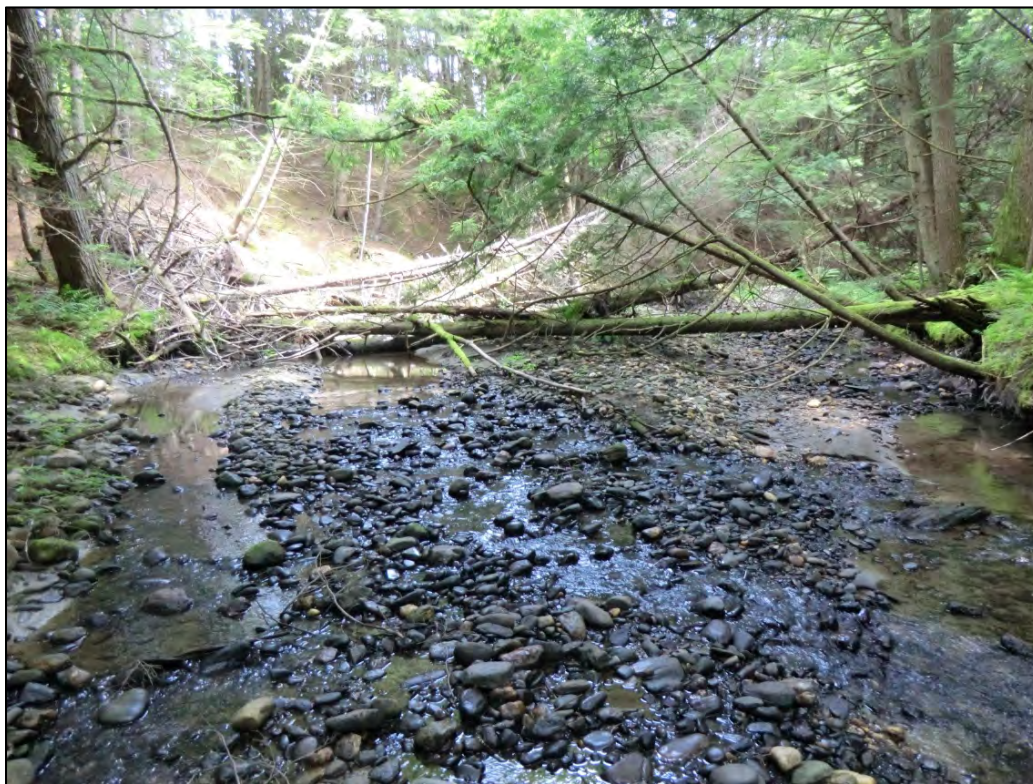
Figure 5.24. Planform change in R13.S1.03-C as channel navigates through debris and aggradation.

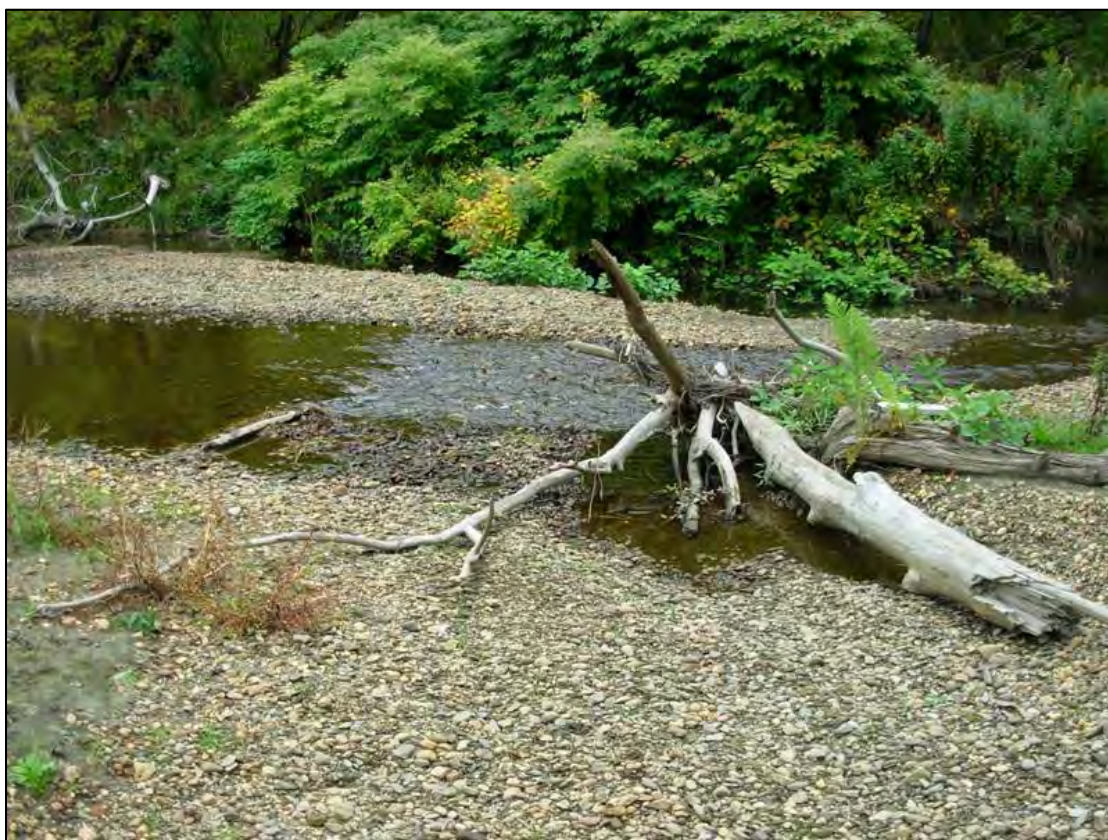
Figure 5.28. Depositional features are abundant in segment D of reach one of Thatcher Brook.

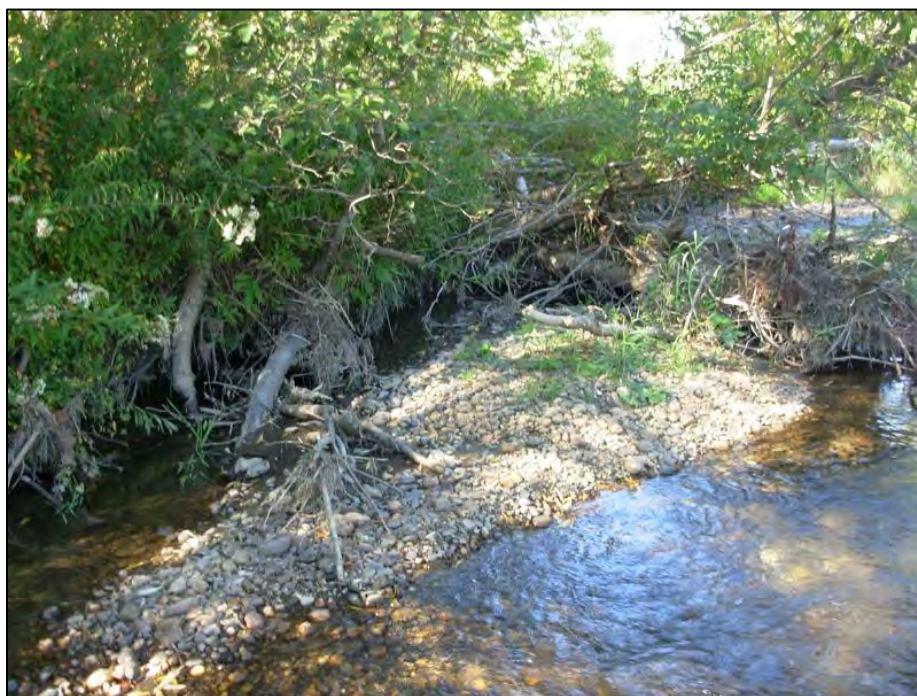
Figure 5.30. Aggradation and debris jams are driving adjustments in R13.S1.02-S1.03.

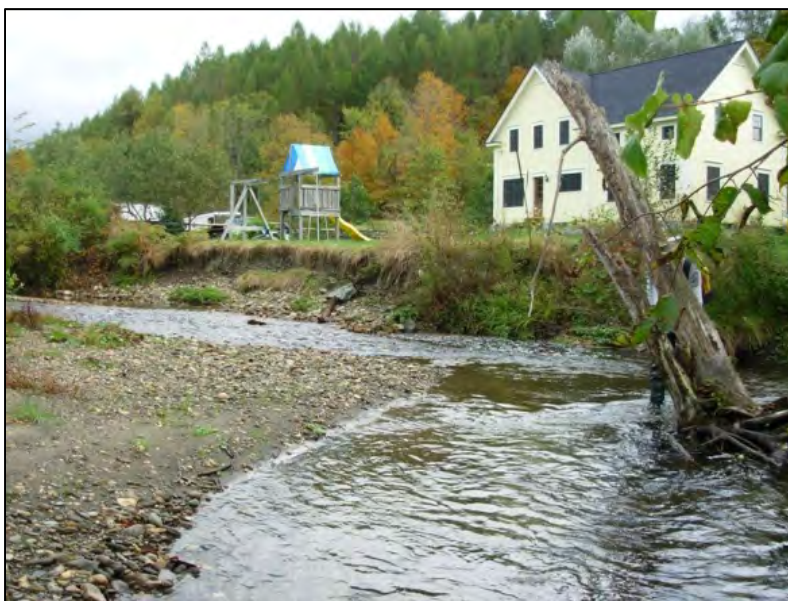
Figure 5.31. River corridor encroachment and lack of riparian buffer in R13.S1.02-S1.04-A.

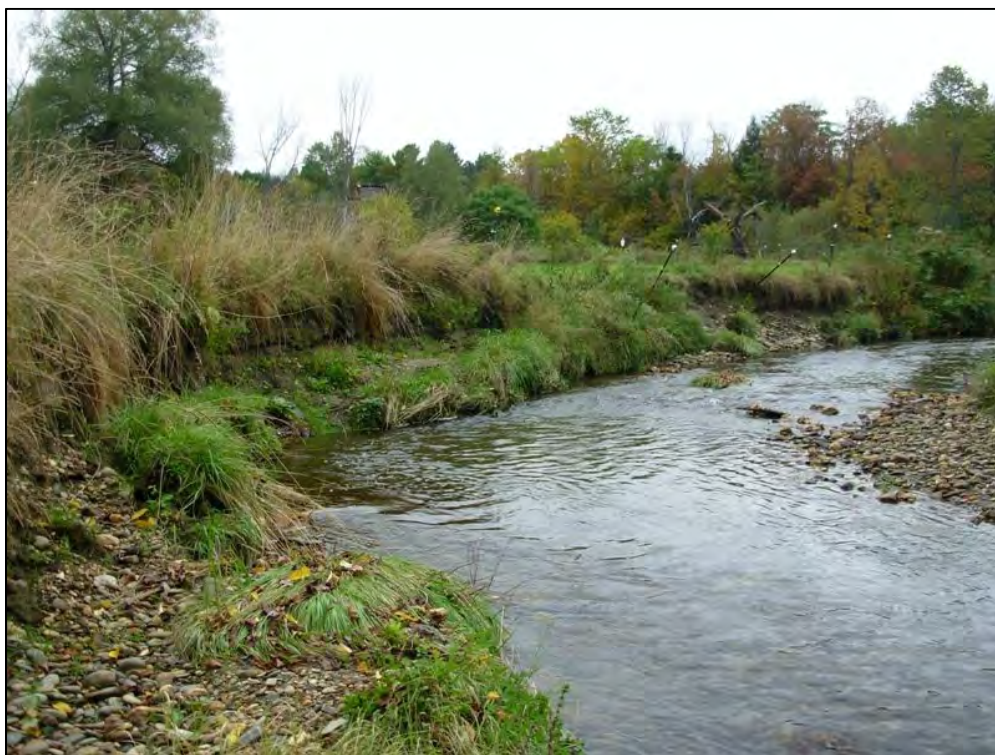
Figure 5.32. Bank erosion and lack of riparian buffer along pasture in R13.S1.02-S1.04-B.

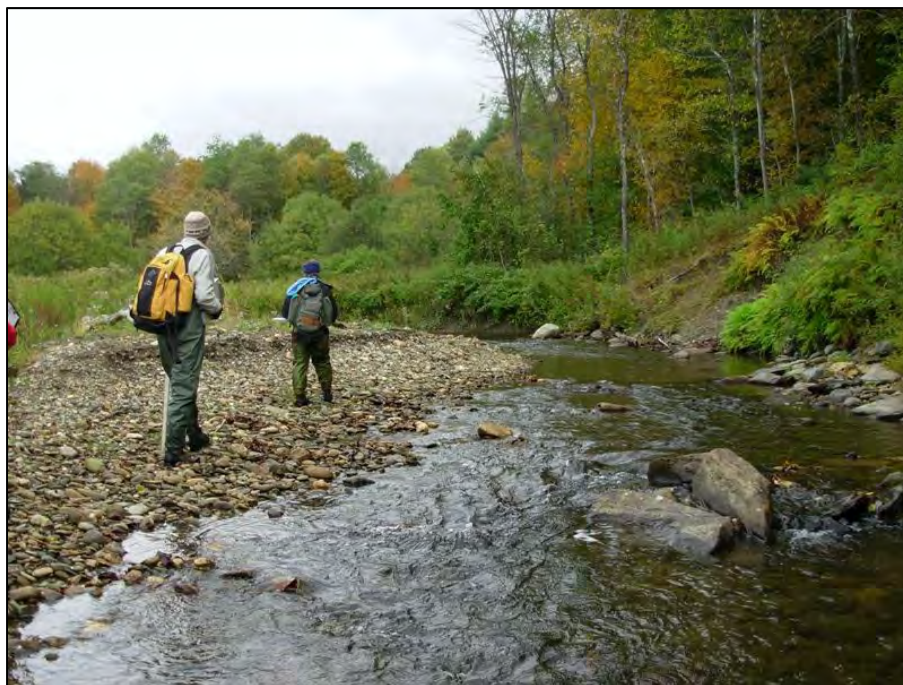
Figure 5.33. Large bar in R13.S1.02-S1.05-C causing major channel widening.

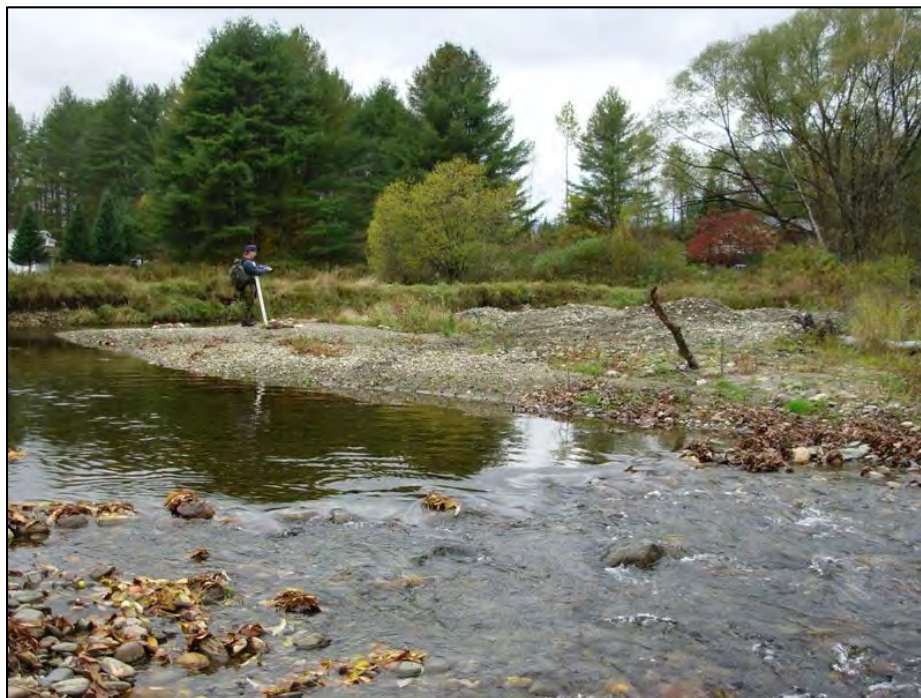
Figure 5.34. Large bar in R13.S1.02-S1.05-A where gravel mining appears to have occurred.

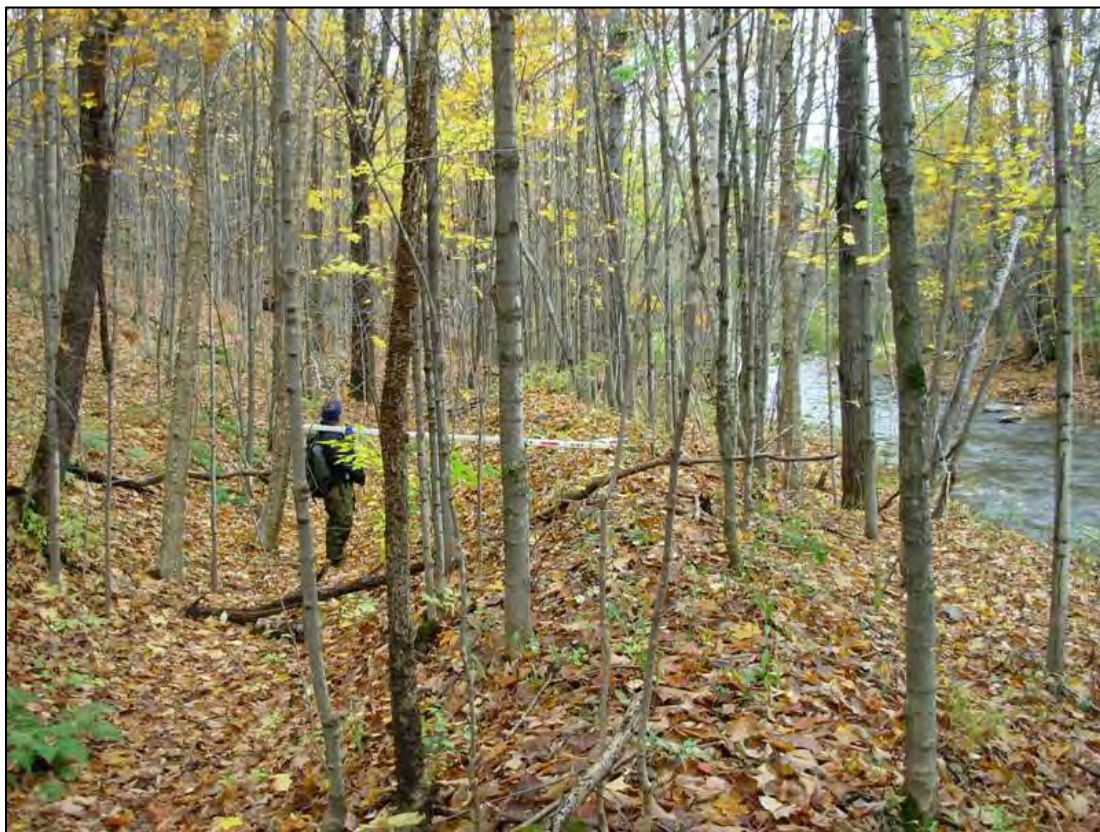
Figure 5.35. Historic berm preventing floodplain access in R13.S1.02-S1.05-B.

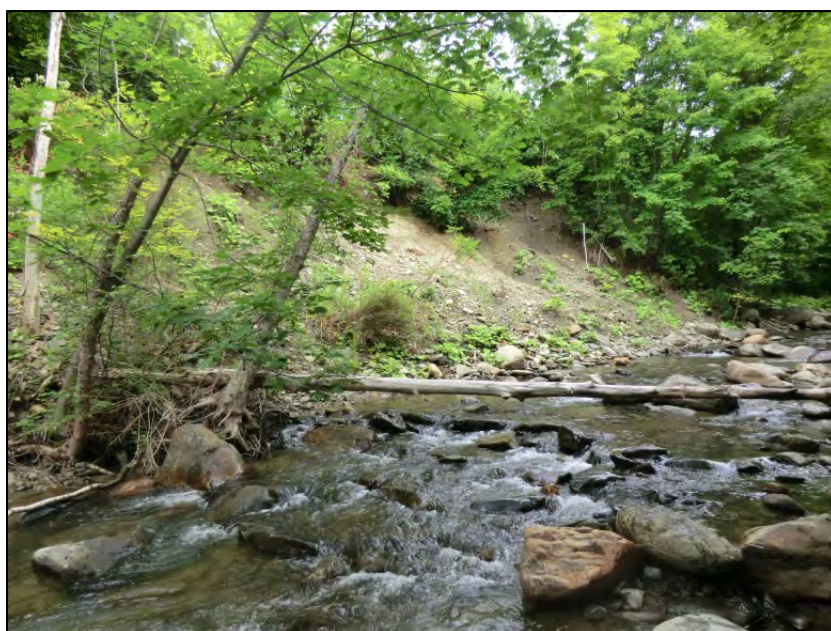
Figure 5.36. One of three mass failures in R13.S1.02-S1.06-A contributing sediment to the channel.

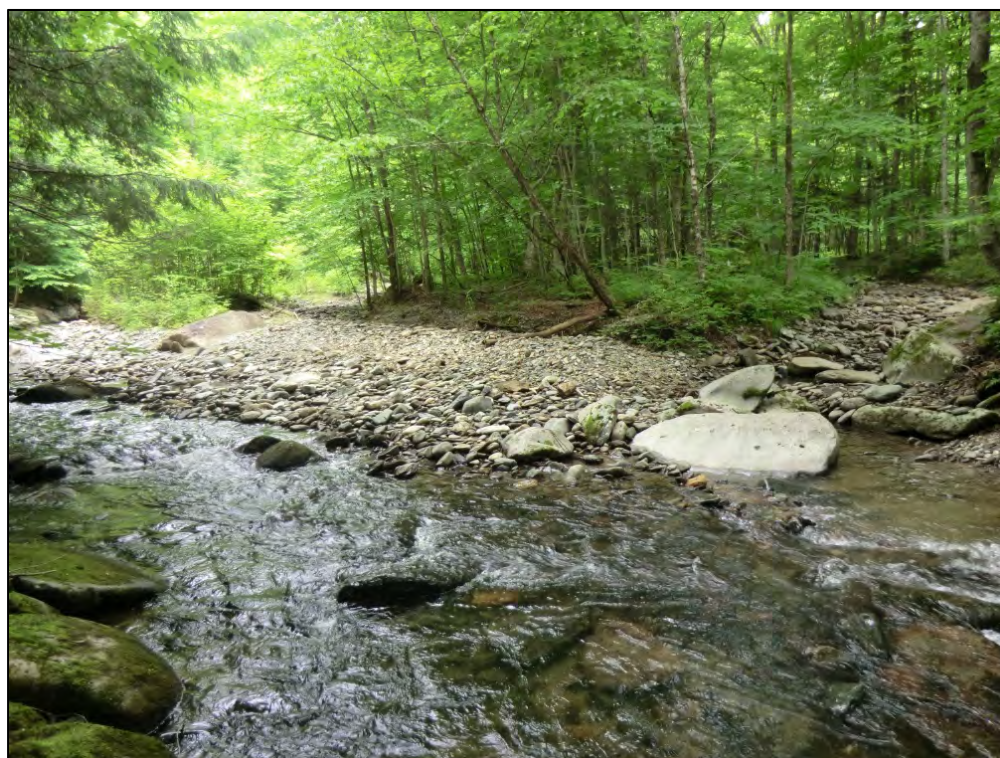
Figure 5.38. Large point bar where material from TSI may have been deposited.

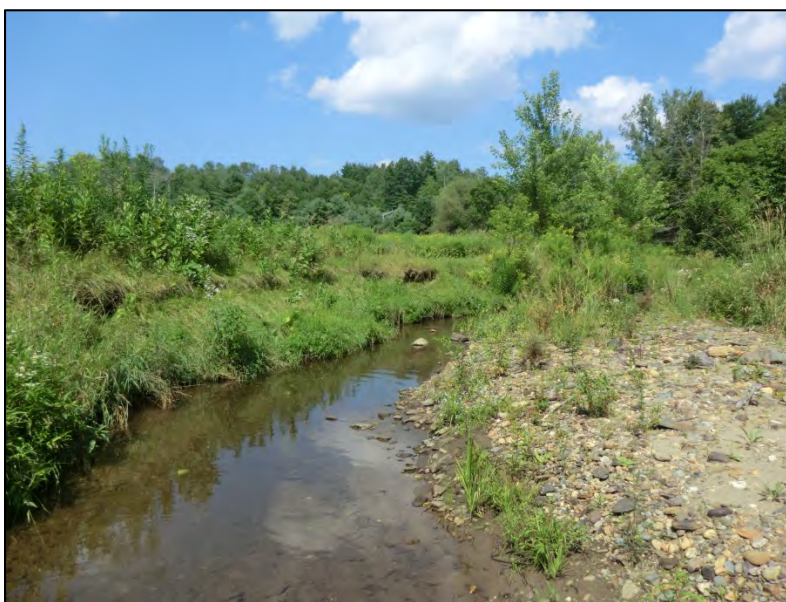
Figure 5.45. R13.S1.02-S1.02-S1.01-A is an alluvial fan with abundant aggradation.

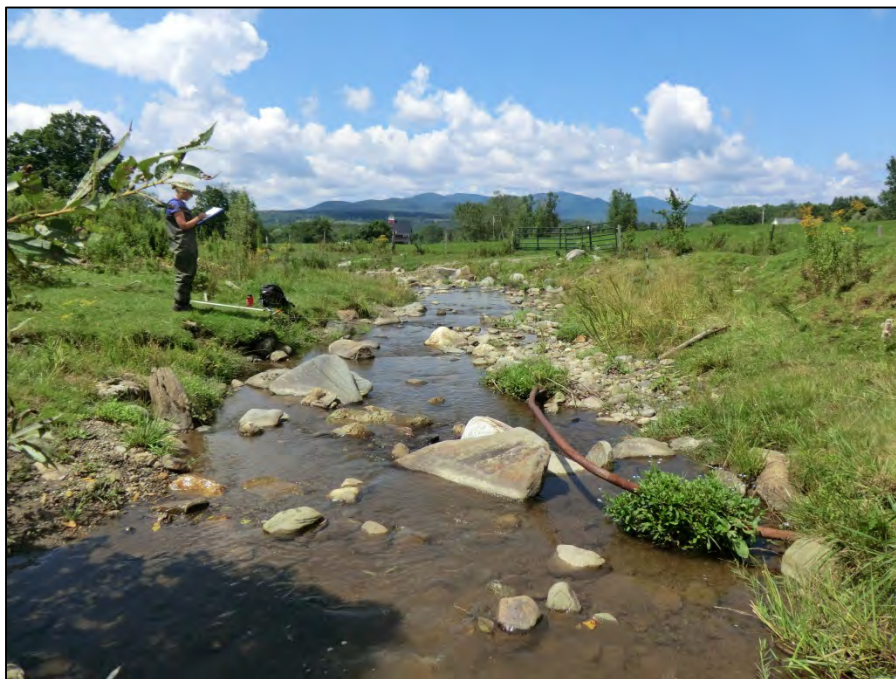
Figure 5.49. R13.S1.02-S1.02-S1.01-E flows through pastured lands and is impacted by grazing animals.

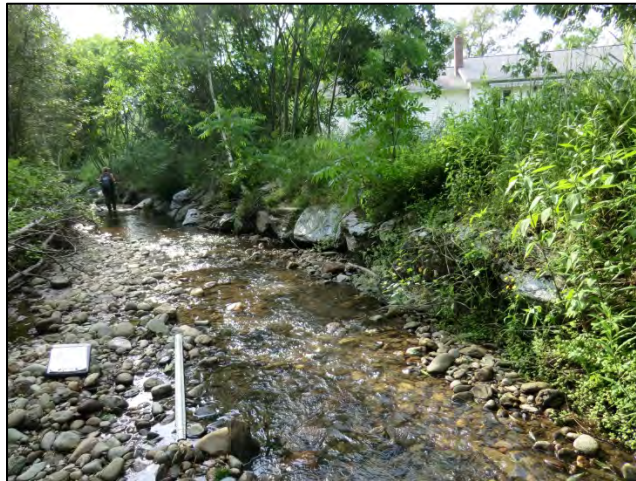
Figure 5.52. Riprap and development are common in R13.S1.02-S1.03-S1.01-A.

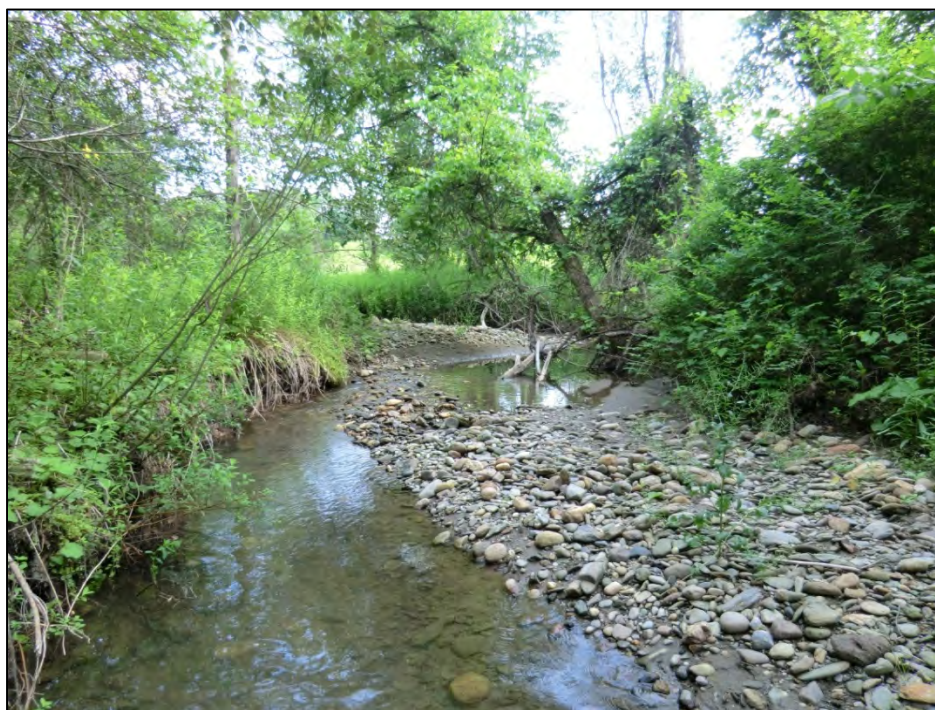
Figure 5.53. Aggradation is driving planform adjustment in R13.S1.02-S1.03-S1.01-B.
