Waterbury, Vermont Middle Winooski River Corridor Plan

December 15, 2015

Middle Winooski River Corridor Plan

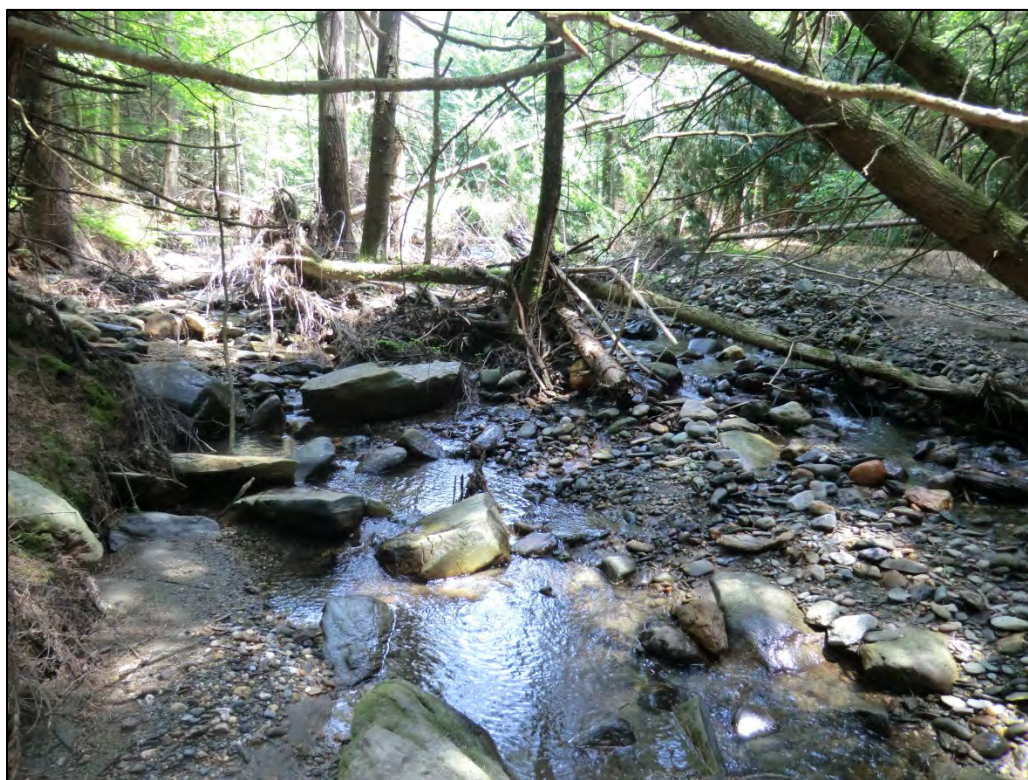
Figure 5.54. Deposition and woody debris are common in the stream channel of R13.S1.02-S1.03-S1.01-C.

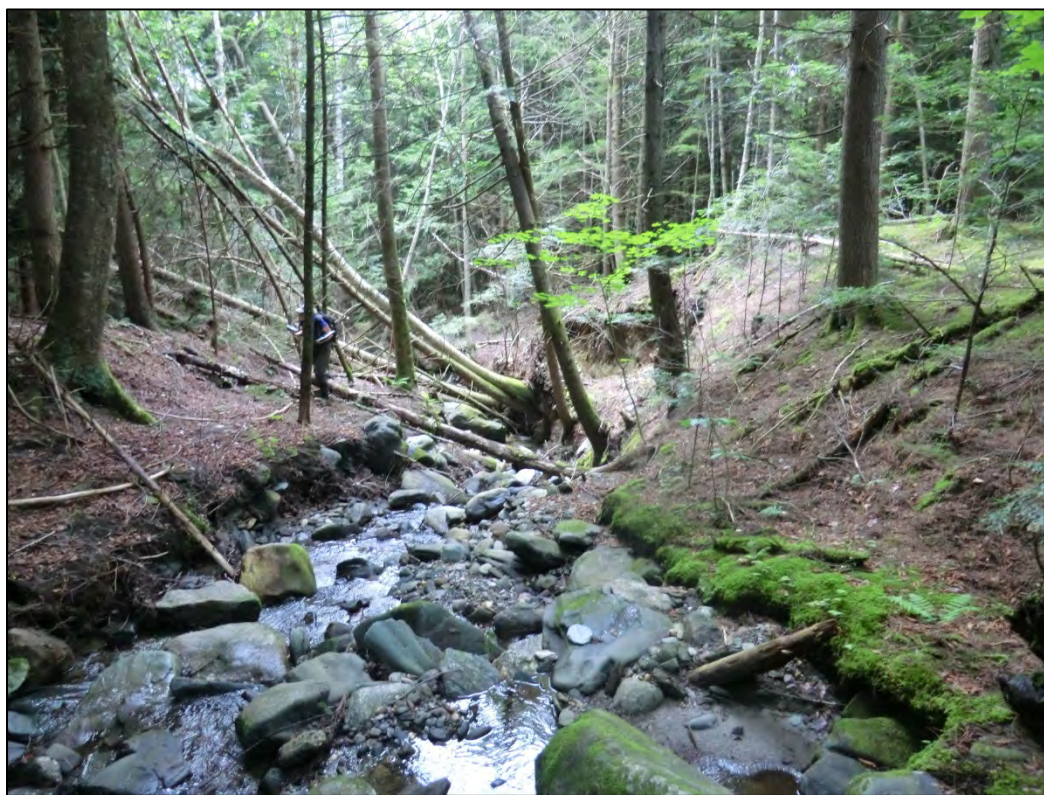
Figure 5.57. R13.S1.02-S1.03-S1.02-C is actively incising via headcuts.
