**Final Design Report:**  
**Long Meadow Brook Strategic Wood Additions**

Stream/Floodplain Restoration Project: for submission by Friends of the Winooski River to the Central Vermont Regional Planning Commission and Vermont Department of Environmental Conservation.

In-field scoping work completed 8/6/2024/2024 and report/project design completed 10/25/2024, by Redstart, Inc.

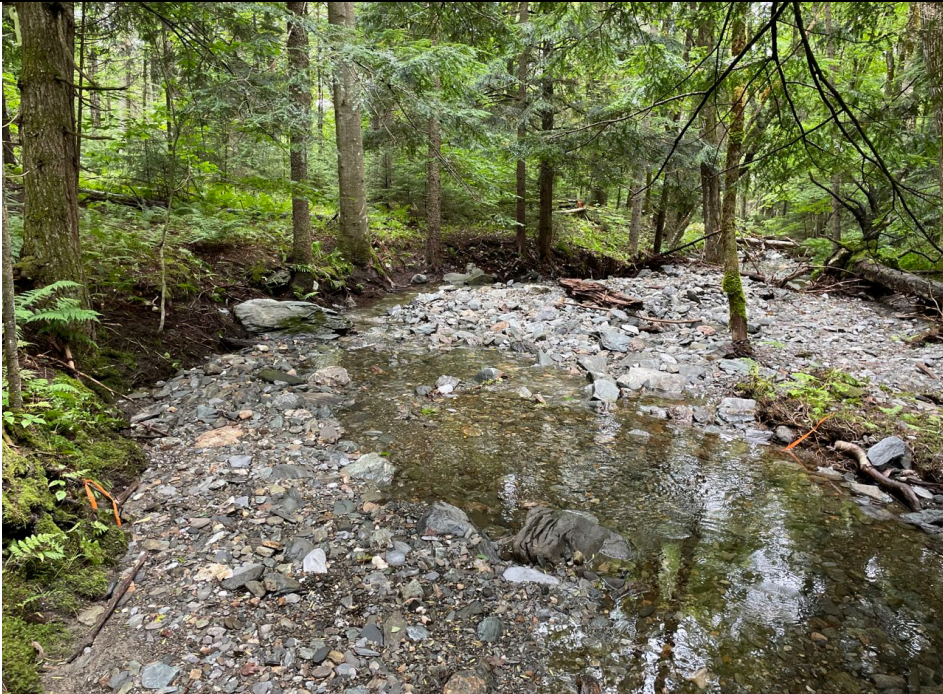
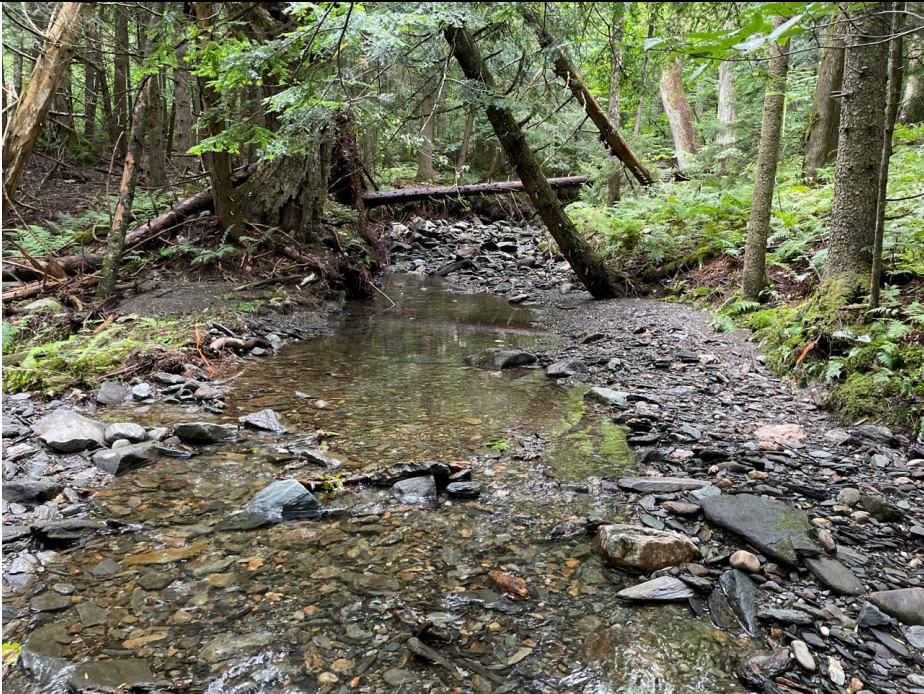
Stream Name: LMB Segment 1	FID(see map): 1	Coordinates: 44.332887, -72.544741	
Bank full width (ft): 13	Brook trout presence: Unknown	Avg.#CWM per 100 ft: 0	
Slope (looking upstream): 4%	Dominant substrate: Cobble	Riparian forest type: Mixed Woods	Avg. DBH of riparian trees: 10-12"
Corridor type: lowgradefloodplain	Bank full height (ft): 0.5	Low floodplain Elevation (ft): 0.5	Incision Ratio: 1
Feasible floodplain reconnection: YRB	Predicted height of structure (ft): 1.5	Checkpoint log: no	
Surveyor: JK(8/6/2024)	Notes: Stream enters property. Lots of cobble deposition. Work should not disturb scour pool 50 ft ahead

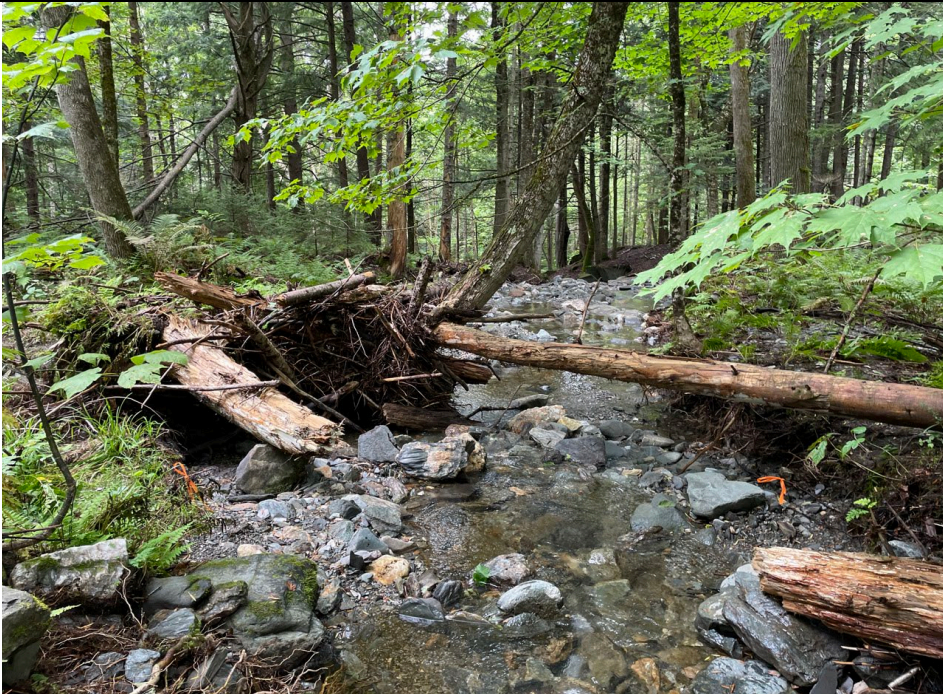
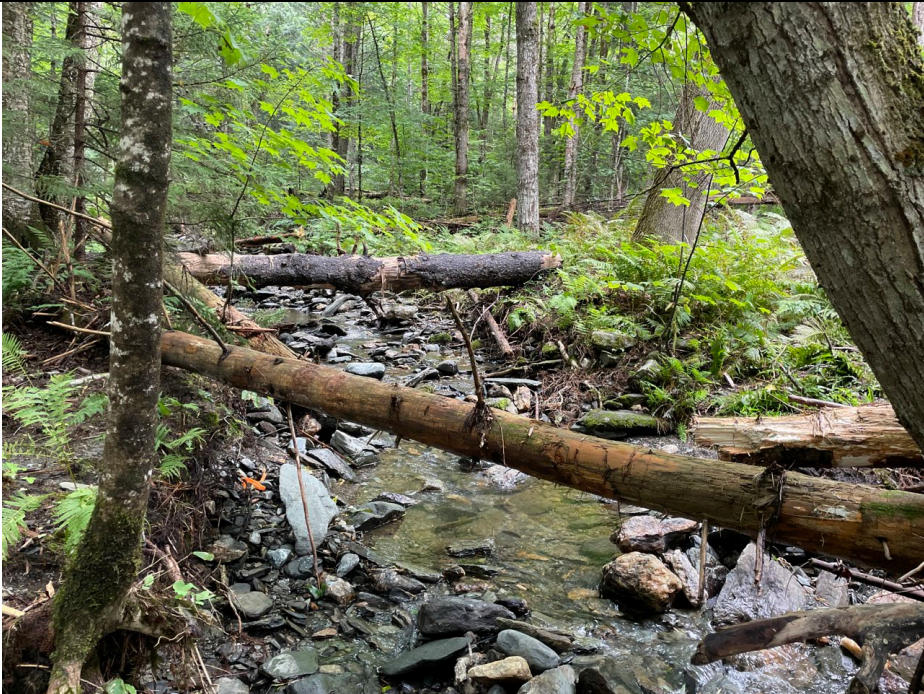
Stream Name: LMB Segment 1	FID(see map): 2	Coordinates: 44.33291, -72.545274	
Bank full width (ft): 9.5	Brook trout presence: Unknown	Avg.#CWM per 100 ft: 1	
Slope (looking upstream): 6%	Dominant substrate: Cobble	Riparian forest type: Mixed Woods	Avg. DBH of riparian trees: 12-18"
Corridor type: lowgradefloodplain	Bank full height (ft): 0.8	Low floodplain Elevation (ft): 1.5	Incision Ratio: 1.875
Feasible floodplain reconnection: YRB	Predicted height of structure (ft): 2	Checkpoint log: yes	
Surveyor: JK(8/6/2024)	Notes: Potential for re engagement with a large structure

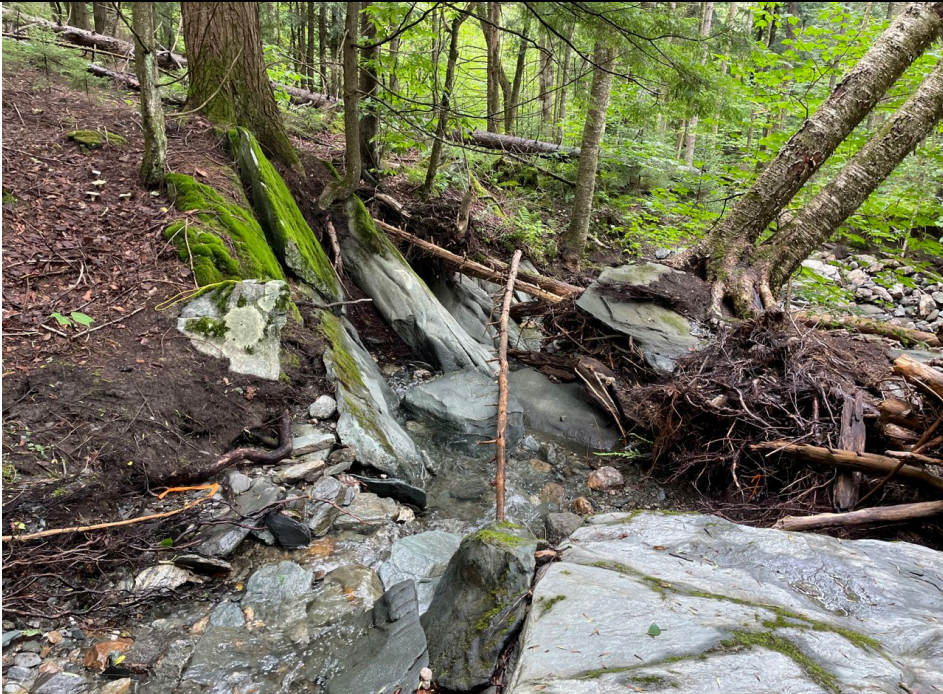
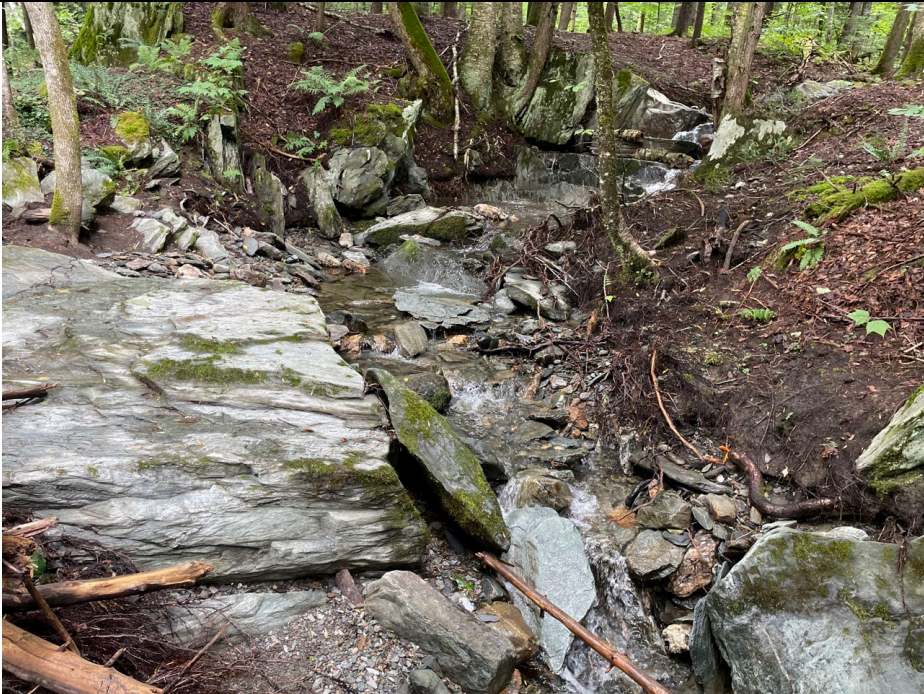
Stream Name: LMB Segment 1	FID(see map): 3	Coordinates: 44.332971, -72.545613	
Bank full width (ft): 9	Brook trout presence: Unknown	Avg.#CWM per 100 ft: 1	
Slope (looking upstream): 12%	Dominant substrate: Bedrock	Riparian forest type: Mixed Woods	Avg. DBH of riparian trees: 10-12"
Corridor type: rock outcrops	Bank full height (ft): 1.5	Low floodplain Elevation (ft): na	Incision Ratio: na
Feasible floodplain reconnection: N	Predicted height of structure (ft): 2.5	Checkpoint log: no	
Surveyor: JK(8/6/2024)	Notes: Good spot to secure wood for long term sediment capture

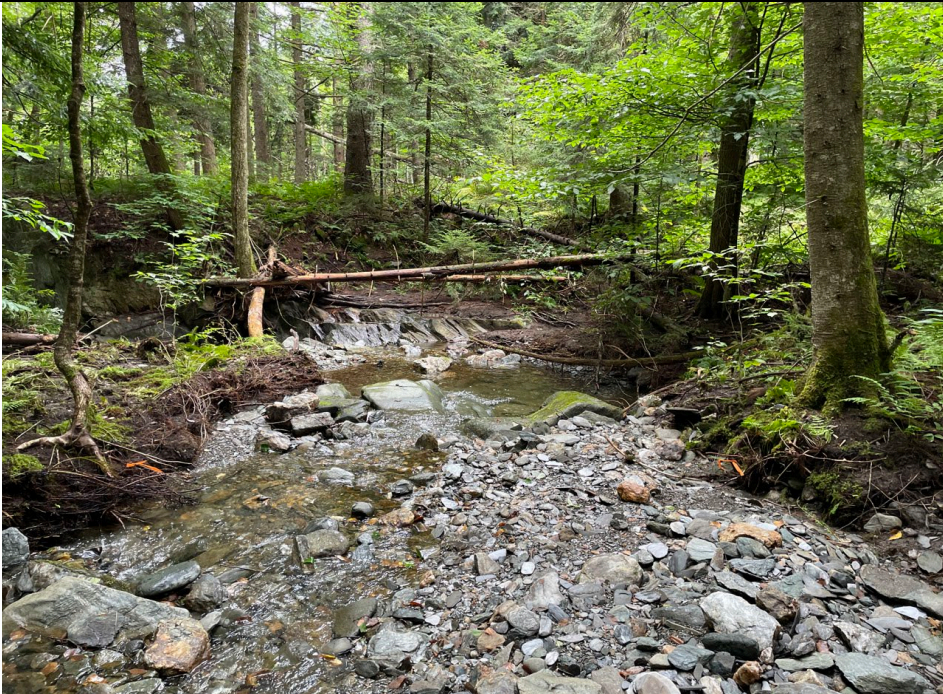
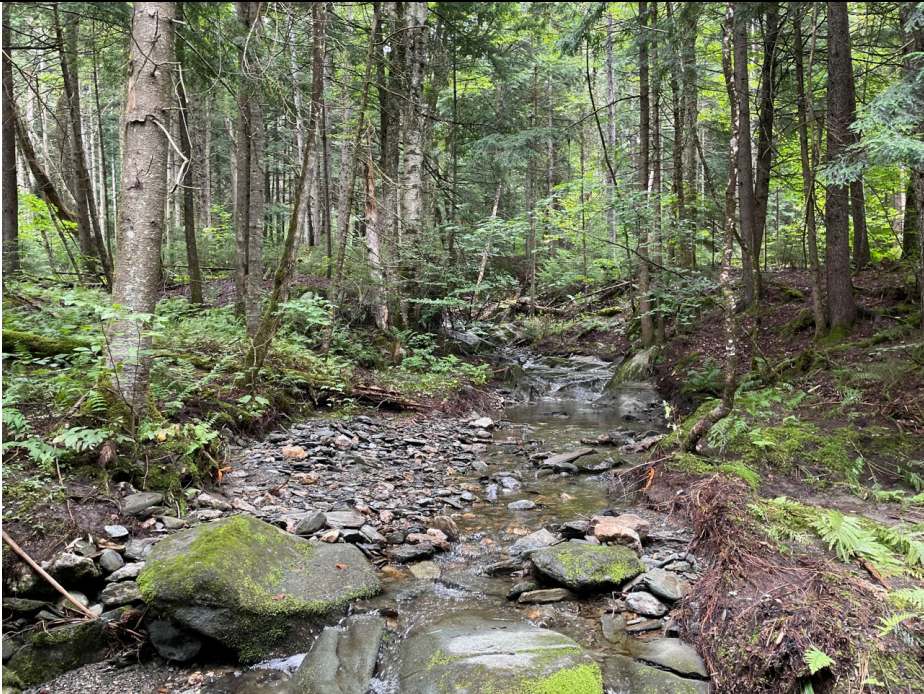
Stream Name: LMB Segment 1	FID(see map): 4	Coordinates: 44.33282, -72.54605	
Bank full width (ft): 11.5	Brook trout presence: Unknown	Avg.#CWM per 100 ft: 1	
Slope (looking upstream): 9%	Dominant substrate: Cobble	Riparian forest type: Mixed Woods	Avg. DBH of riparian trees: 12-18"
Corridor type: highgradefloodplain	Bank full height (ft): 1	Low floodplain Elevation (ft): 1.3	Incision Ratio: 1.3
Feasible floodplain reconnection: YLB	Predicted height of structure (ft): 1.5	Checkpoint log: yes	
Surveyor: JK(8/6/2024)	Notes: Riffle with good adjacent trees and small but feasible floodplain

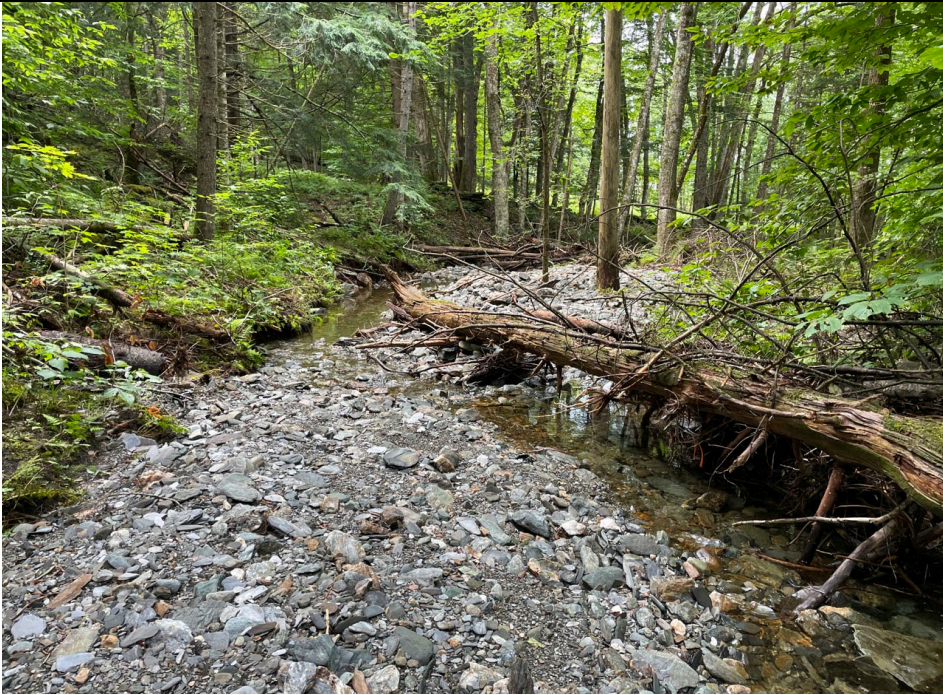
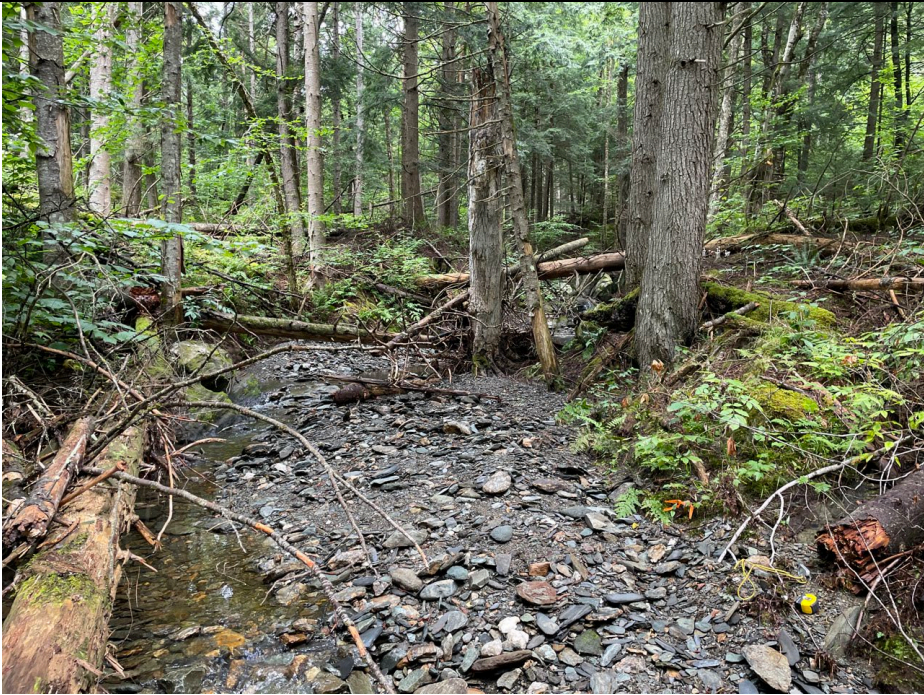
Stream Name: LMB Segment 1	FID(see map): 5	Coordinates: 44.332395, -72.546269	
Bank full width (ft): 12	Brook trout presence: Unknown	Avg.#CWM per 100 ft: 3	
Slope (looking upstream): 5%	Dominant substrate: Cobble	Riparian forest type: Mixed Woods	Avg. DBH of riparian trees: 12-18"
Corridor type: lowgradefloodplain	Bank full height (ft): 1.3	Low floodplain Elevation (ft): 1.6	Incision Ratio: 1.23
Feasible floodplain reconnection: YRB	Predicted height of structure (ft): 2	Checkpoint log: no	
Surveyor: JK(8/6/2024)	Notes: Stream approaches large floodplain; potential reach break here. Floodplain has been frequently engaged in 2 seasons from extreme rain events particularly from a large wood jam 100 ft downstream. Wood here will reconnect floodplain at more frequent floods (5 yr flood).

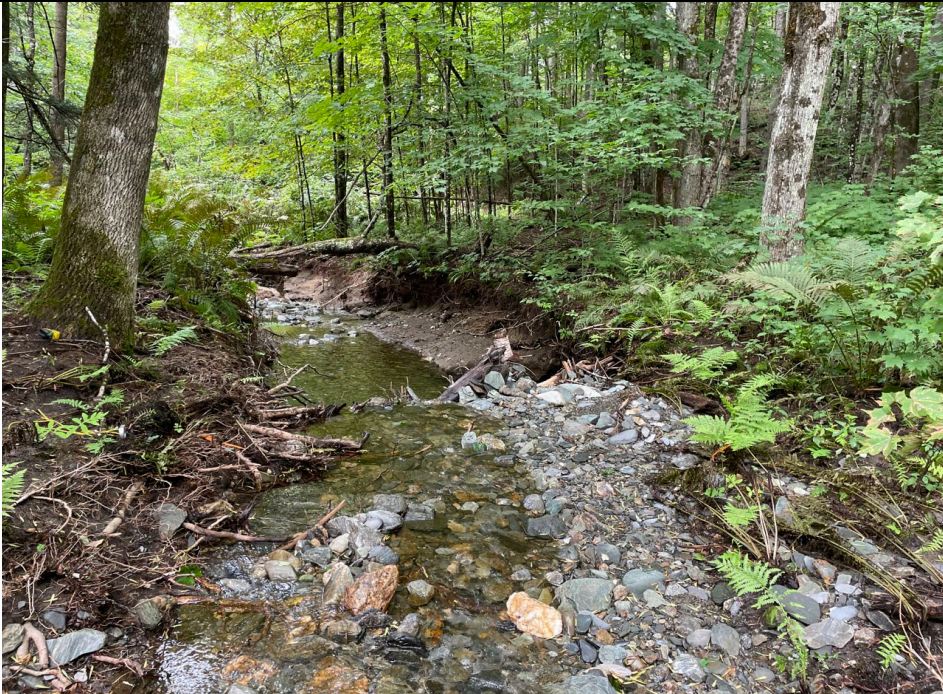
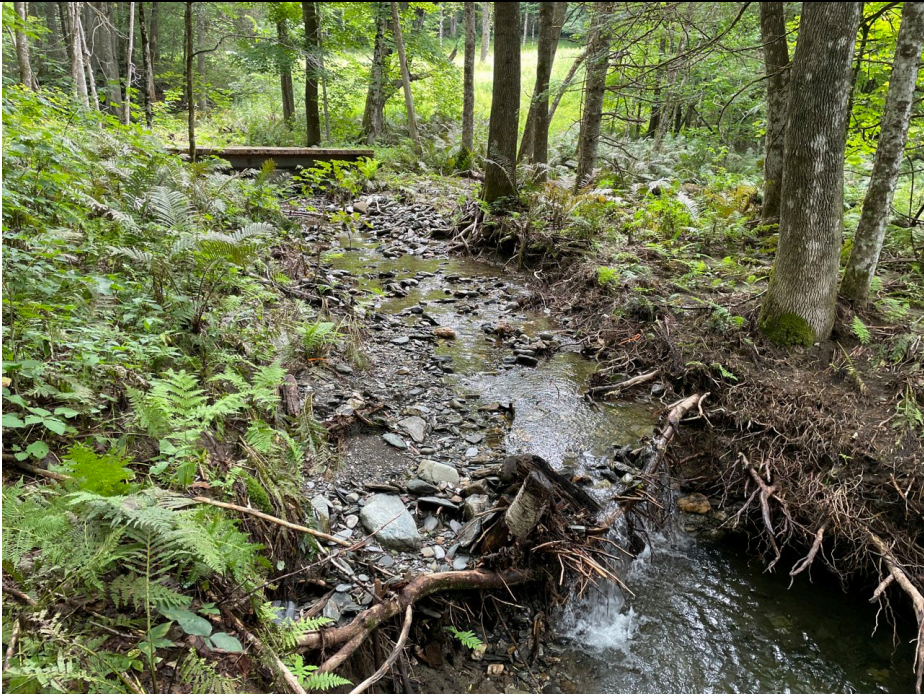
Stream Name: LMB Segment 2	FID(see map): 8	Coordinates: 44.331916, -72.547467	
Bank full width (ft): 9	Brook trout presence: Unknown	Avg.#CWM per 100 ft: 0	
Slope (looking upstream): 2%	Dominant substrate: Cobble	Riparian forest type: Hardwoods	Avg. DBH of riparian trees: 12-18"
Corridor type: lowgradefloodplain	Bank full height (ft): 1.5	Low floodplain Elevation (ft): 2.6	Incision Ratio: 1.73
Feasible floodplain reconnection: YLB	Predicted height of structure (ft): 3	Checkpoint log: yes	
Surveyor: JK(8/6/2024)	Notes: Good spot to engage floodplain and enhance downstream pool. Work here poses low risk to upstream bridge

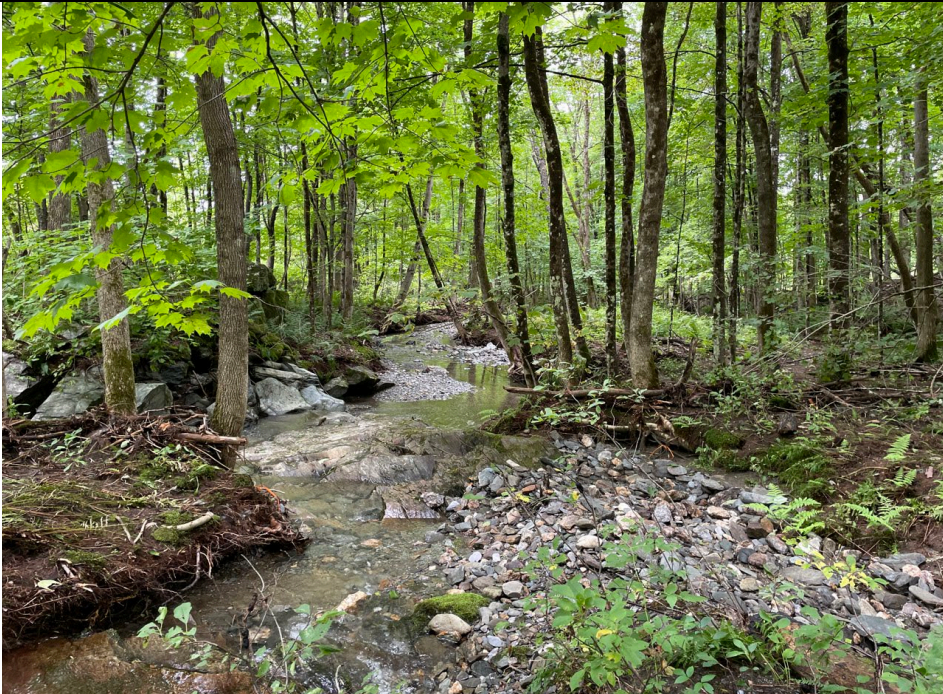
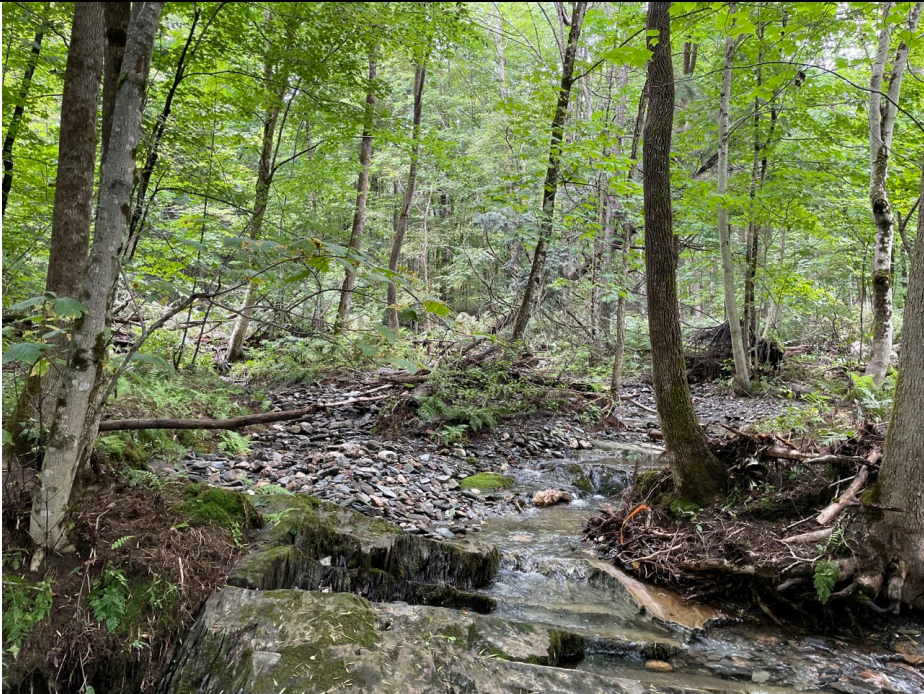
Stream Name: LMB Segment 2	FID (see map): 9	Coordinates: 44.331674, -72.547876	
Bank full width (ft): 9.5	Brook trout presence: Unknown	Avg.#CWM per 100 ft: 0	
Slope (looking upstream): 2%	Dominant substrate: Cobble	Riparian forest type: Hardwoods	Avg. DBH of riparian trees: 10-12”
Corridor type: lowgradefloodplain	Bank full height (ft): 1.6	Low floodplain Elevation (ft): 2.5	Incision Ratio: 1.56
Feasible floodplain reconnection: YRB	Predicted height of structure (ft): 2.5	Checkpoint log: yes	
Surveyor: JK(8/6/2024)	Notes: Anastomised above and disconnected above. Wood here at secure pinch point will capture a large floodplain

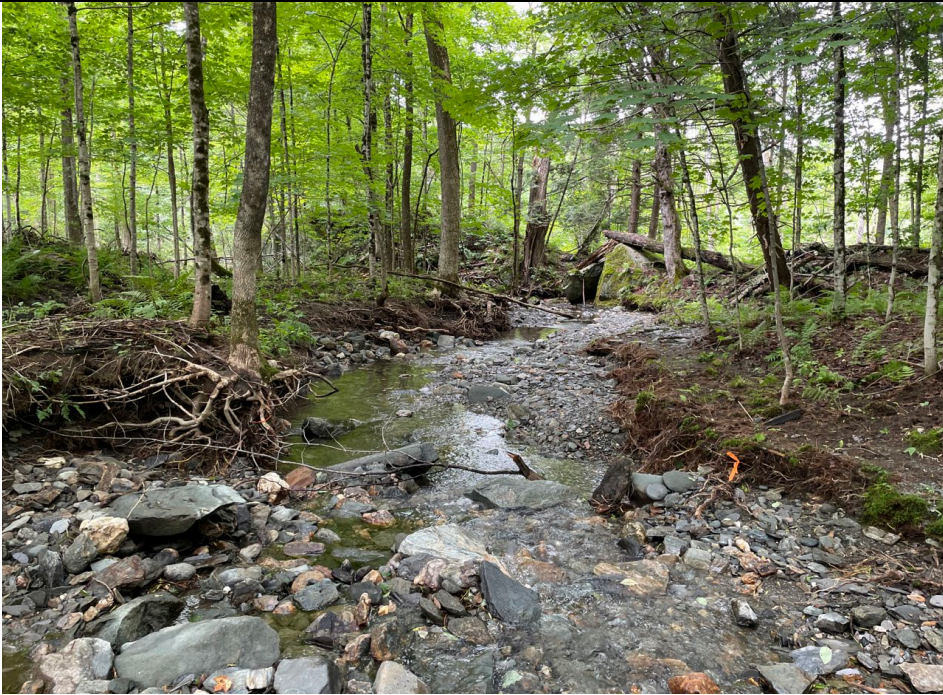
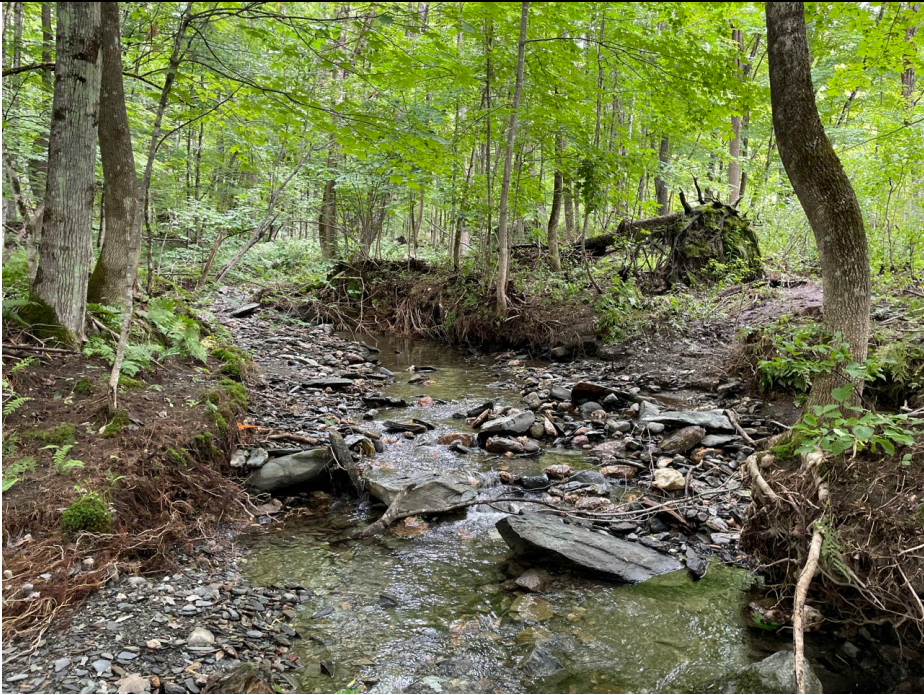
Stream Name: LMB Segment 2	FID(see map): 10	Coordinates: 44.331469, -72.548295	
Bank full width (ft): 12	Brook trout presence: Unknown	Avg.#CWM per 100 ft: 1	
Slope (looking upstream): 3%	Dominant substrate: Cobble	Riparian forest type: Hardwoods	Avg. DBH of riparian trees: 10-12"
Corridor type: lowgradefloodplain	Bank full height (ft): 1.6	Low floodplain Elevation (ft): 2	Incision Ratio: 1.25
Feasible floodplain reconnection: YRB	Predicted height of structure (ft): 2.2	Checkpoint log: yes	
Surveyor: JK(8/6/2024)	Notes: Limited potential for reconnecting floodplain due to size of trees. Banks have eroded significantly in past two years. Target lowest potential terrace

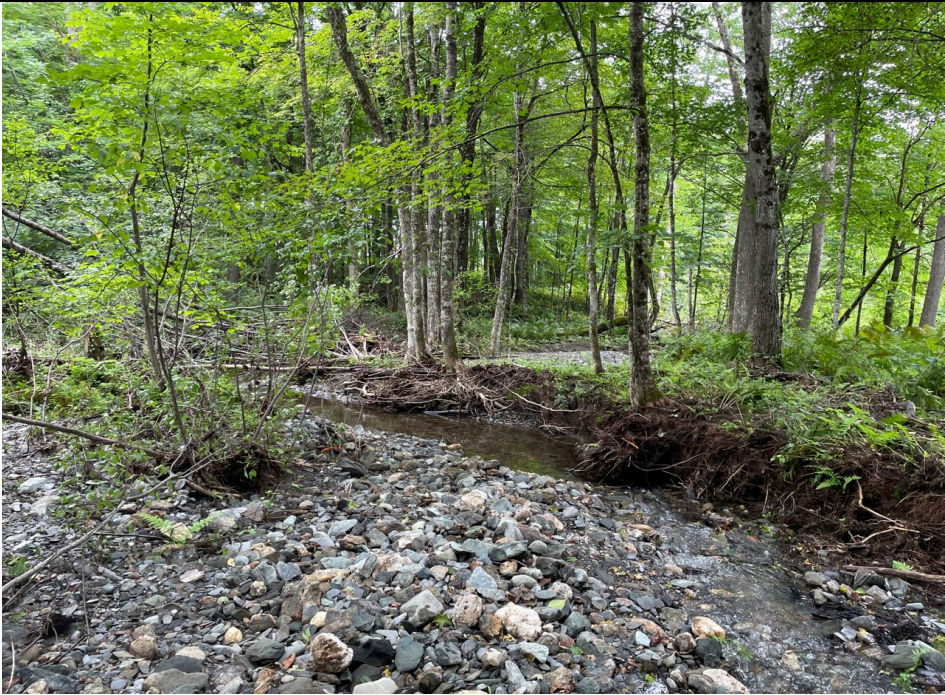
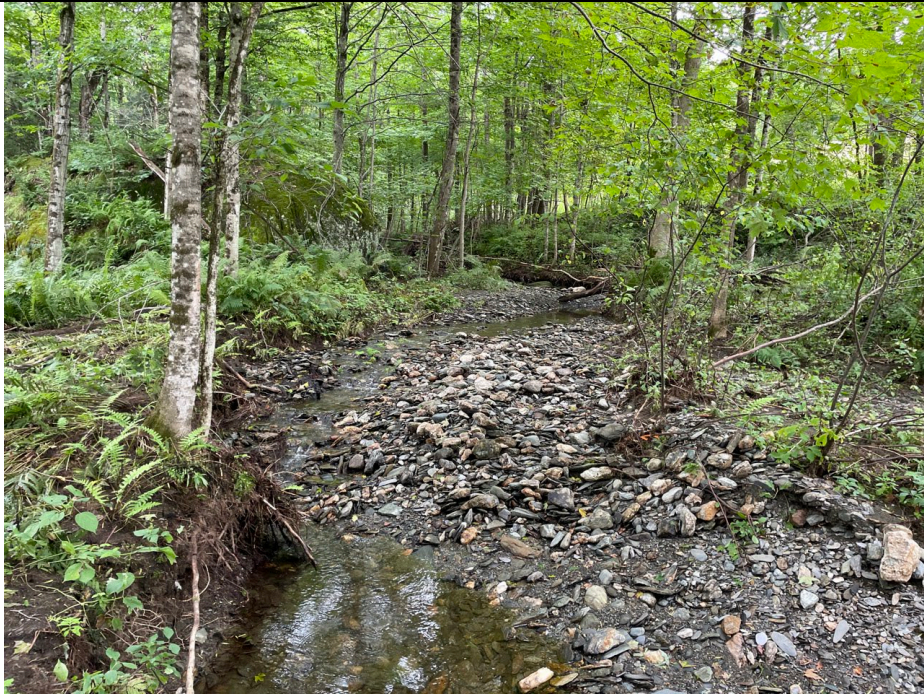
Stream Name: LMB Segment 2	FID(see map): 11	Coordinates: 44.331215, -72.548882	
Bank full width (ft): 12.5	Brook trout presence: Y	Avg.#CWM per 100 ft: 0	
Slope (looking upstream): 1%	Dominant substrate: Cobble	Riparian forest type: Hardwoods	Avg. DBH of riparian trees: 10-12"
Corridor type: lowgradefloodplain	Bank full height (ft): 2	Low floodplain Elevation (ft): 3 Incision Ratio: 1.5	
Feasible floodplain reconnection: YBB	Predicted height of structure (ft): 3	Checkpoint log: yes	
Surveyor: JK(8/6/2024)		Notes: Downstream end with large structure. Many small trout. Stream navigates sharp bend and leaves property and soon enters a wetland. The area has good floodplain engagement potential

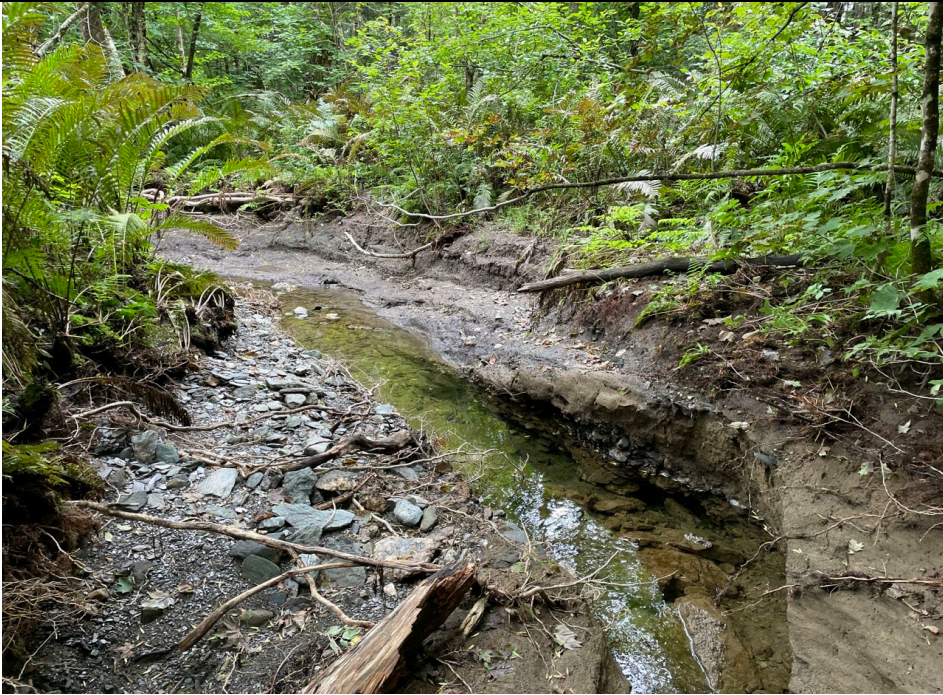
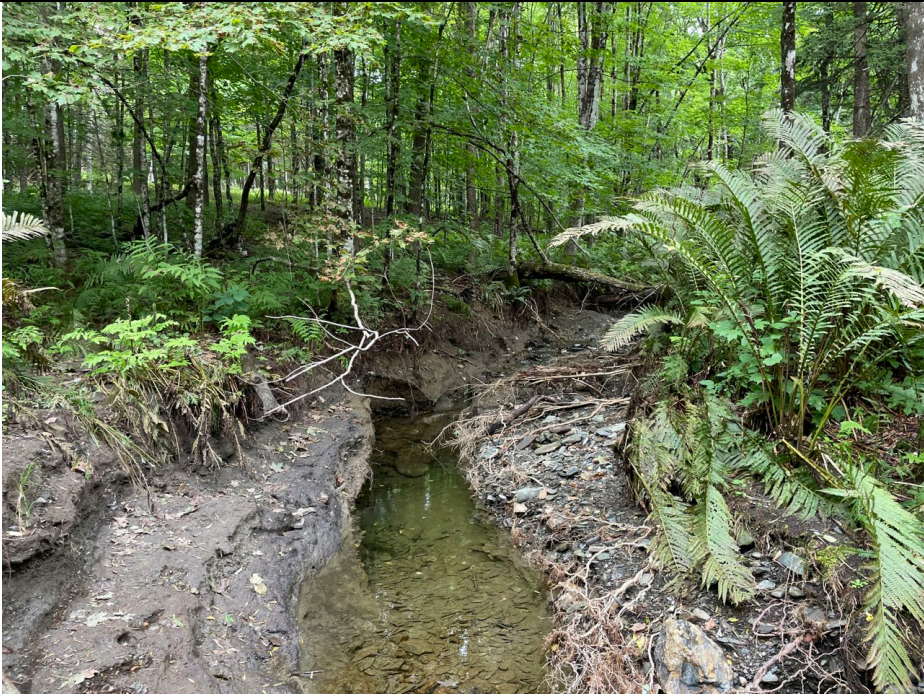
Stream Name: LMB Segment 2	FID(see map): 12	Coordinates: 44.331951, -72.547559	
Bank full width (ft): na	Brook trout presence: Y	Avg.#CWM per 100 ft: 0	
Slope (looking upstream): 5%	Dominant substrate: Cobble	Riparian forest type: Hardwoods	Avg. DBH of riparian trees: 10-12"
Corridor type: lowgradefloodplain	Bank full height (ft): na	Low floodplain Elevation (ft): 6	Incision Ratio: na
Feasible floodplain reconnection: YBB	Predicted height of structure (ft): na	Checkpoint log:	
Surveyor: JK(8/6/2024)		Notes: Severe downcutting. Brook trout abundant here and area seems very unstable Avoid working directly in this area and concentrate on more stable floodplains

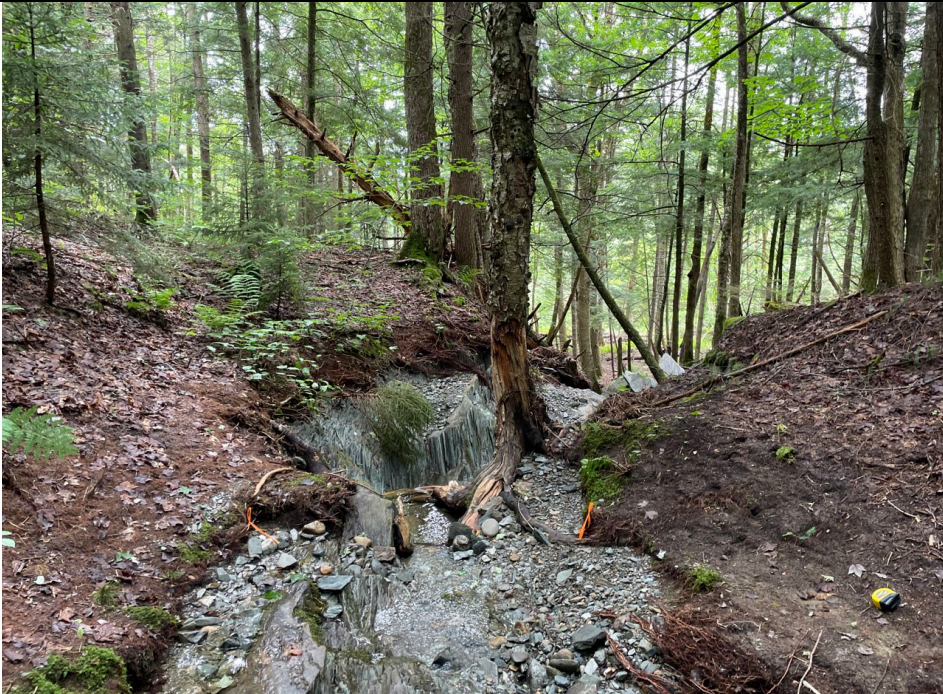
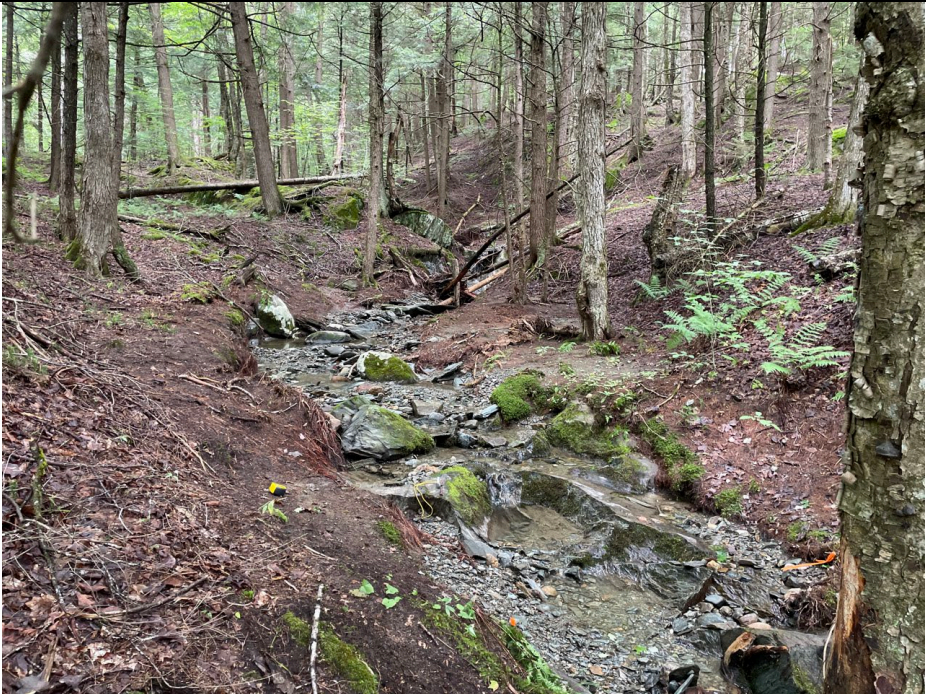
Stream Name: LMB Trib 1	FID(see map): 14	Coordinates: 44.333215, -72.550015	
Bank full width (ft): 6	Brook trout presence: Y	Avg.#CWM per 100 ft: 2	
Slope (looking upstream): 8%	Dominant substrate: Bedrock	Riparian forest type: Mixed Woods	Avg. DBH of riparian trees: 10-12"
Corridor type: rock outcrops	Bank full height (ft): 1.4	Low floodplain Elevation (ft): na	Incision Ratio: na
Feasible floodplain reconnection: N	Predicted height of structure (ft): 2.5	Checkpoint log: no	
Surveyor: JK(8/6/2024)	Notes: Downstream end above steep cascade good place to catch sediment and aggrade stream bed

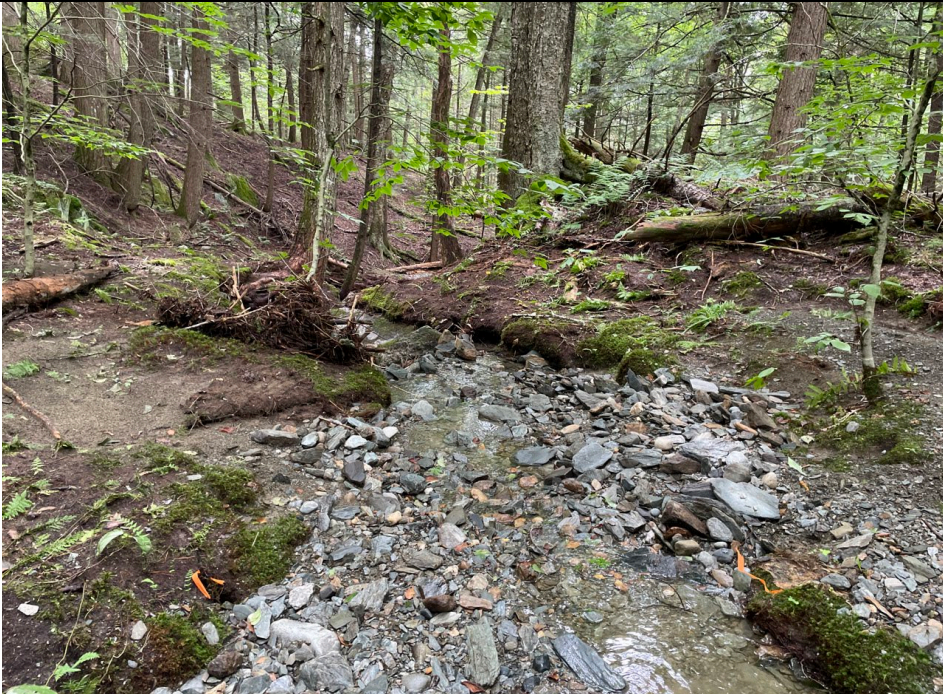
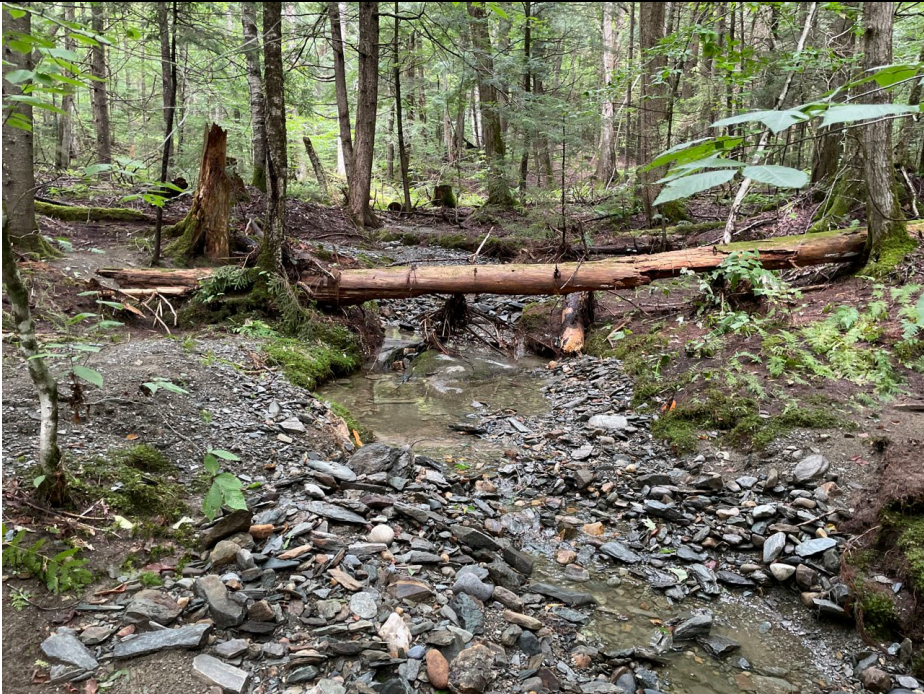
Stream Name: LMB Trib 1	FID(see map): 15	Coordinates: 44.333624, -72.549859	
Bank full width (ft): 6.5	Brook trout presence: Unknown	Avg.#CWM per 100 ft: 1	
Slope (looking upstream): 5%	Dominant substrate: Cobble	Riparian forest type: Softwoods	Avg. DBH of riparian trees: 10-12"
Corridor type: highgradefloodplain	Bank full height (ft): 0.6	Low floodplain Elevation (ft): 1.7	Incision Ratio: 2.83
Feasible floodplain reconnection: YBB	Predicted height of structure (ft): 2	Checkpoint log: no	
Surveyor: JK(8/6/2024)	Notes: A few small structures could provide consistent but limited area of floodplain engagement through here

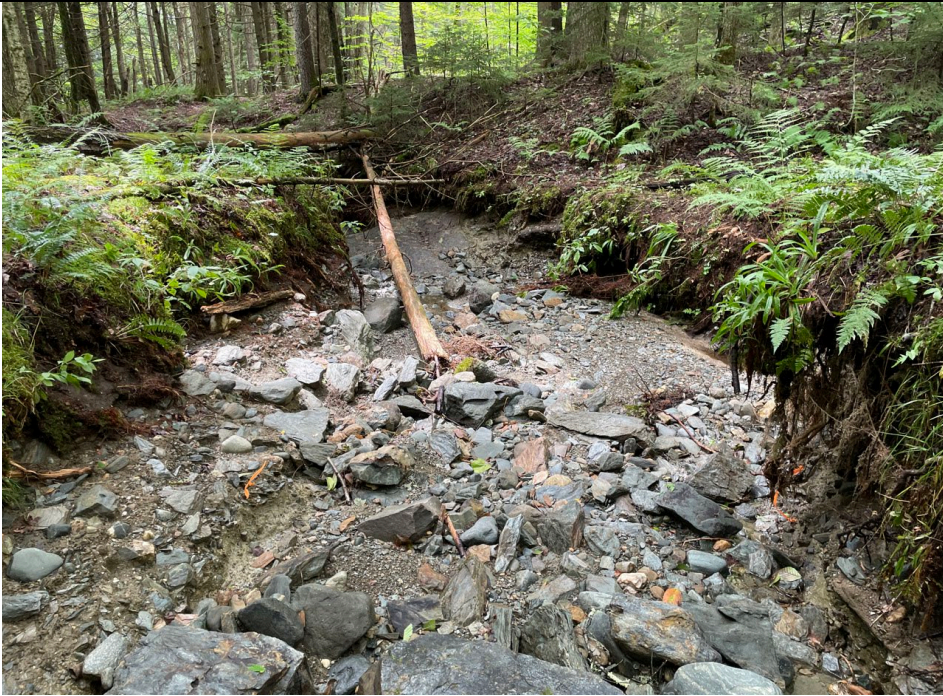
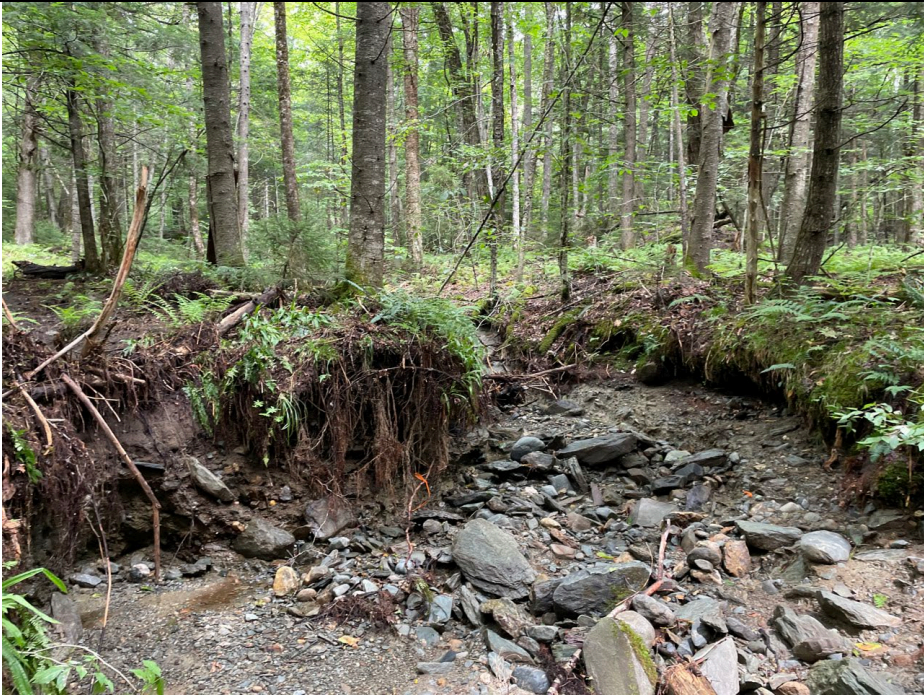
Stream Name: LMB Trib 1	FID(see map): 16	Coordinates: 44.334045, -72.550018	
Bank full width (ft): 7	Brook trout presence: Unknown	Avg.#CWM per 100 ft: 2	
Slope (looking upstream): 7%	Dominant substrate: Cobble	Riparian forest type: Mixed Woods	Avg. DBH of riparian trees: 10-12”
Corridor type: highgradefloodplain	Bank full height (ft): 0.8	Low floodplain Elevation (ft): 4	Incision Ratio: 5
Feasible floodplain reconnection: YBB	Predicted height of structure (ft): 2.5	Checkpoint log: yes	
Surveyor: JK(8/6/2024)	Notes: Very incised. Floodplain could be engaged from above but more sediment will be captured by large install here

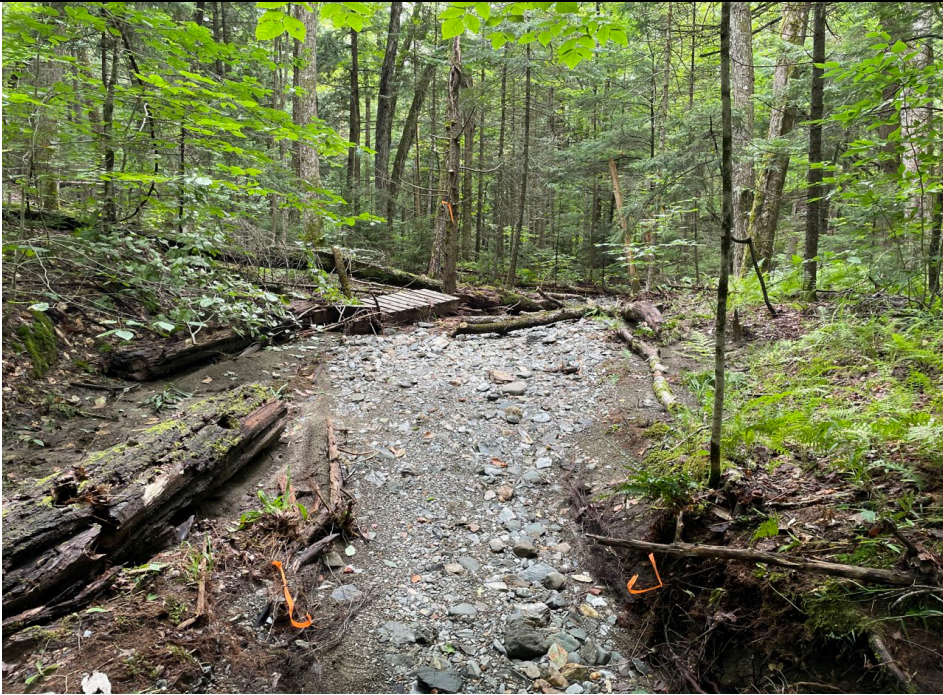
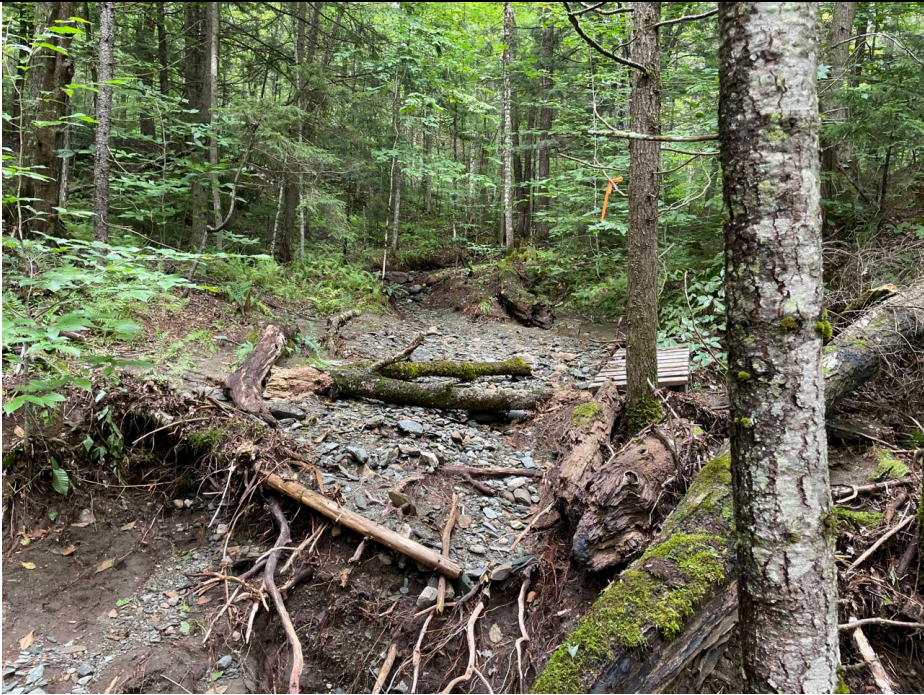
Stream Name: LMB Trib 1	FID(see map): 17	Coordinates: 44.33424, -72.549767	
Bank full width (ft): 5	Brook trout presence: Unknown	Avg.#CWM per 100 ft: 2	
Slope (looking upstream): 3%	Dominant substrate: Cobble	Riparian forest type: Mixed Woods	Avg. DBH of riparian trees: 10-12"
Corridor type: lowgradefloodplain	Bank full height (ft): 0.8	Low floodplain Elevation (ft): 0.8	Incision Ratio: 1
Feasible floodplain reconnection: YBB	Predicted height of structure (ft): 2	Checkpoint log: yes	
Surveyor: JK(8/6/2024)		Notes: Stream is heavily disturbed and aggraded from washed out earth upstream. Channel measurements taken at nearest point upstream while floodplain reconnection target point is at flagging on dead hemlock. Wood is beginning to build up here and the largest area of potential floodplain reconnection is directly downstream of this point

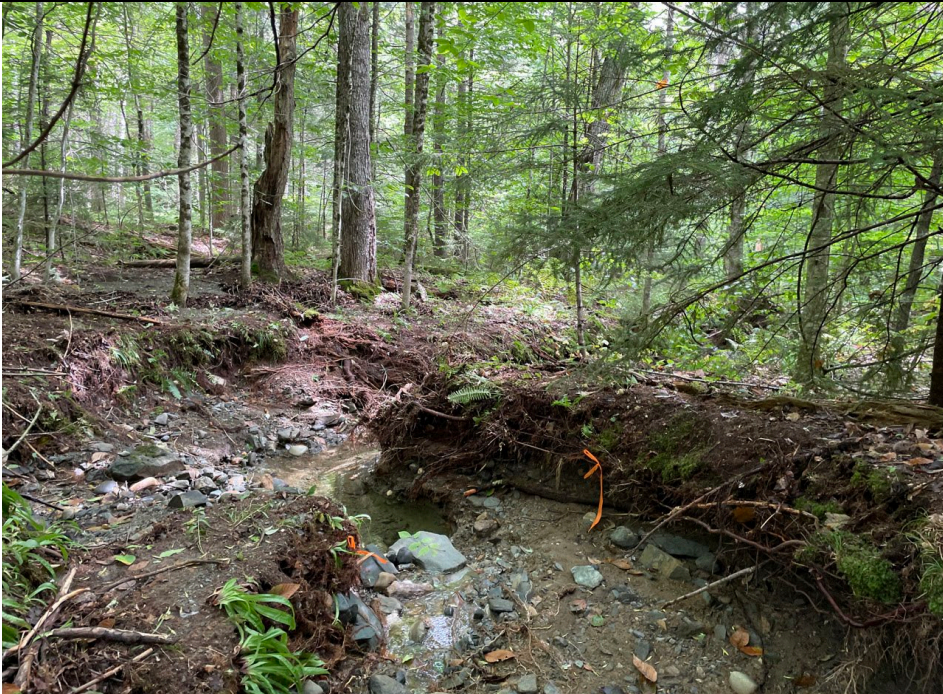
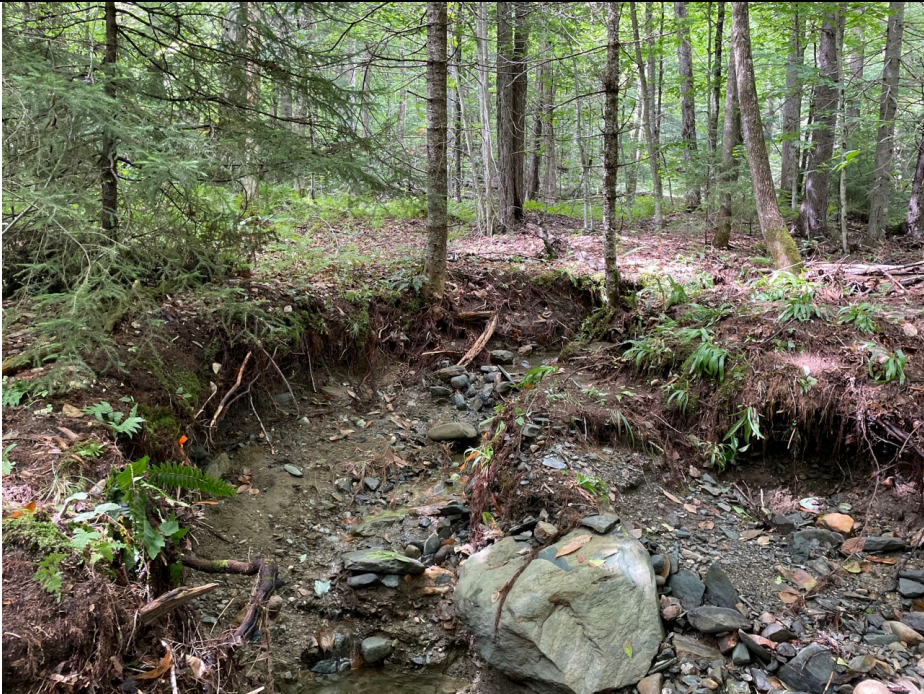
Stream Name: LMB Trib 1	FID(see map): 21	Coordinates: 44.334978, -72.549047	
Bank full width (ft): 5	Brook trout presence: Unknown	Avg.#CWM per 100 ft: 0	
Slope (looking upstream): 3%	Dominant substrate: Gravel	Riparian forest type: Mixed Woods	Avg. DBH of riparian trees: 10-12"
Corridor type: lowgradefloodplain	Bank full height (ft): 1	Low floodplain Elevation (ft): 2.5	Incision Ratio: 2.5
Feasible floodplain reconnection: YLB	Predicted height of structure (ft): 2	Checkpoint log: no	
Surveyor: JK(8/6/2024)	Notes: Upstream start at area of severe downcutting
