**Final Design Report:**  
**Long Meadow Brook Strategic Wood Additions**

Stream/Floodplain Restoration Project: for submission by Friends of the Winooski River to the Central Vermont Regional Planning Commission and Vermont Department of Environmental Conservation.

In-field scoping work completed 8/6/2024/2024 and report/project design completed 10/25/2024, by Redstart, Inc.

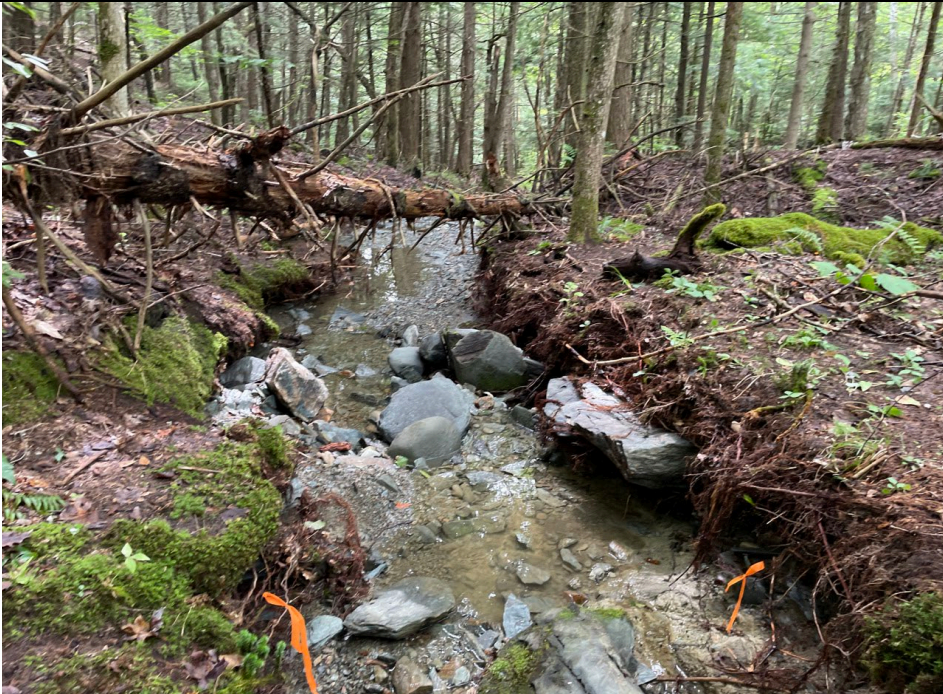
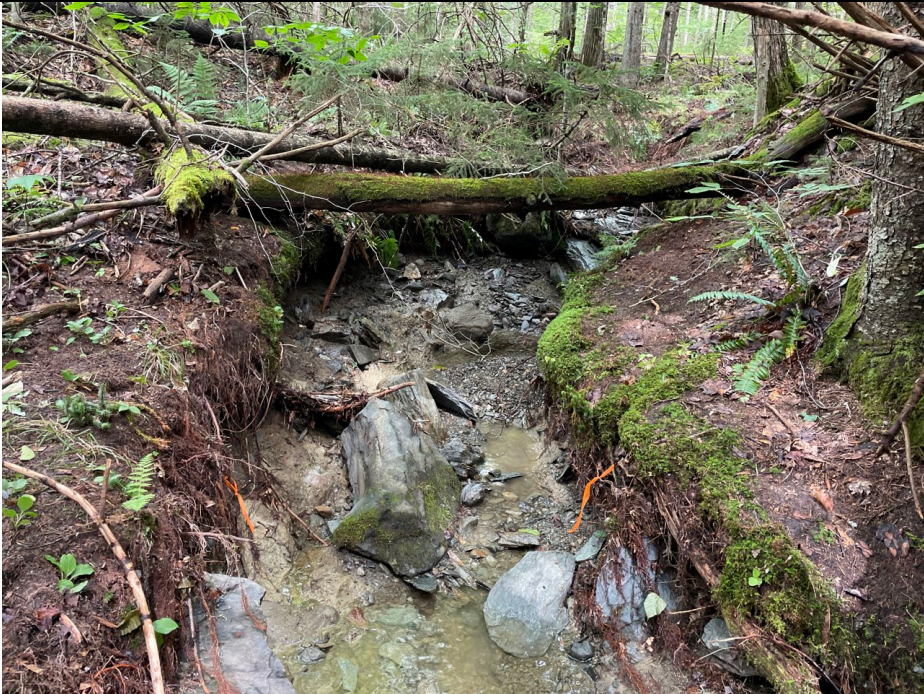
Stream Name: LMB Trib 2	FID(see map): 22	Coordinates: 44.334483, -72.549464
Bank full width (ft): 4	Brook trout presence: Unknown	Avg.#CWM per 100 ft: 0
Slope (looking upstream): 10%	Dominant substrate: Gravel	Riparian forest type: Mixed Woods      Avg. DBH of riparian trees: 10-12"
Corridor type: highgradefloodplain	Bank full height (ft): 1	Low floodplain Elevation (ft): 2    Incision Ratio: 2
Feasible floodplain reconnection: YRB	Predicted height of structure (ft): 2.2	Checkpoint log: no
Surveyor: JK(8/6/2024)	Notes: Upstream start. Feasible to reconnect floodplain here

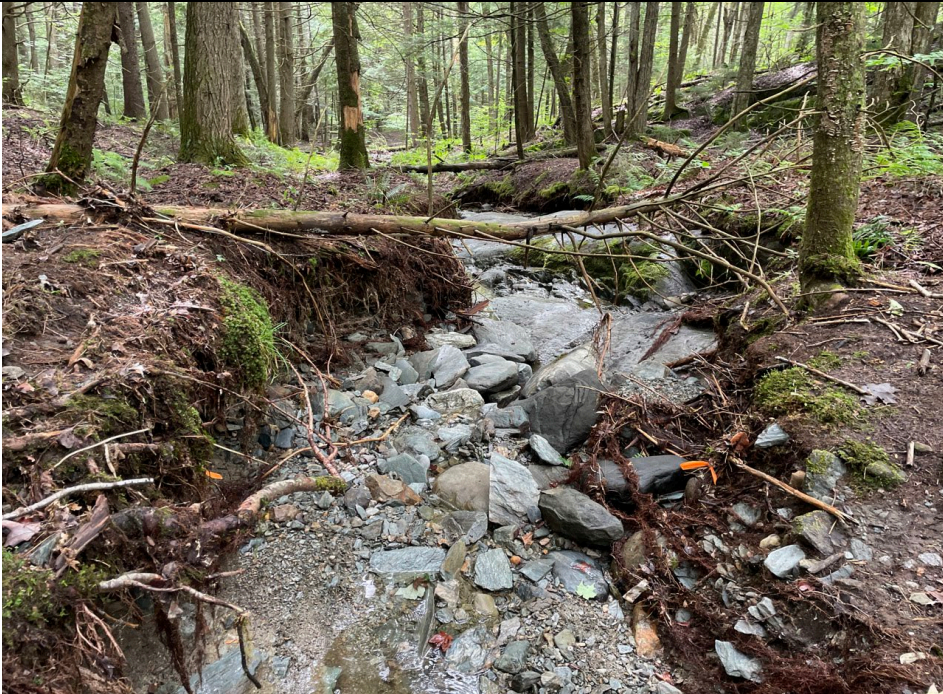
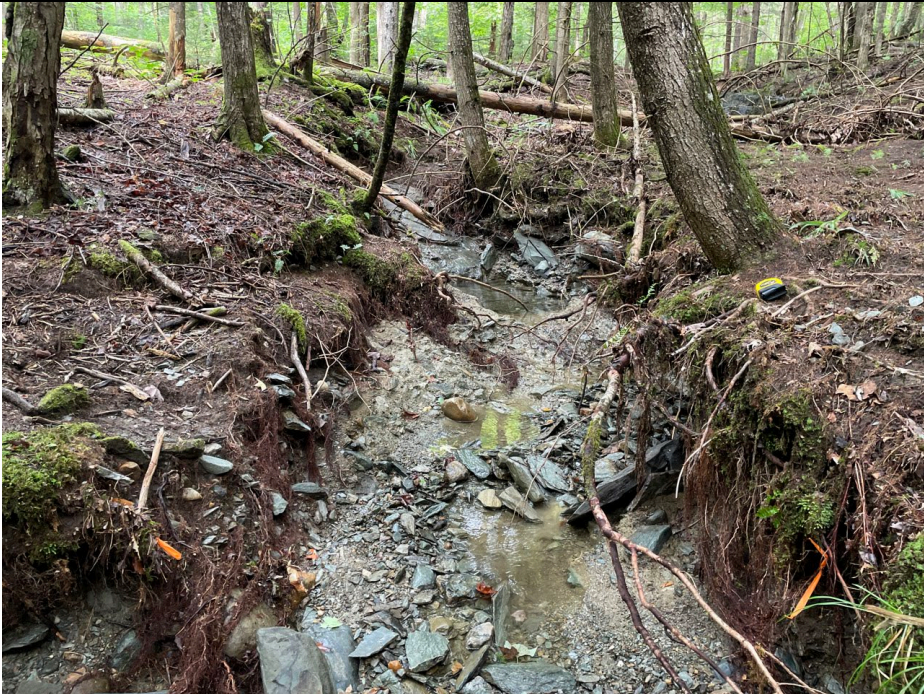
Stream Name: LMB Trib 2	FID(see map): 23	Coordinates: 44.334195, -72.549262
Bank full width (ft): 6	Brook trout presence: Unknown	Avg.#CWM per 100 ft: 1
Slope (looking upstream): 14%	Dominant substrate: Gravel	Riparian forest type: Softwoods Avg. DBH of riparian trees: 10-12"
Corridor type: highgradefloodplain	Bank full height (ft): 1.1	Low floodplain Elevation (ft): 2.8 Incision Ratio: 2.56
Feasible floodplain reconnection: N	Predicted height of structure (ft): 2.5	Checkpoint log: yes
Surveyor: JK(8/6/2024)	Notes: Too incised to reconnect along here. Focus on sediment capture within channel

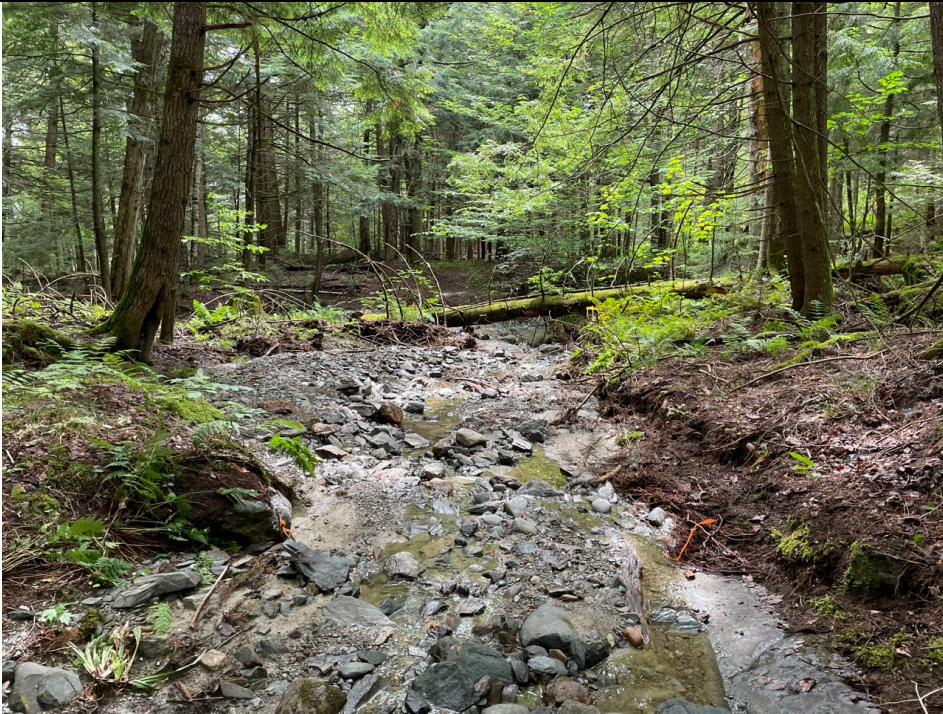
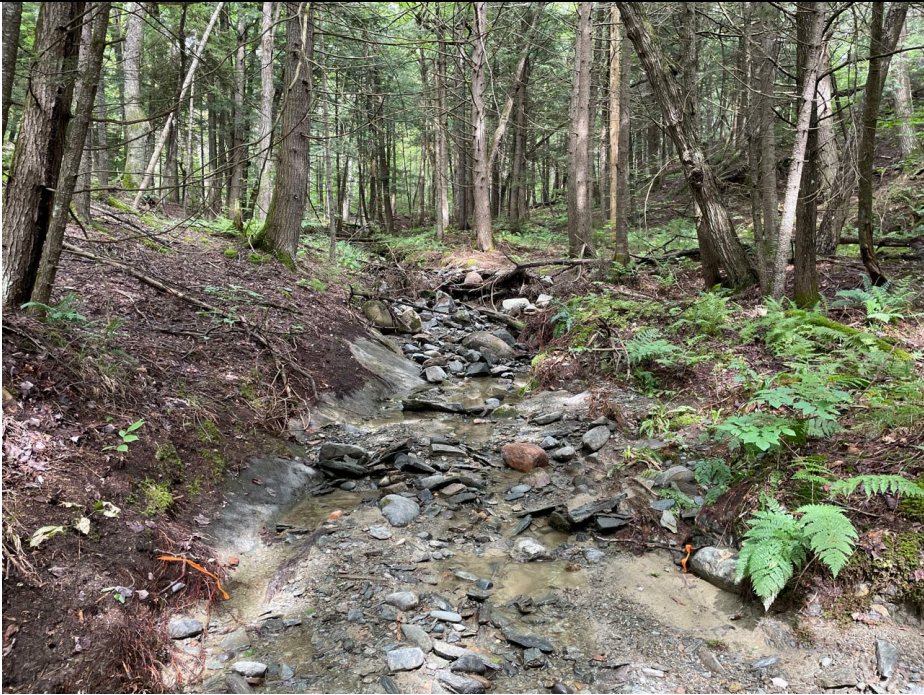
Stream Name: LMB Trib 2	FID(see map): 24	Coordinates: 44.333916, -72.549709
Bank full width (ft): 7.5	Brook trout presence: Unknown	Avg.#CWM per 100 ft: 1
Slope (looking upstream): 10%	Dominant substrate: Cobble	Riparian forest type: Softwoods Avg. DBH of riparian trees: 12-18"
Corridor type: lowgradefloodplain	Bank full height (ft): 0.8	Low floodplain Elevation (ft): 1.3 Incision Ratio: 1.625
Feasible floodplain reconnection: YLB	Predicted height of structure (ft): 2	Checkpoint log: yes
Surveyor: JK(8/6/2024)	Notes: Stream flattens here at approach to trib 1 with opportunity for floodplain engagement. Large install at spot of flagged measurement will maximize floodplain connection here

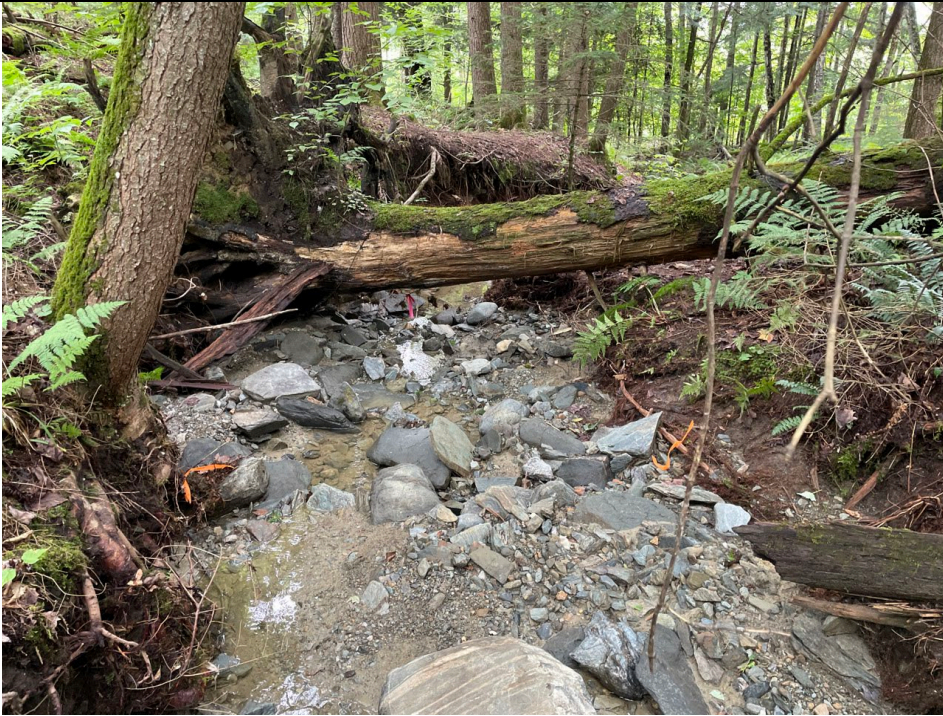
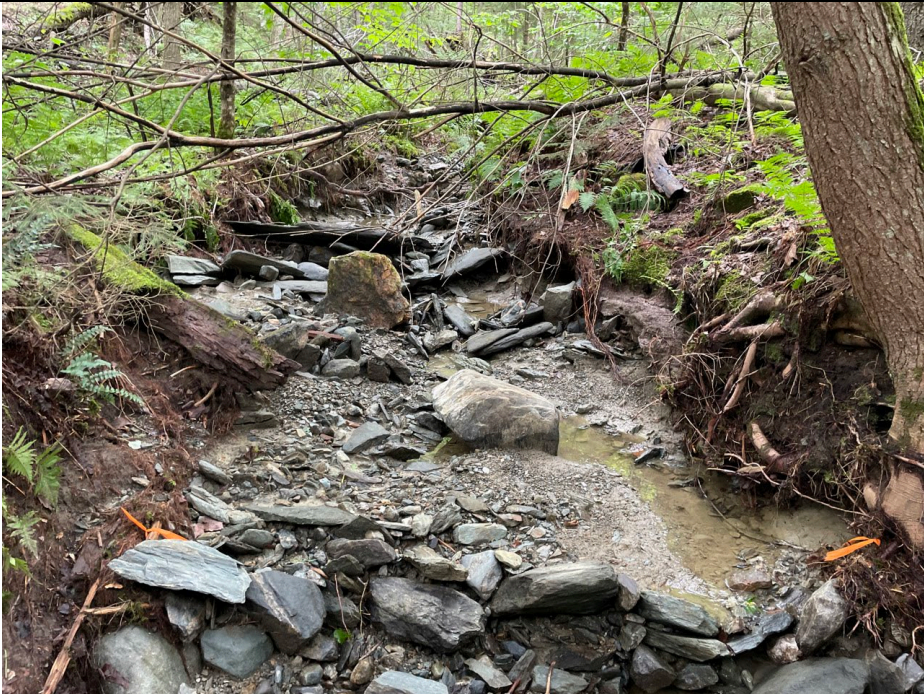
Stream Name: LMB Trib 3	FID(see map): 25	Coordinates: 44.332687, -72.548468
Bank full width (ft): 5.5	Brook trout presence: Unknown	Avg.#CWM per 100 ft: 0
Slope (looking upstream): 7%	Dominant substrate: Cobble	Riparian forest type: Mixed Woods      Avg. DBH of riparian trees: 10-12"
Corridor type: V-shaped	Bank full height (ft): 0.7	Low floodplain Elevation (ft): na Incision Ratio: na
Feasible floodplain reconnection: N	Predicted height of structure (ft): 2	Checkpoint log: no
Surveyor: JK(8/6/2024)	Notes: Downstream end at property boundary ( pink flag and barbed wire )

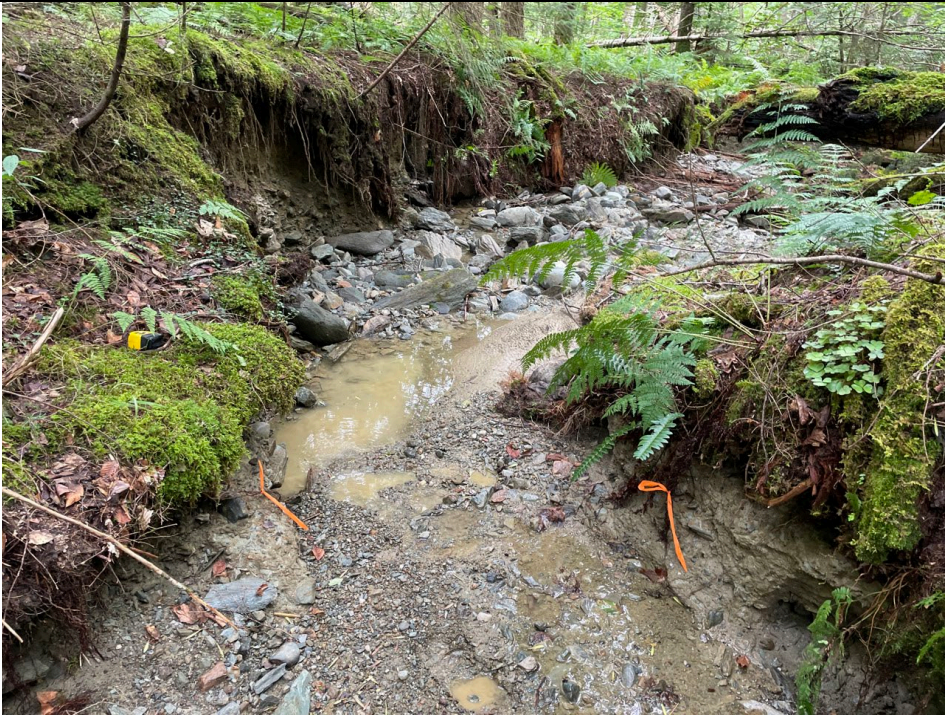
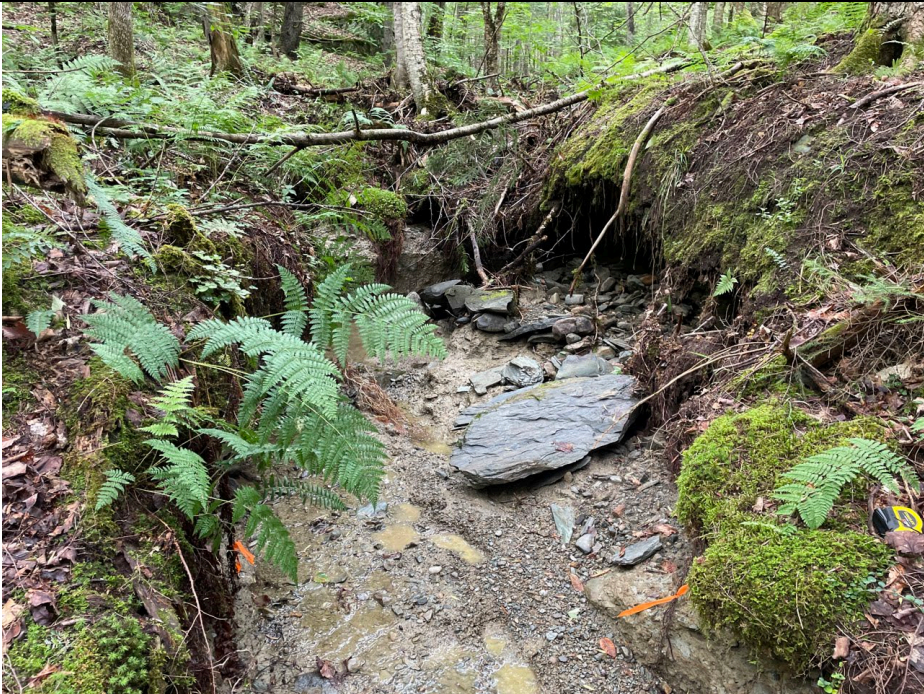
Stream Name: LMB Trib 3	FID(see map): 26	Coordinates: 44.332961, -72.54829	
Bank full width (ft): 4	Brook trout presence: Unknown	Avg.#CWM per 100 ft: 1	
Slope (looking upstream): 8%	Dominant substrate: Gravel	Riparian forest type: Softwoods Avg. DBH of riparian trees: 12-18"	
Corridor type: highgrade floodplain	Bank full height (ft): 0.7	Low floodplain Elevation (ft): 1.2	Incision Ratio: 1.71
Feasible floodplain reconnection: YRB	Predicted height of structure (ft): 2Checkpoint log: no		
Surveyor: JK(8/6/2024)	Notes: Severe bank erosion

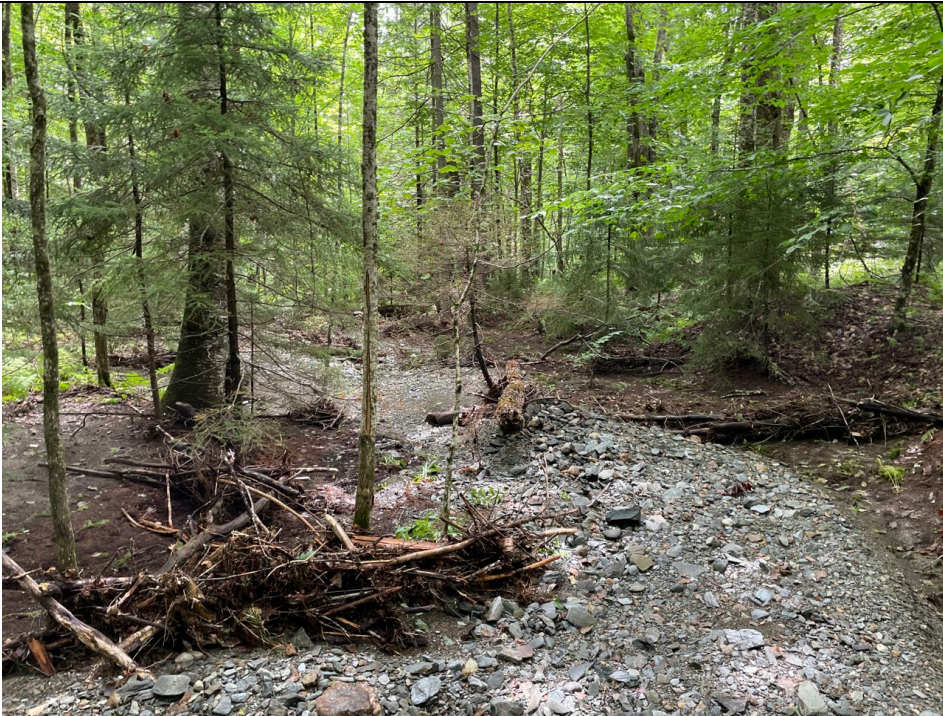
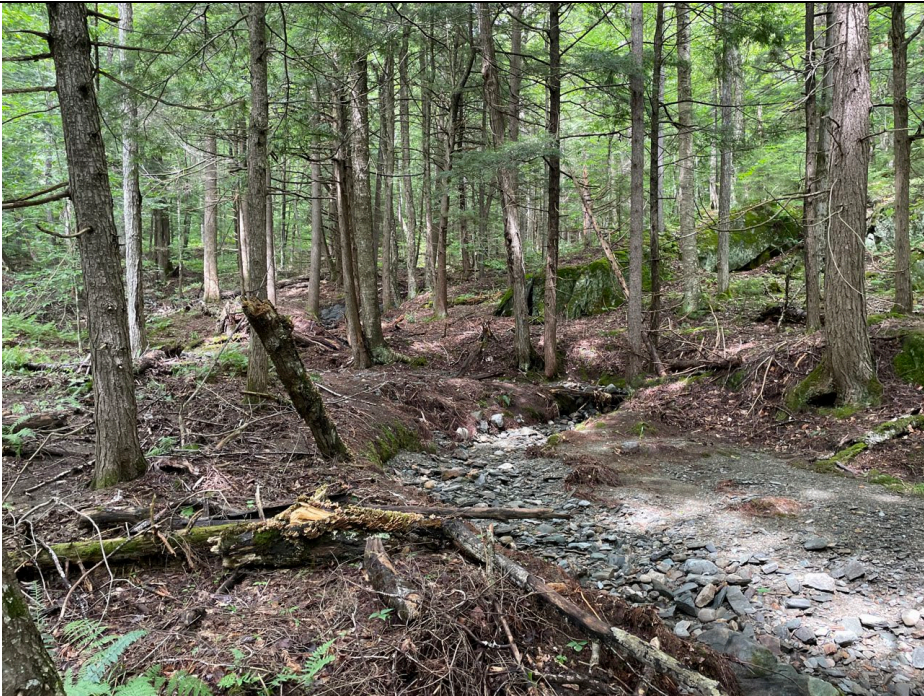
FID(see map): 20

Notes: Massive deposition along here from washouts above. Stream is aggraded to low floodplain elevation

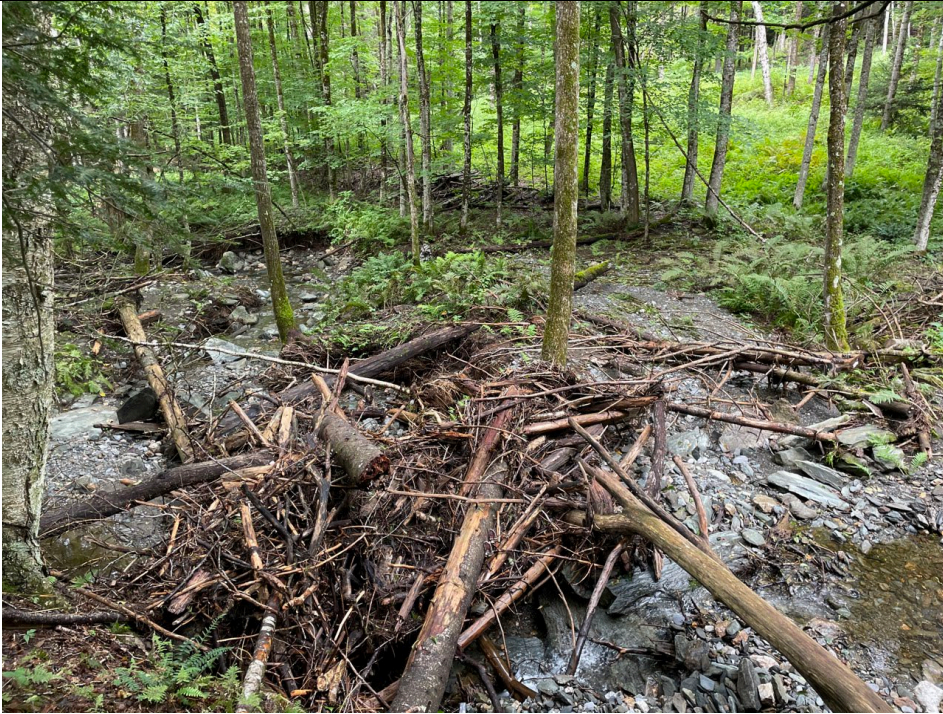
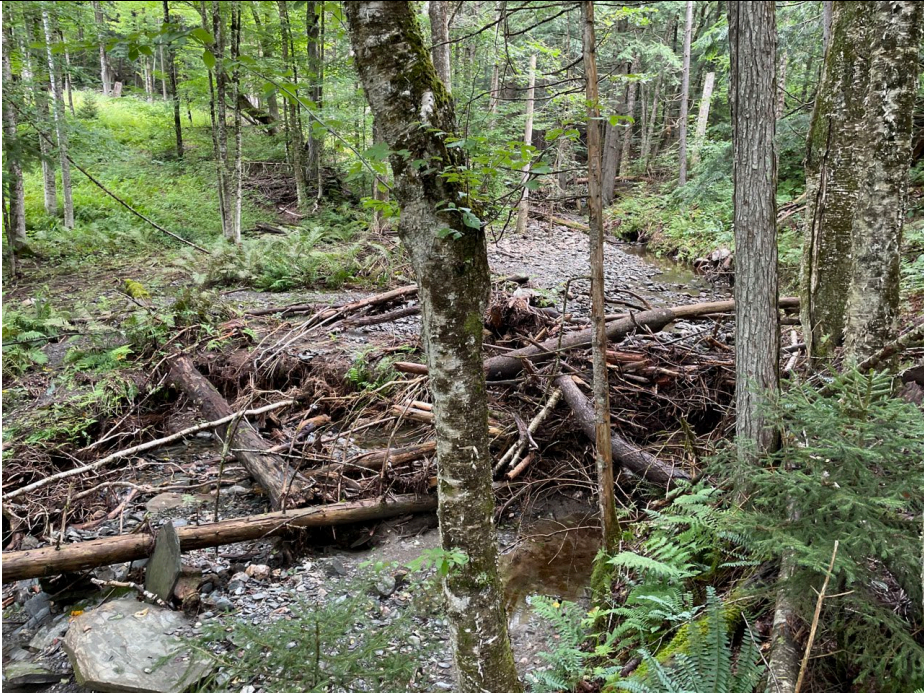
FID(see map): 6

Surveyor: JK(8/6/2024)      Notes: large natural wood jam is inducing floodplain engagement (100 yr flood). Aggradation above and scouring below. Avoid restoration here and start next reach below bridge

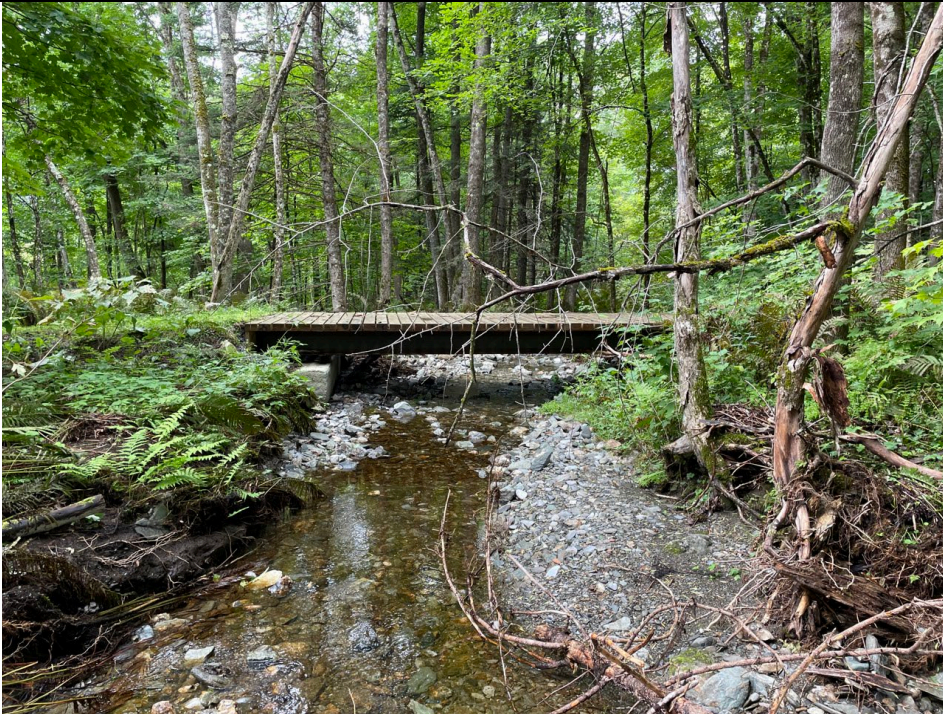
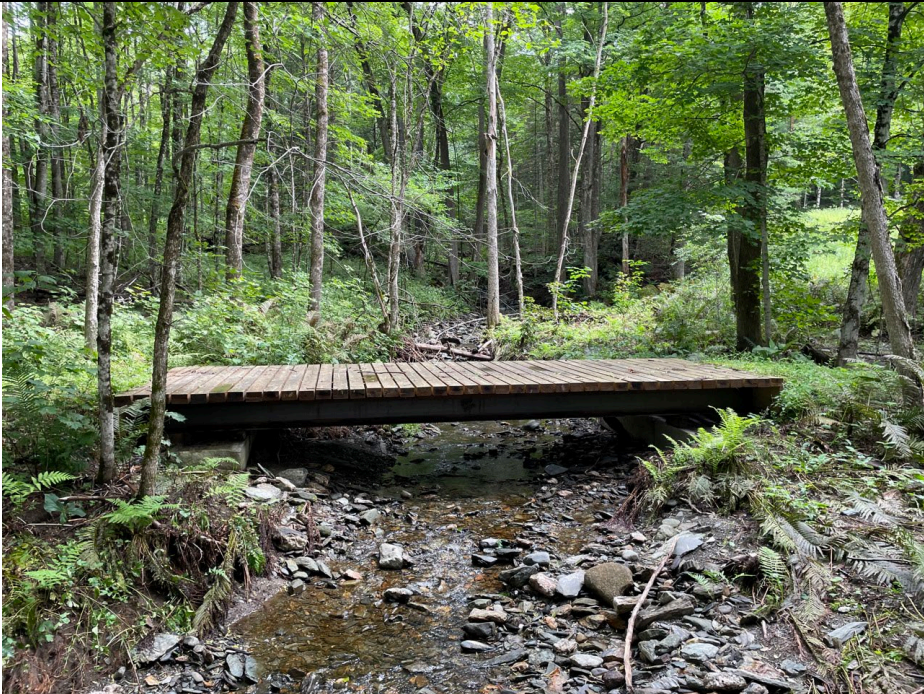
Stream Name: Bridge	FID(see map): 7	Coordinates: 44.331922, -72.547224
Surveyor: JK(8/6/2024)	Notes: Bank spanning iron bridge with concrete abutments. Bridge is in floodplain with anastomising channel to south
