**Waterbury Bridge #36  
Feasibility Study**  
Existing Conditions Report

September 28, 2018

Central Vermont Regional Planning  
Commission

Stantec Consulting Services  
55 Green Mountain Drive  
South Burlington, VT 05403

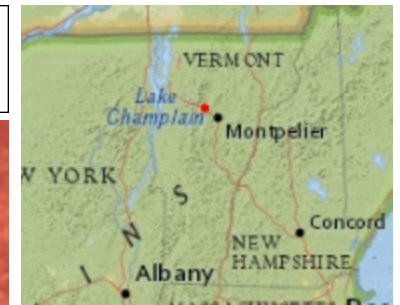
Map from Vermont Agency of Natural Resources website identifying the project area as being inside the floodplain and having Class I wetlands on site. Stantec's environmental scientist surveyed this area for wetlands to identify Class I wetland boundaries.
