# Great Brook Bridge Alternatives Analysis

Plainfield, Vermont  
February 15, 2016

**Prepared for:**  
Town of Plainfield  
149 Main Street  
P.O. Box 217  
Plainfield, Vermont 05667  
[www.plainfieldvt.us](http://www.plainfieldvt.us)

**Prepared by:**  
MILONE & MACBROOM, INC.  
1 South Main Street  
Waterbury, Vermont 05676  
(802) 882-8335  
[www.miloneandmacbroom.com](http://www.miloneandmacbroom.com)

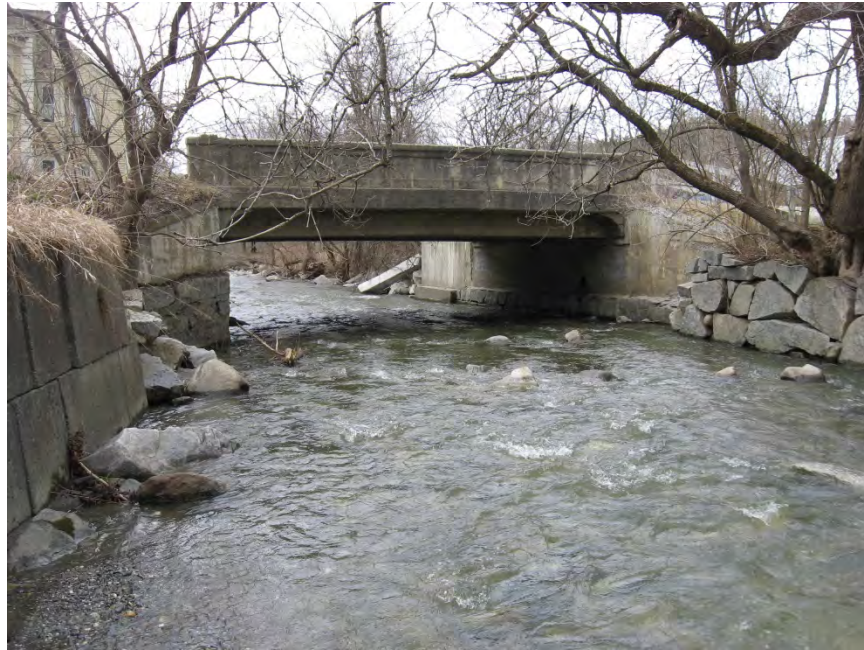
*Figure 1: Mill Street Bridge Looking Downstream*

The Mill Street Bridge and the Brook Road Bridge are concrete structures with solid concrete railings (i.e., parapets) (Figures 1 and 2). The Mill Street Bridge was reportedly built in 1929, and the Brook Road Bridge was reportedly built in 1920.

The opening at the Mill Street Bridge is approximately 30 feet wide providing approximately 7.5 feet of vertical clearance between the channel bottom and concrete support beams. The approach channel is lined with dry-stacked stone masonry and concrete block walls tying into concrete wingwalls at the opening. The exit channel includes a concrete retaining wall and multistory building on river left (facing downstream) and a wingwall on river right. The channel leading into and out of the bridge is aligned with the opening and confined.

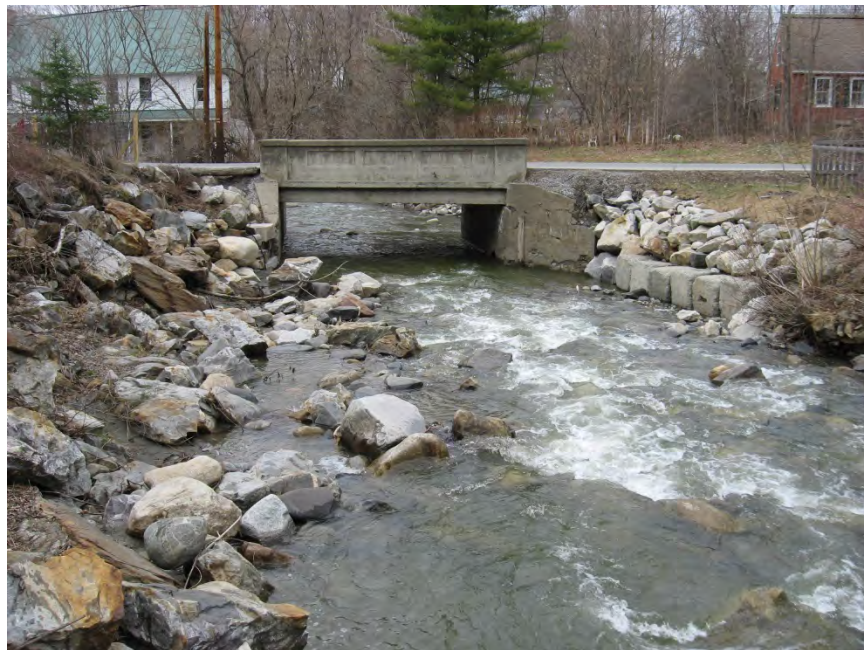
*Figure 2: Brook Road Bridge Looking Downstream*

Both subject bridges are not designed to the most current standards (Schiff et al., 2014) and have deficiencies in terms of hydraulic capacity and debris transport. The conveyance of flood flows, woody debris, and sediment is impeded at the Brook Road Bridge because of the following:

- It is undersized and
- It is backwatered during the 25-year flood and larger.

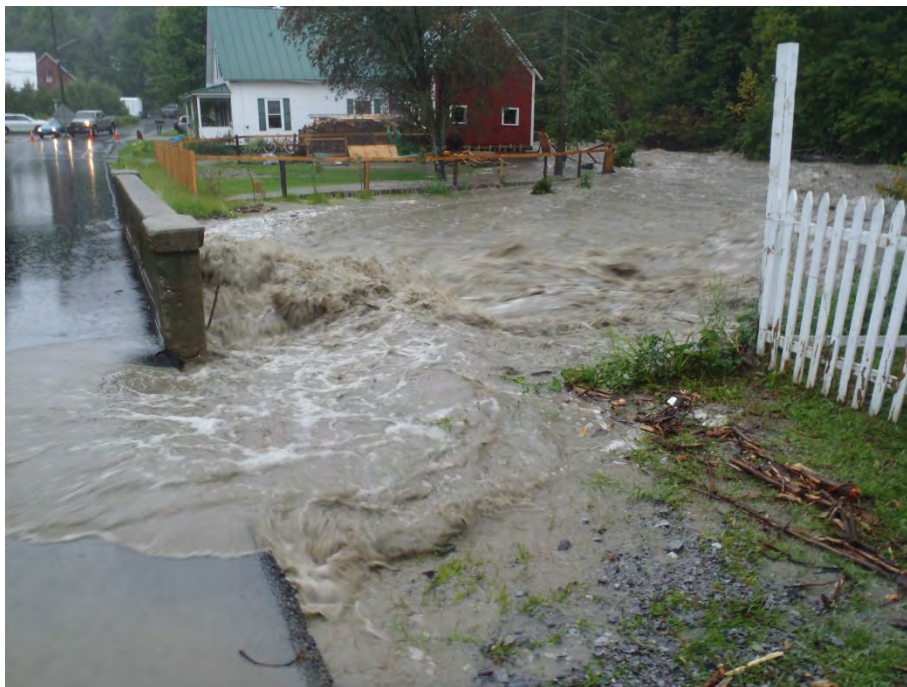
*Figure 3: Upstream Face of the Brook Road Bridge Full (Springston, 2011)*

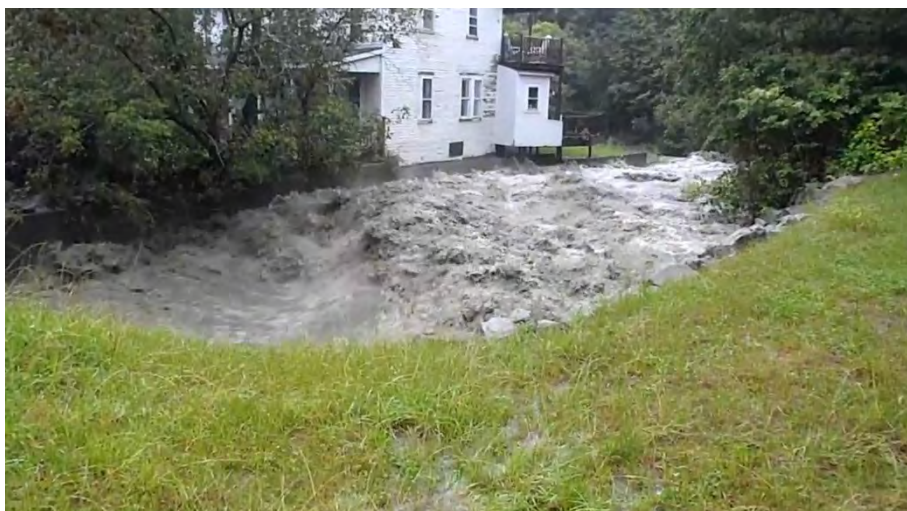
*Figure 4: Hydraulic Roller Downstream of Brook Road Bridge (Springston, 2011)*

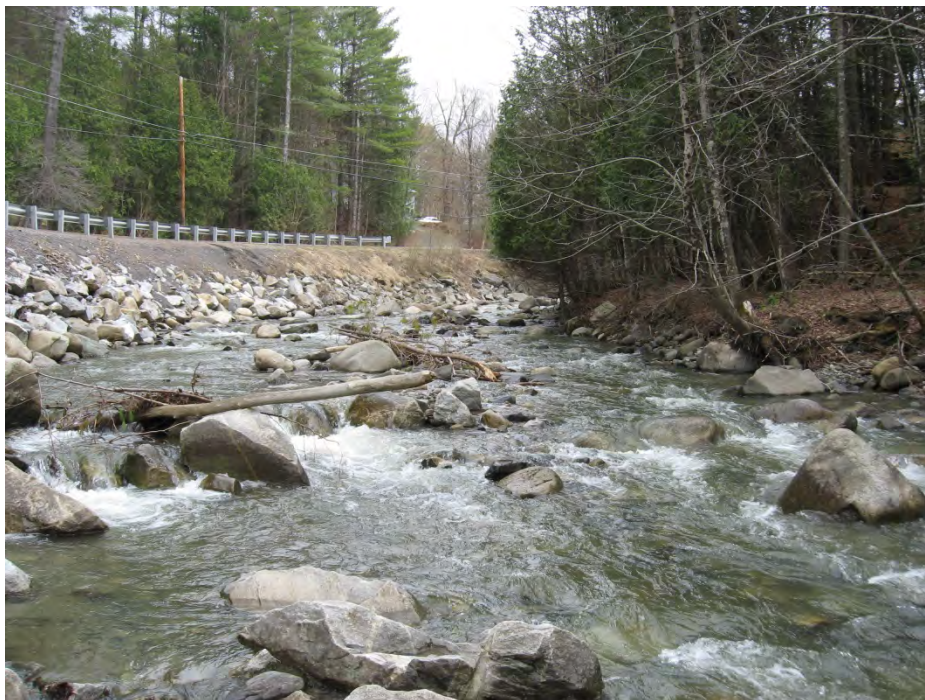
*Figure 6: Great Brook (Milone & MacBroom, Inc., 2015)*

A geomorphic assessment (BCE, 2013) and river corridor planning (BCE, 2014) were completed during the past decade, and current field observations indicate that the results of that assessment primarily remain valid today. The channel bankfull width in the study area (M3.01B) is 36 feet, and the bankfull channel depth is 2.5 feet. The channel is dominated by riffle-pool bed features with high sediment bedload and woody debris movement during flooding (Figure 6). The channel sediment is gravel, with cobble and some boulders.

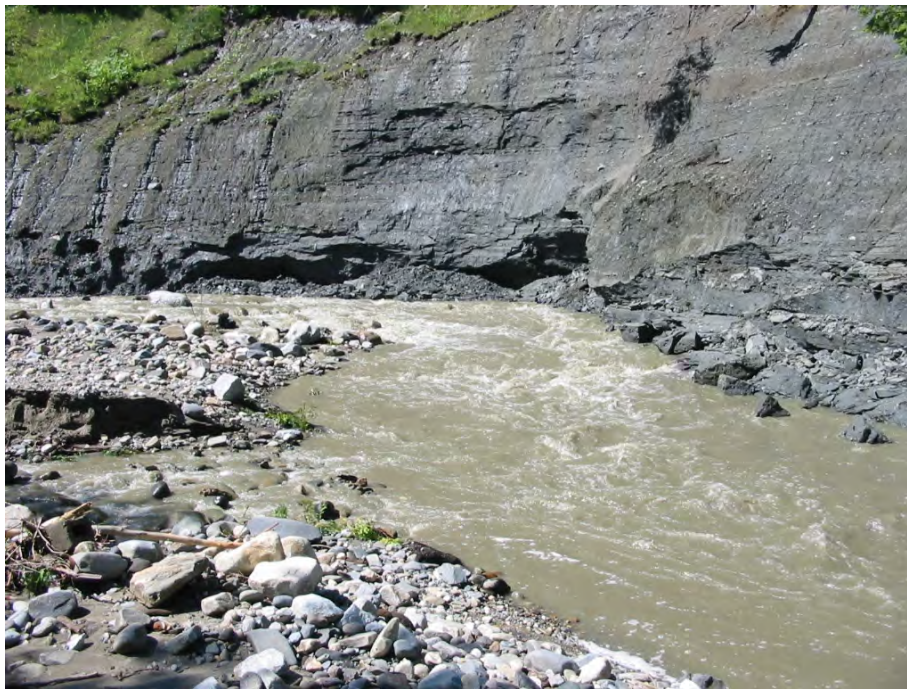
*Figure 7: Landslide on Great Brook (Milone & MacBroom, Inc., 2015)*

Channel downcutting has initiated landslides through the erosion of the bottom of steep valley walls during flooding and subsequent slope failure (Figure 7). Springston and Thomas (2014) studied the landslides along Great Brook and identified 47 active landslides, 3 inactive landslides, 7 bank erosion sites, and 15 sites with gullying on the slopes. The study showed that most landslides are in the lower reaches of Great Brook approaching the village (Figure 8). Gullies are common throughout the watershed.

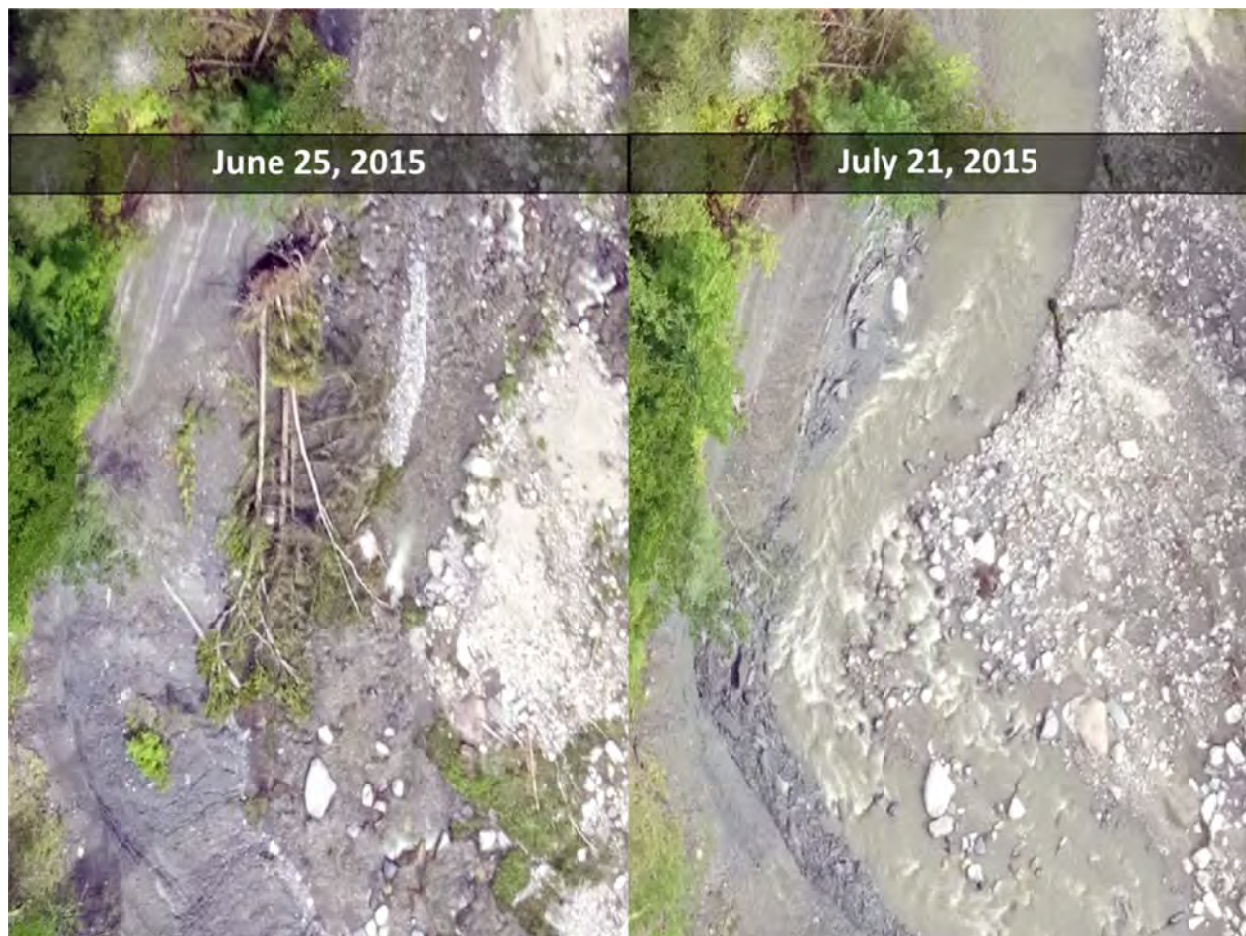
*Figure 9: A Comparison of UAV Photographs Showing Wood Removal on Great Brook Approximately 300 feet Downstream of the Cameron Road Bridge (O'Neil-Dunne and Ahles, 2015)*

investigated by counting the amount of wood in the aerial photographs before and after the July 2015 flood (Figure 9). The results show a highly dynamic wood load during the 10-year flood. The data suggest that small wood piles (i.e., those with less than five trees) are regularly being generated and flushed through the system (Figure 10). Large amounts of wood are thus likely passing through the Brook Road Bridge and the Mill Street Bridge and exiting the system since there were only relatively small accumulations in these areas compared to the wood generation and movement during floods.

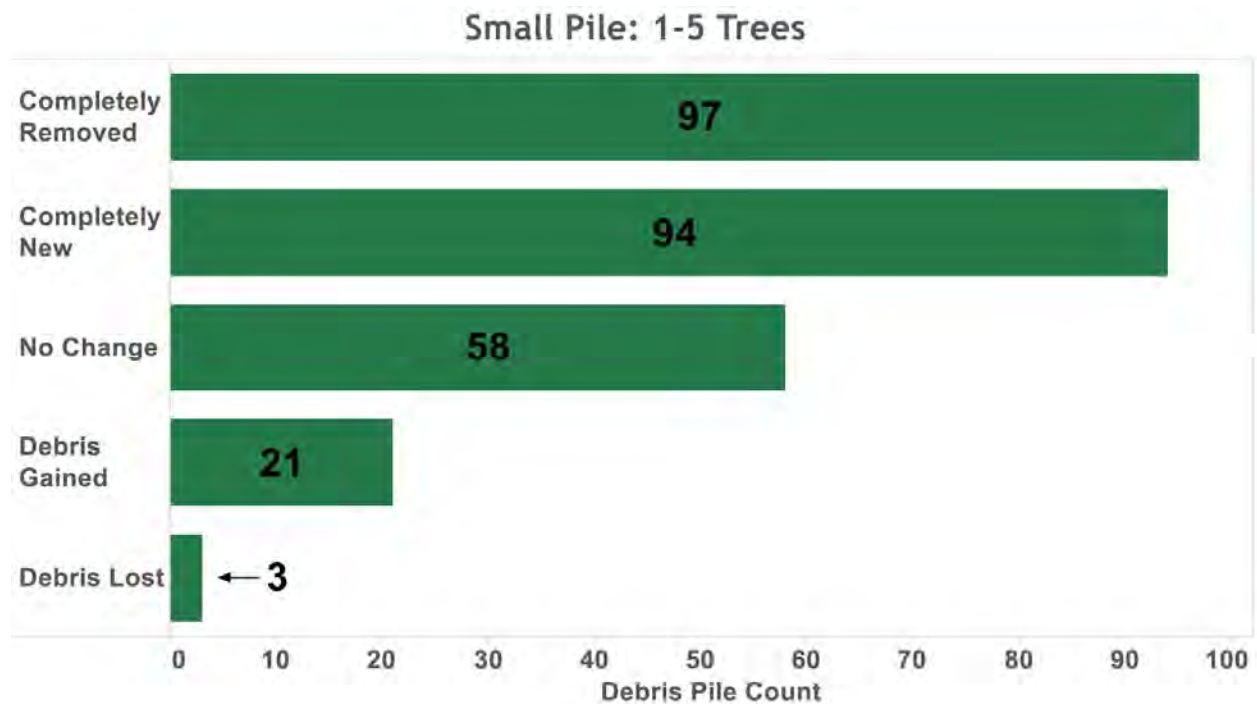
Figure 10: Changes of Small Wood Piles Due to the 2015 Flood on Great Brook (O'Neil-Dunne and Ahles, 2015)

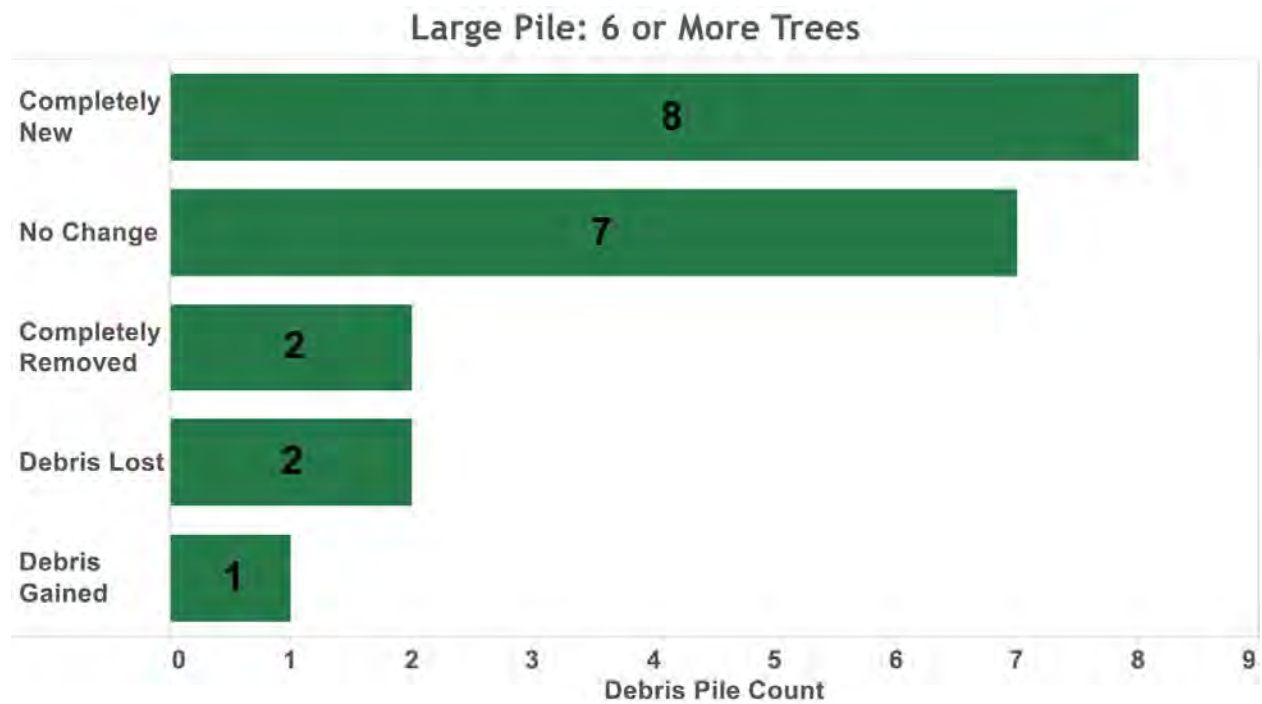
*Figure 11: Changes of Large Wood Piles Due to the 2015 Flood on Great Brook (O'Neil-Dunne and Ahles, 2015)*

The number of new large wood piles is about equal to the number of existing piles that are unchanged for the 10-year flood (Figure 11). During this flood, large piles of wood were not flushed out of the system as appeared to happen to small piles. This is likely due to the moderate size of the flood. Larger piles, and thus more wood, would likely move during a larger flood such as Irene or the May 2011 flood.

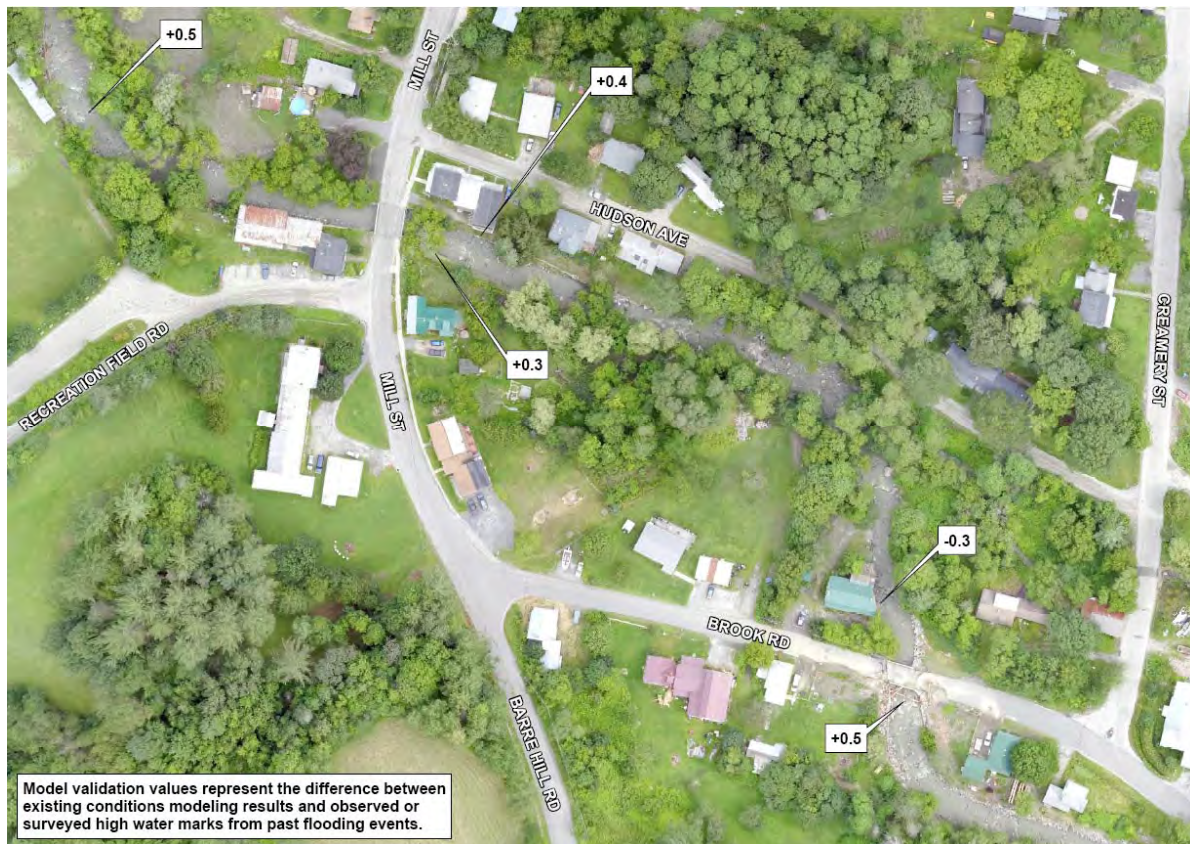
Figure 12: Model Validation Results

Model validation was conducted to check the performance of the model to represent flood levels from a past flood flow. The input parameters of the base model, such as Manning's N values, contraction and expansion coefficients, and the bridge modeling approach were adjusted to match the conditions during the past floods. The Tropical Storm Irene (Irene) flood was used to validate the model. The results of the validation show that the difference between observed and modeled flood levels is  $\pm 0.5$  feet (Figure 12). This level of accuracy is suitable for the current analysis.

Another check on the model was performed using the high water marks on the concrete pipe housing adjacent to town recreation fields. Again the modeled flood levels were within 0.5 feet of the surveyed flood level.

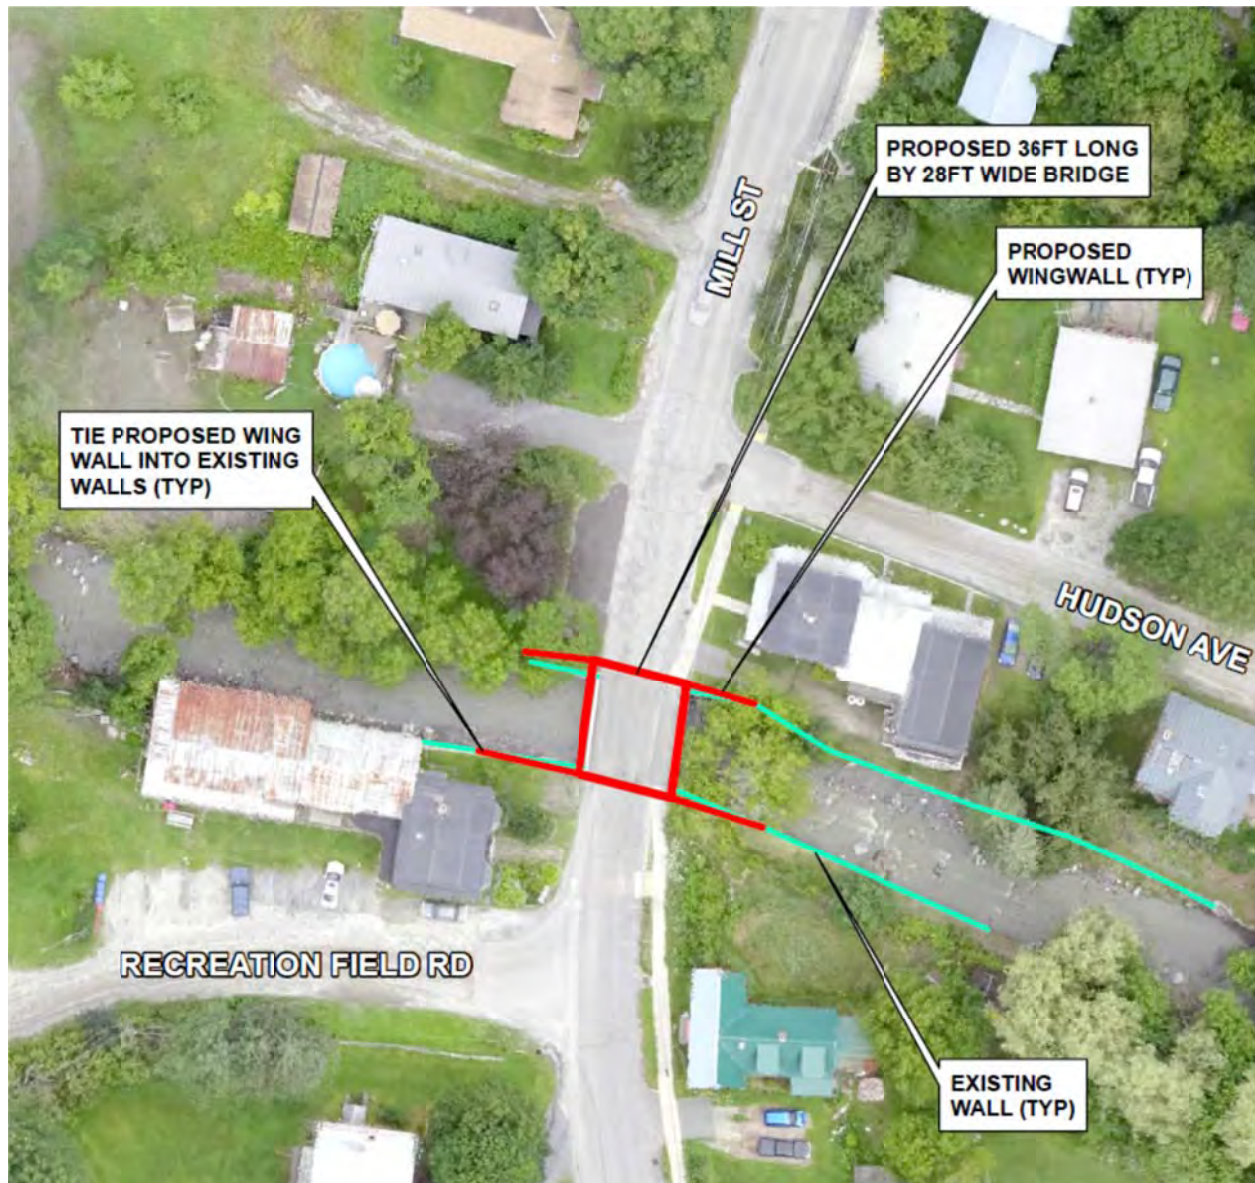
Figure 17: Mill Street Bridge Concept Design

The preferred alternative at Mill Street is to replace the structure with a new wider bridge providing a span equal to 100% of the bankfull channel width (Alternative 12). Since woody debris clogging at Mill Street is less common, bridge replacement at Mill Street would be less of a priority compared to replacing the Brook Road Bridge. Although bridge replacement at Mill Street would result in performance gains, the improvement is smaller compared to the gains at Brook Road.
