**Phase 2 Stream Geomorphic Assessment
Winooski River Watershed
Main Stem in Village and Tributaries
Town of Cabot
Washington County, Vermont**

Final Report
March 30, 2006

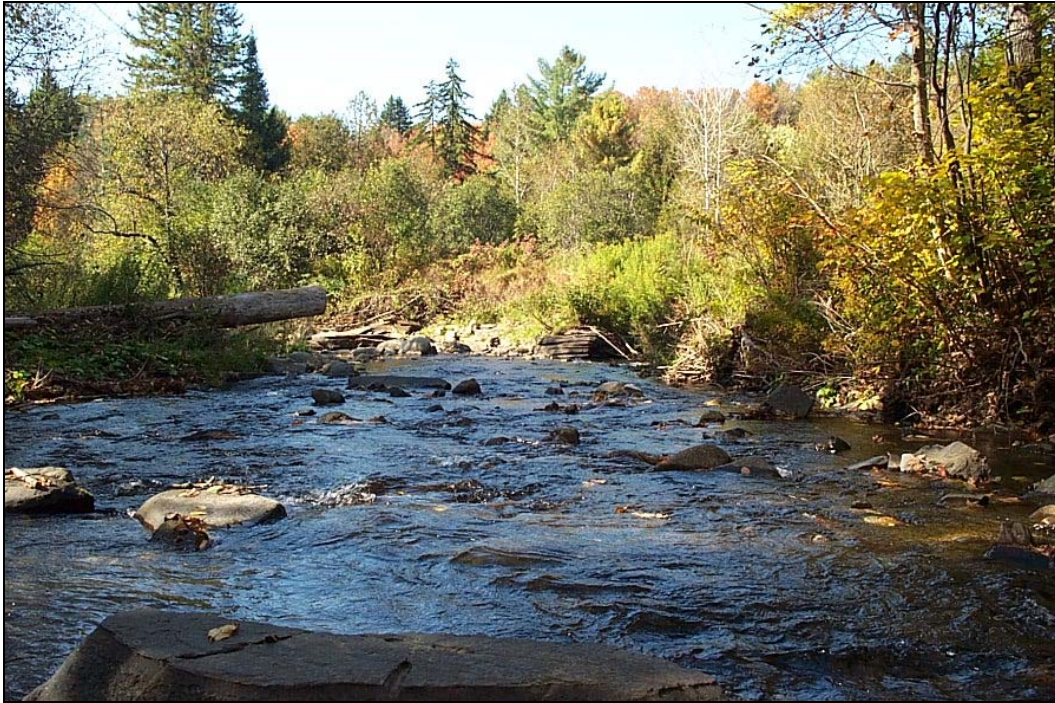
Winooski River segment R39-D begins across from Cabot Creamery and flows for 850 feet upstream to just below the Elm Street Bridge. The reach was believed to have been a “C” channel by reference; however, the segment has historically incised becoming a Bc. This incision has led to loss of a riffle-pool bedform. The stream has been actively adjusting through this reach through channel widening and planform adjustment. These adjustment processes have created a new smaller floodplain bench at the new bankfull level, however, the reach remains entrenched (Figure 4).

The stream corridor of this reach has been impacted by development. There are several stormwater outfalls into this reach. The right buffer averages between 5 and 25 feet, indicating disturbance.

Figure 4: R39-D is a C channel by reference that has undergone historic incision. The stream is actively widening and undergoing planform adjustment as it works to build a new floodplain bench.

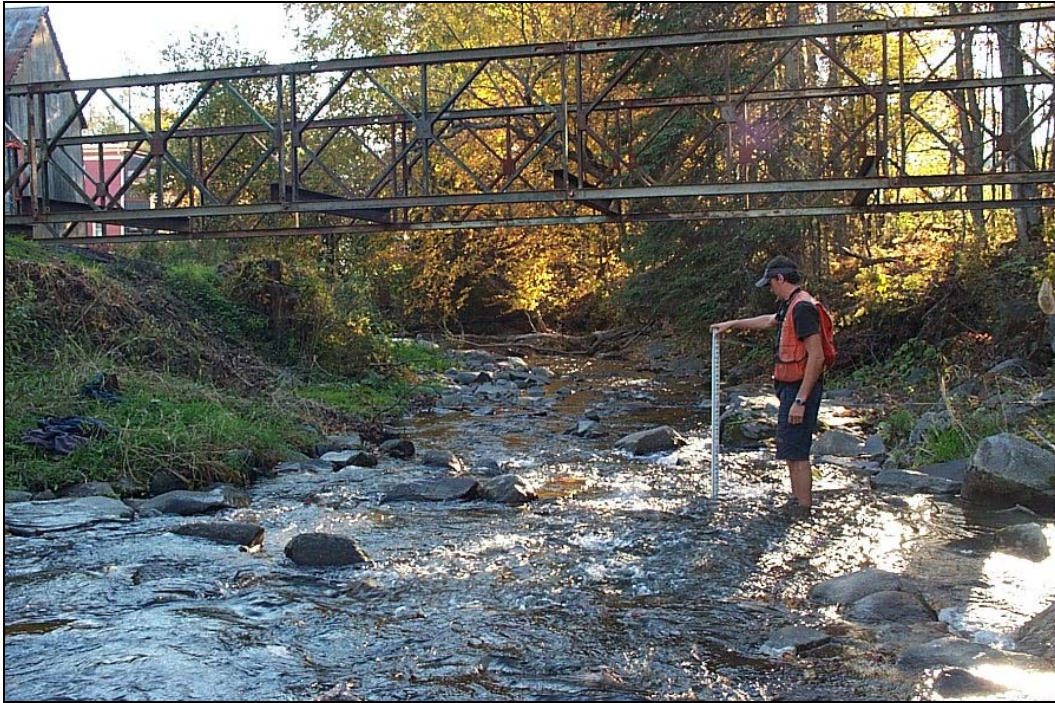
Segment R39-E begins just downstream of the Elm Street Bridge and continues upstream to the end of the reach, just north of the hardware store in Cabot Village. Here the valley walls of the Winooski River naturally narrow to a semi-confined valley. The reference stream type for this segment is a “B” channel dominated by cobbles. Floodplain encroachment, channel straightening, and streambank armoring, however, have combined to cause historic channel degradation within this reach and a change to a narrowly confined stream. The left streambank had 100% development within its corridor and less than five feet of riparian vegetation width (Figure 5). BCE scientists classified the reach as an F type channel with a plane bed form.

Figure 5: R39-E has undergone historic incision that may be associated with floodplain encroachment, straightening and armoring.

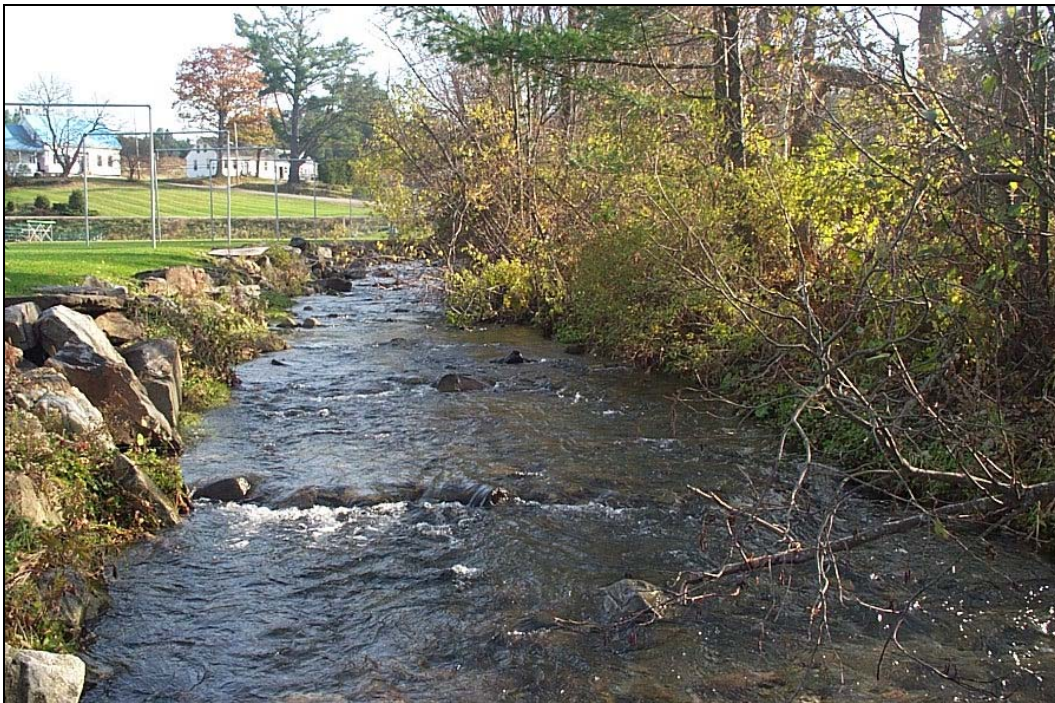
BCE scientists found evidence of historic channel incision (the incision ratio was measured to be 2.1). This incision was followed by widening as the stream attempted to redevelop a new floodplain at a lower elevation. Widening, characterized by severe bank erosion, has been managed by extensive armoring of the banks. The resulting response and management has led to an “F” type channel with a plane bed form (Figure 6).

Figure 6: T2.01 has been straightened. Incision and widening have created an “F” type channel that is no longer a riffle-pool system.

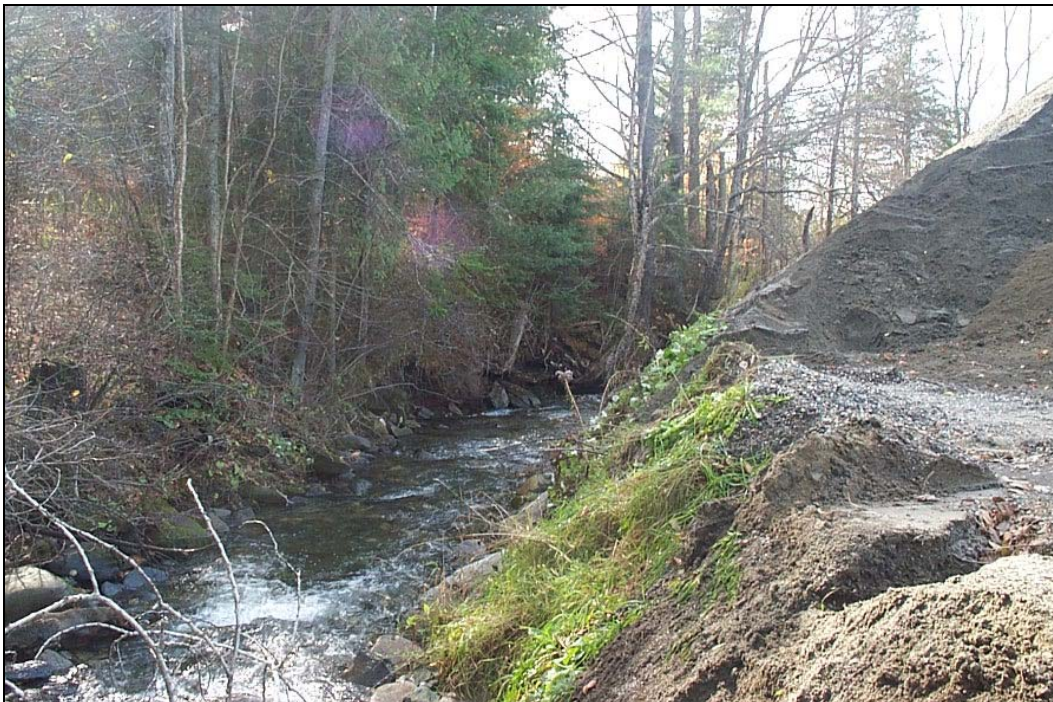
Cabot Town sand and gravel storage yard. Sand piles from the storage yard have removed access to the floodplain as well as allowing fine sediments to actively enter the stream system (Figure 7). Upstream of the town's sand yard the segment flows through a forested valley until reaching a bedrock waterfall that marks the end of the segment.

Figure 7: The Cabot Town sand and gravel storage yard has filled in the floodplain of segment T2.02-A as well as contributed fine sediment to the stream system.

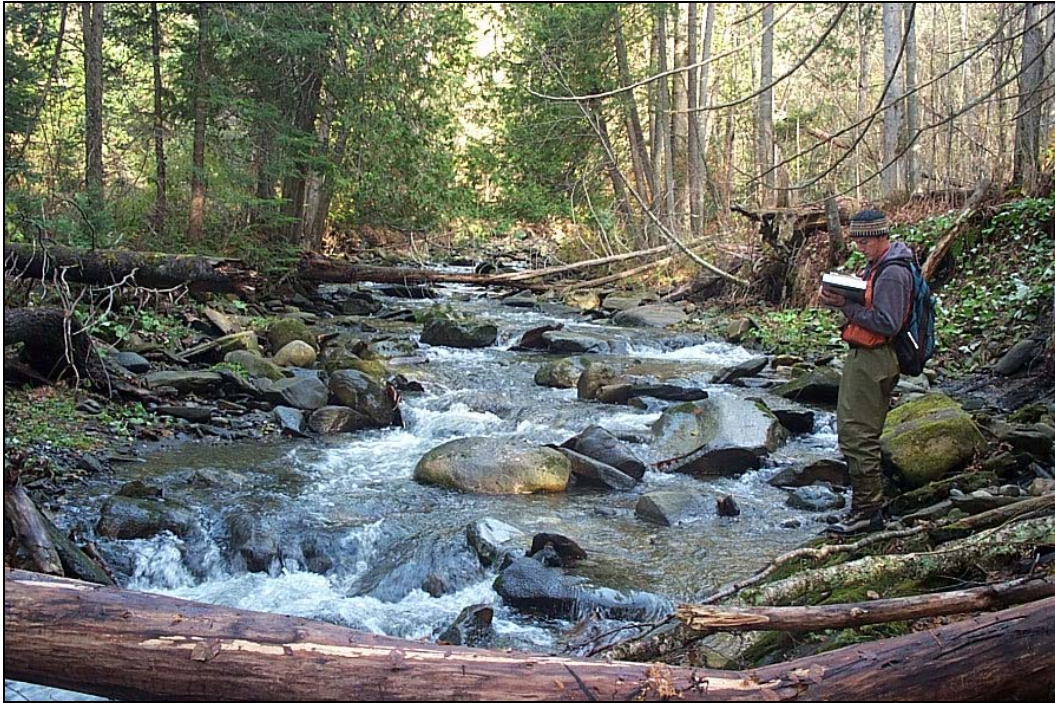
Extreme historic degradation has occurred in this segment. BCE scientists measured the incision ratio to be 2.8. As a result of floodplain loss, the stream has widened and undergone major planform adjustments (Figure 8). BCE scientists recorded that nearly half of the total length of each bank has been eroded by channel adjustment processes. In addition to this excess sediment, several mass failures were observed within this reach. By reference, this stream flows through a broad valley and is a "C" type channel with a plane bed form by reference. The major channel adjustments, however, have caused a stream type departure to a "B" channel. Widening and planform adjustment is likely to continue to occur where boundary conditions allow as the stream works to develop a wide floodplain and evolve back into a "C" type channel.

Figure 8: Segment T2.02-A has historically incised, widened, and rebuilt a small floodplain.

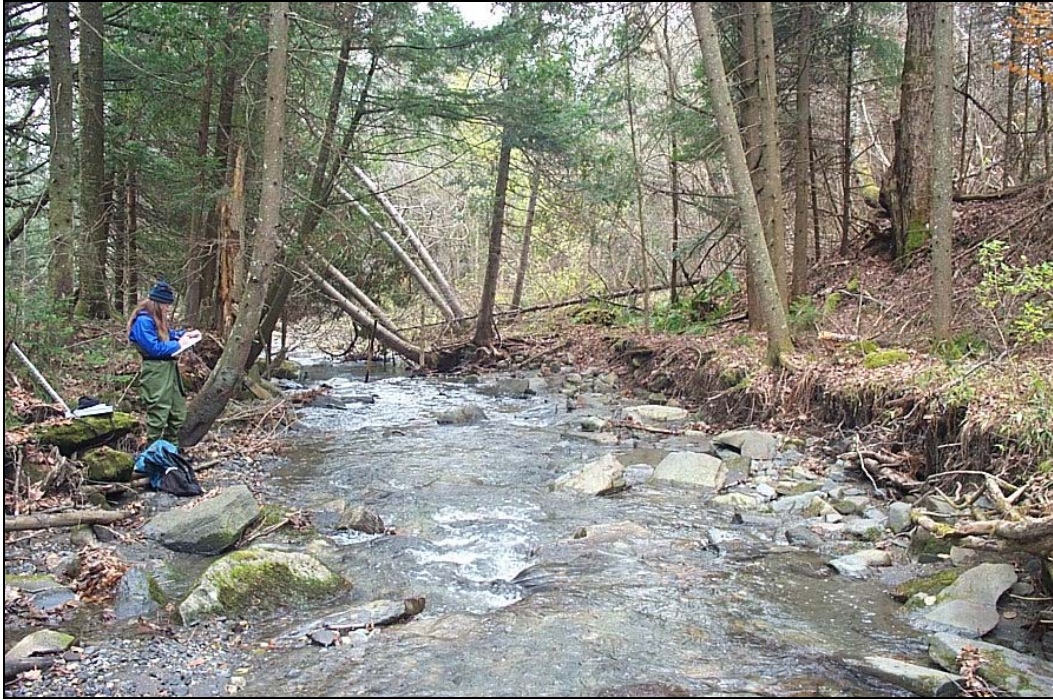
Tributary segment T2.02-B begins at a bedrock waterfall and continues upslope for 4500 feet until reaching the confluence of a major tributary several hundred feet upstream from Menard Road. The segment flows through a forested valley with well forested buffers on both banks. Despite grade control at the downstream end of this reach, this reach has also undergone extreme incision. The incision ratio was measured to be 2.1. Although the river is a “C” channel by reference flowing through a very broad valley, active incision has led to major widening and planform adjustment as the stream attempts to redevelop a new floodplain at a lower elevation (Figure9). Widening is evident in that nearly half of both streambanks were eroded and many trees had fallen into the channel. Planform adjustment was evident through multiple channel avulsions, flood chutes, and the undercutting of outside banks which has led to multiple mass failures.

The combination of these channel adjustments has led to a predominately “F” type stream channel. This reach will likely continue to undergo major planform adjustment and widening as a new floodplain is developed.

Figure 9: Typical cross-section along segment T2.02-B with weak riffle-pool bedform. The brook has shown extreme degradation, widening, and planform adjustment.

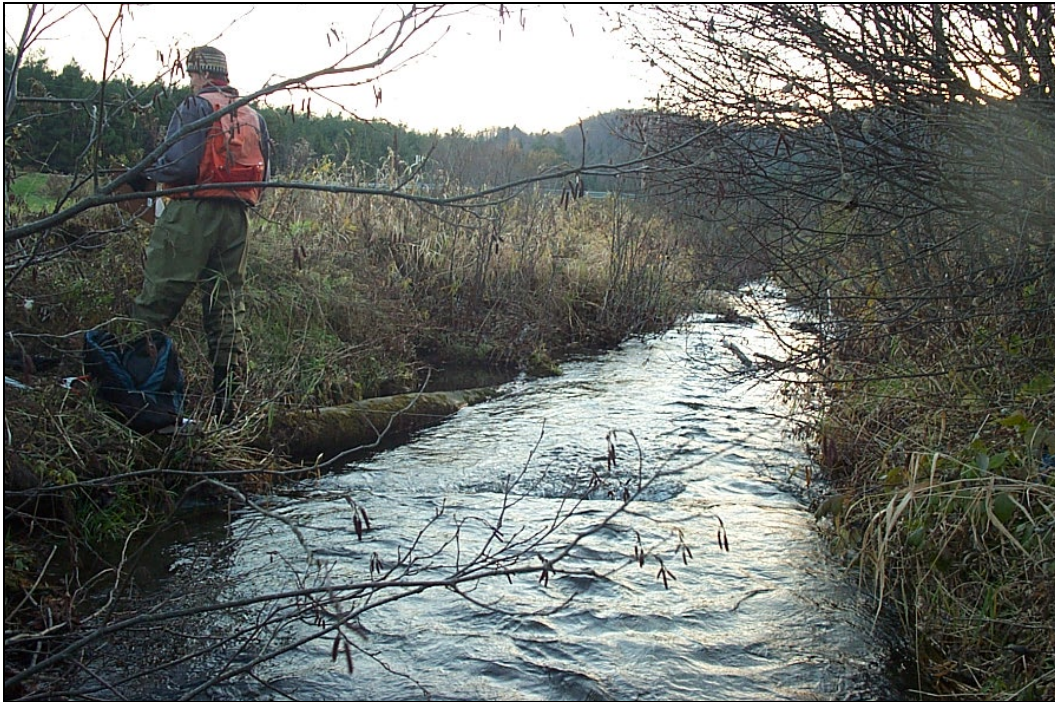
(less than 5 feet wide) riparian buffer and has likely lost much of its former floodplain access (Figure 10). In response, the channel was observed to be in the process of major widening and undergoing minor planform adjustment as it works to redevelop a low floodplain bench and regain its former sinuosity.

Figure 10: Segment T3.01 is an “E” type channel that has incised due to historic straightening and armoring.

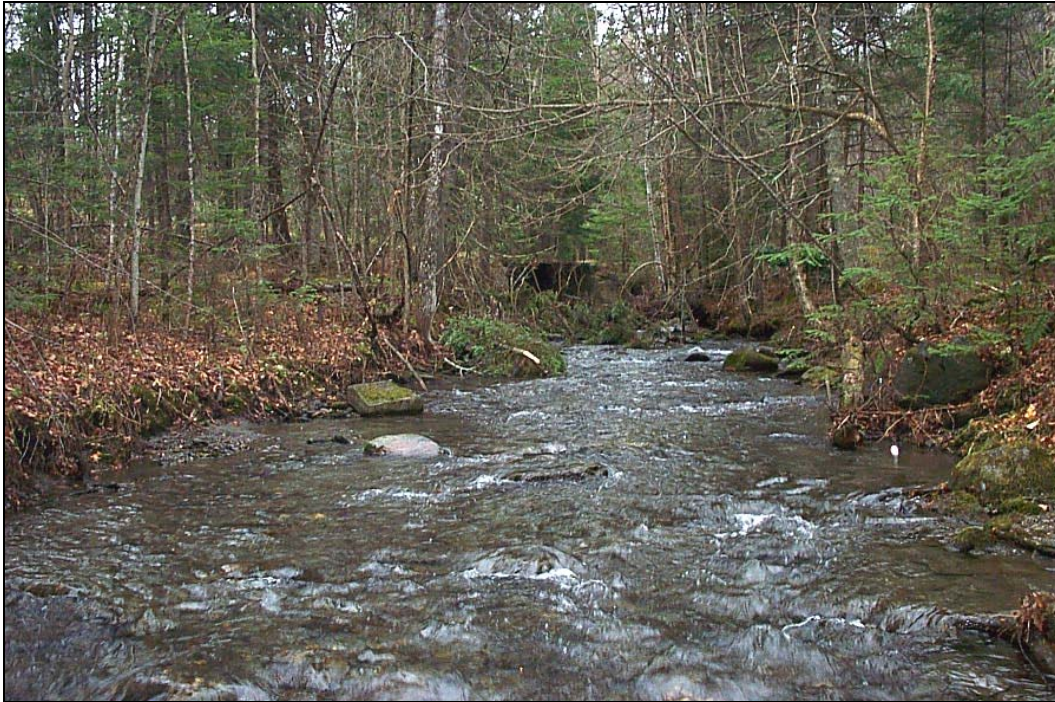
stream have been manually straightened. Four hundred feet of windrowing was observed on the right bank. One quarter of each bank has been impacted by rip-rap and channel armoring. The major adjustment process found was historic degradation which has led to an incision ratio of 1.5. Minor widening and planform adjustment is currently occurring within the segment. Despite these historic impacts and adjustment, the channel remains a “C” type stream which has a weak riffle-pool bedform (Figure 11).

Figure 11: Despite historic incision associated with straightening and floodplain encroachment, segment T3.02-A has retained some floodplain access and remains a “C” type channel.

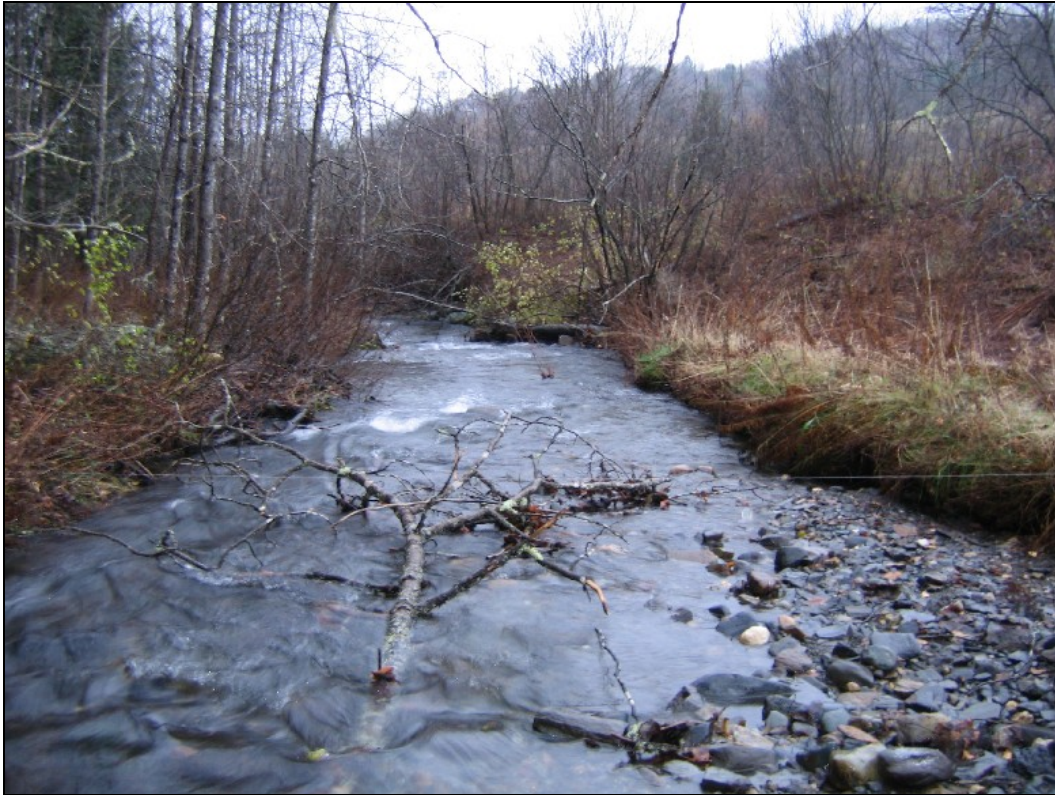
Segment T3.02-C is another short segment. It begins above the bedrock grade control of T3.02-B and continues upstream for 800 feet until a tributary enters the brook and reach T3.03 begins. This segment flows through a fairly well forested riparian buffer comprised of mixed trees. There is only minor floodplain encroachment within the reach from S. Walden Road. In general, the stream appears to have retained its natural sinuosity through this reach and its reference “C” type riffle-pool system. Minor degradation (incision ratio was measured to be 1.2) may have initiated some minor widening and planform adjustment through the reach; however, overall it is in good geomorphic condition (Figure 13).

Figure 13: Segment T3.02-C is undergoing some minor widening and planform adjustment, however, is in good geomorphic condition as a “C” type riffle-pool stream.

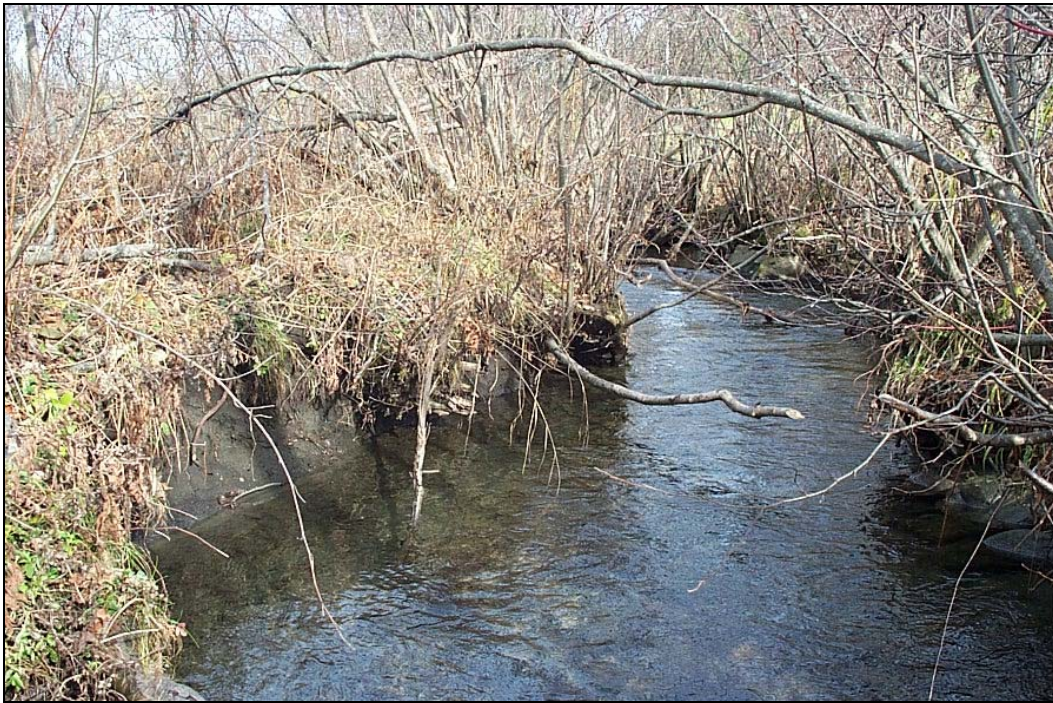
streambanks of this reach to show sign of active erosion. In response, over one third of each bank has been rip-rapped with rock armor, further destabilizing the channel. The reach is currently undergoing extreme planform adjustment and widening (Figure 14). At the time of the study the reach has remained an “E” type channel with a riffle-pool bedform.

Figure 14: Segment T3.03-A is undergoing extreme planform adjustment and widening.

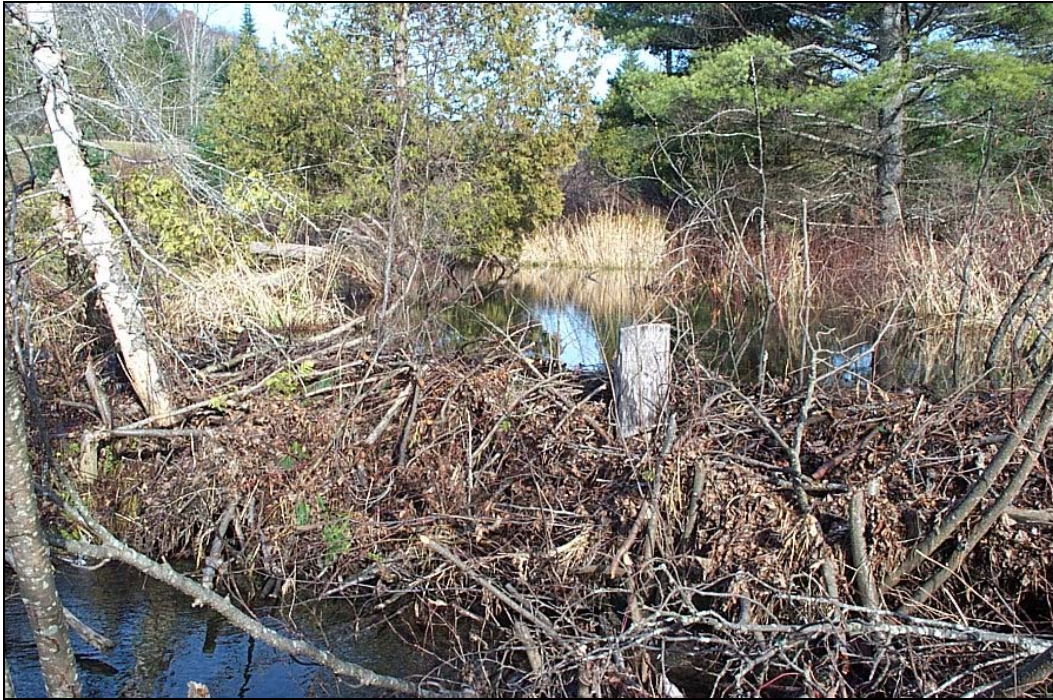
Segment T3.03-B was only partially assessed due to six beaver dams which have altered nearly all of the 650 feet of the 850 total feet of this segment at the time of this study (Figure 15). In general this reach was bordered by a healthy riparian buffer and would be considered an “E” type stream by reference.

Figure 15: Water and sediment flow through segment T3.03-B was altered by six beaver dams at the time of the study.

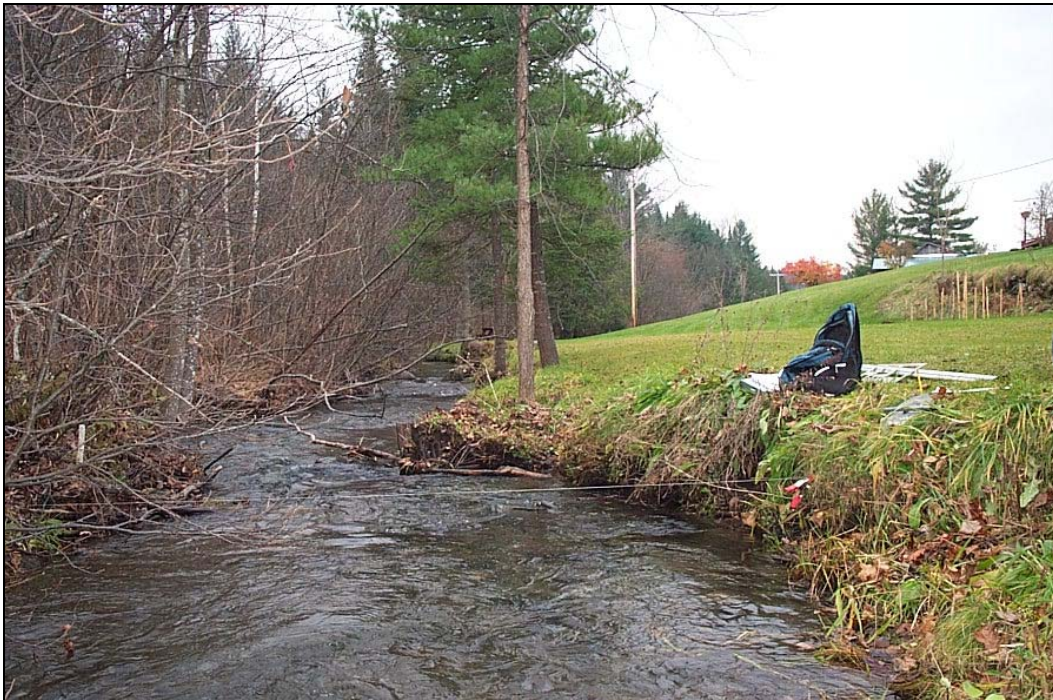
Segment T3.04-A is a 750 foot segment that has been extensively historically straightened. The segment corridor is dominated by shrub and saplings on the left side (where the buffer width is over 100 feet wide) and residential development on the right (where the buffer width is less than 5 feet wide) (Figure 16). Rock armoring of the channel exists on 360 feet of the right bank. While this segment has remained an “E” type channel, historic straightening has caused the reference riffle-pool bedform to be replaced with a plane bed system. In addition, this straightening has likely led to bed degradation (the incision ratio was measured to be 1.7). This major historic incision is being followed by minor aggradation, widening, and planform adjustment.

Figure 16: Segment T3.04-A has been straightened and incised. The right buffer has been significantly impacted.

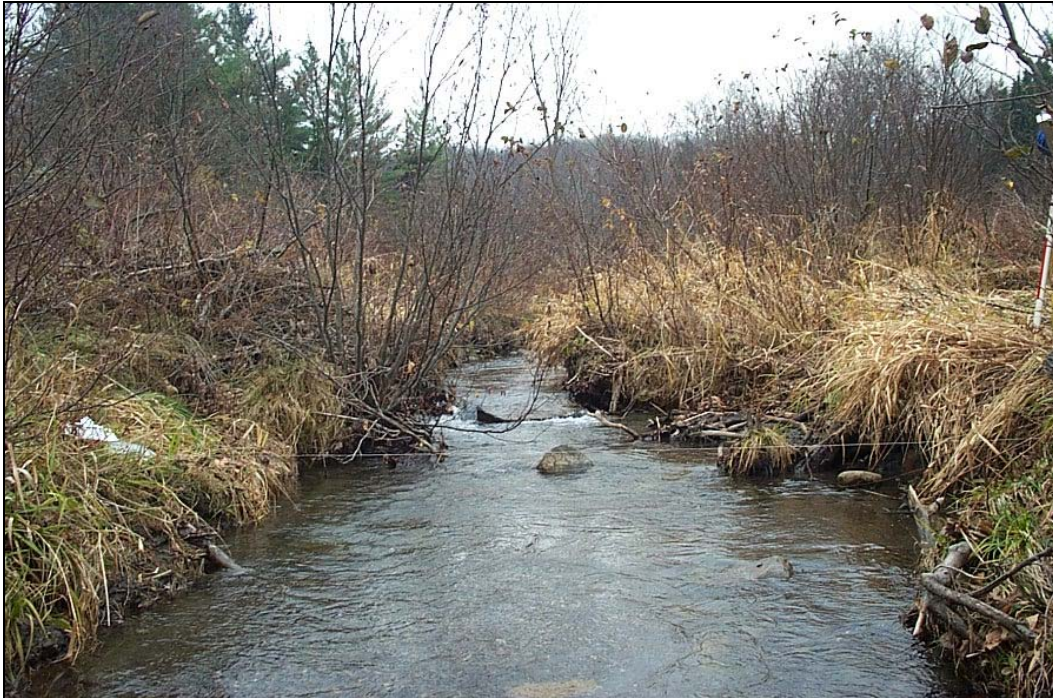
Figure 17: Segment T3.04-B has a healthy riparian buffer of native shrubs that help to maintain the “E” type channel.

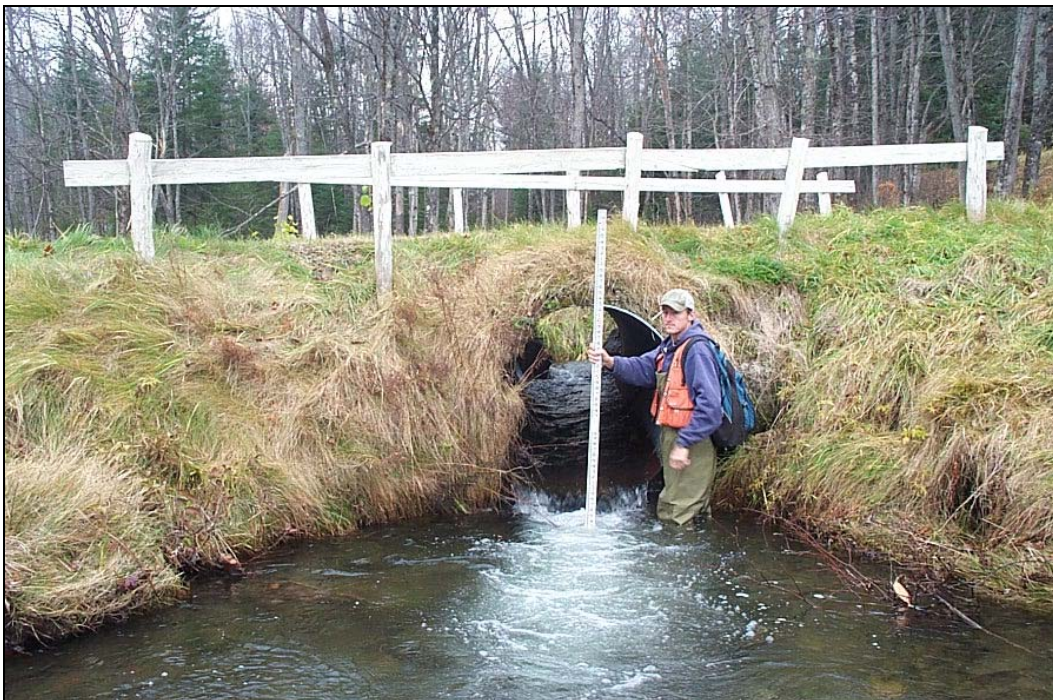
Of the impacts that have occurred to this reach, perhaps the most profound are the two channel constrictions, a four foot diameter culvert (Figure 18) and an old foot bridge, that are disrupting sediment transport in the reach.

Figure 18: An undersized culvert on segment T3.04-B is disrupting sediment transport and flow through this reach.

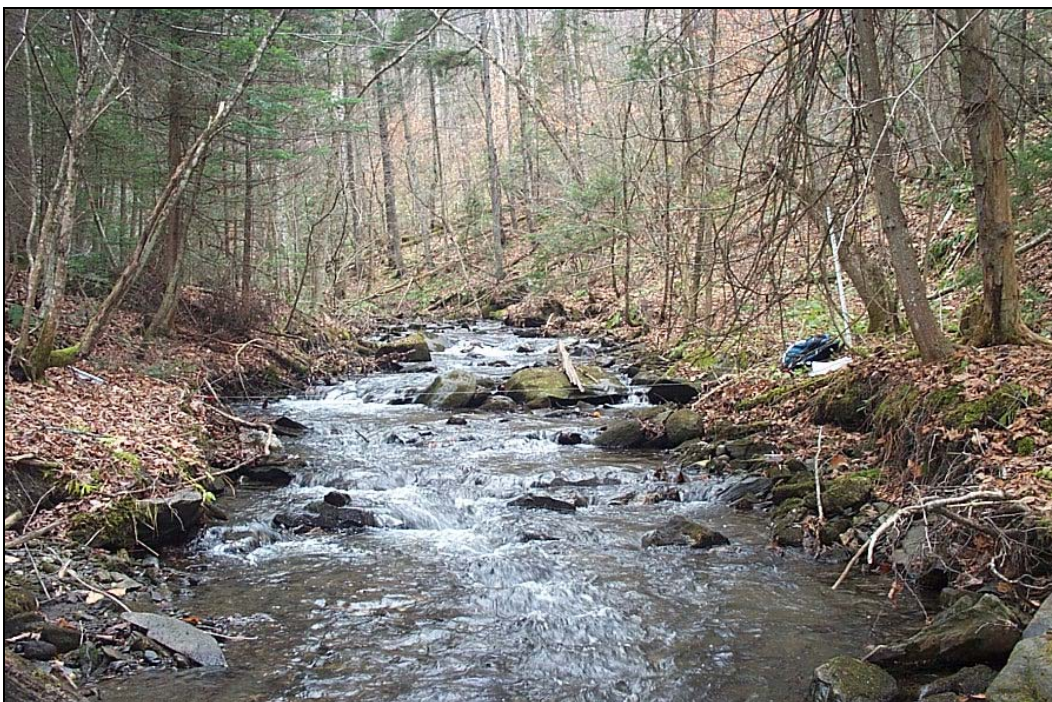
Segment T3.04-C is a segment of nearly 2500 feet that begins where the valley wall confines and the slope of the tributary increases. The segment flows through forested land of mixed trees over several bedrock ledges that provide grade control to the reach. The stream is a naturally semi-confined “B” type system with a step-pool form (Figure 19). While there has been some evidence of channel straightening along 500 feet of the segment, the reach appears to be mostly unaffected by it. Again good grade controls and a forested buffer are keeping the segment relatively stable. Some minor planform adjustment was noted by BCE scientists; however, this was typically associated with large woody debris recruitment as the stream adjusted around a fallen tree. Overall this reach was in good geomorphic condition.

Figure 19: Segment T3.04-C is a “B” type channel with a healthy riparian buffer.

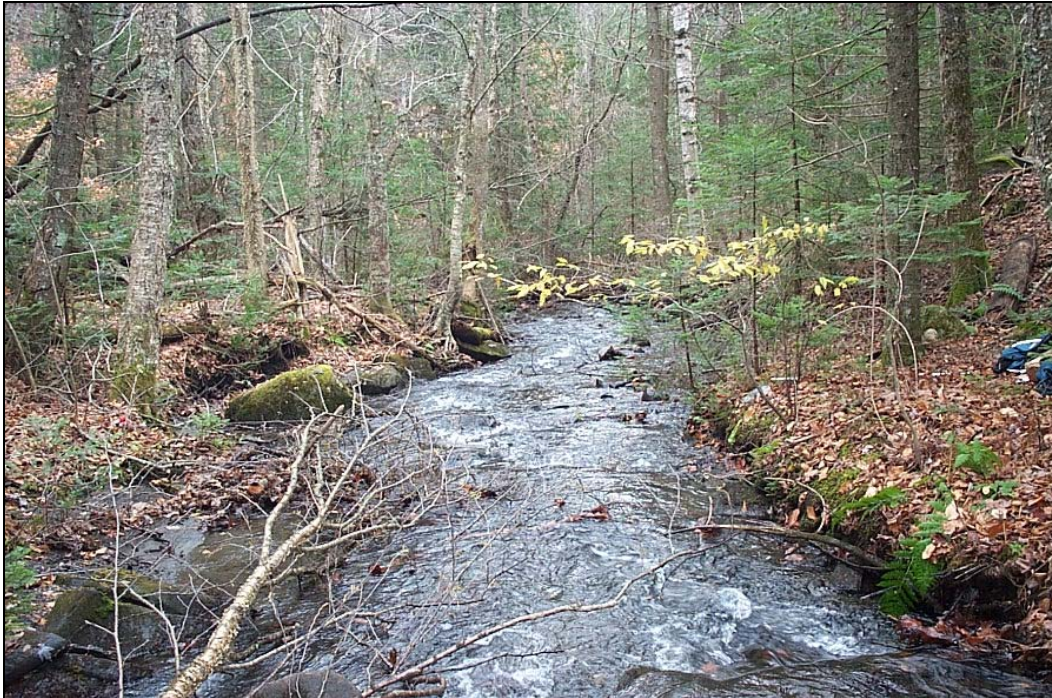
bedform (Figure 20). This segment flows through an undisturbed forested buffer. Only very minor degradation was observed in this reach, which is in overall good geomorphic condition.

Figure 20: Segment T3.04-D is in good geomorphic condition.

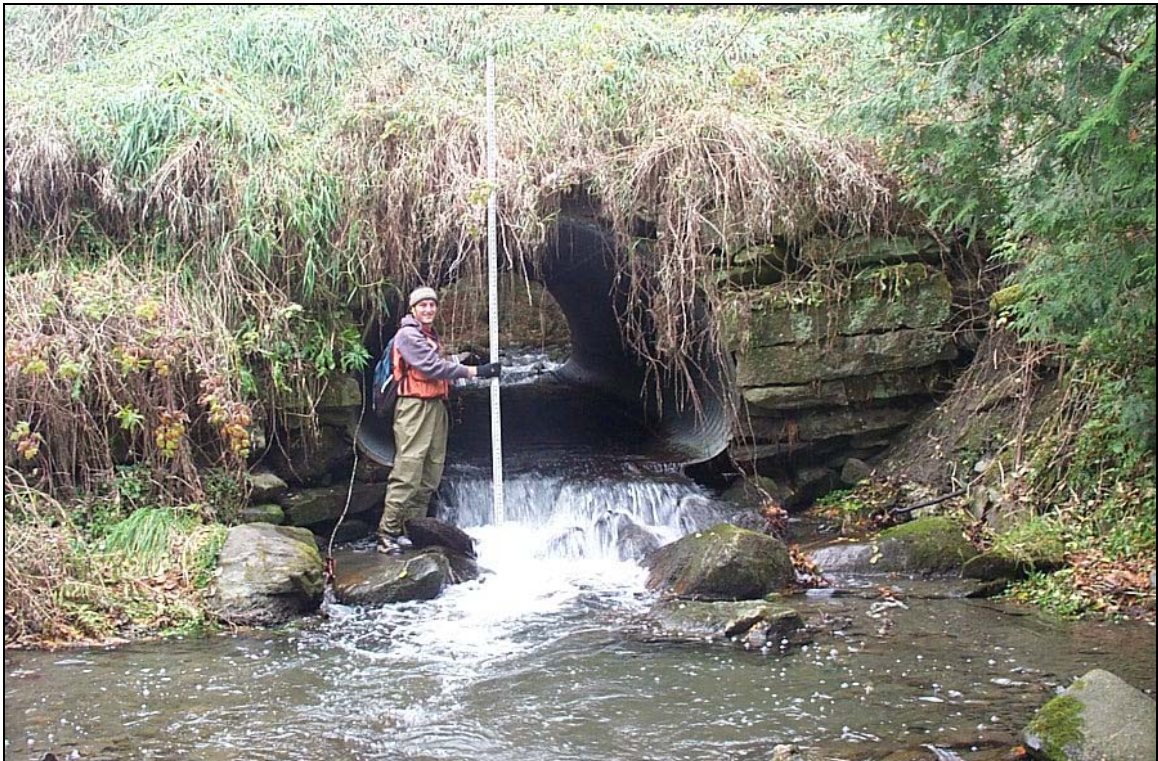
Figure 21: Undersized culverts disrupt the sediment transport capacity of the stream and may lead to both upstream and downstream destabilization. Improperly sized structures, such as this one on T2.02-B, can create scour below.

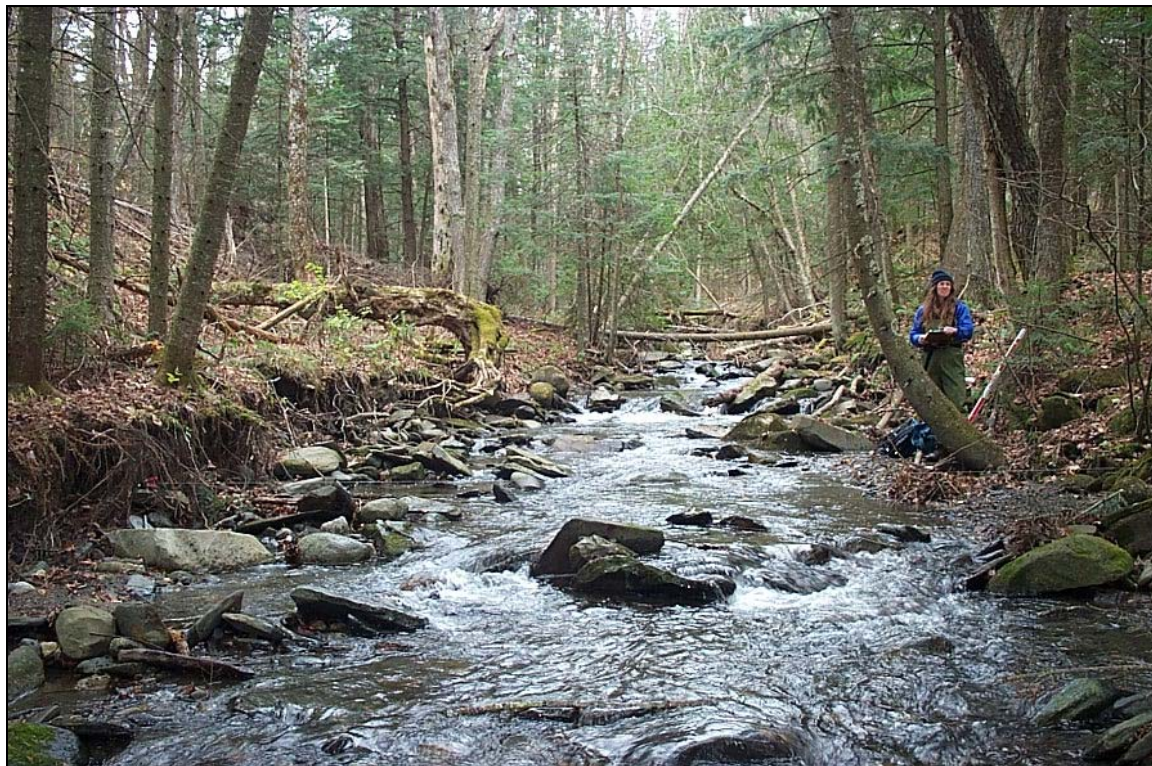
Figure 25: Reach T2.02-B rated “fair” for habitat, but poor for geomorphic condition. The reach had a high percentage of unstable banks and substrate embeddedness was rated as only fair.

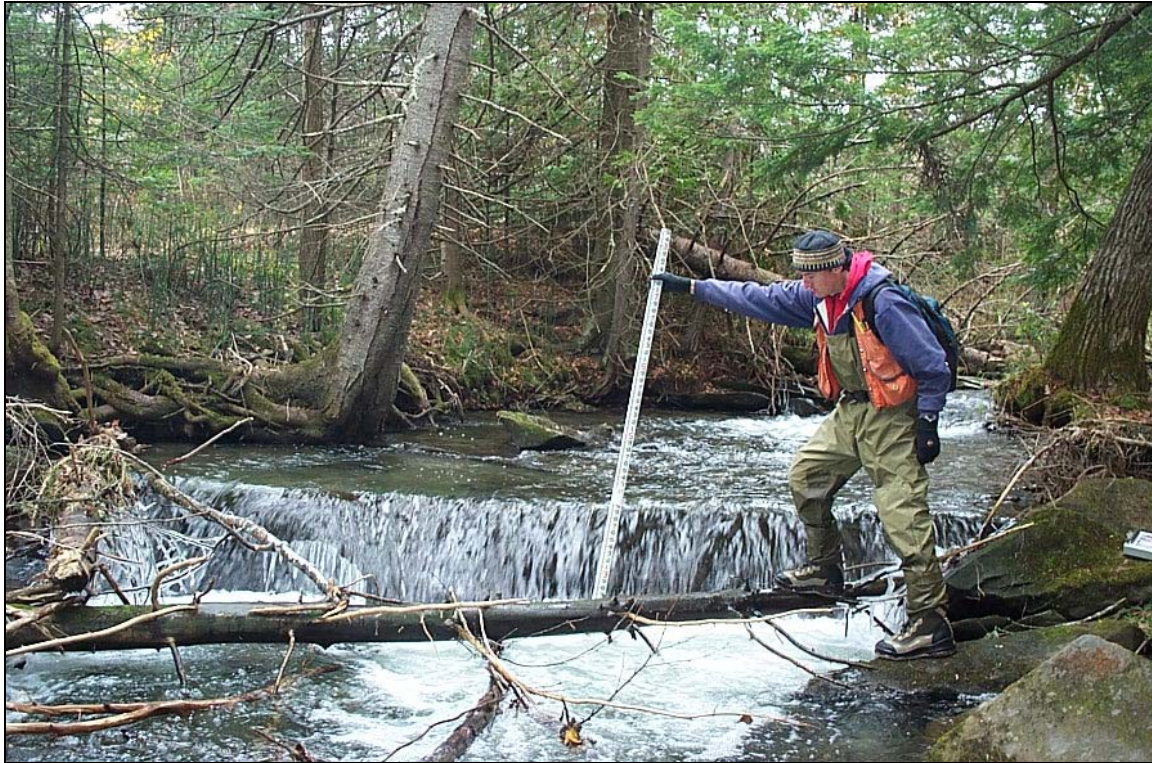
Figure 26: Reach T3.02-B rated “good” for habitat. The reach had in-stream woody habitat, excellent riparian vegetation and riparian buffer, a diversity of substrates, and a diversity of flows including several deep pools.
