Upper Winooski River River Corridor Management Plan Cabot, Vermont

June 15, 2006

Executive Summary

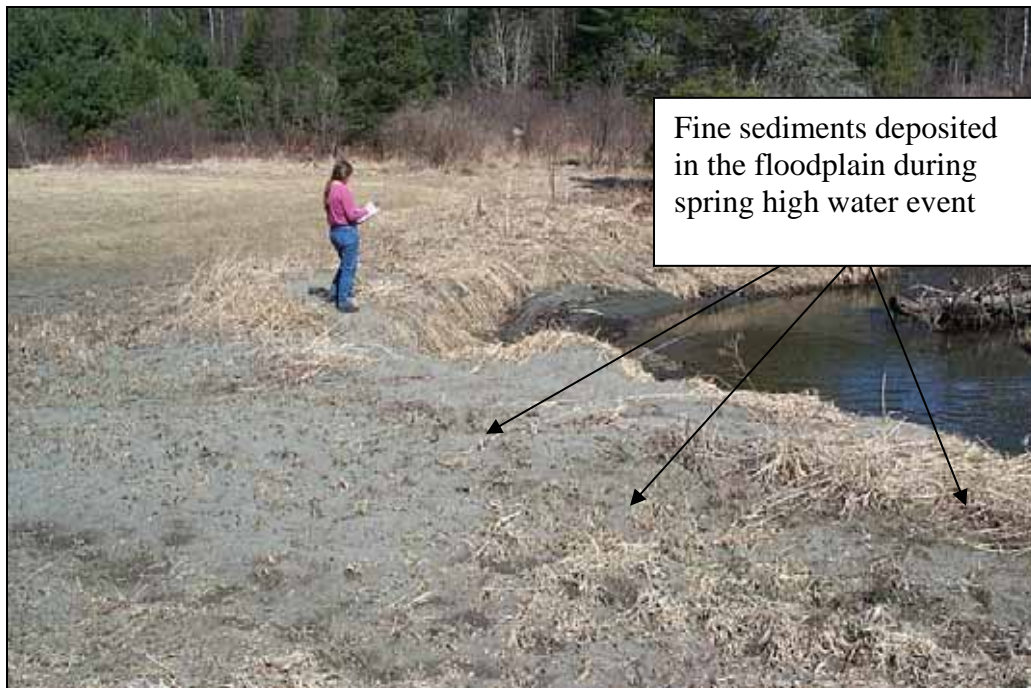
Functioning floodplains play a crucial role to providing long term stability to a river system (see Figure 4). Natural and anthropogenic impacts may alter the delicate equilibrium of sediment and discharge in natural stream systems and set in motion a series of morphological responses (aggradation, degradation, and widening and/or planform adjustment) as the channel tries to reestablish a dynamic equilibrium. Small to moderate changes in slope, discharge, and/or sediment supply can alter the size of transported sediment as well as the geometry of the channel; while large changes can transform reach level channel types (Ryan 2001). Human-induced practices that have contributed to stream instability within the Winooski watershed include:

Figure 4: Sediment deposition along an accessible floodplain of the Winooski River.

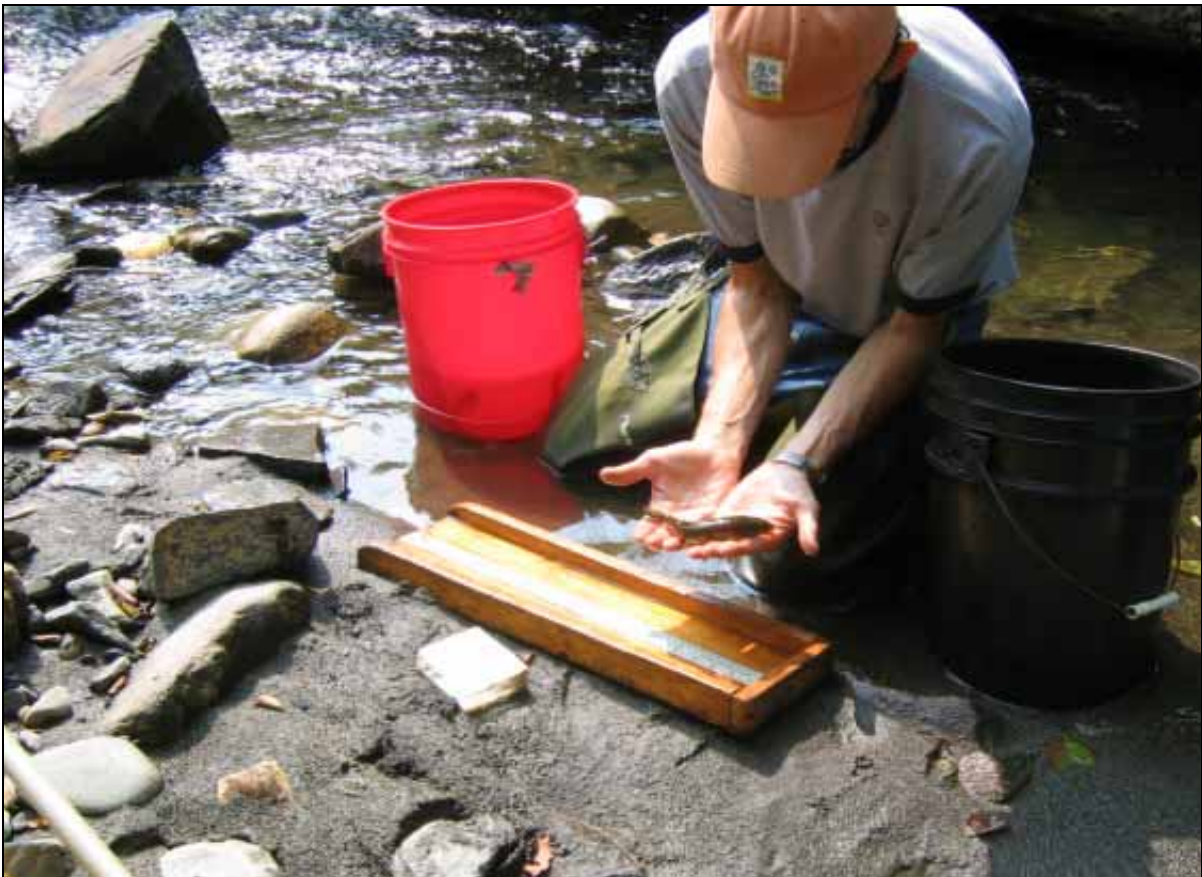
Figure 6: Rich Langdon measures the length of a longnosed sucker during fisheries monitoring conducted by the Vermont Department of Environmental Conservation in September 2005 on the upper Winooski River in Cabot.

The Vermont Department of Environmental Conservation has conducted biological assessments of fish assemblages from three sites on the Winooski River in Cabot since 1994. Fish population monitoring by the ANR was conducted as recently as September 2005 on the Winooski River just downstream of the Cabot Recreation Field (see Figure 6). According to Langdon (2006), the fish and macroinvertebrate assemblages of the Winooski River in the vicinity of Cabot are in *very good* to *excellent* condition, upstream and across from, the village. The macroinvertebrate assemblage downstream, near Durant Cemetery, was rated as *very good*, but the fish community was only in *fair* condition when sampled in 2000. The macroinvertebrates were sampled again in 2005, providing a similar evaluation of very good. Fish density at all three Upper Winooski River sites was low, indicating a fairly unproductive system (Langdon 2006).

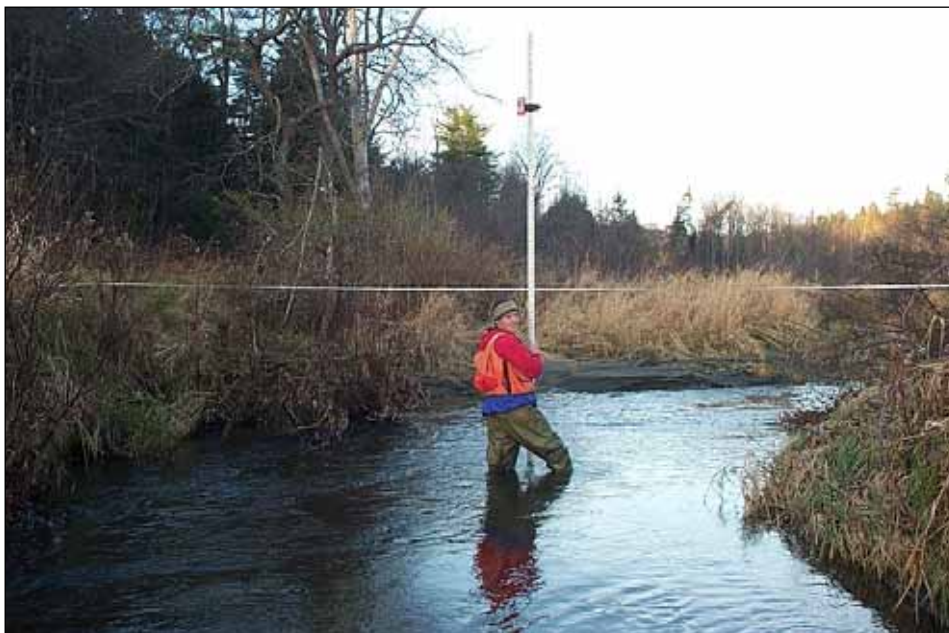
Figure 9. Michael Blazewicz of Bear Creek Environmental measures the cross-sectional area of the channel above Cabot Village during a Phase 2 Assessment in fall 2005.

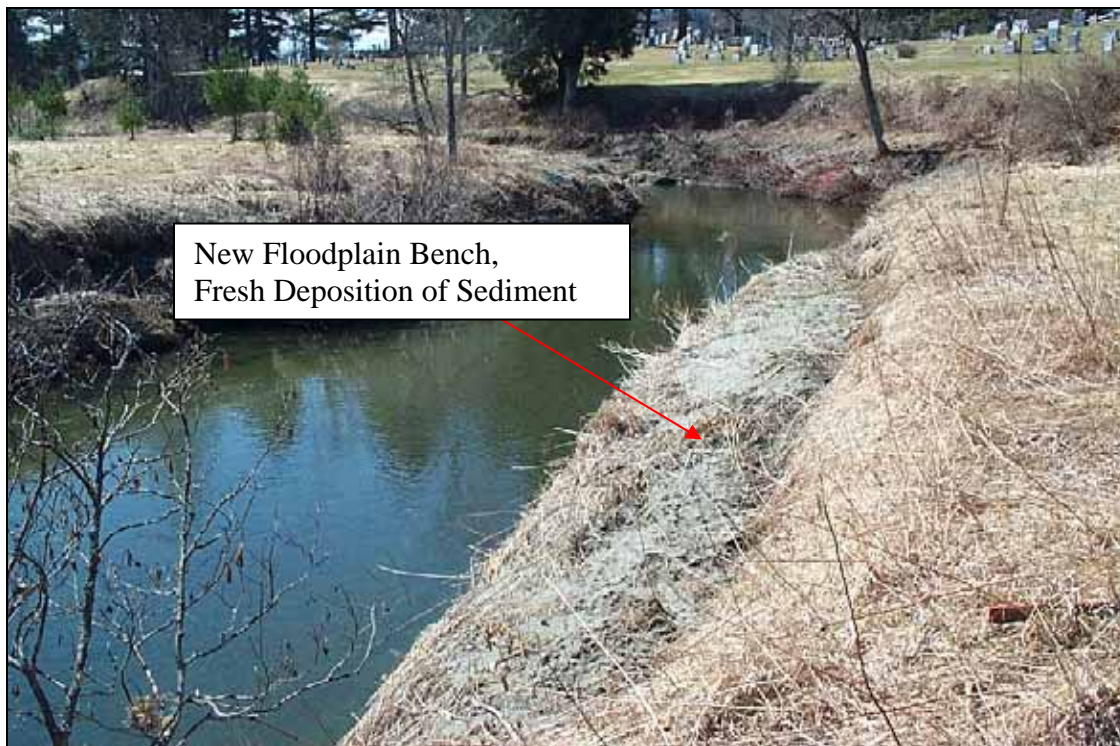
Figure 11. The upper Winooski River is working to create a new floodplain bench just upstream of Durant Cemetery.

The Phase 2 Rapid Geomorphic Assessment (RGA) provides information on the geomorphic condition of each segment within the study area (Figures 10). Many of the tributaries and the main stem of the Upper Winooski River in Cabot are experiencing high rates of bank erosion. The bank erosion has been accelerated due to land use activities and channel and floodplain modifications. Significant channel straightening, bank armoring, berming, and floodplain encroachment have occurred within this river system both on the mainstem and on the lower ends of the tributaries. These impacts have resulted in the loss of natural energy dissipation of the river system via meandering and flooding the fields along the river. Over time, the river has down cut into the streambed resulting in loss of floodplain access and increased energy within the channel. The increased energy within the channel has lead to severe bank erosion and subsequent channel widening. Along much of the main stem, the river channel is currently migrating laterally to recreate a new floodplain at a lower elevation to dissipate the energy and to become more stable (see Figure 11).

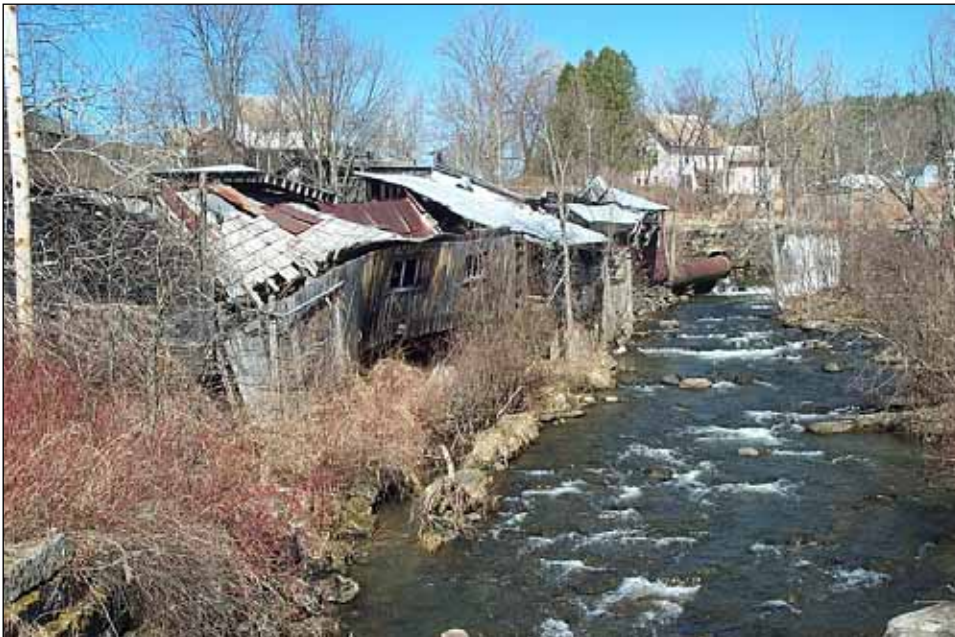
Structures that encroach into the river corridor (see Figure 12) are not only threatened by the river, but the armoring and berming of the river banks often deemed necessary to protect these investments may pose a threat to downstream areas, by limiting slope adjustments and increasing flood velocities and stream power of the confined stream. Floodplain encroachments typically concentrate flow in the channel during floods, increasing the stress of flood flows on the channel bed and banks. They can also effectively turn a response or depositional stream into a transfer stream, which may lead to an increase in sediment loading and aggradation, as well as bank erosion, in downstream reaches.

Figure 12: An example of encroachments within the river corridor below Clark's Saw Mill Dam.

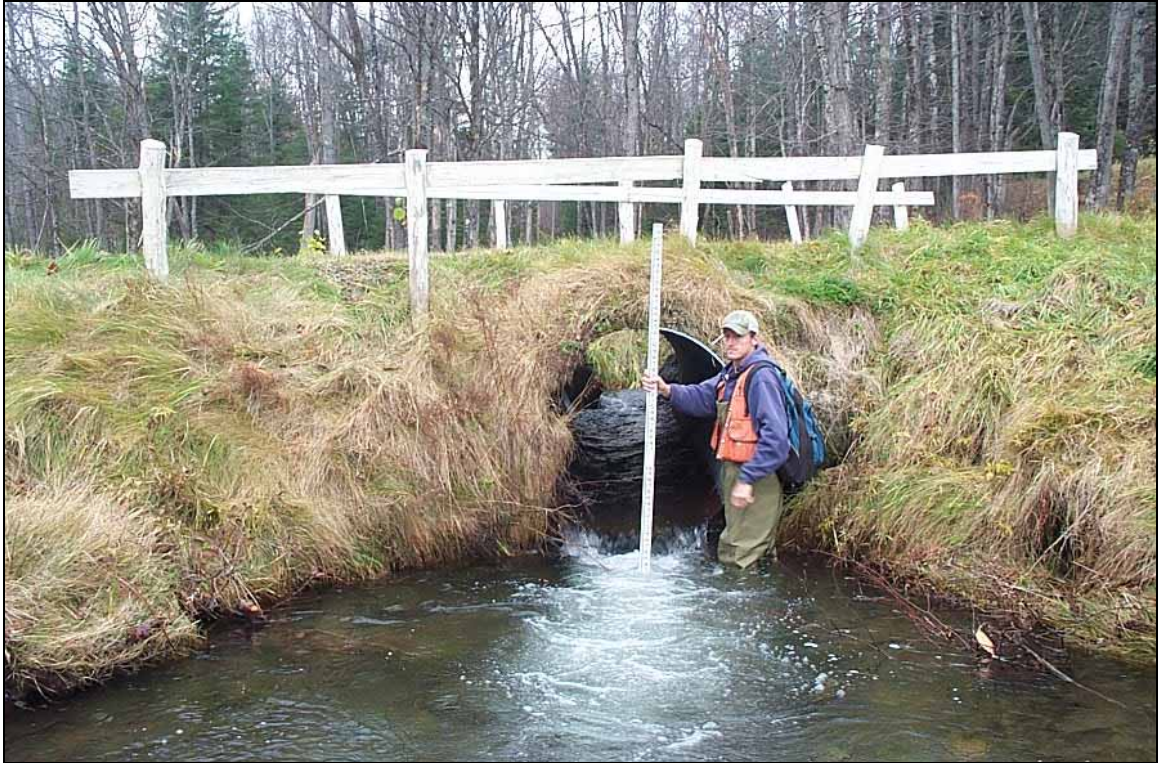
Within the Upper Winooski River study area, improperly sized bridge and culvert crossings were identified during the Phase 2 Stream Geomorphic Assessment as contributors to localized channel instabilities (Figure 13). A more detailed assessment of stream crossings using the Vermont Agency of Natural Resources Bridge and Culvert Assessment is recommended to better understand and catalog the geomorphic instability caused by stream crossings on a reach level. The geomorphic context of stream crossings should be given strong consideration when designing new and rehabilitating existing structures. The Town of Cabot could establish ordinances or identify zoning requirements which would ensure adherences to proper siting and design practices for future development, especially on private crossings.

Figure 13: An example of an undersized culvert on Walden Brook.

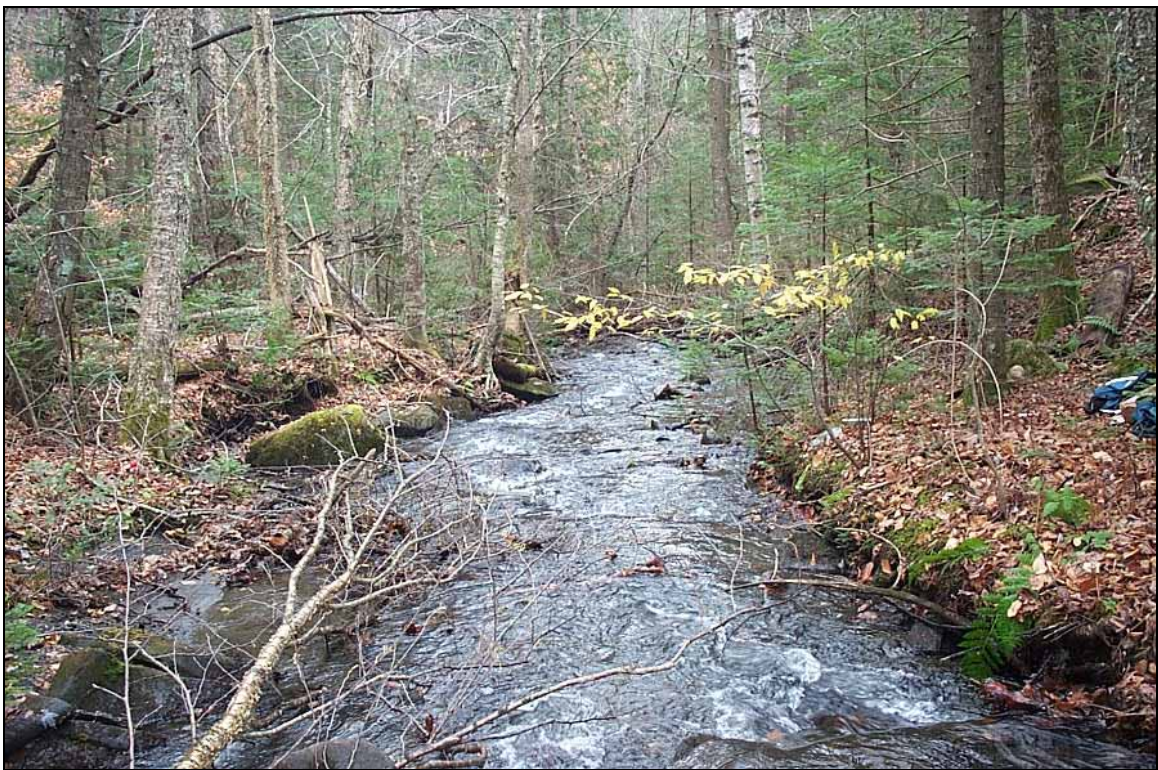
Figure 20: Reach T3.04-D, an exemplary conservation reach in the headwaters of Walden Brook.

Conservation reaches are generally in stable geomorphic condition and need little restoration work (see example in Figure 20). In Cabot, three of the four conservation reaches identified flow through bedrock controlled channels that help to define their width and depth. Conserving a riparian corridor along these reaches is good policy.

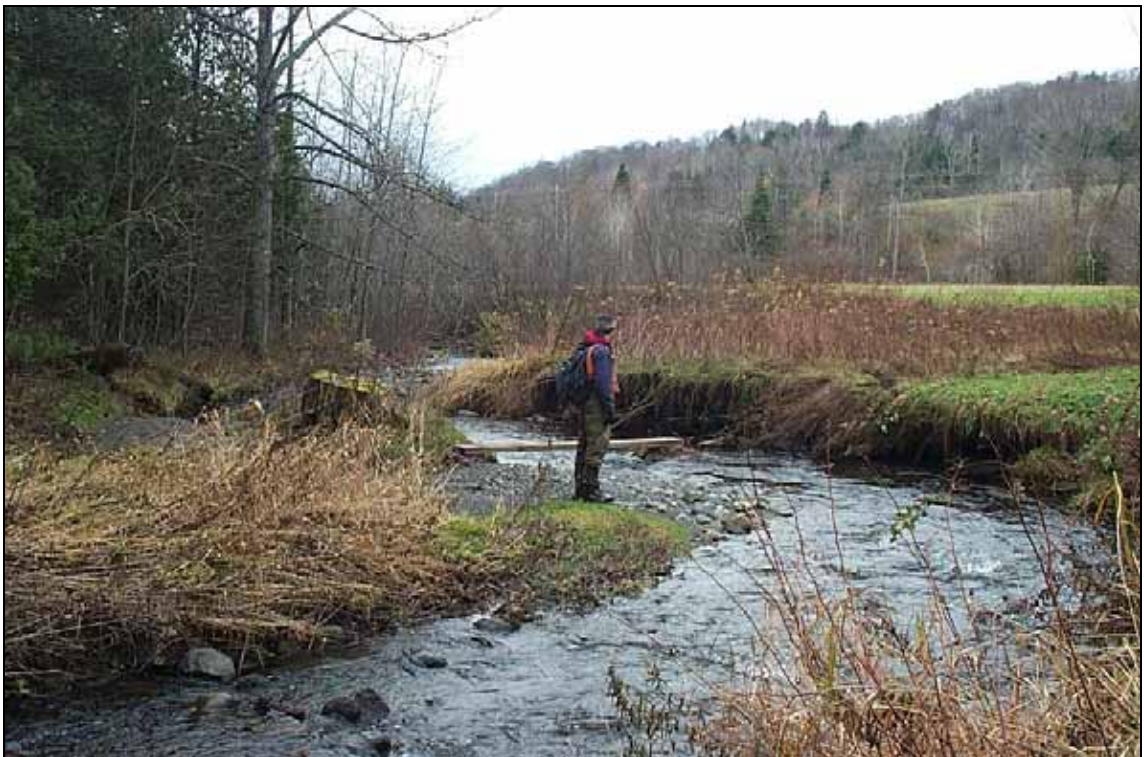
Figure 21: Reach T3.02-C, of Walden Brook, is an exemplary high recovery reach.

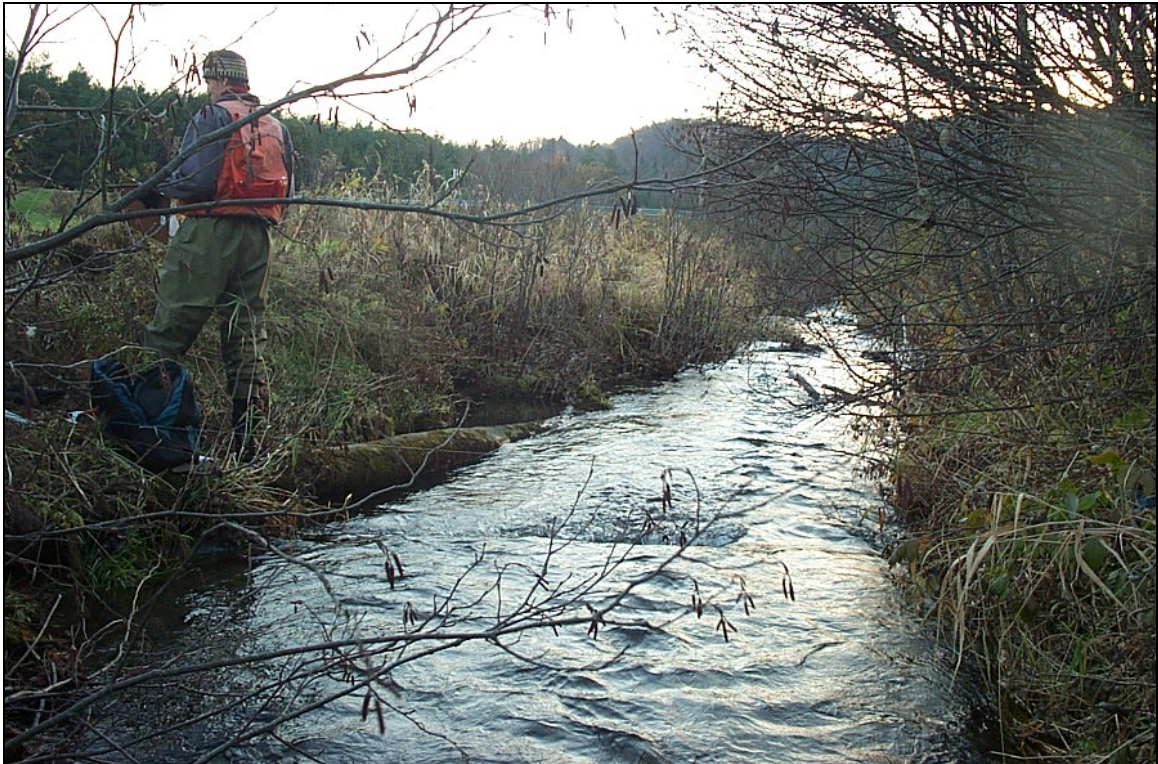
Moderately unstable reaches may not have expected channel dimensions, patterns, or profile (see Figure 22). They are best approached through conducting alternatives analysis in order to determine the best strategy for restoration. General strategies for implementation may include the following:

Figure 22: Due to historic channel straightening, reach T3.01, has incised and is considered a moderately unstable reach.

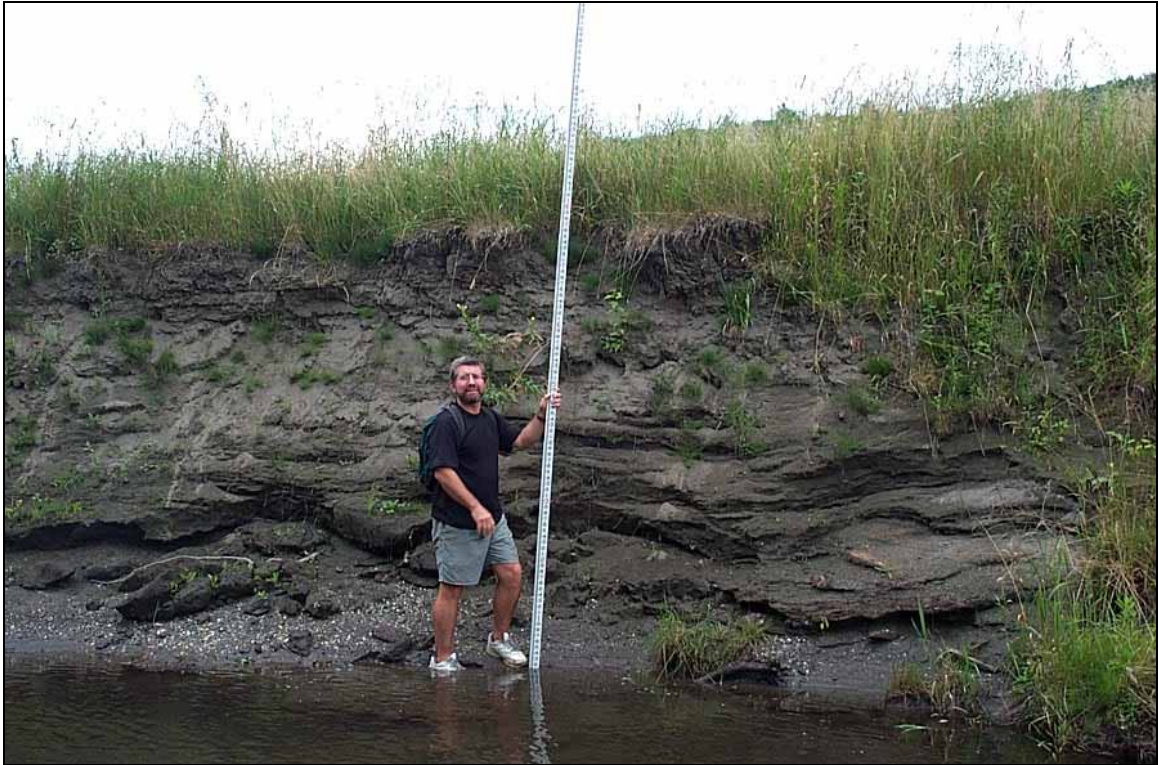
Figure 23: Reach R37-B, is highly incised and has been classified as a highly unstable reach.
