Lake Watershed Action Plans

Alison Marchione
Shoreland Restoration Ecologist
Vermont Department of Environmental Conservation
Alison.Marchione@vermont.gov

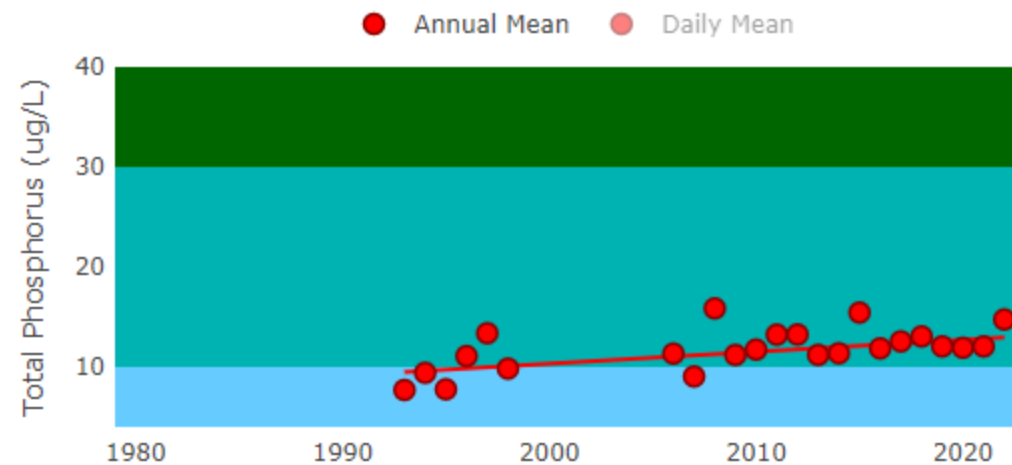
Summer Phosphorus

Trend: Highly Significantly Increasing (p-value = 0.0052)

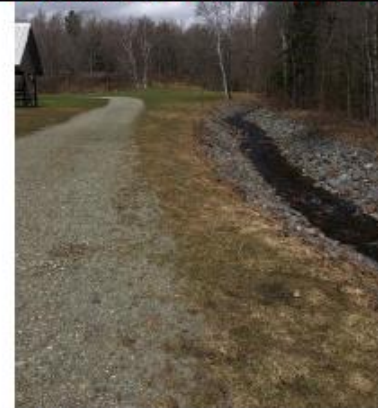
Photo 1: Tributary is straightened, armored, and lacks an adequate buffer.

Site Description: The stream passing through the park is straightened and lined with rip-rap for approximately 400 feet, with no buffer on the west side adjacent to the gravel picnic area access. The lakeshore is also lacking a native buffer, with mowed lawn extending from the east side of the swimming area to the tributary outlet. Gravel roads and parking areas could be mitigated with enhanced infiltration on the property. [See concept design in Appendix E for updated scope and cost opinion.](#)

BMP Description: Plant a buffer along the east side of the stream. Install infiltration steps to provide an access to the stream. Consider moving the picnic area road to the west side of the pavilions. The tributary channel could be naturalized with a flood bench, natural substrate, and wood habitat features. Implement "no mow" areas along the hill on the east side of the property, around trees, and near lakeshore if possible. Install grass-lined swales or infiltration basins to enhance infiltration on the property.

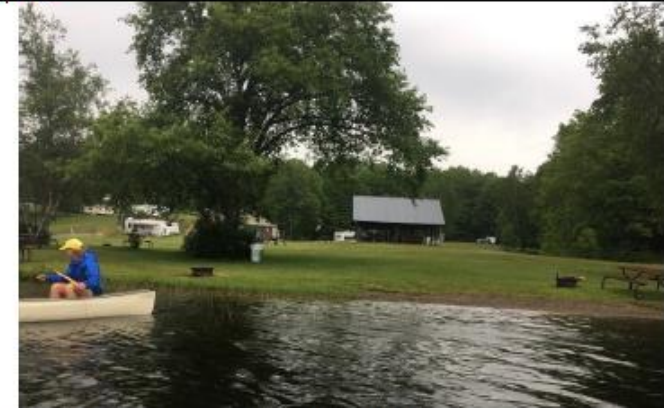
Photo 2: Mowed lawn along the lakeshore with potential space for an infiltration feature.
