Natural Resources Conservation Service
DAMAGE SURVEY REPORT (DSR)
Emergency Watershed Protection Program – Recovery

D. Client's Objective(s) (purpose): To stabilize an actively eroding stretch of Winooski River that is threatening infrastructure along Martin Meadow Road in the Town of Plainfield.		A. Client Name: Town of Plainfield B. Conservation Plan ID # (as applicable): 50 01 24 5042 017-126 Program Authority (optional): EWP C. Identification # (farm, tract, field #, etc. as required): 203 Martin Meadow Road, Plainfield, VT

DSR 50-01-24-5042-017

Purpose: This report presents a review of available geologic data used to evaluate conditions which may affect the planning, design and scope of a proposed stream bank stabilization project. After a brief initial desk review it was determined that a field reconnaissance investigation was required to properly assess the site. The results and interpretations of the desktop and field investigations are summarized here.

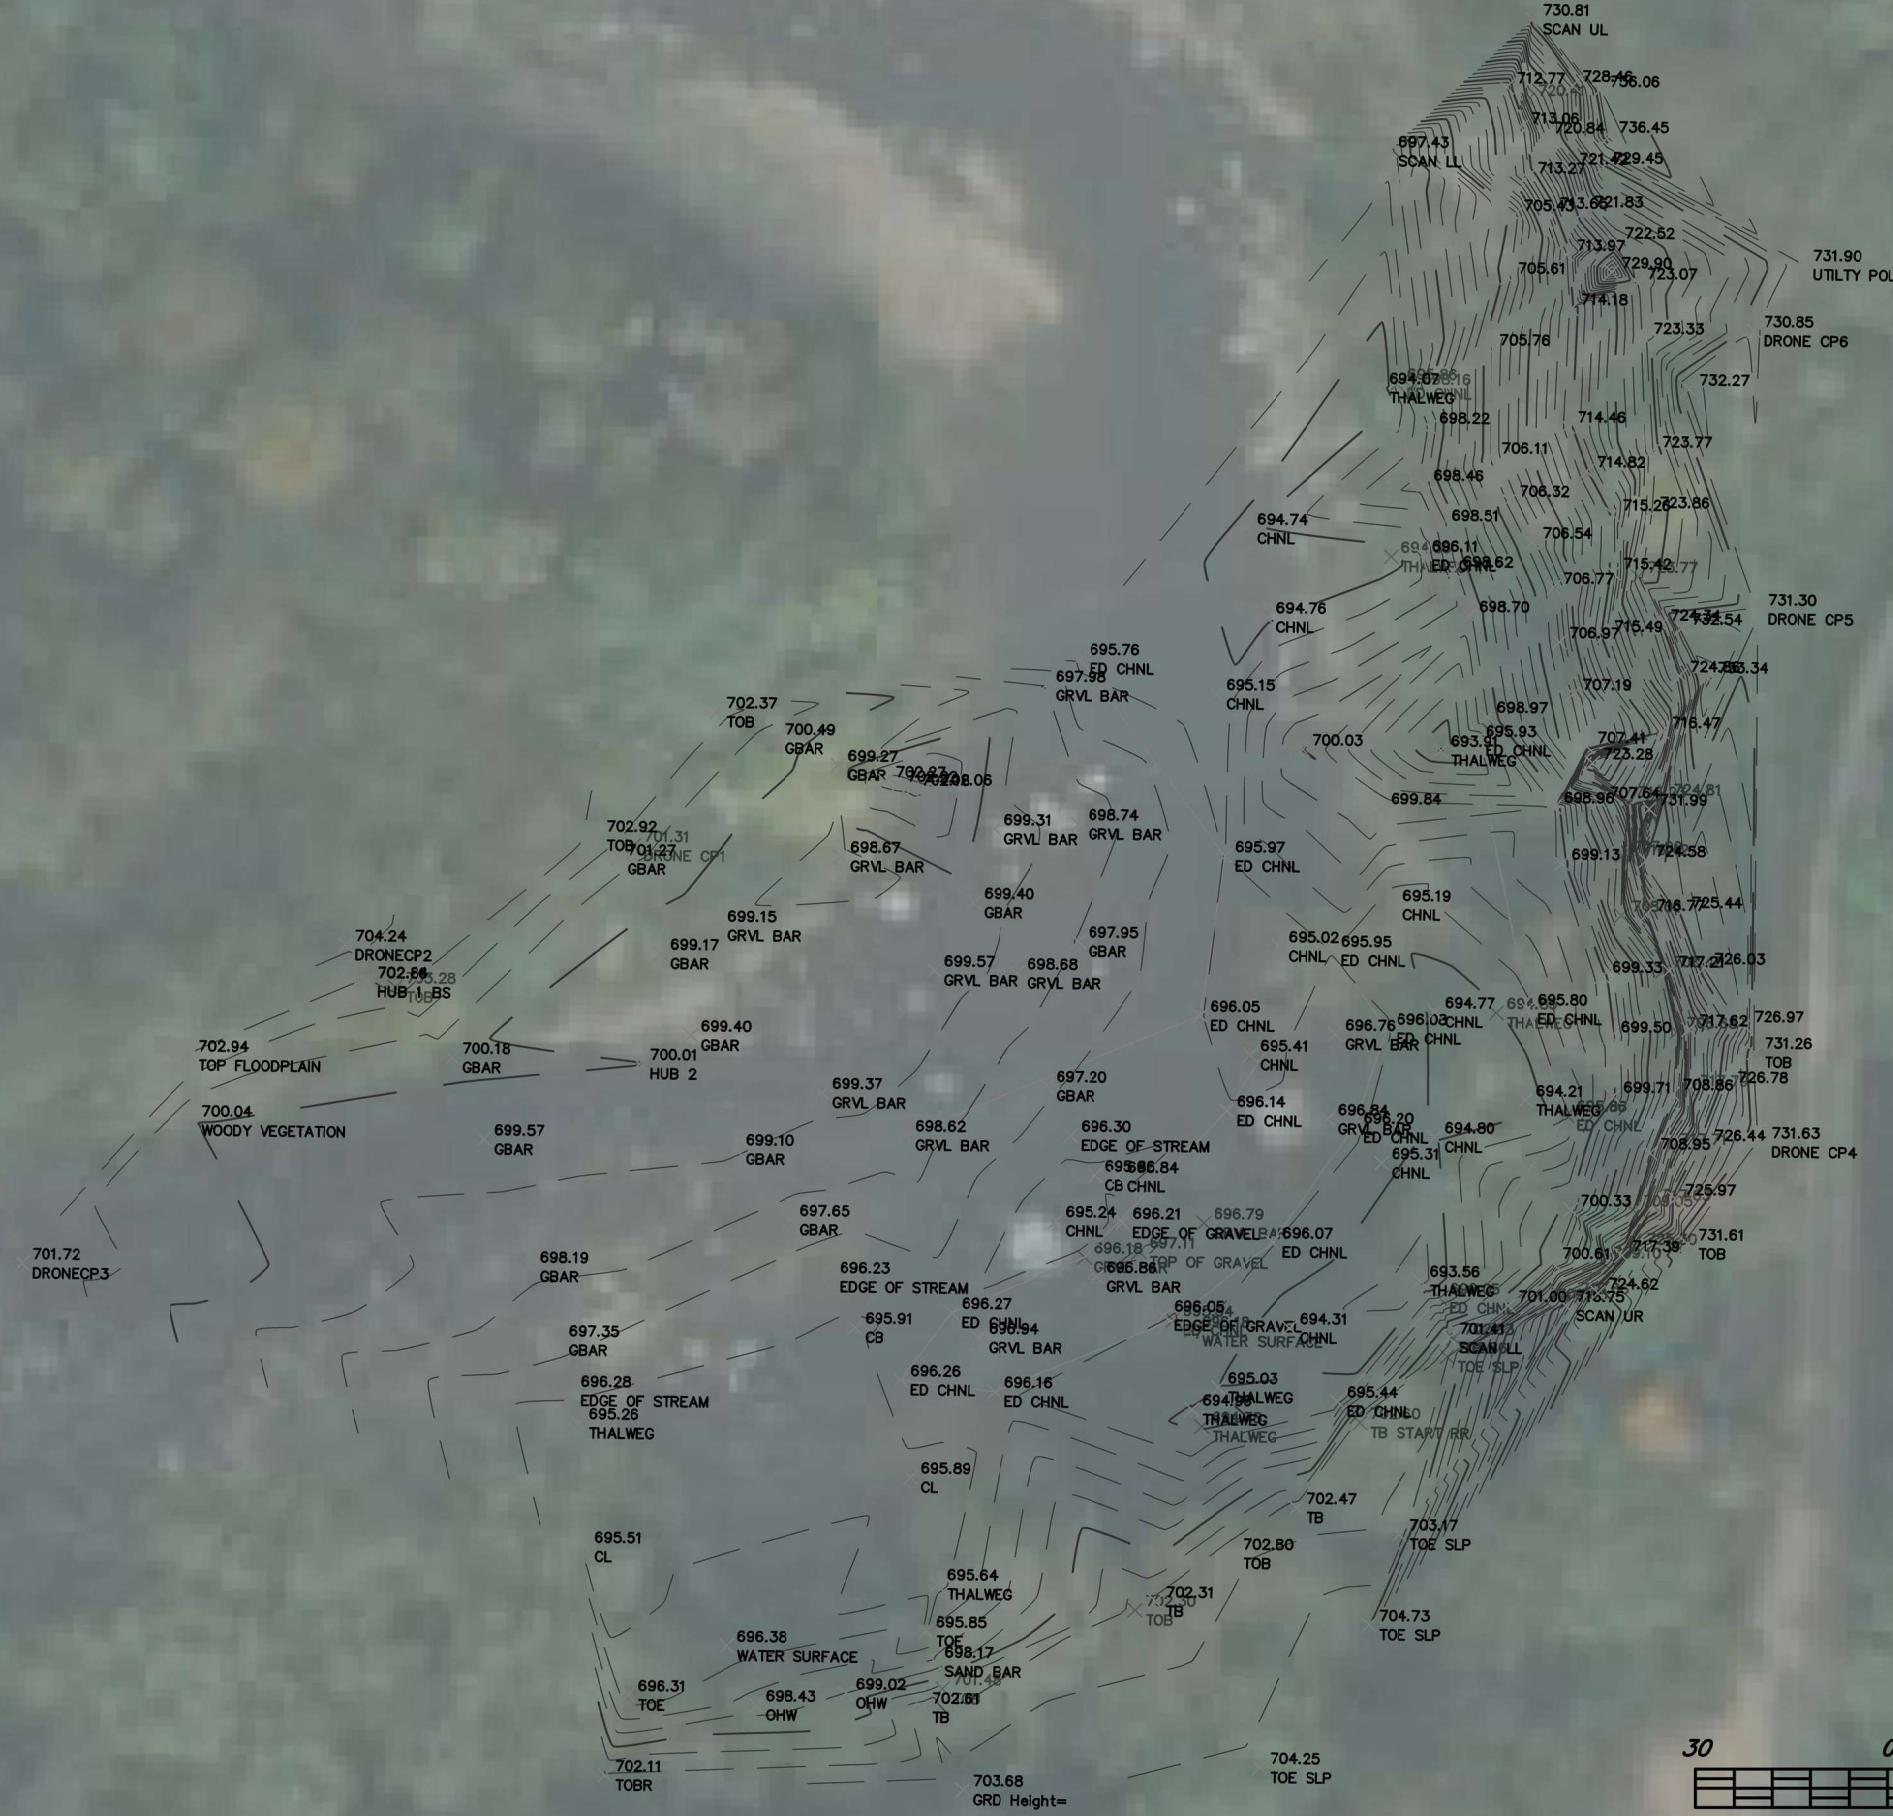
EWP PROJECT 5042-017-126 EWP MARTIN MEADOW ROAD SURVEY		HAZARD CLASS SIGNIFICANT		JOB CLASS VI	
		VERMONT		PLAINFIELD	
File Name					
Drawing Name		5042-017-126			
Sheet 1 of 1

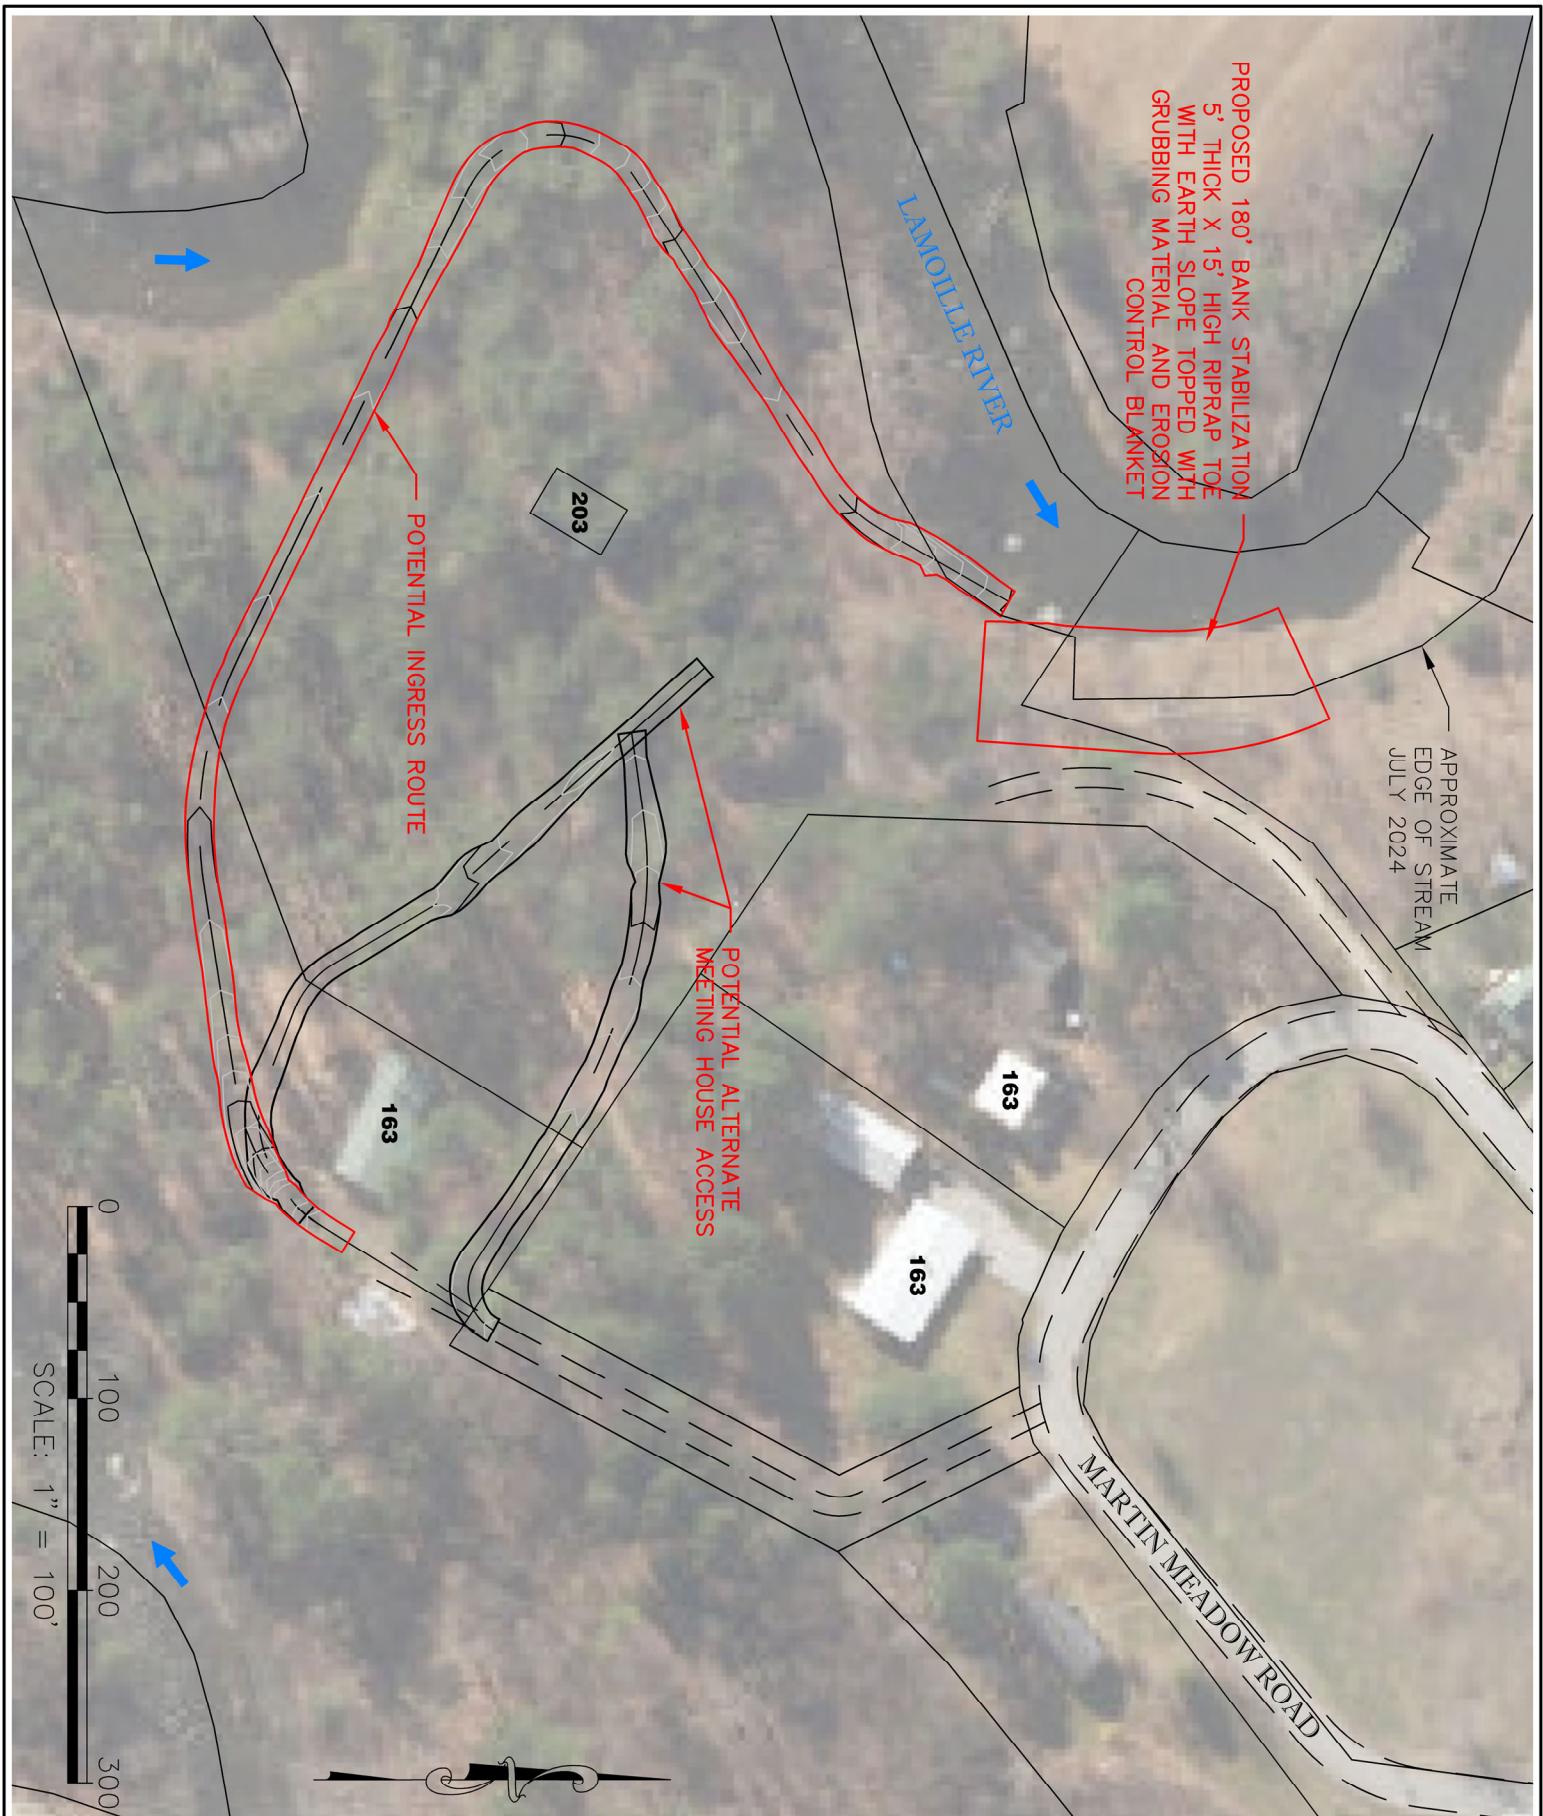
File Name	PLAINFIELD EWP 5042			HAZARD CLASS SIGNIFICANT	USDA United States Department of Agriculture	Date
DSR Number	50-01-24-5042-017-126 DSR SKETCH			JOB CLASS VI	Natural Resources Conservation Service	Designed _____ Drawn M.JL 12/16/2024 Checked _____ Approved by _____
Sheet 1 of 2	PLAINFIELD VERMONT

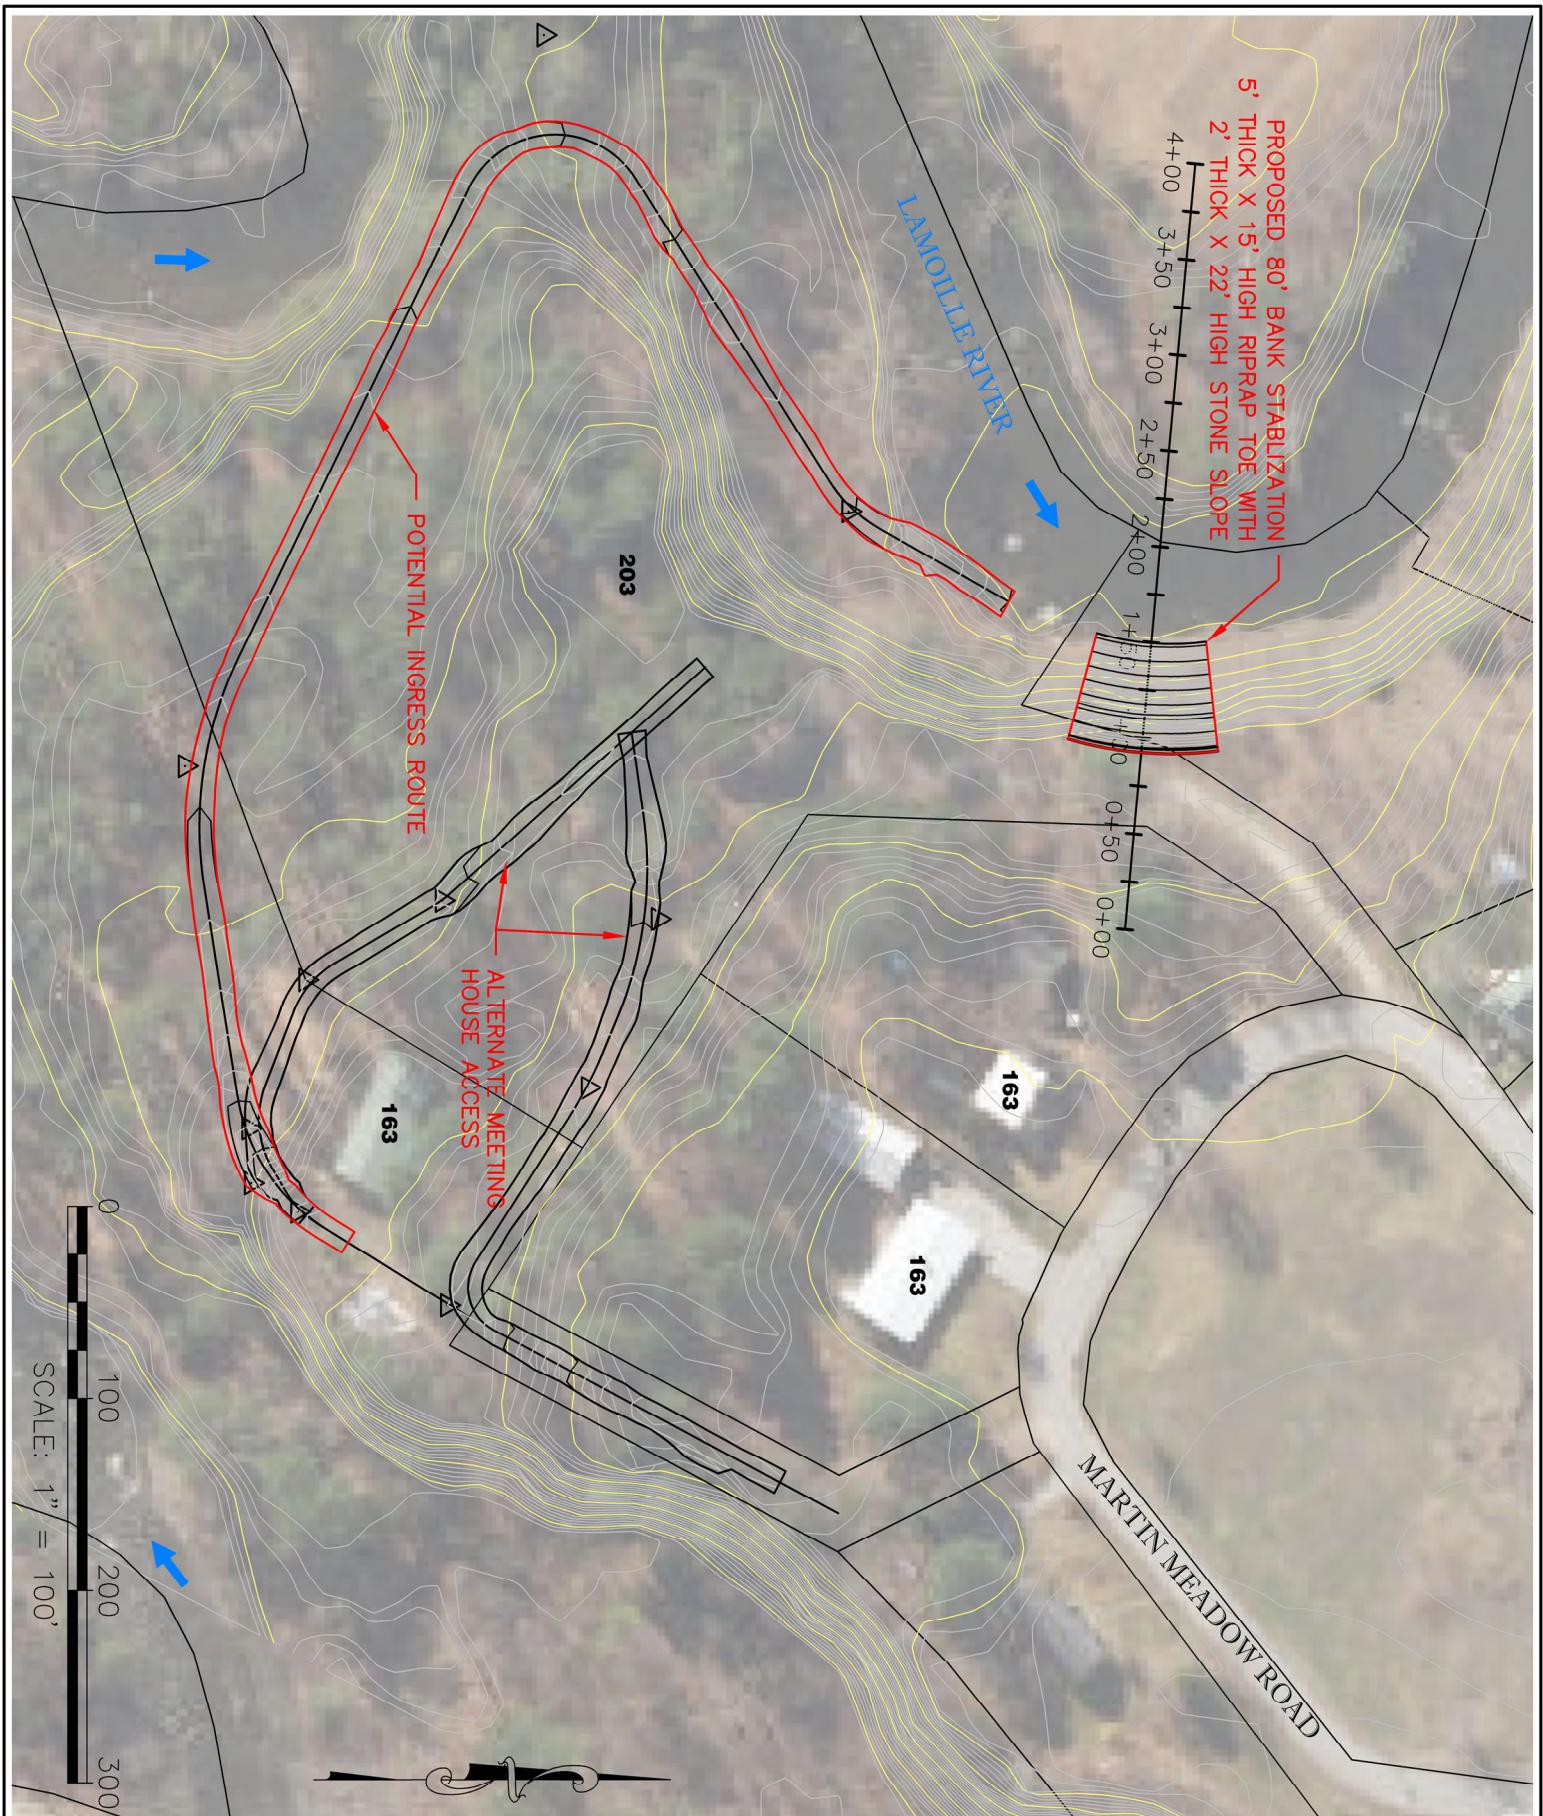
File Name	PLAINFIELD EWP 5042		HAZARD CLASS SIGNIFICANT	USDA United States Department of Agriculture	Date
DSR Number	50-01-24-5042-017-126		JOB CLASS VI	Natural Resources Conservation Service	12/16/2024
Sheet 1 of 2	DSR SKETCH PLAINFIELD		VERMONT	Approved by

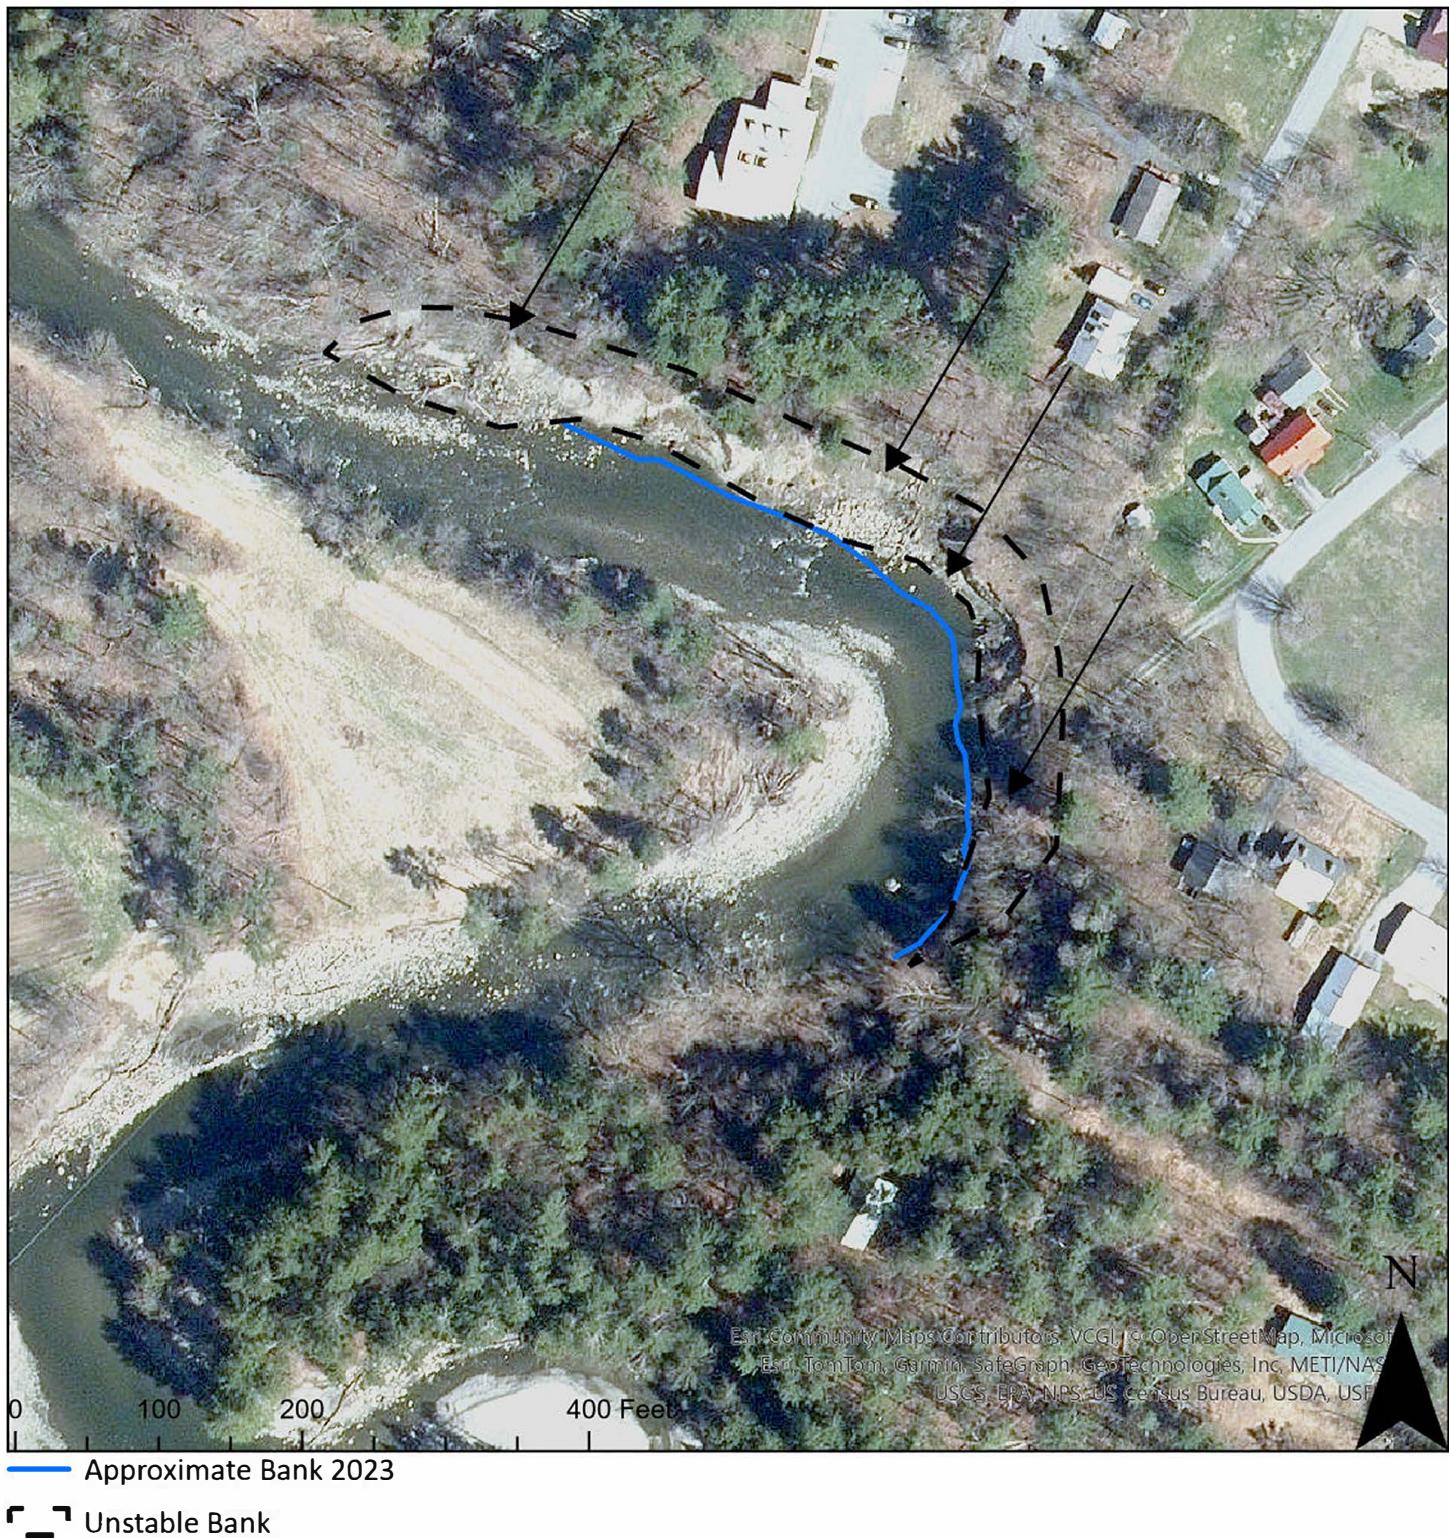
Figure 1: Aerial imagery with the approximate 2023 streambank outlined in blue to show movement. Black arrow shows areas that appear to have the most land movement. Dotted line highlights approximate area of instability.

Design Recommendations: As illuded to in the previous section it is recommended to stabilize the entire length of the failing/unstable bank (Figure 1). The entire length of the bank is unstable due to toe erosion and over steepening. There is evidence of cyclical incremental failure progressing and the site has a significant potential for catastrophic event-based failure. Armoring only the portion of the cut bank underlying the access road to stabilize the slope would likely succeed but would also potentially exacerbate the risk to more significant structures just downstream through the redirection of water at increased velocity toward an unstable over steepened slope. If stabilizing the whole bank is not feasible it is highly recommended to include some features in the design to redirect water away from the downstream portion of the bank underlying the house and health center.

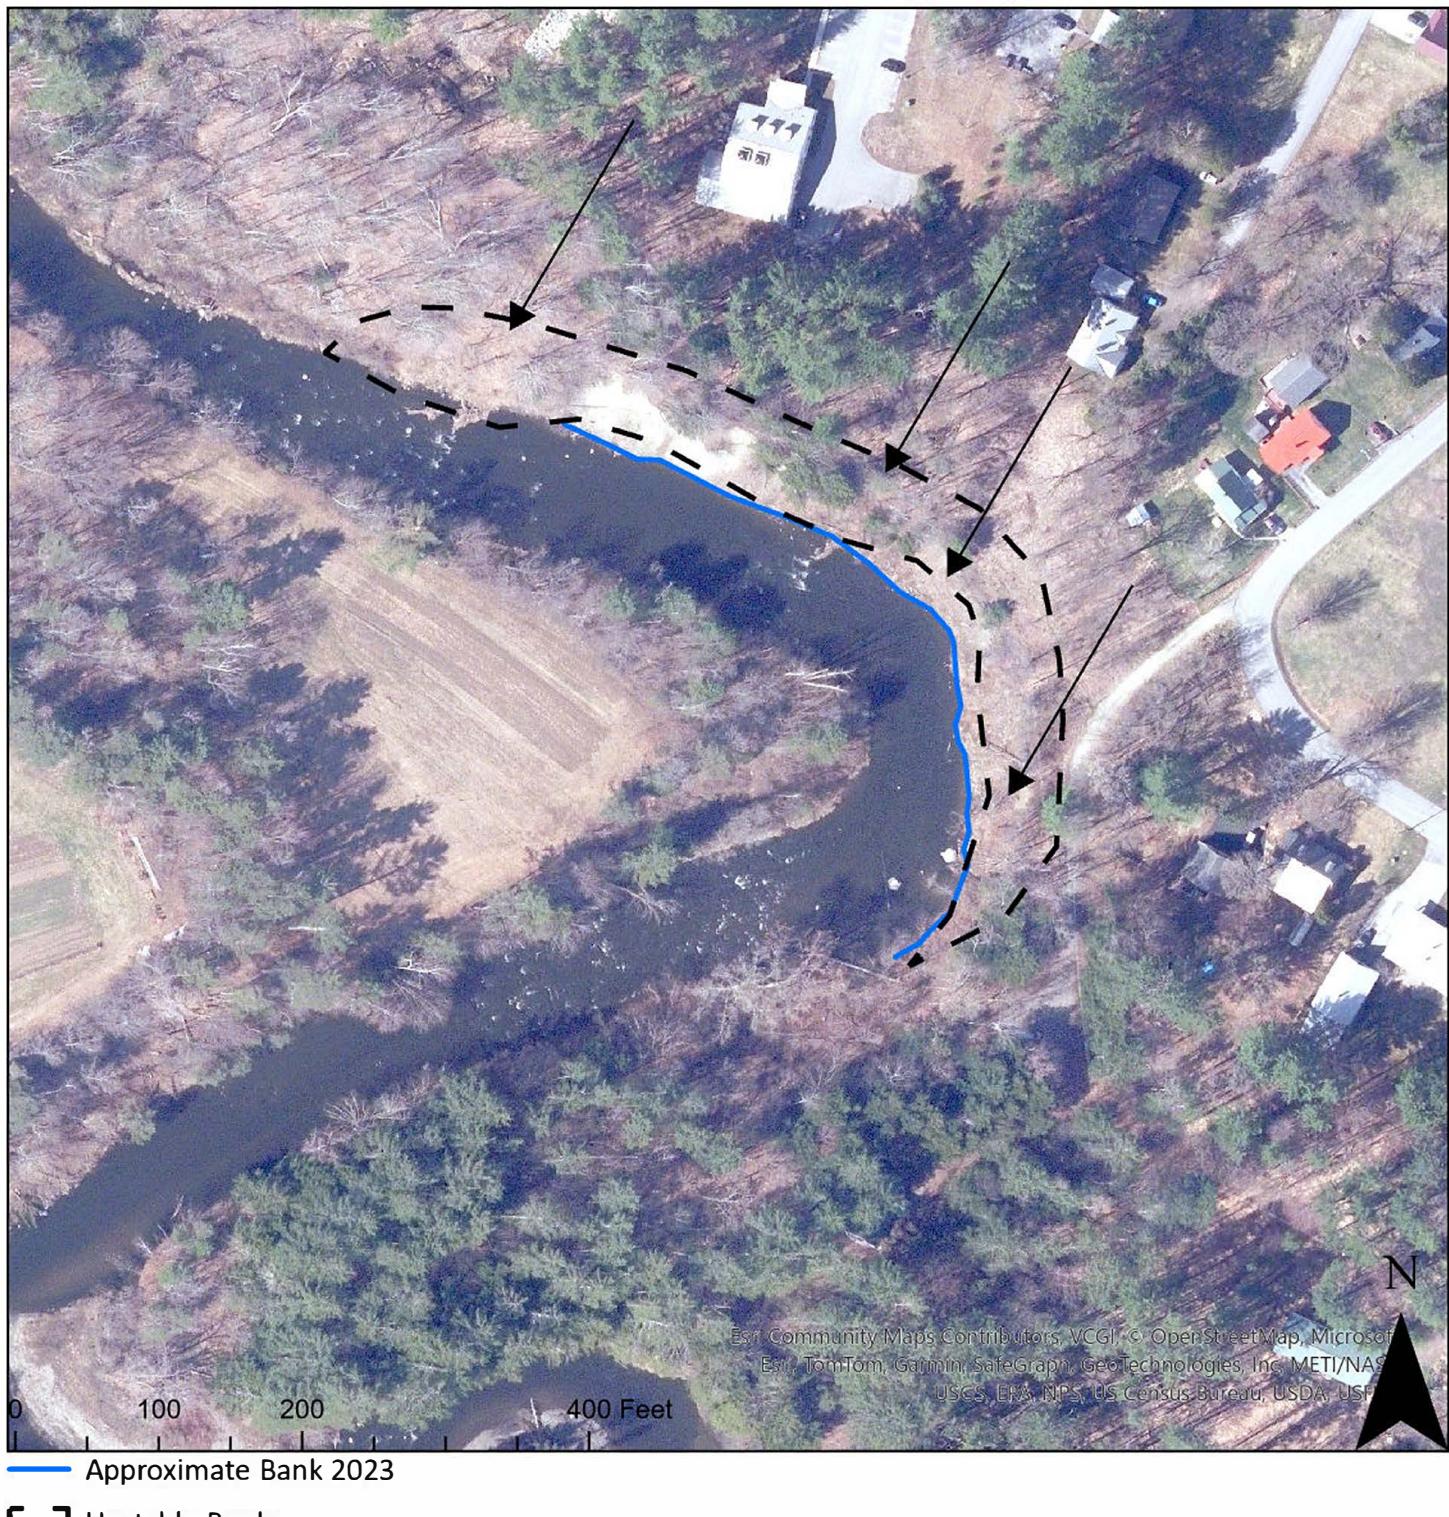
Figure 2: Aerial imagery with the approximate 2023 streambank outlined in blue. Black arrow shows areas that appear to have the most land movement. Dotted line highlights approximate area of current instability.

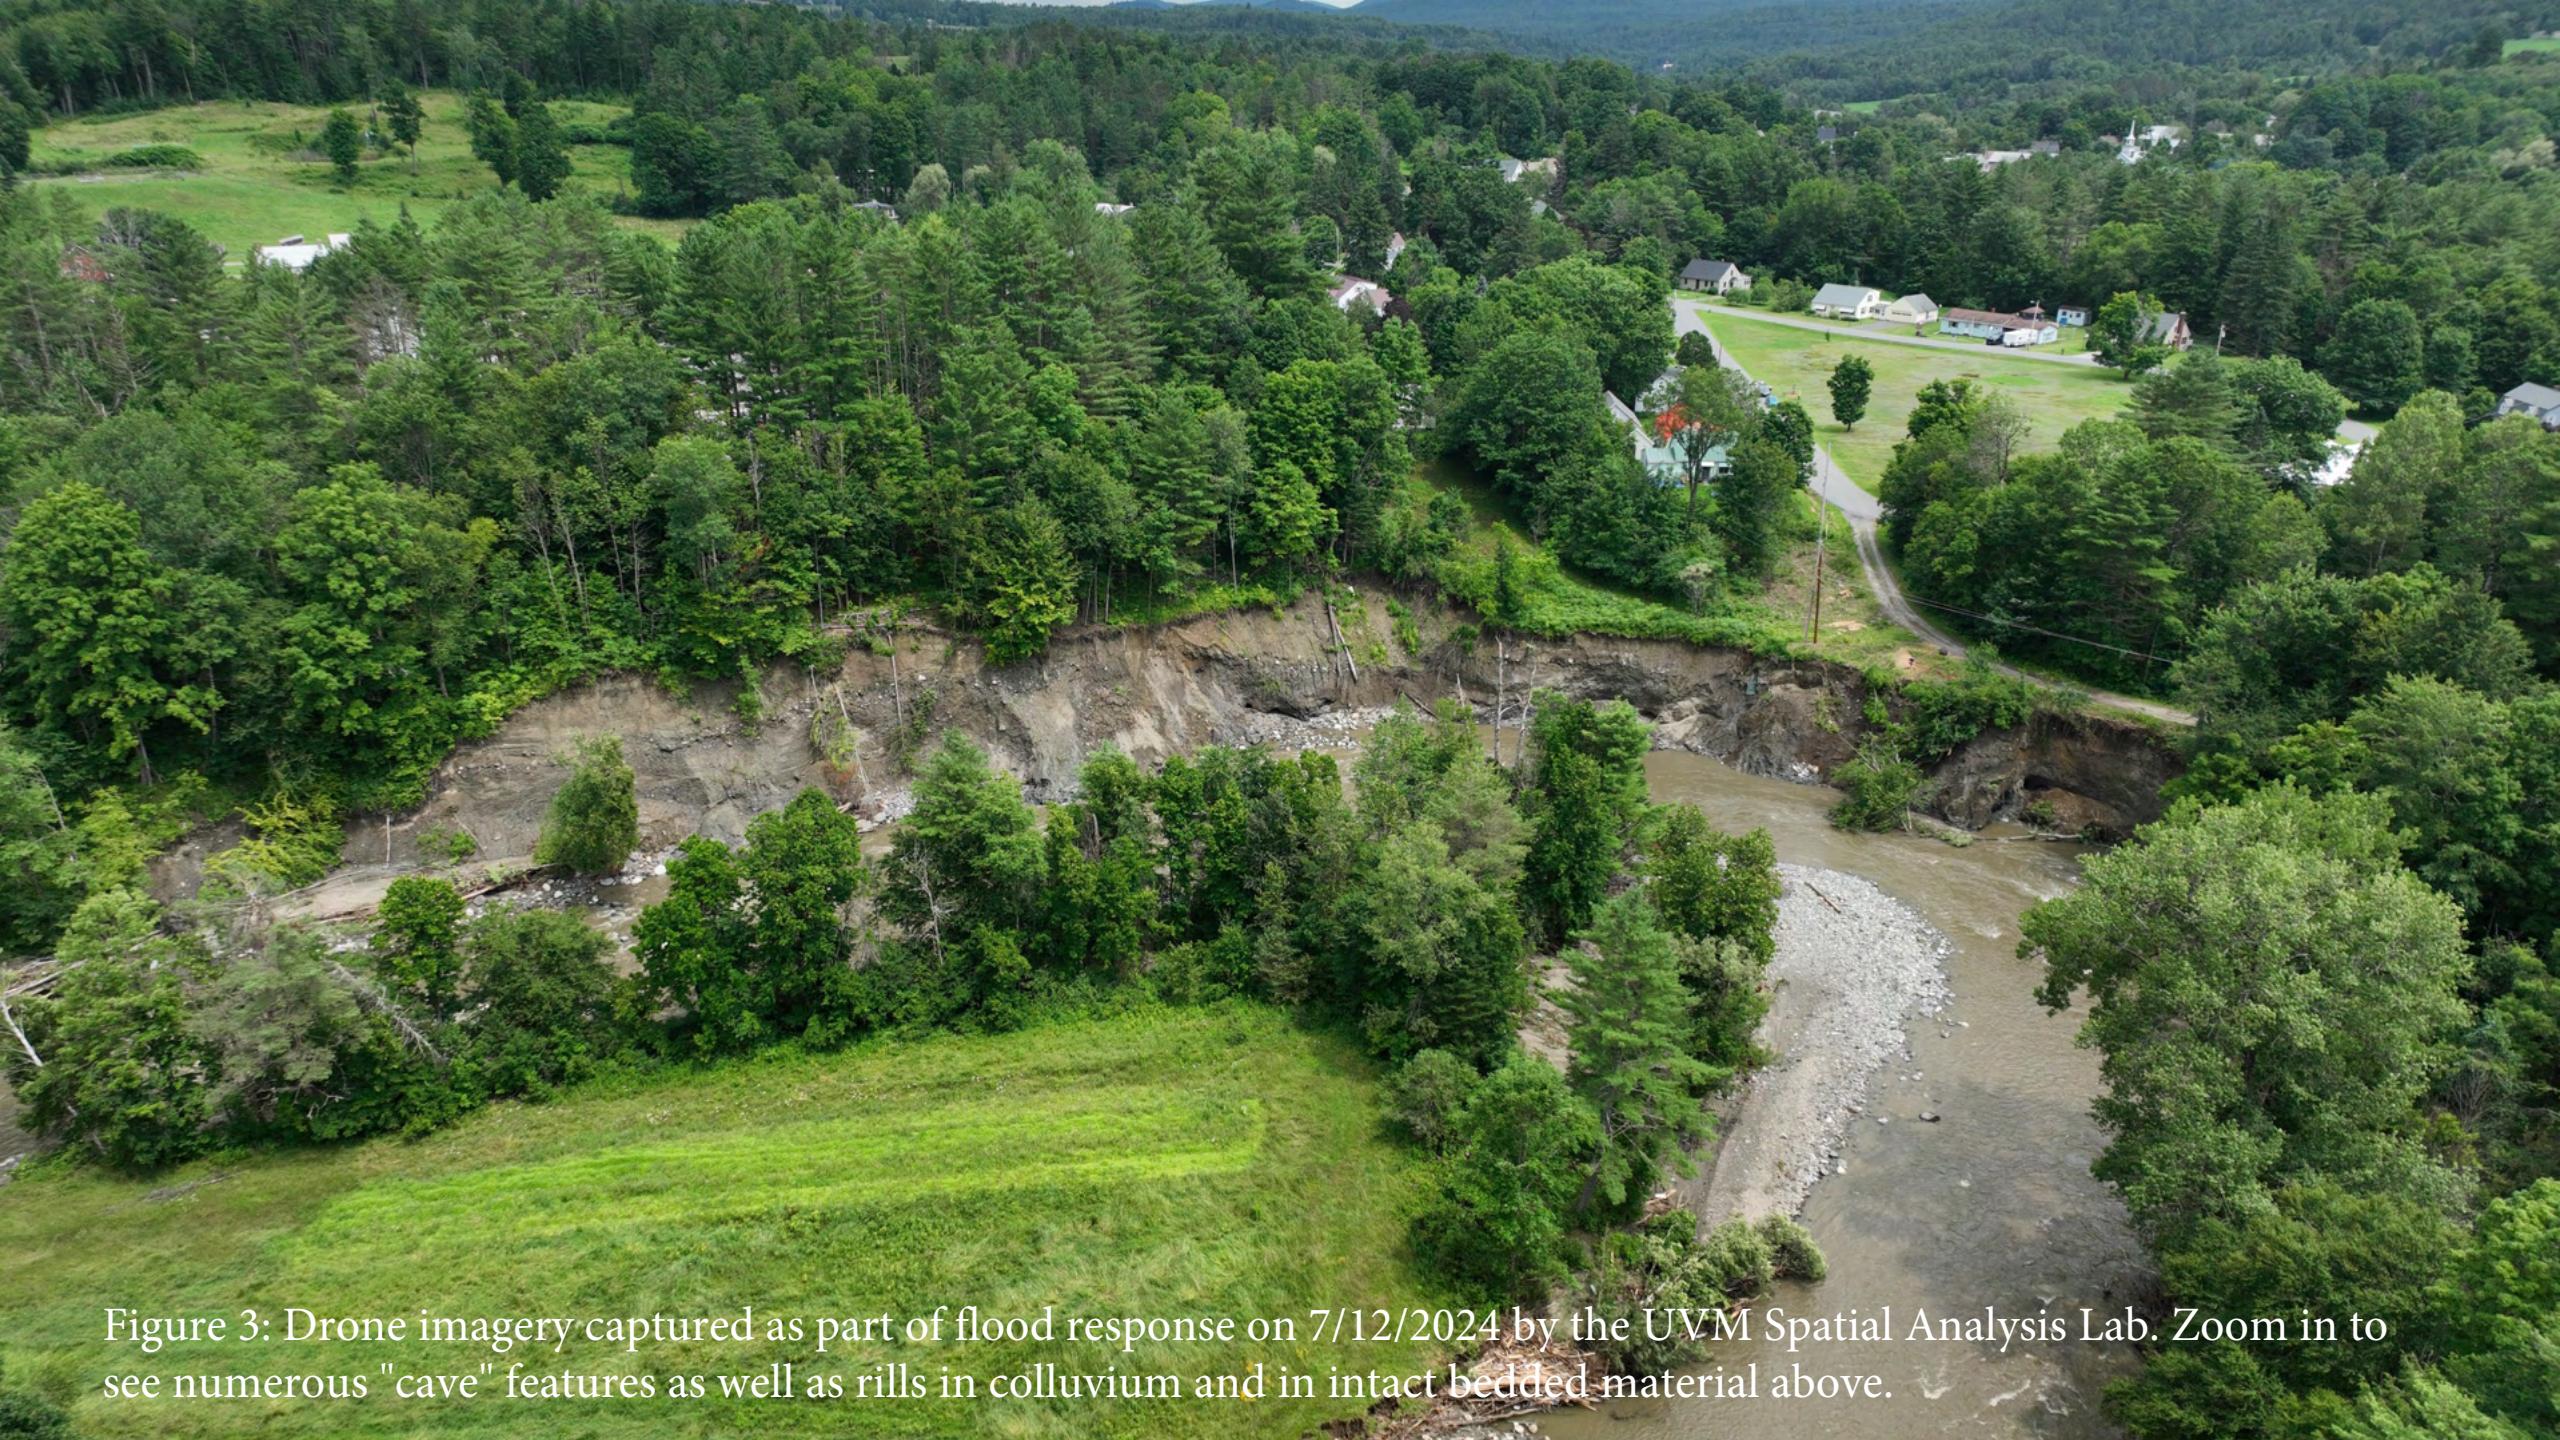
Figure 3: Drone imagery captured as part of flood response on 7/12/2024 by the UVM Spatial Analysis Lab. Zoom in to see numerous "cave" features as well as rills in colluvium and in intact bedded material above.

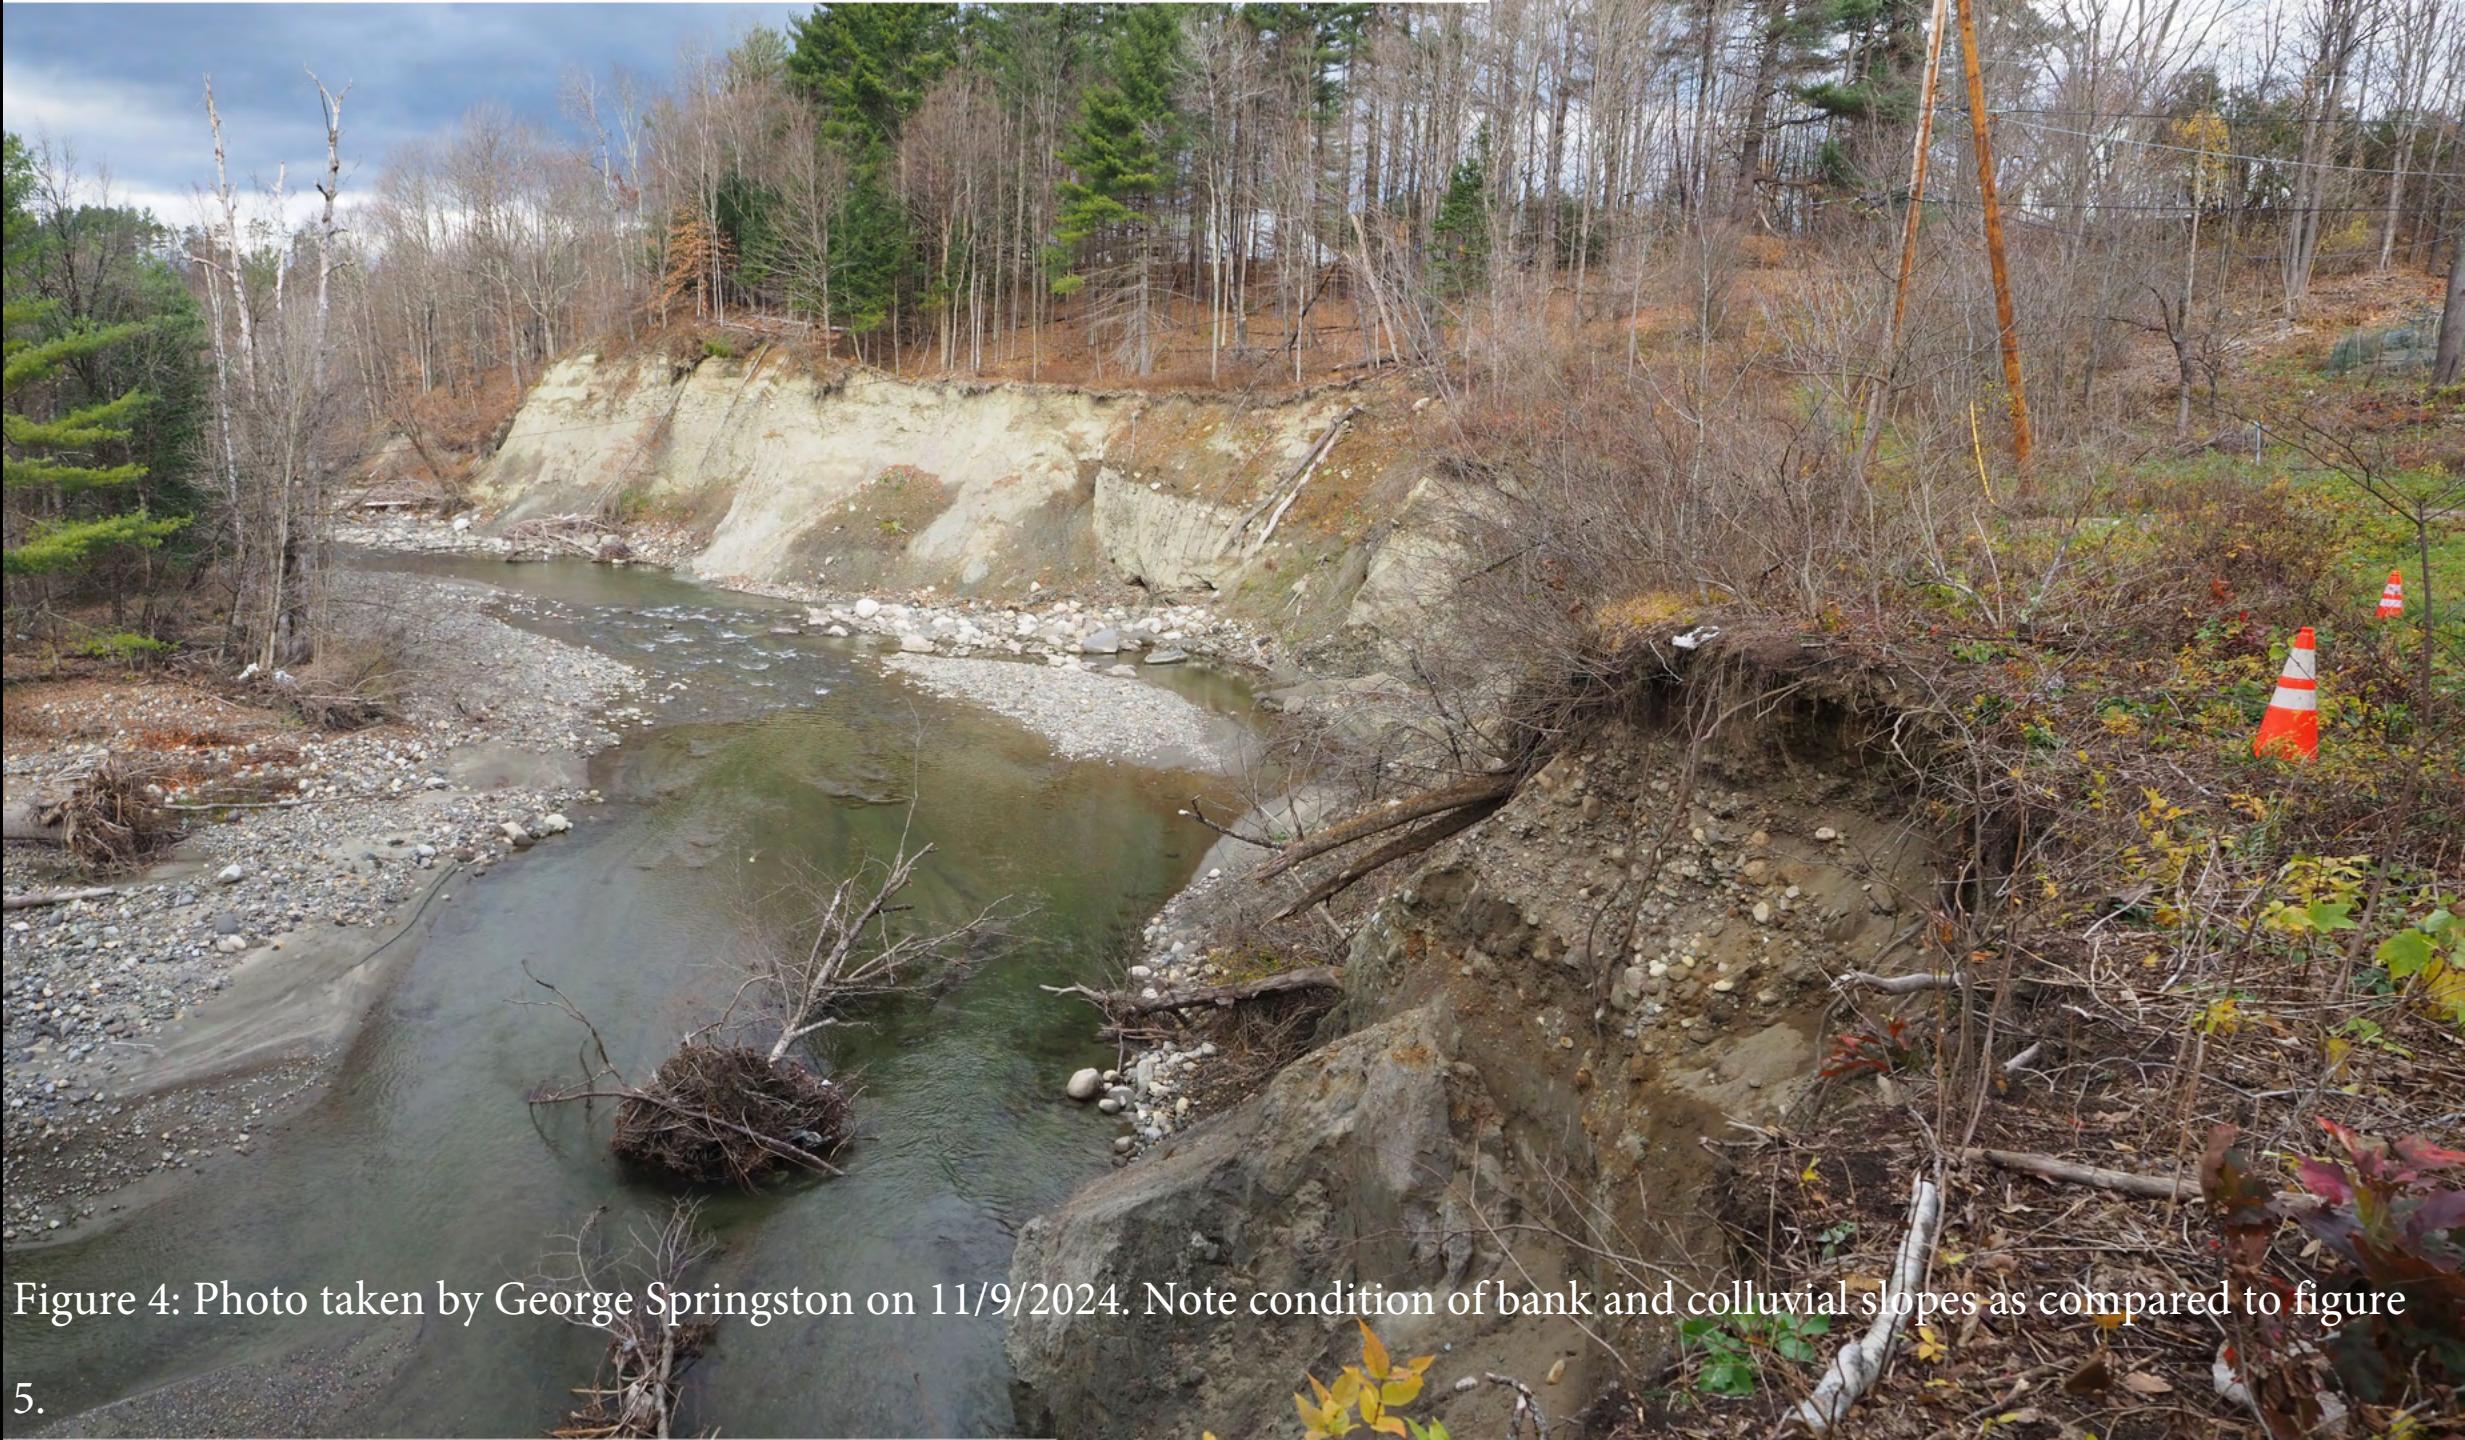
Figure 4: Photo taken by George Springston on 11/9/2024. Note condition of bank and colluvial slopes as compared to figure
