Natural Resources Conservation Service
DAMAGE SURVEY REPORT (DSR)
Emergency Watershed Protection Program – Recovery

D. Client's Objective(s) (purpose): To stabilize an actively eroding stretch of Winooski River that is threatening infrastructure along Martin Meadow Road in the Town of Plainfield.		A. Client Name: Town of Plainfield B. Conservation Plan ID # (as applicable): 50 01 24 5042 017-126 Program Authority (optional): EWP C. Identification # (farm, tract, field #, etc. as required): 203 Martin Meadow Road, Plainfield, VT

DSR 50-01-24-5042-017

Purpose: This report presents a review of available geologic data used to evaluate conditions which may affect the planning, design and scope of a proposed stream bank stabilization project. After a brief initial desk review it was determined that a field reconnaissance investigation was required to properly assess the site. The results and interpretations of the desktop and field investigations are summarized here.

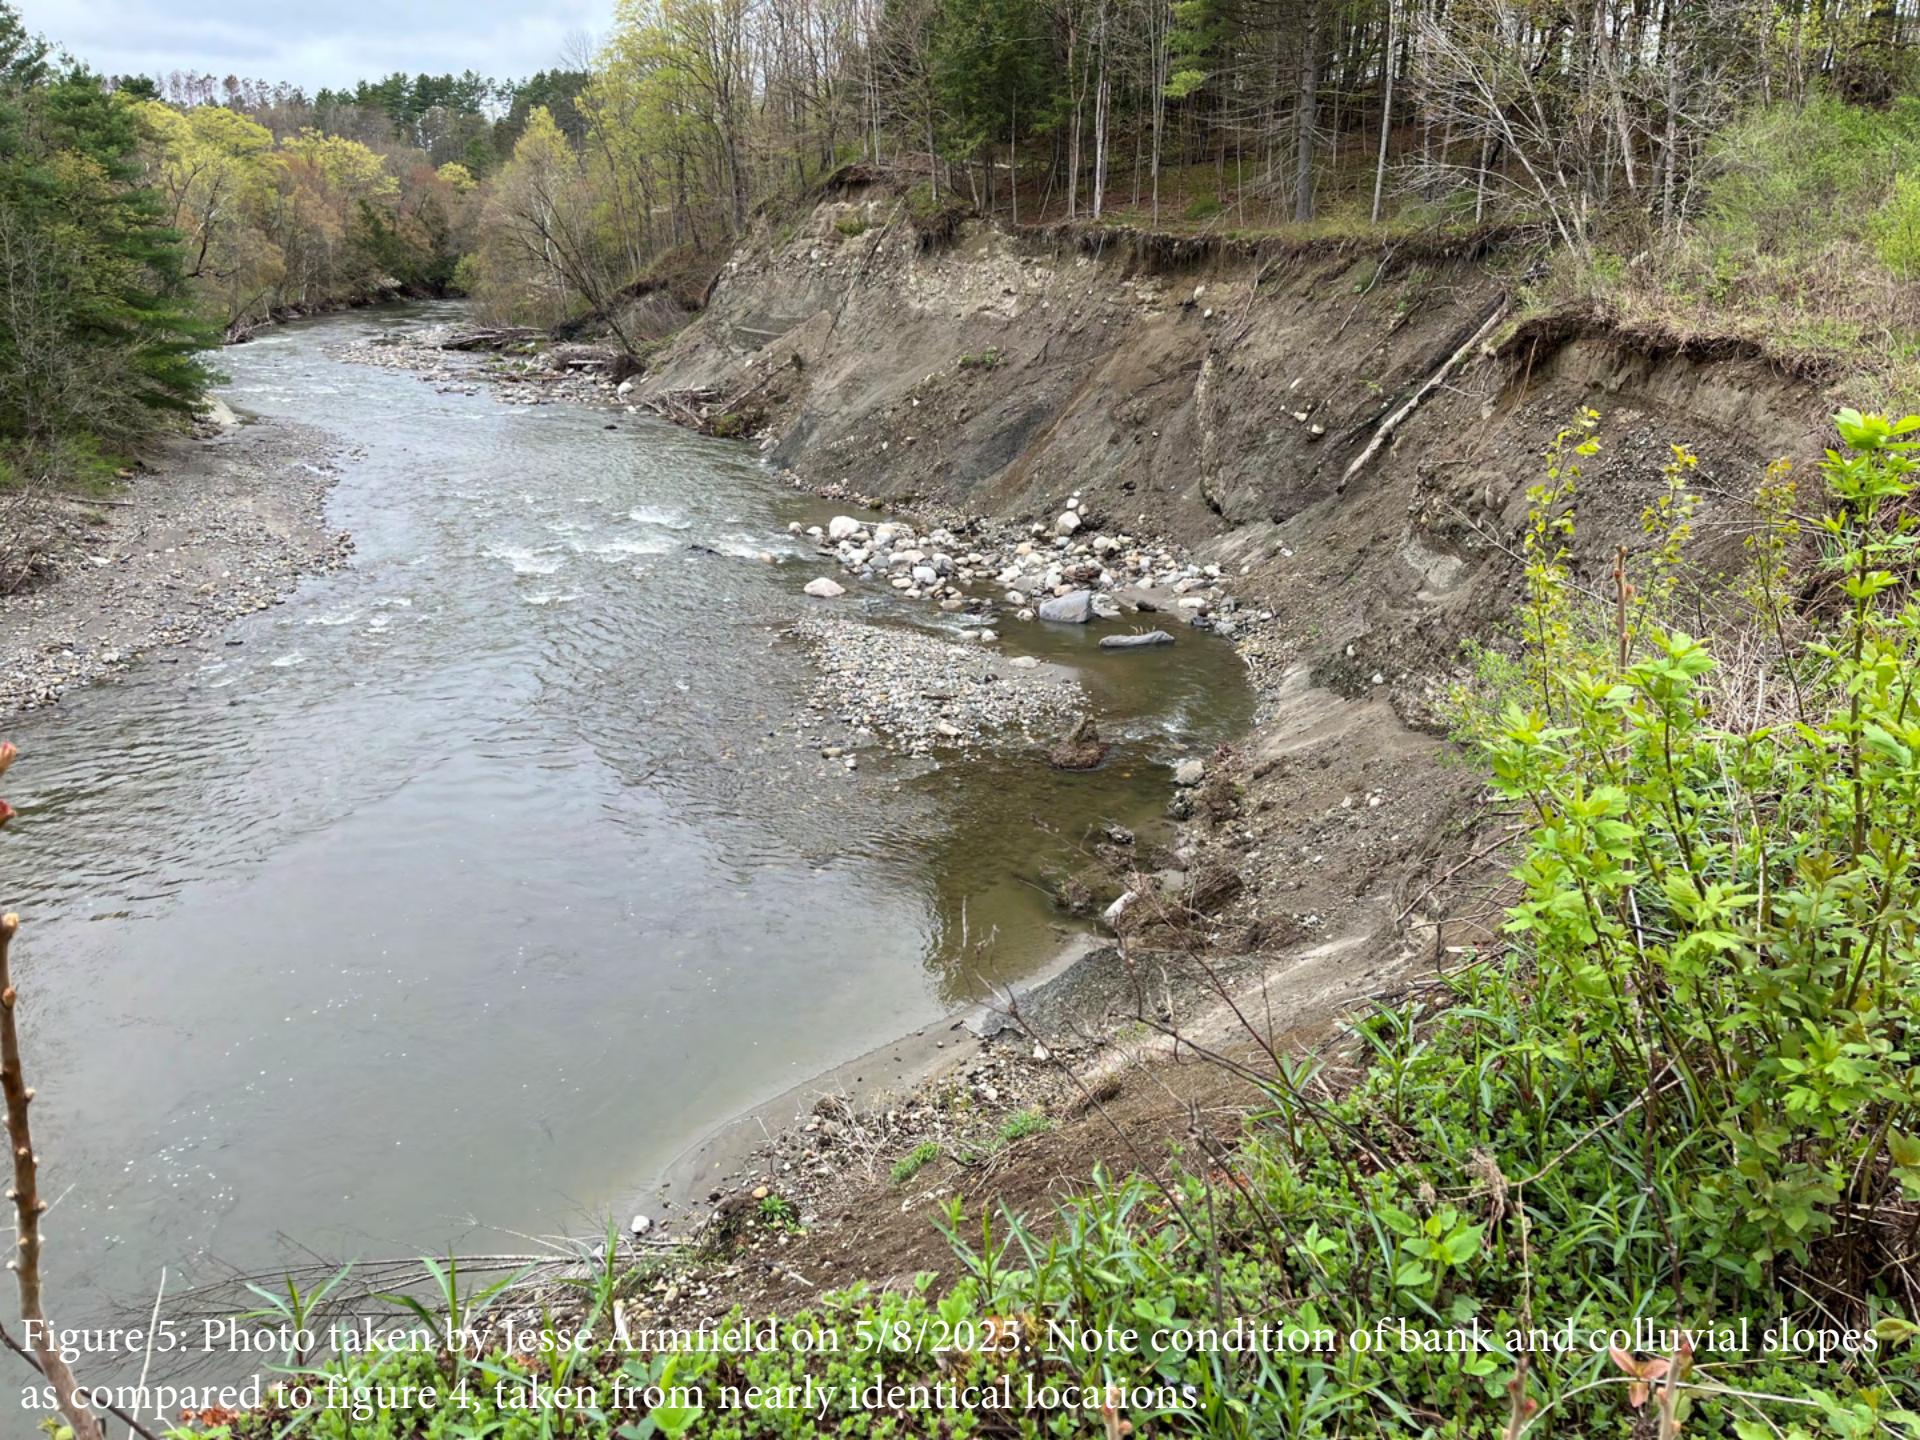
Figure 5: Photo taken by Jesse Armfield on 5/8/2025. Note condition of bank and colluvial slopes as compared to figure 4, taken from nearly identical locations.

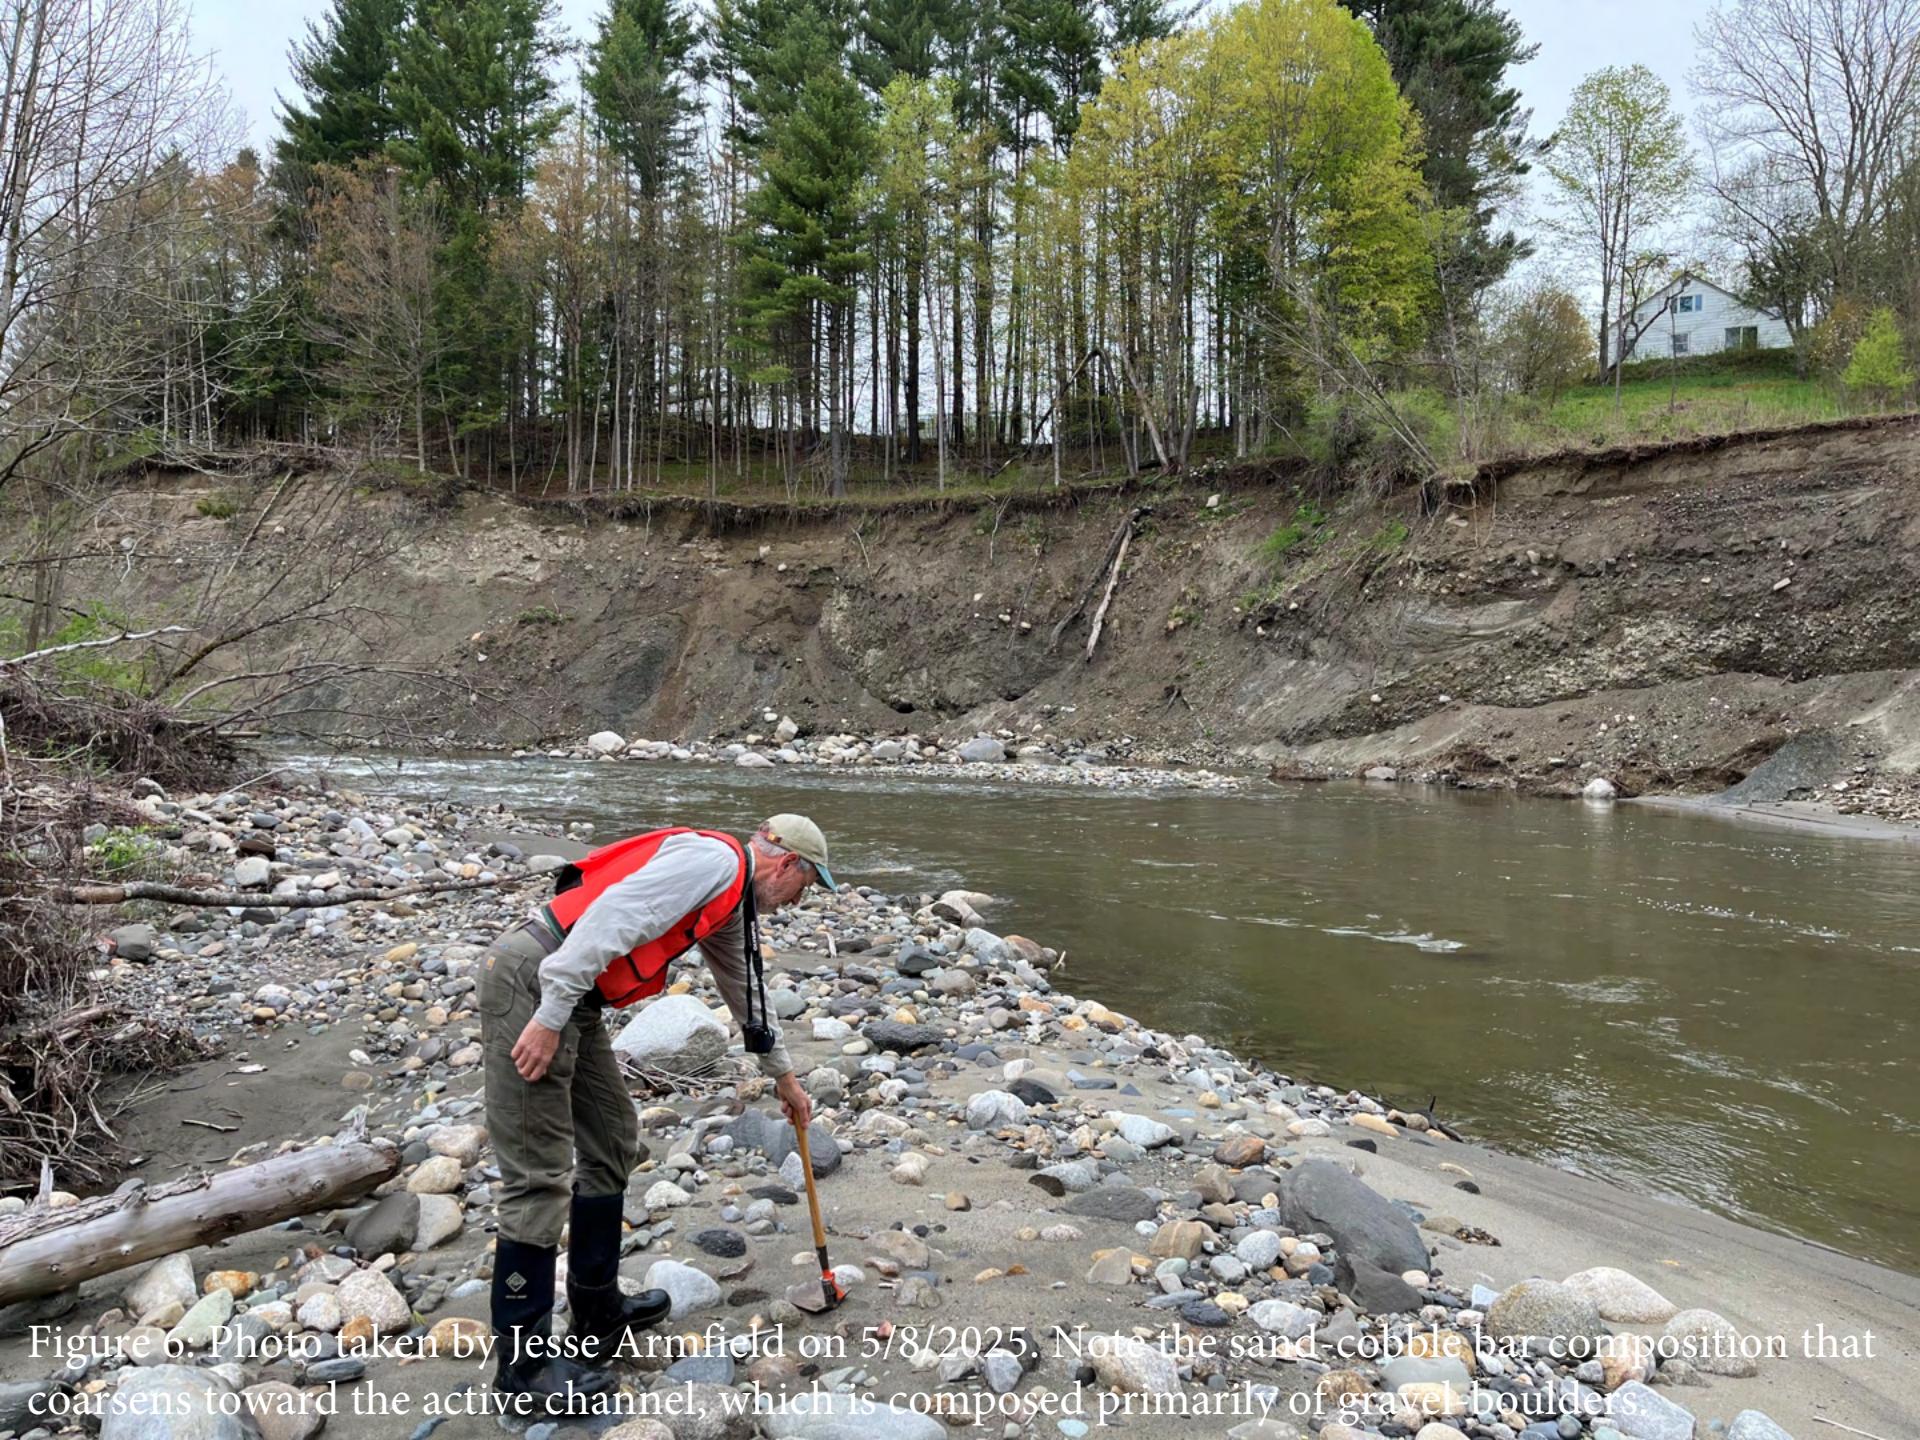
Figure 6: Photo taken by Jesse Armfield on 5/8/2025. Note the sand-cobble bar composition that coarsens toward the active channel, which is composed primarily of gravel-boulders.

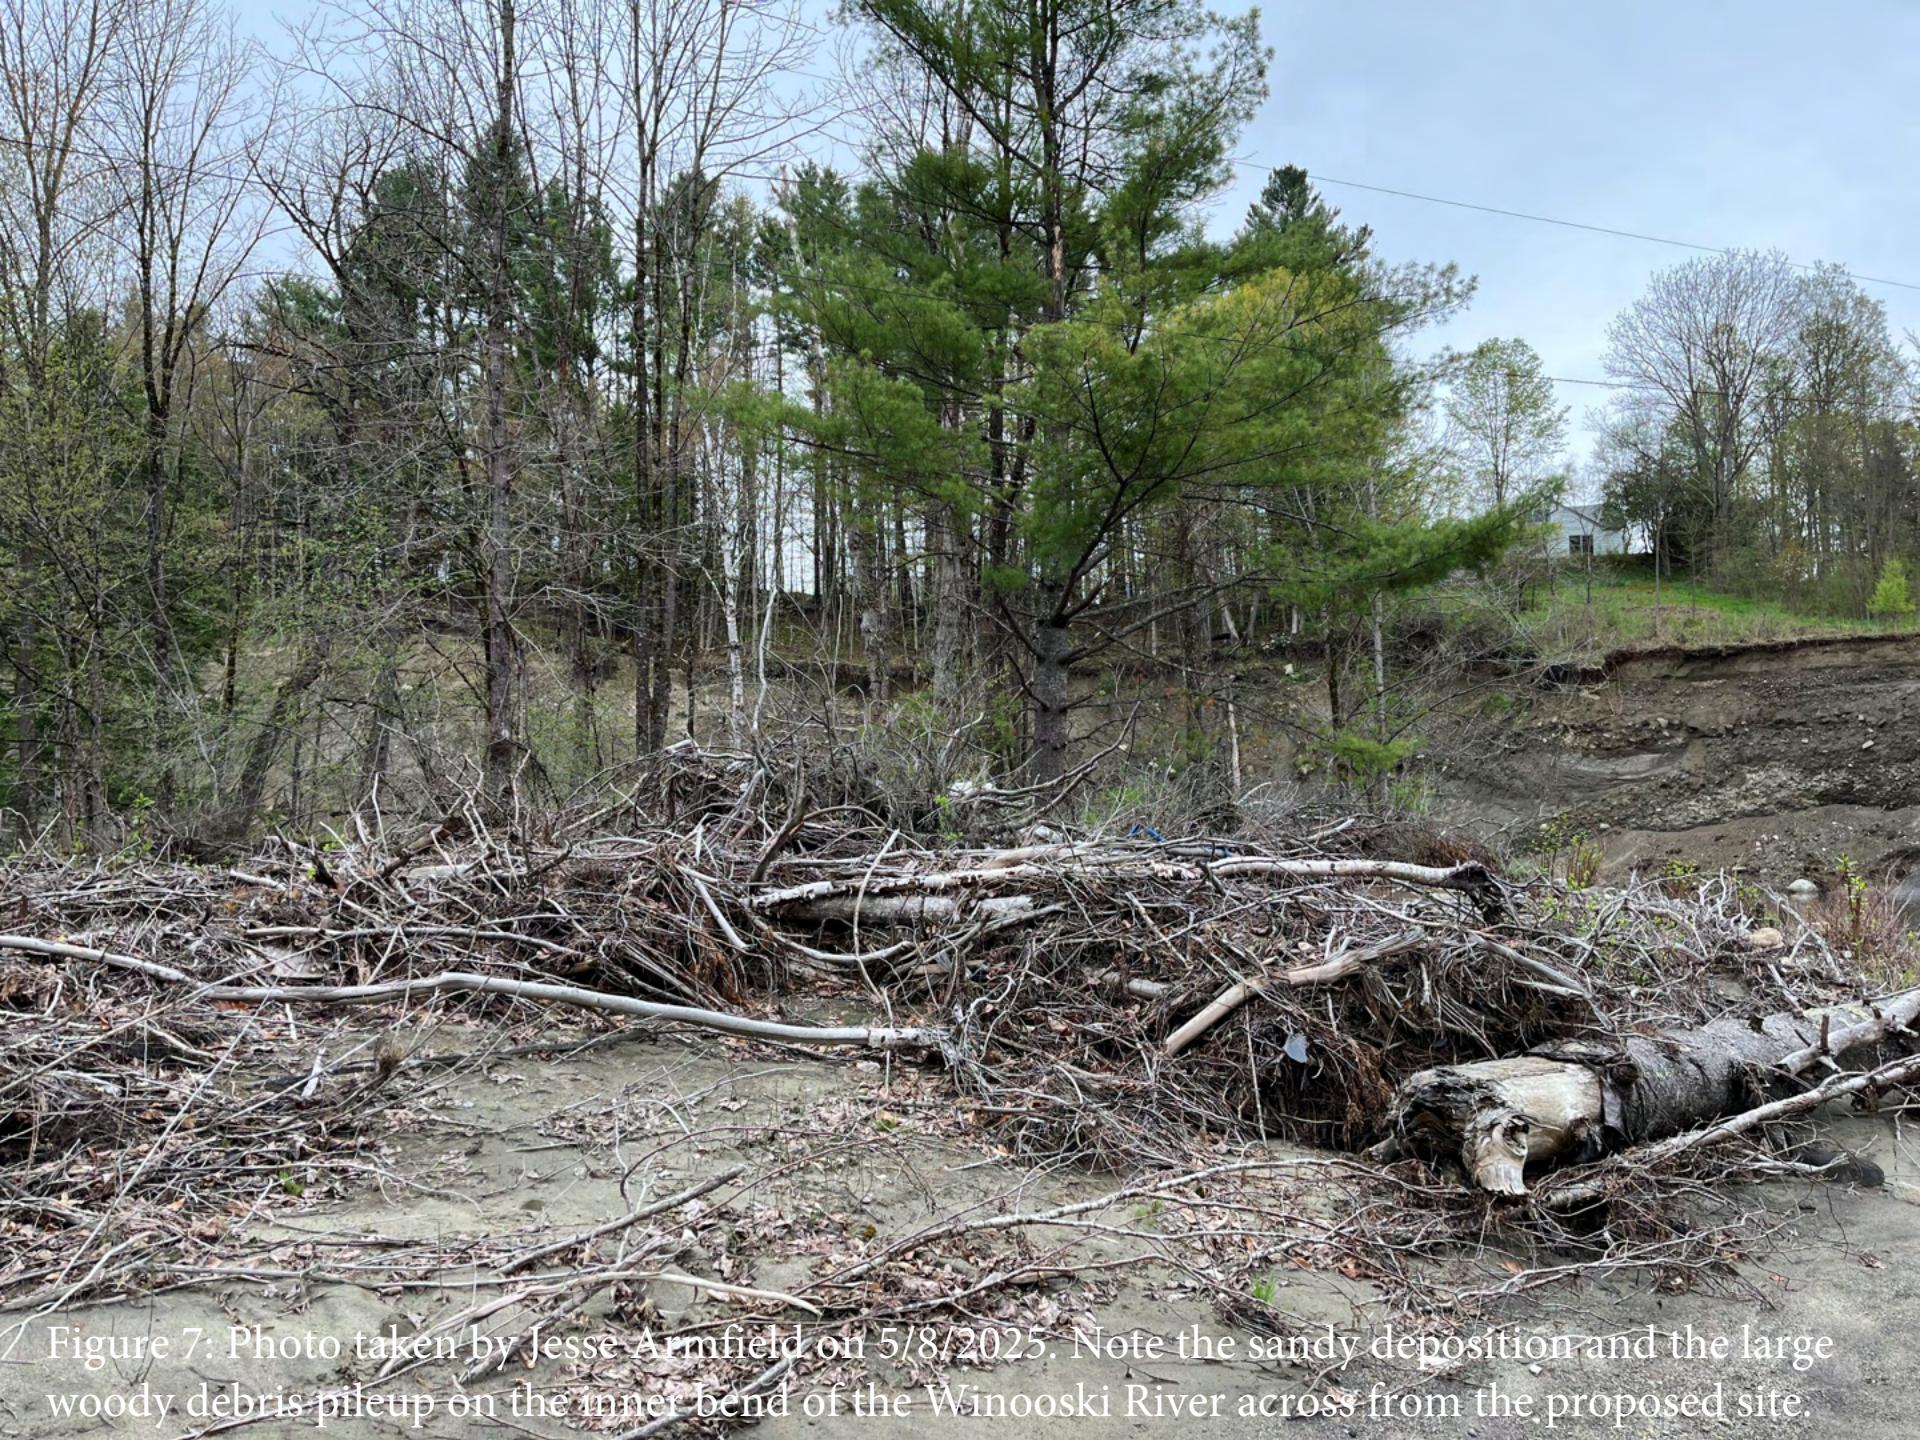
Figure 7: Photo taken by Jesse Armfield on 5/8/2025. Note the sandy deposition and the large woody debris pileup on the inner bend of the Winooski River across from the proposed site.

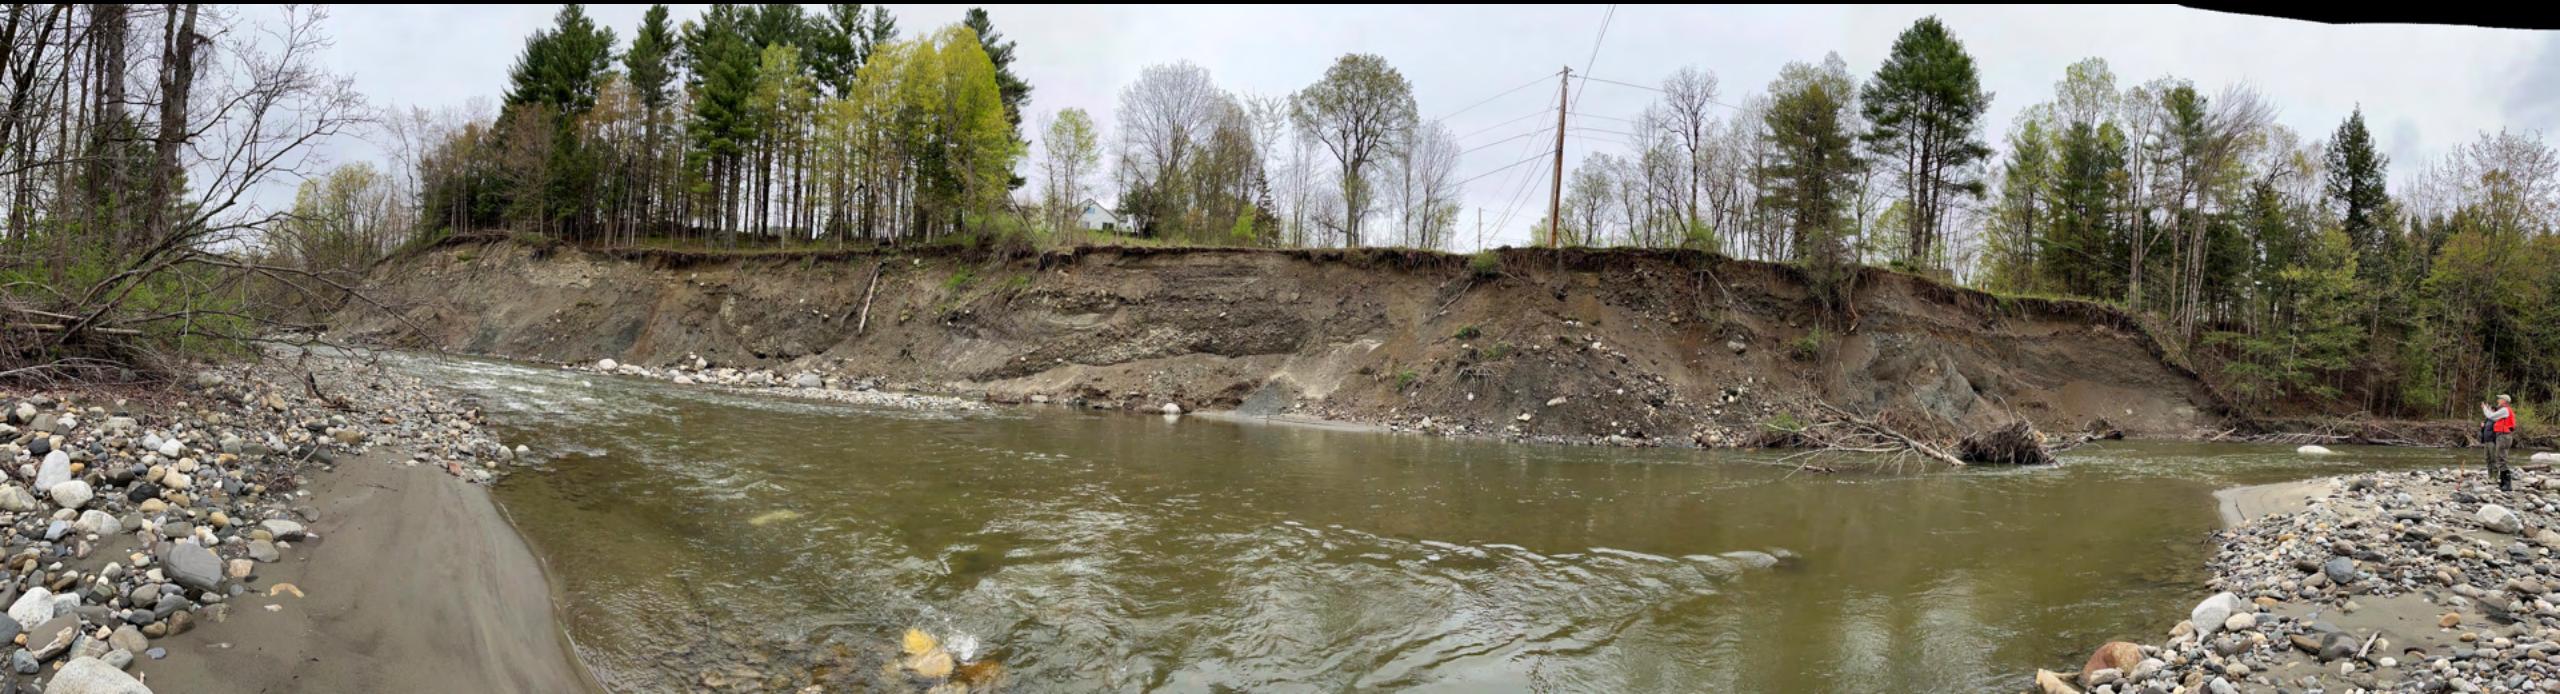
Figure 8: Panoramic photo taken by Jesse Armfield on 5/8/2025. This photo shows the entire failing bank as well as the health center, house, utility pole, and the location of the road on top of the bank to the right of the pole. Note that the image is distorted because it was captured as a panoramic photo.

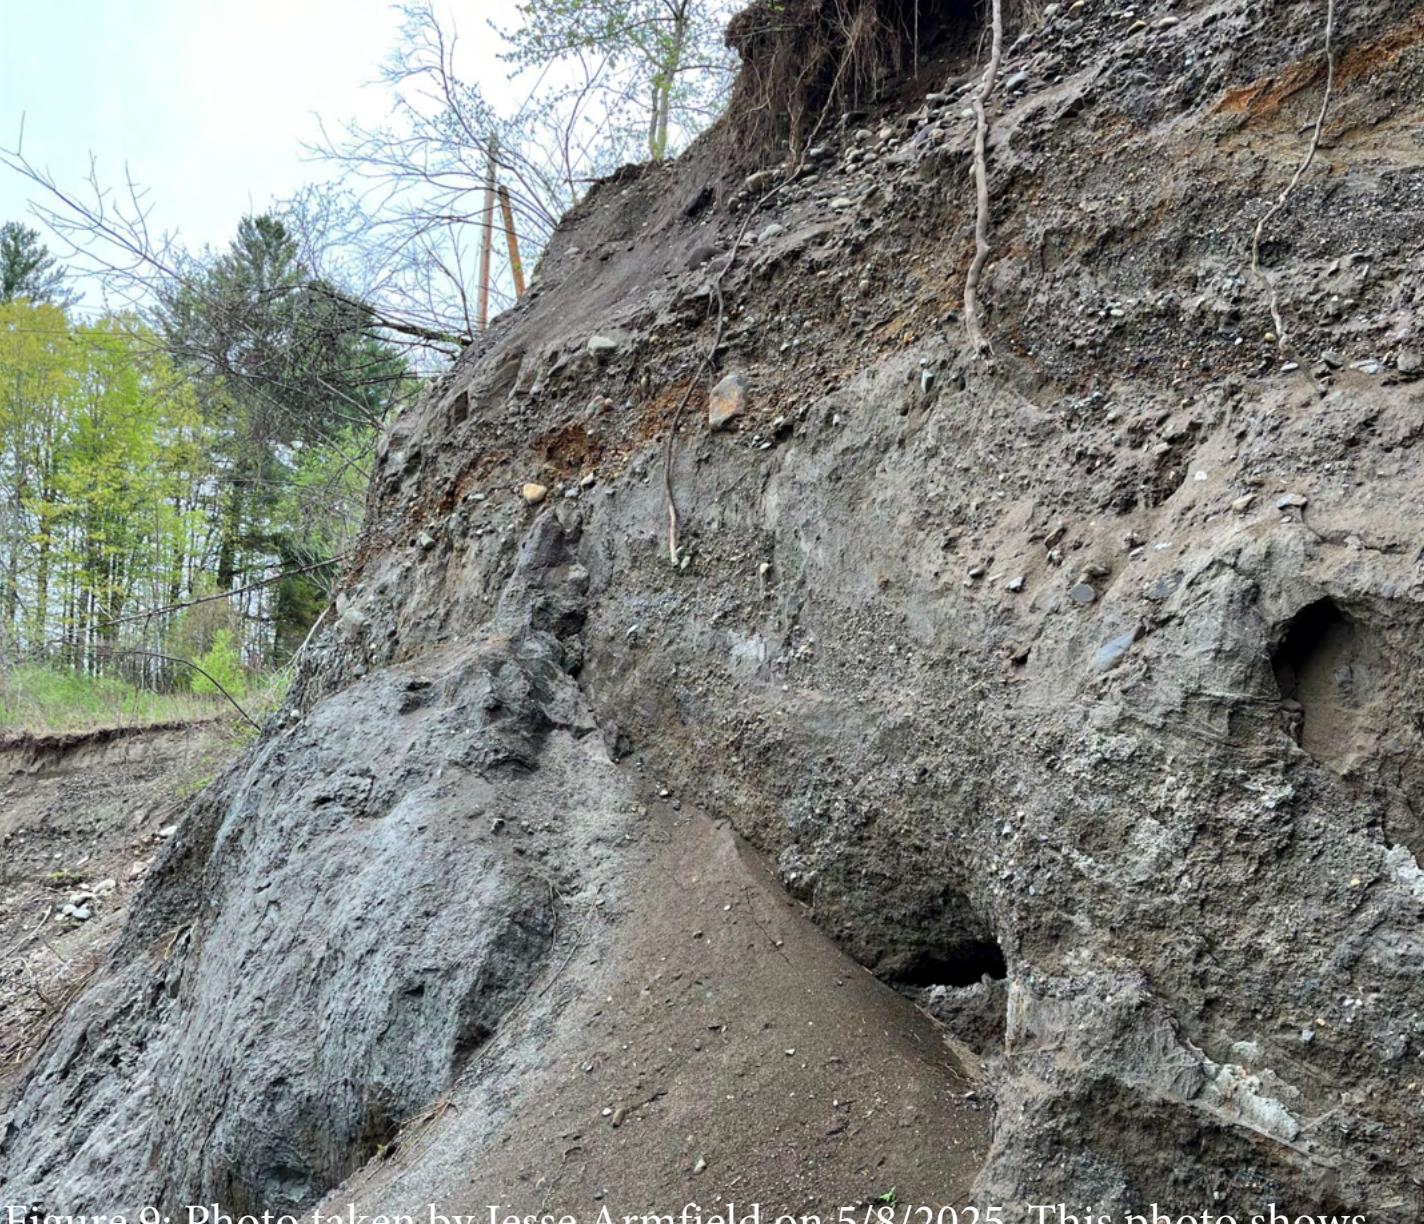
Figure 9: Photo taken by Jesse Armfield on 5/8/2025. This photo shows the most upstream exposure of glacial lake fines protruding from the bank and the colluvium collecting on the upstream side. Also of note is the small "cave" feature just above the colluvium.

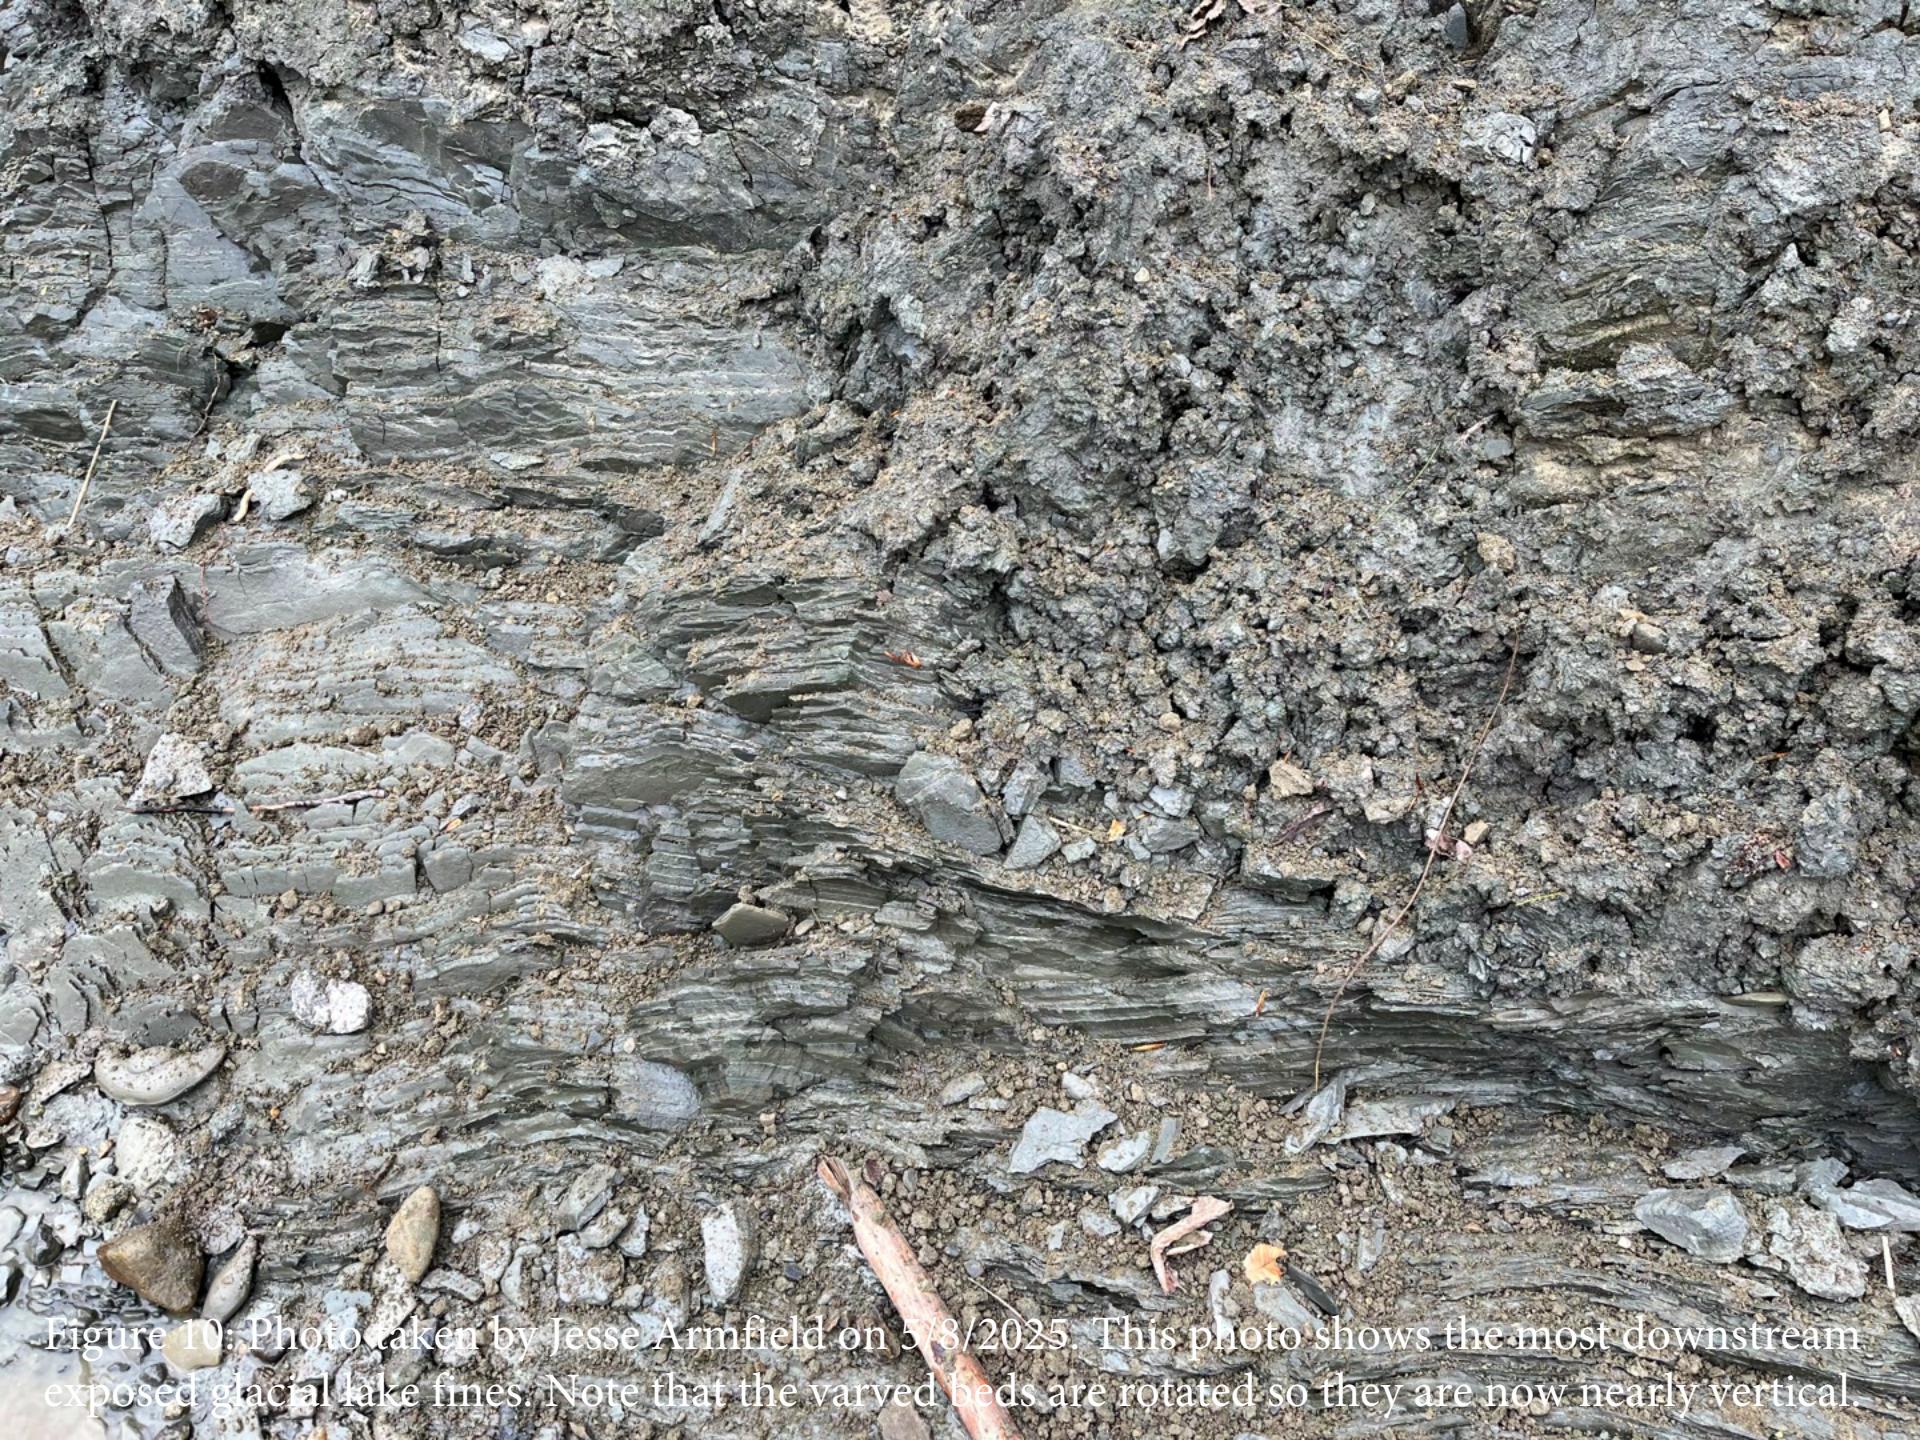
Figure 10: Photo taken by Jesse Armfield on 5/8/2025. This photo shows the most downstream exposed glacial lake fines. Note that the varved beds are rotated so they are now nearly vertical.

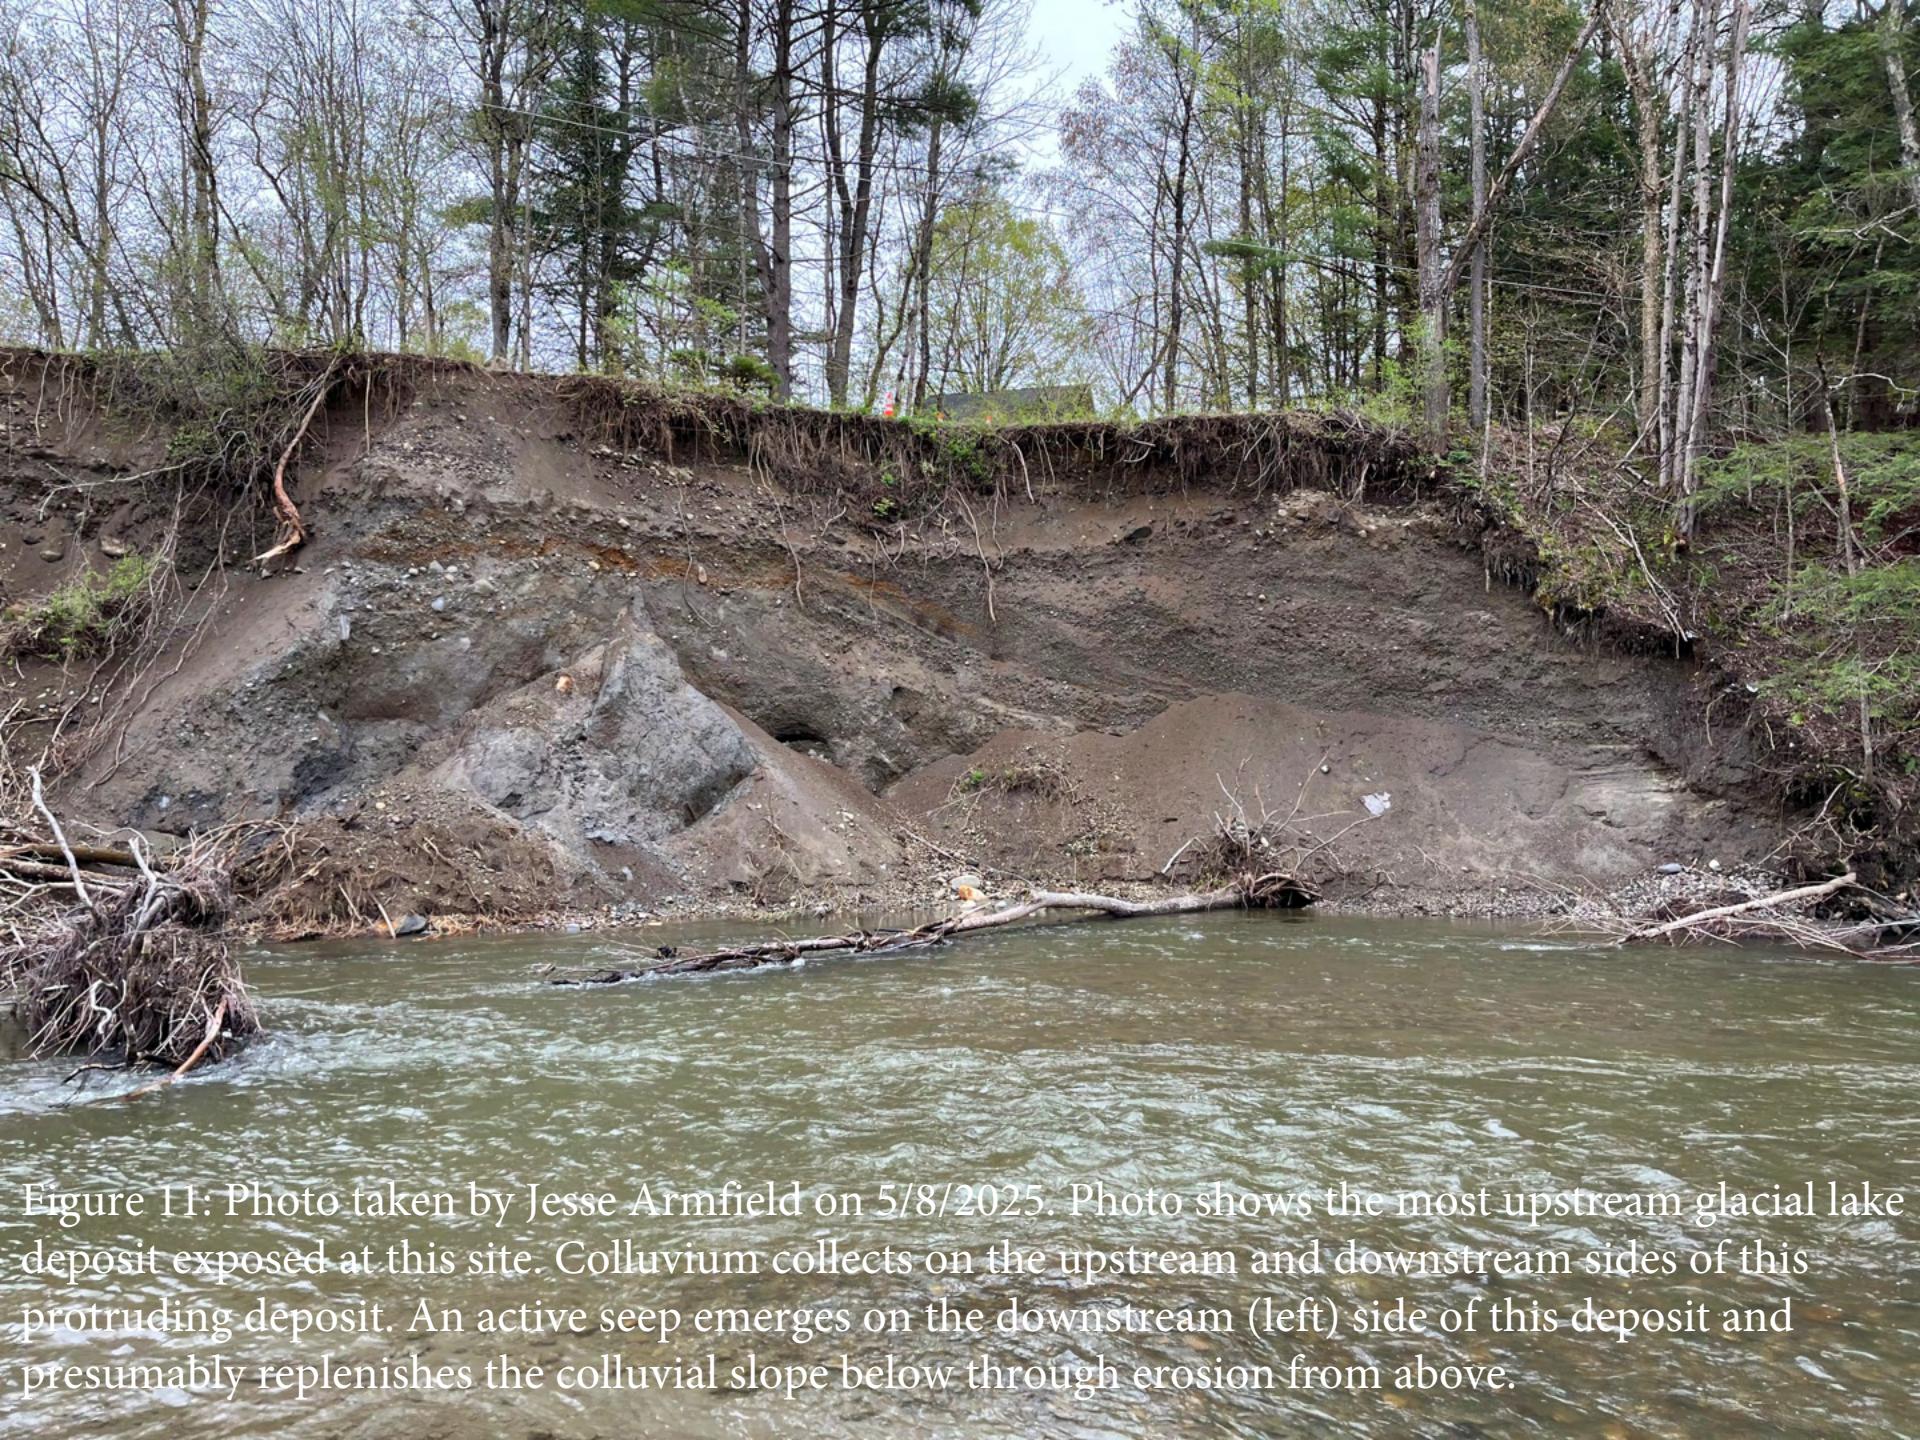
The glacial lake deposits appear to be less erodible than the overlying material, these deposits stick out of the bank and colluvium accumulates on the upstream and downstream sides (Figure 11). Further evidence of these deposits' erosion resistance can be found at the downstream contact between the ice contact deposit (esker) and lake bottom deposits (glacial lake deposits). At the contact the bank failure ends and does not progress into the glacial lake material demonstrating the difference in erosion potential (Figure 12).

Figure 11: Photo taken by Jesse Armfield on 5/8/2025. Photo shows the most upstream glacial lake deposit exposed at this site. Colluvium collects on the upstream and downstream sides of this protruding deposit. An active seep emerges on the downstream (left) side of this deposit and presumably replenishes the colluvial slope below through erosion from above.

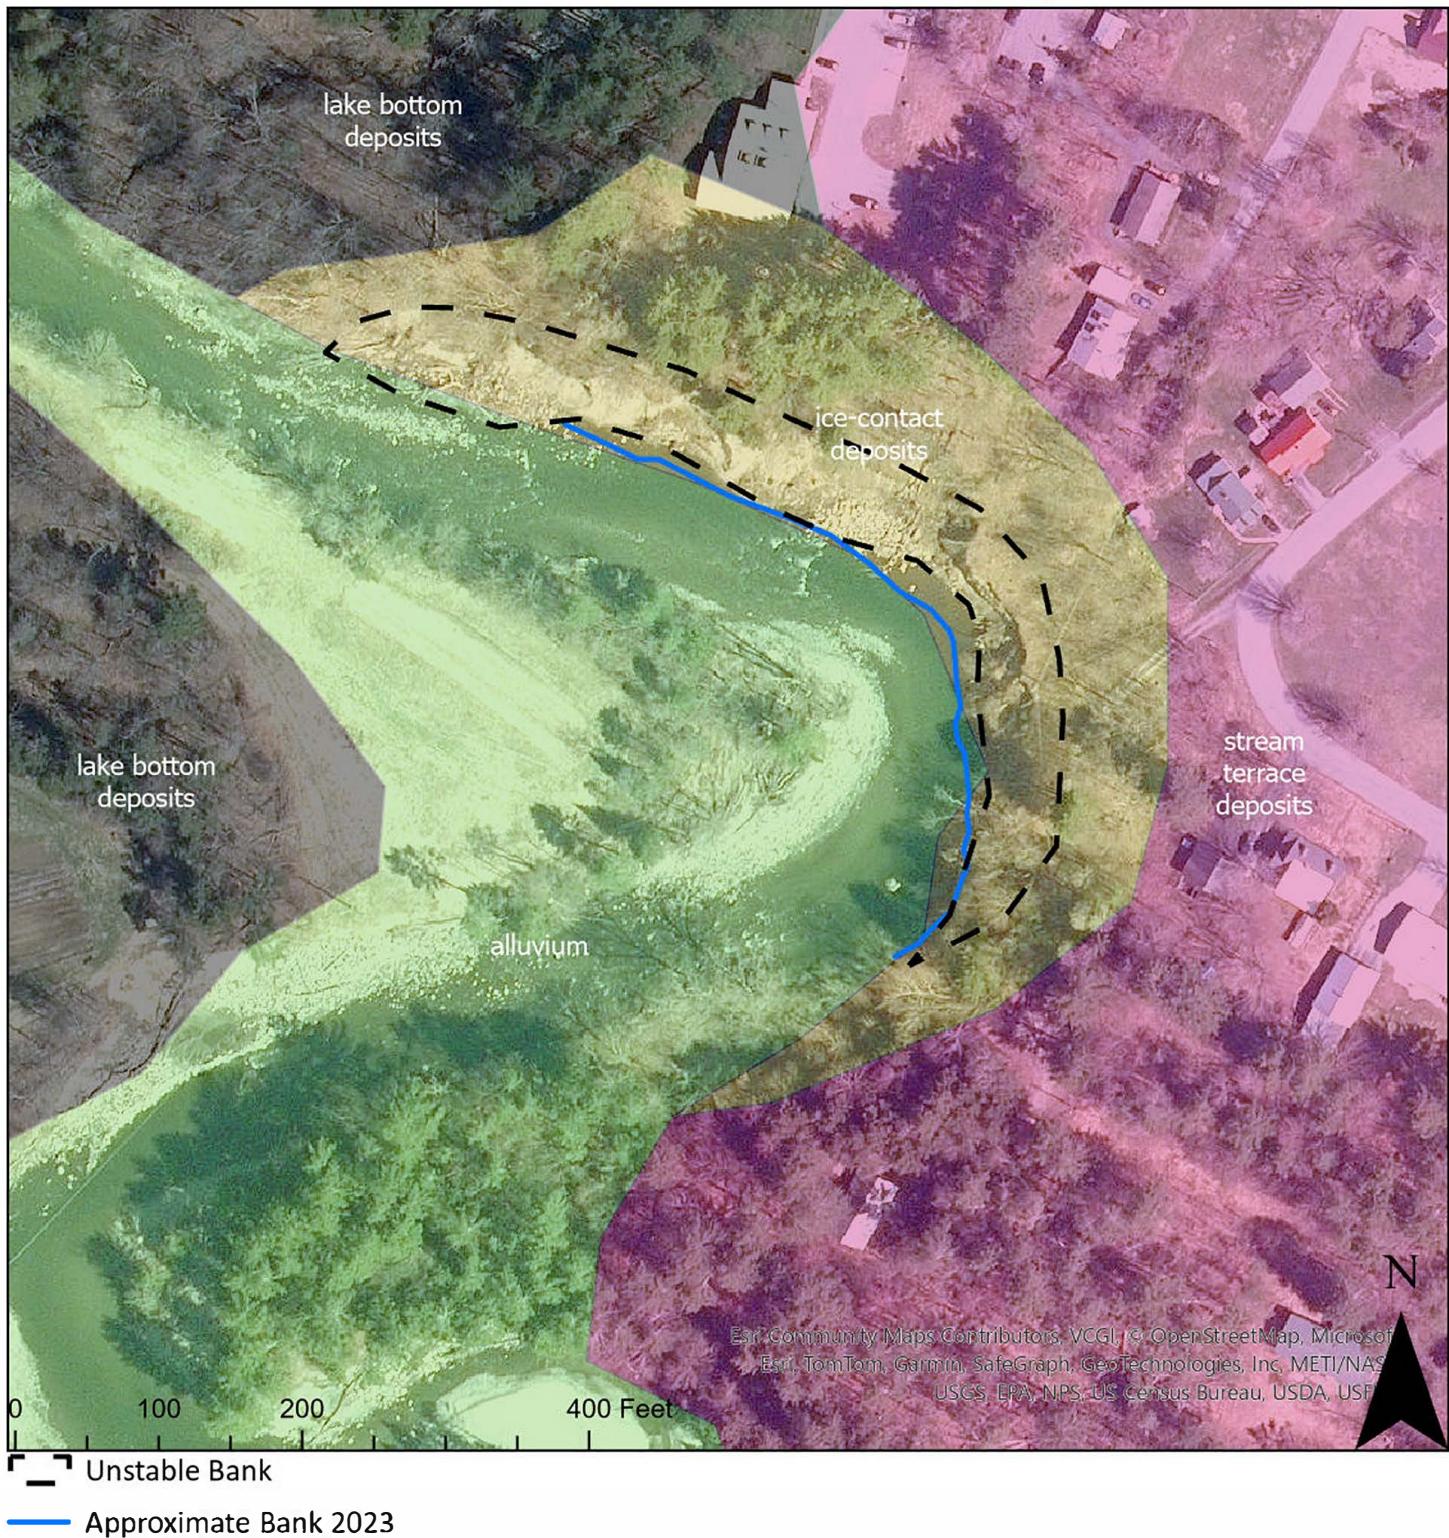
Figure 12: Surficial materials map overlayed on 2024 aerial imagery with the approximate 2023 streambank outlined in blue. Note how the bank failure begins and ends approximately where the ice-contact (esker) deposit is in contact with the river. Created using shapefiles from Springston, 2011.

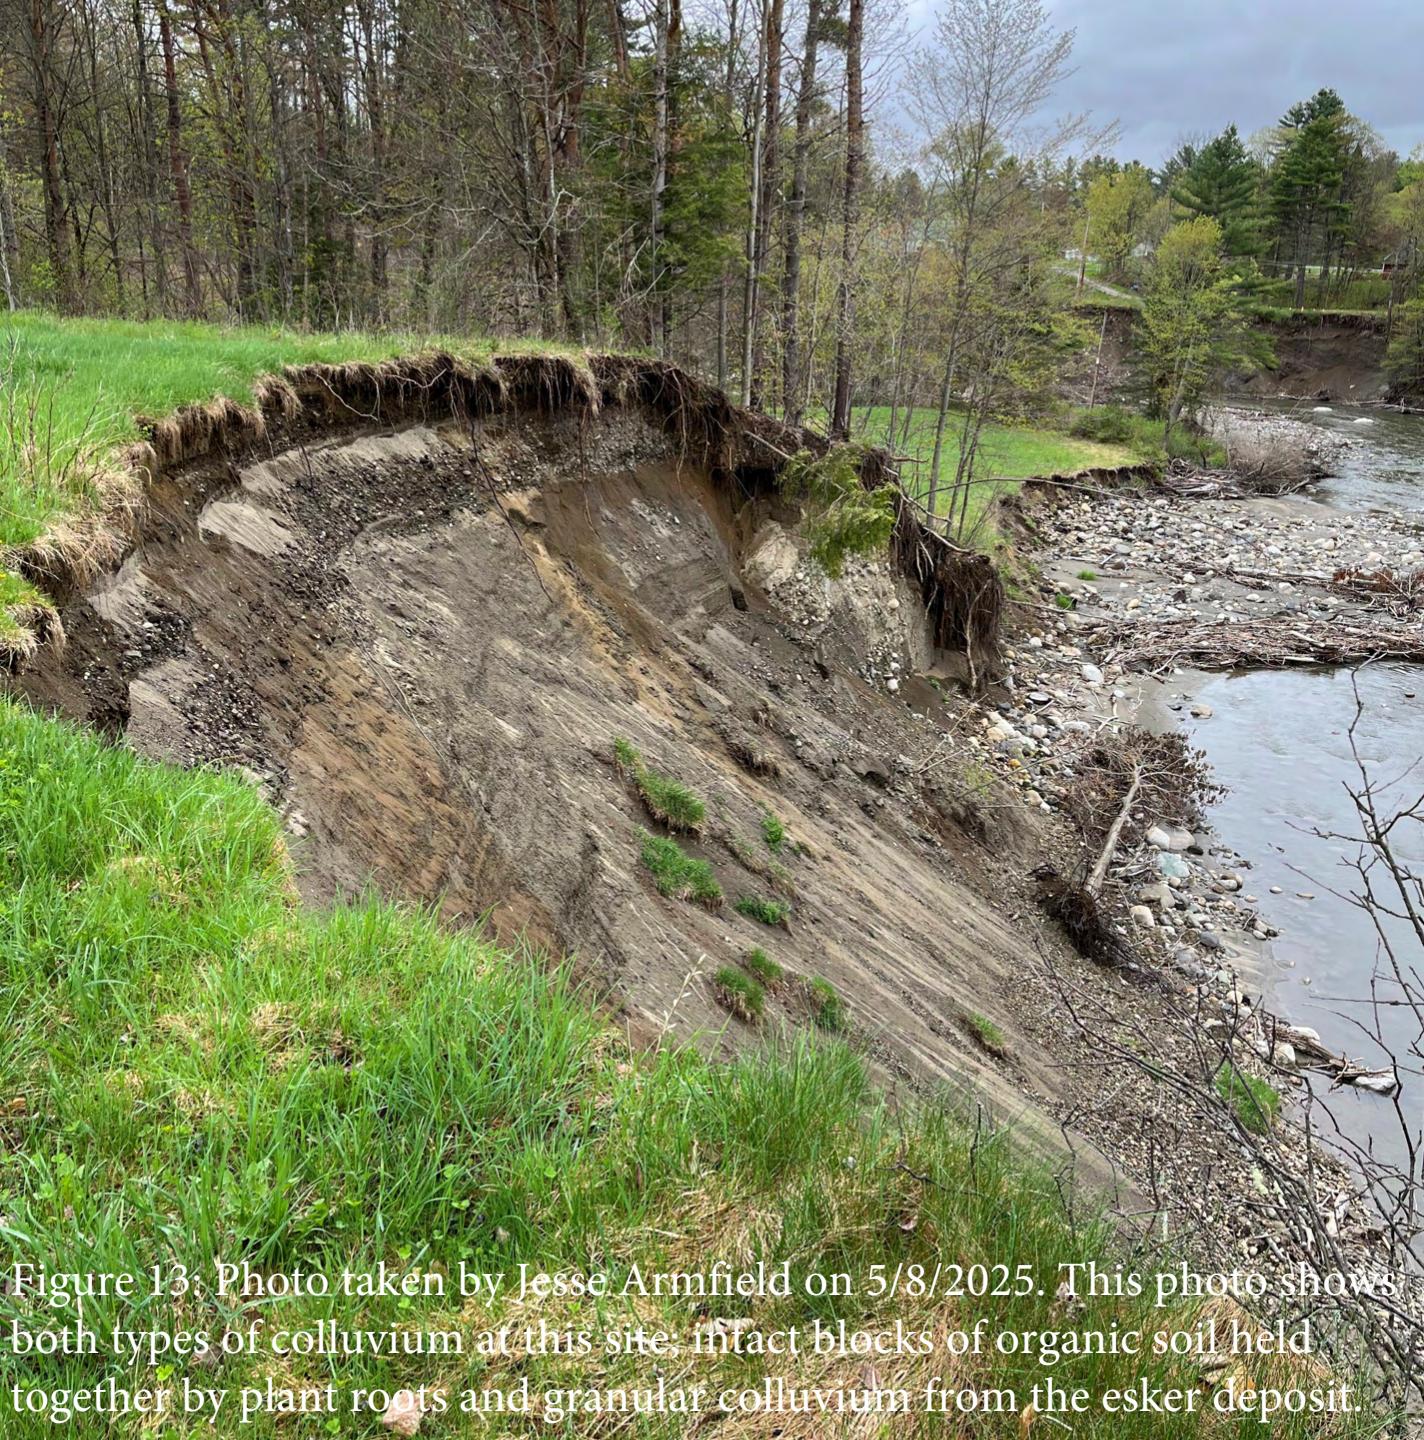
A significant portion of the esker deposit is covered by colluvium. Two distinct types of colluvium cover this slope, intact blocks of organic soil presumably held together by plant roots and granular colluvium from the esker itself presumably slumping as the bank fails (Figure 13). Fractures running parallel to the bank are exposed on the grass surface above the bank near the access road. Fractures similar to these are likely responsible for the intact blocks of organic soil seen at various locations across the colluvial slope. These fractures will likely propagate due to the over steepened slope below, and failure will progress. Colluvium from the esker deposit may fail in blocks but due to the nature of the deposit the colluvial slopes from this deposit are granular and loose.

Figure 13: Photo taken by Jesse Armfield on 5/8/2025. This photo shows both types of colluvium at this site: intact blocks of organic soil held together by plant roots and granular colluvium from the esker deposit.
