Natural Resources Conservation Service
DAMAGE SURVEY REPORT (DSR)
Emergency Watershed Protection Program – Recovery

D. Client's Objective(s) (purpose): To stabilize an actively eroding stretch of Winooski River that is threatening infrastructure along Martin Meadow Road in the Town of Plainfield.		A. Client Name: Town of Plainfield B. Conservation Plan ID # (as applicable): 50 01 24 5042 017-126 Program Authority (optional): EWP C. Identification # (farm, tract, field #, etc. as required): 203 Martin Meadow Road, Plainfield, VT

DSR 50-01-24-5042-017

Purpose: This report presents a review of available geologic data used to evaluate conditions which may affect the planning, design and scope of a proposed stream bank stabilization project. After a brief initial desk review it was determined that a field reconnaissance investigation was required to properly assess the site. The results and interpretations of the desktop and field investigations are summarized here.

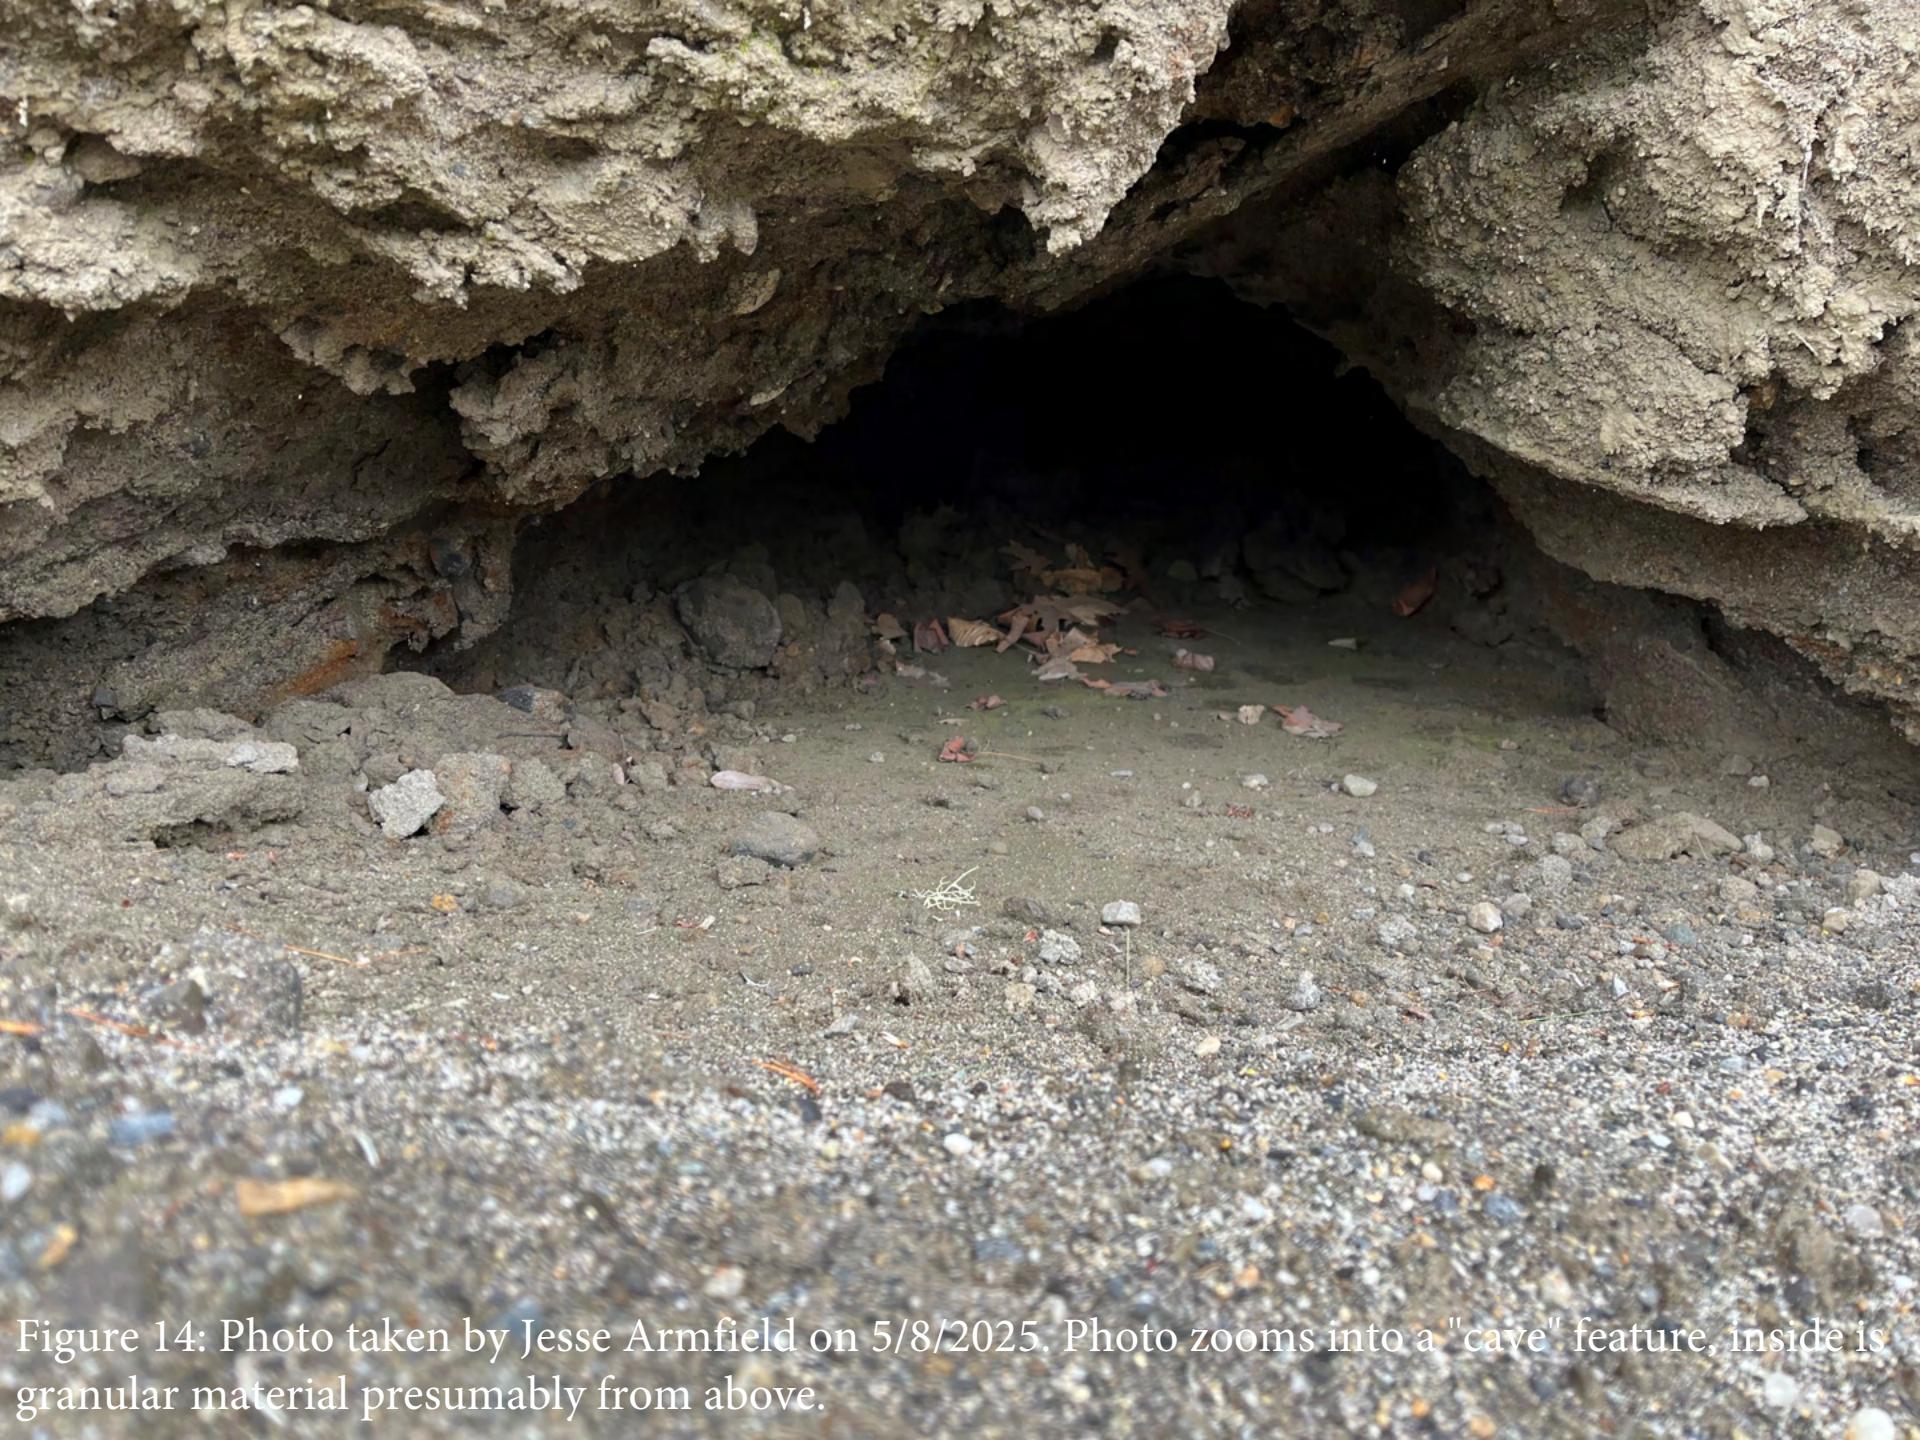
The esker deposit also hosts “cave” features (3 noted), described as large voids with openings near the top of colluvium (Figure 14). These cave features were likely formed as 2024 flood waters cut into the bank and undermined it. The cave features in figure 15 (11/2024) and figure 3 (7/2024) appear larger and more numerous than during the investigation on 5/8/2025 (Figure 16). Soil fractures above the cave features (and in other locations) reveal complex block movement as the void spaces are filled with collapsing material from above (Figure 17). These caves are thought to further the imminent risk of further collapse/bank failure. Note that it is possible additional “caves” are covered by or filled in by colluvium and were not noted.

Figure 14: Photo taken by Jesse Armfield on 5/8/2025. Photo zooms into a "cave" feature, inside is granular material presumably from above.

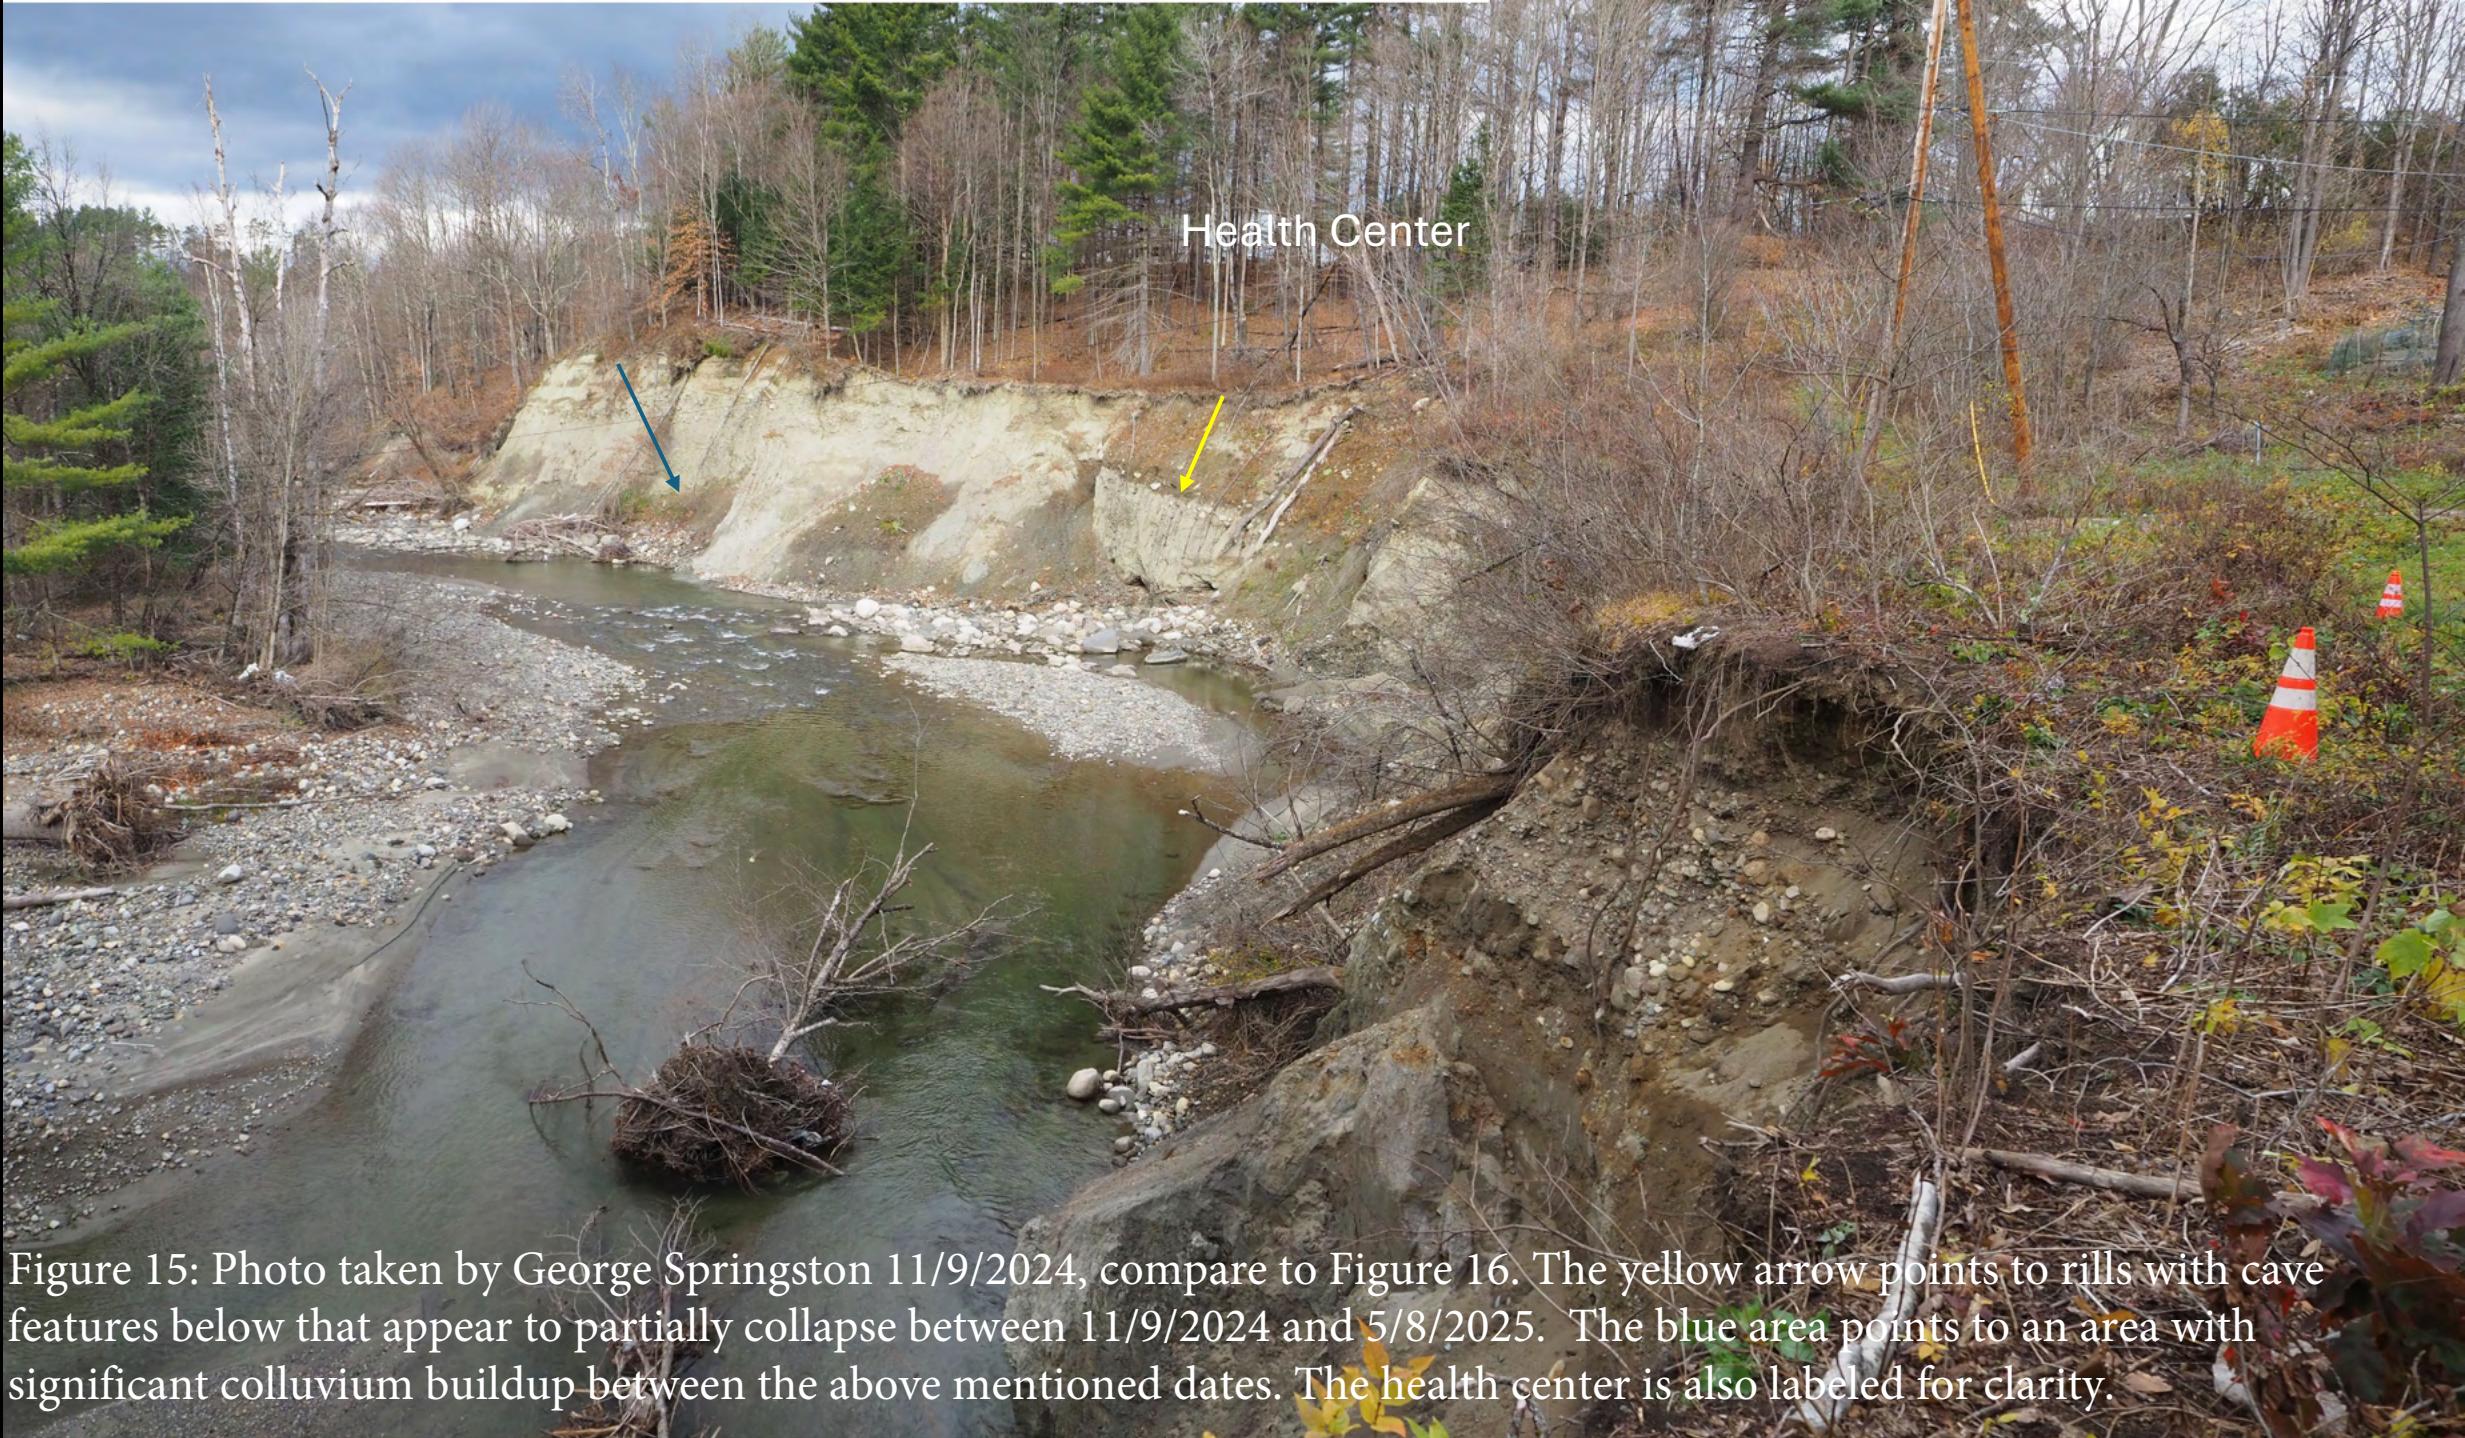
Figure 15: Photo taken by George Springston 11/9/2024, compare to Figure 16. The yellow arrow points to rills with cave features below that appear to partially collapse between 11/9/2024 and 5/8/2025. The blue area points to an area with significant colluvium buildup between the above mentioned dates. The health center is also labeled for clarity.

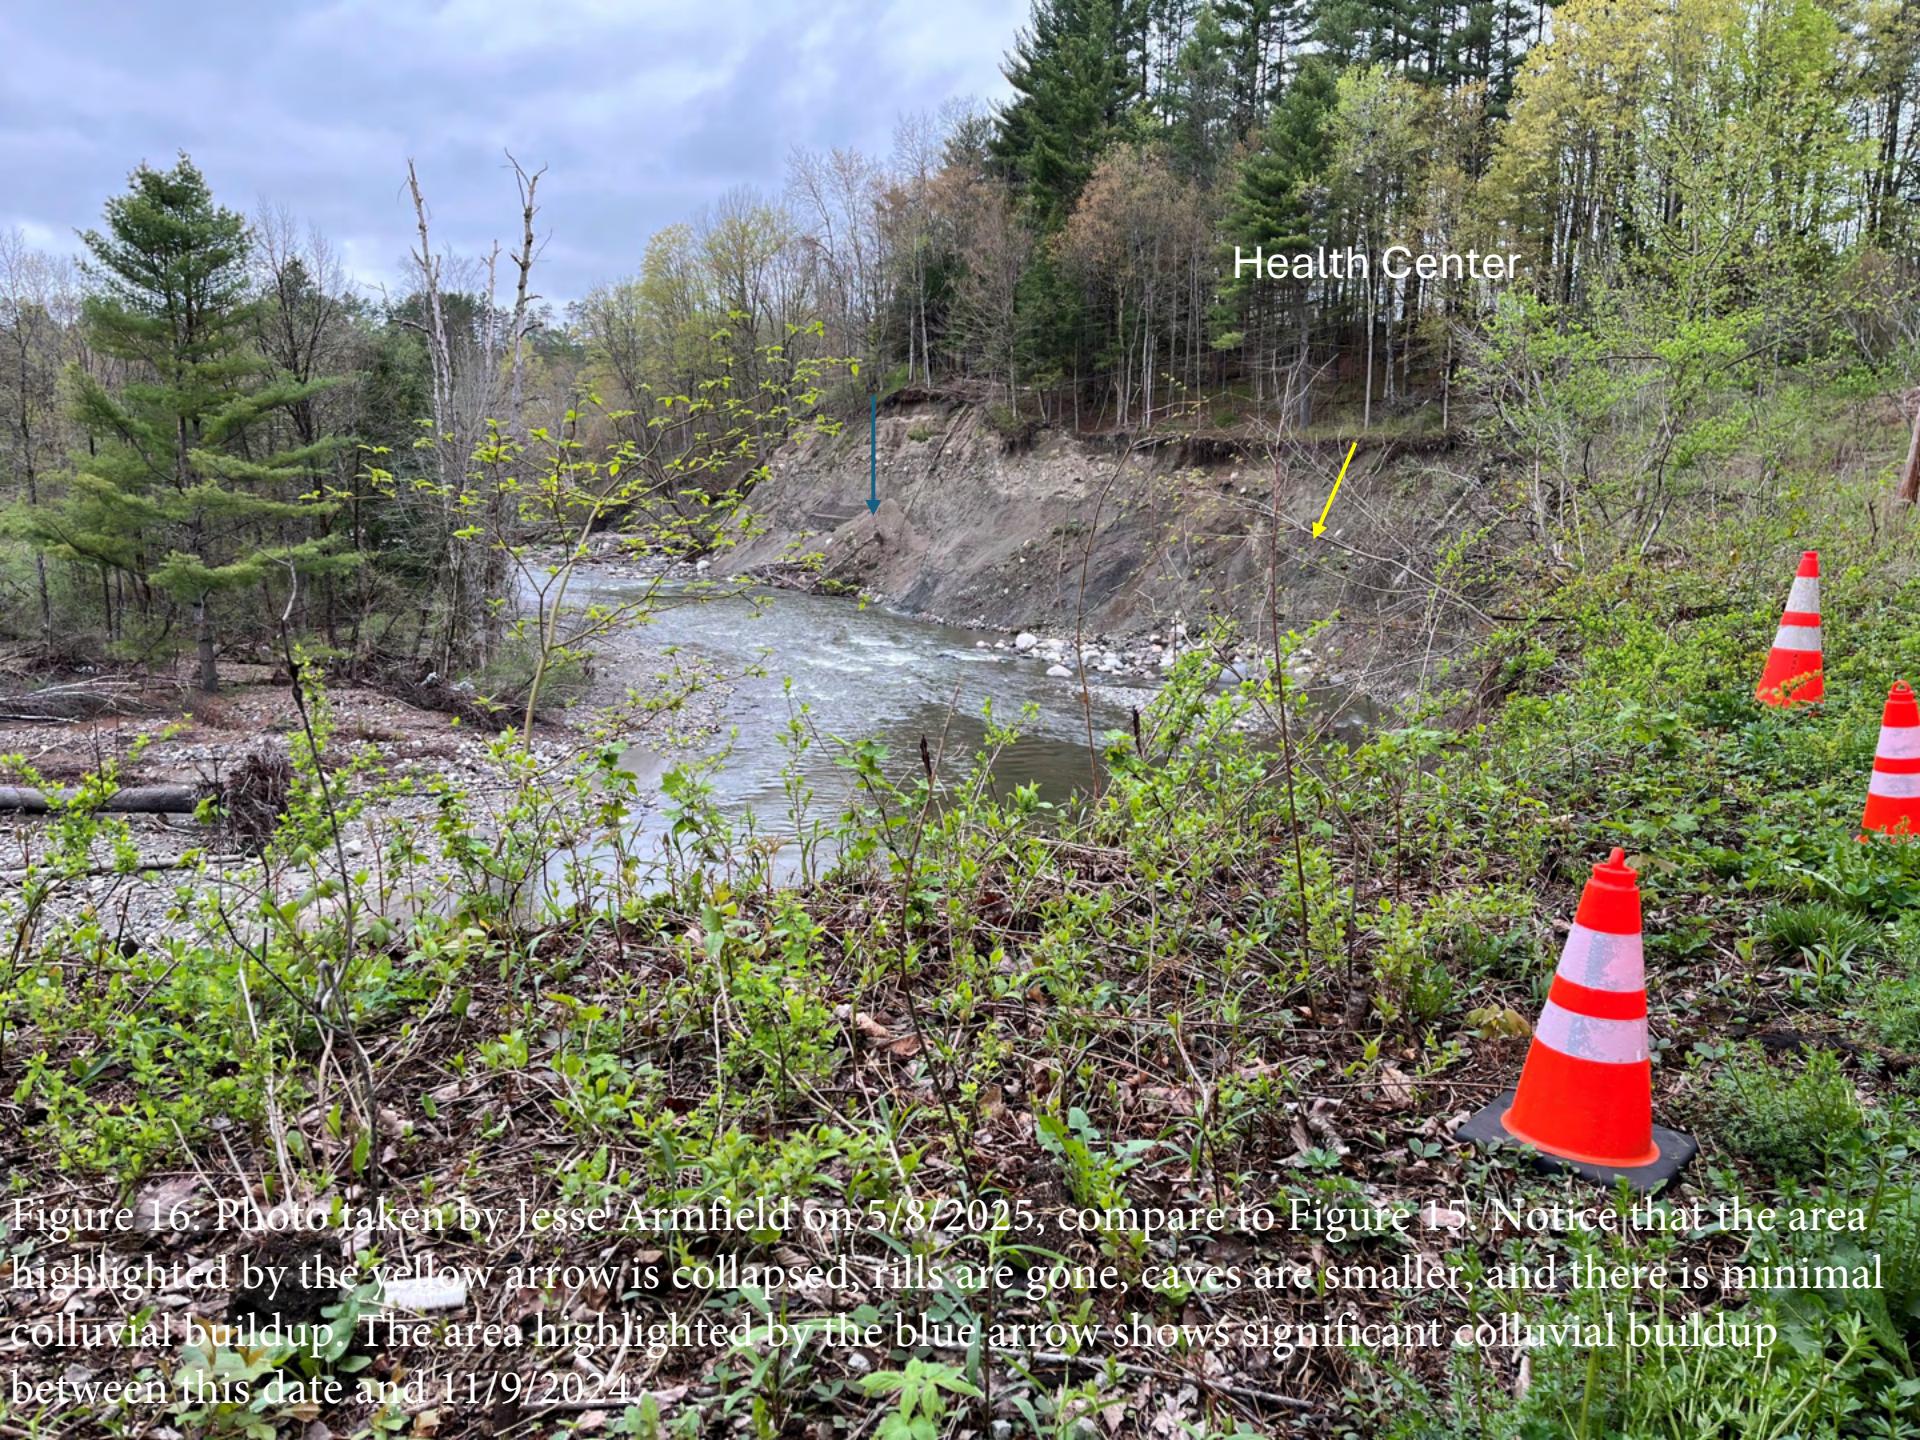
Figure 16: Photo taken by Jesse Armfield on 5/8/2025, compare to Figure 15. Notice that the area highlighted by the yellow arrow is collapsed, rills are gone, caves are smaller, and there is minimal colluvial buildup. The area highlighted by the blue arrow shows significant colluvial buildup between this date and 11/9/2024.

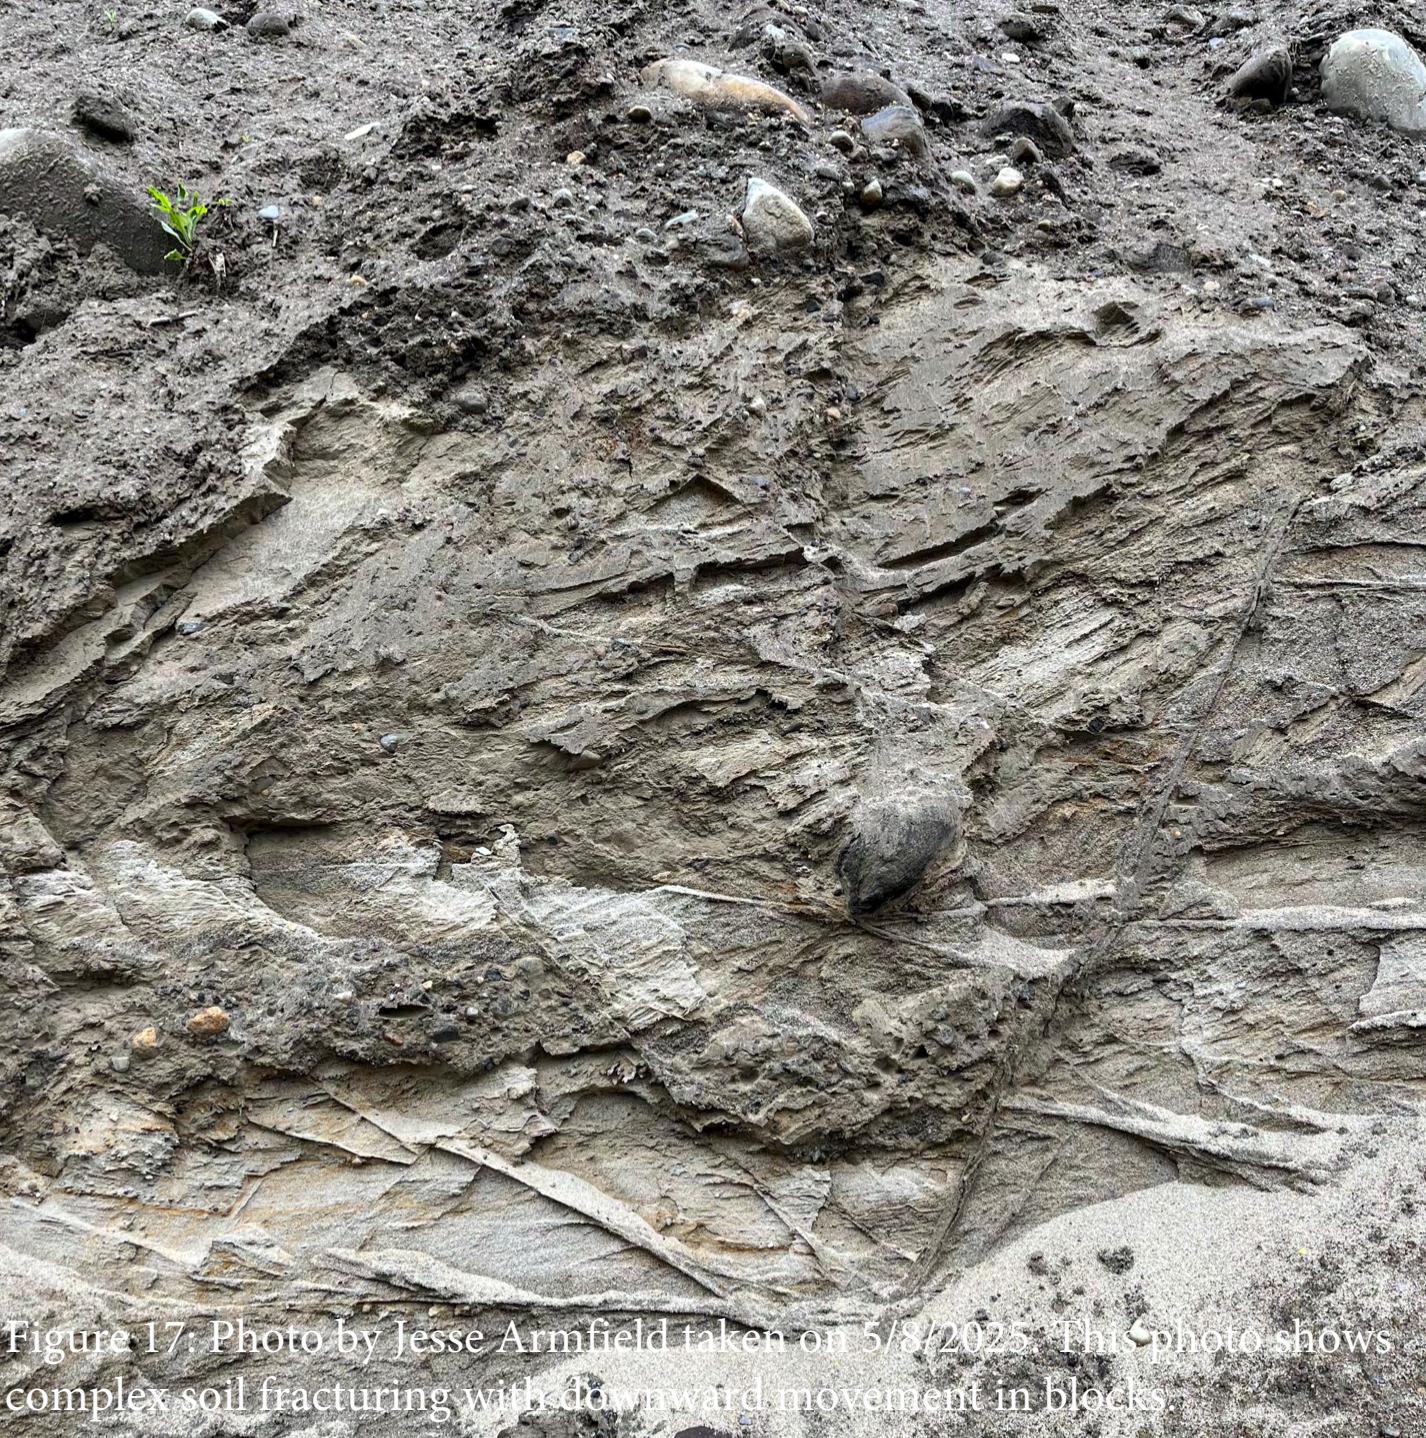
Figure 17: Photo by Jesse Armfield taken on 5/8/2025. This photo shows complex soil fracturing with downward movement in blocks.

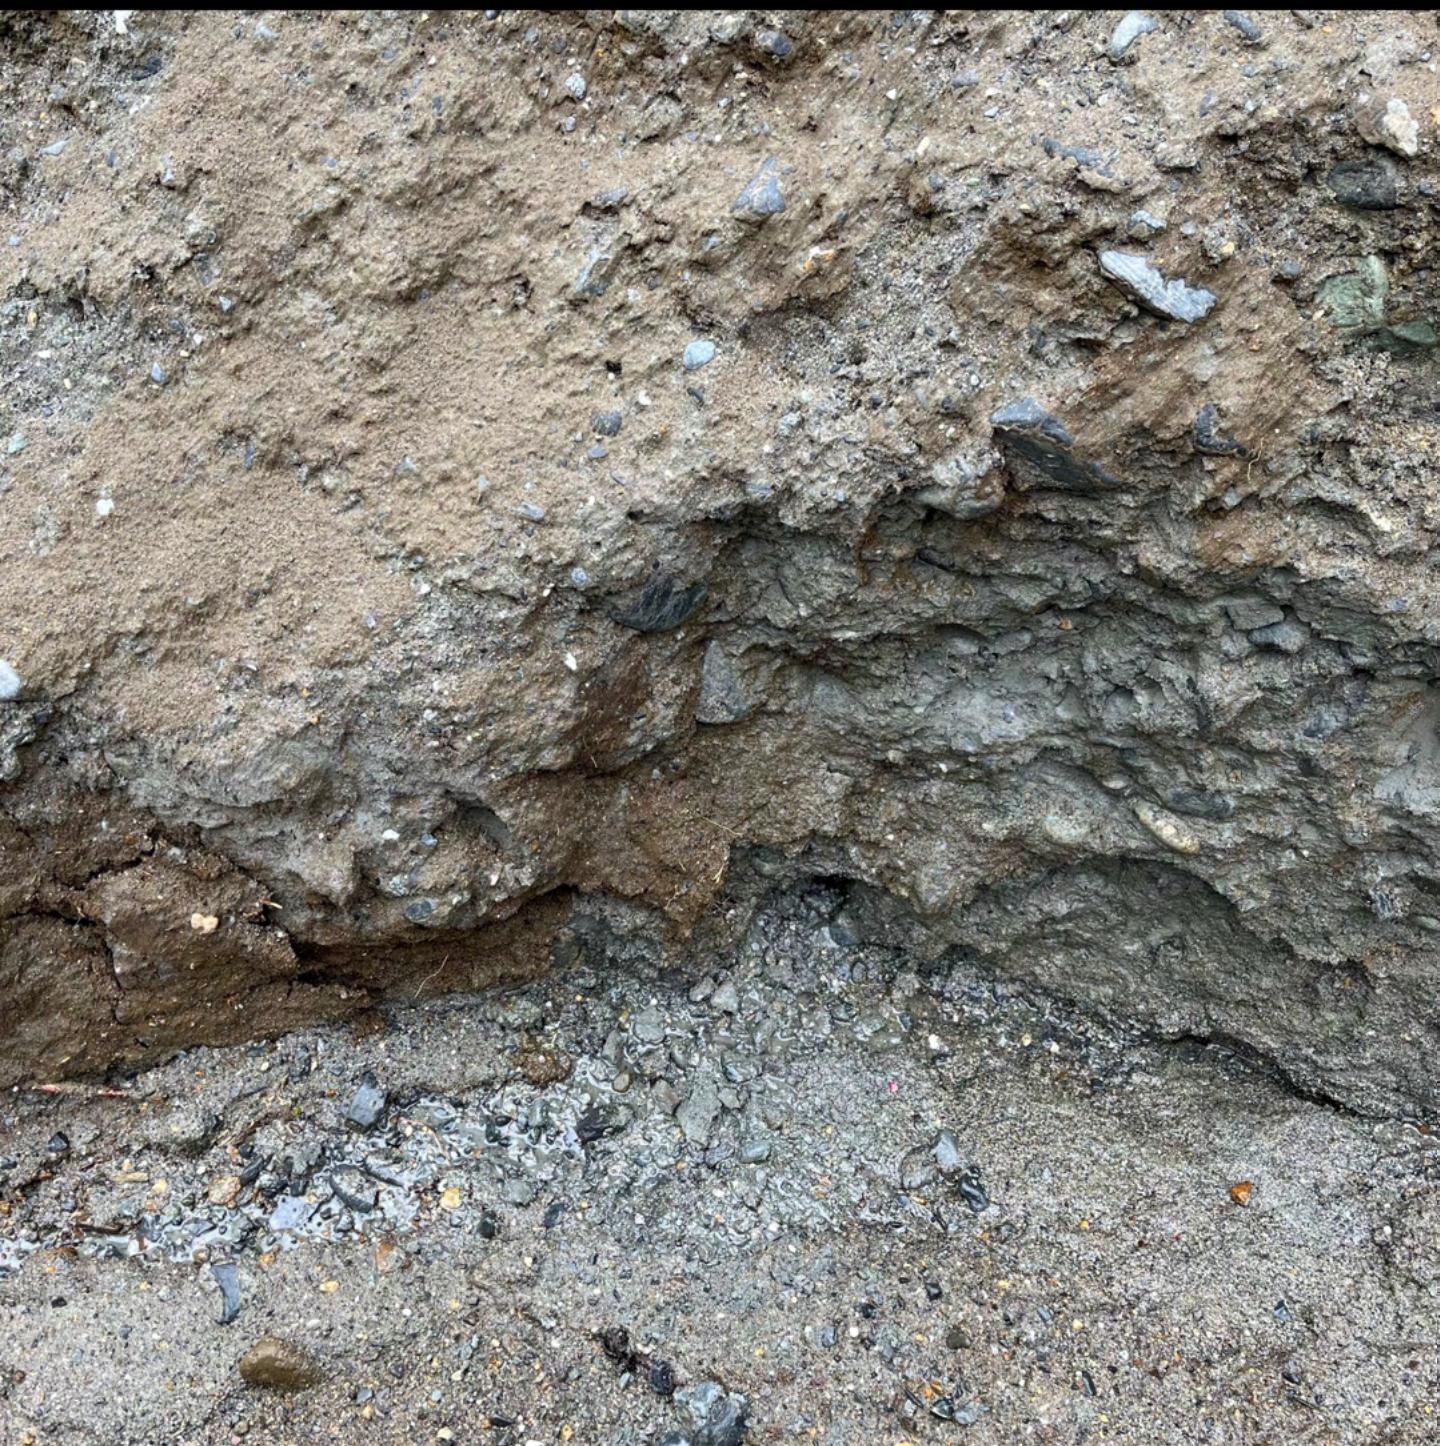
The esker deposit also hosts numerous active and inactive groundwater seeps (Figure 18-19). Three active groundwater seeps were noted during the field investigation that were visibly eroding around where they emerged and eroded material was presumably being added to the colluvium below (Figure 11). The water from these active seeps saturated the colluvium below and these areas slid when additional load was added (they slid when walked on). It's hypothesized that the seeps are causing material to sluff off the intact bedded material which then increases the volume and slope of the colluvium until small scale sliding periodically occurs (Figure 20). These small-scale slides end up in the active channel, or become inundated during events, and are subsequently eroded furthering the instability of this slope. Further evidence of this hypothesis and of continued slope failure through other mechanisms is presented in the following paragraph. Seeps that were inactive during the field investigation were marked by beds weakly cemented by calcite or small stalactites containing fines (Figure 19).

Figure 18: Photo taken by Jesse Armfield on 5/8/2025. This photo shows an active groundwater seep emerging from the bank. Fines are removed from the area of flowing water and a nearly vertical wall is above the seep presumably due to erosion caused by the seep.

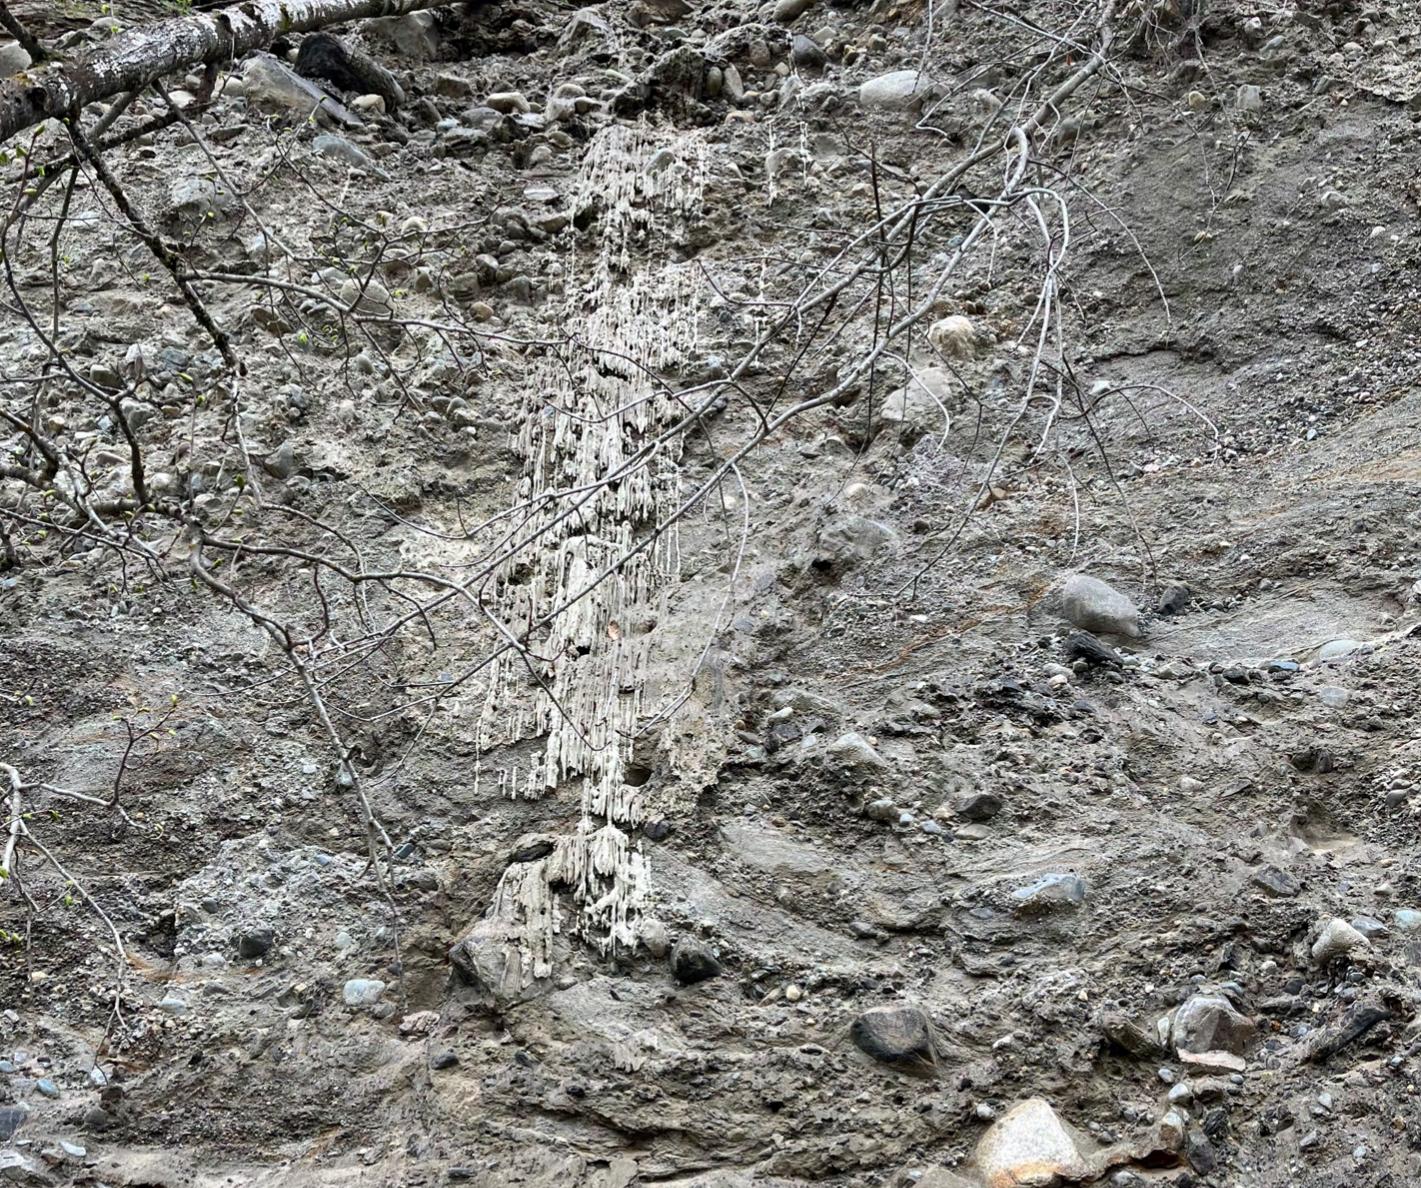
Figure 19: Photo taken by Jesse Armfield on 5/8/2025. This photo shows evidence of an inactive seep that presumably activates when the water table is higher. The stalactite features in the center of the photo are weakly cemented together and have an ML texture.

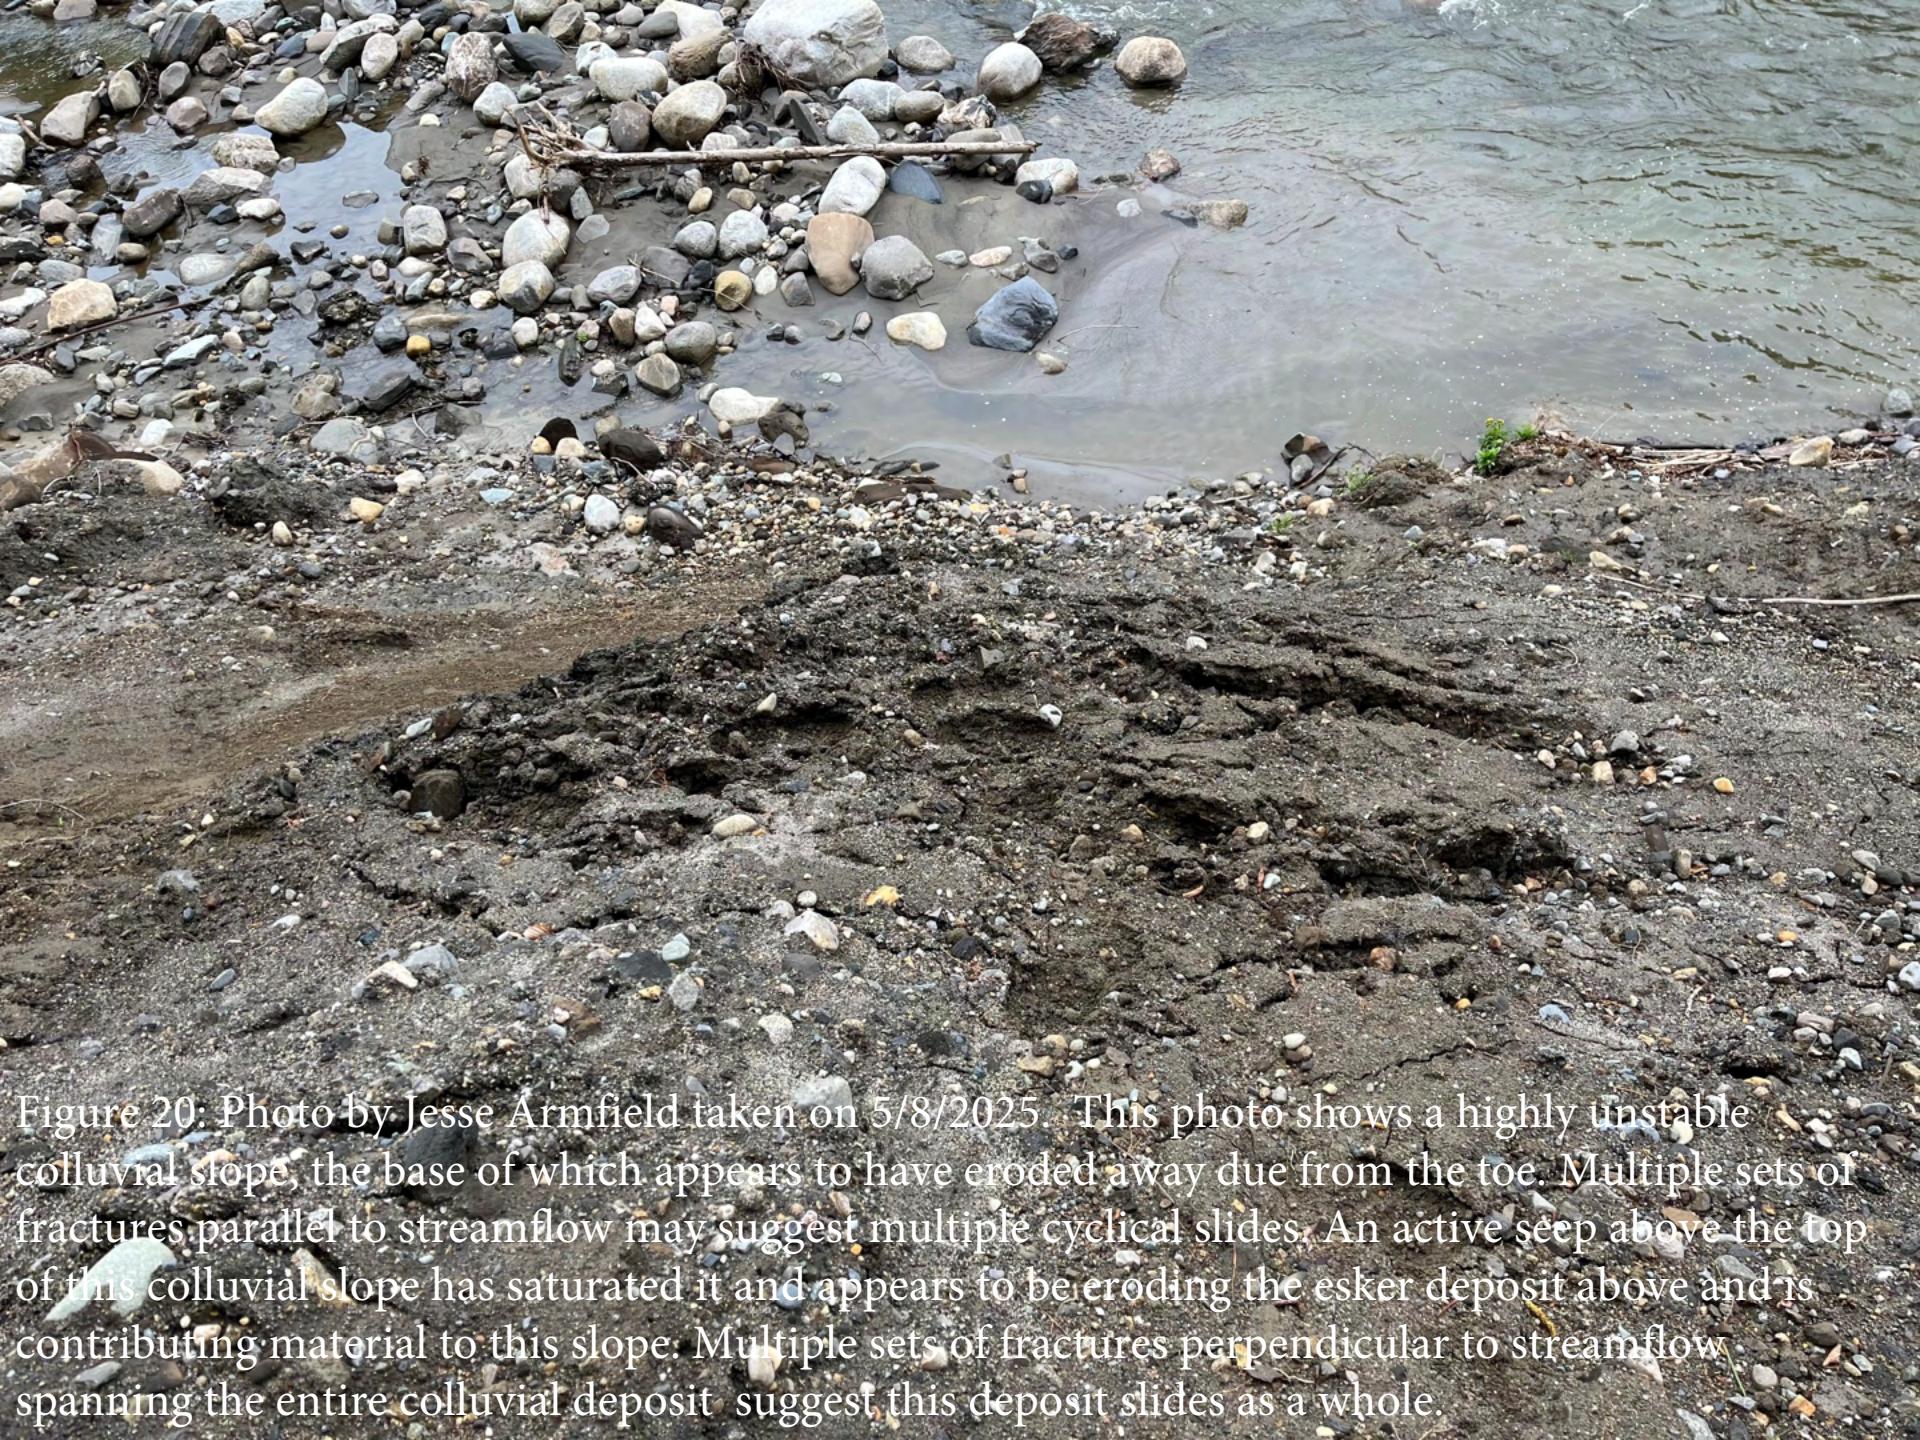
Figure 20: Photo by Jesse Armfield taken on 5/8/2025. This photo shows a highly unstable colluvial slope, the base of which appears to have eroded away due from the toe. Multiple sets of fractures parallel to streamflow may suggest multiple cyclical slides. An active seep above the top of this colluvial slope has saturated it and appears to be eroding the esker deposit above and is contributing material to this slope. Multiple sets of fractures perpendicular to streamflow spanning the entire colluvial deposit suggest this deposit slides as a whole.

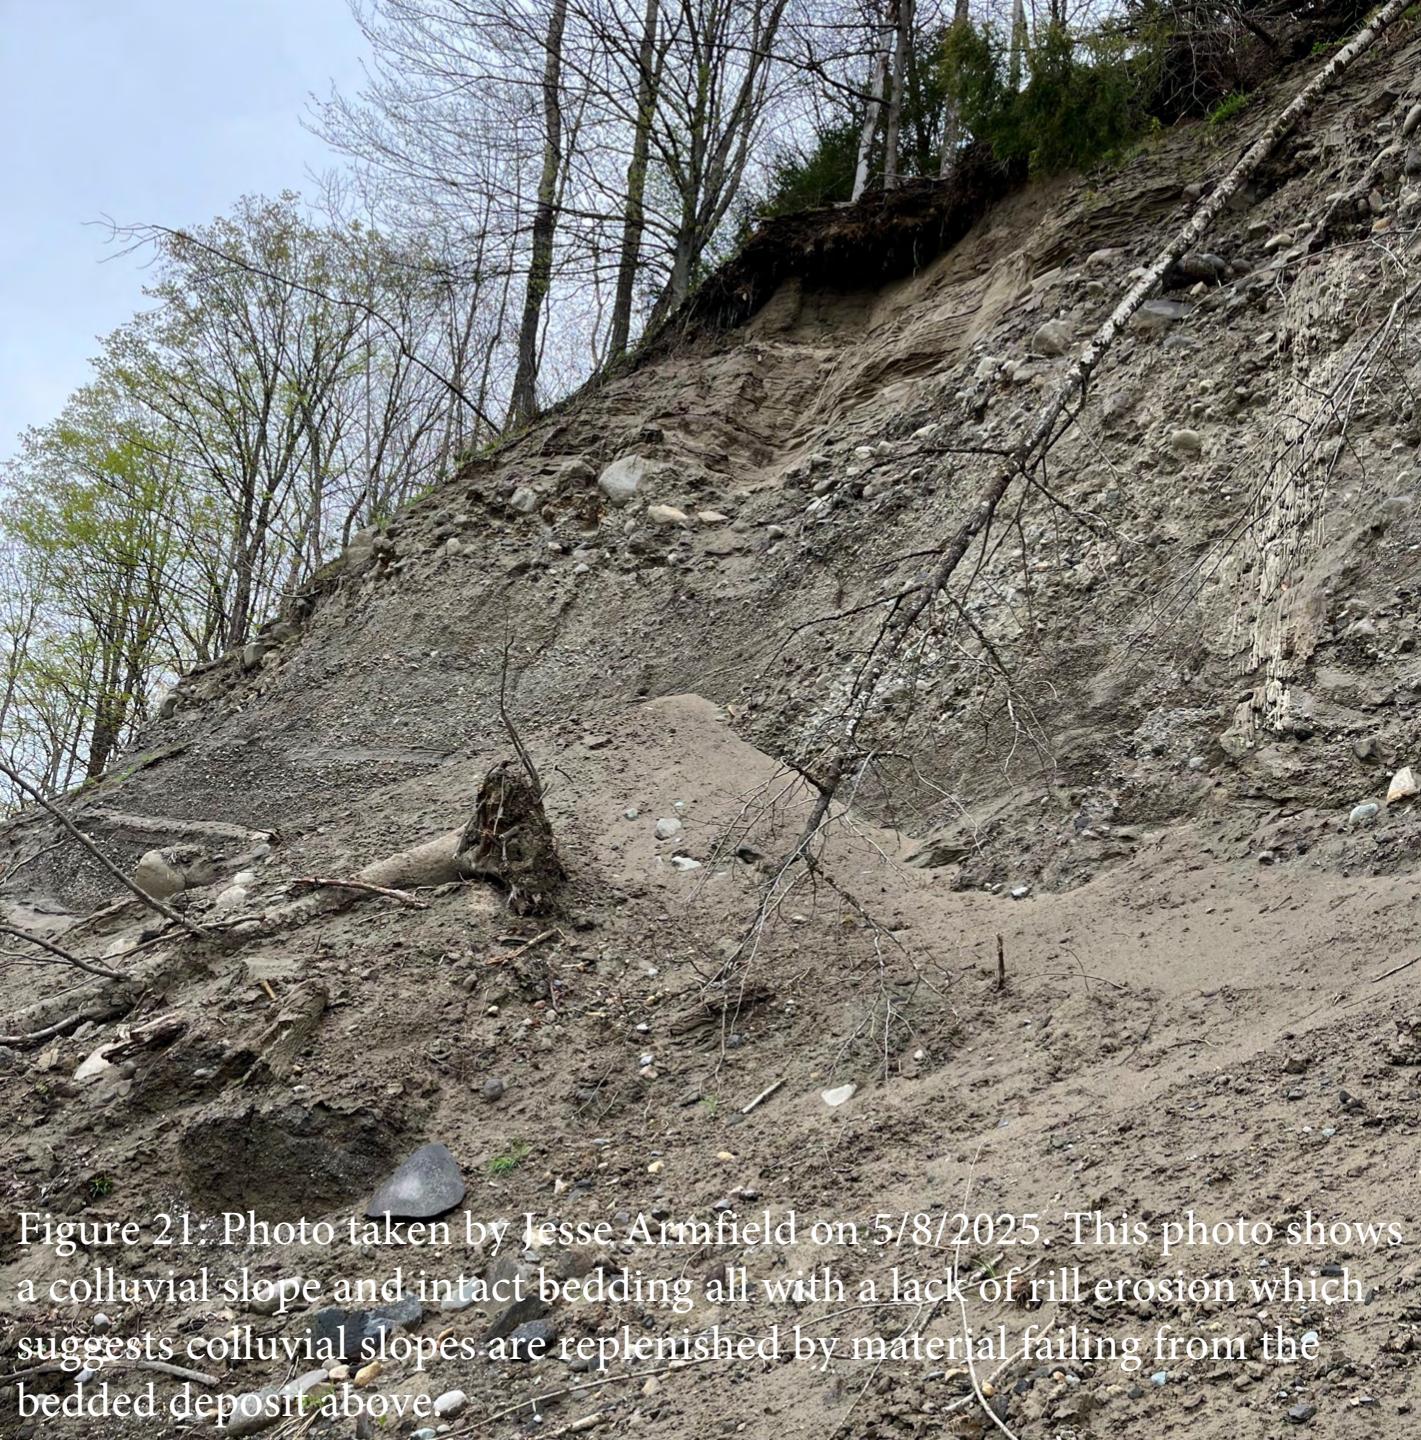
Figure 21: Photo taken by Jesse Armfield on 5/8/2025. This photo shows a colluvial slope and intact bedding all with a lack of rill erosion which suggests colluvial slopes are replenished by material failing from the bedded deposit above.

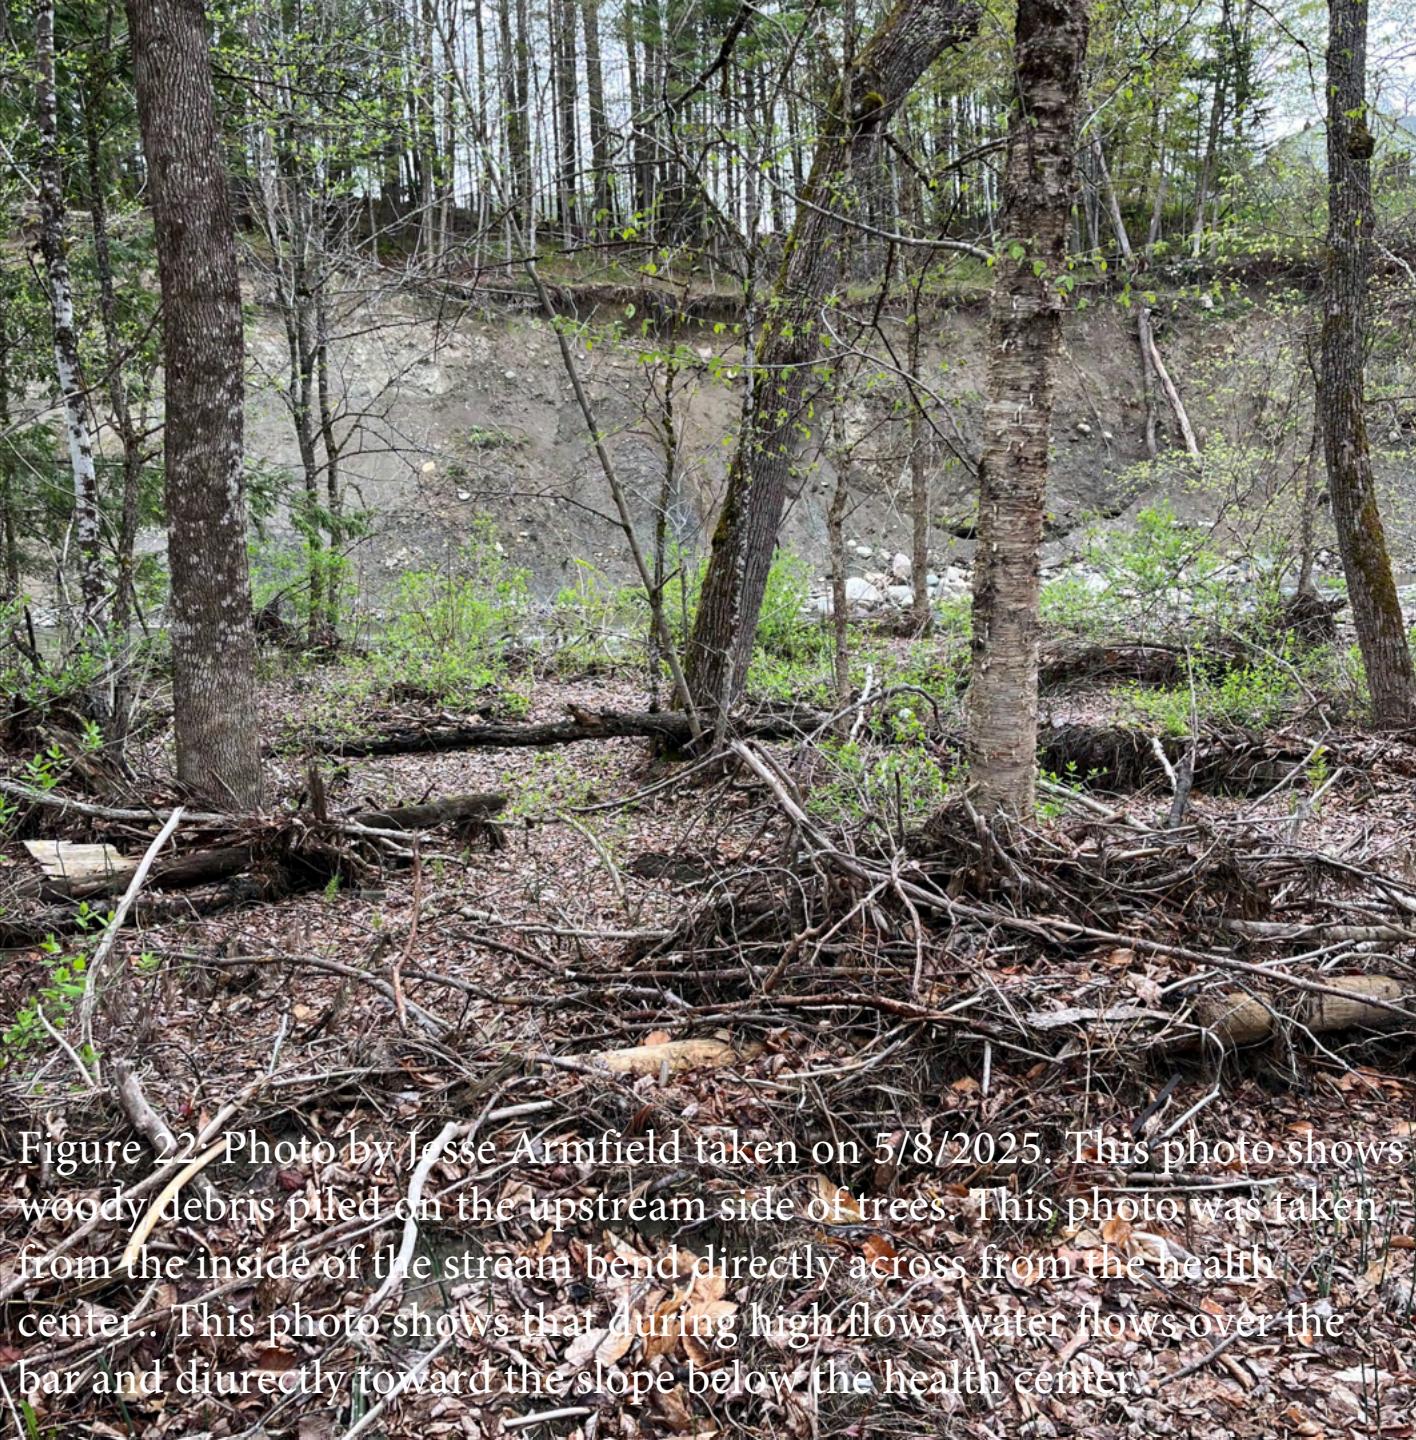
Figure 22: Photo by Jesse Armfield taken on 5/8/2025. This photo shows woody debris piled on the upstream side of trees. This photo was taken from the inside of the stream bend directly across from the health center.. This photo shows that during high flows water flows over the bar and directly toward the slope below the health center.
