# **North Branch and Kingsbury Branch Class Three and Four Road Erosion Assessment**

Project funded with a grant from VT DEC ERP

Central Vermont Regional Planning Commission with assistance from

December 26, 2012

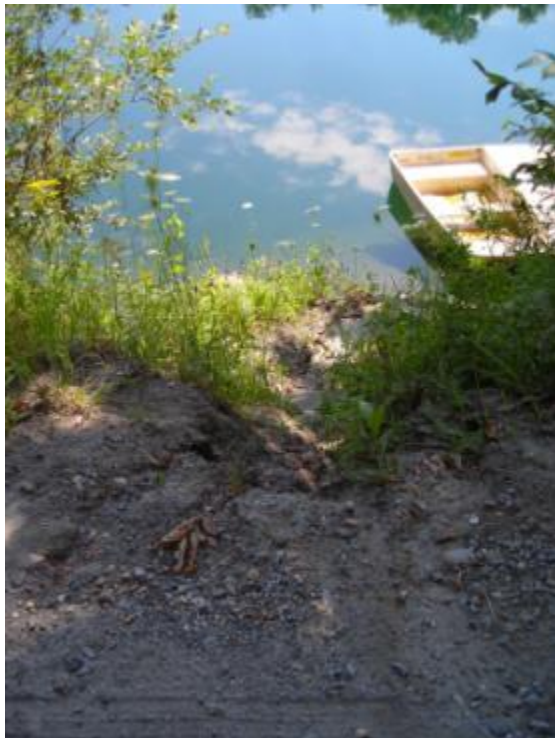
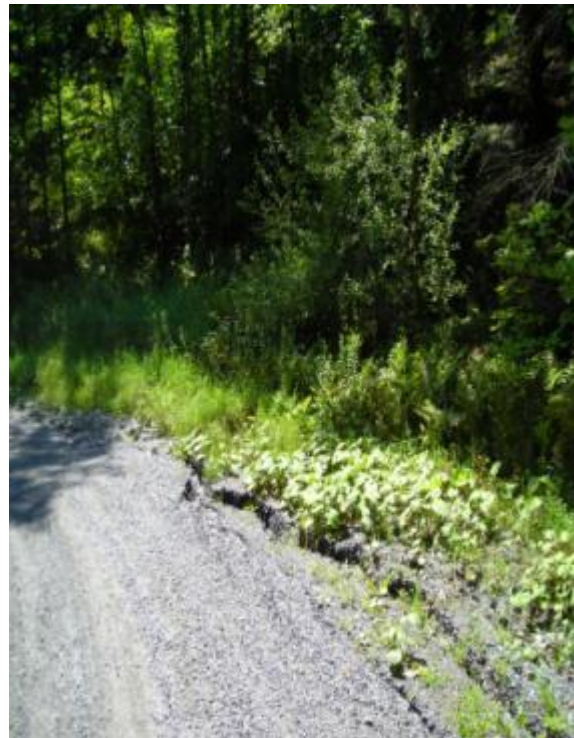
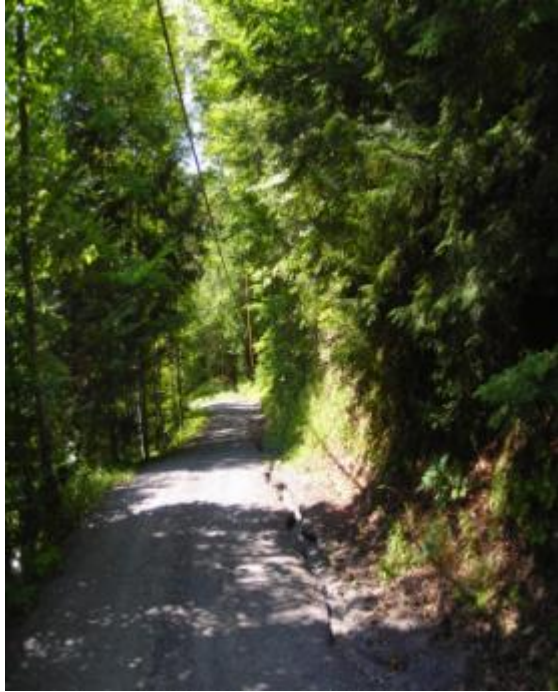
**Erosion site 2** – Good site for Better Back Roads Grant

Location – 820 feet of road shoulder erosion along Mirror Lake Rd 0.16 miles west of Number 10 Pond Rd in Calais, VT.

- Add 1-2 new cross culverts above existing culverts
- Realign existing cross culverts
- Add stone aprons at outlets of new culverts and existing culverts
- Install headers and footers on all new culverts and existing culvert
- Improve ditch and stone line for length of erosion about 820 ft
- Replace existing culvert if undersized for location.

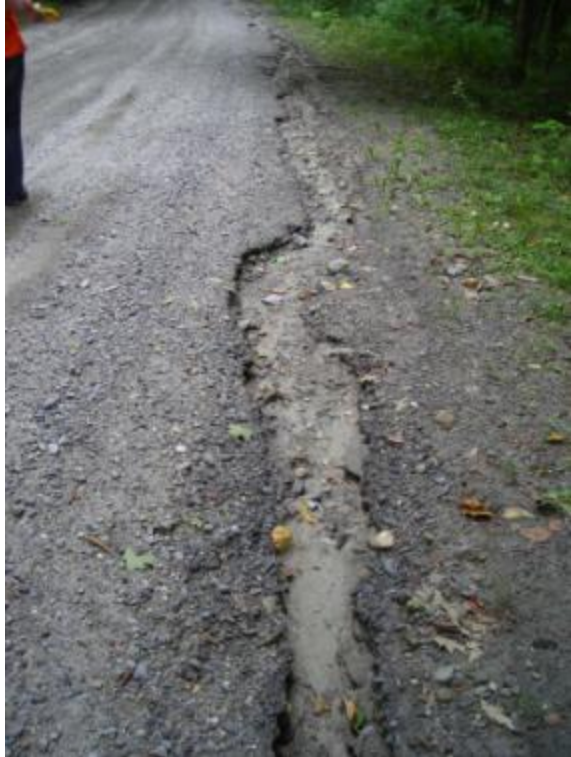
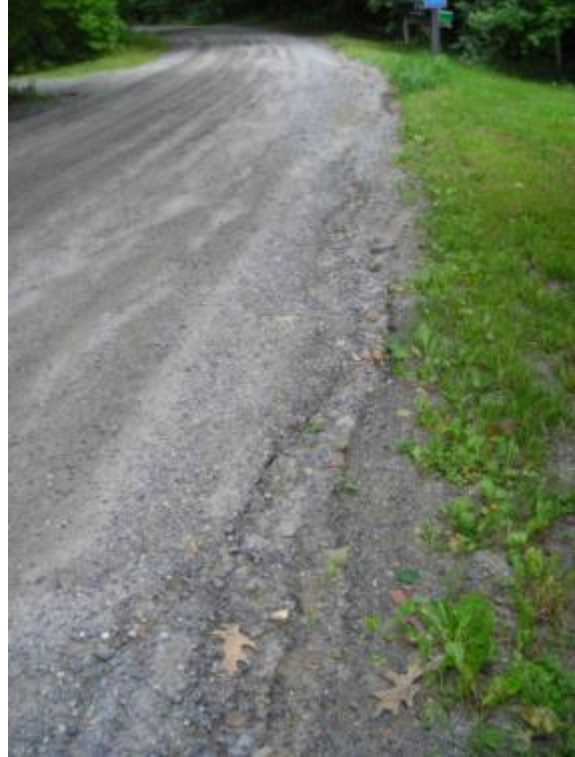
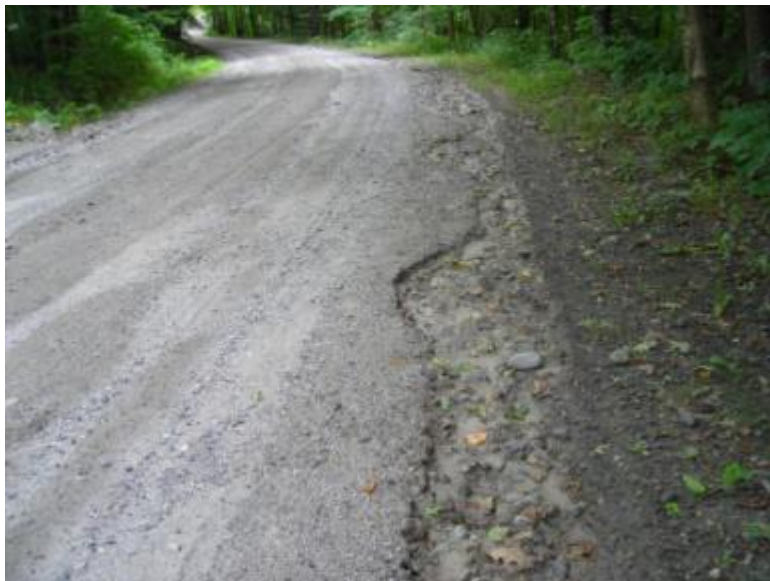
### Erosion site 3

Location – 320 feet of road shoulder erosion along Dugar Brook Rd 220 feet east of West County Rd in Calais, VT.

- Add 1-2 new cross culverts above existing culvert
- Add stone aprons at outlets of new culverts and existing culvert
- Install headers and footers on all new culverts and existing culvert
- Improve ditch and stone line for length of erosion about 320 ft
- Replace existing culvert if undersized for location.

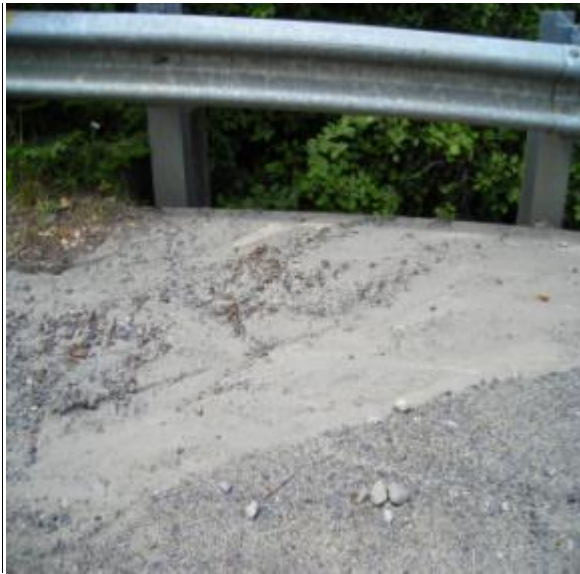
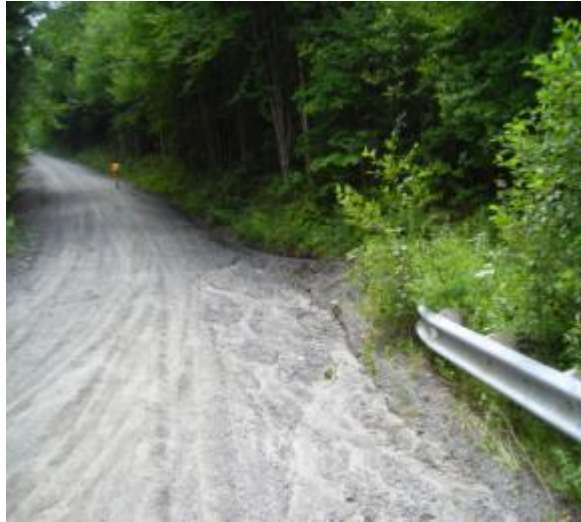
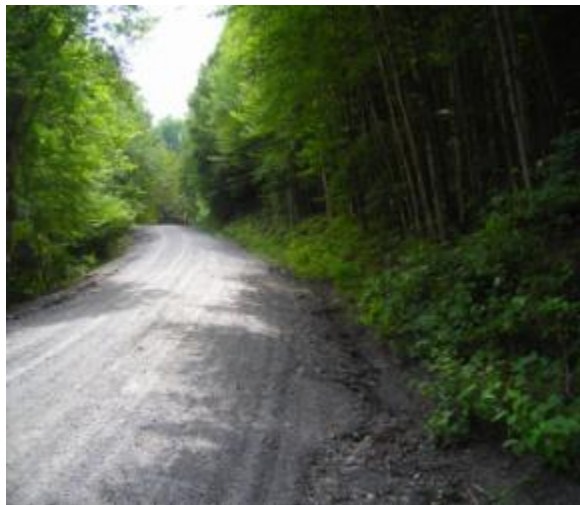
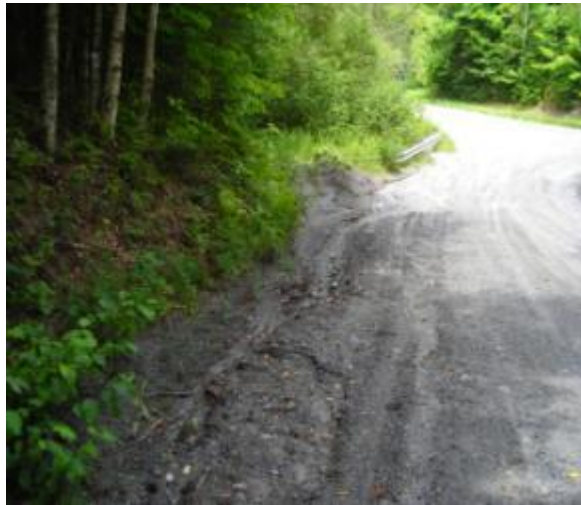
**Erosion site 4** - Good site for Better Back Roads Grant

Location – 320 feet of road shoulder erosion along Apple Hill 350 feet south of Dugar Brook Rd in Calais, VT.

- Calculate stone needed for ditch, turnout, settling pond – estimate about 80 Yards

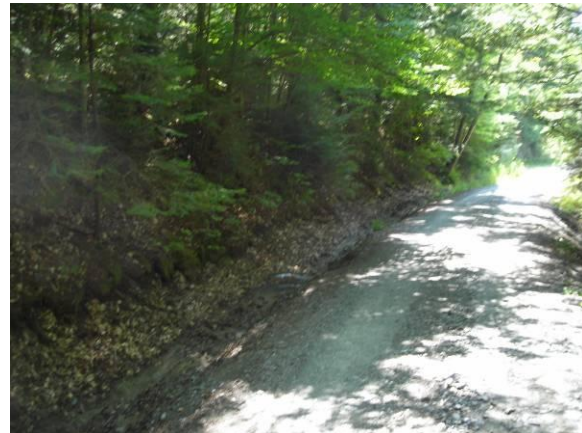
Photos of Site

Location – 520 feet of ditch erosion on Hancock Brook Rd (Class 4) 0.38 miles west of Elmore Rd (Route 12) in Worcester, VT.

- Add 2-3 new cross culverts above existing culvert
- Add stone aprons at outlets of new culverts and existing culvert
- Install headers and footers on all new culverts and existing culvert
- Improve ditch by stone lining for length of erosion about 520 ft
- Replace existing culvert if undersized for location.

- Existing culvert dimensions and condition
- Existing culvert alignment
- Existing culvert header and footer information
- Calculate stone needed for ditch – estimate about 100 Yards
- Calculate stone needed for stone aprons at culvert outlets - estimate about 6 Yards
- Price of new and replacement culverts

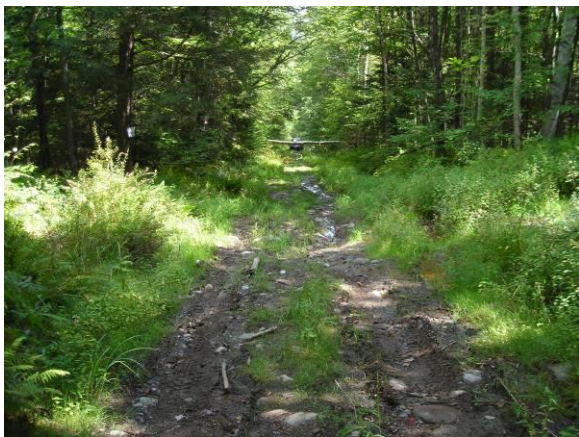
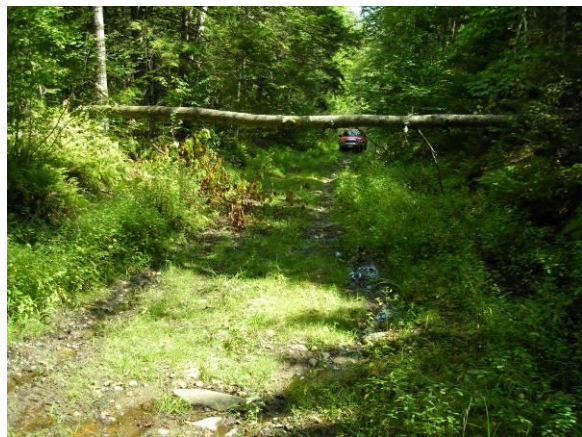
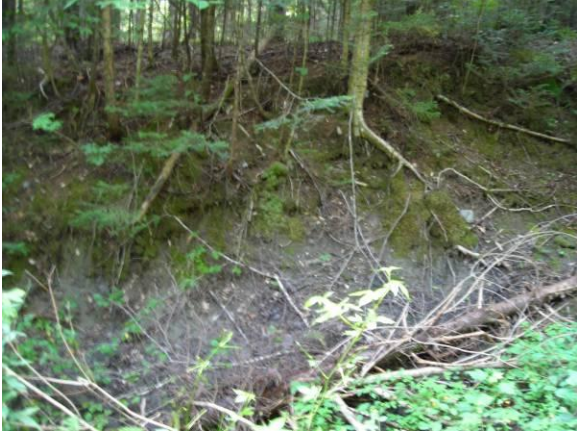
Photos of Site

Location – 745 feet of road ditch erosion on Downs Rd (Class 4) 1.36 miles west of Elmore Rd (Route 12) in Worcester, VT.

- Sunken road bed needs to be built back up
- Add 3-4 new culverts if possible
- Add water bars in roadway if culverts are not possible
- Add stone aprons at outlets of new culverts and existing culvert
- Install headers and footers on all new culverts and existing culvert
- Add turnouts along roadway where culverts are not possible
- Stone line turnout apron
- Improve ditch by stone lining for length of erosion about 745 ft
- Replace existing culverts if undersized for location.

- Existing culvert dimensions and condition
- Existing culvert alignment
- Existing culvert header and footer information
- Calculate stone needed for ditch – estimate about 150 Yards
- Calculate stone needed for stone aprons at culvert outlets and turnout - estimate about 6 Yards
- Calculate stone needed to build up road bed.
- Price of new and replacement culverts

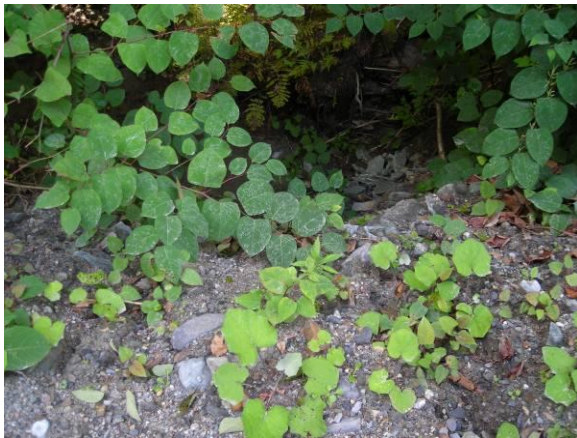
Photo of Site

Location – Erosion along road edge over outlet of culvert on Harris Hill Rd 0.26 miles north of Eagle Ledge Rd in Worcester, VT.

- Armor road shoulder above culvert
- Replace existing culvert if undersized for location.

- Existing culvert dimensions and condition
- Existing culvert alignment
- Determine stream bankful width at culvert
- Existing culvert header and footer information
- Calculate stone needed for stone apron at culvert outlet - estimate about 2 Yards
- Price of replacement culvert
