Landslide Hazard Analysis of the Great Brook Watershed, Plainfield, Vermont

George Springston and Ethan Thomas
Norwich University Department of Geology and Environmental Science
108 Harmon Drive
Northfield, VT 05663
802-485-2734
gsprings@norwich.edu

Revised, March 17, 2014

Prepared for
Central Vermont Regional Planning Commission
29 Main Street, Suite 4
Montpelier, VT 05602

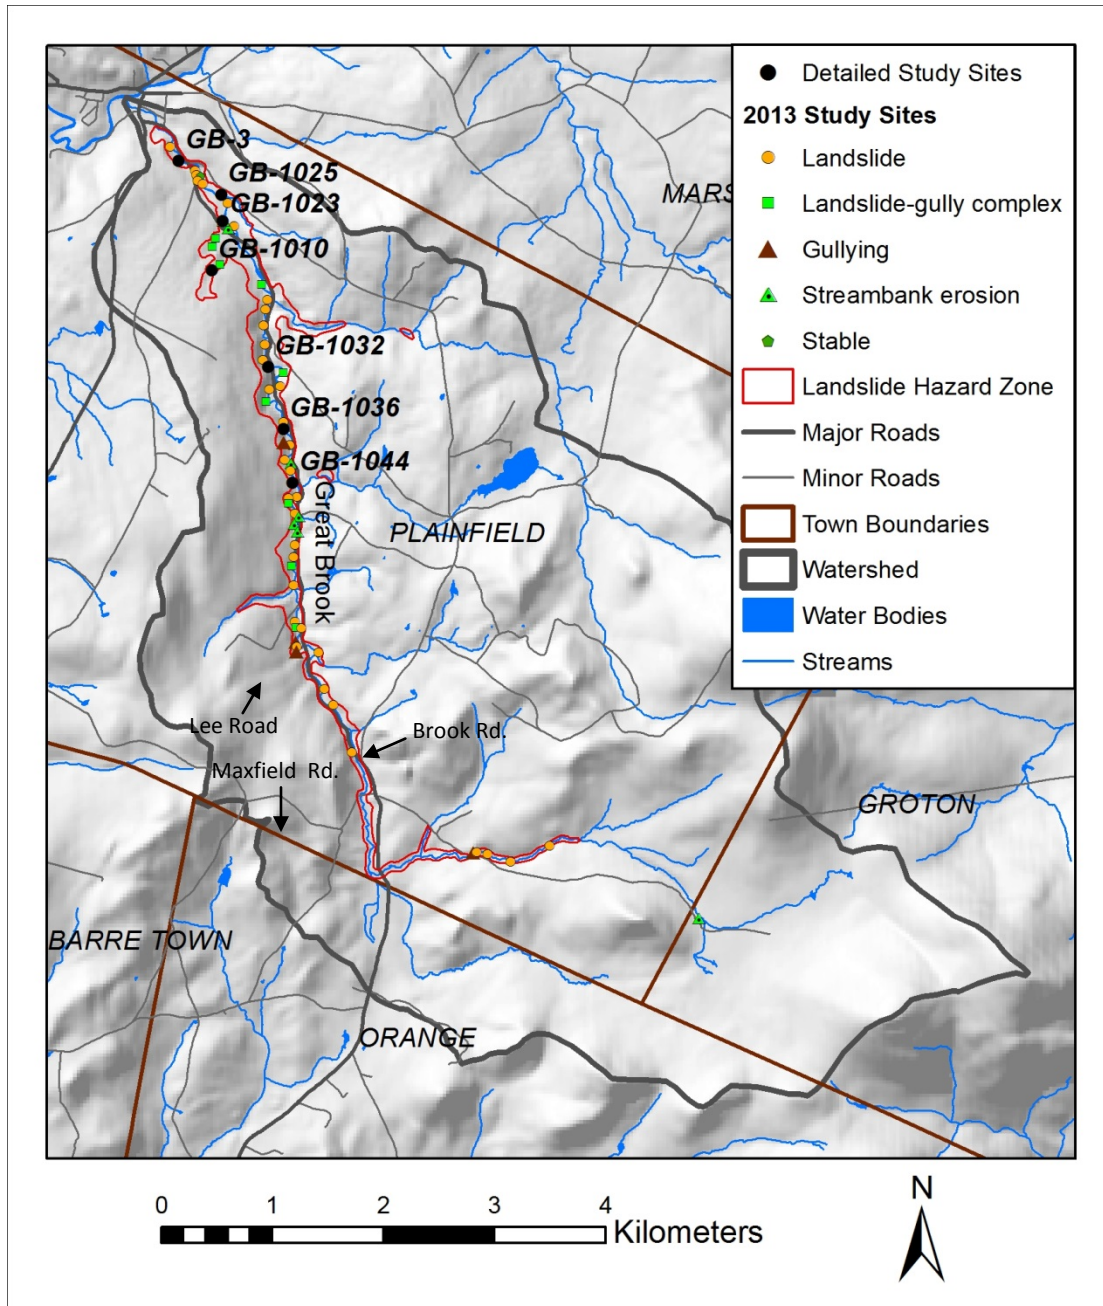
Figure 2. Study sites. Preliminary landslide hazard zone outlined in red. The detailed study sites are shown as black dots and labeled. The study sites are shown in more detail in Figures 3a and b.

The landslide hazard zone is shown on Plate 1 and several of the figures within this report. It has been delineated to encompass all of the known landslides and gullies and to also include areas with similar slopes that are underlain by similar surficial materials. The sites are broken out into several types in Figure 2, which shows the locations of the landslides, inactive landslides, landslide-gully complexes (all active), gullies. No relict landslides were encountered in this study. Gullies are scattered along the entire length of the brook. Note that in many cases only the

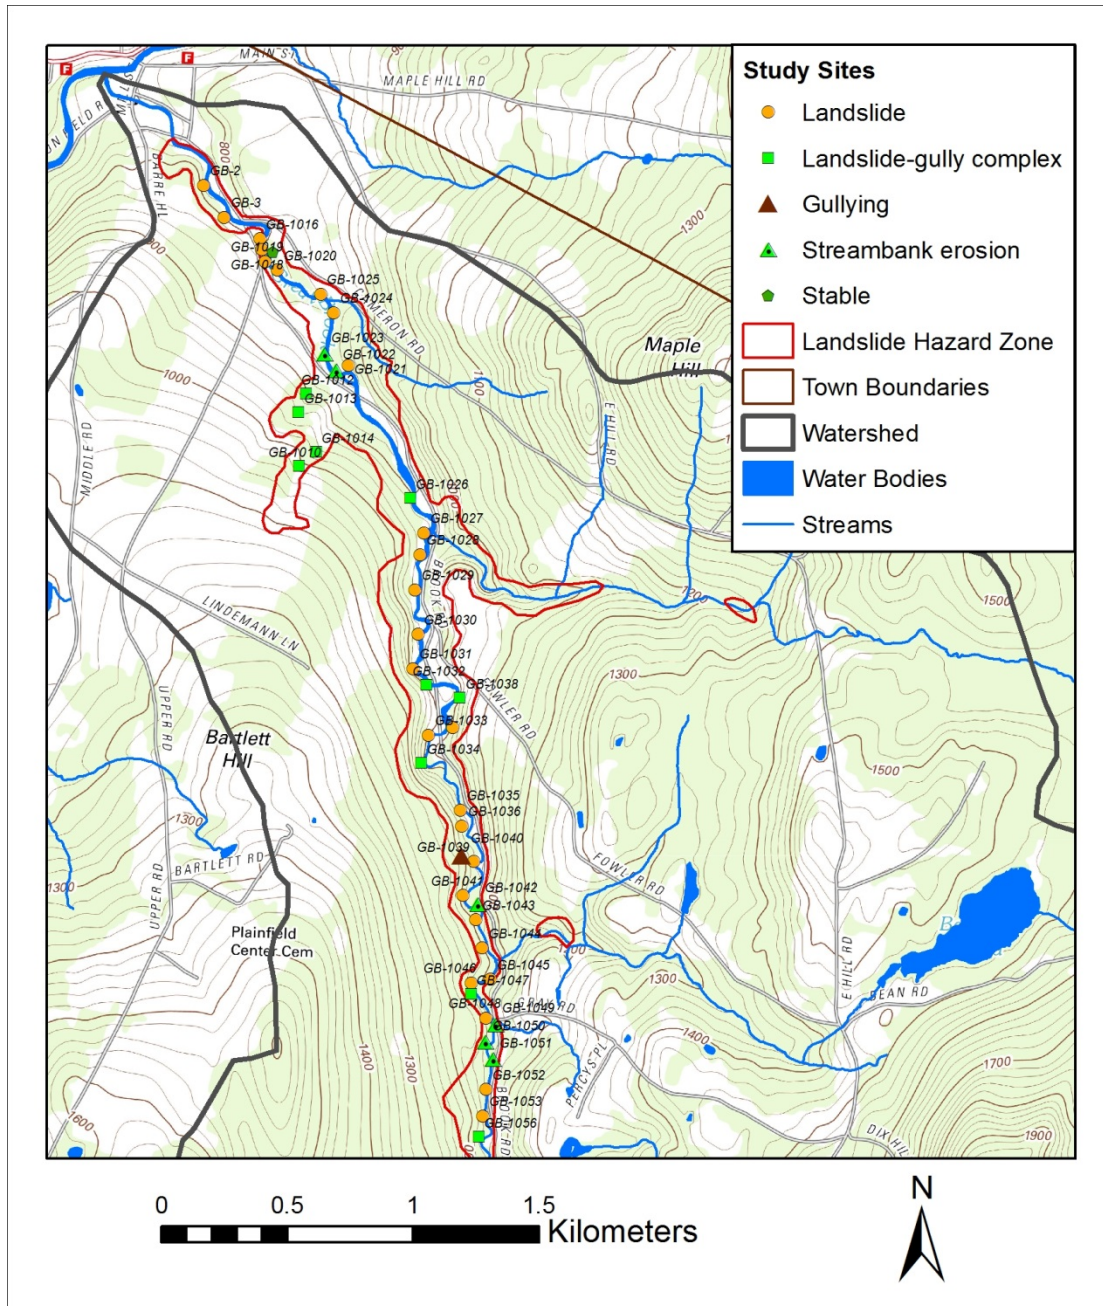
Figure 3a. Study sites in the northern part of the watershed. Base map from U.S. Geological Survey. Contour interval 20 feet.

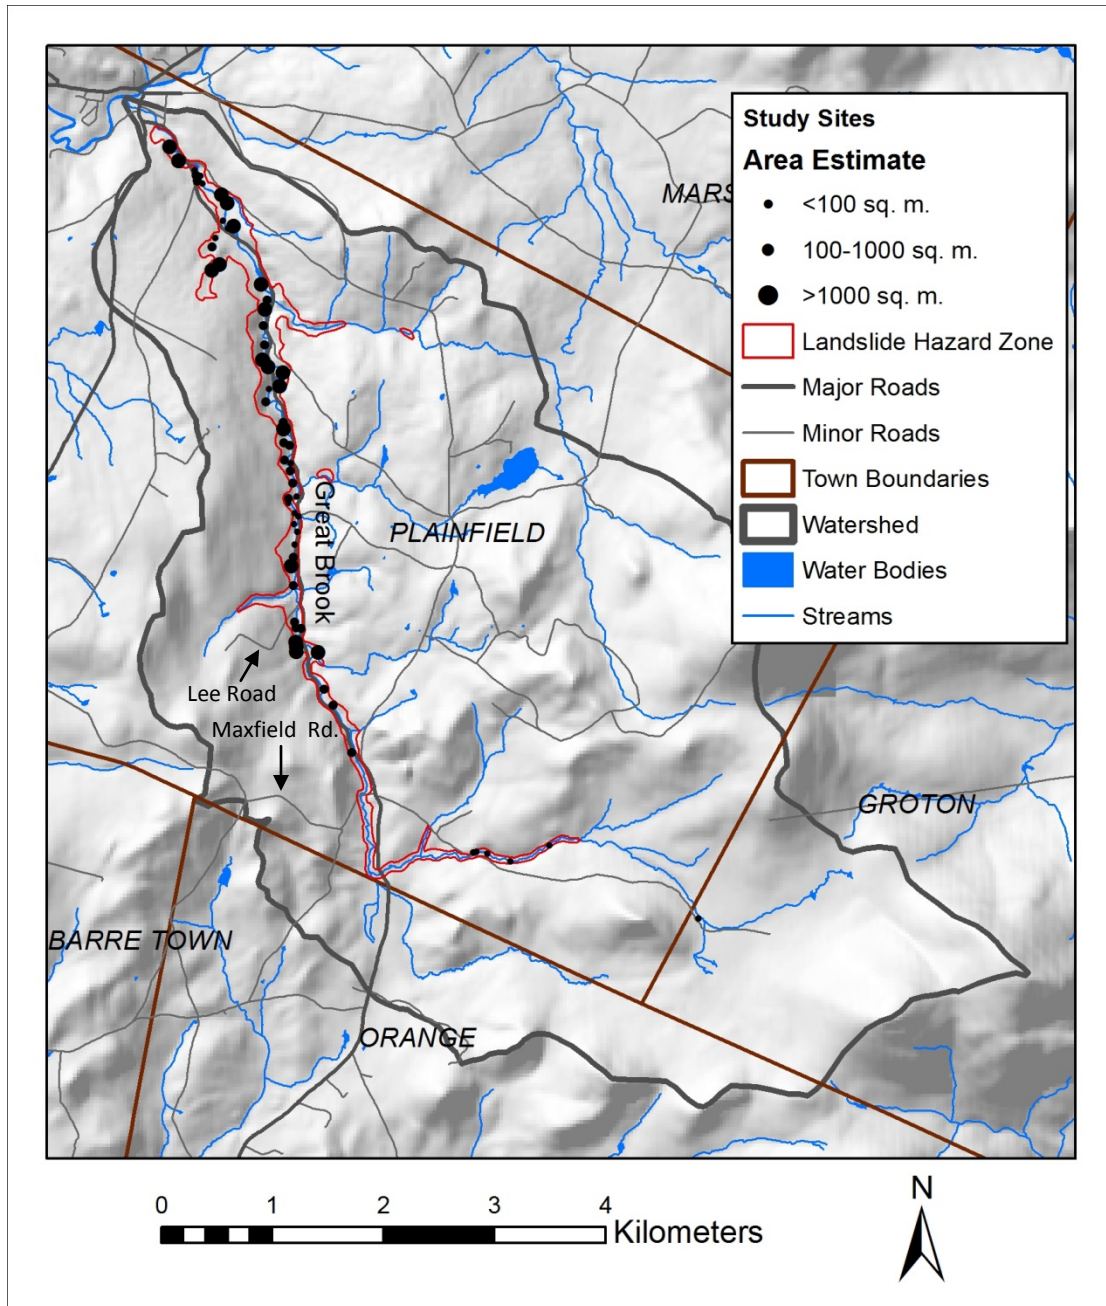
Figure 4 shows the sites classified by estimated size. Note that most of the sites that are greater than 1000 square meters in area are downstream of Lee Road.

Figure 4. Study sites classified by estimated area. Note that almost all of the large sites are located downstream of Lee Road.

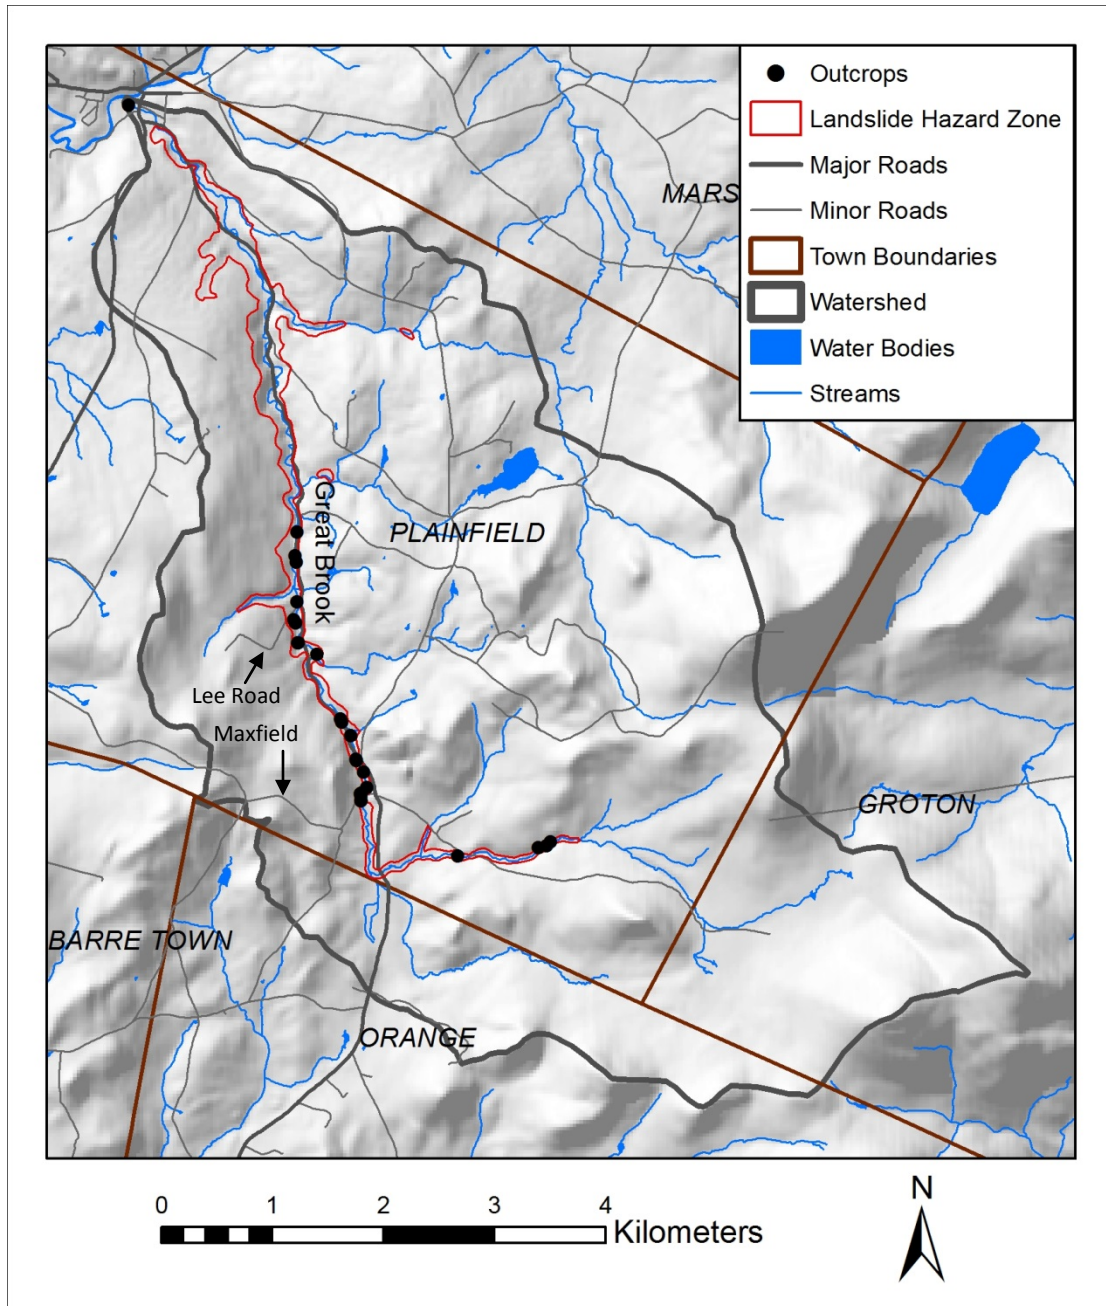
Figure 5 shows the locations of bedrock outcrops or ledge in or adjacent to the channel. The presence of bedrock limits the erosive possibilities of the stream. Channel spanning bedrock exposures begin just below Lee Road and effectively limit the amount of channel incision that is possible. No large landslides occur upstream of Maxfield Road. See page 30 for a discussion of the connections between the presence of bedrock grade controls, channel gradients, and the size of landslides..

Figure 5. Bedrock outcrop (ledge) locations along Great Brook. Note that all are located in the southern (upstream) reaches and most are upstream of Lee Road. The first channel-spanning outcrops occur just downstream of Lee Road. Outcrop locations that are distant from the brook are not shown in this figure but are included in the GIS data.

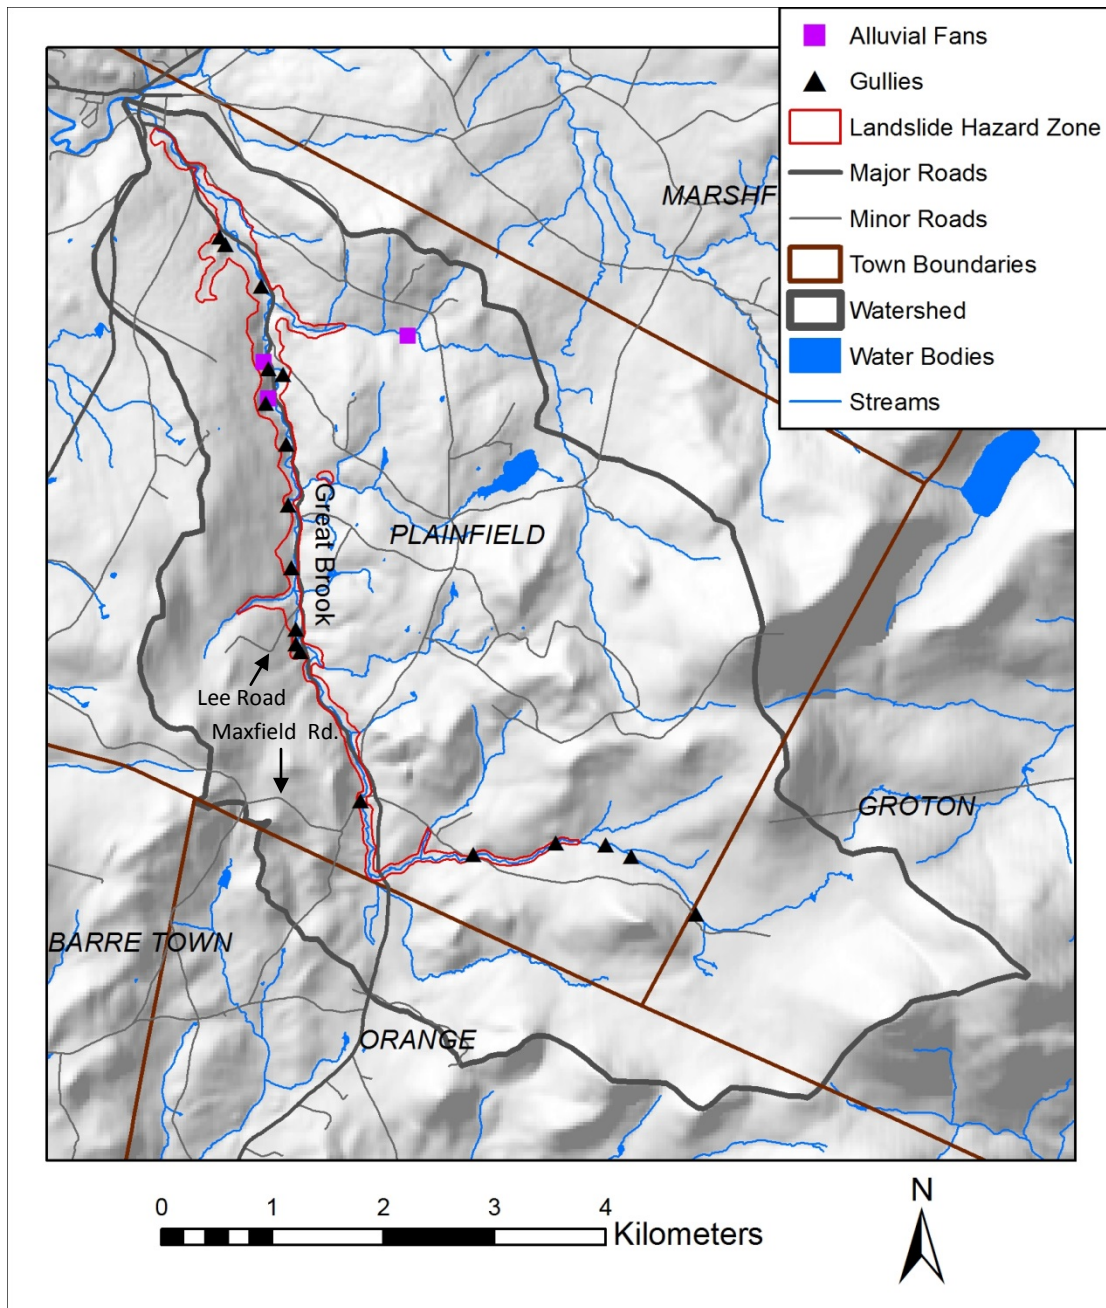
Alluvial fans and gullies are shown on Plate 1 and in Figure 6. The alluvial fans are all relatively minor features on small streams. Most are at the mouths of active gullies, although there is one fan on a tributary located east of the main brook. As abrupt channel shifts are common on alluvial fans, these should be viewed as hazardous features and included in any FEH Zones. The gully sites included on this figure include all landslide-gully complexes as well as isolated gullies. These too should be included in FEH Zones.

Figure 6. Locations of alluvial fans and gullies. The alluvial fans are all small features associated with first-order tributaries. The gullies range in size from quite small up to the large gullies at the MacLaren Farm and Fowler sand pit in the northern part of the watershed (see text).
