# Town of Waterbury Tropical Storm Irene Inundation Area

In late August of 2011, Vermont was hit hard by Tropical Storm Irene (TSI). Heavy rain totaled over seven inches in areas over the course of one day. The immense downpours caused raging floodwaters to tear through Vermont's streams, devastating people and infrastructure throughout central and southern Vermont. In some areas, TSI flooding approached historic flood levels, while in other areas, the storm greatly exceeded them. Over 500 miles of state roads were damaged as a result of TSI, in addition to over 2000 segments of municipal roads. In total, approximately 500 bridges were damaged or destroyed, as well as almost 1,000 culverts. Approximately 1,500 residences were significantly damaged or destroyed as a result of flooding, as well as state, municipal, and commercial buildings (VANR 2012). Flooding associated with Tropical Storm Irene (TSI) in late August 2011 greatly impacted Waterbury, Vermont. Due to very high stream flows from TSI, the channels of Graves and Thatcher Brook may have experienced major changes. In order to observe any changes in channel geometry, Bear Creek Environmental (BCE) looked at pre-TSI geomorp

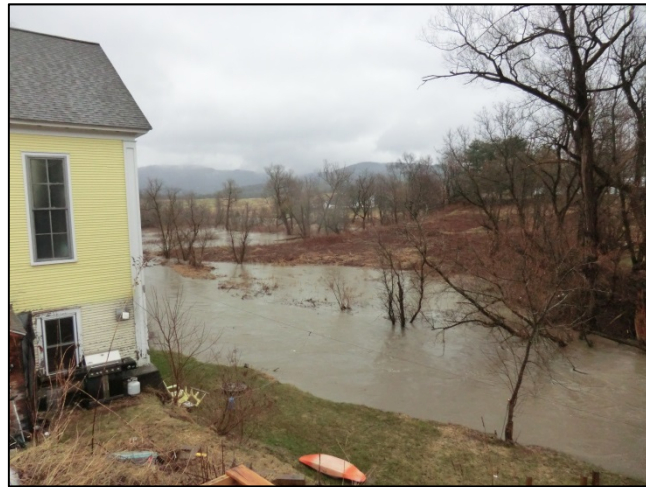
**Figure 4.** Floodwater attenuation in wetlands along Thatcher Brook.

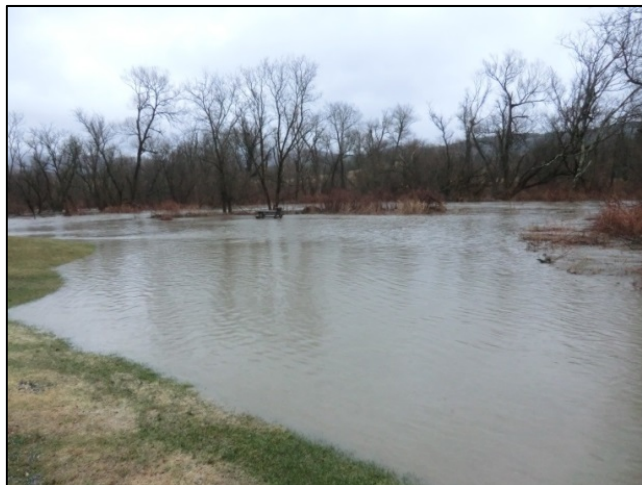
**Figure 5.** Water disperses energy out onto the floodplain in many areas along Thatcher Brook.

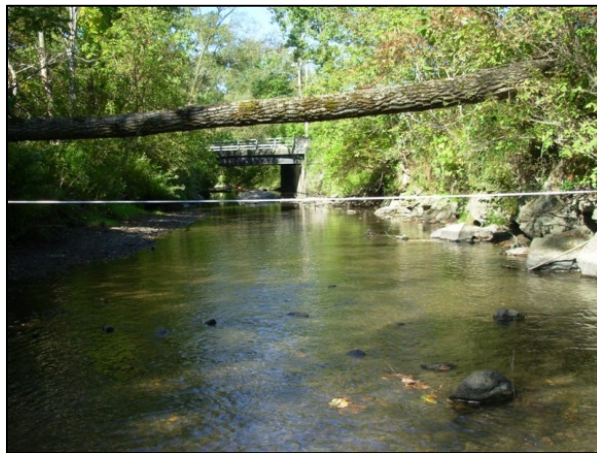
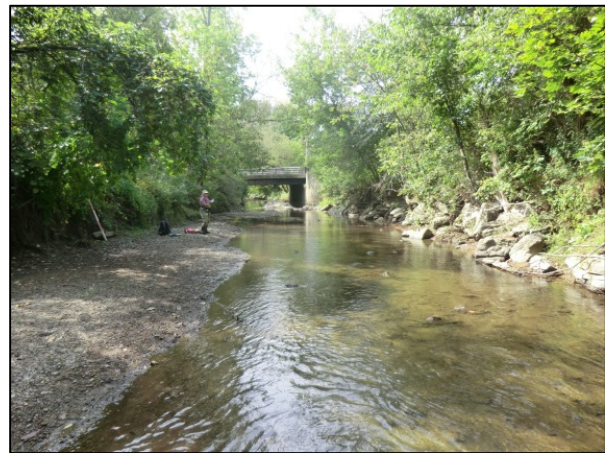
**Figure 7.** Cross section R13.S1.01-A in 2009 (left) and in 2014 (right)

Table 1: Comparison of 2009 and 2014 Cross Sections at R13.S1.01-A					
River Scientist Team	Cross Sectional Area	Bankfull Width	W/D Ratio	Entrenchment Ratio	Incision Ratio
Redstart (2009)	146.8	35.3	8.5	3.39	1.8
BCE (2014)	151.4	36.6	8.8	3.17	1.8
Percent change	3.1%	3.7%	3.5%	-6.5%	0%
Comments: Cross sections very similar. No significant change due to TSI. Left valley wall differs due to 2014 cross section extending to railroad bed. 2009 cross section ended at road. Bedform in 2014 was more of a run and not a riffle.

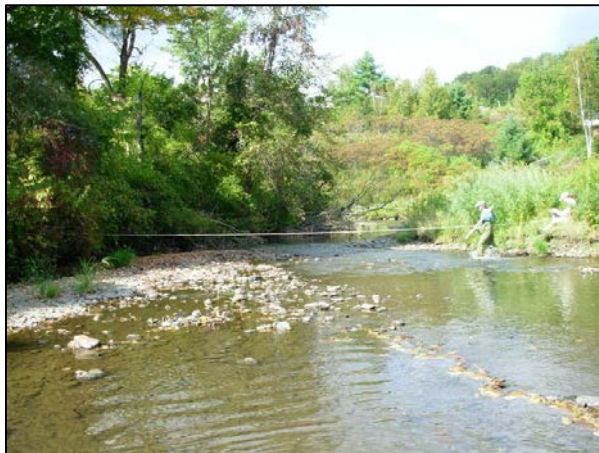
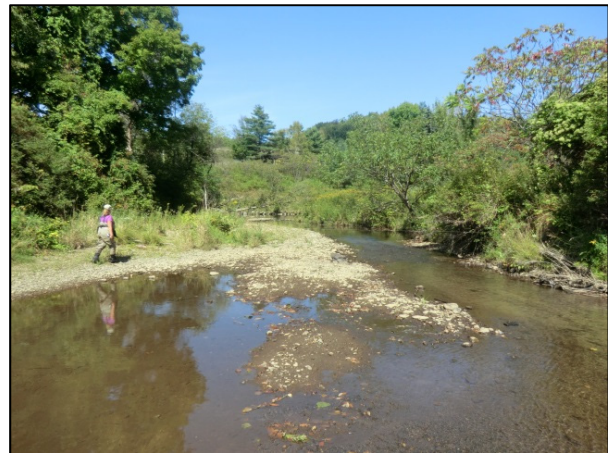
**Figure 9.** Cross section R13.S1.01-B in 2009 (left) and in 2014 (right)

Table 2: Comparison of 2009 and 2014 Cross Sections at R13.S1.01-B					
River Scientist Team	Cross Sectional Area	Bankfull Width	W/D Ratio	Entrenchment Ratio	Incision Ratio
Redstart (2009)	135	50.8	19.1	2.96	1.6
BCE (2014)	138	54.3	21.4	2.27	1.9
Percent change	2.2%	6.9%	12.0%	-23.3%	18.8%
Comments: 2009 cross section location is now a pool. 2014 cross section was surveyed just upstream (about 35 feet) of 2009 cross section location, which may account for the difference in left terrace elevation. Channel has slightly widened. No more undercut on left bank and left bank has slumped. More aggradational in 2014 possibly due to TSI (See Figure 9).

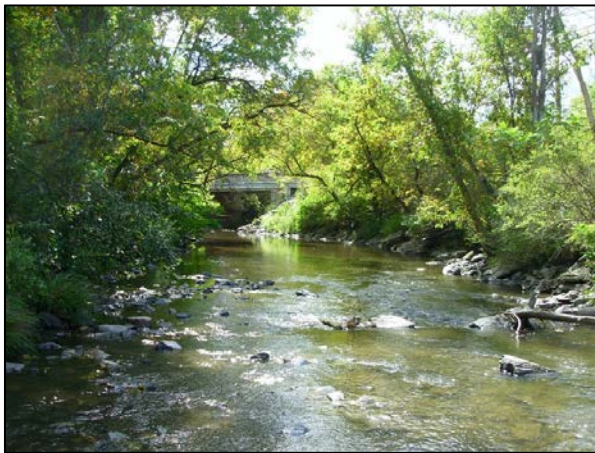
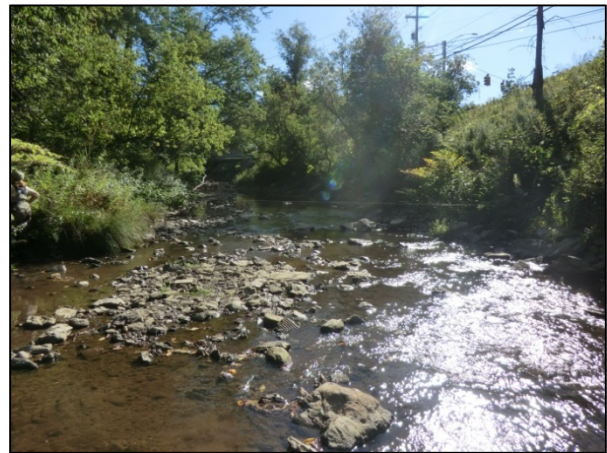
**Figure 11.** Cross section R13.S1.02-B in 2009 (left) and in 2014 (right)

Table 3: Comparison of 2009 and 2014 Cross Sections at R13.S1.02-B					
River Scientist Team	Cross Sectional Area	Bankfull Width	W/D Ratio	Entrenchment Ratio	Incision Ratio
Redstart (2009)	127.6	44.0	15.2	1.43	3.5
BCE (2014)	120.9	46.2	17.7	1.40	3.0
Percent change	-5.3%	5.0%	16.4%	-2.1%	-14.3%
Comments: Cross sections very similar from 2009 to 2014. Channel may have widened based on increased w/d ratio.

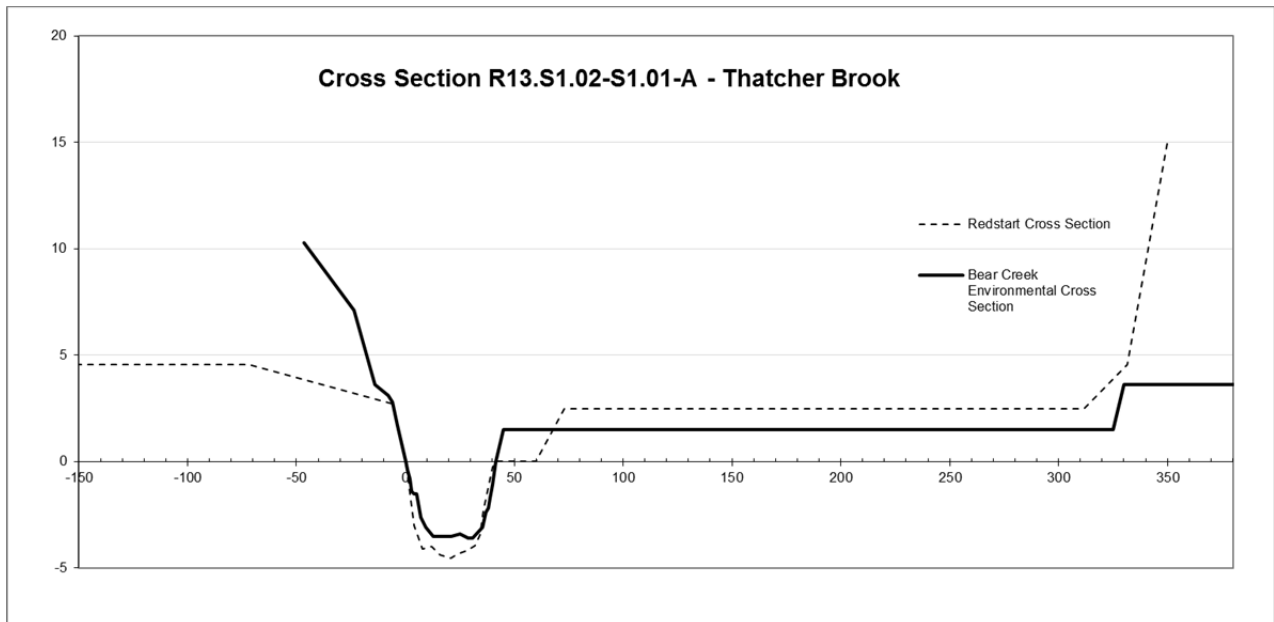
**Figure 12.** 2009 and 2014 Cross sections done by Redstart and BCE in Segment R13.S1.02-S1.01-A.

River Scientist Team	Cross Sectional Area	Bankfull Width	W/D Ratio	Entrenchment Ratio	Incision Ratio
Redstart (2009)	141.2	41.6	12.3	9.7	1.55
BCE (2014)	116.4	41.6	14.9	8.3	1.42
Percent change	-17.6%	0%	21.1%	-14.4%	-8.4%

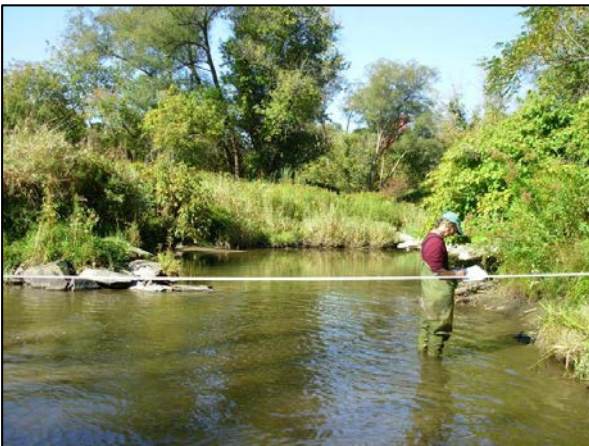
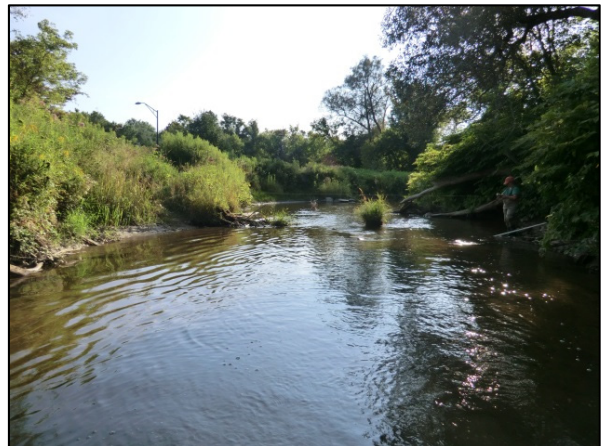
**Figure 13.** Cross section R13.S1.02-S1.01-A in 2009 (left) and in 2014 (right)

Comments: Cross sectional area for 2014 was lower than 2009, but consistent with upstream cross sectional areas. Cross section in 2014 was measured just 45 feet upstream of 2009 cross section due to bank slump in 2009 location (indicating channel widening). This resulted in different valley widths. Bankfull width in 2014 cross section was the same as 2009 cross section. Width to depth ratio in 2014 showed “C” stream type.

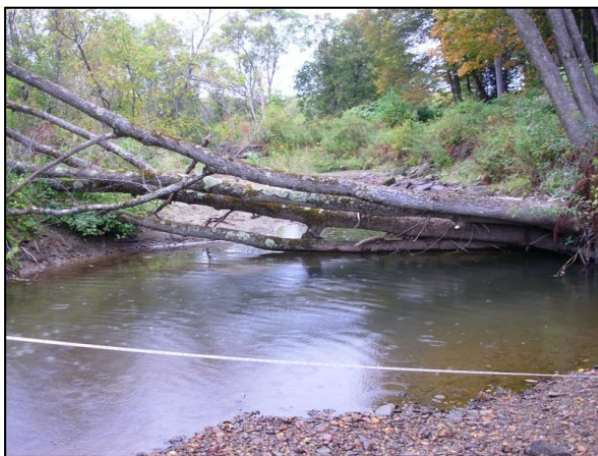
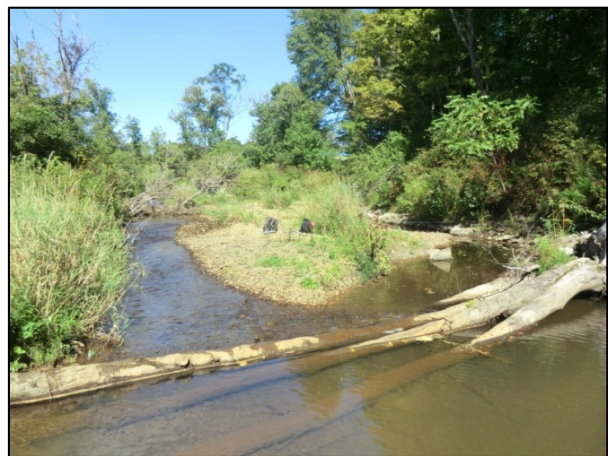
**Figure 15.** Looking upstream at cross section R13.S1.02-S1.01-D in 2009 (left) and 2014 (right).

Table 5: Comparison of 2009 and 2014 Cross Sections at R13.S1.02-S1.01-D					
River Scientist Team	Cross Sectional Area	Bankfull Width	W/D Ratio	Entrenchment Ratio	Incision Ratio
Redstart (2009)	95.9	37.4	14.6	6.9	1.5
BCE (2014)	121.7	47.1	18.3	5.0	1.5
Percent change	26.9%	25.9%	25.3%	-27.5%	0%
Comments: Cross sectional area was higher in 2014 than 2009. The 2014 cross section was measured just upstream (about 20 feet) of the 2009 cross section due to channel changes. The fallen tree and large pool were present in the 2009 location (Figure 15). Channel may have experienced widening based on increased w/d ratio.

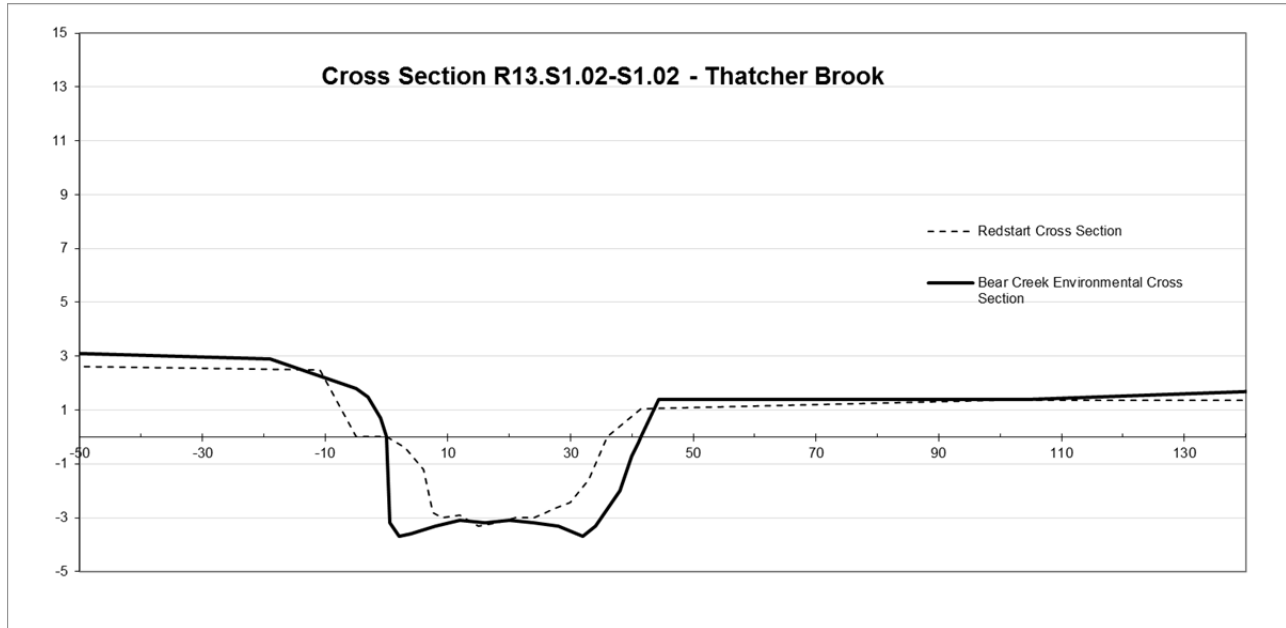
**Figure 16.** 2009 & 2014 Cross sections done by Redstart and BCE, respectively in Segment R13.S1.02-S1.02.

Table 6: Comparison of 2009 and 2014 Cross Sections at R13.S1.02-S1.02					
River Scientist Team	Cross Sectional Area	Bankfull Width	W/D Ratio	Entrenchment Ratio	Incision Ratio
Redstart (2009)	81.2	36	15.9	18.1	1.3
BCE (2014)	125.5	41.4	13.7	12.8	1.4
Percent change	54.6%	15.0%	-13.8%	-29.3%	7.7%
Comments: Cross sectional area for 2014 was higher than 2009. Depositional features in 2014 were larger than in 2009, and new debris noted in channel in 2014; both most likely due to TSI (See Figure 17). Both teams noted that bankfull was hard to find in the field. Redstart used a “low new bench” for determining the bankfull elevation, while Bear Creek used the tree line. This likely accounts for differences in the bankfull cross sectional areas measured.

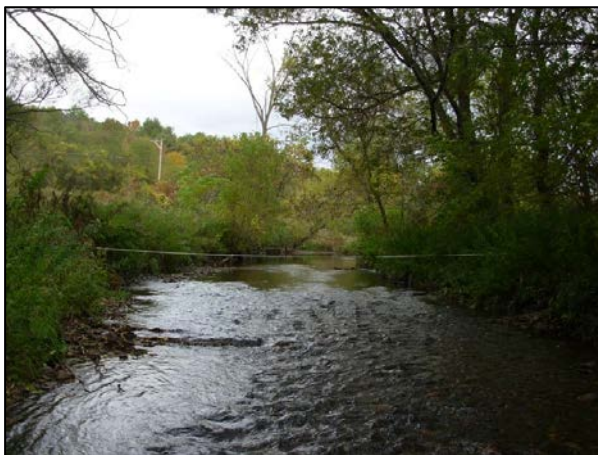
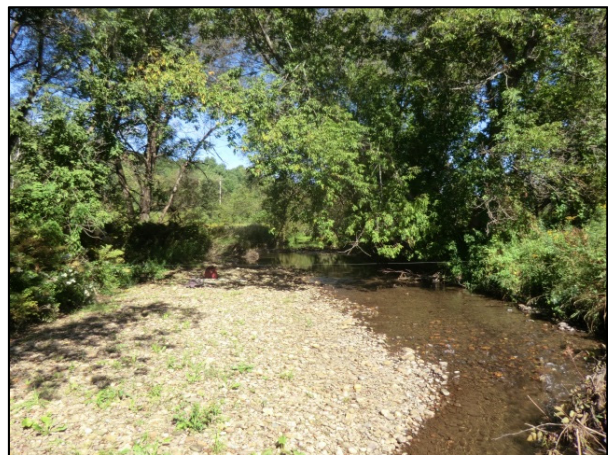
**Figure 19.** Cross section R13.S1.02-S1.03 in 2009 (left) where there is now a beaver dam and in 2014 (right) – more aggradational.

Table 7: Comparison of 2009 and 2014 Cross Sections at R13.S1.02-S1.03					
River Scientist Team	Cross Sectional Area	Bankfull Width	W/D Ratio	Entrenchment Ratio	Incision Ratio
Redstart (2009)	97.1	38.2	15.0	16.5	1.0
BCE (2014)	91.9	40.2	17.6	14.3	1.1
Percent change	-5.4%	5.2%	17.3%	-13.3%	10%
Comments: 2014 cross section was surveyed just downstream (about 40 feet) of 2009 cross section due to new beaver dam. Channel still has good floodplain access. More aggradational than in 2009 (Figure 19).

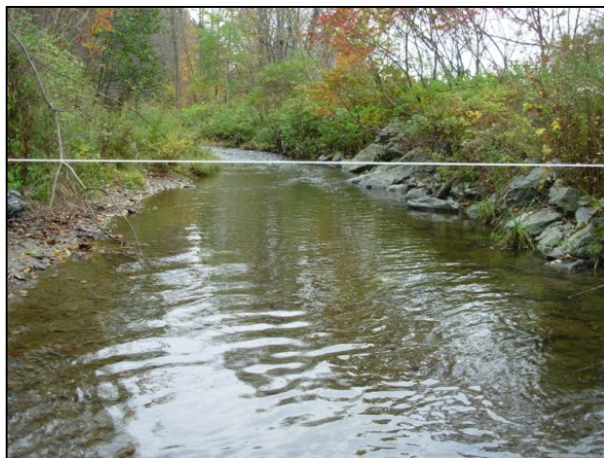
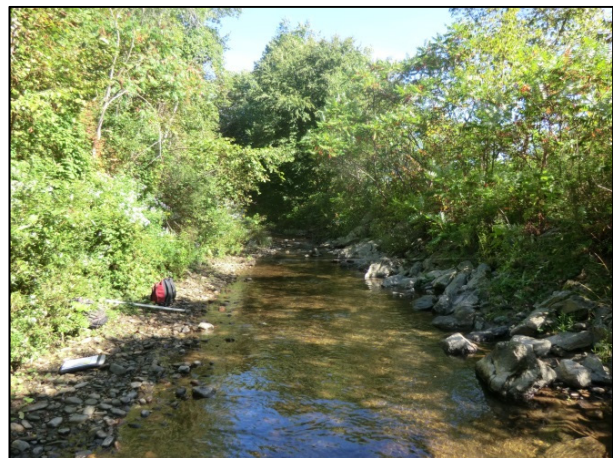
**Figure 21.** Cross section R13.S1.02-S1.04-A in 2009 (left) and 2014 (right).

Table 8: Comparison of 2009 and 2014 Cross Sections at R13.S1.02-S1.04-A					
River Scientist Team	Cross Sectional Area	Bankfull Width	W/D Ratio	Entrenchment Ratio	Incision Ratio
Redstart (2009)	91.4	31.9	11.1	11.9	1.5
BCE (2014)	67.4	27.3	11.1	6.5	1.9
Percent change	-26.3%	-14.4%	0%	-45.4%	21.1%
Comments: Cross sectional area lower in 2014 than 2009, but consistent with upstream cross sectional areas measured in 2014.

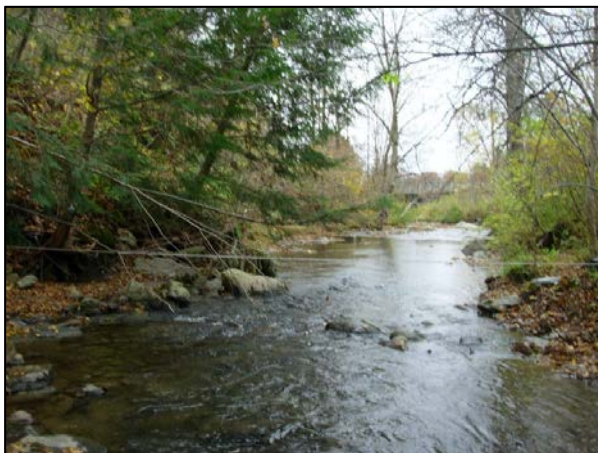
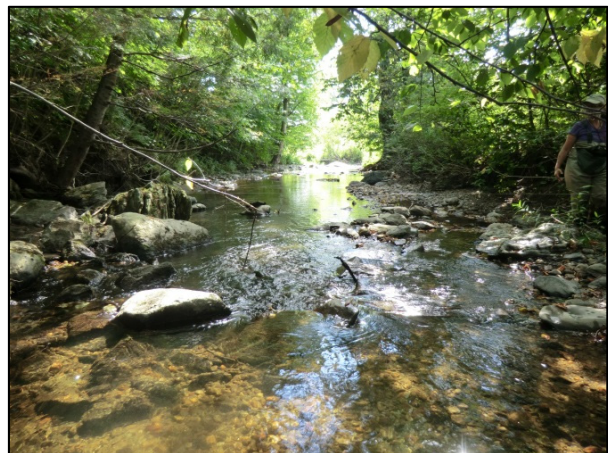
**Figure 23.** Cross section R13.S1.02-S1.04-B in 2009 (left) and 2014 (right).

Table 9: Comparison of 2009 and 2014 Cross Sections at R13.S1.02-S1.04-B					
River Scientist Team	Cross Sectional Area	Bankfull Width	W/D Ratio	Entrenchment Ratio	Incision Ratio
Redstart (2009)	74.8	32.5	14.1	8.5	1.8
BCE (2014)	63.7	27.8	12.1	2.9	1.9
Percent change	-14.8%	-14.5%	-14.2%	-65.9%	5.6%
Comments: Cross sections similar. No significant changes from TSI except for some fallen debris from left bank.

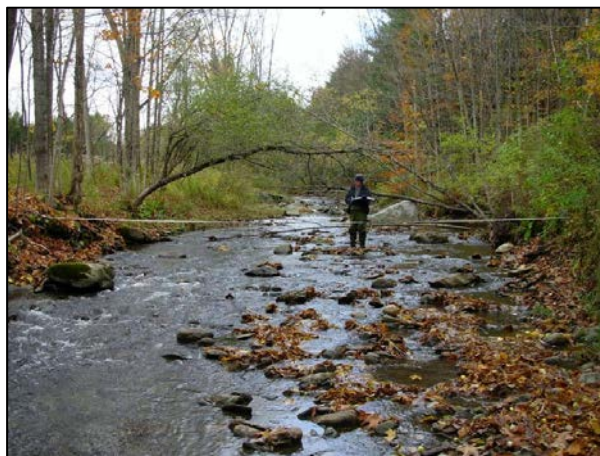
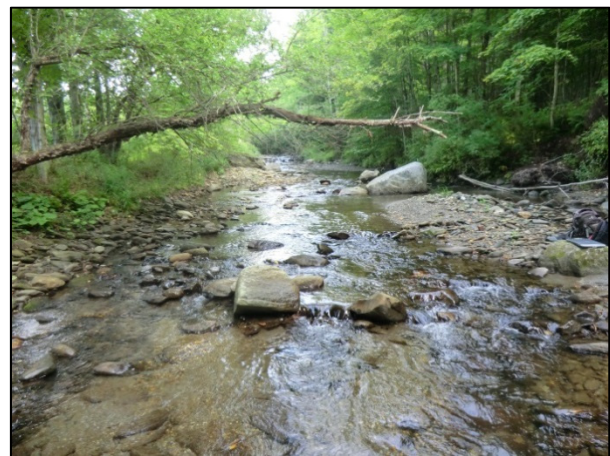
**Figure 29.** Cross section in Segment R13.S1.02-S1.05-B in 2009 (left) and 2014 (right).

Table 12: Comparison of 2009 and 2014 Cross Sections at R13.S1.02-S1.05-B					
River Scientist Team	Cross Sectional Area	Bankfull Width	W/D Ratio	Entrenchment Ratio	Incision Ratio
Redstart (2009)	74.3	30.5	12.5	6.7	1.6
BCE (2014)	86.9	33.7	13.1	2.5	1.9
Percent change	17%	10.5%	4.8%	-62.7%	15.8%
Comments: Cross sections were similar in 2009 and 2014. More aggradational in 2014 than in 2009 most likely due to TSI (See Figure 29).

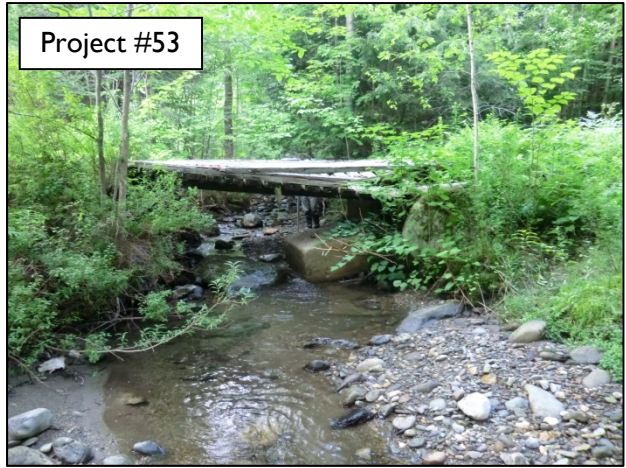
Project #53

A snowmobile bridge on the VAST trail is in poor condition and is partially collapsing. The bridge is a safety issue if it is currently in use, and if it is not in use, it should be removed as it is undersized and failing.
Project #54 R13.S1.02-S1.03-S1.01-A (Refer to Map 7)	Structure Replacement/ Removal	Replace Bridge	Unnamed Tributary 2 to Thatcher Brook	Waterbury	Bridge on Guptil Road almost 800 feet northeast of intersection with Kneeland Flats Road	High

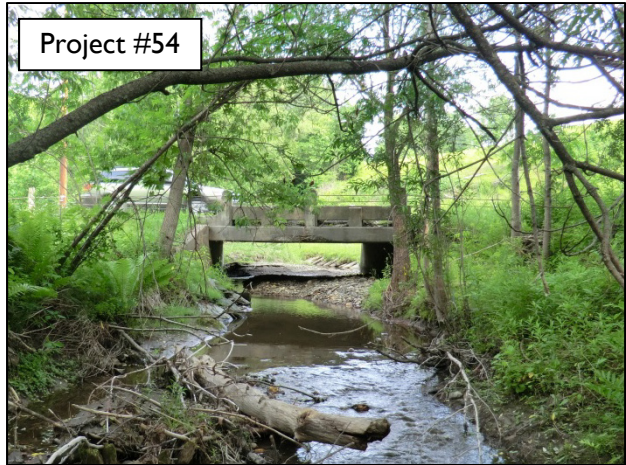
Project #54

Bridge is slightly undersized and is in poor condition. Riprap around the bridge has all fallen into the stream and a large amount of sediment has accumulated beneath the bridge, causing it to have a very low clearance. It could be easily overtopped and damaged during high flows.

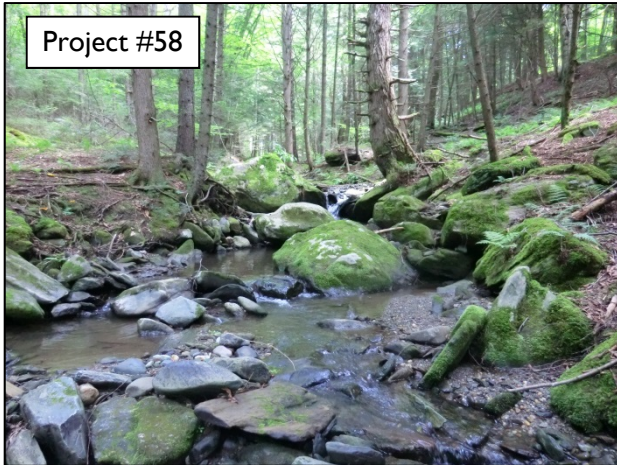
Project #58 R13.S1.02-S1.03-S1.02-B & C (Refer to Map 7)	Floodplain Improvement and Conservation	River Corridor or Conservation Easement	Unnamed Tributary 2 to Thatcher Brook	Waterbury	Between Shaw Mansion Road and Ripley Road	Moderate	<div></div>	<div></div>	<div></div>	<div></div>	One large parcel (55 acres) is suggested for river corridor or conservation easement. There is no development present in the parcel and the stream is actively adjusting in this area.
Project #59 R13.S1.02-S1.03-S1.02-C (Refer to Map 7)	Structure Replacement/ Removal	Culvert Replacement	Unnamed Tributary 2 to Thatcher Brook	Waterbury	Culvert under Ripley Road	High	<div></div>	<div></div>	<div></div>	<div></div>	This culvert is severely undersized and creates a barrier to aquatic organism passage due to the drop at its outlet.
