APPENDIX A

In late August of 2011, Vermont was hit hard by Tropical Storm Irene (TSI). Heavy rain totaled over seven inches in areas over the course of one day. The immense downpours caused raging floodwaters to tear through Vermont's streams, devastating people and infrastructure throughout central and southern Vermont. In some areas, TSI flooding approached historic flood levels, while in other areas, the storm greatly exceeded them. Over 500 miles of state roads were damaged as a result of TSI, in addition to over 2000 segments of municipal roads. In total, approximately 500 bridges were damaged or destroyed, as well as almost 1,000 culverts. Approximately 1,500 residences were significantly damaged or destroyed as a result of flooding, as well as state, municipal, and commercial buildings (VANR 2012). Flooding associated with Tropical Storm Irene (TSI) in late August 2011 greatly impacted Waterbury, Vermont. Due to very high stream flows from TSI, the channels of Graves and Thatcher Brook may have experienced major changes. In order to observe any changes in channel geometry, Bear Creek Environmental (BCE) looked at pre-TSI geomorphic data and aerial imagery and compared it to

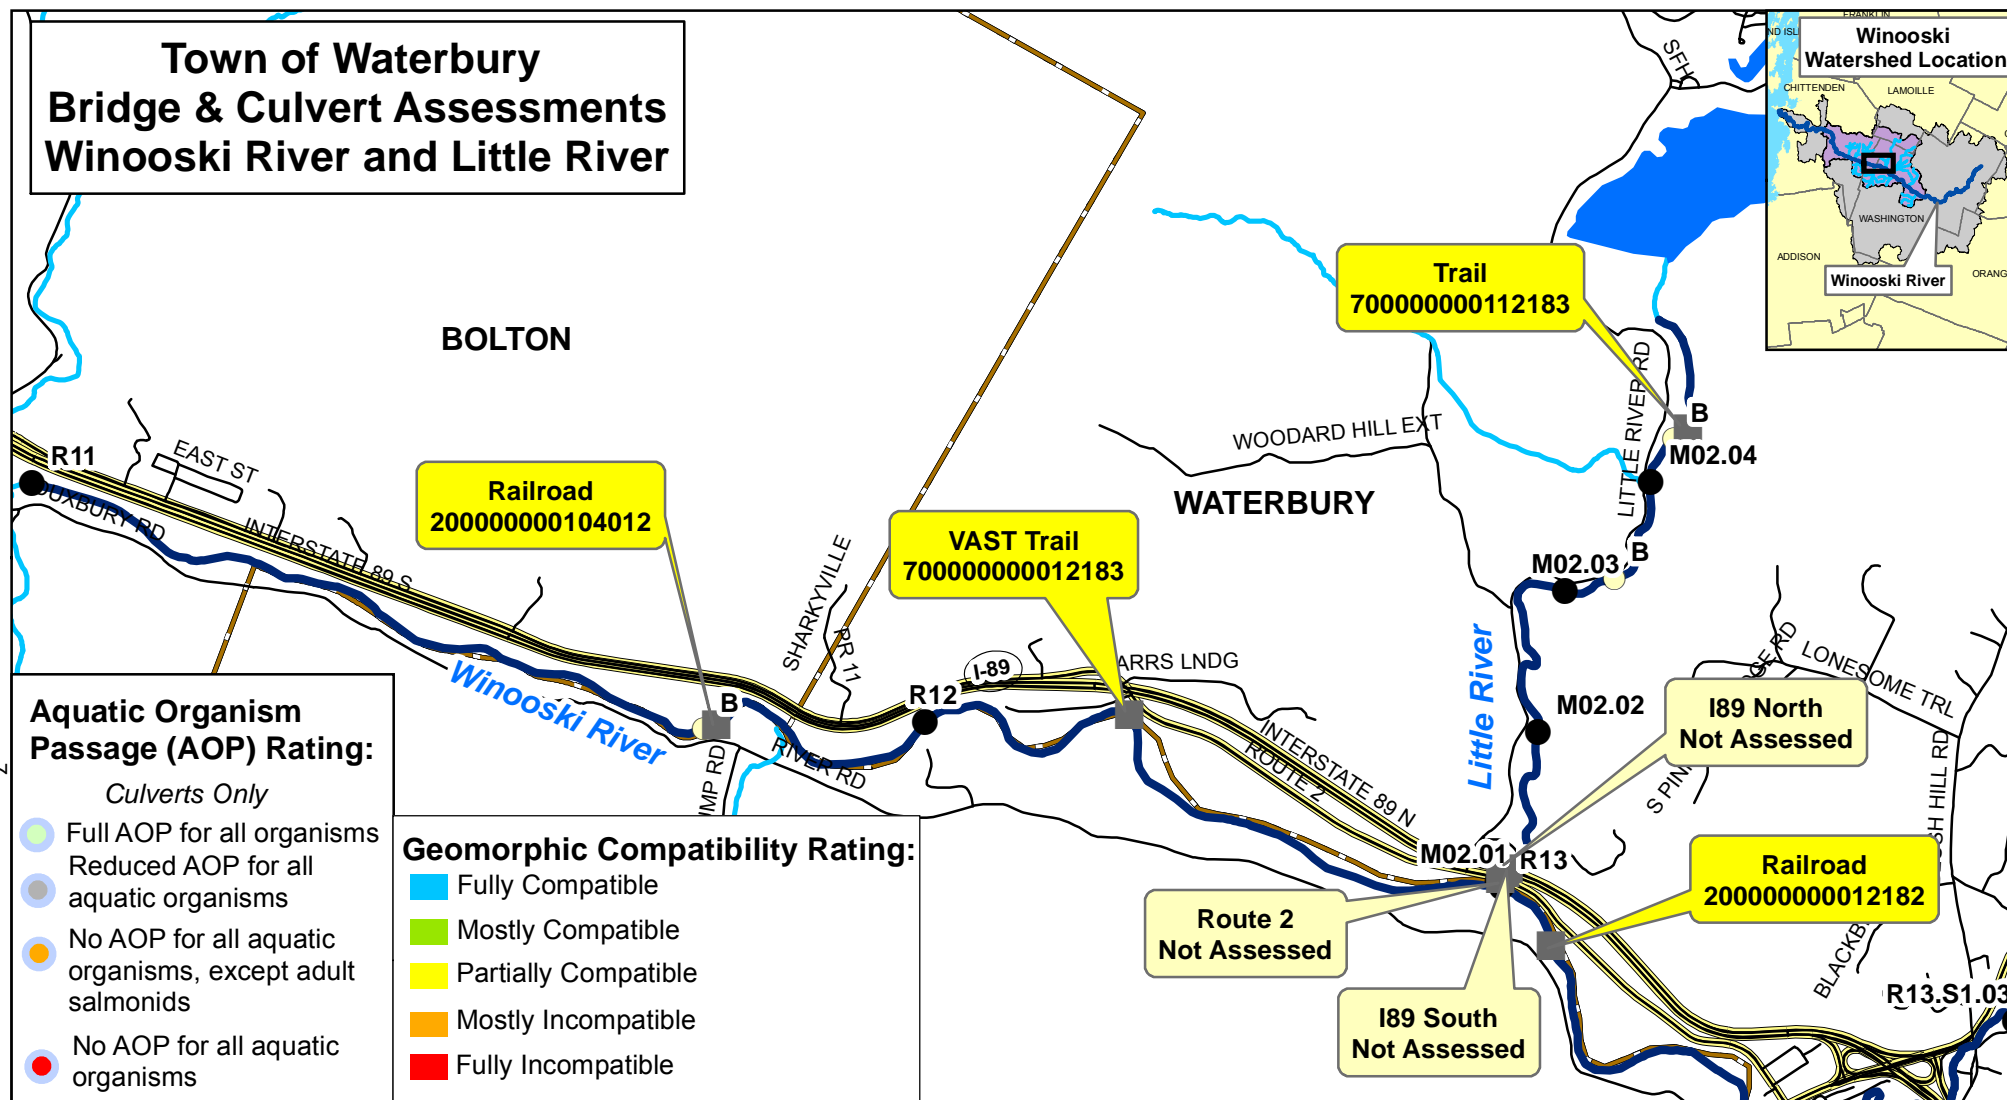
Town of Waterbury Bridge & Culvert Assessments Winooski River and Little River

R13	Waterbury /Duxbury	Railroad	200000000012182	450/234.5 = 192	Old railroad bridge constructed in 1926. I-beams rusted, piers cracked, scour around piers. Significant deposition between piers and an island at the outlet.	5	2	3 Mild Bend	0	10	Partially Compatible	Moderate (Poor condition)
R13	Waterbury /Duxbury	Route 2	200013004812182	279/234.5 = 119	New structure in good condition and not a channel constriction. Bridge is curved horizontally and does not go straight across the river.	4	5	2 Channelized Straight	0	11	Partially Compatible	Not recommended for replacement (Newly constructed)
R13	Waterbury /Duxbury	Winooski Street	101218003112181	207/23.45 = 88	Bridge was damaged and overtopped during Tropical Storm Irene. The right side approach was washed out during TSI. Bedrock along left bank.	3	4	2 Channelized Straight	2	11	Partially Compatible	Moderate (Damaged and overtopped during TSI)
R14	Moretown/ Middlesex	Route 2	200284005012122	285/229.6 = 124	New bridge in good condition. Left side abutment built into bedrock. Bald eagle sighted at time of assessment.	5	5	2 Channelized Straight	2	14	Mostly Compatible	Not recommended for replacement (Newly constructed)

M2-04-B	Waterbury	Trail	700000000112183	75/105.3 = 71	Bridge appears to have been used by cars at one time but is now blocked off. Current use most likely snowmobiles; connects into VAST trail. Fair condition. Decking is old and worn. Large pool below bridge due to bend in channel. Left abutment built into bedrock.	2	5	3 Mild Bend	0	10	Partially Compatible	Low (Slightly undersized; deteriorating decking)
R13.S1.01-A	Waterbury	North Main Street ⁴	200013004712182	37/47.9 = 77	Bridge on US Route 2 (North Main Street) at Union Street intersection (brook flows under both roads); railroad bridge crosses above the road	3	3	3 Mild Bend	0	9	Partially Compatible	Low (Slightly undersized with failing armoring)
R13.S1.01-A	Waterbury	Armory Drive ⁴	101218003312181	51/47.9 = 106	Bridge has minimal issues	4	5	2 Channelized Straight	0	11	Partially Compatible	Not recommended for replacement (Bridge span is wider than bankfull width; minimal problems)

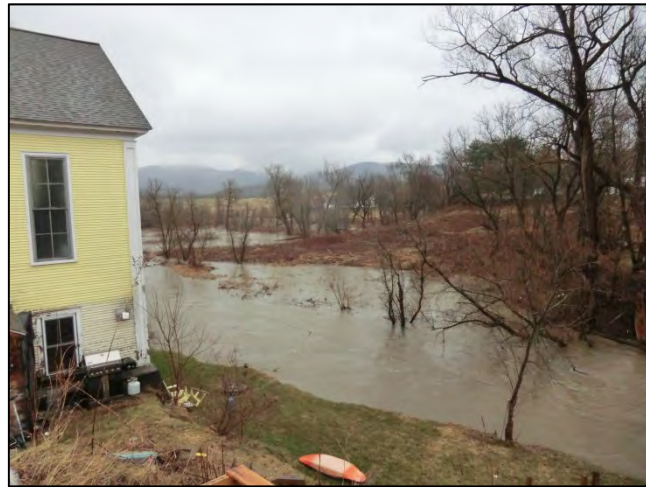
Figure 4. Floodwater attenuation in wetlands along Thatcher Brook.

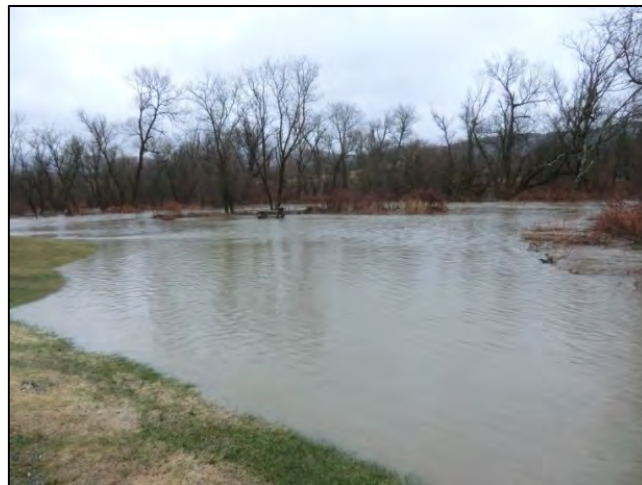
Figure 5. Water disperses energy out onto the floodplain in many areas along Thatcher Brook.

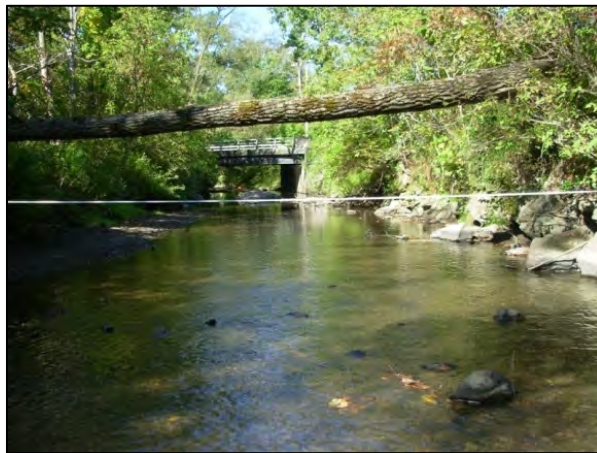
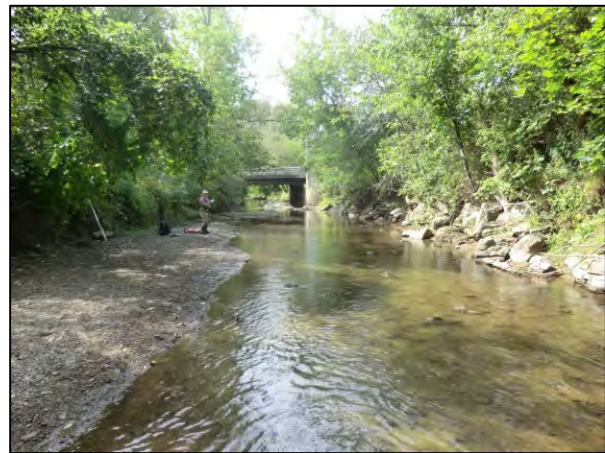
Figure 7. Cross section R13.S1.01-A in 2009 (left) and in 2014 (right)

Table 1: Comparison of 2009 and 2014 Cross Sections at R13.S1.01-A					
River Scientist Team	Cross Sectional Area	Bankfull Width	W/D Ratio	Entrenchment Ratio	Incision Ratio
Redstart (2009)	146.8	35.3	8.5	3.39	1.8
BCE (2014)	151.4	36.6	8.8	3.17	1.8
Percent change	3.1%	3.7%	3.5%	-6.5%	0%
Comments: Cross sections very similar. No significant change due to TSI. Left valley wall differs due to 2014 cross section extending to railroad bed. 2009 cross section ended at road. Bedform in 2014 was more of a run and not a riffle.

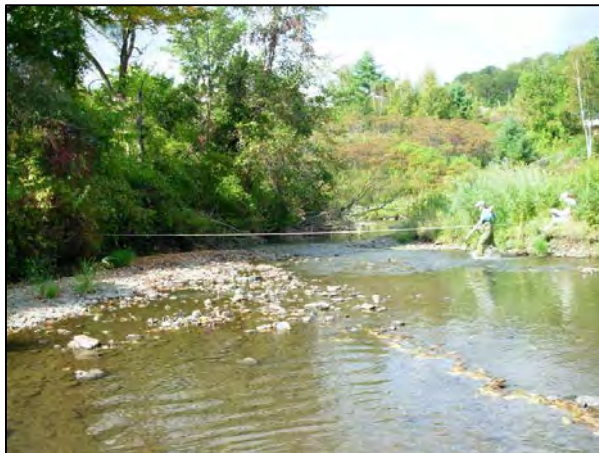
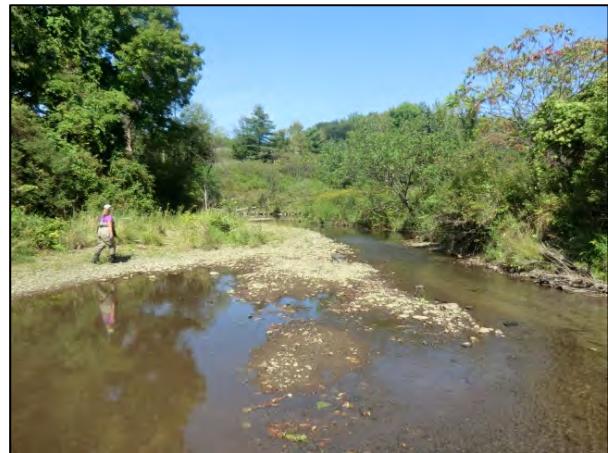
Figure 9. Cross section R13.S1.01-B in 2009 (left) and in 2014 (right)

Table 2: Comparison of 2009 and 2014 Cross Sections at R13.S1.01-B					
River Scientist Team	Cross Sectional Area	Bankfull Width	W/D Ratio	Entrenchment Ratio	Incision Ratio
Redstart (2009)	135	50.8	19.1	2.96	1.6
BCE (2014)	138	54.3	21.4	2.27	1.9
Percent change	2.2%	6.9%	12.0%	-23.3%	18.8%
Comments: 2009 cross section location is now a pool. 2014 cross section was surveyed just upstream (about 35 feet) of 2009 cross section location, which may account for the difference in left terrace elevation. Channel has slightly widened. No more undercut on left bank and left bank has slumped. More aggradational in 2014 possibly due to TSI (See Figure 9).

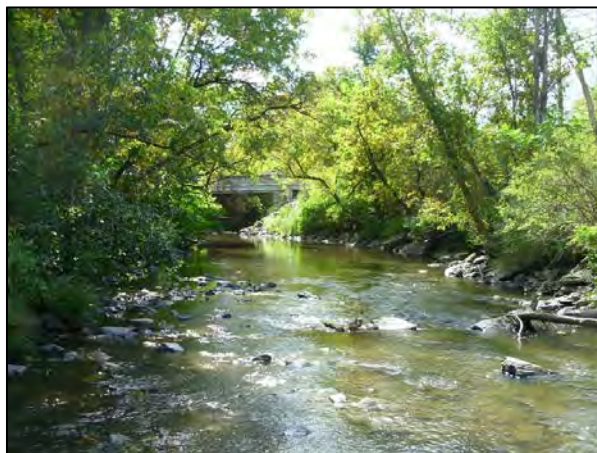
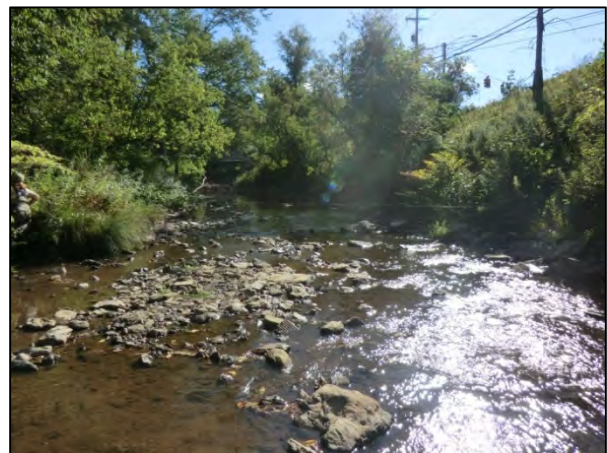
Table 3: Comparison of 2009 and 2014 Cross Sections at R13.S1.02-B					
River Scientist Team	Cross Sectional Area	Bankfull Width	W/D Ratio	Entrenchment Ratio	Incision Ratio
Redstart (2009)	127.6	44.0	15.2	1.43	3.5
BCE (2014)	120.9	46.2	17.7	1.40	3.0
Percent change	-5.3%	5.0%	16.4%	-2.1%	-14.3%
Comments: Cross sections very similar from 2009 to 2014. Channel may have widened based on increased w/d ratio.

Figure 11. Cross section R13.S1.02-B in 2009 (left) and in 2014 (right)

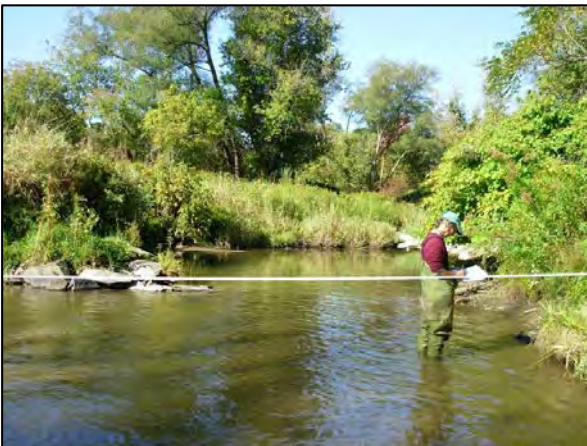
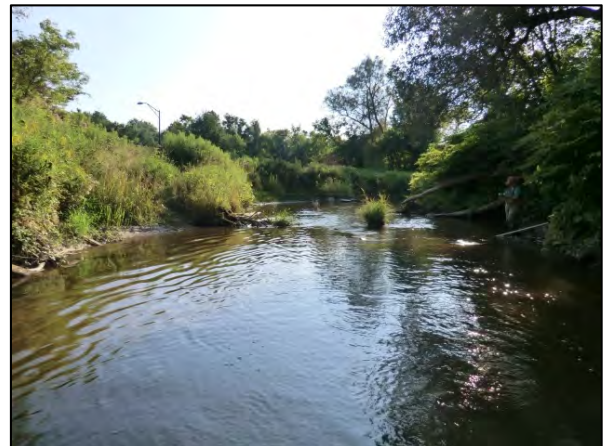
Comments: Cross sectional area for 2014 was lower than 2009, but consistent with upstream cross sectional areas. Cross section in 2014 was measured just 45 feet upstream of 2009 cross section due to bank slump in 2009 location (indicating channel widening). This resulted in different valley widths. Bankfull width in 2014 cross section was the same as 2009 cross section. Width to depth ratio in 2014 showed “C” stream type.

Figure 13. Cross section R13.S1.02-S1.01-A in 2009 (left) and in 2014 (right)

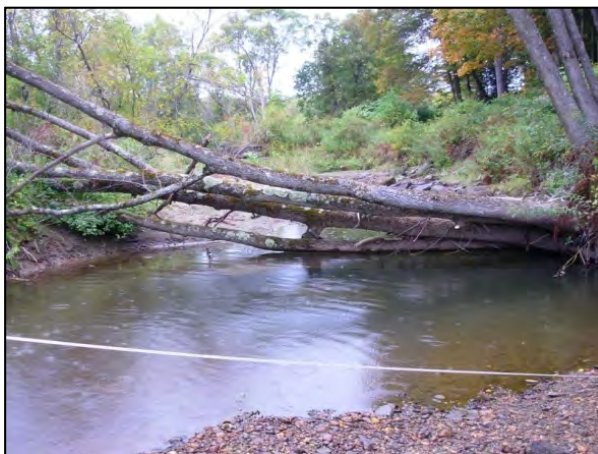
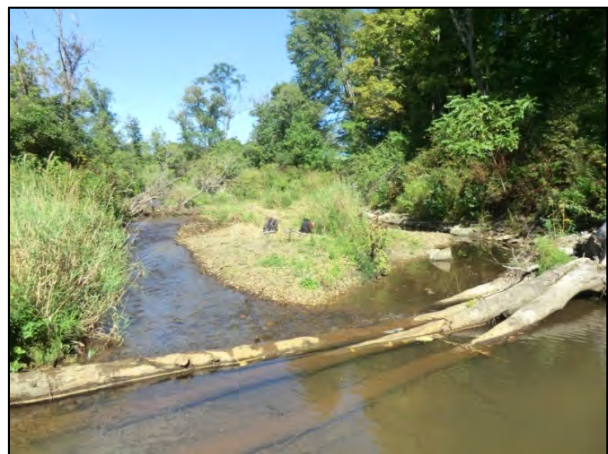
Table 5: Comparison of 2009 and 2014 Cross Sections at R13.S1.02-S1.01-D					
River Scientist Team	Cross Sectional Area	Bankfull Width	W/D Ratio	Entrenchment Ratio	Incision Ratio
Redstart (2009)	95.9	37.4	14.6	6.9	1.5
BCE (2014)	121.7	47.1	18.3	5.0	1.5
Percent change	26.9%	25.9%	25.3%	-27.5%	0%
Comments: Cross sectional area was higher in 2014 than 2009. The 2014 cross section was measured just upstream (about 20 feet) of the 2009 cross section due to channel changes. The fallen tree and large pool were present in the 2009 location (Figure 15). Channel may have experienced widening based on increased w/d ratio.

Figure 15. Looking upstream at cross section R13.S1.02-S1.01-D in 2009 (left) and 2014 (right).

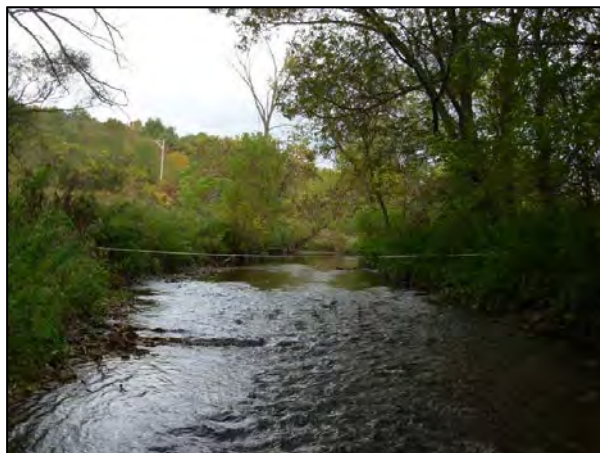
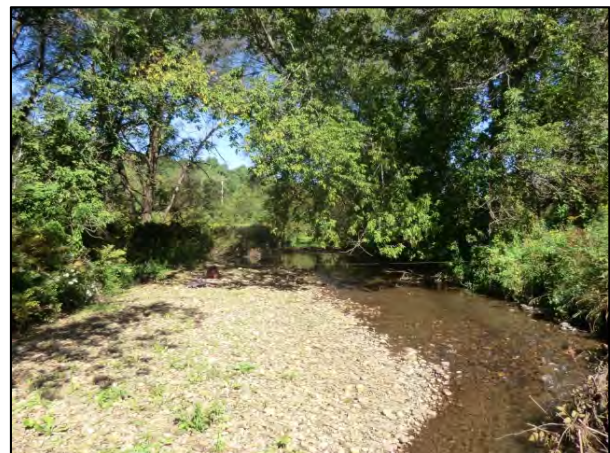
Table 7: Comparison of 2009 and 2014 Cross Sections at R13.S1.02-S1.03					
River Scientist Team	Cross Sectional Area	Bankfull Width	W/D Ratio	Entrenchment Ratio	Incision Ratio
Redstart (2009)	97.1	38.2	15.0	16.5	1.0
BCE (2014)	91.9	40.2	17.6	14.3	1.1
Percent change	-5.4%	5.2%	17.3%	-13.3%	10%
Comments: 2014 cross section was surveyed just downstream (about 40 feet) of 2009 cross section due to new beaver dam. Channel still has good floodplain access. More aggradational than in 2009 (Figure 19).

Figure 19. Cross section R13.S1.02-S1.03 in 2009 (left) where there is now a beaver dam and in 2014 (right) – more aggradational.

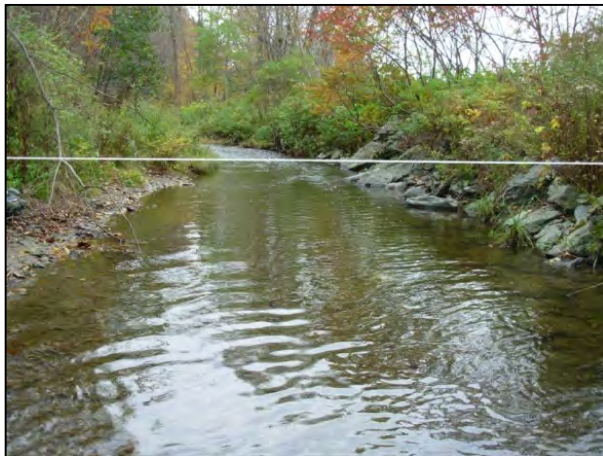
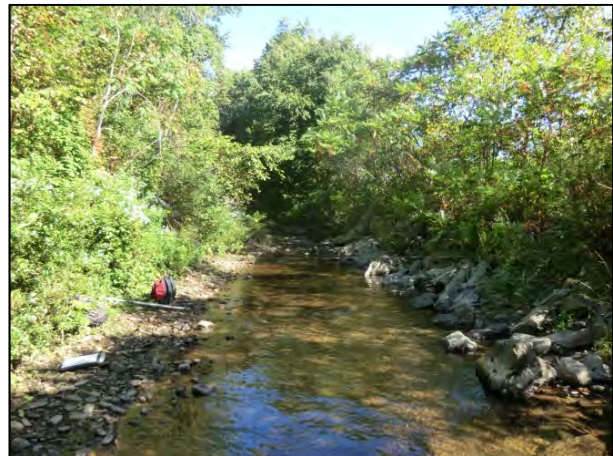
Table 8: Comparison of 2009 and 2014 Cross Sections at R13.S1.02-S1.04-A					
River Scientist Team	Cross Sectional Area	Bankfull Width	W/D Ratio	Entrenchment Ratio	Incision Ratio
Redstart (2009)	91.4	31.9	11.1	11.9	1.5
BCE (2014)	67.4	27.3	11.1	6.5	1.9
Percent change	-26.3%	-14.4%	0%	-45.4%	21.1%
Comments: Cross sectional area lower in 2014 than 2009, but consistent with upstream cross sectional areas measured in 2014.

Figure 21. Cross section R13.S1.02-S1.04-A in 2009 (left) and 2014 (right).

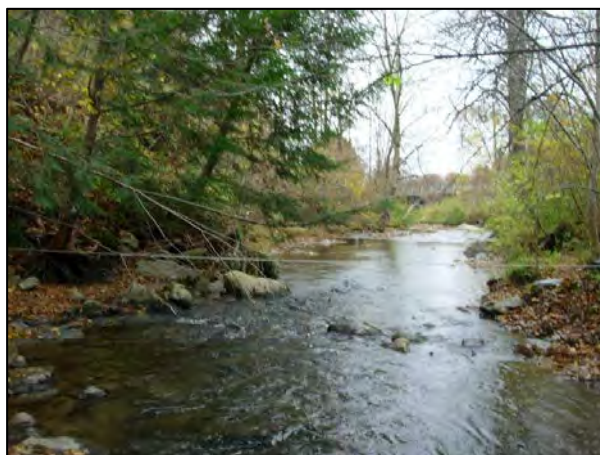
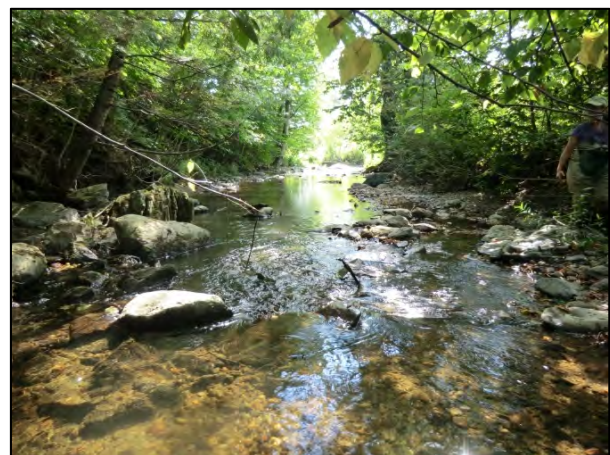
Table 9: Comparison of 2009 and 2014 Cross Sections at R13.S1.02-S1.04-B					
River Scientist Team	Cross Sectional Area	Bankfull Width	W/D Ratio	Entrenchment Ratio	Incision Ratio
Redstart (2009)	74.8	32.5	14.1	8.5	1.8
BCE (2014)	63.7	27.8	12.1	2.9	1.9
Percent change	-14.8%	-14.5%	-14.2%	-65.9%	5.6%
Comments: Cross sections similar. No significant changes from TSI except for some fallen debris from left bank.

Figure 23. Cross section R13.S1.02-S1.04-B in 2009 (left) and 2014 (right).

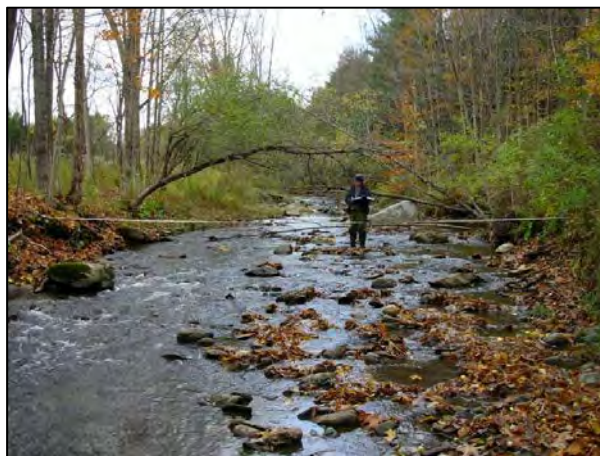
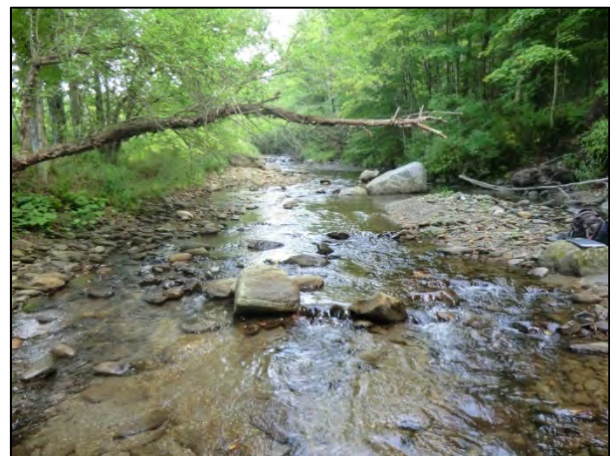
Table 12: Comparison of 2009 and 2014 Cross Sections at R13.S1.02-S1.05-B					
River Scientist Team	Cross Sectional Area	Bankfull Width	W/D Ratio	Entrenchment Ratio	Incision Ratio
Redstart (2009)	74.3	30.5	12.5	6.7	1.6
BCE (2014)	86.9	33.7	13.1	2.5	1.9
Percent change	17%	10.5%	4.8%	-62.7%	15.8%
Comments: Cross sections were similar in 2009 and 2014. More aggradational in 2014 than in 2009 most likely due to TSI (See Figure 29).

Figure 29. Cross section in Segment R13.S1.02-S1.05-B in 2009 (left) and 2014 (right).

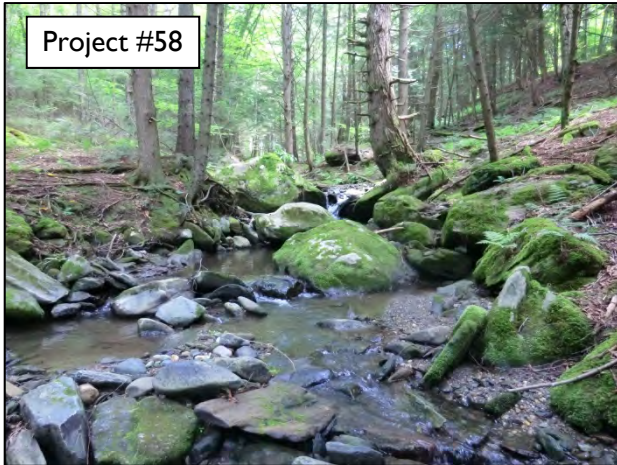
Project #58 R13.S1.02-S1.03-S1.02-B & C (Refer to Map 7)	Floodplain Improvement and Conservation	River Corridor or Conservation Easement	Unnamed Tributary 2 to Thatcher Brook	Waterbury	Between Shaw Mansion Road and Ripley Road	Moderate	Effective	Limited	Limited	Limited	One large parcel (55 acres) is suggested for river corridor or conservation easement. There is no development present in the parcel and the stream is actively adjusting in this area.
Project #59 R13.S1.02-S1.03-S1.02-C (Refer to Map 7)	Structure Replacement/ Removal	Culvert Replacement	Unnamed Tributary 2 to Thatcher Brook	Waterbury	Culvert under Ripley Road	High	Effective	Limited	Effective	Effective	This culvert is severely undersized and creates a barrier to aquatic organism passage due to the drop at its outlet.
