Moretown, Vermont Phase 2 Stream Geomorphic Assessment & River Corridor Plan

April 20, 2018

Prepared by:
Bear Creek Environmental, LLC
149 State Street, Suite 3
Montpelier, Vermont 05602

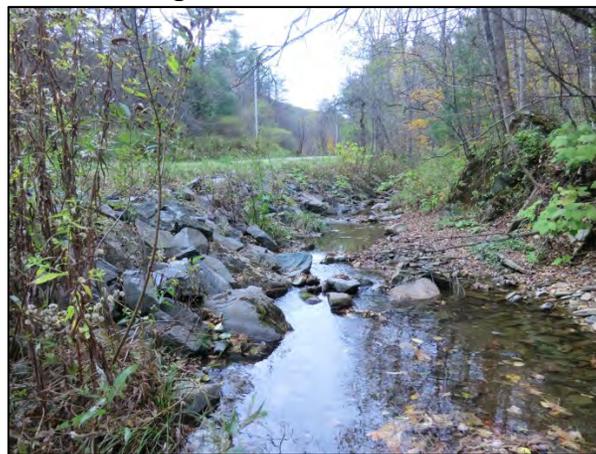
The downstream segment on reach one of Kelley Brook is characterized by a broad valley and moderate channel slope. Bedrock grade controls are common throughout this segment. Ward Brook Road is a corridor encroachment for nearly the entire length of the segment (Appendix C, Map 8). Almost all of R16.S2.02-S1.01-A has been historically straightened due to the placement of Ward Brook Road and houses along it. Additionally, there is extensive bank armoring, especially in areas where the brook is directly adjacent to the road. Channel straightening and bank armoring have led the brook to undergo major historic incision in this segment, resulting in a loss of floodplain access and a stream type departure. Channel widening is prevented by bank armoring on one side of the channel and the location of the valley wall on the other side for much of the segment; however, bank erosion is common where armoring is not present. Segment A was placed in **fair** geomorphic condition for these reasons. Habitat condition is also **fair** due to the altered channel planform, as well as lacking large woody debris, pool features, and bank and buffer vegetation.

Figure 5.25. R16.S2.02-S1.01-A flows directly along Ward Brook Road for much of the segment.

R16.S2.02-S1.01-A Data Summary		Reference	Existing
Length:	3,425ft	Broad	Broad
Drainage Area:	2.1 sq. mi.	C _b	G
Evolution Stage:	F-II	> 2.2	1.3
Sensitivity:	Very High	< 1.2	2.3
		Dominant Bed Material	Cobble
		Dominant Bedform	Riffle-Pool
Major Stressors:	Channel straightening, encroachment, lacking buffers, bank armoring, stormwater inputs

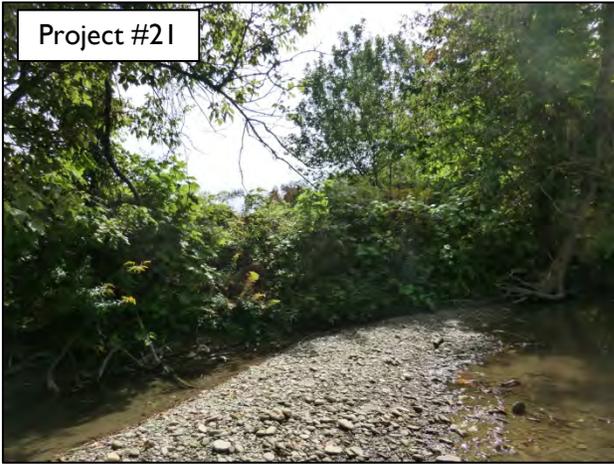
Project #21

21	6	Buffer planting in agricultural fields along R16.S2.01-A	Riparian buffer is lacking on both sides of brook for most of segment. Abundant erosion and riprap; planting could help stabilize banks.	River - Planting	5	R16.S2.01-A	44.269982	-72.637569	Landowner expressed concern via phone correspondence about people being on his property for the Phase 2 assessment because he did not want his crop fields damaged. May not be willing to lose any crop land for buffer improvements.	Berlin	Tributaries to Upper Mid-Winooski	Moderate	Winooski Natural Resources Conservation District, Friends of the Winooski River, Landowner(s)
22	6	River corridor easement on lower Jones Brook	Protect the river corridor from future development and the channel from future management activities in a very dynamic section (braided, multiple channels).	River Corridor Easement - Design	57	R16.S2.01-B	44.265294	-72.63898	One large parcel.	Berlin	Tributaries to Upper Mid-Winooski	Moderate	Winooski Natural Resources Conservation District, Friends of the Winooski River, Vermont Land Trust, Vermont River Conservancy, Landowner(s)
