Kingsbury Branch of the Winooski River Watershed River Corridor Plan October 2008

Kingsbury Branch of the Winooski River Watershed River Corridor Plan

October 24, 2008

Bear Creek Environmental, LLC

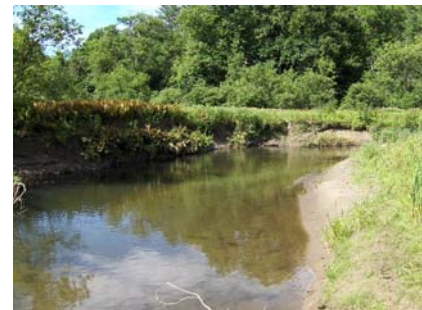
Reach M02 begins about 1200 feet upstream of the bridge at Cate Farm Road. This reach is highly sinuous and is also highly influenced by North Montpelier Pond. The lack of sediment below the pond has likely contributed to historic incision within this reach. This reach has undergone a stream type departure from an “E” to a “C” channel due to widening or planform migration and is currently undergoing a major aggradation process. M02 has an excellent riparian buffer and has abundant wetlands adjacent to the channel.

I. Protect River Corridor

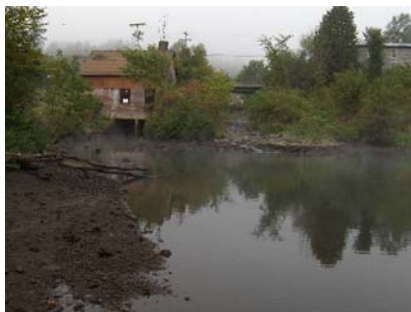
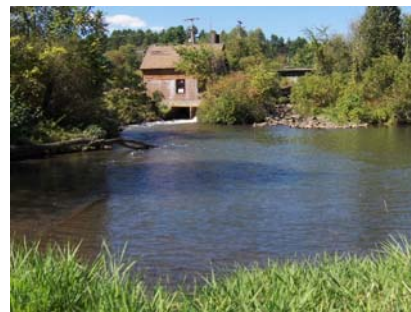
Located directly downstream of North Montpelier Pond, Reach M03 is highly influenced by the Kingsbury Hydroelectric Project. The photos below show the river below the power house prior to and after a release on September 17, 2007. Bedrock ledge, acting as a grade control, was noted above the Route 14 bridge that is located directly below North Montpelier and upstream of the powerhouse. A partial geomorphic assessment was conducted of this reach due to limited landowner access. Although no cross section was surveyed, the reach appeared to be highly incised. This incision is likely attributed to the influence of North Montpelier Pond. The river may have incised in this area due to being sediment starved. M03 was dominated by buffer widths of greater than 100 feet of the river. There were some areas with buffers less than 25 feet

in length adjacent to commercial landuse. The reach was walked under very low flow conditions (prior to release from the hydroelectric project). Over 200 pieces of large

woody debris was counted in this reach, in part due to the amount of stream bed that was exposed due to the low flow conditions.

I. Protect River Corridor

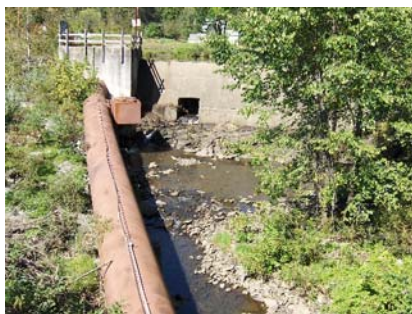
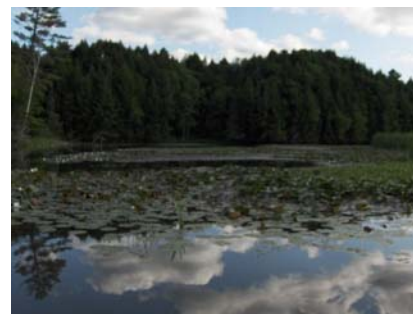
Reach M04 – North Montpelier Pond

North Montpelier Pond is an onstream impoundment created by a concrete, gravity dam that was constructed in 1920. The dam is 15 feet high

and 85 feet wide and is owned by the Kingsbury Hydroelectric Company. The facility is store and release with a maximum discharge of 1200 cubic feet per second. The impoundment is used for recreational purposes (FindLakes, 2008).

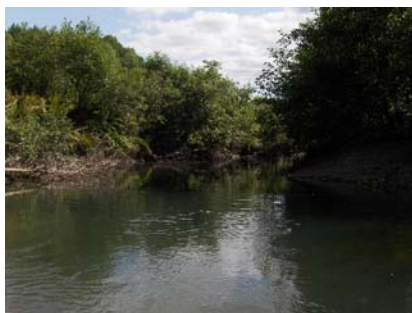
Reach M05

The Kingsbury Branch within reach M05 is highly influenced by North Montpelier dam and did not receive a full phase 2 assessment for this reason. There are abundant wetlands adjacent to the channel and shrub sampling dominates the near bank, buffer and riparian corridor.

I. Protect River Corridor

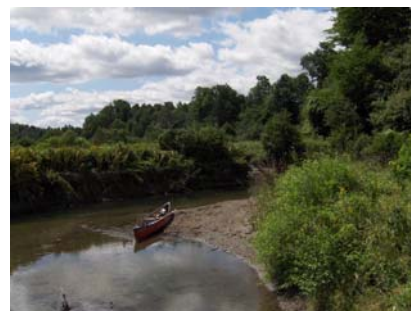
Reach M06 begins upstream of the impounded influence from North Montpelier Pond. Much of this reach was historically straightened for agricultural purposes and it runs through Legare Farm. The

Winooski Conservation District has been working with the farmer to plant native woody vegetation within the river corridor. This vegetation is small at this time, and will provide a high quality buffer in the future. This “E” channel is not incised but is experiencing major planform adjustment as it attempts to regain sinuosity. A tributary entering from the east at the reach break between M06 and M07 is contributing considerable sediment. A Phase 2 assessment of Tributary 2 is recommended.

2. Evaluate Tributary 2

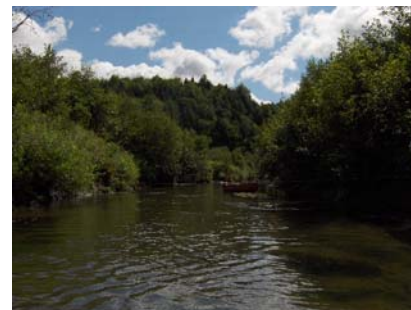
Reach M07 begins about 950 feet downstream of where Route 14 encroaches along the Kingsbury Branch, just upstream of Legare Farm. This “E” channel has been historically channelized, and major planform adjustment is evident. Overall the riparian vegetation seems to be holding the channel in place.

1. Protect River Corridor

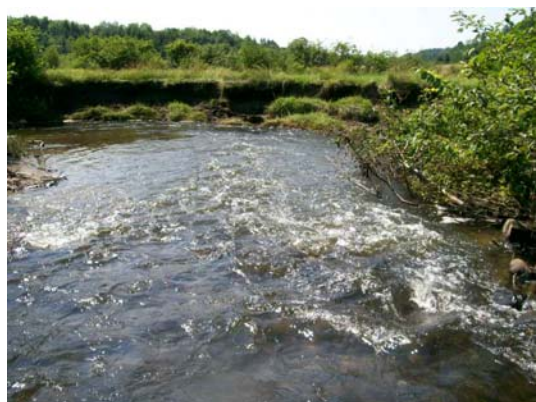
Reach M08

The downstream end of reach M08 is at the confluence of Pekin Brook. M08 is highly influenced by beaver dams and did not receive a full Phase 2 assessment. This reach was broken into two segments due to differences in land use. The lower segment was dominated by shrub sampling in the near bank, buffer and riparian corridor and had abundant wetland adjacent to the channel. The buffer width was generally greater than 100 feet in width. The upper segment (M08-

B) is hayed and is a good candidate for riparian buffer improvement.

1. Improve Buffer (M08-B)

2. Protect River Corridor

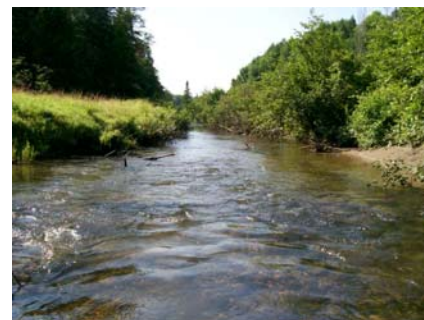
Reach M09 begins where the channel becomes very straight and begins to run very close to Route 14. The riffle pool bedform in this “E” channel is weak primarily due to historic straightening. Some areas are becoming more sinuous and the stream is beginning to build small benches. The channel is still widening and migrating laterally due to increased stream power. The buffer is generally good,

although some areas where the stream runs very close to Route 14 are less than 25 feet wide.

1. Protect River Corridor

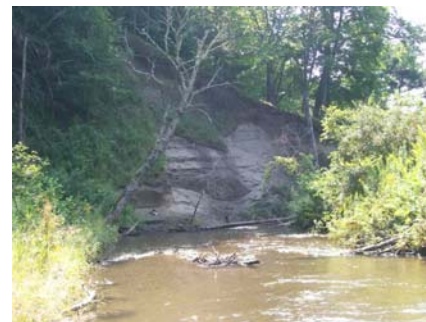
Reach M10 begins where the Kingsbury become more sinuous along Route 14. This “E” channel is undergoing major widening with evidence of a newly created bankfull bench. This reach is also experiencing major aggradation of fine sediment and severe bank erosion on all outside beds indicating major planform adjustment. The riparian buffer is generally wider than 50 feet, although some isolated area close to Route 14, where the buffer is less than 25 feet.

1. Protect River Corridor

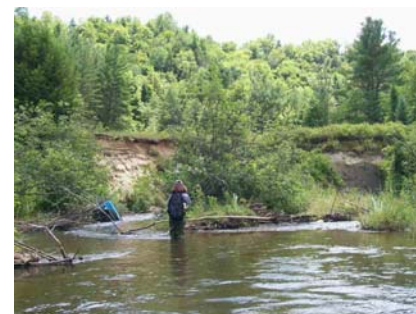
Segment M11-A begins just upstream of where Peck Hill Road meets Route 14, where the stream begins to move away from Route 14. This “C” channel has very good floodplain access and its location along the Kingsbury Branch is where the stream types change from “E” by reference to “C” by reference. This segment is extremely aggradational, having become overloaded with sediment from incision that occurred upstream in M11-B and reach 12. Also a braided channel was noted in the middle of the segment indicating major planform adjustment. The dominant buffer on both sides of this segment was substandard (<25 feet) and would be a good segment to work with landowners on river corridor protection and improving buffers.

2. Protect River Corridor

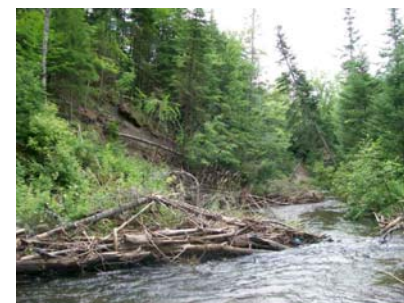
Segment M11-B begins approximately 800 feet upstream of the snowmobile bridge in segment M11-A. This segment has historically incised resulting in a stream type departure from a “C” to a “B” channel, likely in response to being sediment starved from the onstream pond located in reach M13. This segment has an excellent riparian buffer and many downed trees creating good habitat.

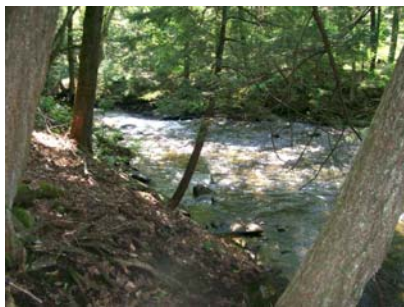
Segment M12-A begins about 900 feet upstream of the Route 14 bridge. This “B” channel is a transitional segment between upstream bedrock falls and “C” channels downstream. This segment has incised due to being sediment starved from onstream pond upstream in reach M13. Major planform adjustment is occurring at the base of the falls and the lower end of the

I. Protect River Corridor

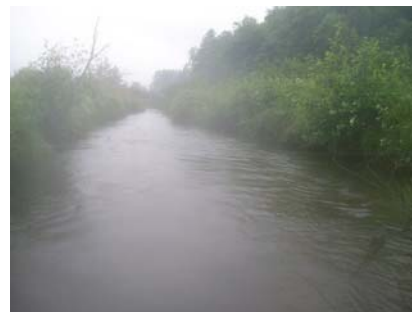
Reach M14

M14 was broken into three segments for the Phase 2 assessment. The lower segment, M14-A, did not receive a full phase 2 assessment because it is highly influenced by an old mill dam and is a wetland. A description of the other two segments is provided below.

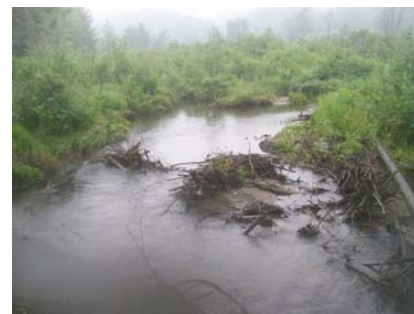
Segment M14-C begins where channel changes from “E” ripple dune to “C” riffle pool near meander that is close to Route 14. Numerous remnant beaver dams were noted in this segment. This segment is not incised and has abundant wetlands adjacent to the channel. Major planform adjustment is occurring in this segment. This segment has excellent riparian buffers.

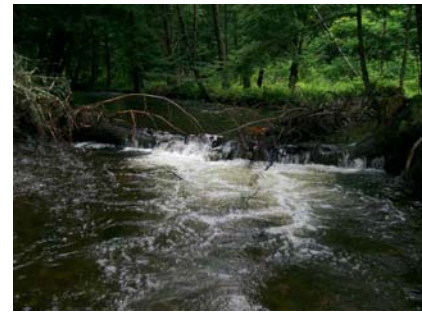
Reach M16 begins just upstream of the Route 14 bridge that is in between the Route 14 intersections with Balentine Road and Lamberton Camp Road and continues to the outlet of Sabin Pond. The sinuosity and planform has changed due to debris jam influence on this “C” channel. This reach generally has excellent riparian buffers.

I. Protect River Corridor

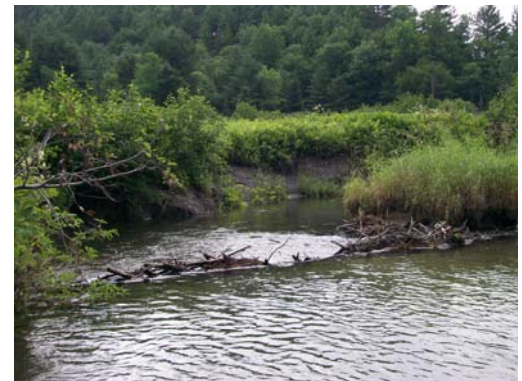
The lowest reach on Pekin Brook was heavily influenced by beavers during the Phase 2 assessment in 2007. Three beaver dams were recorded within 800 feet. Reach T3.01 is an “E” ripple-dune system. Pekin Brook Road has been responsible for a human caused change in valley width, which has also resulted in channel straightening along much of the reach. Overall, this reach appeared to be in fair geomorphic condition. The section below the Route 14 crossing and the confluence of the Kingsbury Branch had buffers less than 25 feet on both sides.

I. Improve Riparian Buffer

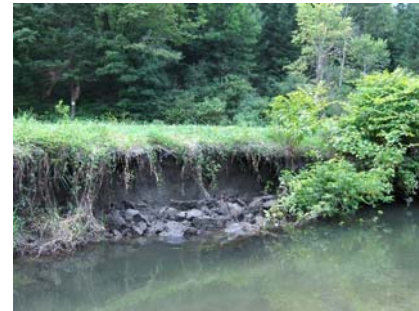
Segment T3.03-B begins about 1300 feet upstream of Pekin Brook Road culvert. This “E” channel runs through an agricultural area and lacks a healthy riparian buffer along most of the segment. This segment is undergoing major planform adjustment.

- 1. Improve Riparian Buffer**
- 2. Protect River Corridor**

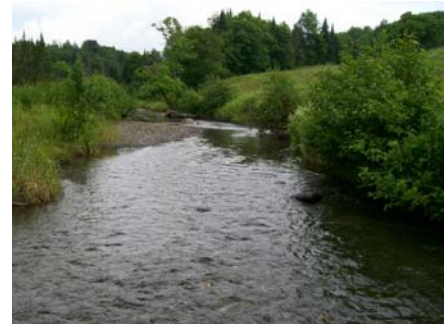
Segment T3.05-A begins about 0.5 miles upstream of the intersection of Jack Hill Road and Pekin Brook Road where valley opens up. This “C” segment has a fairly healthy and new riparian buffer, as it used to be a dairy farm but cows are no longer grazing within the corridor. No major adjustment processes are occurring within this segment.

I. Protect River Corridor

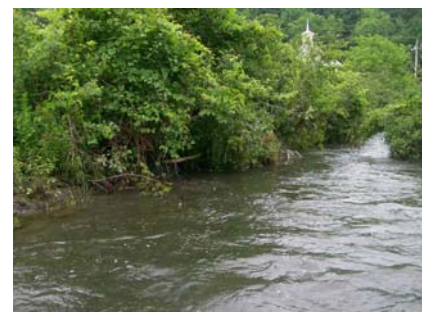
Segment T3.06-B begins where a small tributary enters on the right bank, about 450 feet downstream of the Kent Hill Road culvert. This segment has been altered and its floodplain has been bermed to protect the town hall. This segment is experiencing major planform alteration and is lacking a healthy riparian buffer in many areas.

2. Alternative Analysis for Berm Removal
