# Moretown, Vermont Phase 2 Stream Geomorphic Assessment & River Corridor Plan

April 20, 2018

Prepared by:  
Bear Creek Environmental, LLC  
149 State Street, Suite 3  
Montpelier, Vermont 05602

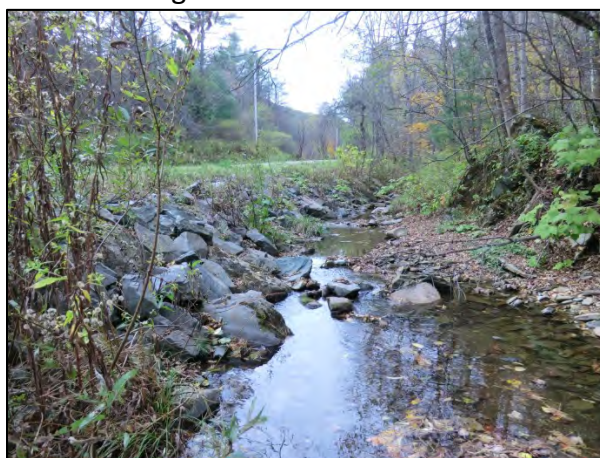
The downstream segment on reach one of Kelley Brook is characterized by a broad valley and moderate channel slope. Bedrock grade controls are common throughout this segment. Ward Brook Road is a corridor encroachment for nearly the entire length of the segment (Appendix C, Map 8). Almost all of R16.S2.02-S1.01-A has been historically straightened due to the placement of Ward Brook Road and houses along it. Additionally, there is extensive bank armoring, especially in areas where the brook is directly adjacent to the road. Channel straightening and bank armoring have led the brook to undergo major historic incision in this segment, resulting in a loss of floodplain access and a stream type departure. Channel widening is prevented by bank armoring on one side of the channel and the location of the valley wall on the other side for much of the segment; however, bank erosion is common where armoring is not present. Segment A was placed in **fair** geomorphic condition for these reasons. Habitat condition is also **fair** due to the altered channel planform, as well as lacking large woody debris, pool features, and bank and buffer vegetation.

**Figure 5.25.** R16.S2.02-S1.01-A flows directly along Ward Brook Road for much of the segment.
