# **Fluvial Geomorphology Assessment of the Mad River Watershed, Vermont**

Prepared for

Friends of the Mad River  
Waitsfield, VT

Field Geology Services  
Farmington, ME

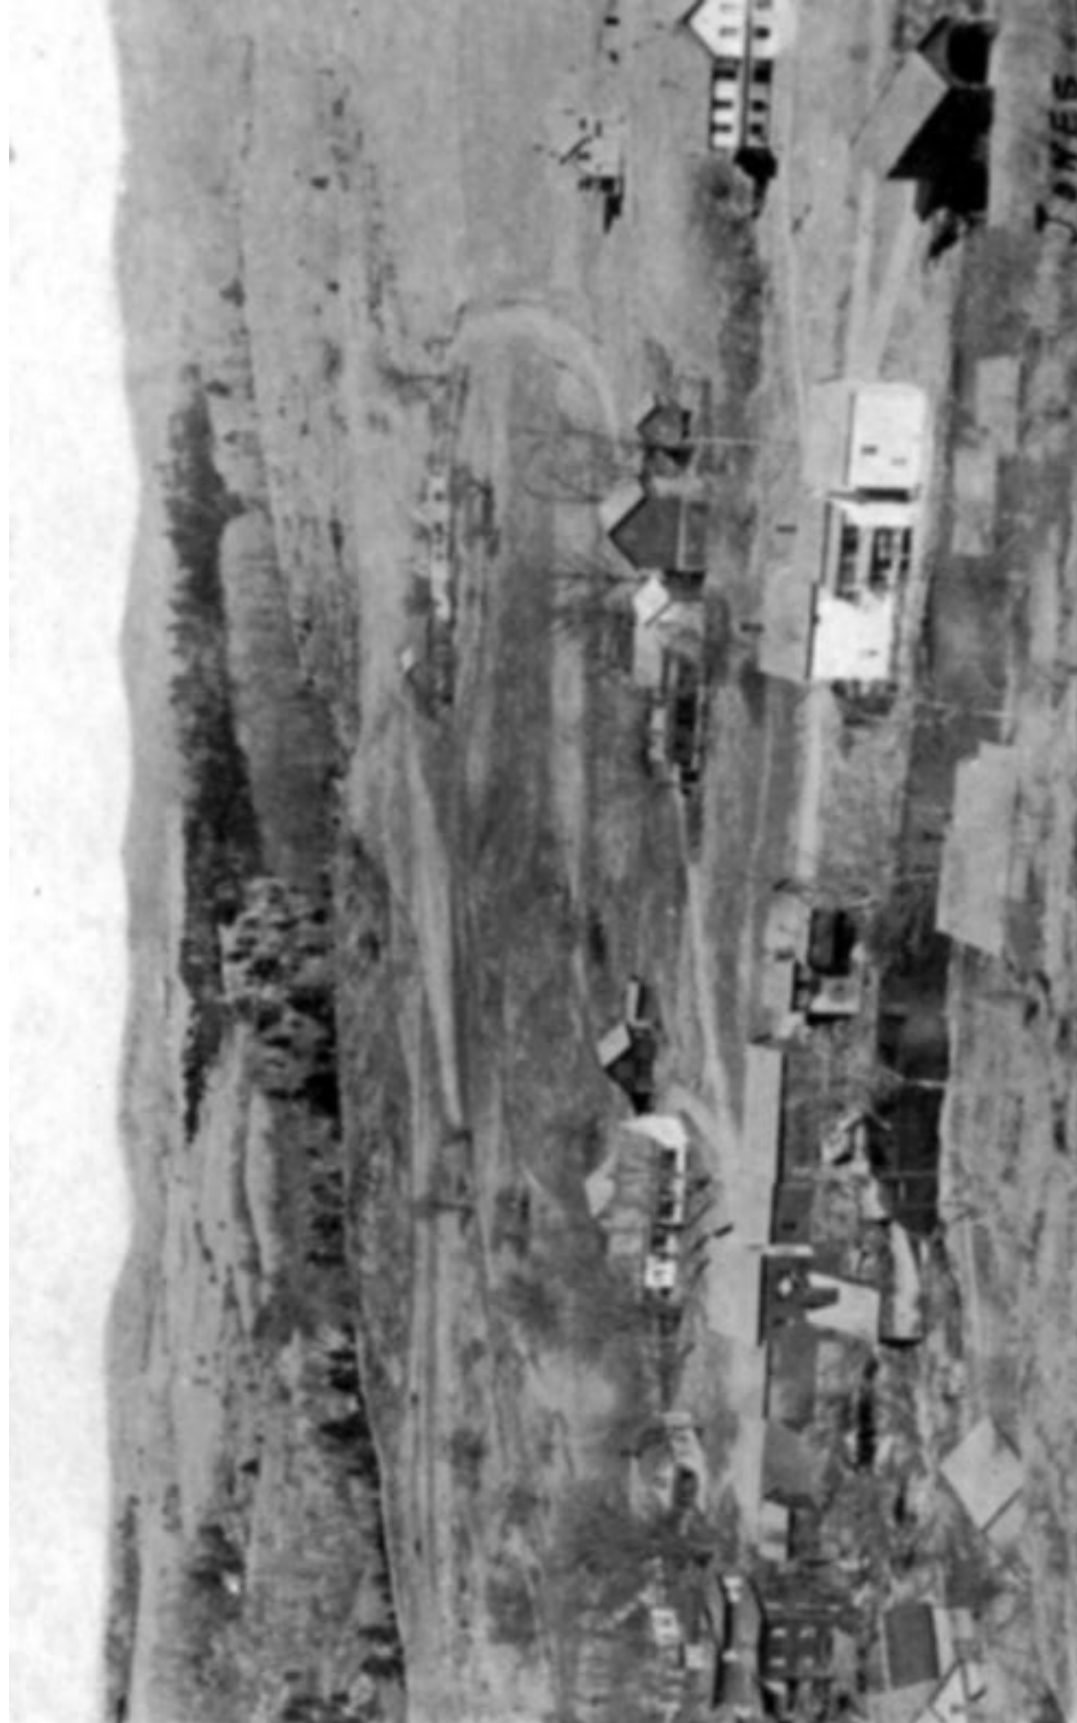
Figure 3: View of Warren Village prior to 1911 showing extensive land clearance. Impoundment behind the Warren Crib Dam can be seen at the bottom of the photo. Photo Courtesy of Vermont Landscape Change Program.

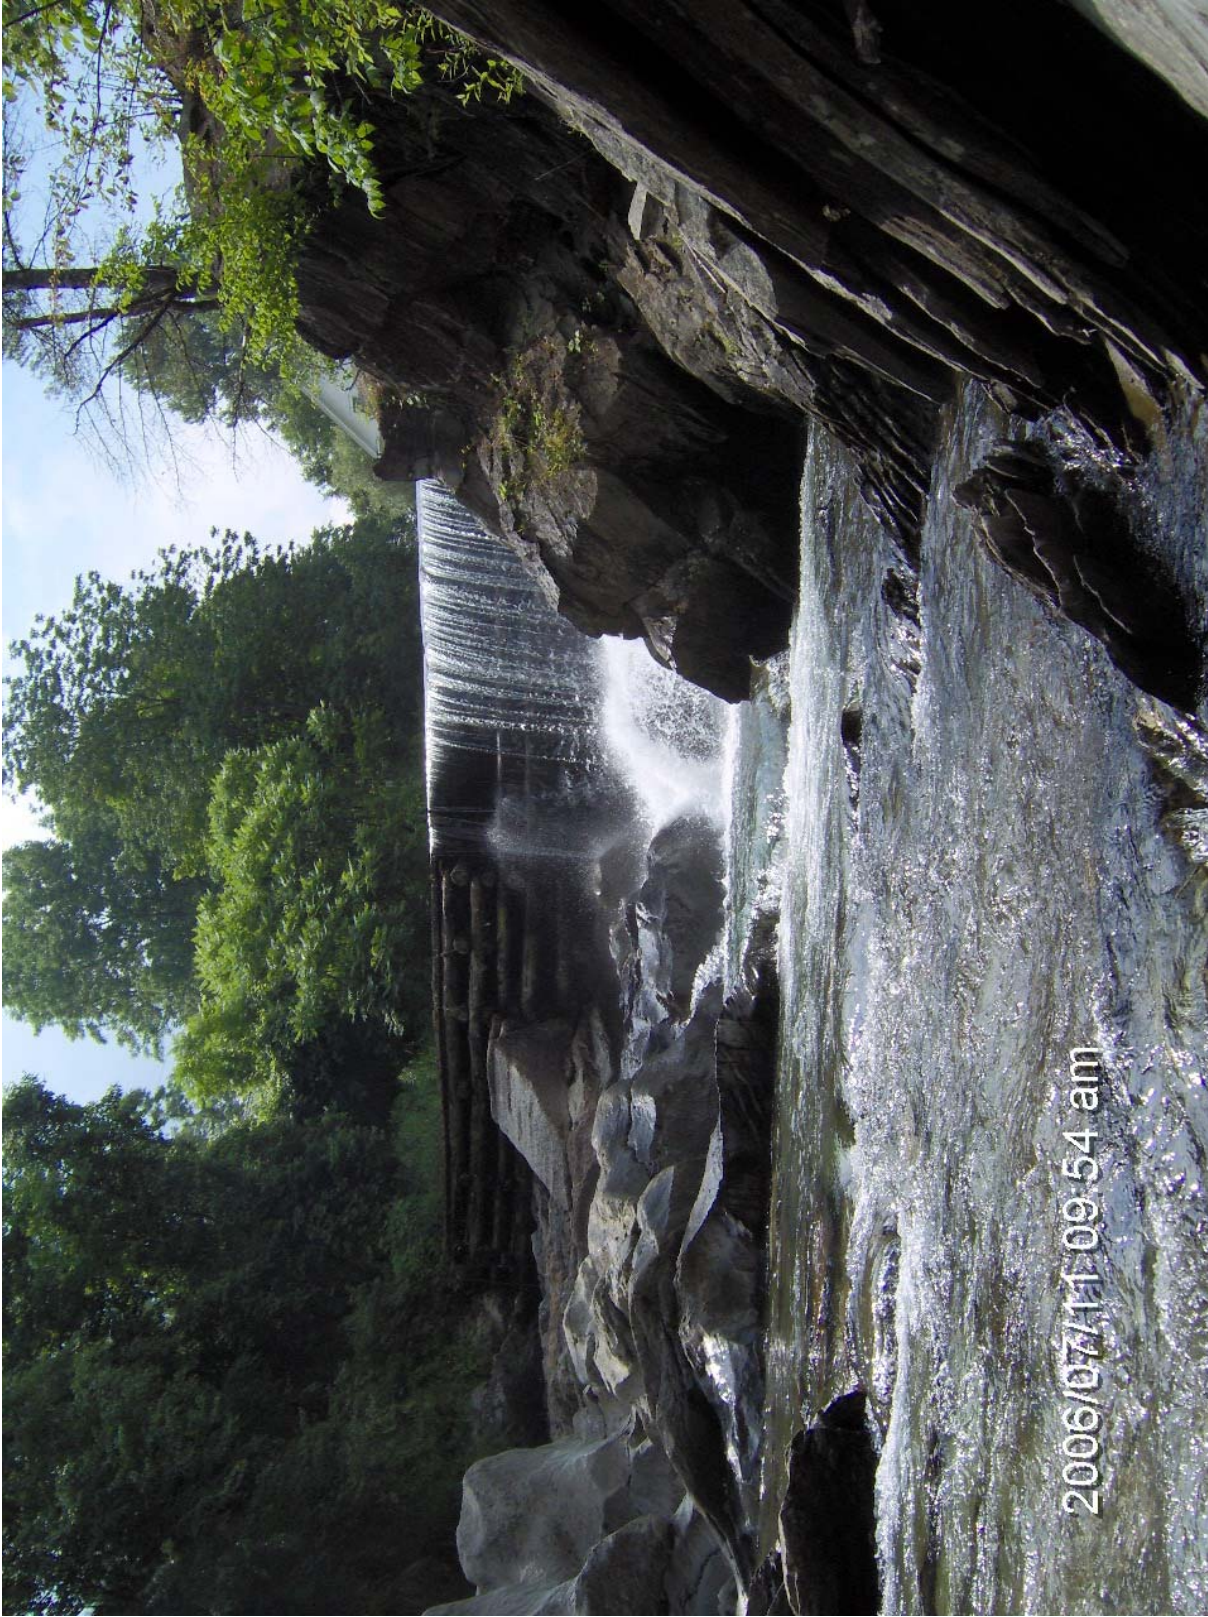
Figure 5: Warren crib dam looking upstream

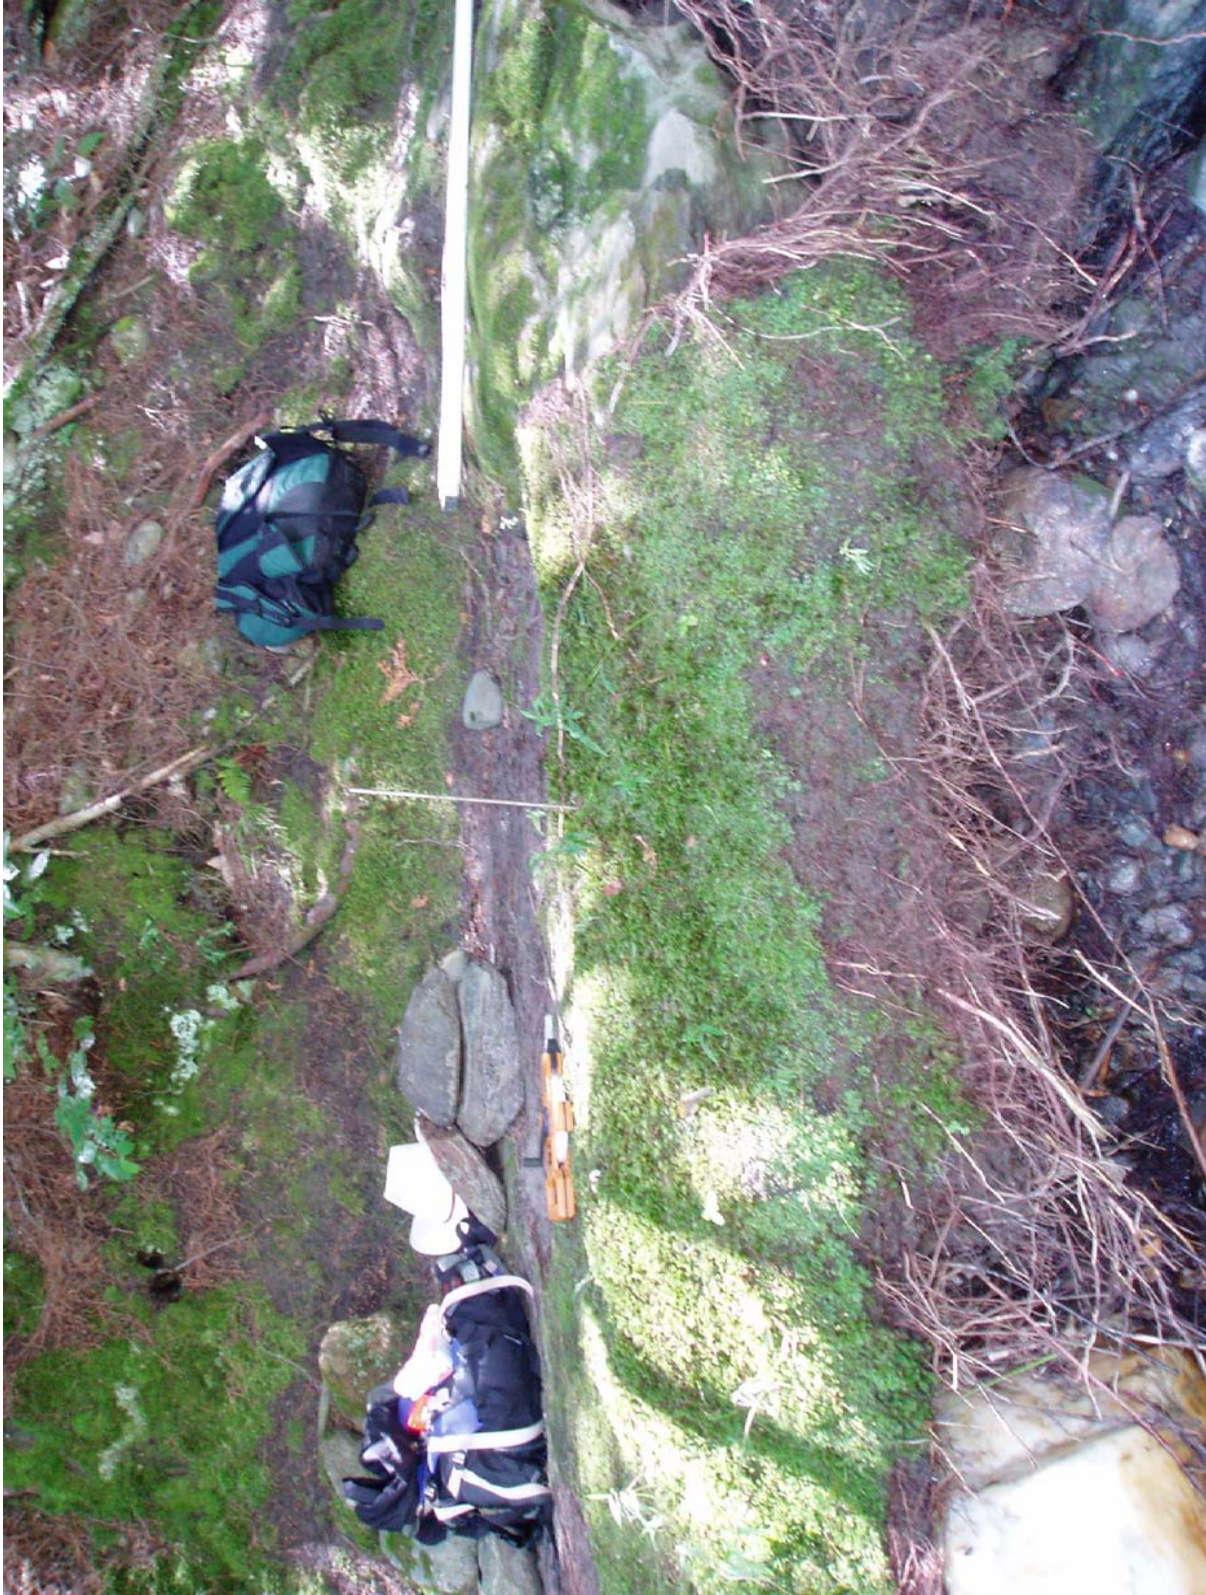
Figure 9: Mossy bench of silt and sand representing an emergent floodplain along the margins of the channel in Reach M14

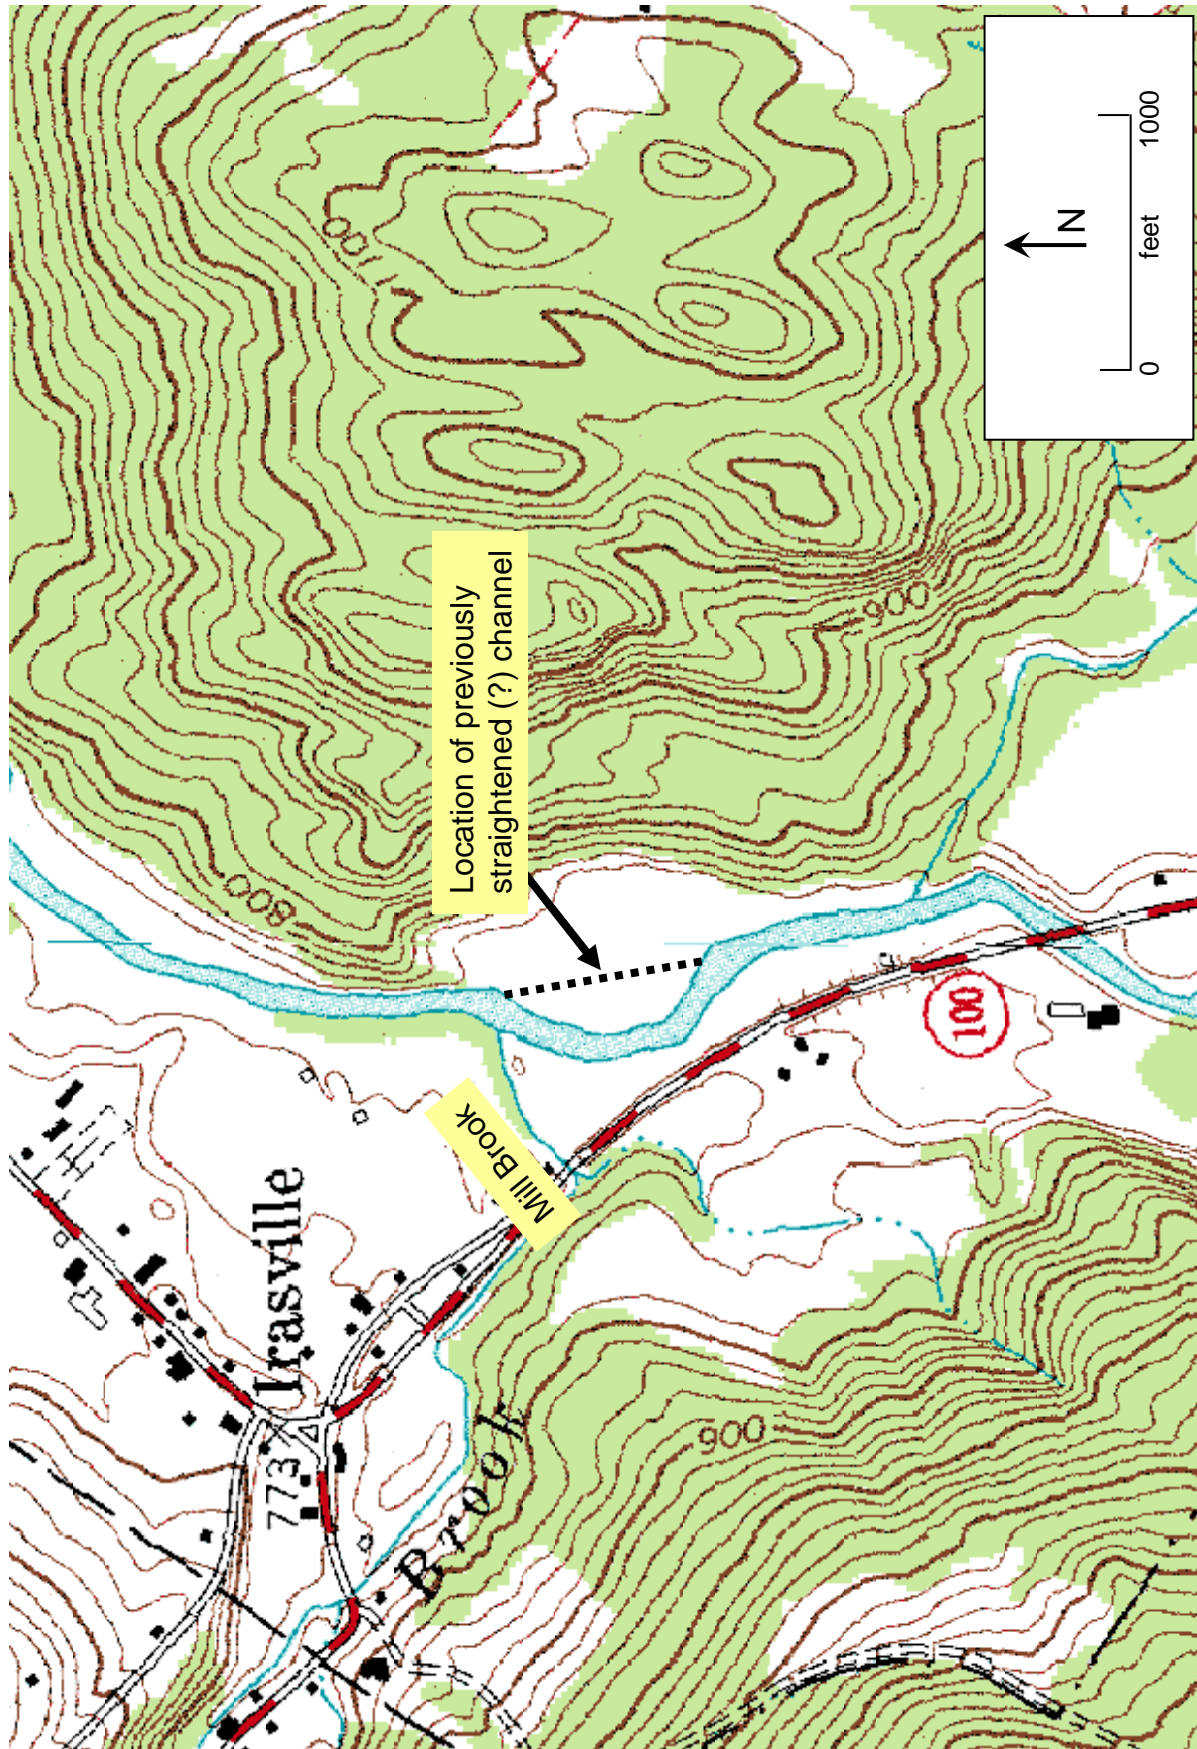
Figure 12: Large meander formed upstream of Mill Brook confluence where the river was likely previously straightened

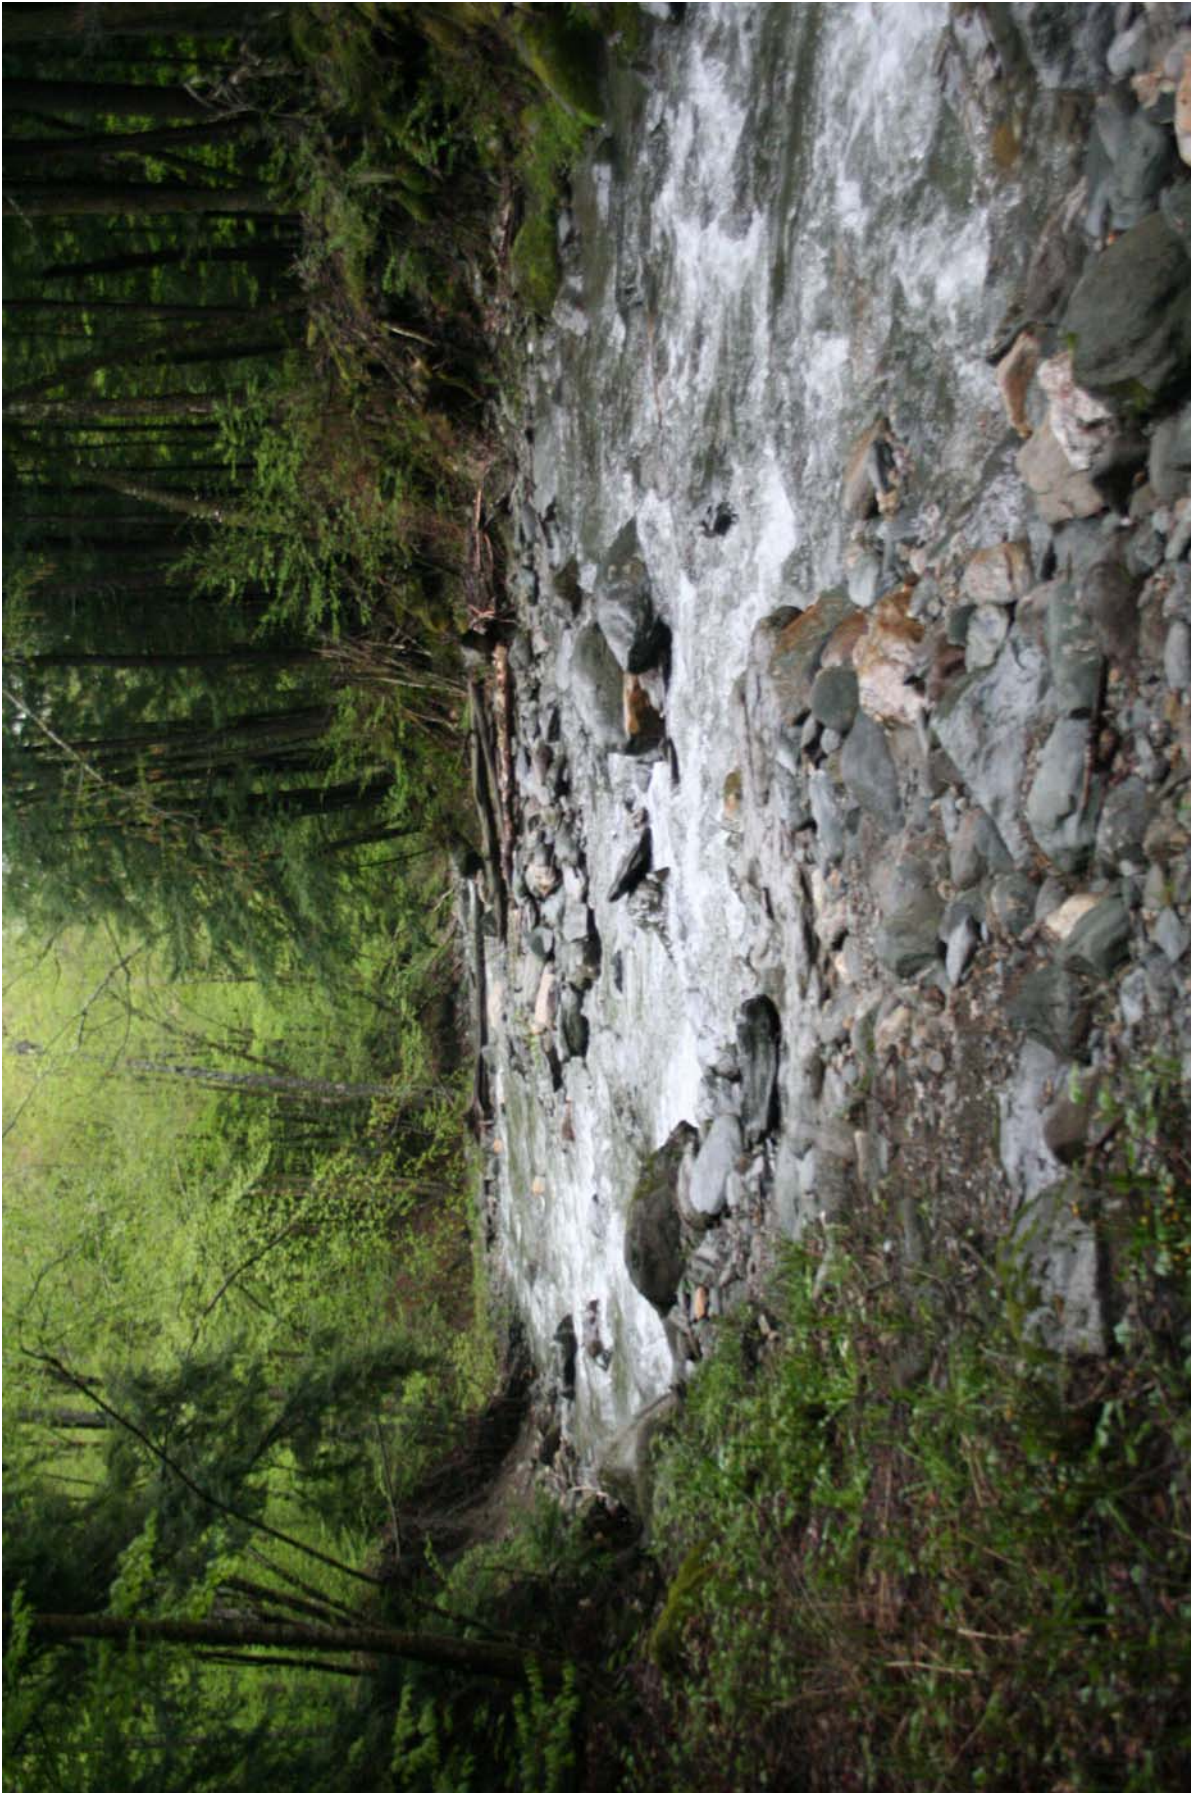
Figure 20: Clay Brook (Reach T9.02). Note lack of debris and sediment accumulation in channel after large flood in 1998.

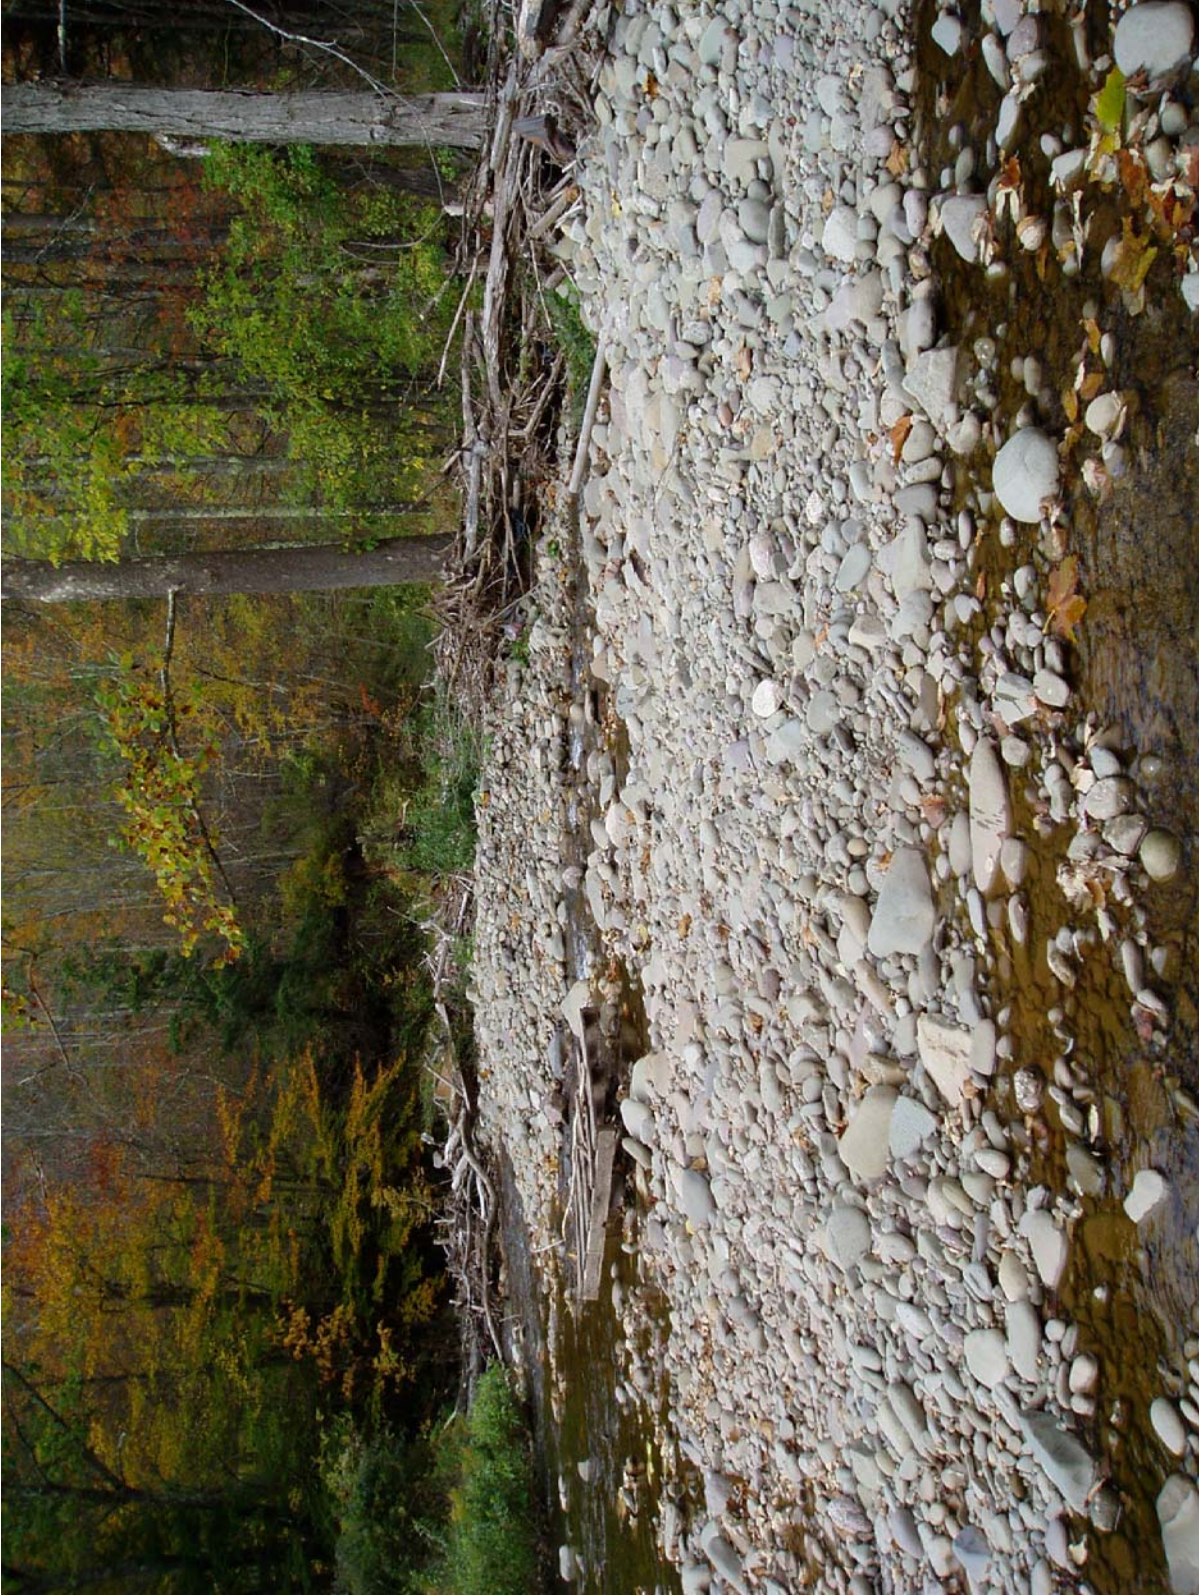
Figure 23: Gravel bar formed upstream of a natural woody debris jam on Esopus Creek in the Catskills, New York.

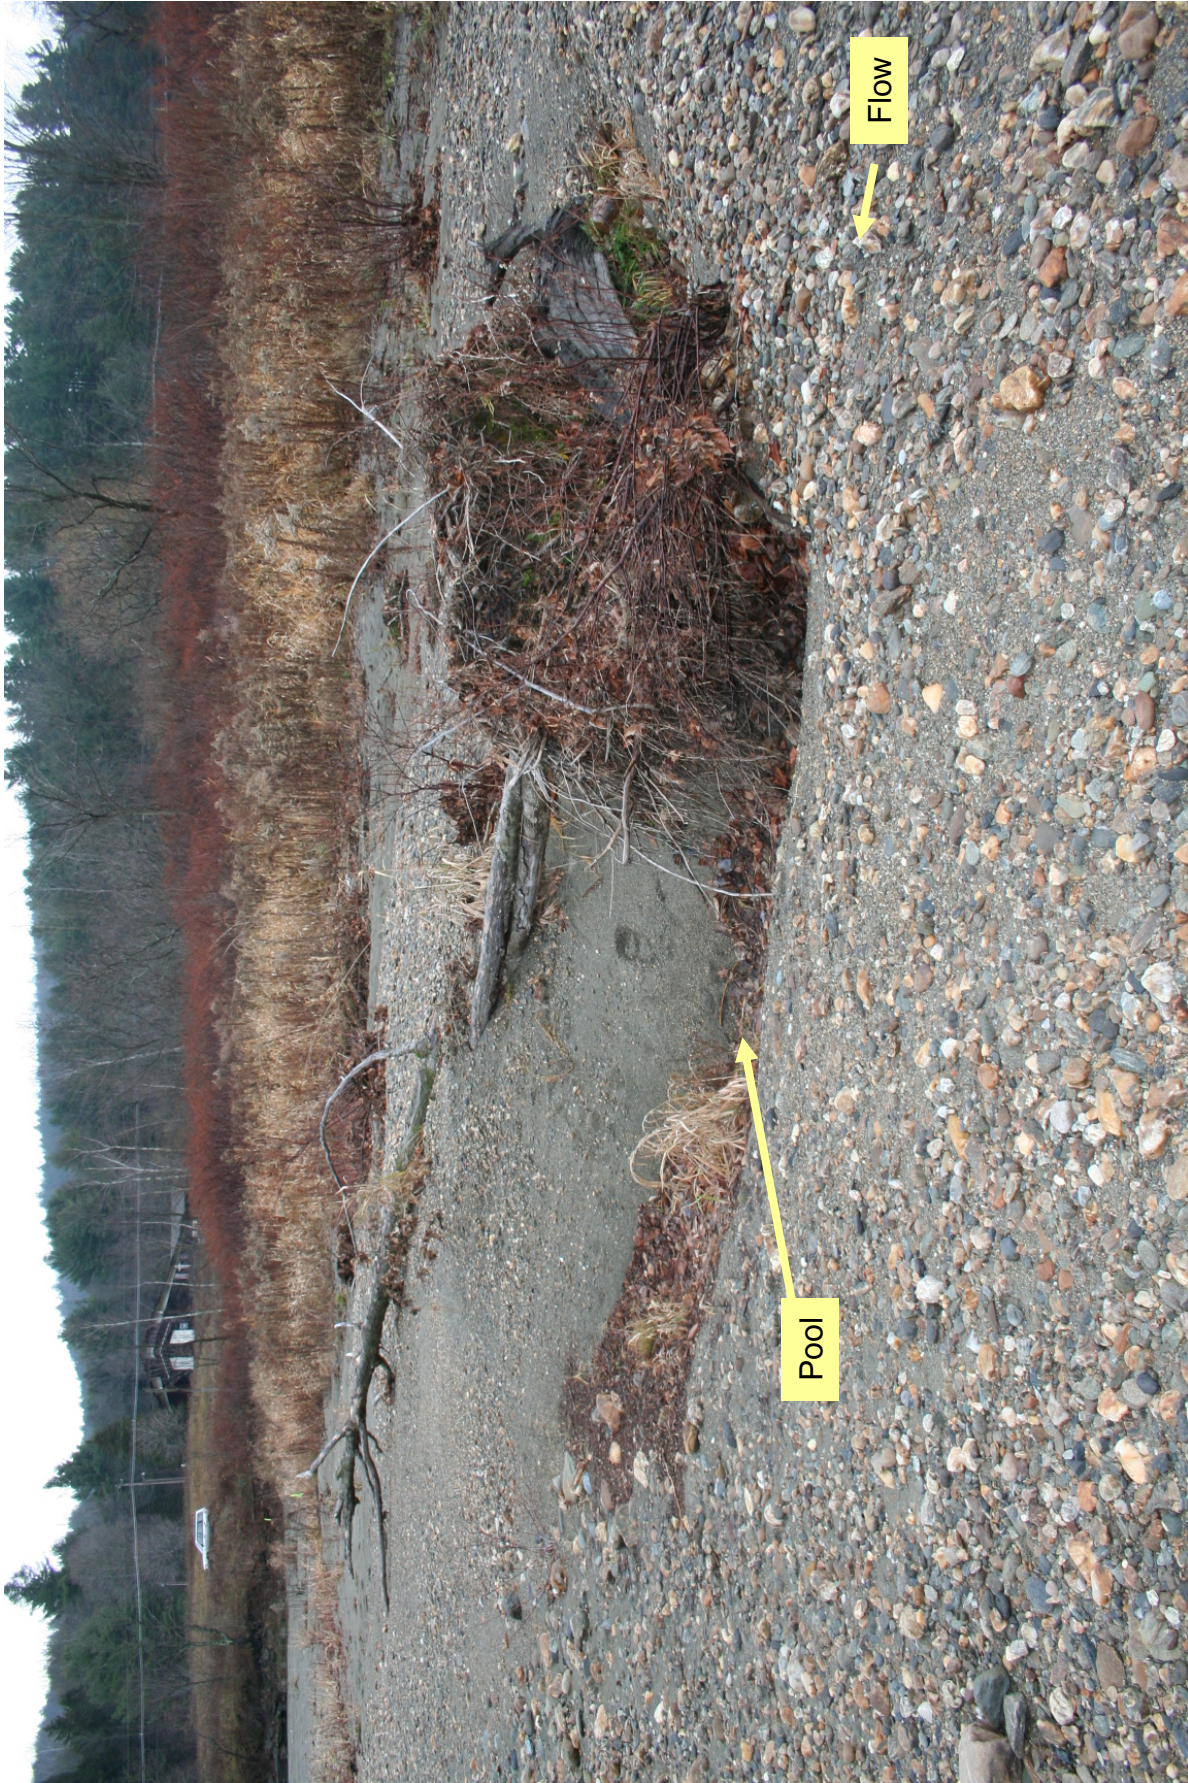
Figure 24: Small pool scoured locally around logs in channel (Reach M13)

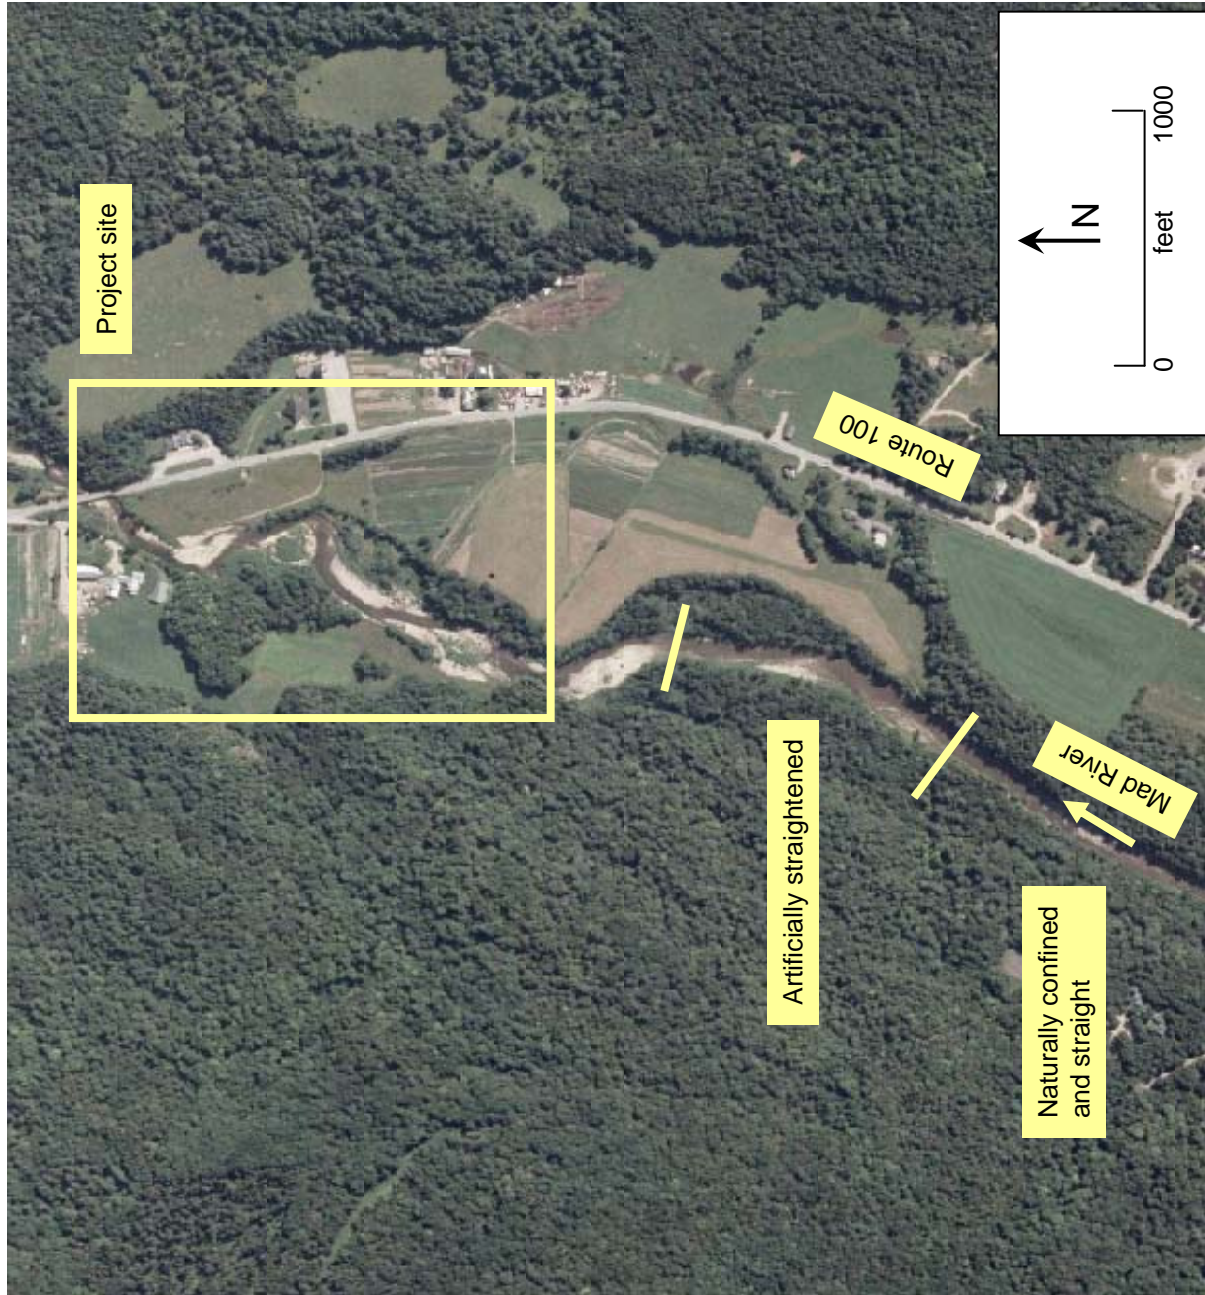
Figure 27. Aerial photograph of Mad River in Reach M13 showing location of project reach in relation to artificially straightened area upstream. Box around project site is roughly the area shown in Figure 28.

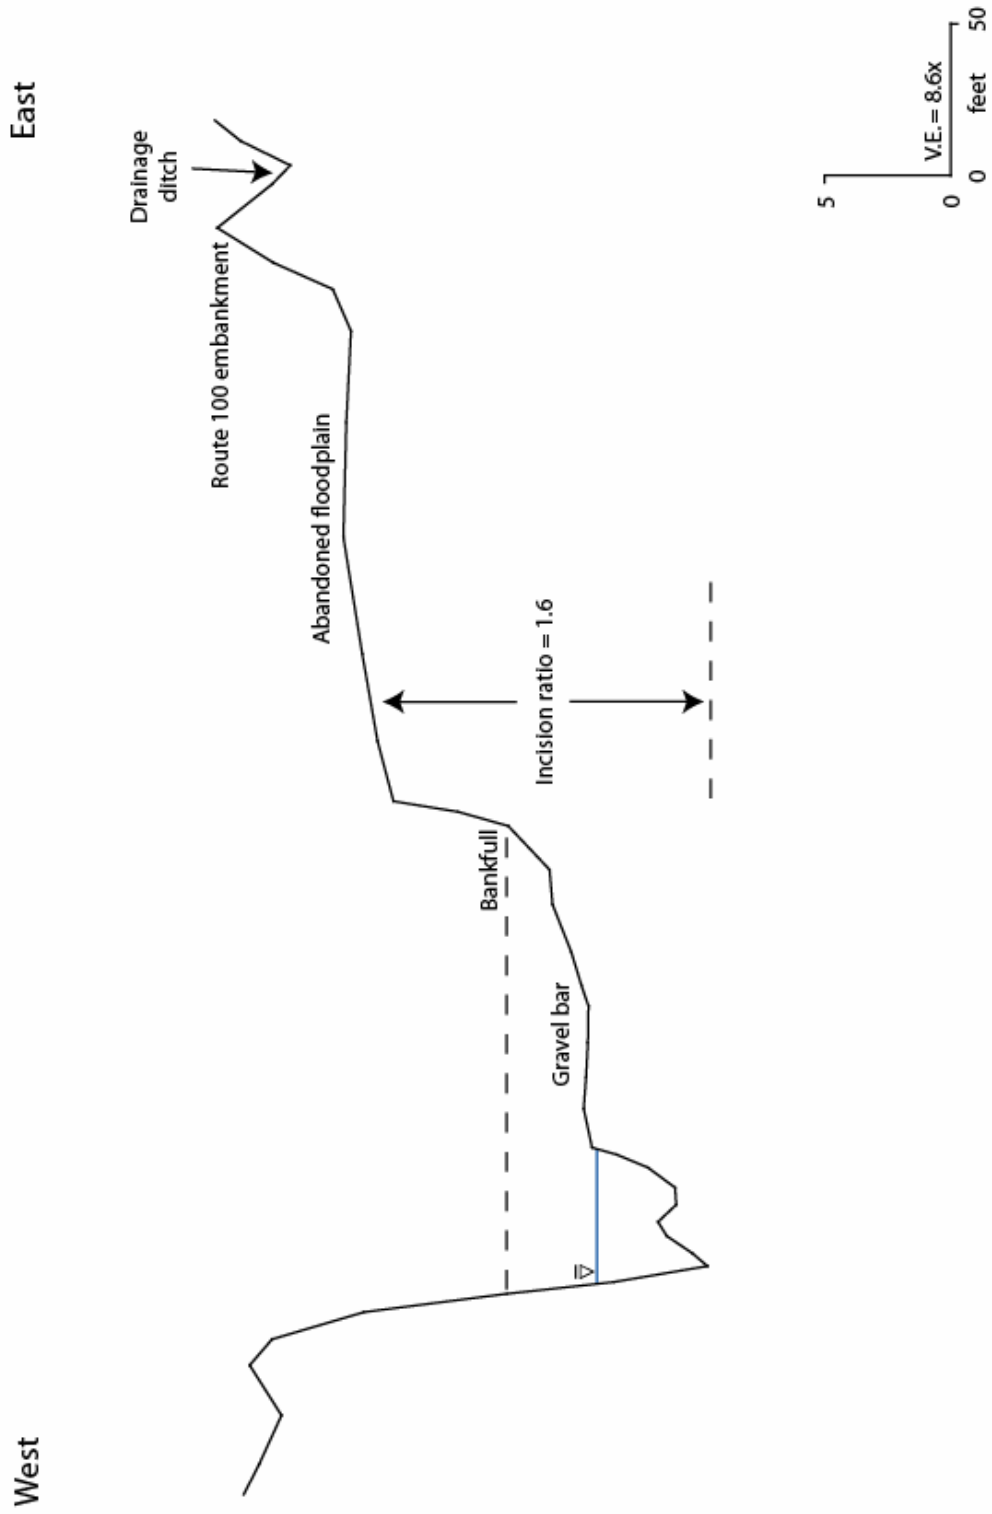
Figure 29. Cross Section 1 as shown on Figure 2 illustrating channel incision typical of Reach M13 and formation of gravel bars where widening has occurred.

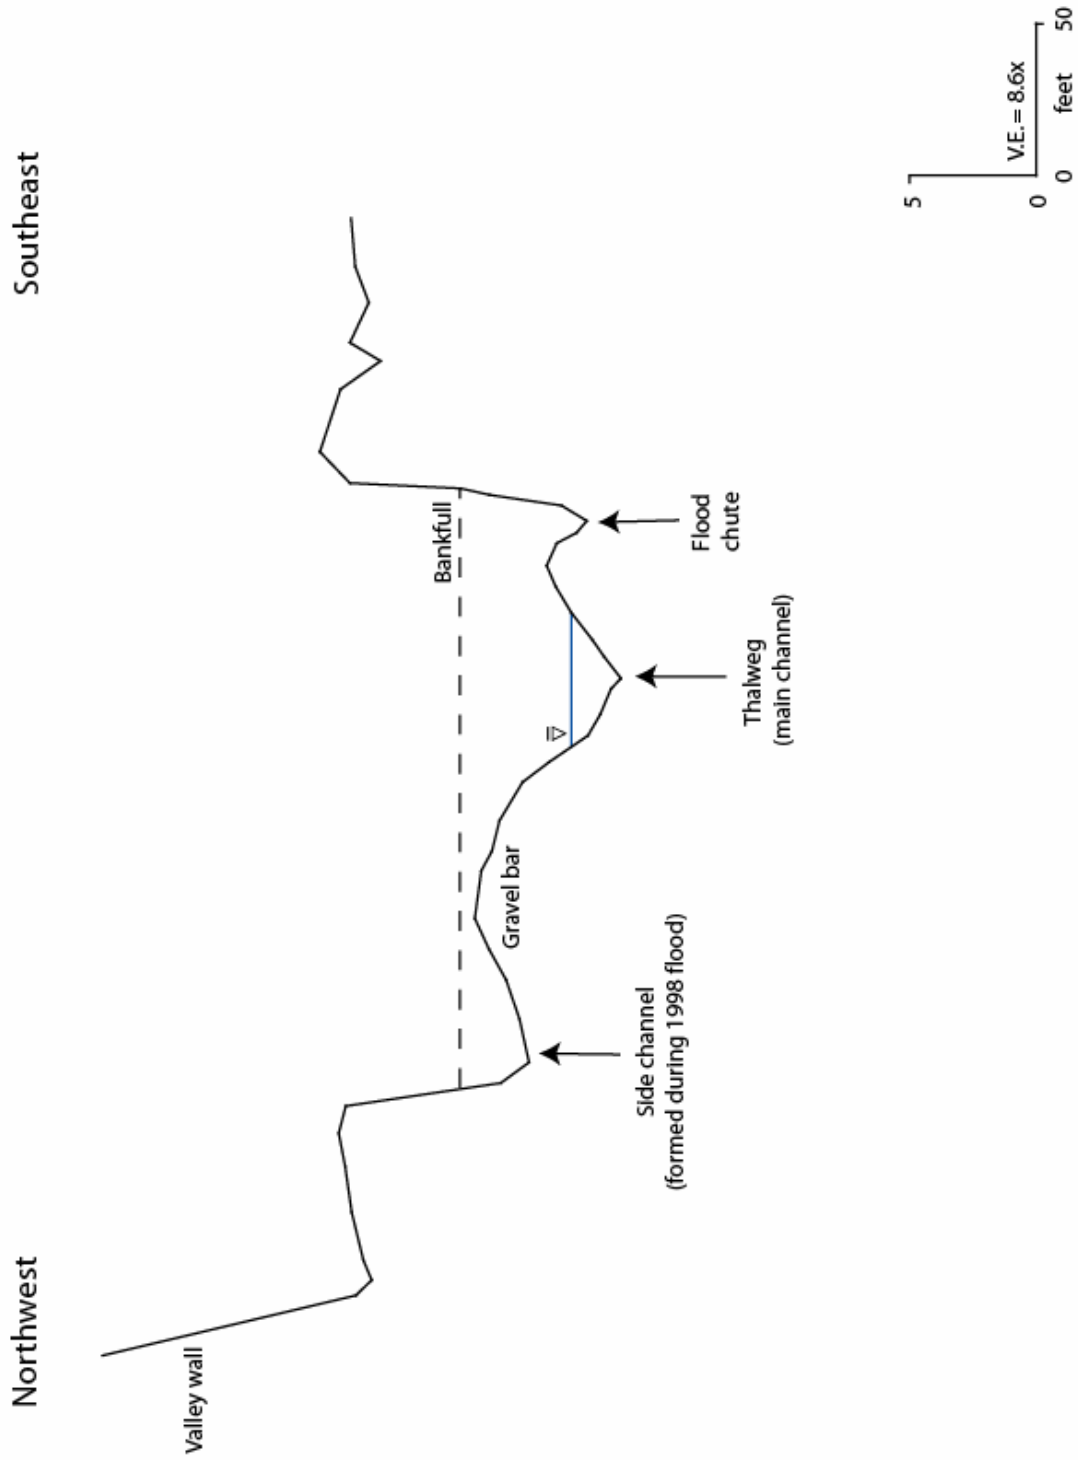
Figure 30. Cross Section 3 as shown on Figure 28 with side channel formed during 1998 flood.

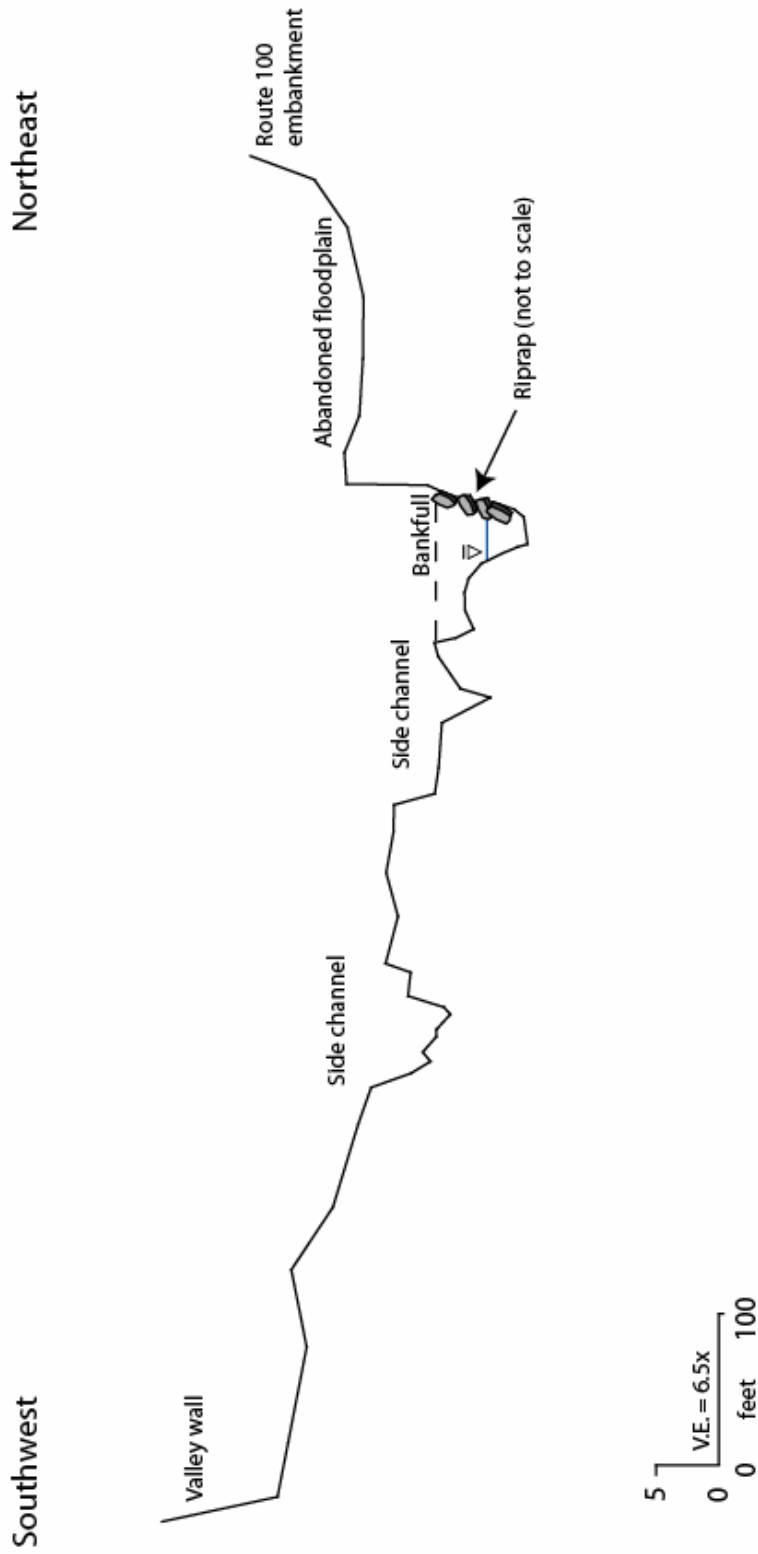
Figure 33. Cross Section 2 as shown on Figure 28 with multiple side channels at varying heights and occupied at different flow stages. The higher side channel further to the southwest is the one discussed under Option 3 in text.

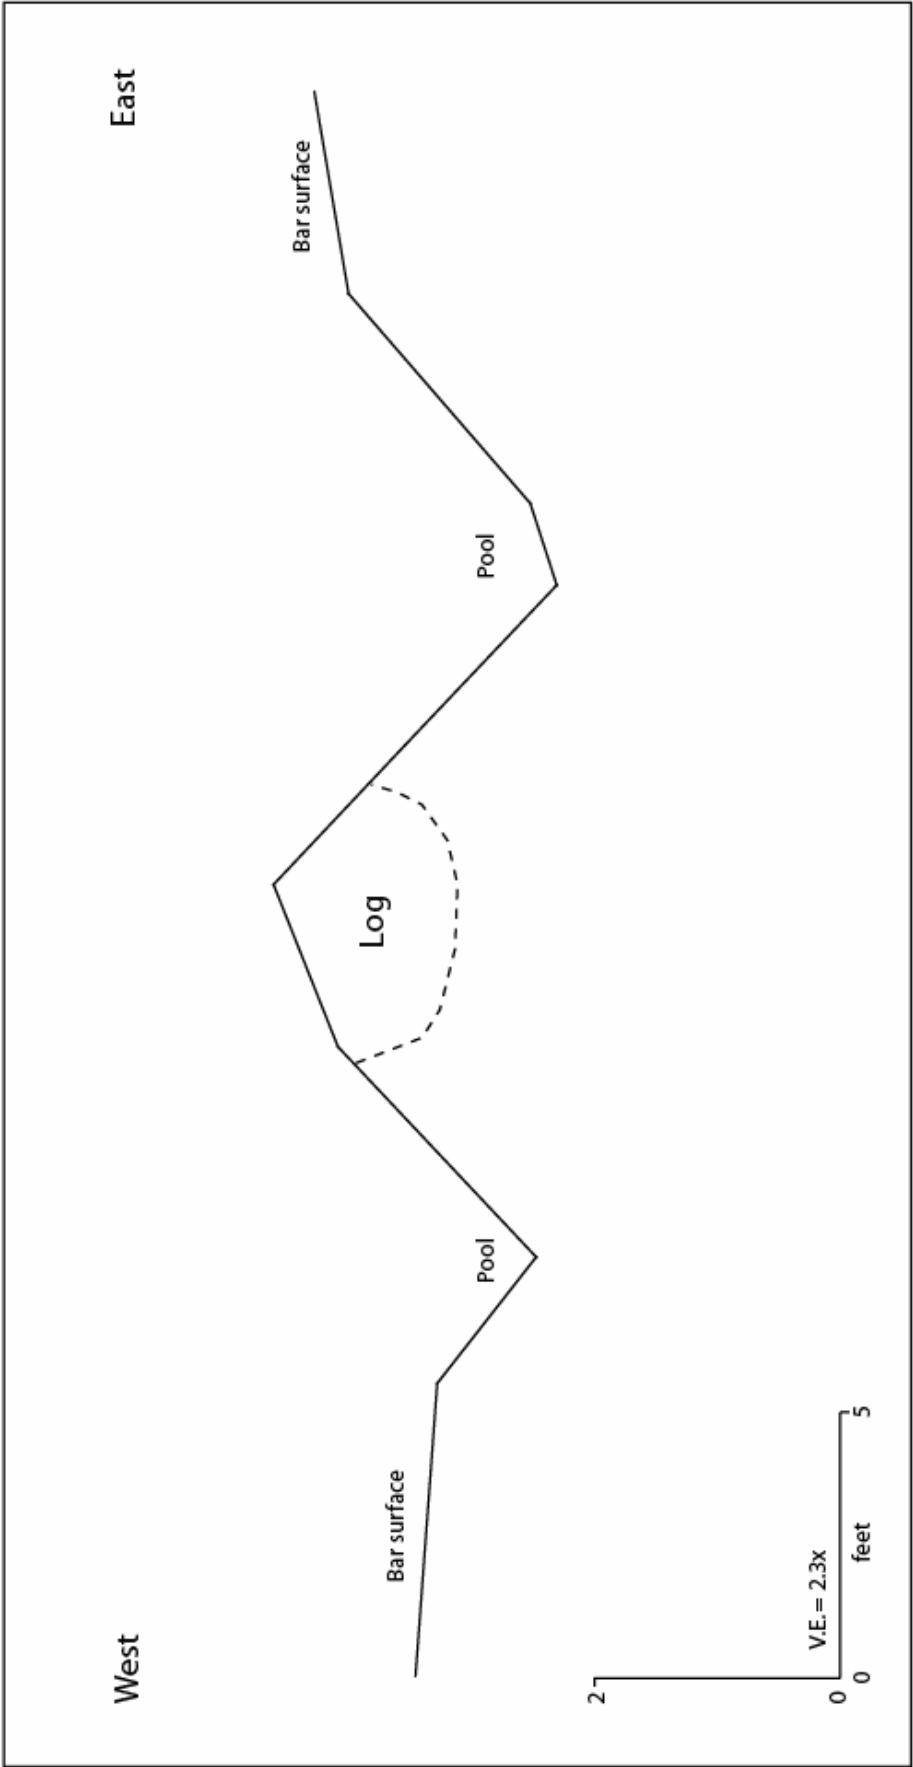
Figure 38. Cross section just downstream of root wad of log visible in Figure 24 showing pool formation resulting from scour around root wad.
