Waterbury, Vermont Middle Winooski River Corridor Plan

December 15, 2015

Middle Winooski River Corridor Plan

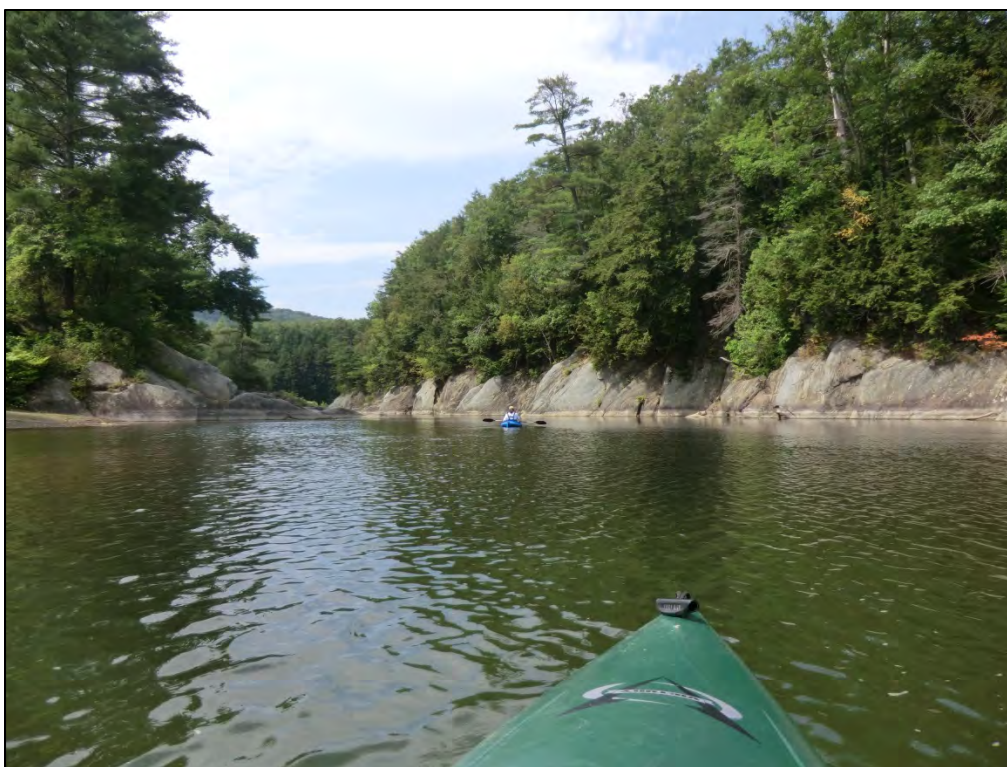
The upstream-most reach on the Winooski River included in this assessment is R14. It is just over 3 miles long and extends from just above Waterbury Village to just below the confluence of the Mad River in Middlesex/Moretown. The river has a steeper slope in this reach than in the surrounding reaches, and bedrock is prevalent along the banks. The river valley is naturally narrow, but has been further narrowed due to the placement of Route 2, the New England Central Railroad, and I-89. In R14, the river has incised slightly, but bedrock outcrops may be preventing further downcutting. The channel has not widened in comparison to the reaches below it. Small areas of bank erosion are present, as well as small areas of riprap. Several large flood chutes and three islands are present in R14 in areas where bedrock is not present. Buffers are comprised of nice floodplain forests where the river flows away from development. Geomorphic condition is **fair** in R14 due to incision and planform change. Habitat condition is also **fair** as a result of lacking woody debris and areas of poor bank vegetation.

Figure 5.11. Bedrock is abundant on the bed and banks of the Winooski River in R14.

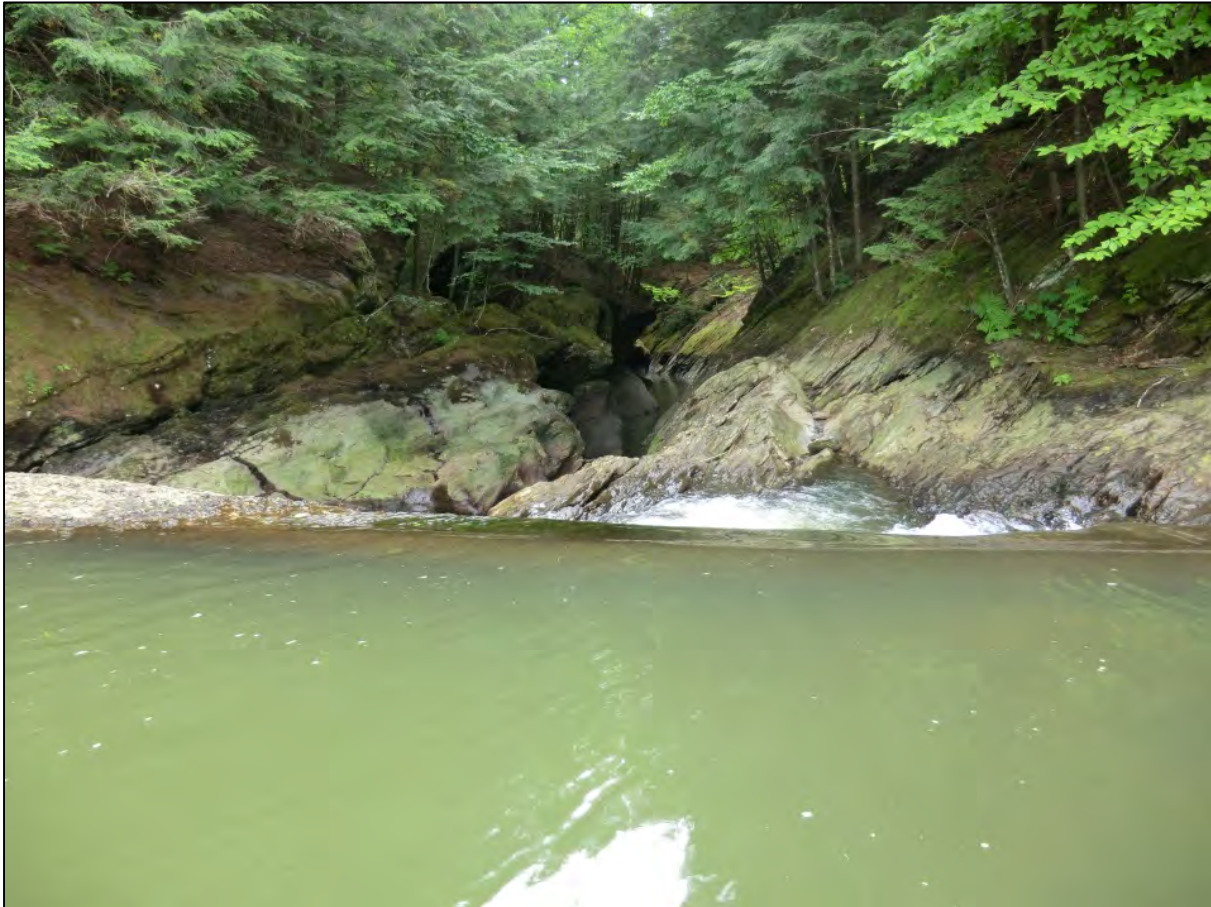
This segment is a 2,000 foot bedrock gorge. At the top of the gorge there is an old concrete run-of-river dam. Due to the nature of the channel, M2.03-B was not fully assessed and was placed in **good** geomorphic condition based on administrative judgement.

Figure 5.15. Looking downstream into bedrock gorge and old dam in M2.03-B.

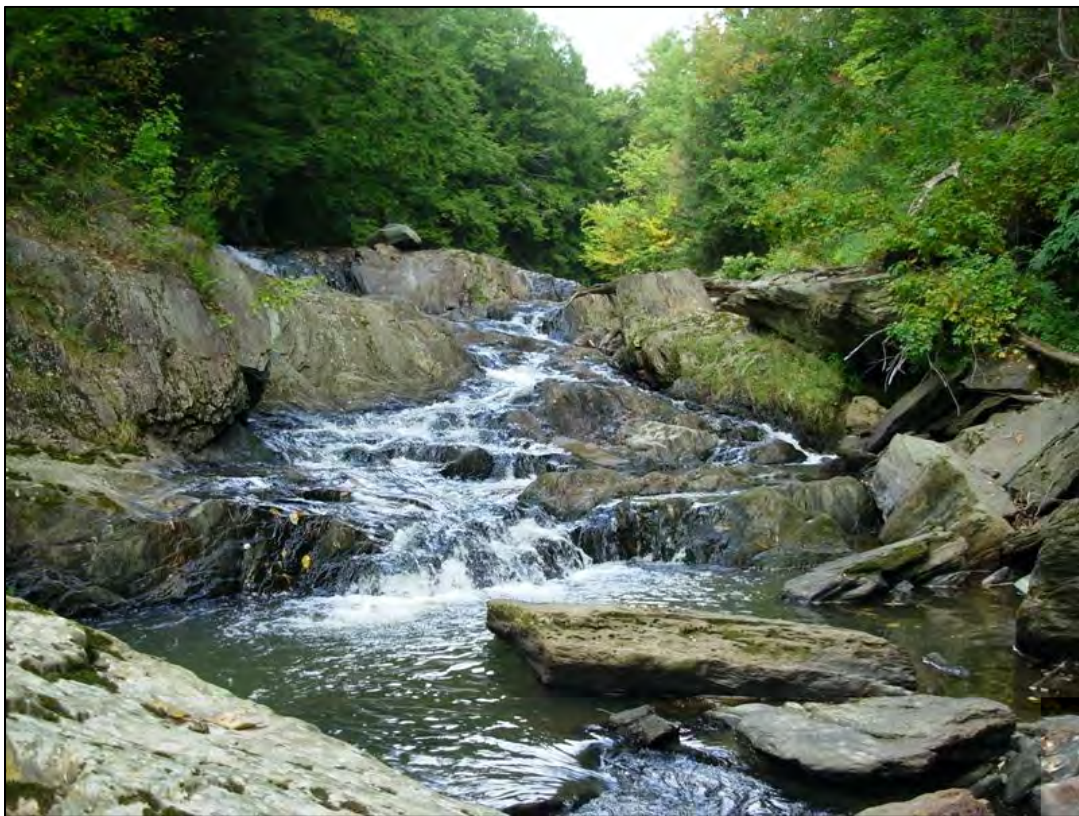
The downstream-most segment on reach two of Graves Brook is a bedrock gorge, beginning just above the I-89 bridges and continuing upstream nearly 1,000 feet to just below the Stowe Street crossing where bedrock becomes less dominant in the channel. This segment was not fully assessed during 2010 because it is bedrock controlled and very stable. Graves Brook flows through a confined valley and has minimal human impacts. Bank erosion and one mass failure are present in short sections where bedrock does not dominate the stream banks.

Figure 5.20. R13.S1.02-A is a bedrock gorge and is very stable.

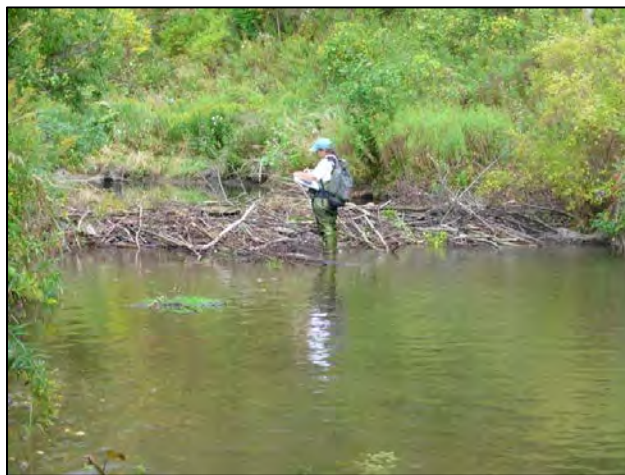
The first segment on reach one of Thatcher Brook is just over 1,900 feet in length, beginning at the mouth and continuing upstream to the base of the bedrock gorge. Beaver activity is prevalent in this segment, and beaver dams are causing frequent channel adjustment. Over two-thirds of this segment appears to have been historically straightened, which has led to slight historic incision. The stream channel is in the process of widening, aggrading, and adjusting planform. Bank erosion is common along both banks as the stream widens and moves laterally. R13.S1.02-S1.01-A is in **fair** geomorphic condition due to these active adjustments. It is also in **fair** habitat condition due to lacking pool habitat and unstable banks.

Figure 5.25. Beaver activity is common in R13.S1.02-S1.01-A.

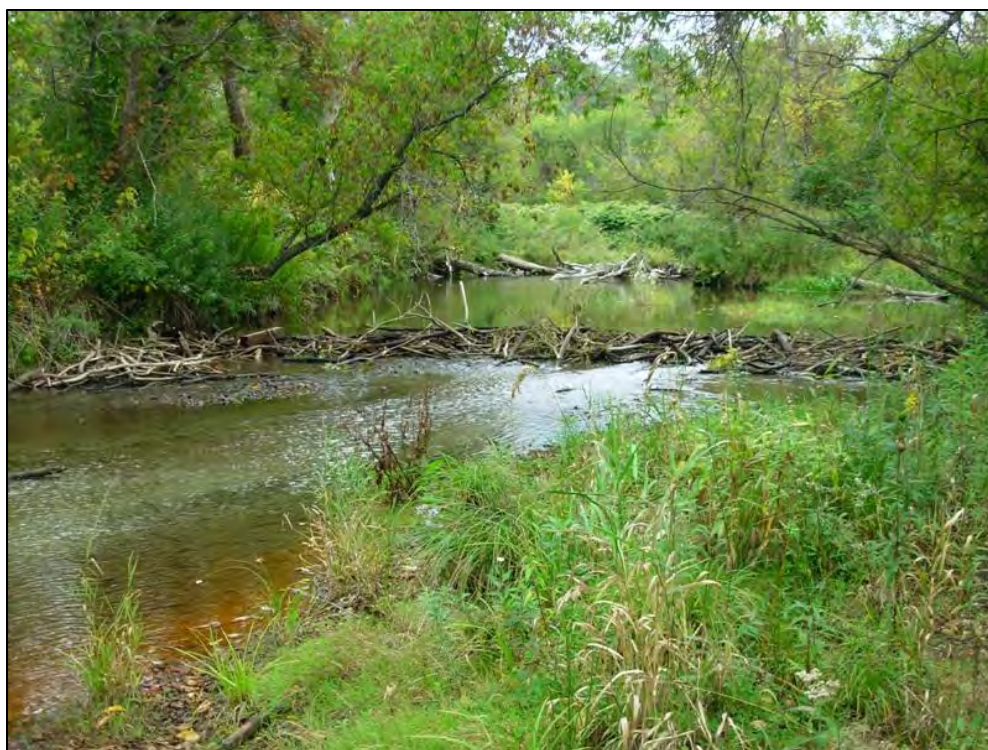
Segment C on reach one of Thatcher Brook is nearly 2,000 feet in length and flows along Route 100 in Waterbury Center. Similarly to downstream, R13.S1.02-S1.01-C is affected by beaver activity. Just over half of this segment appears to have been historically straightened along Route 100. Despite this, Thatcher Brook does not appear to have incised in this section. The dams and bedrock outcrops downstream afford vertical stability to this segment, and are likely deterring downcutting. Aggradation is major in segment C and is causing some planform adjustment. Beaver dams, which are scattered throughout the segment, are exacerbating lateral movement. Bank erosion is common along both banks and may be associated with these adjustments. Riprap is present where the brook flows directly along Route 100, toward the downstream end of the segment. R13.S1.02-S1.01-C is in **fair** geomorphic condition as a result of the major active adjustment occurring here. It is also in **fair** habitat condition due to a lack of diverse bed features and impacted bank and buffer vegetation.

Figure 5.27. R13.S1.02-S1.01-C is a meandering wetland channel with current beaver activity.

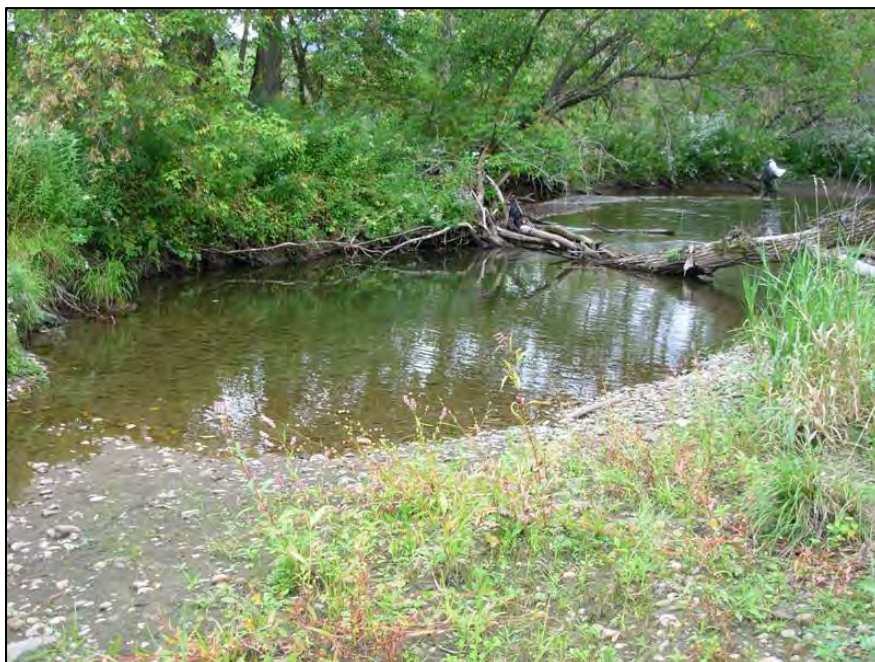
The second reach on Thatcher Brook flows away from Route 100 through wetlands, residential, and agricultural land. It was not divided into any segments during the 2010 assessment. The segment is just over 4,600 feet in length, beginning near the intersection of Guptil Road and Route 100 and ending upstream between the Guptil Road and Kneeland Flats Road bridges. R13.S1.02-S1.02 is characterized by a meandering wetland channel with a mostly natural planform. Historic straightening appears to have occurred in the vicinity of the two bridges within this reach. The brook has undergone slight historic incision and has begun to widen in this area. Floodplain access throughout R13.S1.02-S1.02 is excellent, and it retains a natural riffle-pool bedform. Bank erosion is scattered along both banks, as is bank armoring. The sinuous planform of Thatcher Brook within this reach has led to major planform adjustment including several flood chutes and channel avulsions. Debris jams appear to be exacerbating lateral adjustment in this area. R13.S1.02-S1.02 is in **fair** geomorphic condition as a result of all the aforementioned adjustments. The reach is in **good** habitat condition due to its natural planform and excellent diversity of streambed features.

Figure 5.29. Woody debris is abundant in R13.S1.02-S1.02.

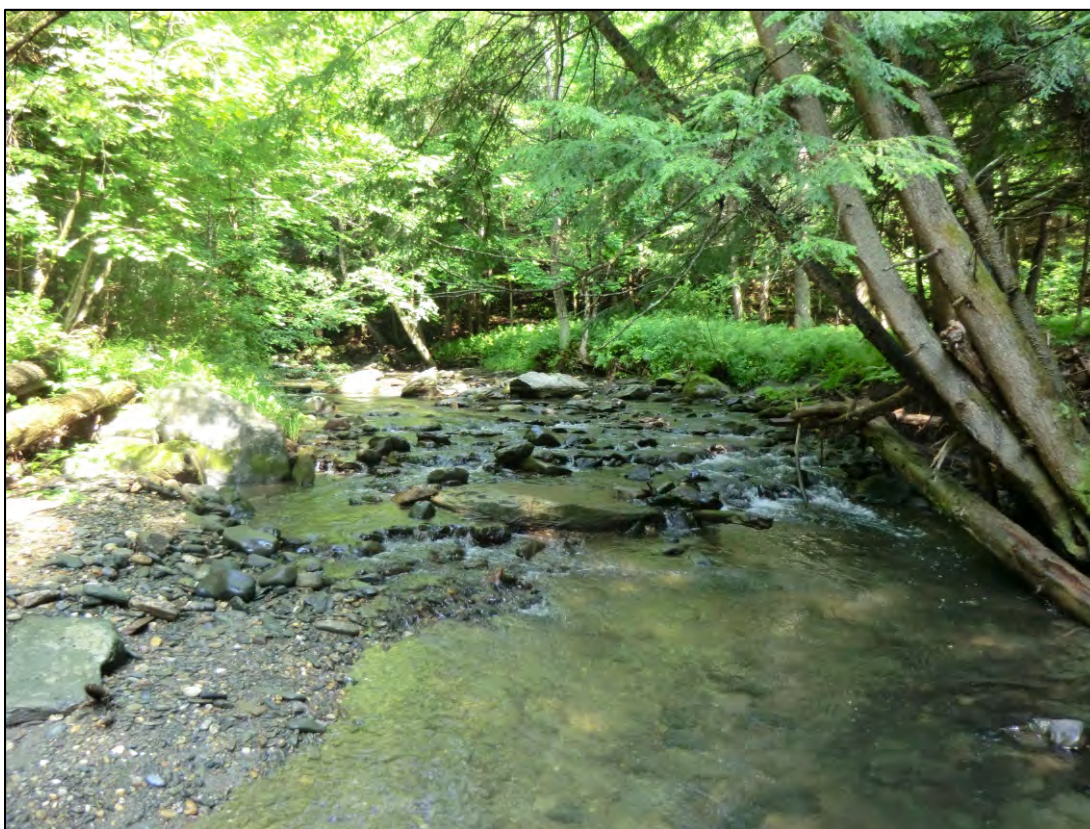
R13.S1.02-S1.06-B

This segment begins approximately 1,100 feet northeast of the intersection of Guild Hill Road and Maple Street and continues upstream for about 1,500 feet. Overall, planform is mostly natural and undisturbed in R13.S1.02-S1.06-B, and the brook has been very minimally straightened. Thatcher Brook has incised moderately in this section but retains access to its floodplain. It is currently in the process of widening, and bank erosion is common along both banks. Major planform adjustment is occurring in this segment, which has led to the formation of two islands. Short sections of braiding occur where the brook is aggrading. Due to the channel incision and planform adjustment, the segment is in **fair** geomorphic condition. Well forested riparian buffers, vegetated banks, abundant large woody debris, and a well-defined bedform have resulted in a **good** habitat condition in R13.S1.02-S1.06-B.

Figure 5.37. Typical channel in R13.S1.02-S1.06-B.

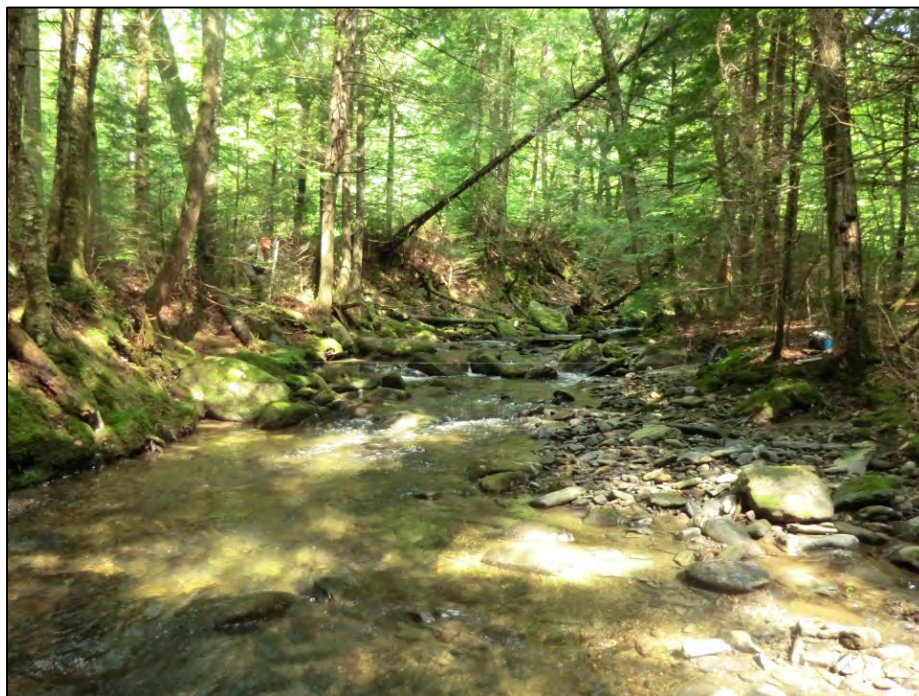
R13.S1.02-S1.08-A

This segment is 2,960 feet in length, beginning just above the confluence with tributary R13.S1.02-S1.07-S1. The brook flows through a densely forested area for the whole segment, with no development. Overall, the channel has incised and not yet widened but there are locations with good floodplain access. Some areas have more planform adjustment than others via flood chutes, neck cut offs, and bifurcation around islands. Mass failures and small areas of bank erosion are present as well, but overall the banks are stable and mossy. The geomorphic condition of this segment is **fair** due mostly to the channel degradation and localized planform adjustment. However, the segment is in **good** habitat condition due to well forested banks and buffers, abundant woody debris in the channel, excellent substrate cover, and a well-defined step-pool habitat.

Figure 5.39. Well forested banks and buffers in R13.S1.02-S1.08-A.

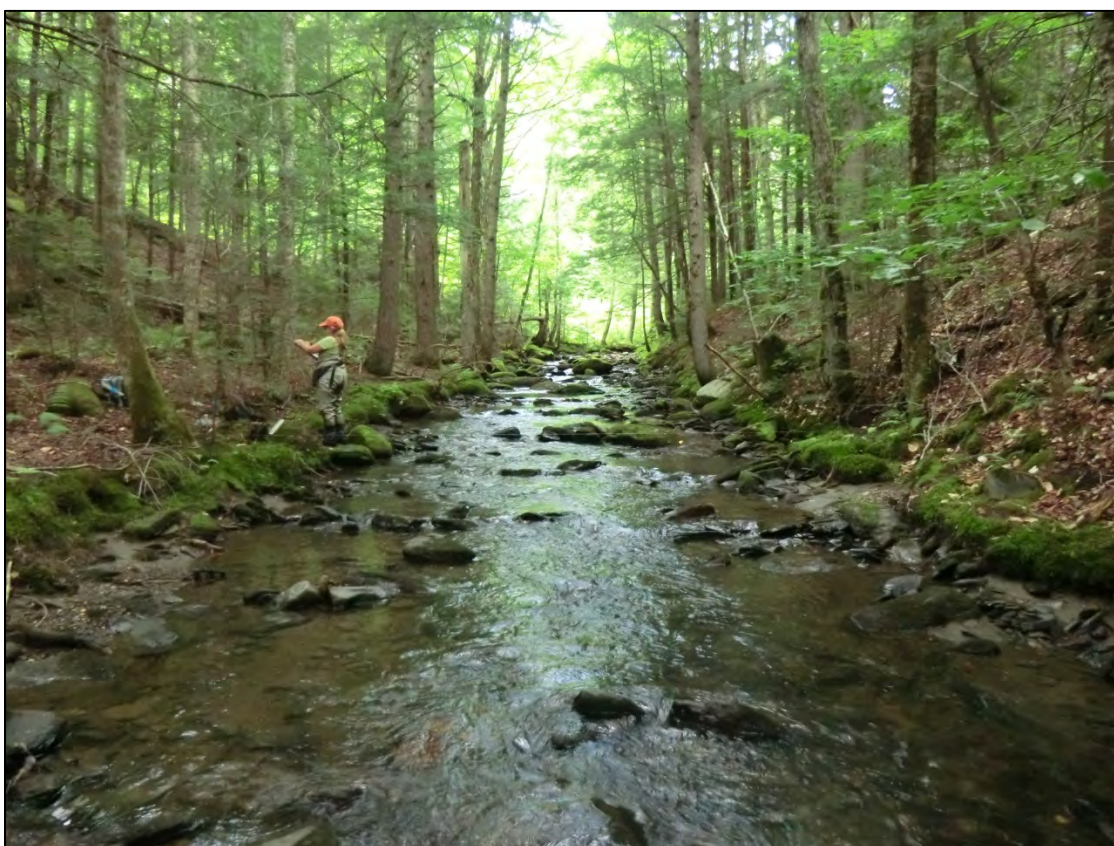
R13.S1.02-S1.08-B

Conditions in this segment are very similar to downstream: well forested riparian habitat with no development along the valley wall. The segment comprises the top 1,250 feet of the reach and begins where the valley width becomes narrower. Valley confinement is variable with some areas semi-confined and some very broad. If not for the extreme incision in this segment, it would be in great condition. Although the degree of incision was extreme in the vicinity of the cross section location, there are areas where incision was not as severe and there was better floodplain access. The channel has not yet widened and there is minor bank erosion resulting in very stable and mossy banks except for two locations where there are mass failures. The segment is in **fair** geomorphic condition due to channel incision but in **good** habitat condition as a result of stable banks and undisturbed riparian habitat.

Figure 5.40. Mossy and stable stream banks in R13.S1.02-S1.08-B.

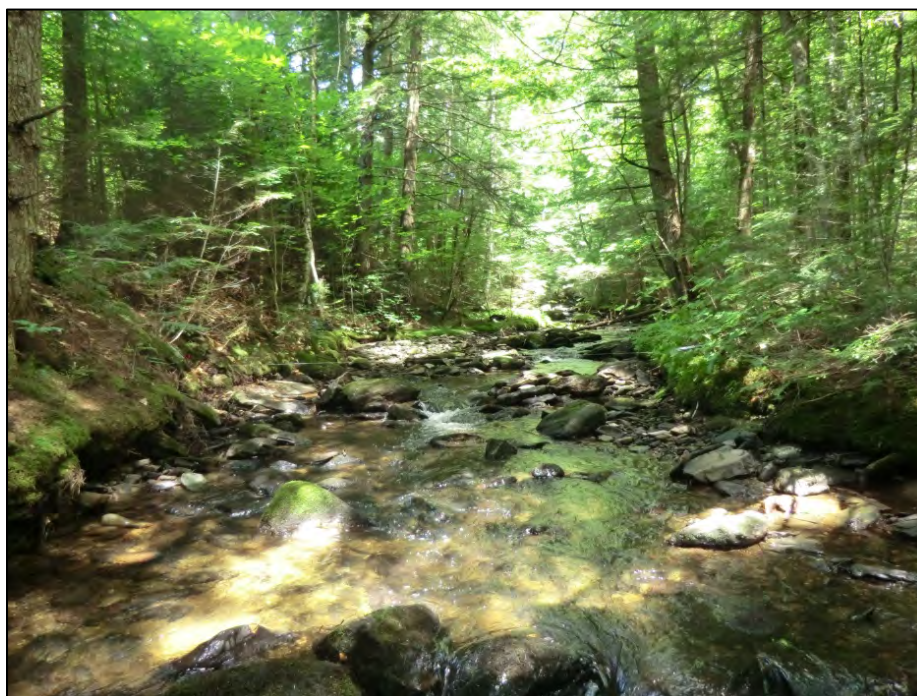
The most downstream segment in reach 9 of Thatcher Brook has characteristics similar to the reach 8. Segment A is 1,340 feet long and flows through densely forested land. The valley is very broad on average but it is narrower toward the upstream end of the segment. Where the valley opens up significantly is where the next segment begins. The downstream section has experienced some planform adjustment around two islands. This segment has incised but retains its reference stream type and access to its floodplain. The channel has not widened and bank erosion is minimal. Overall, Thatcher Brook is in **good** geomorphic condition in this segment despite moderate channel incision. It also is in **good** habitat condition due to undisturbed riparian habitat and stable, well-vegetated banks.

Figure 5.41. R13.S1.02-S1.09-A has well forested banks and buffers.

R13.S1.02-S1.09-A Data Summary		Reference	Existing
Length: 1,339 ft Drainage Area: 2.8 sq. mi. Evolution Stage: F-II Sensitivity: Moderate	Confinement	Very Broad	Very Broad
	Stream Type	B	B
	Entrenchment Ratio	1.4 - 2.2	2.1
	Incision Ratio	< 1.2	1.7
	Dominant Bed Material	Cobble	Cobble
	Dominant Bedform	Step-Pool	Step-Pool
Major Stressors:	None

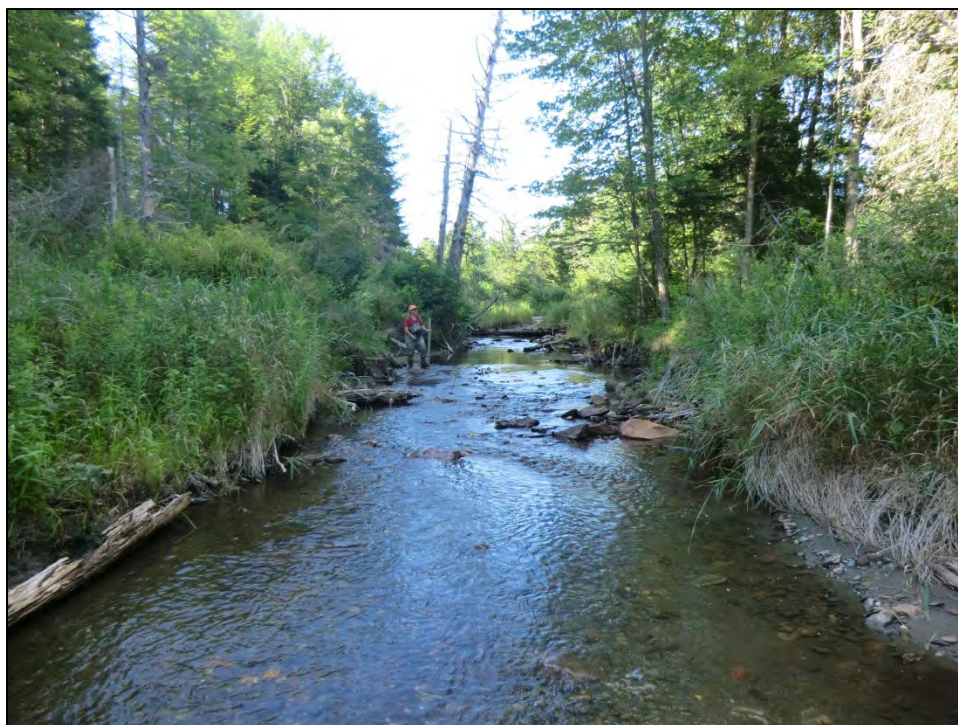
The next segment is characterized by a wetland channel through a very broad valley. The segment begins where the valley opens way up and there is a hay field in the western riparian corridor. The channel continues for approximately 1,100 feet and ends just upstream of a road crossing at a beaver dam, which has created a wetland. Flow out of the wetland is split and results in three culverts at the road crossing. The split flow is reconnected downstream of the crossing. This segment is also incised but only slightly and widening is minor. Aggradation is a major process in this segment and is perhaps a natural condition as the segment is a transition zone between the wetland upstream and the steeper forested section downstream. Many flood chutes indicate major planform change, but this is natural for this type of system. Segment R13.S1.02-S1.09-B is in **fair** geomorphic condition due to the channel incision, aggradation and planform adjustment. However, the habitat condition is **good** as a result of well vegetated banks and buffers, good hydrologic characteristics through wetland drainage and abundant large woody debris.

Figure 5.42. Thatcher Brook in R13.S1.02-S1.09-B is a wetland channel.

R13.S1.02-S1.09-B Data Summary		Reference	Existing
Length: 1,161 ft Drainage Area: 2.8 sq. mi. Evolution Stage: F-IV Sensitivity: Very High	Confinement	Very Broad	Very Broad
	Stream Type	C	C
	Entrenchment Ratio	> 2.2	4.2
	Incision Ratio	< 1.2	1.4
	Dominant Bed Material	Gravel	Gravel
	Dominant Bedform	Riffle-Pool	Riffle-Pool
Major Stressors:		Undersized culverts

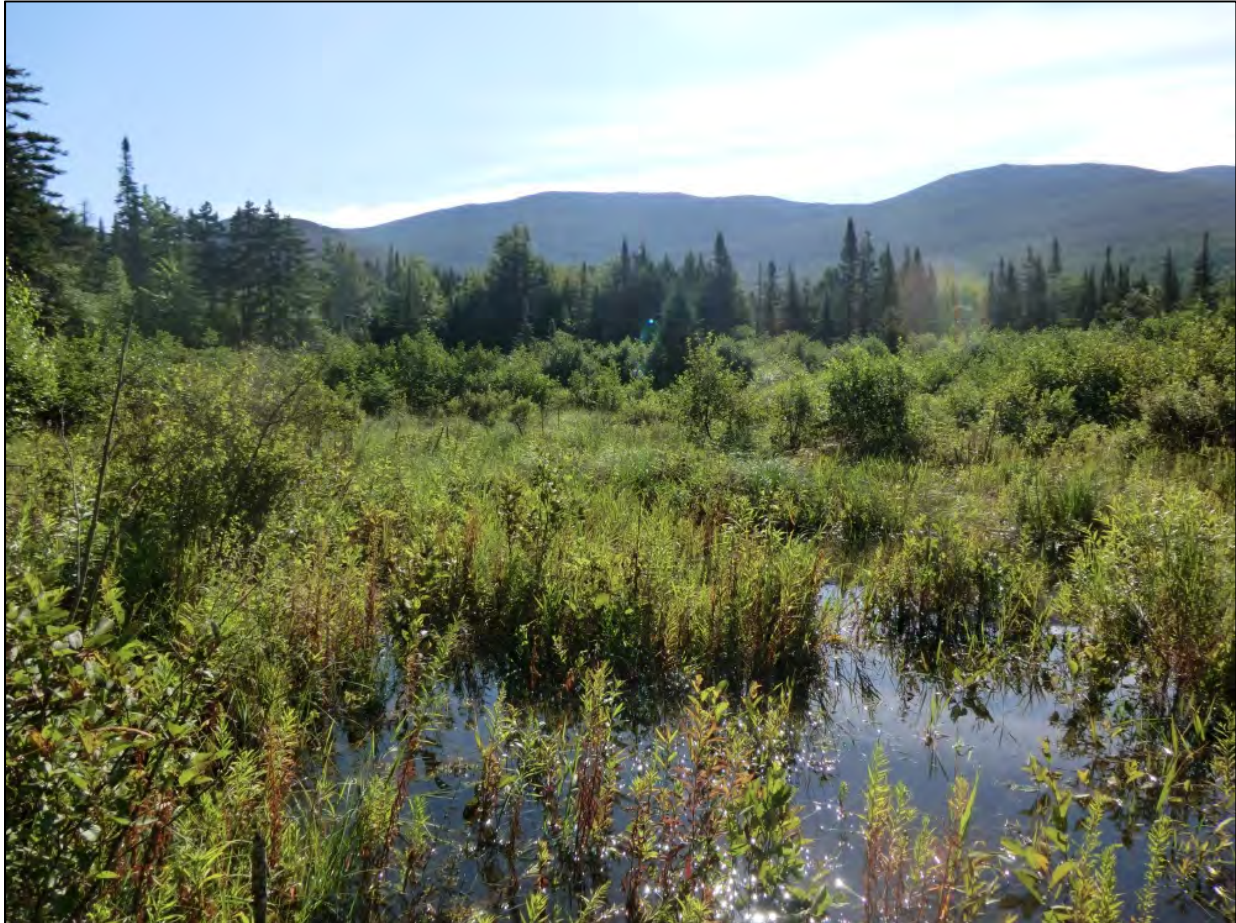
This segment is approximately 300 feet long and was not assessed because it is an impounded wetland. A beaver dam at its downstream end just above a driveway crossing is causing the impoundment.

Figure 5.43. Segment R13.S1.02-S1.09-C is a wetland.

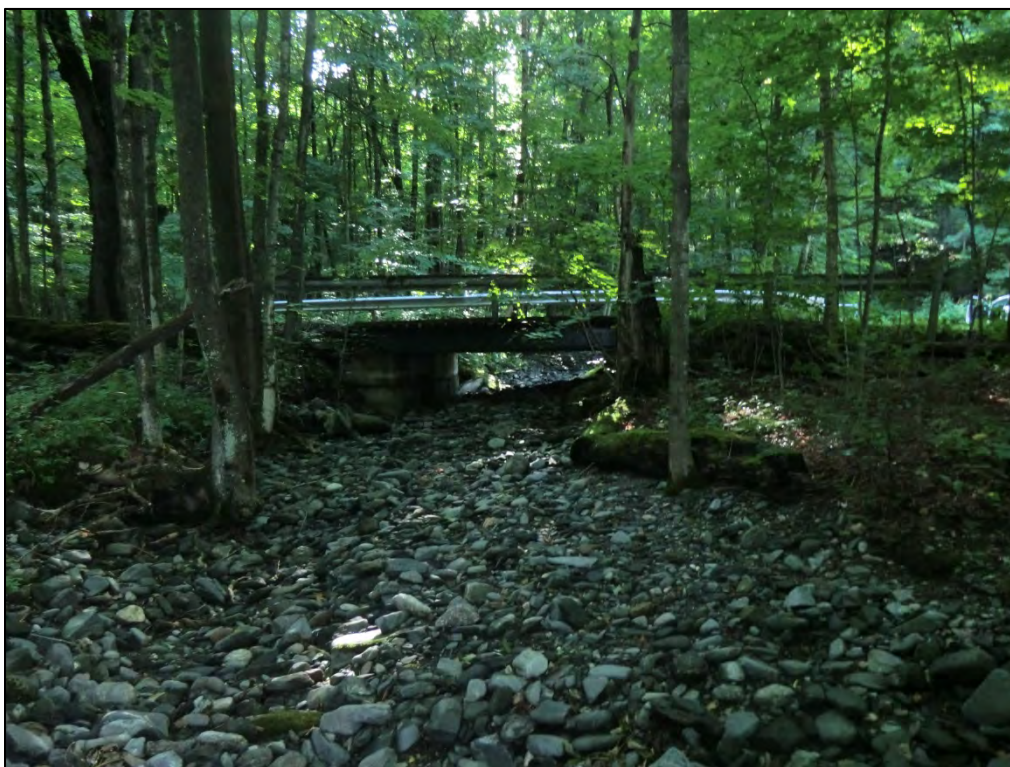
The upstream-most segment on Thatcher Brook is approximately 1,700 feet long and begins at the top of the wetland and continues until just above the Waterworks Road crossing. The riparian conditions are well vegetated and there is little erosion, but the main impact of this segment is flow regulation from the upstream water withdrawal by the Town of Waterbury. At the first visit to this segment, the streambed was completely dry at the upstream end. When BCE returned to the stream to assess the segment, there was flow in the channel. The stream has undergone minor channel incision and retains its reference stream type and access to its floodplain except for one location where the channel material has been windrowed creating a berm. R13.S1.02-S1.09-D is in **fair** geomorphic condition as a result of historic incision, major aggradation and planform adjustment. Despite the impacted flow regime in the upstream end of the segment, overall it is in **good** habitat condition due to stable well vegetated banks and buffers and abundant large woody debris.

Figure 5.44. Dry streambed in R13.S1.02-S1.09-D.

R13.S1.02-S1.09-D Data Summary		Reference	Existing
Length: 1,736 ft Drainage Area: 2.8 sq. mi. Evolution Stage: F-IV Sensitivity: Very High	Confinement	Very Broad	Very Broad
	Stream Type	C	C
	Entrenchment Ratio	> 2.2	5.8
	Incision Ratio	< 1.2	1.3
	Dominant Bed Material	Gravel	Gravel
	Dominant Bedform	Riffle-Pool	Riffle-Pool
Major Stressors:		Windrowing, Flow Regulation

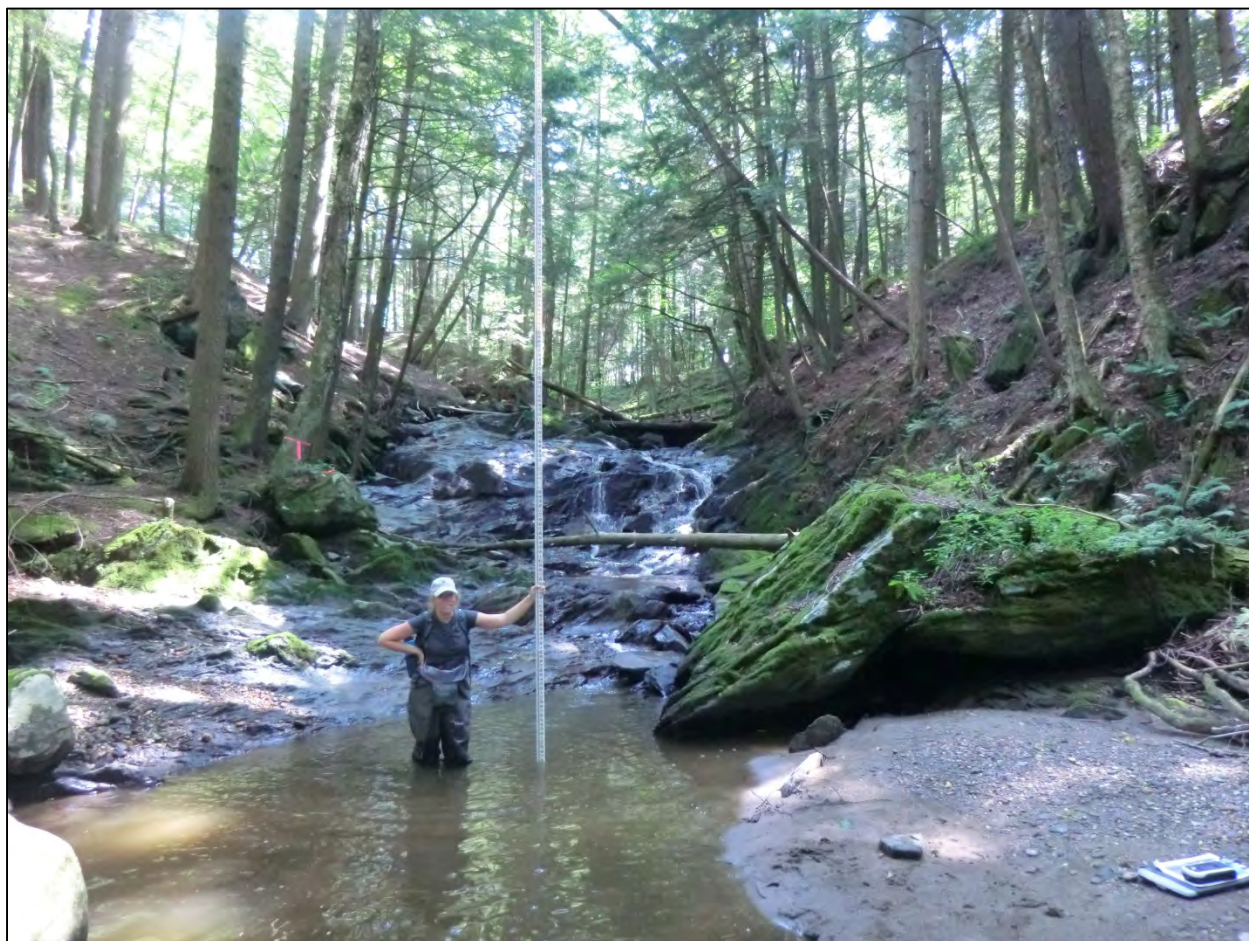
The second segment on reach one of Unnamed Tributary 1 is nearly 500 feet in length. It was not fully assessed because it is a bedrock gorge. There are three large bedrock grade controls present in this segment and abundant bedrock lining the valley walls. The stream channel is stable, but bank erosion is occurring where bedrock is not present on the banks. Based on qualitative field observations, the segment was estimated to be in **good** geomorphic condition.

Figure 5.46. R13.S1.02-S1.02-S1.01-B is a bedrock gorge and was not fully assessed.

R13.S1.02-S1.02-S1.01-B Data Summary		*NOT ASSESSED	Reference	Existing
Length: 487 ft Drainage Area: 2.8 sq. mi. Evolution Stage: N/A Sensitivity: N/A		Confinement	Broad	Broad
		Stream Type	A	A
		Entrenchment Ratio	< 1.4	N/A
		Incision Ratio	< 1.2	N/A
		Dominant Bed Material	Bedrock	Bedrock
		Dominant Bedform	Cascade	Cascade
Major Stressors:		Erosion, Mass Failures

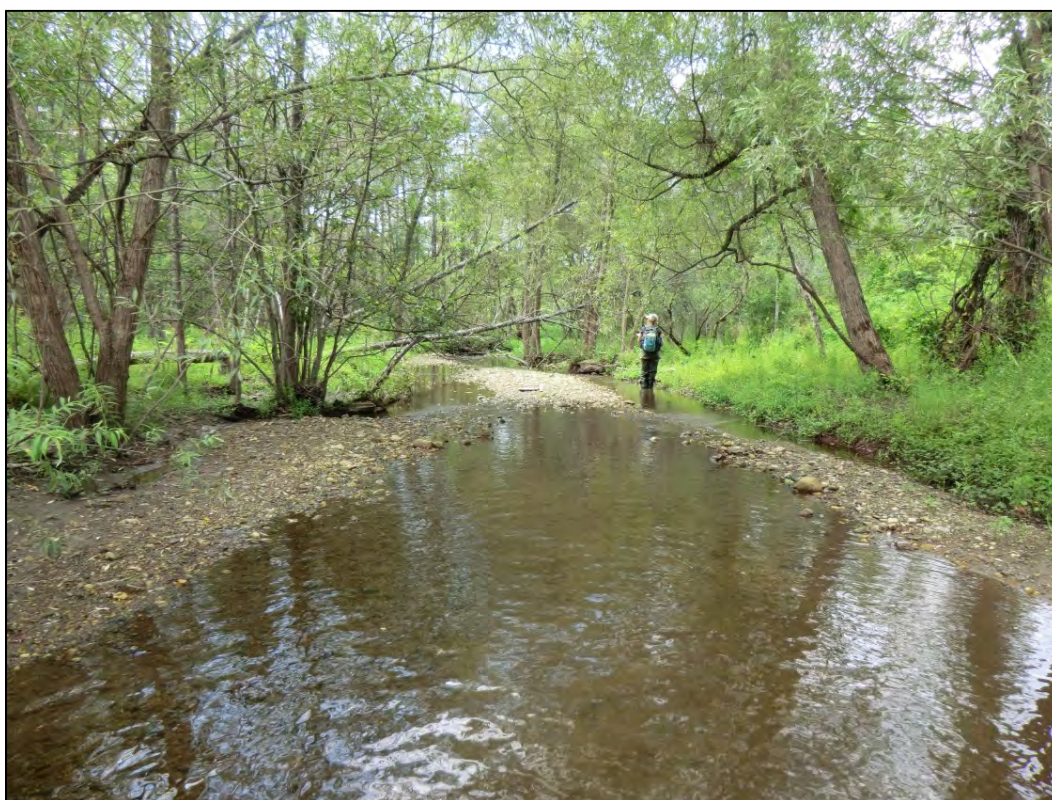
The next most upstream segment on Unnamed Tributary 1 to Thatcher Brook is about 2,700 feet in length, extending from the upper end of the bedrock gorge upstream to slightly above the Twin Peaks Road stream crossing. This section of the stream has incised historically and is actively adjusting planform via flood chutes, but has not widened much. Areas within this segment have majorly aggraded and bank erosion is scattered throughout. One short section was recently windrowed and bermed to protect a landowner's lawn. Segment C mostly flows undisturbed through the woods, though the upstream end is more residential. Geomorphic condition is **fair** because of historic incision and active planform adjustment. R13.S1.02-S1.02-S1.01-C is in **good** habitat condition, as it has ample woody debris to provide in-channel cover and well forested banks and buffers.

Figure 5.47. Segment C flows through the woods in Waterbury Center and is largely undisturbed.

R13.S1.02-S1.02-S1.01-C Data Summary		Reference	Existing
Length: 2,730 ft Drainage Area: 2.8 sq. mi. Evolution Stage: F-IV Sensitivity: High	Confinement	Very Broad	Very Broad
	Stream Type	C	C
	Entrenchment Ratio	> 2.2	3.2
	Incision Ratio	< 1.2	2.0
	Dominant Bed Material	Gravel	Gravel
	Dominant Bedform	Riffle-Pool	Riffle-Pool
Major Stressors:		Erosion, Windrowing

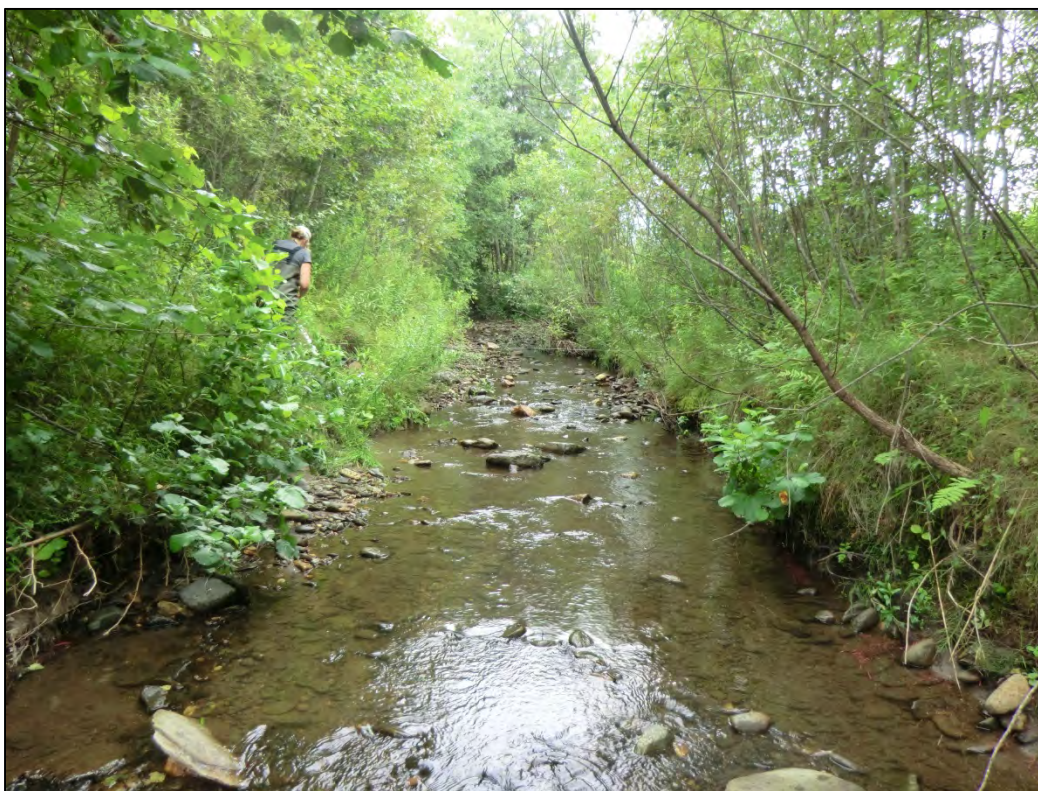
Segment D on reach one begins about 900 feet above the Twin Peaks Road crossing and continues upstream for about 1,300 feet. The stream is surrounded by agricultural lands in this area and is lacking sufficient buffer vegetation for most of the segment. Over two-thirds of this segment was historically straightened, likely to produce contiguous cropland. In response to this straightening, the stream channel has incised substantially, and continues to incise via one active headcut. Clay and glacial till are common on the bed and banks, further suggesting that the channel has downcut. The stream in this area has not yet begun to widen, creating a deep, narrow channel. Scour is prevalent along both banks of the stream within R13.S1.02-S1.02-S1.01-D. This segment is in **fair** geomorphic condition due to historic planform alteration and active downcutting. It is also in **fair** habitat condition because pools, large woody debris, and bank and buffer vegetation are lacking.

Figure 5.48. Segment C flows through the woods in Waterbury Center and is largely undisturbed.

R13.S1.02-S1.02-S1.01-D Data Summary		Reference	Existing
Length: 1,321 ft Drainage Area: 2.8 sq. mi. Evolution Stage: F-II Sensitivity: Extreme	Confinement	Very Broad	Very Broad
	Stream Type	E	E
	Entrenchment Ratio	> 2.2	3.1
	Incision Ratio	< 1.2	2.0
	Dominant Bed Material	Gravel	Gravel
	Dominant Bedform	Riffle-Pool	Riffle-Pool
Major Stressors:		Straightening, Poor Buffers, Headcut, Erosion

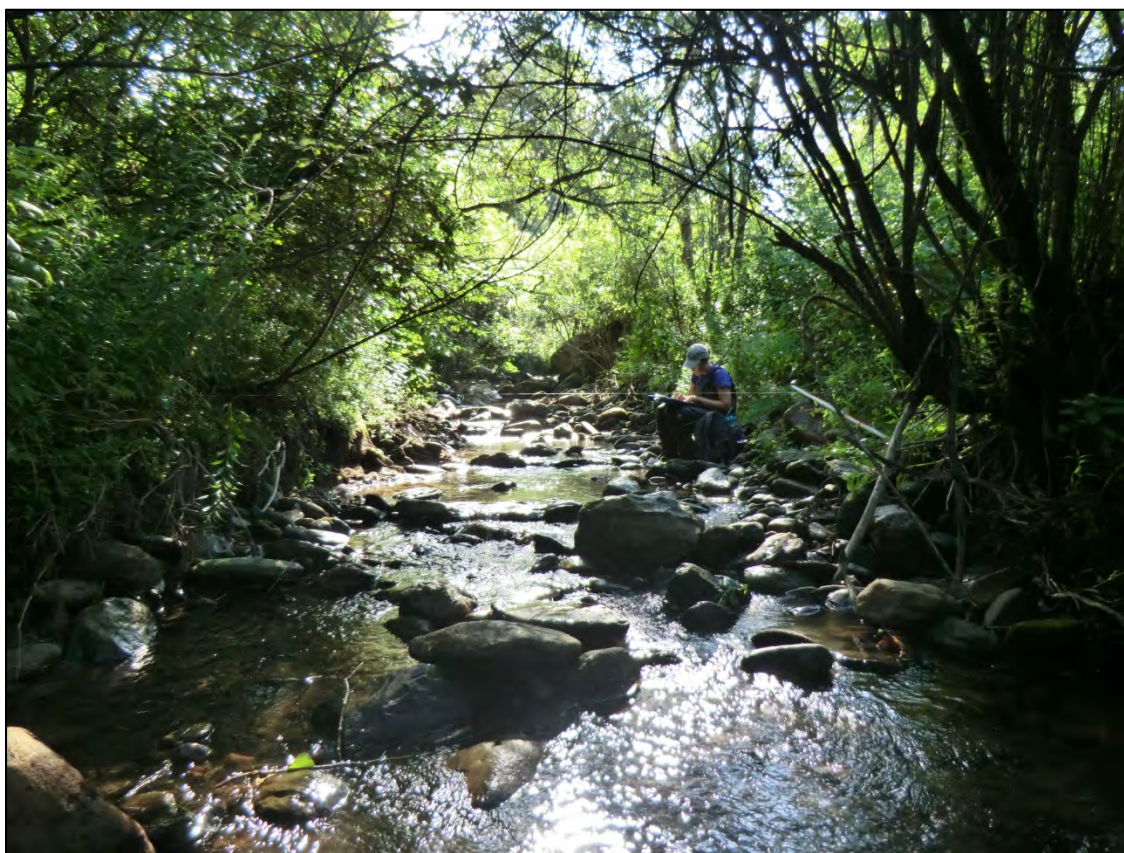
Segment F on R13.S1.02-S1.02-S1.01 is characterized by a narrow channel flowing through shrubby wetlands. The channel has a natural planform in this segment, except for where it was straightened at the downstream-most end where it crosses under Perry Hill Road. The segment is approximately 1,200 feet in length, beginning just below the Perry Hill Road crossing and continuing upstream. The stream channel in R13.S1.02-S1.02-S1.01-F has incised very slightly but has not widened and has great floodplain access. Bank erosion is common along this sinuous stretch of stream. Its undisturbed planform and good floodplain access cause it to be in **good** geomorphic condition. R13.S1.02-S1.02-S1.01-F is in **fair** habitat condition because it is lacking in channel woody debris, there are few pools, and the banks are unstable in areas.

Figure 5.50. Segment F is a naturally narrow channel flowing through a shrubby wetland.

R13.S1.02-S1.02-S1.01-F Data Summary		Reference	Existing
Length: 1,245 ft Drainage Area: 2.8 sq. mi. Evolution Stage: F-II Sensitivity: High	Confinement	Very Broad	Very Broad
	Stream Type	E	E
	Entrenchment Ratio	> 2.2	8.1
	Incision Ratio	< 1.2	1.2
	Dominant Bed Material	Gravel	Gravel
	Dominant Bedform	Riffle-Pool	Riffle-Pool
Major Stressors:	Erosion, Mass Failure

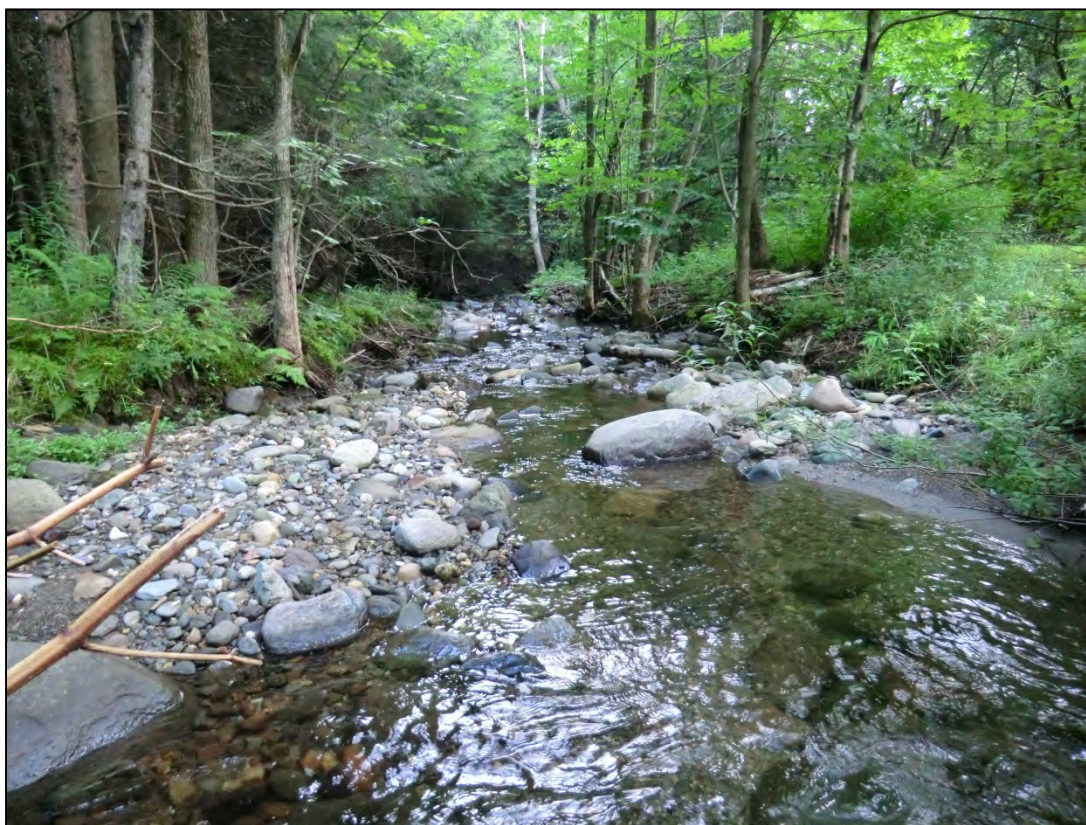
This segment is the uppermost segment included in this study on the first unnamed tributary to Thatcher Brook. It is approximately 1,200 feet in length and flows in the woods behind houses on the south side of Kneeland Flats Road. R13.S1.02-S1.02-S1.01-G is steeper than the downstream segments (other than B) and is undisturbed. Its planform is natural and it has not incised or widened. Floodplain access is excellent. Areas of minor erosion exist on both banks and one short mass failure is present on each side of the stream. Surrounding lands are primarily forested with short sections of agricultural land and residential land closer to Kneeland Flats Road. R13.S1.02-S1.02-S1.01-G is in **good** geomorphic condition due to its stability and undisturbed nature, as well as excellent floodplain access. The segment is also in **good** habitat condition, as large woody debris is abundant in the channel, there is a diversity of bed features, and the banks and buffers are well forested.

Figure 5.51. R13.S1.02-S1.02-S1.01-G flows through forested land and is stable and undisturbed.

R13.S1.02-S1.02-S1.01-G Data Summary		Reference	Existing
Length: 1,226 ft Drainage Area: 2.8 sq. mi. Evolution Stage: F-I Sensitivity: Moderate	Confinement	Very Broad	Very Broad
	Stream Type	C _b	C _b
	Entrenchment Ratio	> 2.2	4.2
	Incision Ratio	< 1.2	1.0
	Dominant Bed Material	Cobble	Cobble
	Dominant Bedform	Riffle-Pool	Riffle-Pool
Major Stressors:	Erosion, Mass Failures

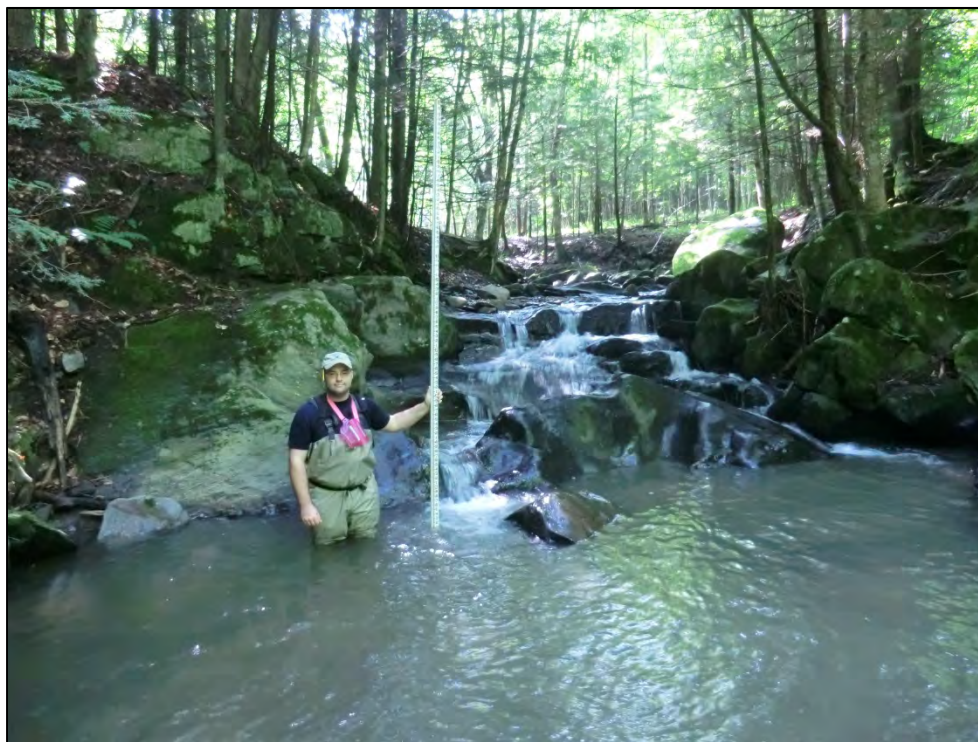
The downstream-most segment on reach two of the second unnamed tributary to Thatcher Brook is characterized by a narrow river valley with abundant bedrock outcrops. There are four bedrock grade controls present in this segment, which have likely prevented channel incision. This segment is very stable and the channel has not undergone widening overall. Bank erosion and mass failures are present in some areas where bedrock is not dominant on the banks and/or valley walls. The stability of this segment and its overall lack of adjustment have caused it to be in **good** geomorphic condition. It is also in **good** habitat condition as a result of good cover on the streambed and well forested banks and buffers.

Figure 5.55. Bedrock outcrops are common in R13.S1.02-S1.03-S1.02-A and afford vertical stability to the channel.

R13.S1.02-S1.03-S1.02-A Data Summary		Reference	Existing
Length: 1,512 ft Drainage Area: 1.8 sq. mi. Evolution Stage: F-I Sensitivity: Moderate	Confinement	Narrow	Narrow
	Stream Type	B	B
	Entrenchment Ratio	1.4 – 2.2	1.5
	Incision Ratio	< 1.2	1.0
	Dominant Bed Material	Cobble	Cobble
	Dominant Bedform	Step-Pool	Step-Pool
Major Stressors:	Erosion, Mass Failure, Gully

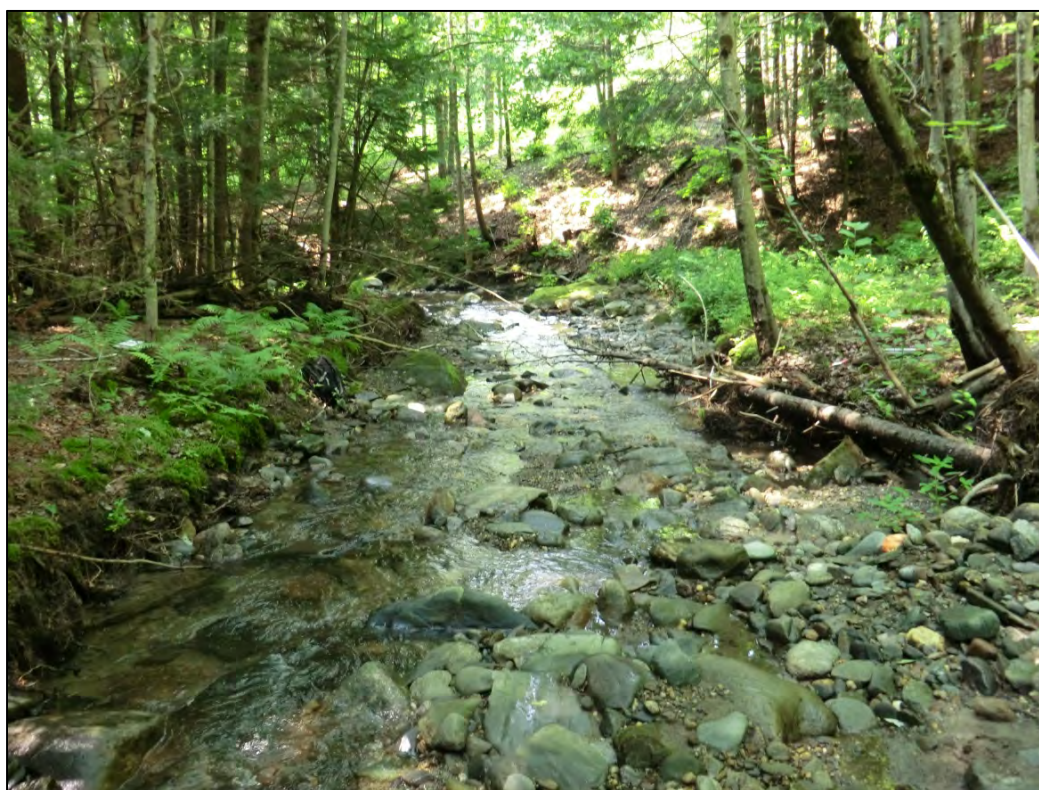
The second segment on reach two of this tributary is 1,800 feet in length, beginning just below the stream crossing on Shaw Mansion Road and ending in the woods between Shaw Mansion Road and Ripley Road where a large tributary enters. This section of stream has incised, but has not widened. Bedrock outcrops are present toward the upstream end of this segment and are holding the grade and deterring further incision. Bank erosion is scattered throughout the segment and one mass failure is present along the southern valley wall. The culvert under Shaw Mansion Road is significantly undersized and is likely contributing to localized geomorphic instability. The stream is adjusting laterally via several flood chutes. For these reasons, R13.S1.02-S.03-S1.01-B is in **fair** geomorphic condition. This segment is in **good** habitat condition because of its well-defined bedform, good floodplain connectivity, and forested banks and buffers.

Figure 5.56. R13.S1.02-S1.03-S1.02-B has well forested banks and buffers.

R13.S1.02-S1.03-S1.02-B Data Summary		Reference	Existing
Length: 1,798 ft Drainage Area: 1.8 sq. mi. Evolution Stage: F-II Sensitivity: High	Confinement	Very Broad	Very Broad
	Stream Type	C _b	C _b
	Entrenchment Ratio	> 2.2	5.0
	Incision Ratio	< 1.2	1.7
	Dominant Bed Material	Gravel	Gravel
	Dominant Bedform	Riffle-Pool	Riffle-Pool
Major Stressors:	Undersized Culvert, Erosion, Mass Failure, Stormwater Inputs
