Waterbury, Vermont Middle Winooski River Corridor Plan

December 15, 2015

Middle Winooski River Corridor Plan

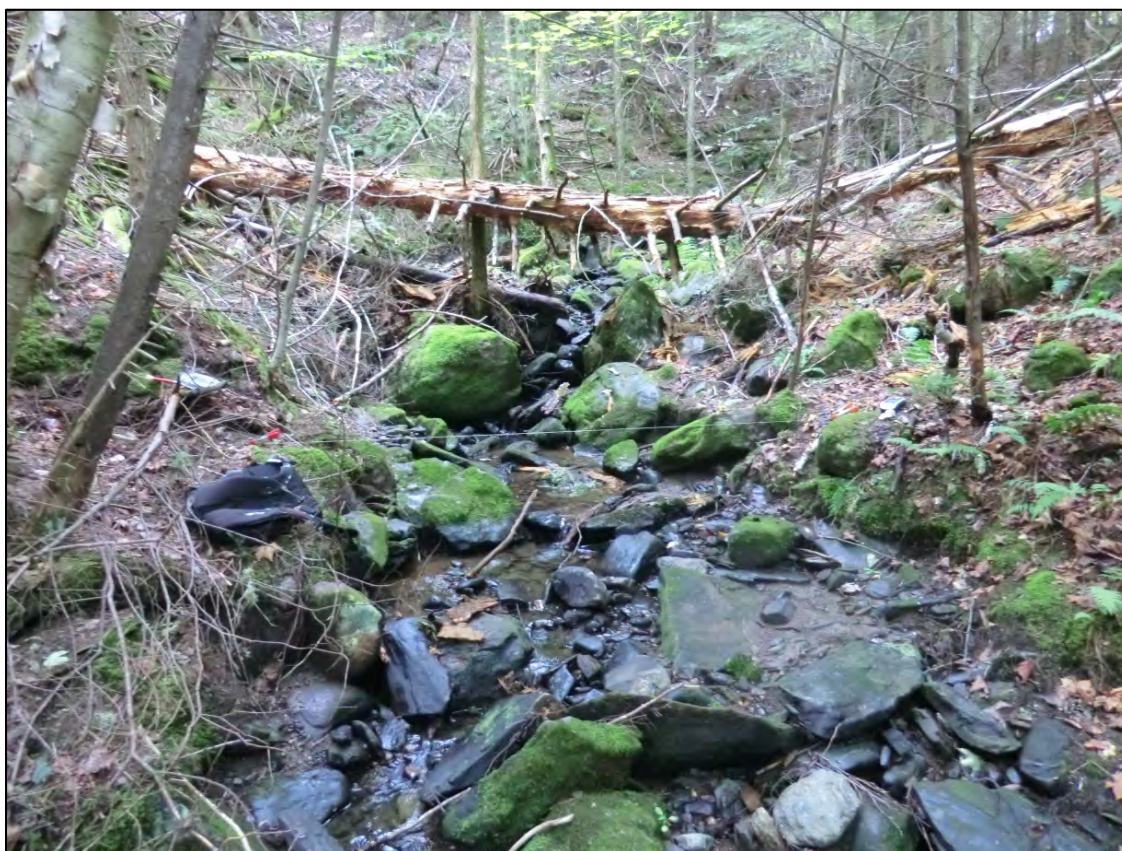
Segment D on reach two is approximately 1,200 feet in length, beginning just above the culvert under Ripley Road and continuing upstream to where the forest canopy opens into a wetland complex. This segment is characterized by having a steep channel slope and a natural planform. R13.S1.02-S1.03-S1.02-D has incised very slightly, but has not widened. Small flood chutes are present in this segment where it is adjusting laterally. The stream's drainage area is very small at the upstream end of this segment, but a tributary enters within this segment and contributes more flow to the channel. This segment is in **good** geomorphic condition because it has not majorly incised, widened, or changed planform. It is also in **good** habitat condition, as there are diverse bed features and well forested banks and buffers.

Figure 5.58. The stream channel in R13.S1.02-S1.03-S1.02-D is small and steep for most of the segment.

R13.S1.02-S1.03-S1.02-D Data Summary		Reference	Existing
Length: 1,244 ft Drainage Area: 1.8 sq. mi. Evolution Stage: F-II Sensitivity: Moderate	Confinement	Broad	Broad
	Stream Type	B	B
	Entrenchment Ratio	1.4 – 2.2	1.8
	Incision Ratio	< 1.2	1.2
	Dominant Bed Material	Cobble	Cobble
	Dominant Bedform	Step-Pool	Step-Pool
Major Stressors:	Erosion, Mass Failures

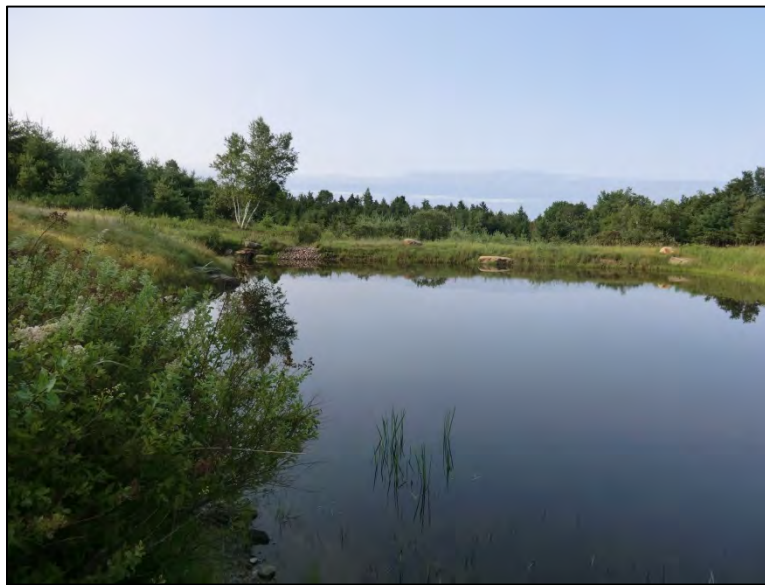
Figure 5.60. R13.S1.02-S1.03-S1.02-E is a man-made pond for part of its length.

R13.S1.02-S1.03-S1.02-E Data Summary	*NOT ASSESSED	Reference	Existing
Length: 1,223 ft Drainage Area: 1.8 sq. mi. Evolution Stage: N/A Sensitivity: N/A	Confinement	Very Broad	Very Broad
	Stream Type	N/A	N/A
	Entrenchment Ratio	N/A	N/A
	Incision Ratio	N/A	N/A
	Dominant Bed Material	N/A	N/A
	Dominant Bedform	N/A	N/A
Major Stressors:	Poor Buffers
