# **Pekin Brook Corridor Plan**

## **Calais, Vermont**

**June 2, 2010**

**Bear Creek Environmental, LLC**  
297 East Bear Swamp Road  
Middlesex, Vermont 05602

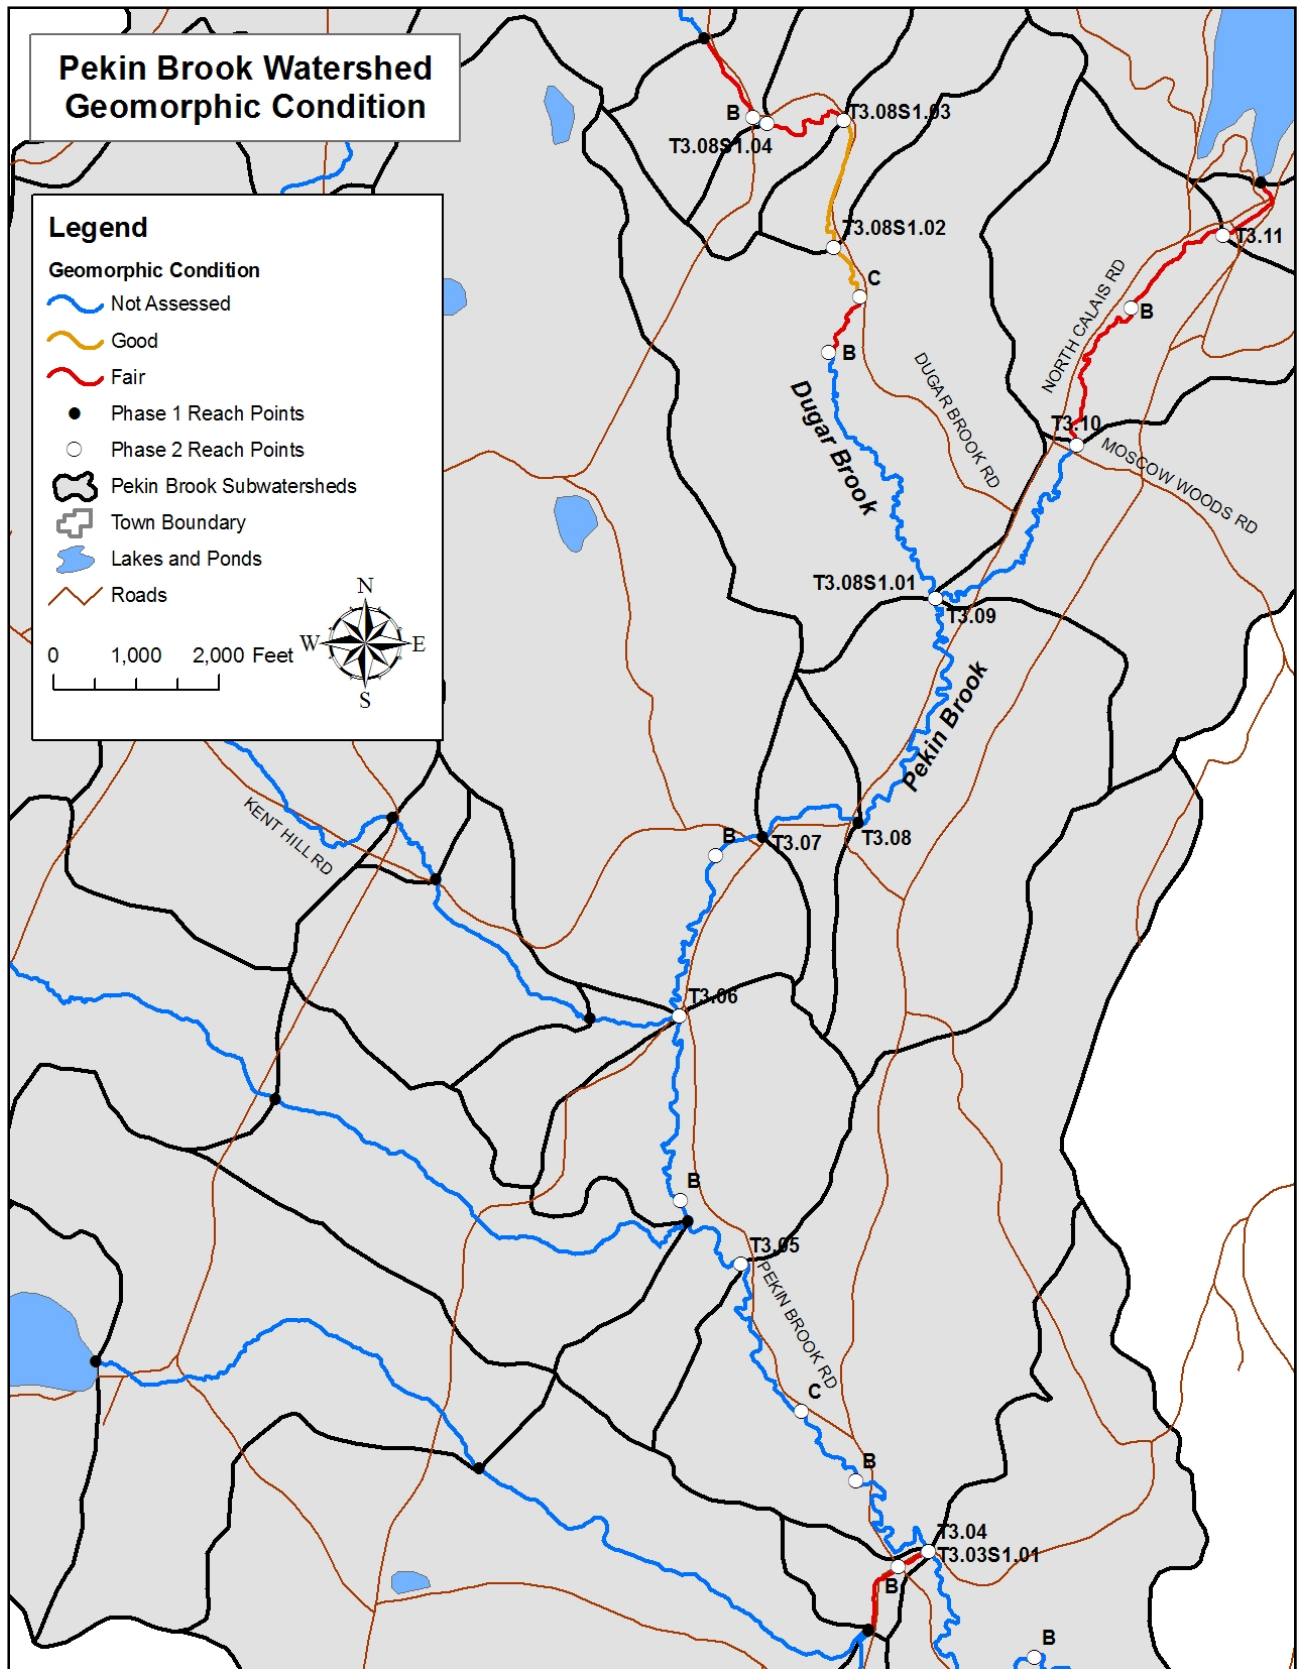
Figure 5.2. Phase 2 Geomorphic Condition of Pekin Brook Watershed

The existing geomorphic condition is depicted in Figure 5.2. Except for two reaches/segments, the assessed segments and reaches in the Pekin Brook watershed were found to be in “fair” geomorphic condition. Segment T3.08SI.01-C and reach T3.08SI.02 on Dugar Brook, which are in close proximity to Dugar Brook Road, were found to be in “good” geomorphic condition. Both of these segments are not incised. Geomorphic condition is determined based on the degree of channel degradation, aggradation, widening, and planform adjustment. Segment T3.08SI.01-A at the mouth of Dugar Brook was not assessed because it is a wetland influenced by beaver dams. Another segment, T3.08SI.04-A, on Dugar Brook is located in a bedrock gorge and was, therefore, not assessed.

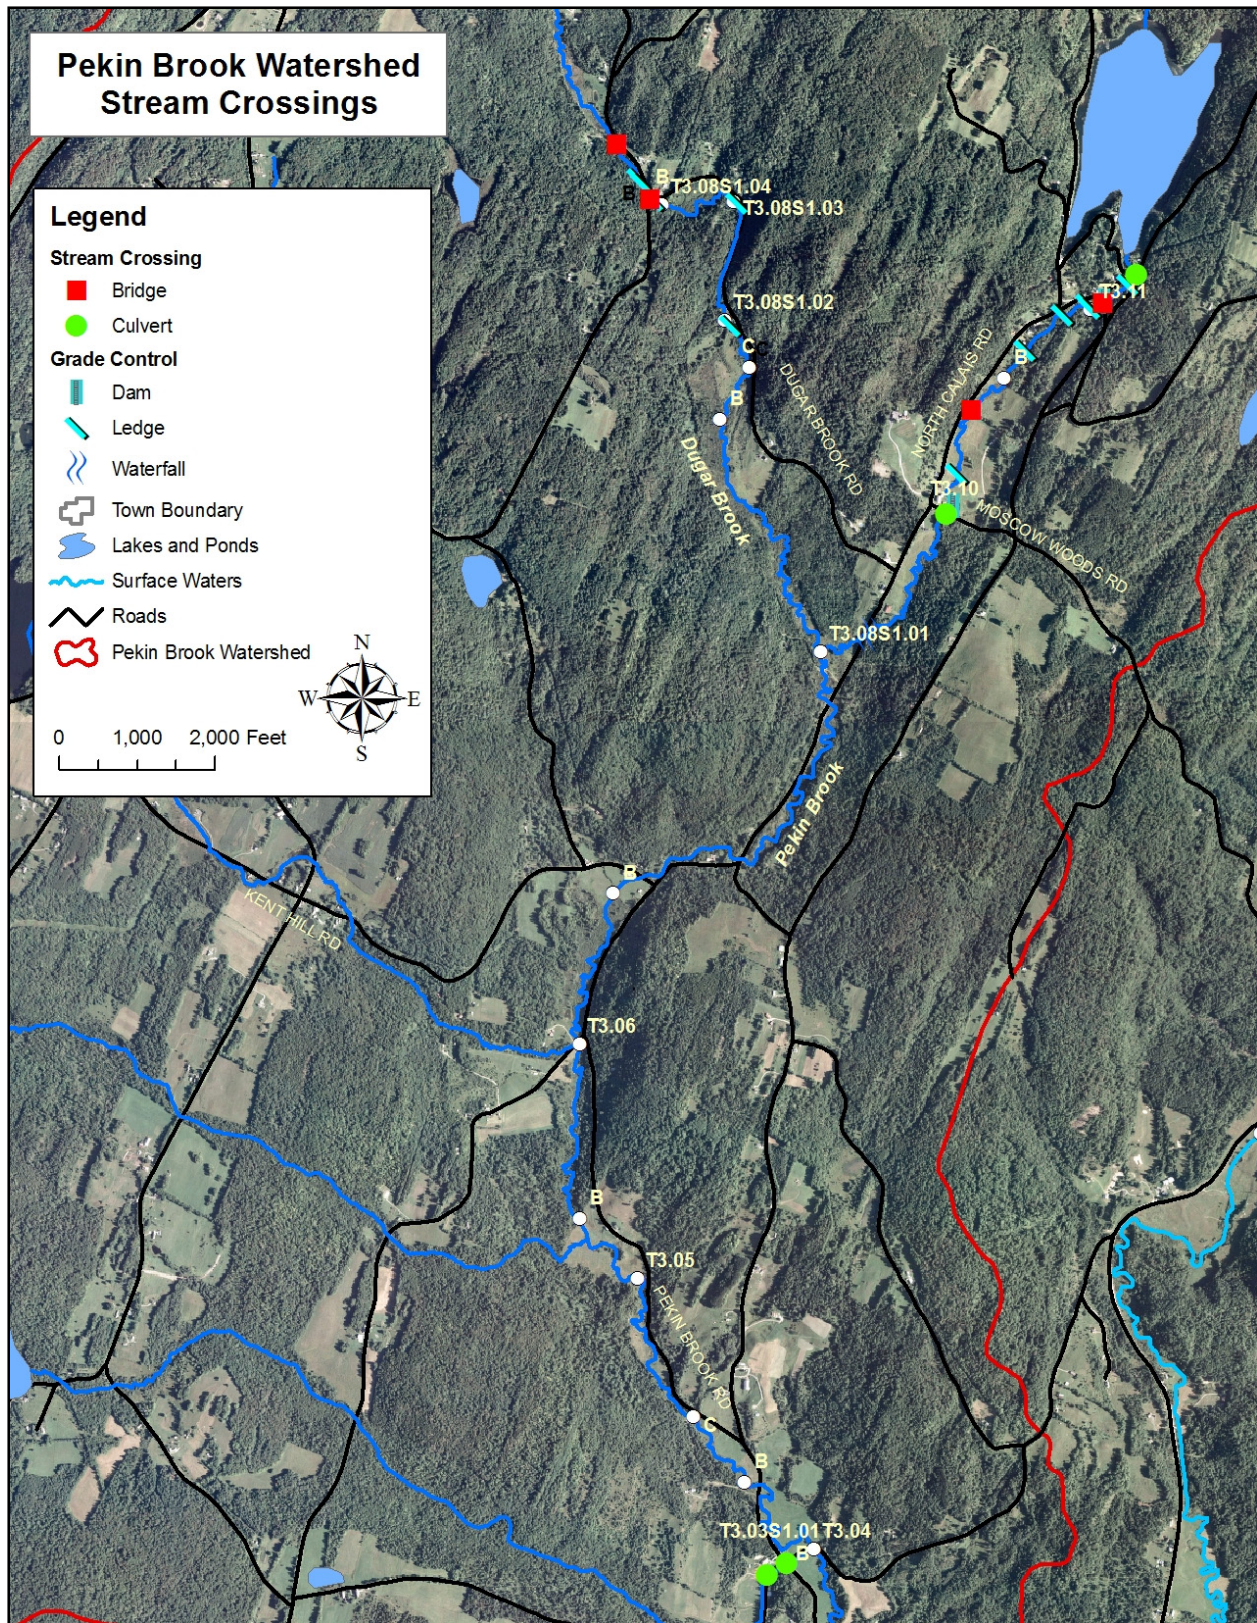
Figure 5.4. Stream Crossings within the Pekin Brook Watershed

A total of eight permanent structures (four bridges and four culverts) are located within the Phase 2 Pekin Brook study area (Figure 5.4). One additional culvert on a reach without landowner access (T3.09), which is at the Moscow Woods Road crossing, was assessed from the upstream end. Six of these stream crossings are on public roads. A bridge and culvert assessment using the VANR protocol was conducted on these structures during the Phase 2 Assessment. The geomorphic compatibility and AOP screening tools, photographs

On Dugar Brook, the bridge at Apple Hill Road is undersized and has a small mass failure associated with some fallen rip-rap armoring on the downstream end. In 1973, a culvert at the Apple Hill Road crossing was washed downstream from a flood event. The culvert was replaced, but in 1984 another flood event caused the culvert to be blocked with debris and floodwaters were diverted onto Dugar Brook Road. The road was washed out for approximately 1,000 feet. According to local residents, the bridge was installed after the culvert at the crossing washed out the second time. The Apple Hill Road Bridge is low priority for replacement due to the abundant bedrock below the structure and the relatively good condition of the bridge.

The culvert at George Road on the tributary to Pekin Brook was assigned a high priority for replacement. This culvert was rated as mostly incompatible using the geomorphic screening tool. Scour is undermining the culvert on both the upstream and downstream ends. Bank armoring is failing and there is considerable erosion in the vicinity of the culvert. The culvert opening is blocked by woody debris and there is a mid-channel bar directly downstream of the culvert. The George Road culvert lacks sediment throughout the structure resulting in reduced aquatic organism passage.

A private driveway bridge on Dugar Brook is significantly undersized. The openings for the bridge are very small and obstructed by woody debris on the upstream end. The structure is unstable and has a low clearance. This bridge has been given a high priority for replacement.

Four structures (two culverts and two bridges) were identified as moderate priority for replacement/retrofit. The culverts in the moderate priority category fall within the partially compatible category using the geomorphic screening tool. Both of these structures, located on Pekin Brook Road and Moscow Woods Road, have reduced AOP passage due to lack of sediment throughout the structure. The Moscow Woods Road culvert is significantly undersized and has a percent bankfull width of less than 50 percent. One bridge that crosses Pekin Brook at TH16 is in poor alignment with the channel and is significantly undersized. Another bridge at a private crossing is significantly undersized. Both these bridges have a moderate priority for replacement.

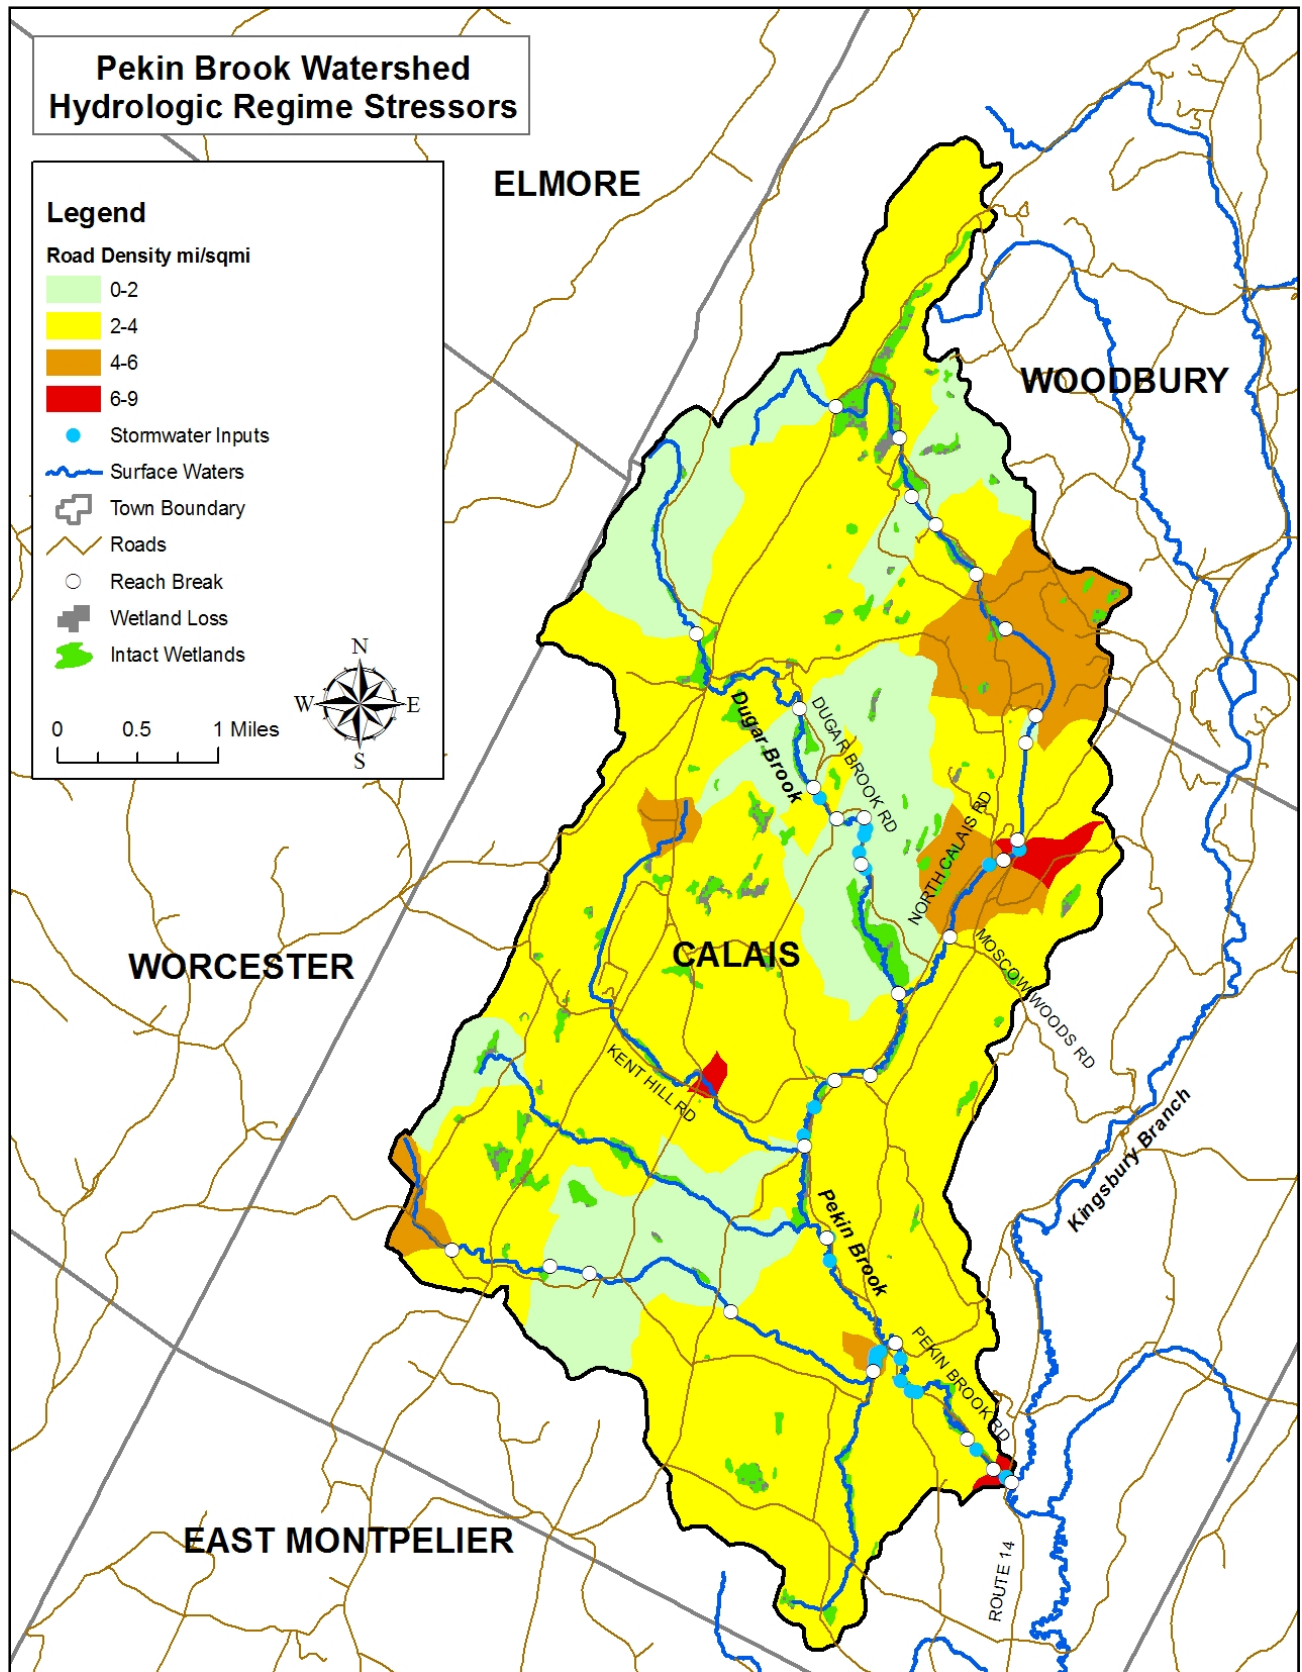
Figure 6.1 Hydrologic Regime Stressors in the Pekin Brook Watershed

The dominant watershed land cover/land use within the Pekin Brook watershed is forest. All Phase 2 reaches resulted in a watershed land cover/land use impact rating of high (10% or more is crop and/or urban). Analysis of hydric soils located where current land uses are agricultural or urban indicates some loss of wetland attenuation (Figure 6.1). Historical deforestation in the Pekin Brook watershed may also have contributed to wetland loss.

The Pekin Brook watershed has a moderate network of roads throughout as shown in Figure 6.1. Extensive road networks can contribute significantly to increased flows within a river resulting both from increased runoff and stormwater ditching. According to Foreman and Alexander (1998), increased peak flows in streams may be evident at road densities of 3.2 miles/ square mile. Subwatersheds with road densities of greater than 3.2 miles/ square mile account for about 25 percent of the Pekin Brook watershed. The highest road densities within the watershed are along Pekin Brook just downstream of No. 10 Pond (Mirror Lake), along a tributary to Pekin Brook that follows Kent Hill Road, and at the mouth of Pekin Brook.

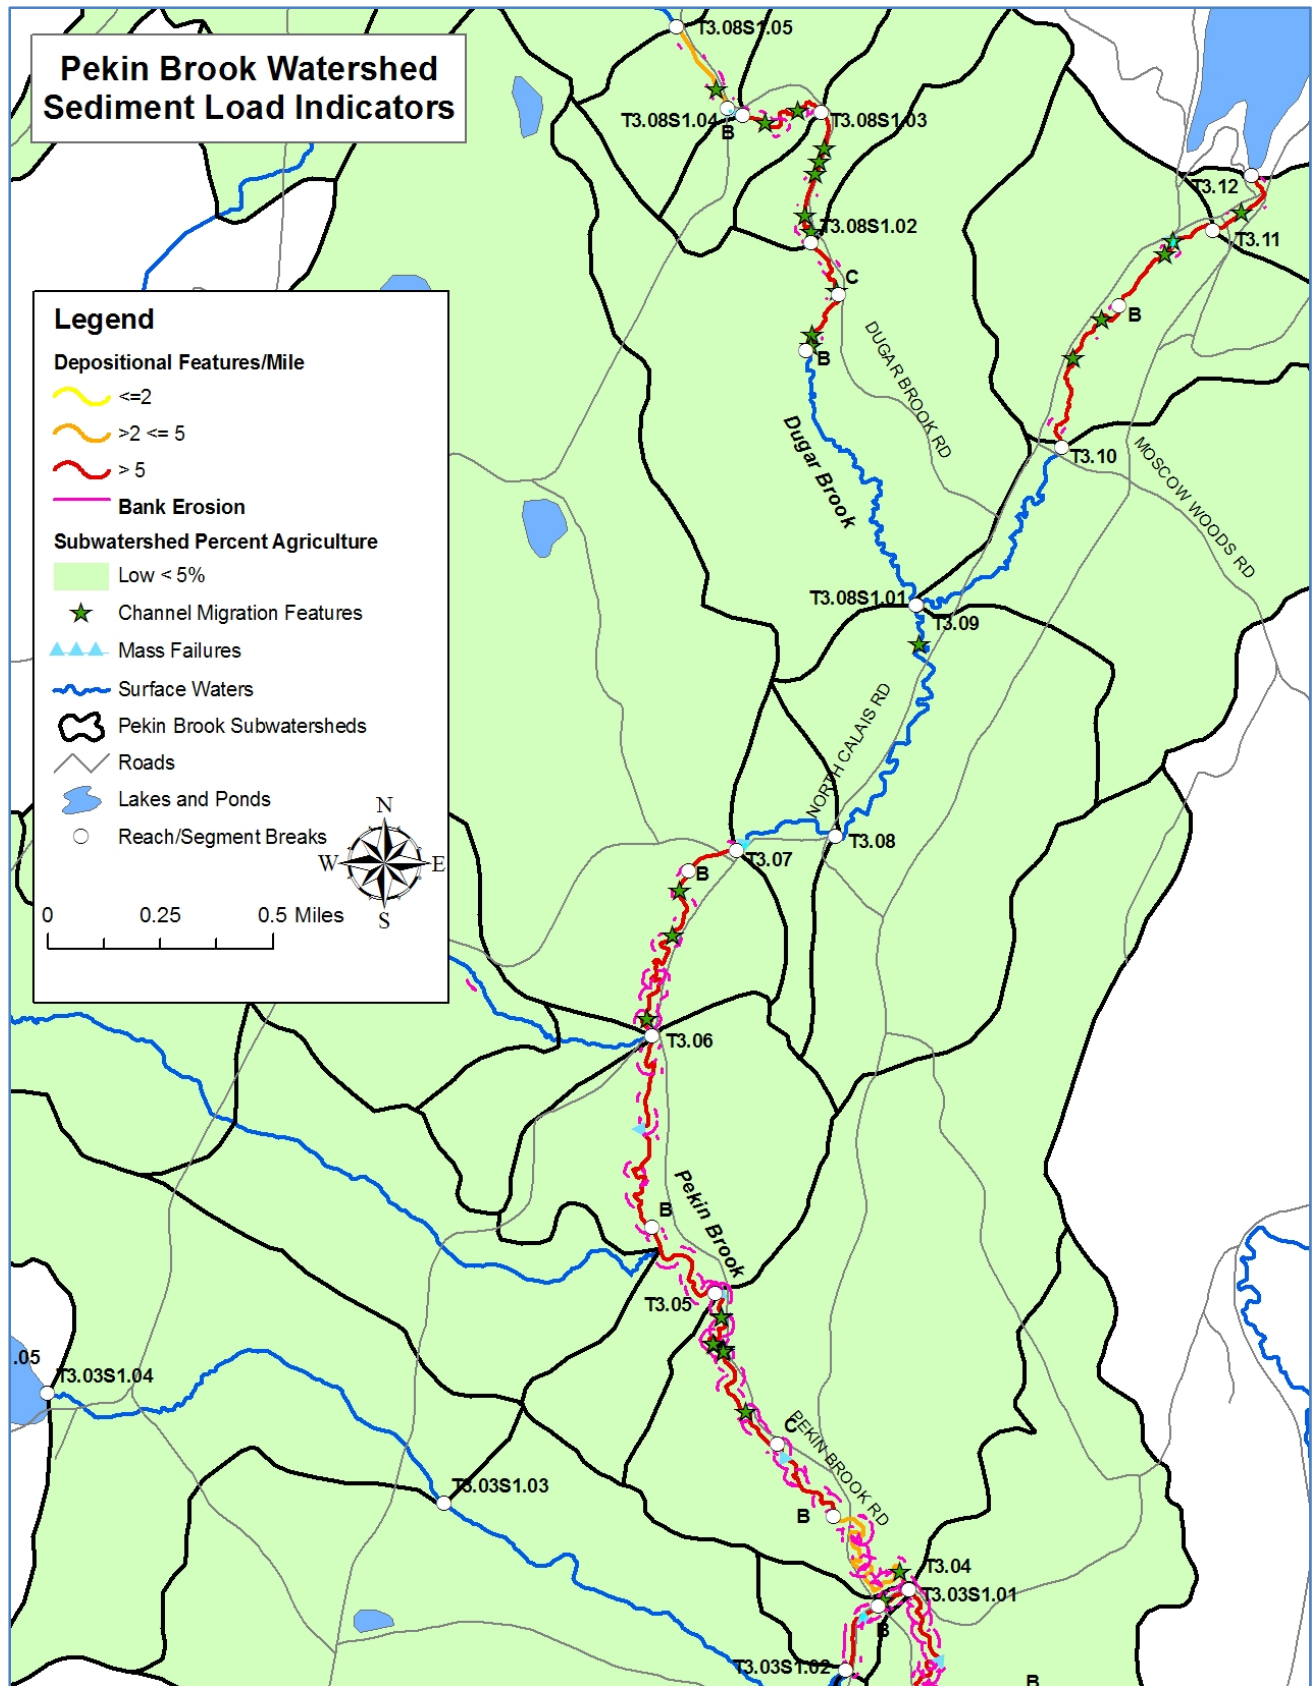
Figure 6.2. Sediment load indicators map for the Pekin Brook Watershed

Depositional features per mile are mapped to show areas of deposition and planform adjustment. Steep riffles, mid-channel bars, delta bars, flood chutes, avulsions and braiding are parameters included in this depositional features parameter. This parameter does not necessarily explain the sources of sediment, but these depositional and channel bifurcation features are common in areas where the sediment transport capacity of the channel has been exceeded (Vermont Agency of Natural Resources, 2007a). Channel migration features (avulsions and flood chutes) are included on the map to show areas of significant planform adjustment. Ninety percent of the Phase 2 segments assessed in 2009 have a high number (>5) depositional features per mile. The most upstream segment assessed for Phase 2 on Dugar Brook (T3.08SI.04-B) is the only reach with a moderate (>2 <=5) number of depositional features per mile.

The moderate bank erosion and the prevalence of mass failures illustrate the streams within the Pekin Brook watershed have a high source of sediment input. This is resulting in the channels being overwhelmed by sediment and exceeding the sediment transport capability as observed by the numerous depositional features per mile. The high level of aggradation is especially evident in T3.08SI.01-B and T3.08SI.01-C on Dugar Brook where there are multiple depositional features and the segments are in stage F-IV and D-IIId, respectively.

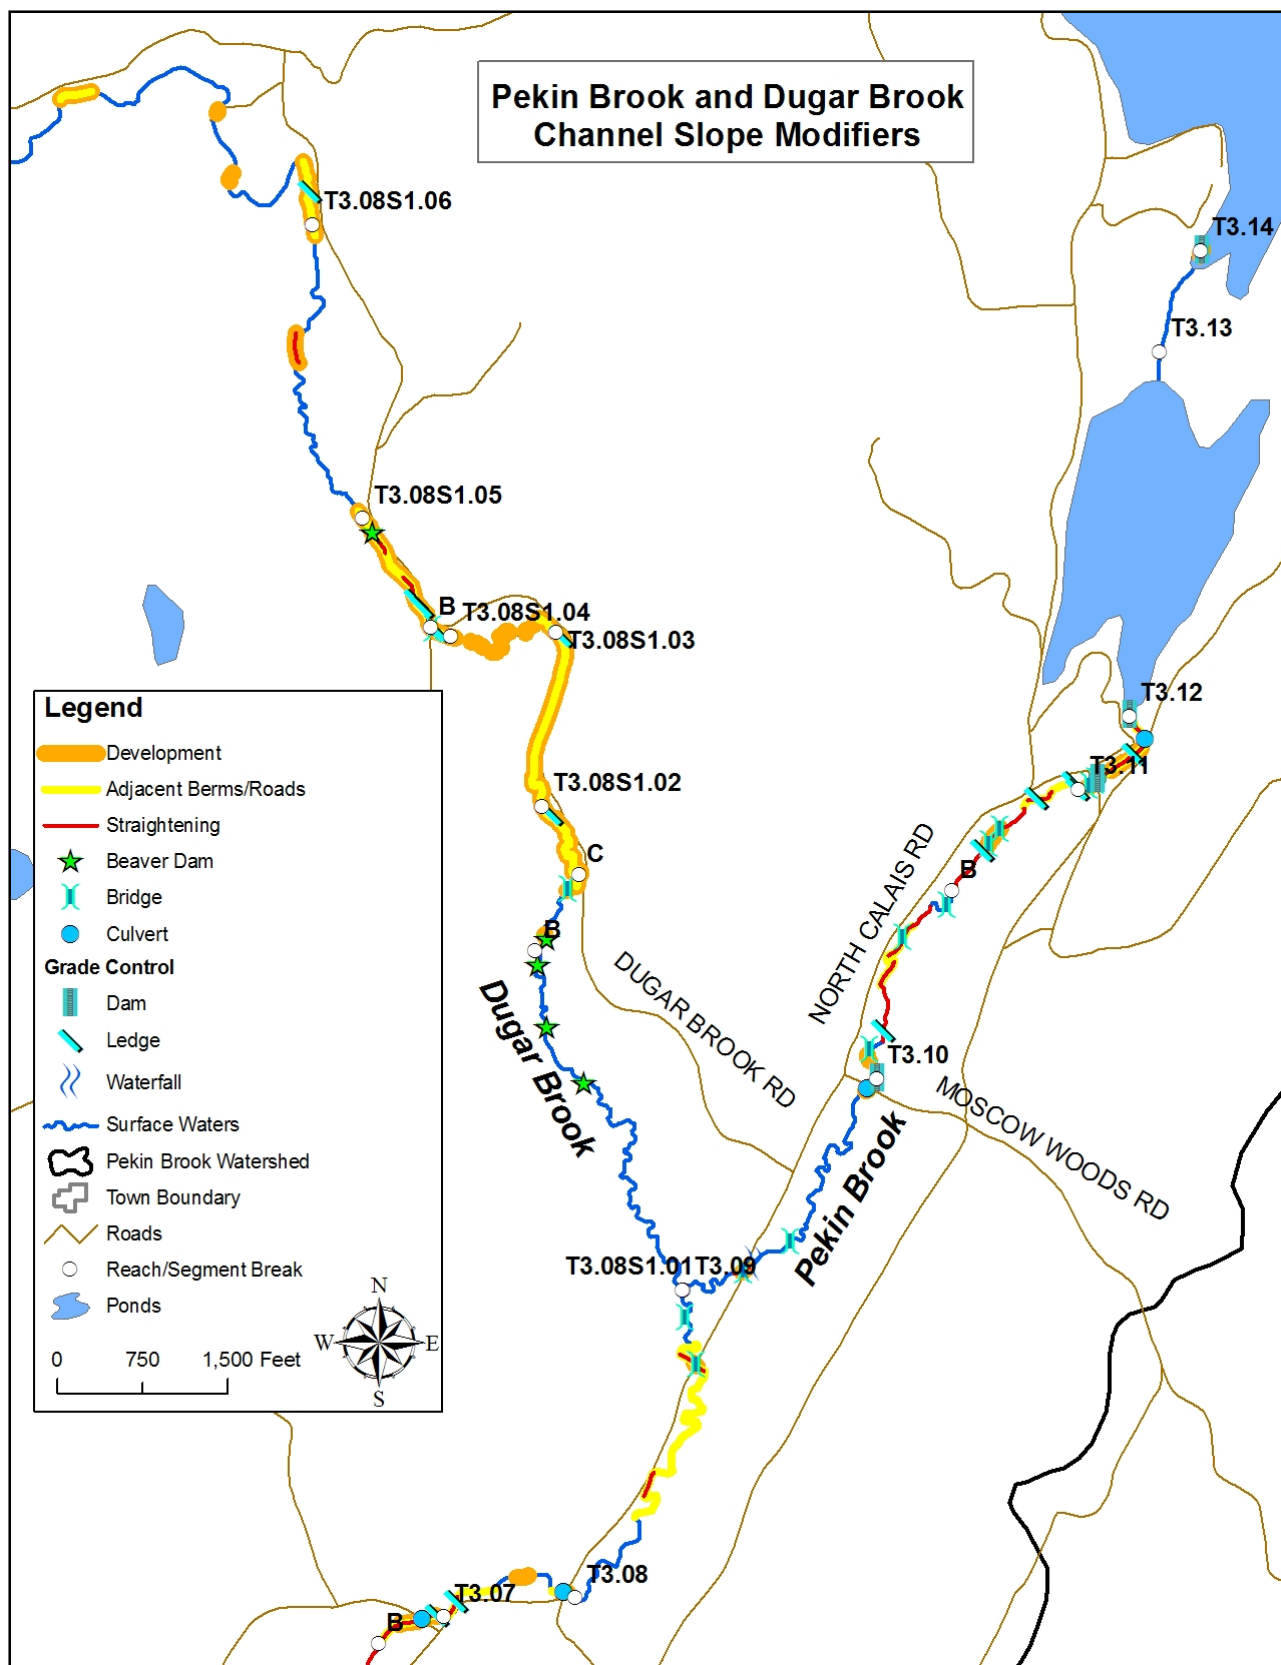
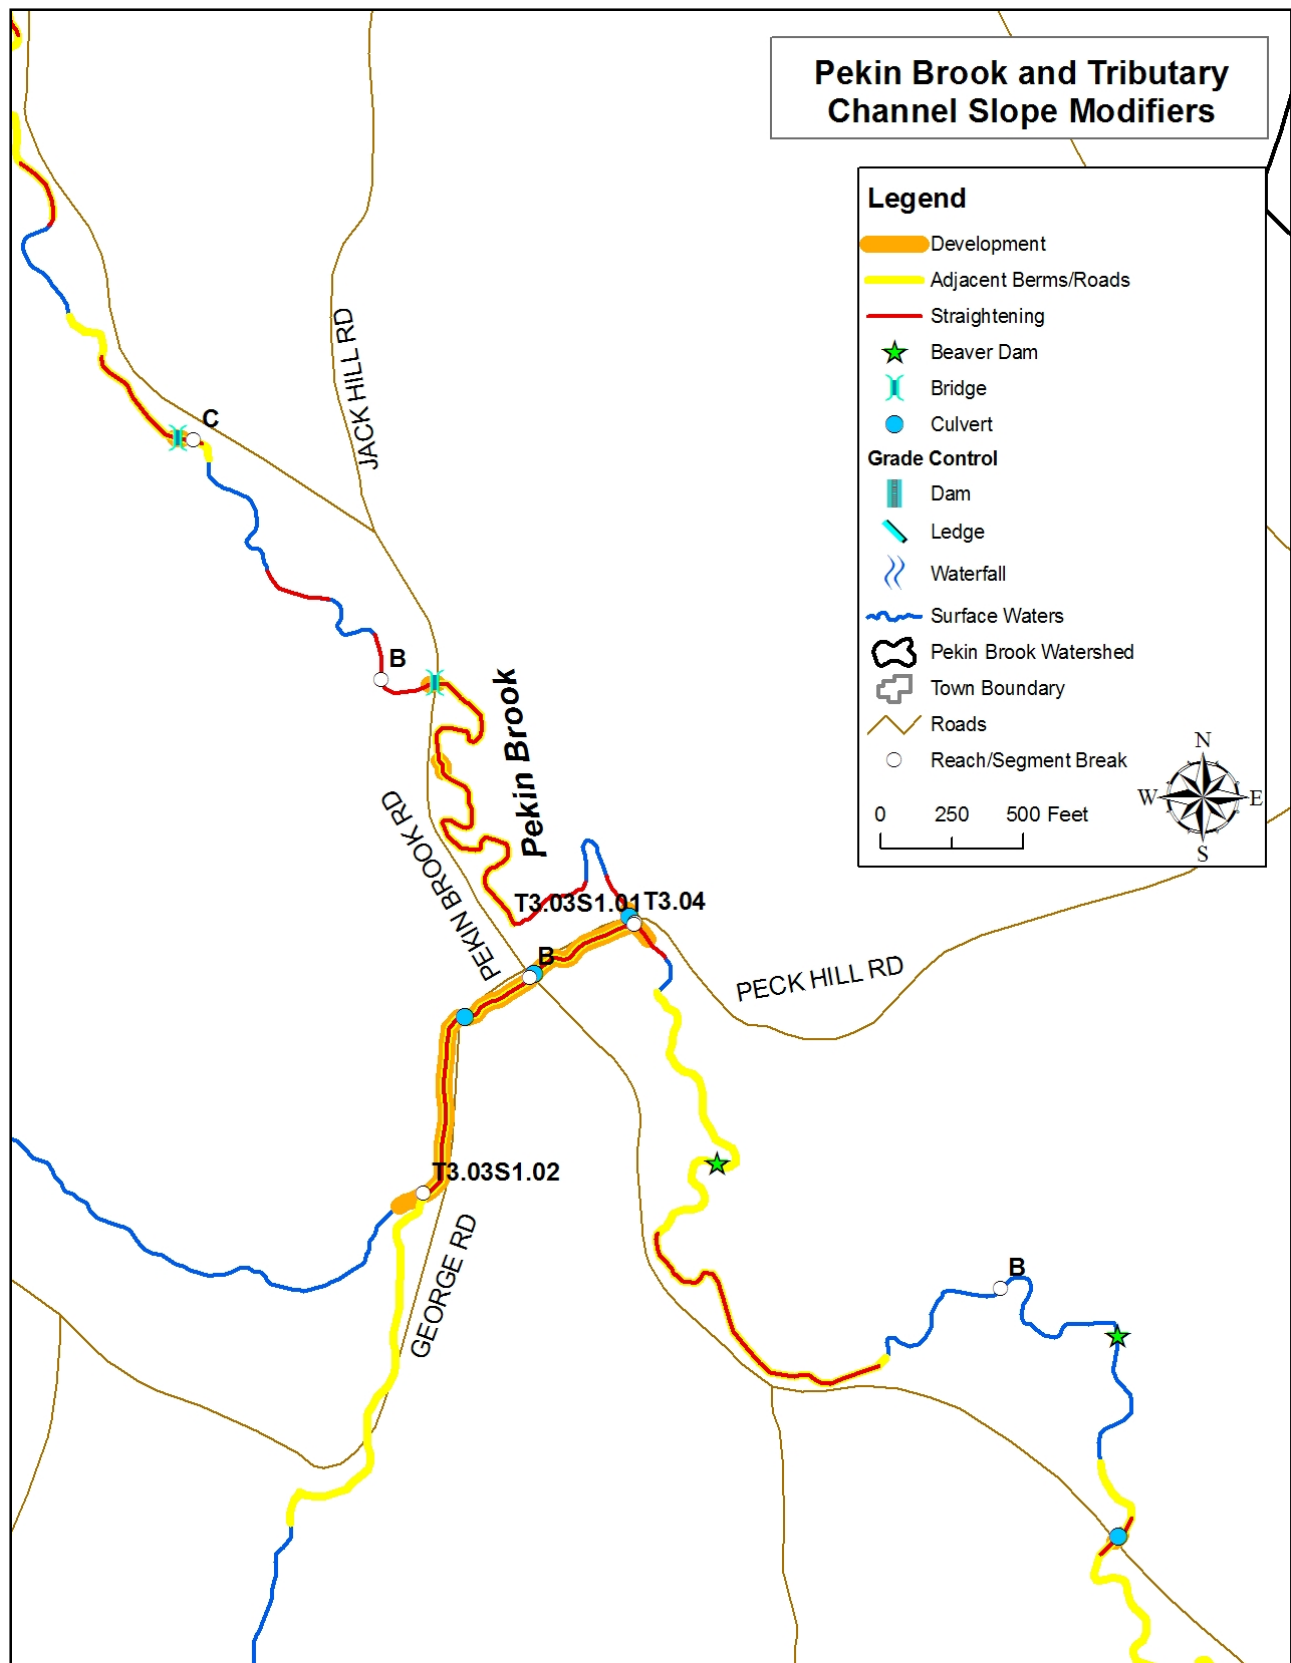
Channel straightening, floodplain encroachment, and berms and roads can increase the slope of a channel resulting in increased stream power. Increases in stream power (shown in red or orange in Figures 6.3 and 6.4) can initiate streambed erosion resulting in incision. The most extensive areas of channel straightening and floodplain encroachment (both development and adjacent berms and roads) are in the upstream reaches of Pekin Brook (T3.10 and T3.11) and the lowest reach on the tributary to Pekin Brook, T3.03SI.01 (Figures 6.3 and 6.4). The channel runs predominantly along North Calais Road and George Road. Dugar Brook has extensive encroachment along the channel from Dugar Brook Road, but only seems to be historically straightened in segment T3.08SI.04-B. Segment T3.08SI.02 appears to be naturally straight and the road was probably placed within the natural valley wall. The majority of the channel straightening within the Pekin Brook watershed is associated with roads that run parallel to the stream. The extensive areas with increases in stream power explain the high degree of channel adjustment that is occurring within the watershed.

Grade controls (waterfalls and ledge) and natural and manmade dams and constrictions (such bridges and culverts) constrict flows or raise the bed elevation. The backwater conditions and sediment deposition associated with these grade controls and constrictions typically reduces channel slope and stream power (Vermont Agency of Natural Resources, 2007a). Localized areas where slope decreases are expected in the Pekin Brook watershed are shown in blue and green in Figures 6.3 and 6.4.

Figure 6.3. Channel slope modifiers map for the upper Pekin Brook watershed showing parameters contributing to increases (red, orange, and yellow) or decreases (blue and green) in slope.

Figure 6.4. Channel slope modifiers map for the lower Pekin Brook watershed showing parameters contributing to increases (red, orange, and yellow) or decreases (blue and green) in slope.

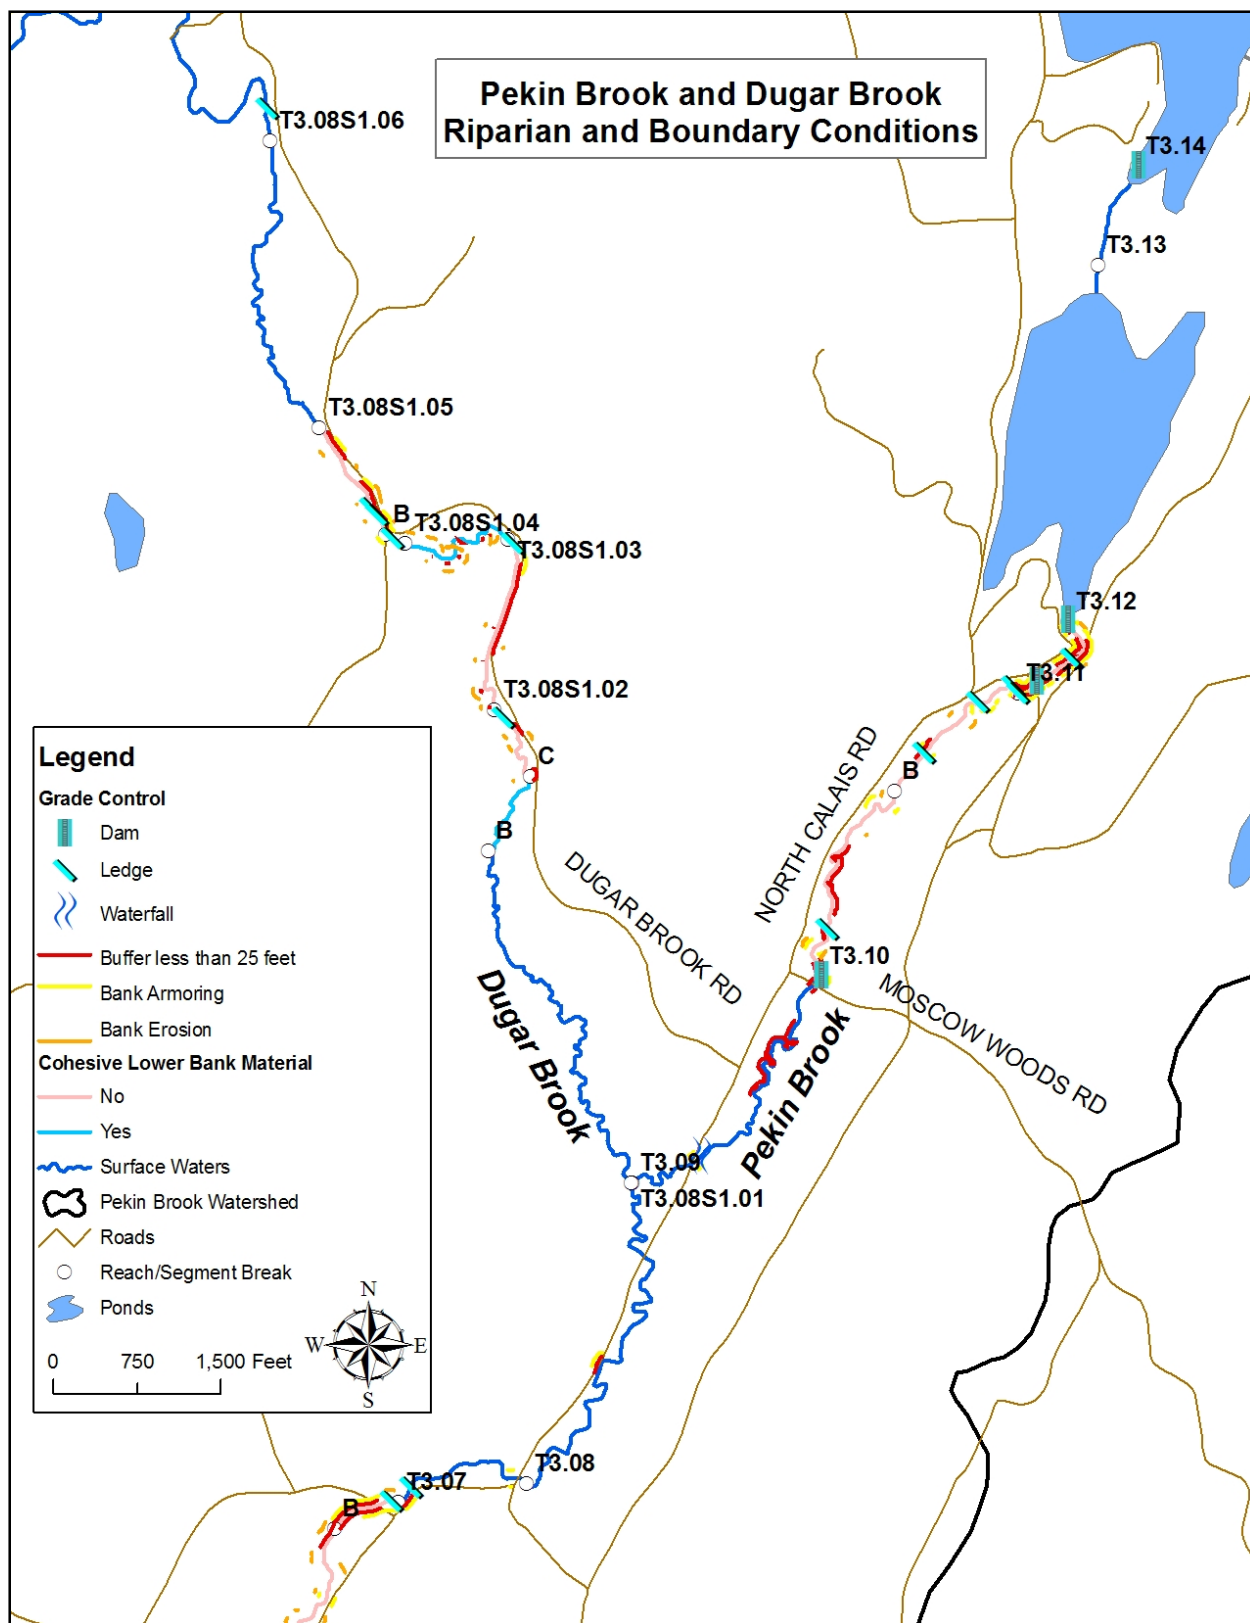
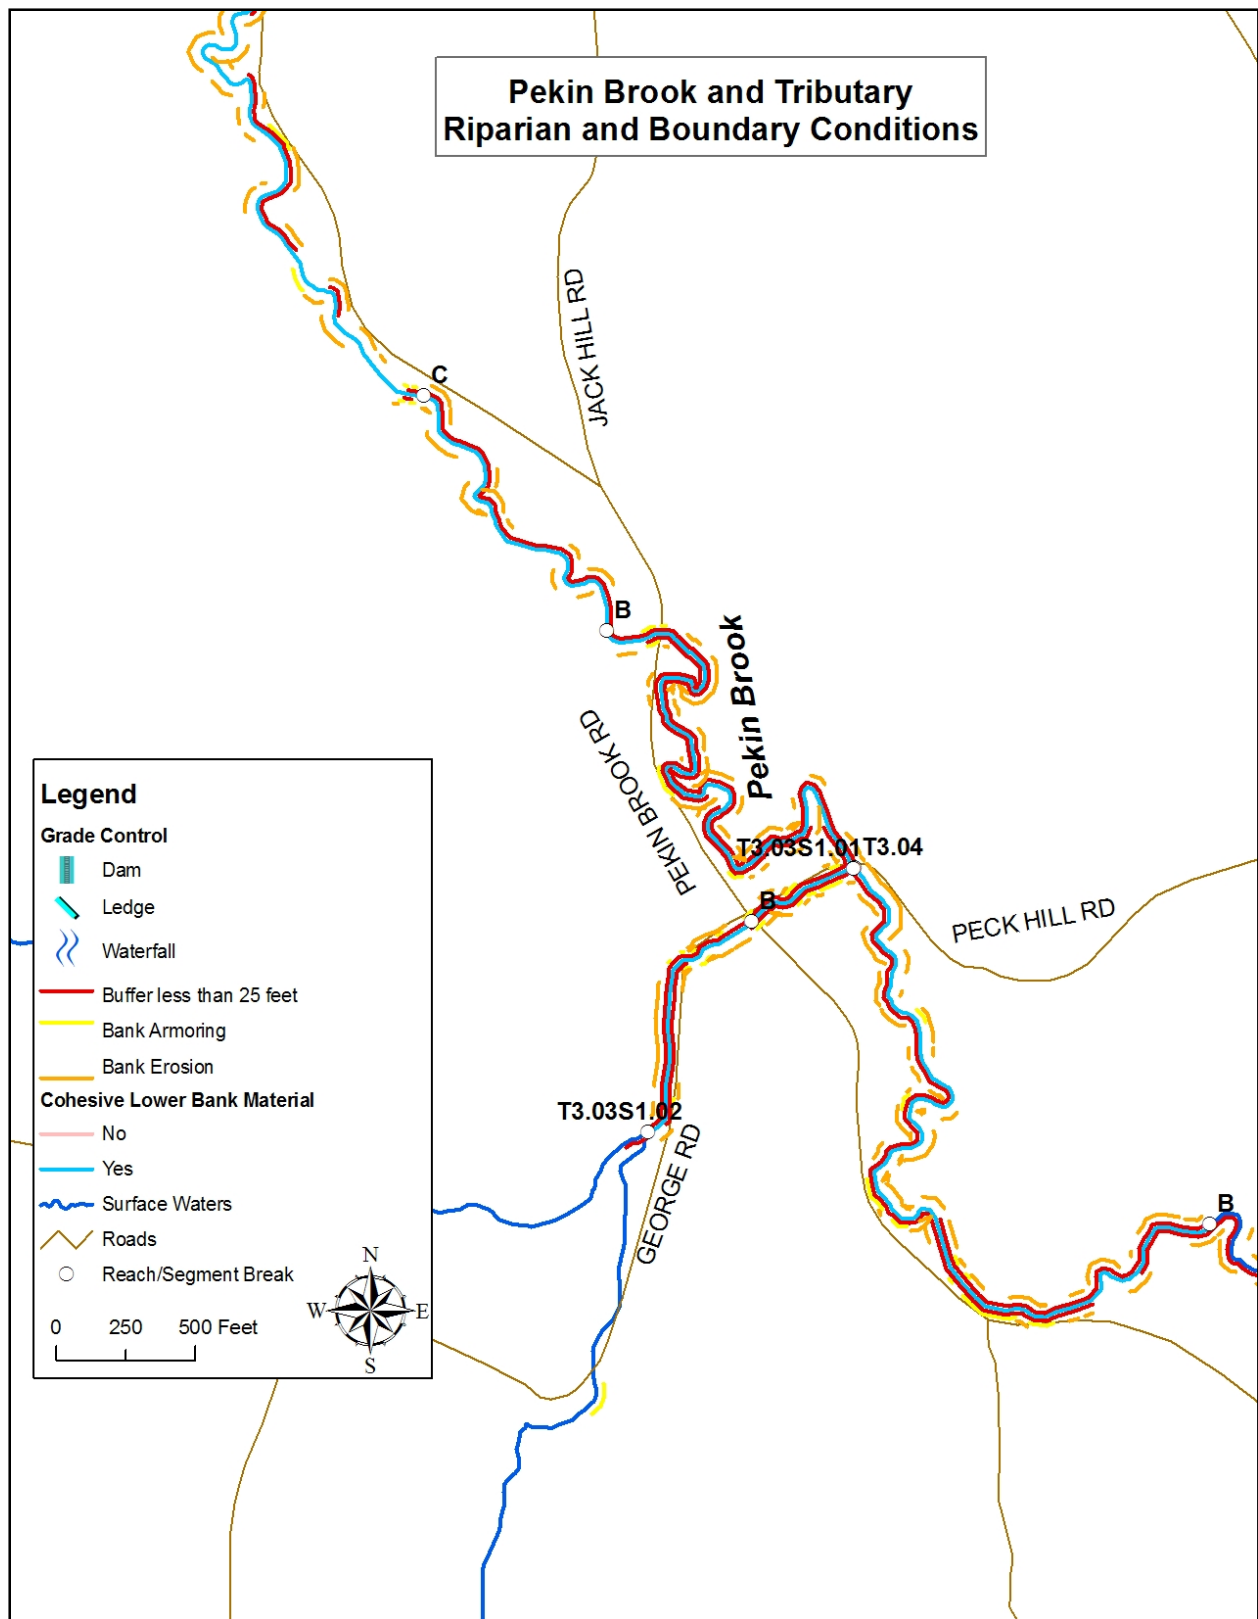
**Figure 6.5. Boundary conditions and riparian modifications map for Pekin Brook and Dugar Brook showing areas of decreased boundary condition (red, orange, and yellow) and increased boundary condition (aqua).**

**Figure 6.6. Boundary conditions and riparian modifications map for Pekin Brook and its tributary showing areas of decreased boundary condition (red, orange, and yellow) and increased boundary condition (aqua).**

Parameters which are indicative of a decrease in boundary condition are shown in red, orange and yellow in Figures 6.5 and 6.6. While bank armoring may temporarily increase the boundary condition, it is indicative of where the stream power has resulted in bank erosion or widening of the channel. Extensive bank armoring may increase the stream power, resulting in erosion of banks located downstream. Areas where woody debris, bed substrate and plant material were removed from the channel also result in increased stream power.

Important factors that result in an increase in boundary condition are included in Figures 6.5 and 6.6 with aqua colored symbols. Natural and man-made grade controls increase the resistance of the bed to erosion. There were several locations where natural grade controls (ledge) were mapped based on the Phase 2 fieldwork including T3.10 and T3.11 on Pekin Brook and T3.08S1.01-C, T3.08S1.02, T3.08S1.04-A and T3.08S1.04-B on Dugar Brook. Man-made grade controls or dams were observed in T3.09 and T3.11. The cohesiveness of the lower bank materials is another factor that was considered in evaluating boundary resistance. Cohesive bank material can increase the boundary condition. The following were the only segments that had cohesive lower banks: T3.03S1.01-A, T3.03S1.01-B, T3.08S1.01-B, and T3.08S1.03.

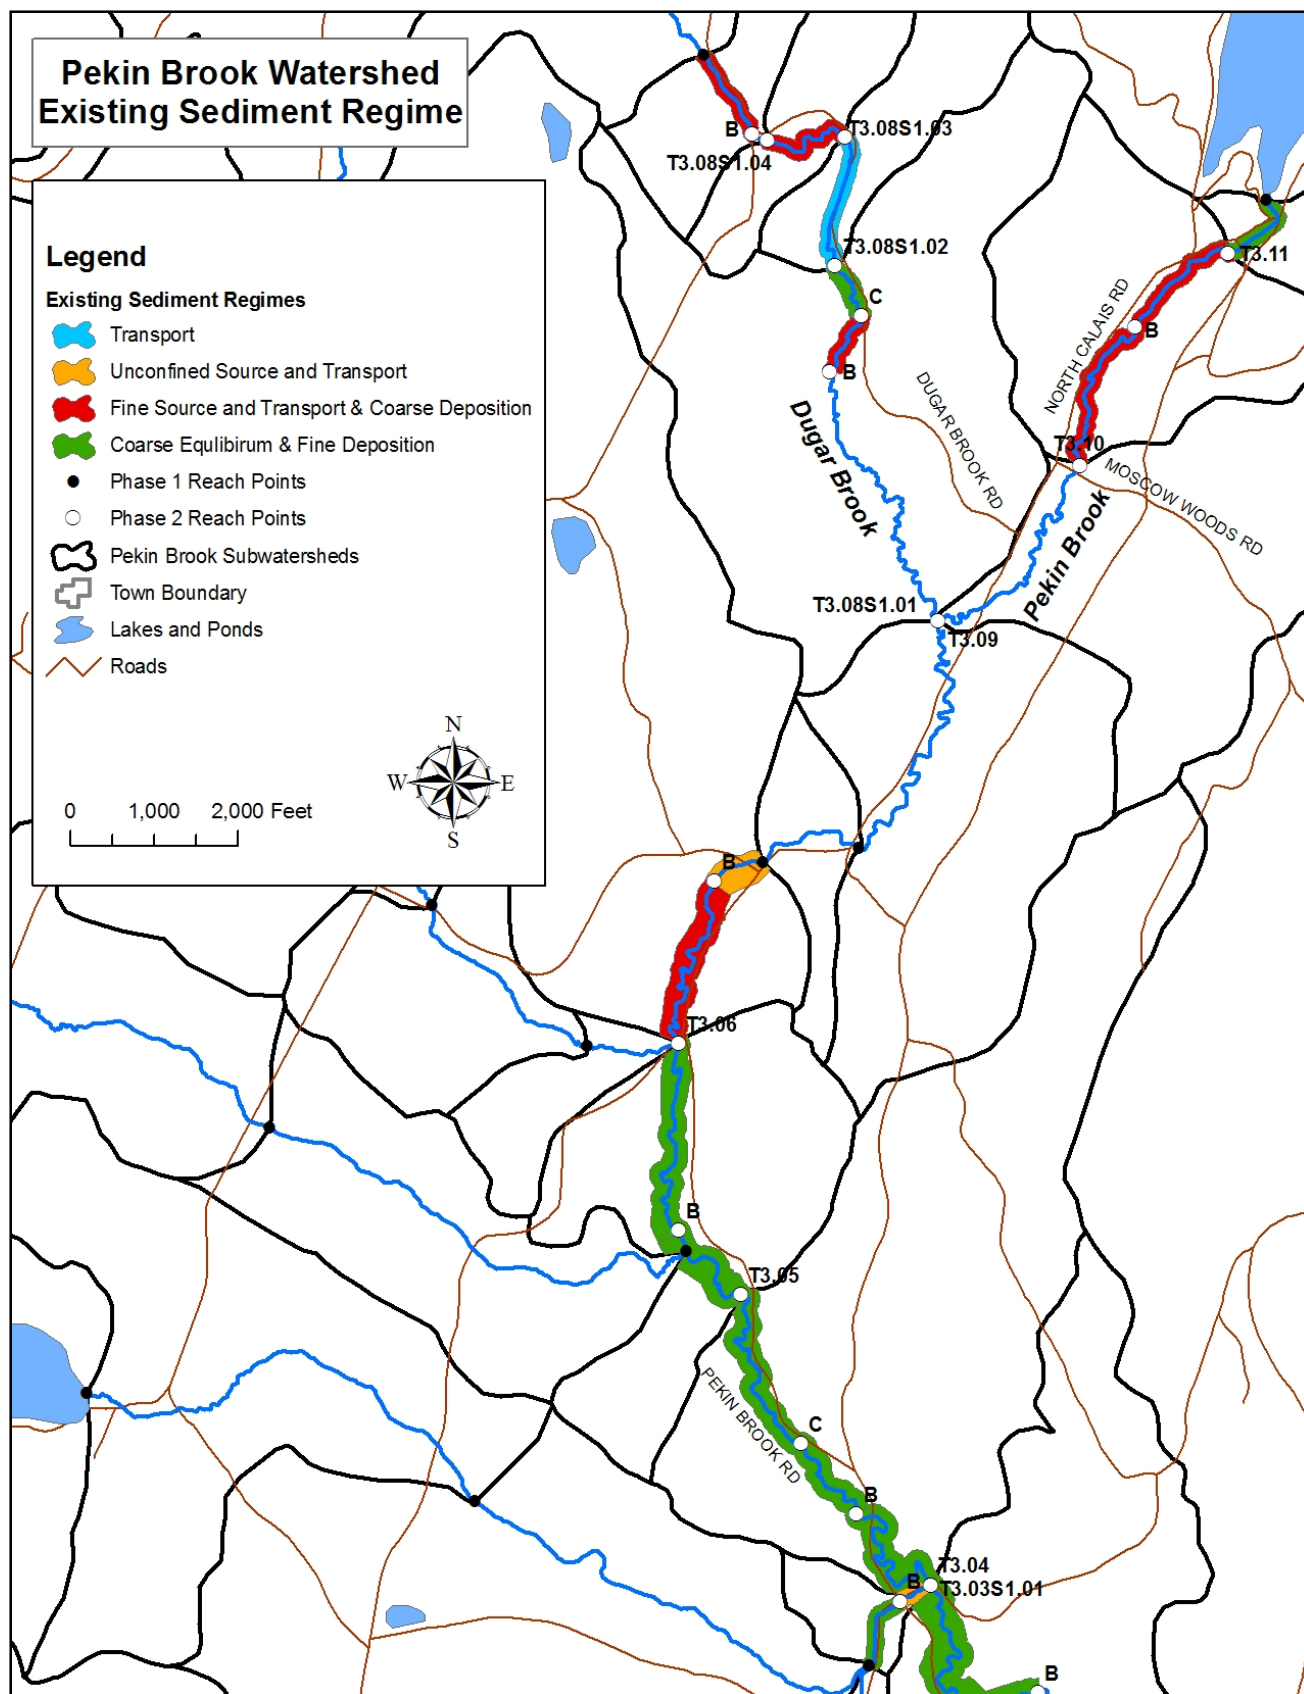
Figure 6.8. Existing Sediment Regime Departure Map

Changes in hydrology (such as development and agriculture within the riparian corridor) and sediment storage within the watershed have altered the reference sediment regime types for some segments. All departures were derived from the DMS according to the sediment regime criteria established by the Vermont Agency of Natural Resources (2007a). Existing sediment regimes have not been established for reaches that were not assessed during the phase 2 stream geomorphic assessment. Many segments that were *Coarse Equilibrium (in=out)* & *Fine Deposition* type segments by reference have been converted to *Fine Source and Transport* & *Coarse Deposition* sediment regimes based on the Phase 2 Stream Geomorphic Assessment data (Figure 6.8). This means that most fine sediment entering the stream is transported through without being deposited as a result of channel incision and reduced floodplain access. Additionally, coarse sediment storage is increased due to increased load along with lower transport capacity. One segment, T3.03SI.01-A, near the mouth of the tributary to Pekin Brook, was converted to *Unconfined Source & Transport*. Due to the boundary resistance from bank armoring, T3.03SI.01-A is not a significant source of sediment. There is, however, some bank erosion; and sediment storage is negligible due to the incision and loss of floodplain access. Segment T3.06-A, which was assessed in 2007, has been converted to *Unconfined Source & Transport* sediment regime due to increased transport capacity derived from bank armoring and channel straightening in the vicinity of the former Calais Town Hall. These channel management practices have resulted in reduced attenuation of flood waters and sediment.

The existing sediment regime for the Pekin Brook watershed includes reduced floodplain access, increased stream power, reduced boundary resistance, and lateral constraints, such as roads, at various locations throughout the stream network. Watersheds which have lost attenuation or sediment storage areas, due to human related constraints, are generally more sensitive to erosion hazards, transport greater quantities of sediment and nutrients to receiving waters, and lack the sediment storage and distribution processes that create and maintain habitat (Vermont Agency of Natural Resources, 2007a).
