# **Pekin Brook Corridor Plan**

## **Calais, Vermont**

**June 2, 2010**

**Bear Creek Environmental, LLC**  
297 East Bear Swamp Road  
Middlesex, Vermont 05602

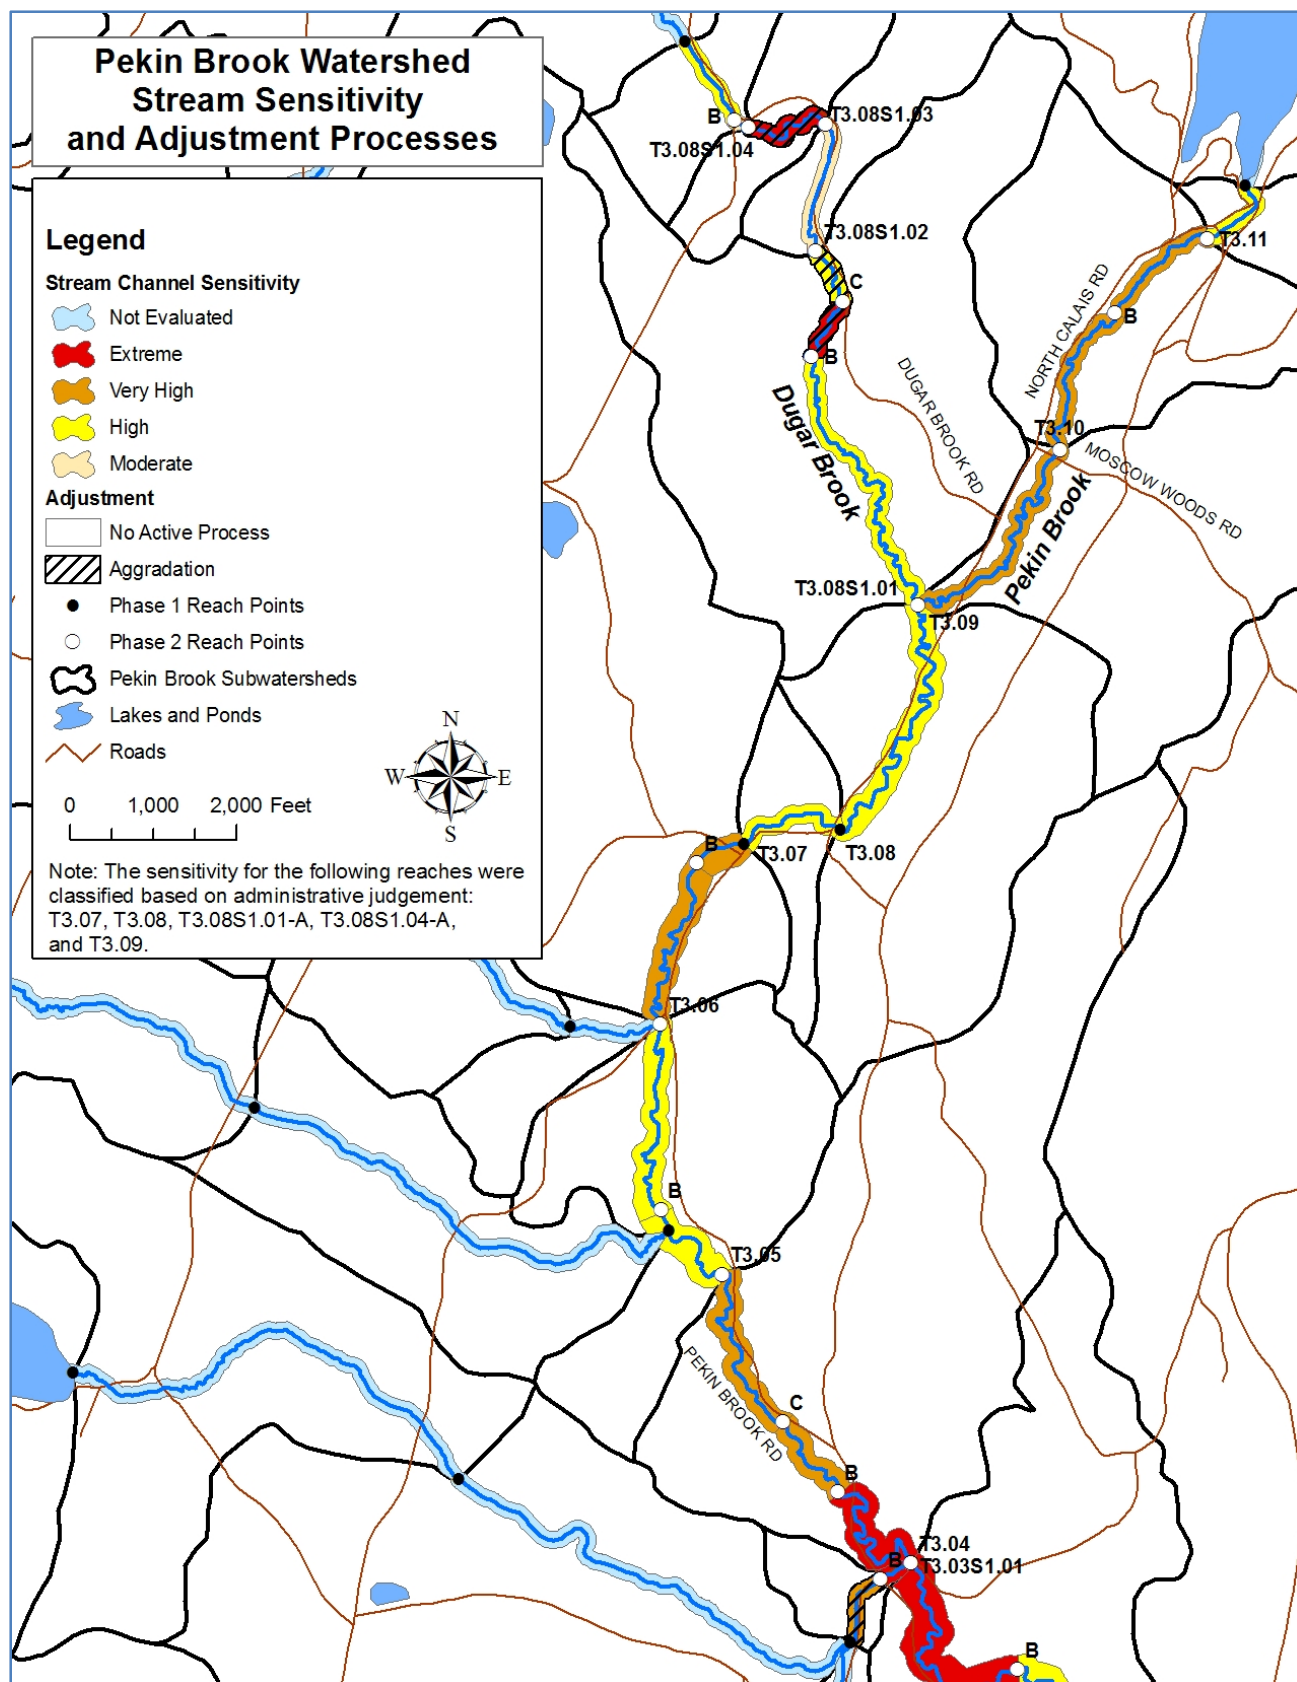
Figure 6.9. Stream sensitivity and current adjustment of the Pekin Brook Watershed

There are many variables that are contributing to the sensitivity of the reaches in the Pekin Brook watershed. In some reaches, the lack of bedrock and cohesive lower banks decrease the resistance to lateral and vertical adjustments; thereby, making the channel more sensitive. Additionally, bank vegetation and roots which hold the soil are lacking especially along Pekin Brook and its tributary along George Road. Reaches that are lacking high quality riparian vegetation are more sensitive to channel adjustment.

The location and slope of a stream affects its morphology and sensitivity. Streams that are transporting sediment through the channel are less sensitive than streams that are storing and responding to sediment. Low gradient streams, like lower Pekin Brook and Dugar Brook, with high sediment supplies are very sensitive and may undergo adjustment following minor changes in channel geometry or boundary condition. Additionally, flow regime and floodplain constrictions may be affecting the sensitivity of the Pekin Brook watershed. Changes in land use and land cover that increase impervious cover, peak discharges, and/or the frequency of high flows will heighten a stream's sensitivity to change and adjustment. Confinement becomes a significant sensitivity concern when structures such as roads, railroads, and berms significantly change the confinement ratio, reduce or restrict a stream's access to floodplain, and result in higher stream power during flood stage.

Figure 6.9 is a map presenting the stream sensitivity, generalized according to stream type and condition as per the VANR protocol, and current adjustments for each reach segment in the Pekin Brook watershed. Sensitivity ratings have not been assigned for bedrock dominated segments, impounded segments, and segments without landowner permission that were not assessed. Segments T3.08SI.01-B, T3.08SI.03, and T3.03SI.01-A are gravel dominated “E” channels that are in “fair” geomorphic condition. The “fair” condition has resulted in a change in sensitivity from high to extreme (Figure 6.9). Since the following segments were in “fair” geomorphic condition, there was a change in sensitivity to very high: T3.10-A, T3.10-B, and T3.03SI.01-B. In the most upstream Phase 2 reach on Pekin Brook, T3.11, a sensitivity change from moderate to high was assigned due to its “fair” condition. Segment T3.03SI.04-B, a cobble dominated segment, has undergone a sensitivity change (moderate to high) because of a stream type departure from a “C” channel to a “B” channel in places. This stream type departure is attributed to historic incision and the encroachment of Dugar Brook Road. Major aggradation adjustment processes are displayed on the corridor where they were found to be actively occurring and not evaluated as historic. Aggradation is a current major active process for three segments (T3.08SI.01-B, T3.08SI.01-C, and T3.08SI.03) on Dugar Brook and one segment (T3.03SI.01-B) on the tributary to Pekin Brook. This information is useful in prioritizing the implementation of the projects identified in Section 7 of this report, as certain management actions may be influenced by these active adjustment processes.

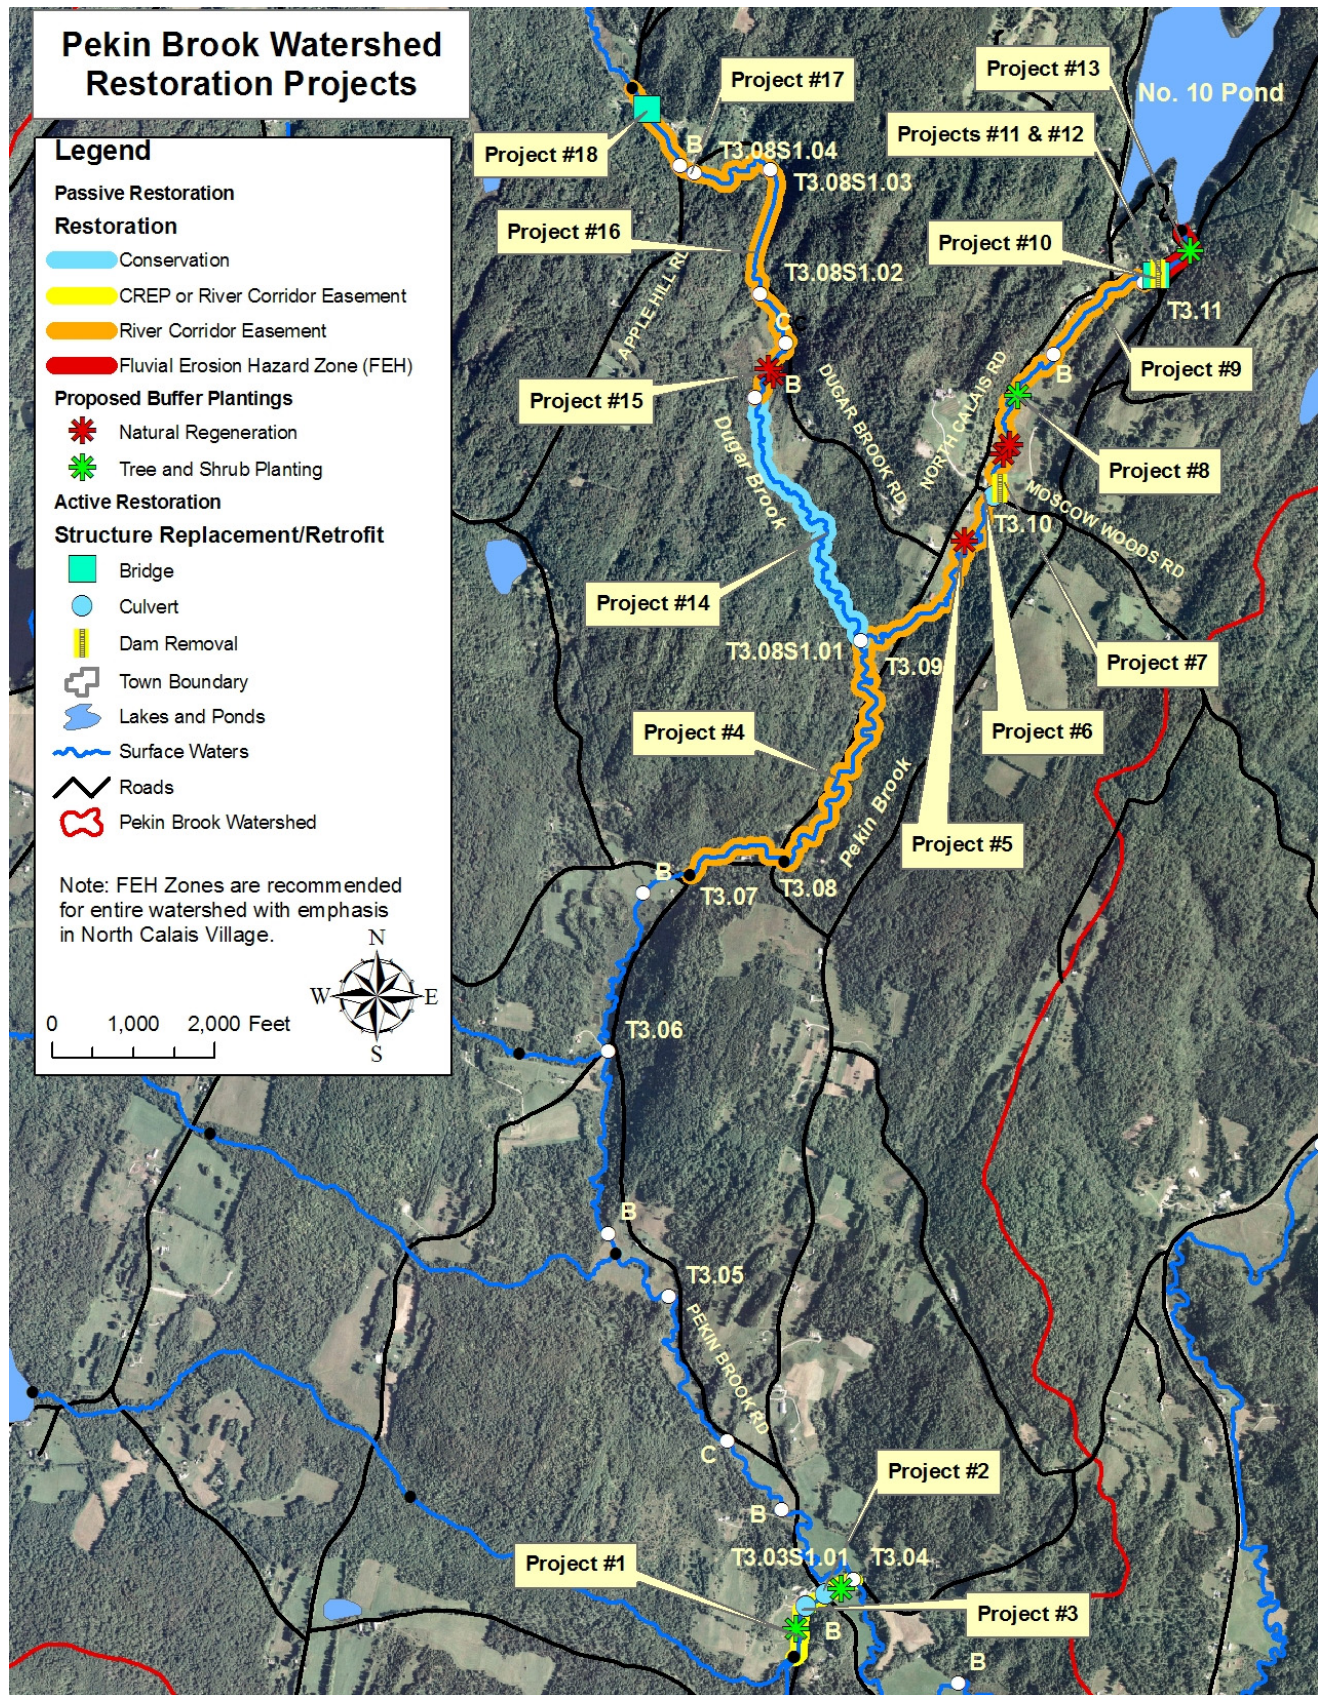
Figure 7.33. Proposed restoration and protection projects for the Pekin Brook Watershed

#17  Just downstream of Apple Hill Road crossing  T3.08S1.04-A	Active Restoration	Mass failure just downstream of Apple Hill Road bridge due to rip-rap failure	Install netting and plants to arrest erosion	Low priority	Prevent erosion	Low cost for plantings and netting	Unknown	ANR, CVRPC, landowners, FWR

#18  Private driveway crossing just downstream of wetland area  T3.08S1.04-B	Active Restoration	The width of the private driveway bridge is 10 percent of the bankfull width. There is debris blocking the two openings on the upstream end of the structure	Bridge Replacement	High priority	Improved geomorphic stability	High cost for replacement	Unknown	ANR, CVRPC, landowner

The project strategy, technical feasibility, and priority for each project are listed by project number and reach. A total of 18 projects were identified to promote the restoration or projection of channel stability and aquatic habitat in the Pekin Brook watershed. Table 7 provides information for each project, including the project strategy, technical feasibility, and general cost. The projects are broken down by category as follows: 10 passive restoration (river corridor protection, streamside plantings or buffer improvement projects); 8 active restoration (5 bridge or culvert replacement or retrofit projects, 2 dam removal projects, and one mass failure stabilization project). The project locations and categories identified for Pekin Brook, Dugar Brook, and the unnamed tributary to Pekin Brook are depicted below in Figure 7.33. The projects include:

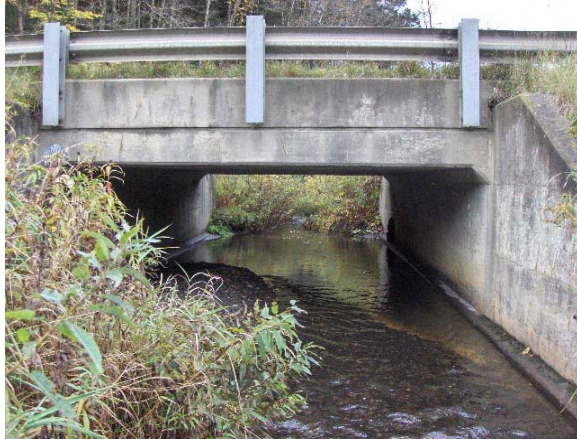
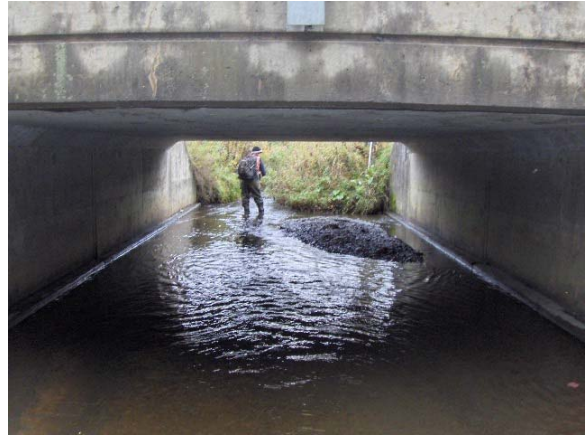
**Unnamed Tributary to Pekin Brook  
Pekin Brook Road  
Segment T3.03SI.01-A**

Culvert Length: 29.5 feet  
Culvert Height: 5.1 feet  
Culvert Width: 14 feet

**Geomorphic Compatibility – Partially Compatible**

Additional problems noted: scour below; mid-channel bar in structure; low clearance

**Priority for Replacement - Moderate**

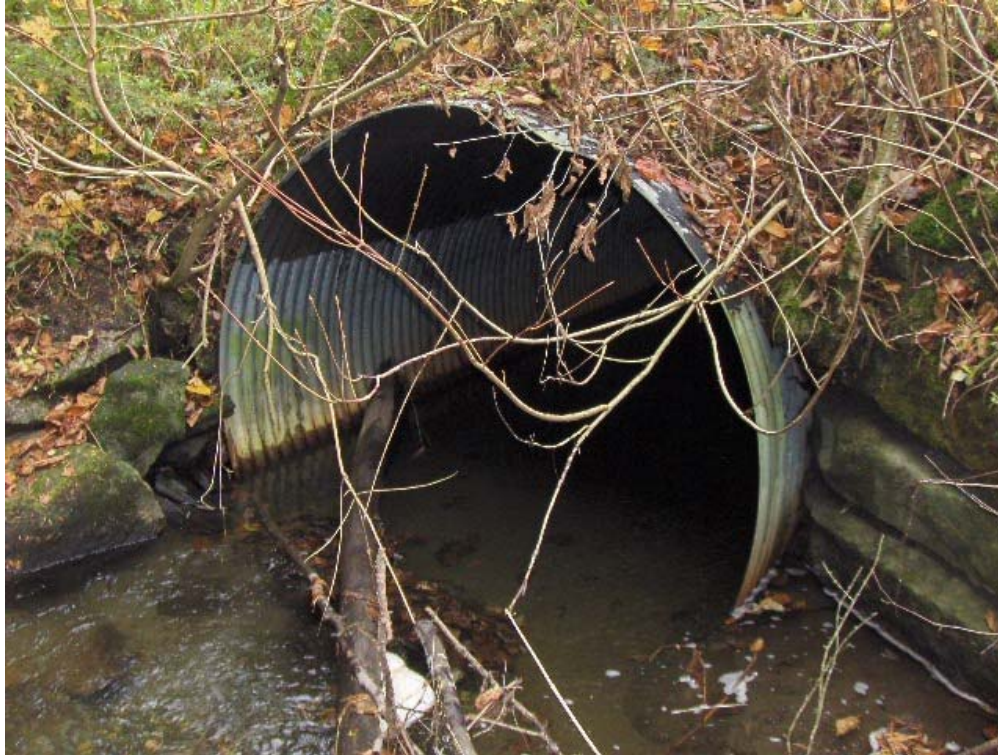
**Unnamed Tributary to Pekin Brook  
George Road  
Segment T3.03SI.01-B**

Culvert Length: 40 feet  
Culvert Height: 5.5 feet  
Culvert Width: 5.5 feet

**Geomorphic Compatibility – Mostly Incompatible**

Erosion and Armoring – Erosion is high and armoring is failing both upstream and downstream

**Priority for Replacement - High**

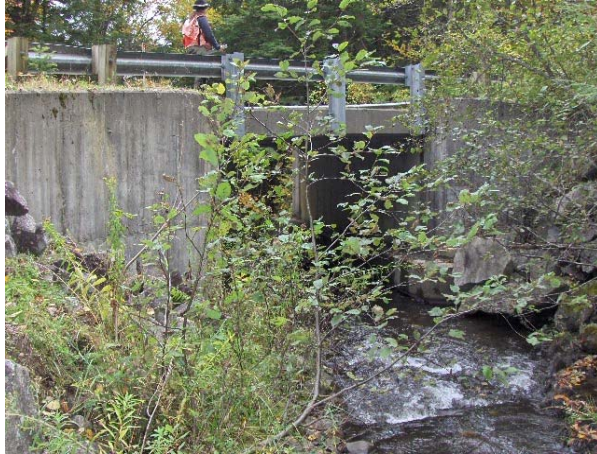
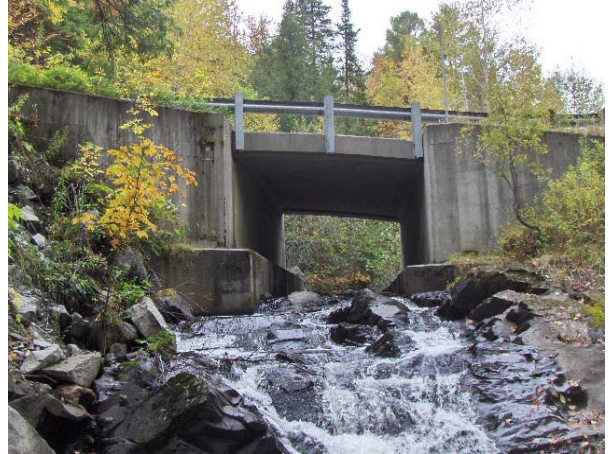
**Dugar Brook  
Apple Hill Road  
Segment T3.08SI.04-A**

Road Width: 29 feet  
Bridge Clearance: 9.1 feet  
Bridge Span: 13 feet

**Geomorphic Compatibility – Not applicable**

Erosion and Armoring – Upstream hard bank armoring intact, downstream failing and creating mass failure

**Priority for Replacement - Low**

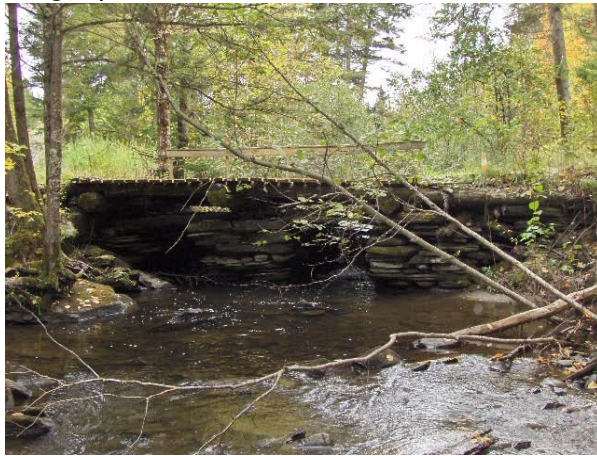
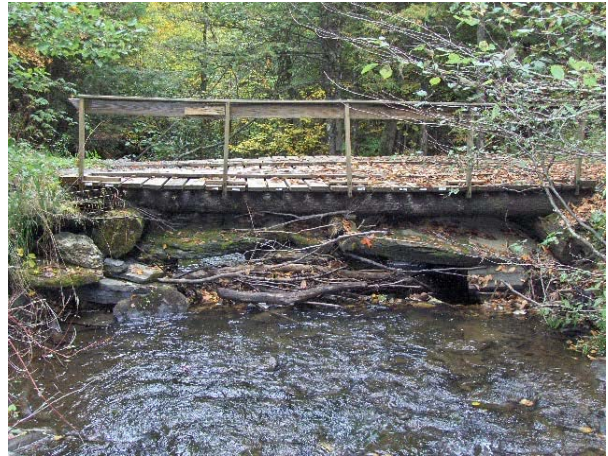
Bridge Clearance: 2.5 feet

Bridge Span: 2.8

**Geomorphic Compatibility – Not applicable**

**Priority for Replacement - High**

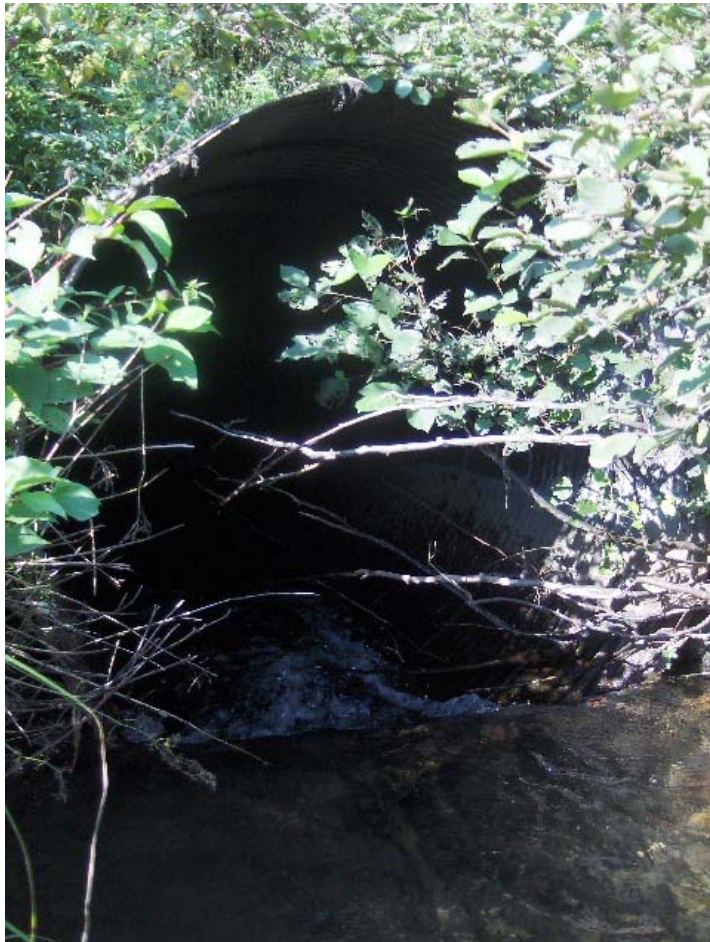
**Pekin Brook  
Moscow Woods Road  
Reach T3.09**

Culvert Length: 47 feet  
Culvert Height: 6.1 feet  
Culvert Width: 5.7 feet

**Geomorphic Compatibility – Partially Compatible**

**Priority for Replacement - Moderate**

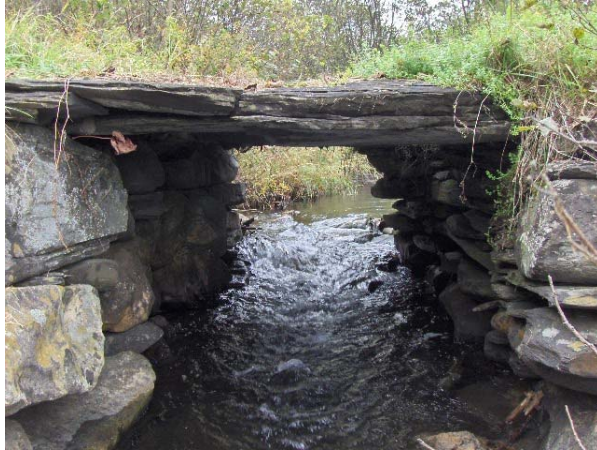
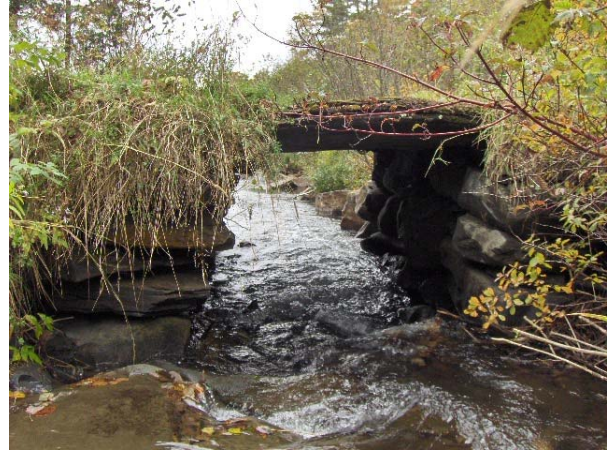
**Pekin Brook  
Private Crossing  
Segment T3.10-A**

Road Width: 12.5 feet  
Bridge Clearance: 3.6 feet  
Bridge Span: 4.4 feet

**Geomorphic Compatibility – Not applicable**

Erosion and Armoring – No erosion upstream and downstream; downstream armoring failing

**Priority for Replacement - Moderate**

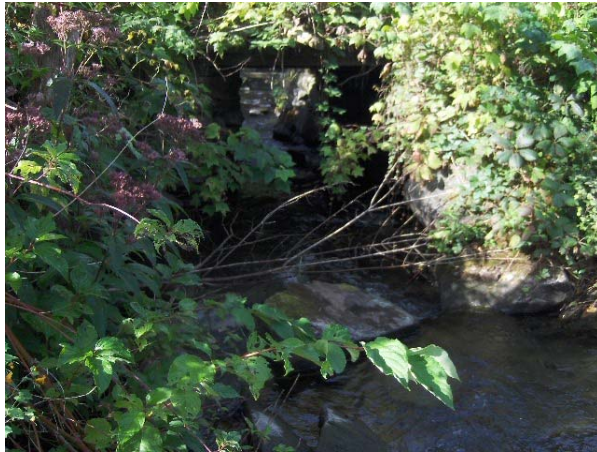
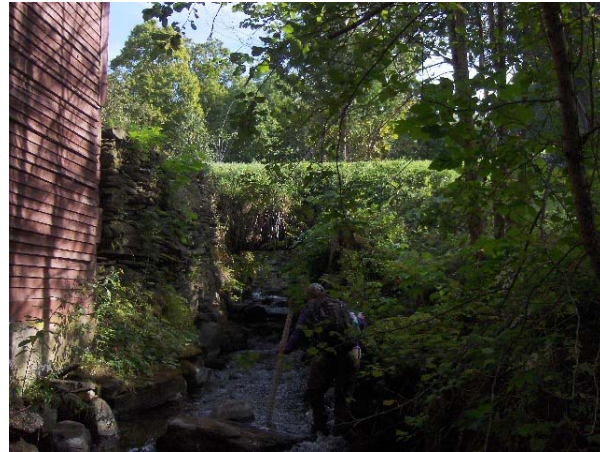
**Pekin Brook  
TH 16  
Reach T3.11**

Road Width: 17 feet  
Bridge Clearance: 6.5 feet  
Bridge Span: 6 feet

**Geomorphic Compatibility – Not applicable**

Erosion and Armoring – Upstream and downstream armoring is failing

**Priority for Replacement - Moderate**

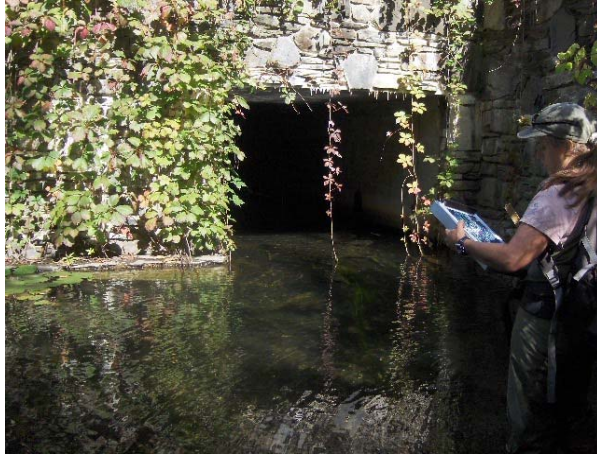
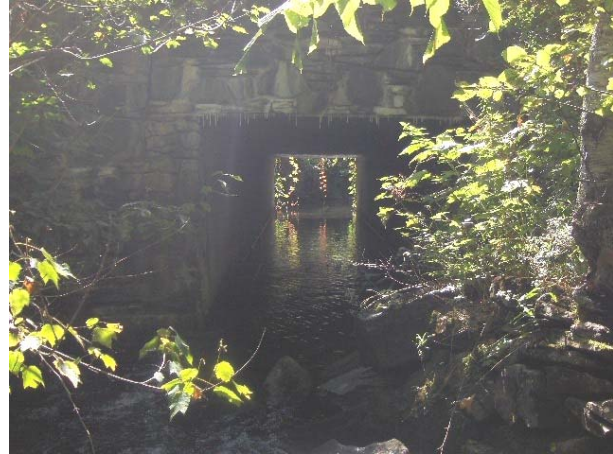
**Pekin Brook  
North Calais Road  
Reach T3.11**

Culvert Length: 50 feet  
Culvert Height: 13 feet  
Culvert Width: 9 feet

**Geomorphic Compatibility – Mostly Compatible**

**Priority for Replacement – Low**
