**Final Design Report:**  
**Long Meadow Brook Strategic Wood Additions**

Stream/Floodplain Restoration Project: for submission by Friends of the Winooski River to the Central Vermont Regional Planning Commission and Vermont Department of Environmental Conservation.

In-field scoping work completed 8/6/2024/2024 and report/project design completed 10/25/2024, by Redstart, Inc.

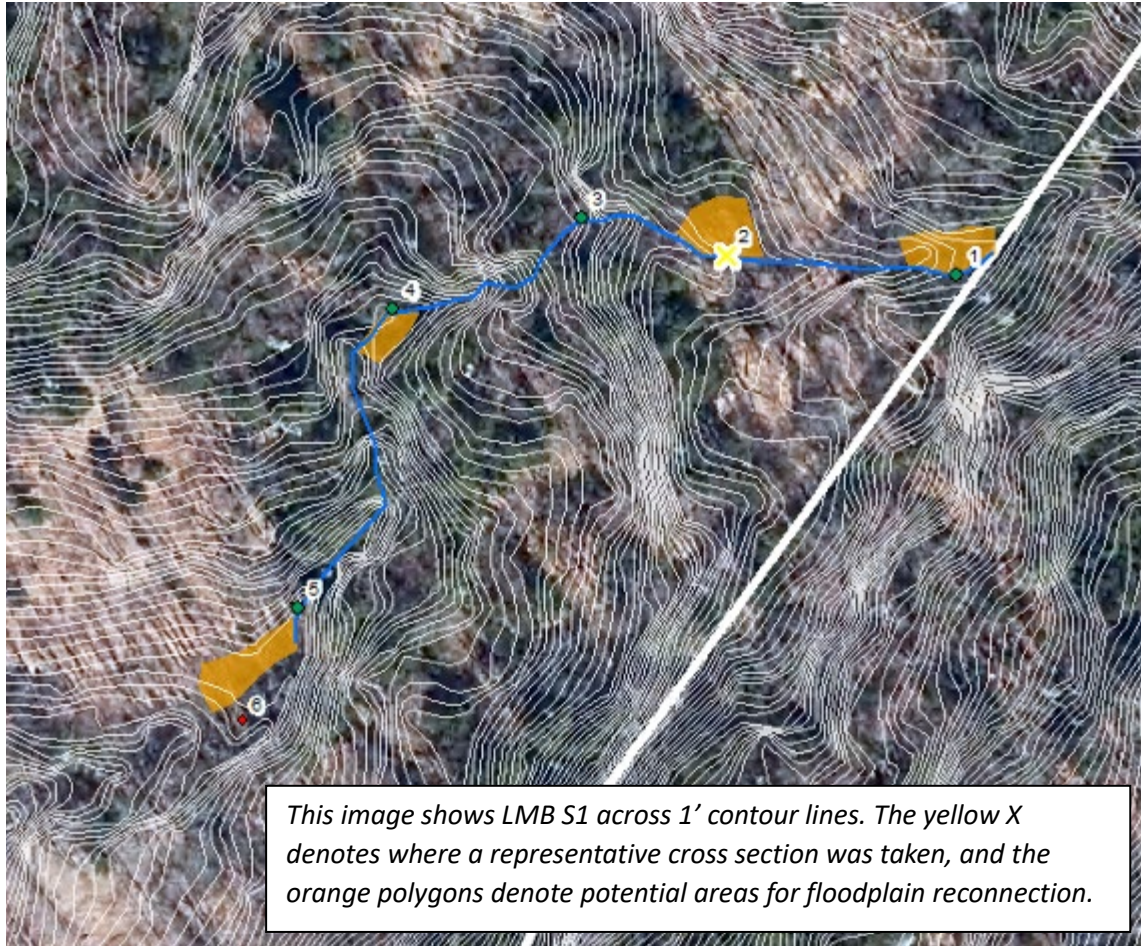
### Stream Name: LMB Segment 1

This reach of Long Meadow Brook enters the property's western boundary as a fairly large 1<sup>st</sup> order stream that flows approximately southwest. Its longitudinal corridor follows a "bead and necklace" pattern that alternates between narrow rocky cascades and more open and gradual areas with potential floodplain engagement. The downstream extent of the restoration on this reach is located where the stream reaches a relatively major floodplain at the base of Long Meadow Hill.

The landowners commented that in the 50 years that they lived by and visited the stream, it has become dramatically more incised, especially between points 1 and 2. They used to have a wooden bridge in this area, but it was washed away in 2023. Recent 100 yr+ flood events have eroded the stream significantly, and mobilized much of the existing coarse wood material (previously 1-2 pieces per 100 ft were observed) the nearest major floodplain downstream where they formed a natural wood jam at point 6. No additional wood will be needed at this location. It has evidently helped the stream better access the floodplain. However, a wood installation at point 5 will help some of this floodplain become accessed at more frequent intervals, such as a 5 yr flood events.

The main objective of restoration along this reach will be maximizing floodplain access by strategically installing wood at

locations with feasible reconnection (moderate incision and wider floodplain areas). Installations will also contribute to sediment capture in other areas while reducing peak velocity and improving habitat as secondary objectives. See SWA Inventory Sheet for more details.

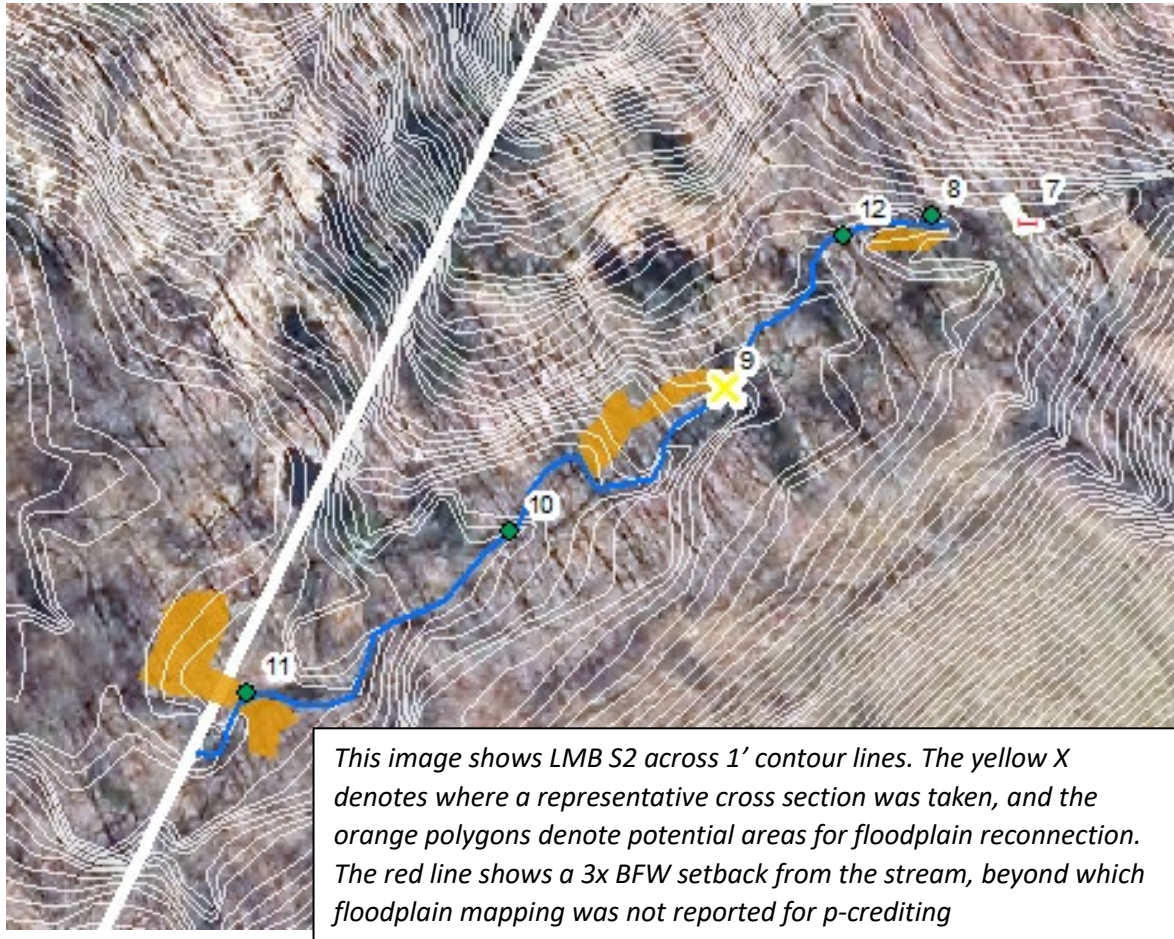
### Stream Name: LMB Segment 2

This section of Long Meadow Brook flows southwest from just downstream of a permanent foot bridge to the western parcel boundary. Its stream corridor features low gradient floodplain along its entire reach, although this floodplain has vertically uneven terraces that indicate a dynamic history of connection, abandonment, partial reconnection from major floods, and potential frequent connection from added wood.

Almost non-existent amounts of large wood indicate that evidence of recent floodplain engagement is from the severity of recent flooding, not from structural roughness. It also indicates the stream's potential power for moving wood and that structures should emphasize weight and secureness by using as large of trees as are available without causing compromising the growth and health of the riparian forest. These feasibility constraints were considered in the data collection that follows for this reach.

Restoration objectives should maximize floodplain reengagement by adding large and secure installations. During implementation this may require spacing that is more irregular than usual (100-150 ft intervals rather than 100 ft intervals), but without compromising forest cover in any particular area. See SWA Inventory sheet for more details.

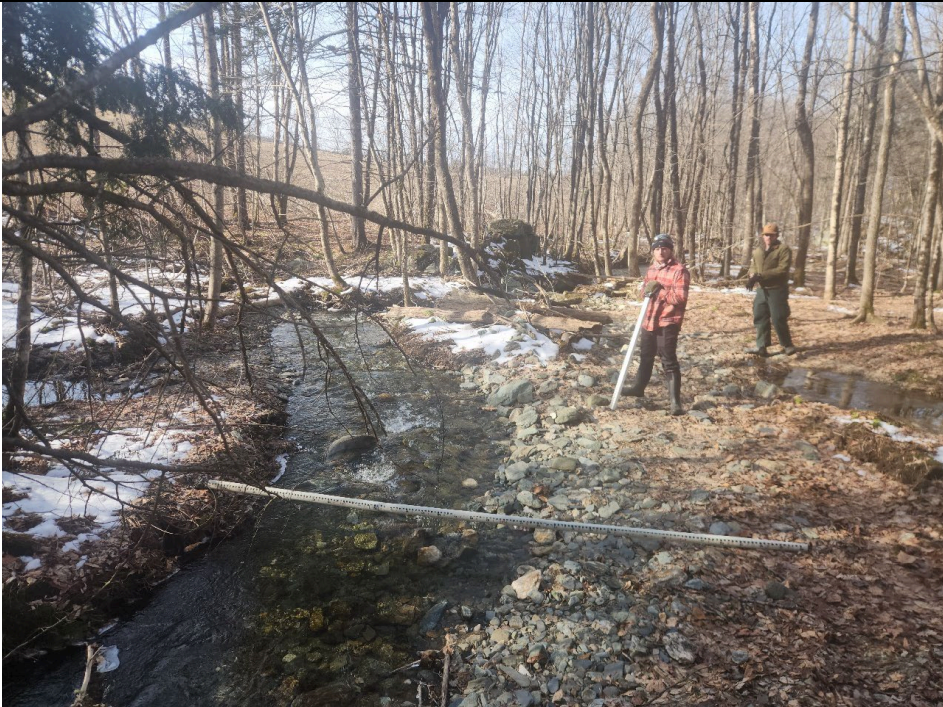
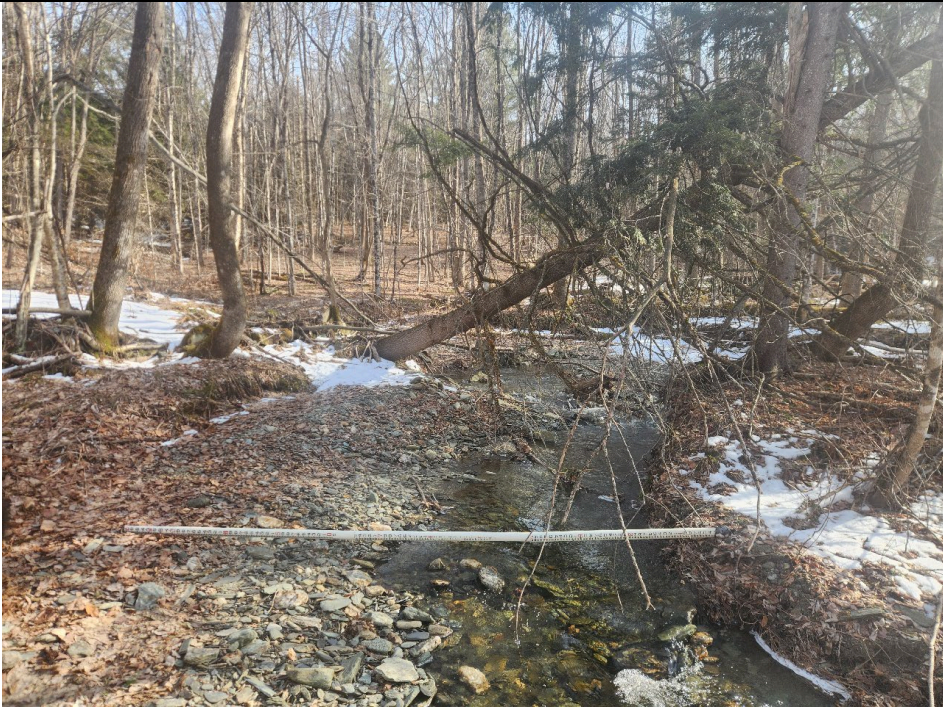
Stream Name: LMB Segment 2	FID(see map): 27	Coordinates: 44.3318,-72.5478	
Bank full width (ft): 10	Brook trout presence: Unknown	Avg.#CWM per 100 ft: 0	
Slope (looking upstream): 5%	Dominant substrate: Cobble	Riparian forest type: Hardwoods	Avg. DBH of riparian trees: 10-12"
Corridor type: lowgradefloodplain	Bank full height (ft): 1.25	Low floodplain Elevation (ft): 1.75	Incision Ratio: 1.4
Feasible floodplain reconnection: YRB	Predicted height of structure (ft): 2.5	Checkpoint log: no	
Surveyor: FL(4/2/25)	Notes: Resurvey point

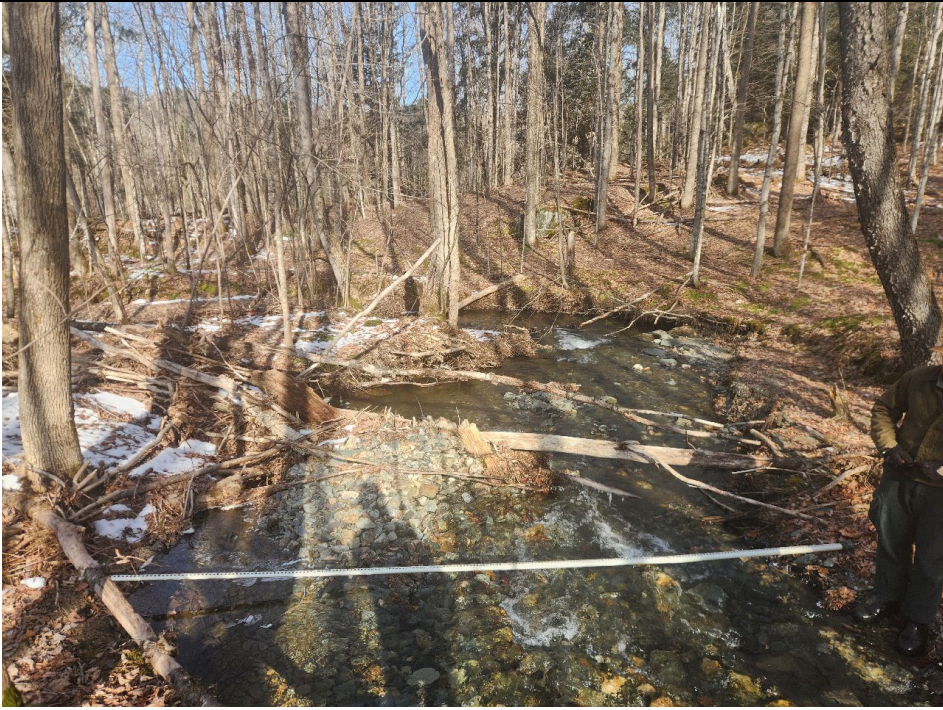
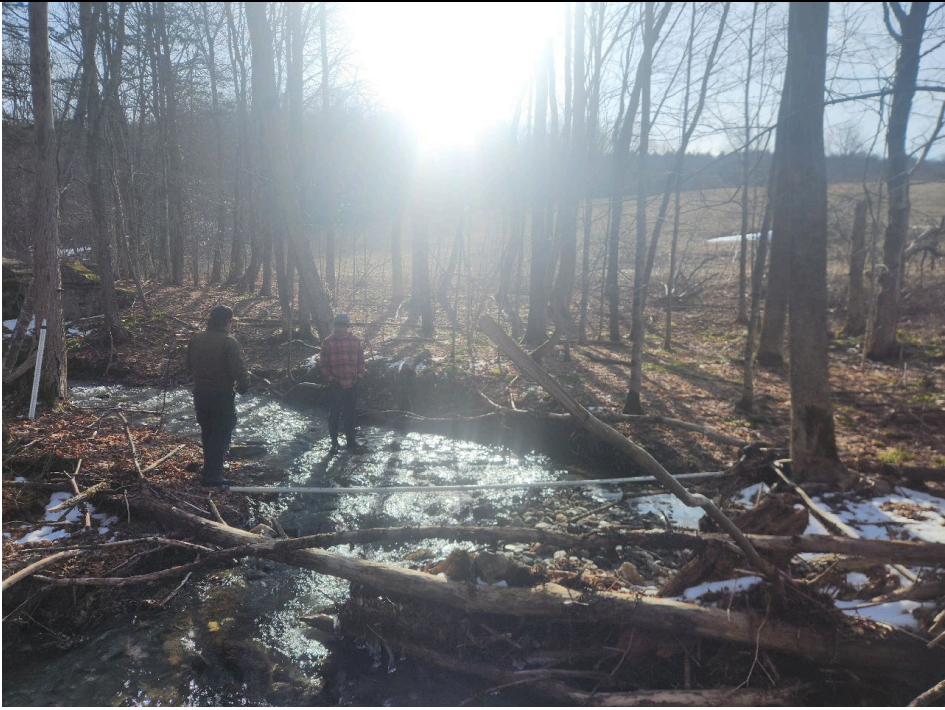
Stream Name: LMB Segment 2	FID(see map): 28	Coordinates: 44.3314,-72.5483	
Bank full width (ft): 17	Brook trout presence: Unknown	Avg.#CWM per 100 ft: 0	
Slope (looking upstream): 5%	Dominant substrate: Cobble	Riparian forest type: Hardwoods	Avg. DBH of riparian trees: 10-12"
Corridor type: lowgradefloodplain	Bank full height (ft): 0.9	Low floodplain Elevation (ft): 1.1	Incision Ratio: 1.22
Feasible floodplain reconnection: YLB	Predicted height of structure (ft): 2.5	Checkpoint log: yes	
Surveyor: FL(4/2/2025)	Notes: Resurvey Point

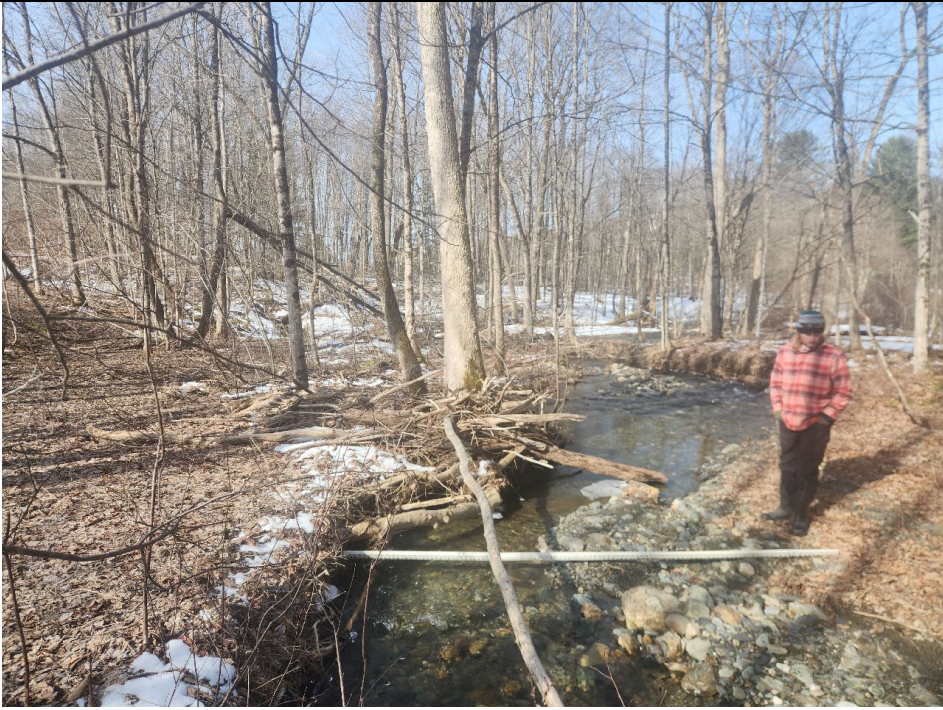
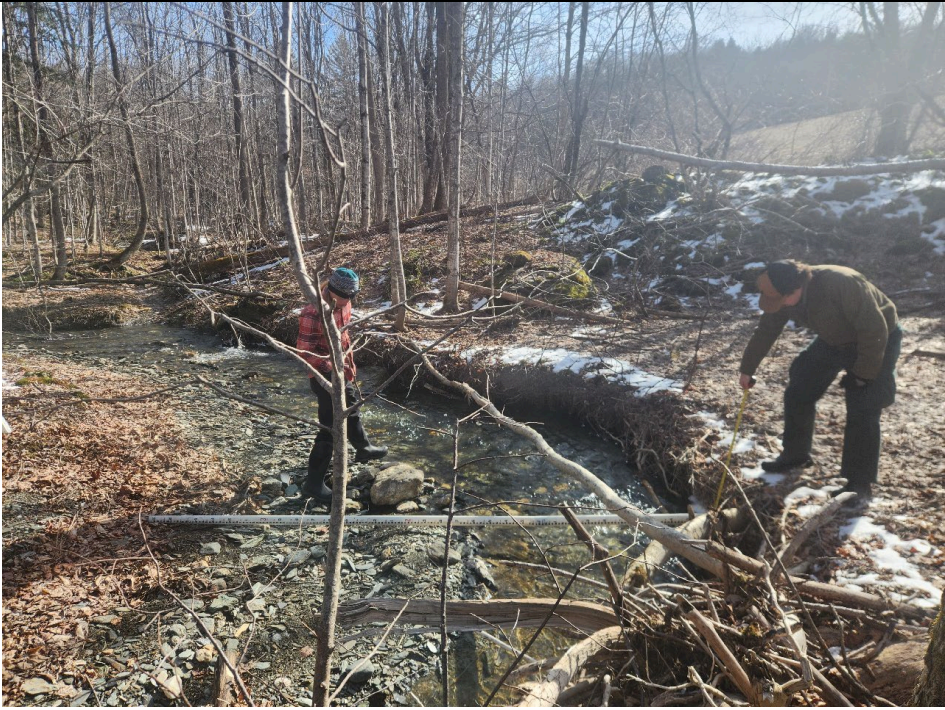
Stream Name: LMB Segment 2	FID(see map): 29	Coordinates: 44.3312,-72.5487	
Bank full width (ft): 9.7	Brook trout presence: Unknown	Avg.#CWM per 100 ft: 0	
Slope (looking upstream): 5%	Dominant substrate: Cobble	Riparian forest type: Hardwoods	Avg. DBH of riparian trees: 10-12”
Corridor type: lowgradefloodplain	Bank full height (ft): 1.2	Low floodplain Elevation (ft): 1.9	Incision Ratio: 1.58
Feasible floodplain reconnection: YLB	Predicted height of structure (ft): 2.5	Checkpoint log: no	
Surveyor: FL(4/2/2025)	Notes: Resurvey Point

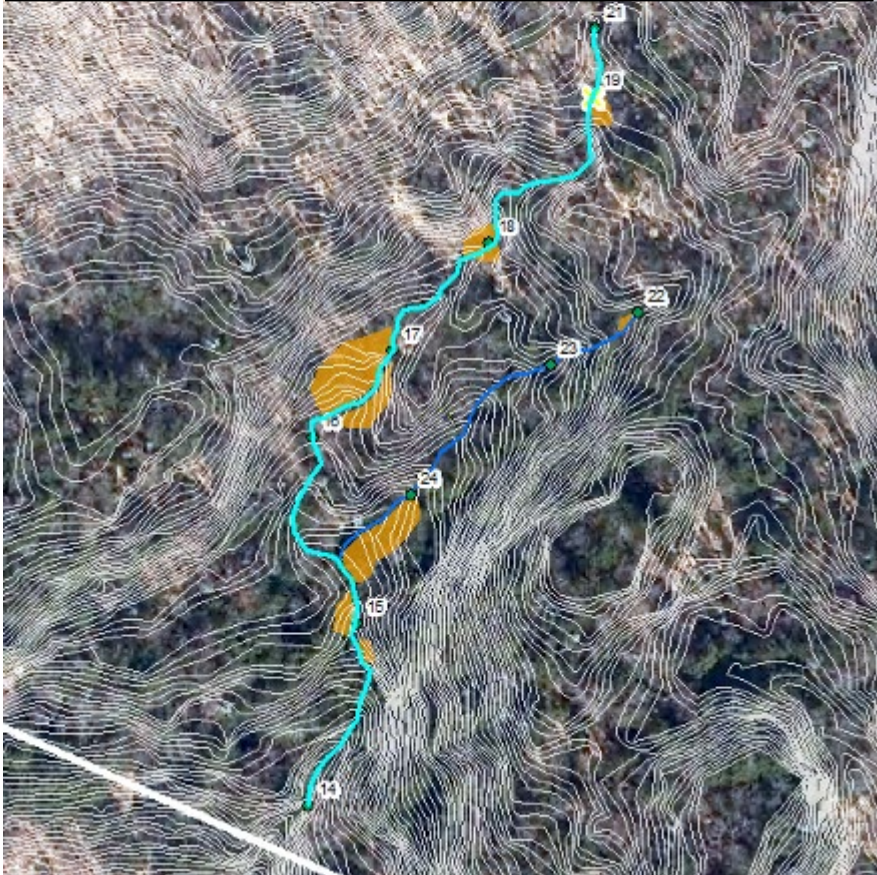
*This image shows LMB Trib 1 (highlighted in brighter blue) across 1' contour lines. The yellow X denotes where a representative cross section was taken, and the orange polygons denote potential areas for floodplain reconnection. The red lines show a 3x BFW setback from the stream, beyond which floodplain mapping was not reported for p-crediting*

This 1<sup>st</sup> order stream flows south along a corridor that features high gradient floodplains and steady moderate slopes. It was noted that many drainages upstream of this stream experienced severe washouts in 2023, and lots of sediment was deposited upstream of point 21 where the reach begins.

2023 flooding had dramatic impacts along this stream, resulting in severe incision at certain locations and deposition of cobble, gravel, and sediment in others. A small wood jam has begun to occur at point 17 and this could be fortified by SWA to provide an obstacle that more frequently connects the downstream floodplain.

Floodplain reconnection would be the primary restoration objective along this reach. Most assessment points had feasible opportunities for floodplain reconnection. A few other areas had incision ratios that were greater than 2 that would likely be infeasible for locations for SWA to engage the floodplains. However, installing structures at regular 100 ft intervals that mostly align with floodplain reconnection, while in other locations reducing incision and providing stability and improved habitat will have a positive impact on the stream. See SWA Inventory Sheet for more details.

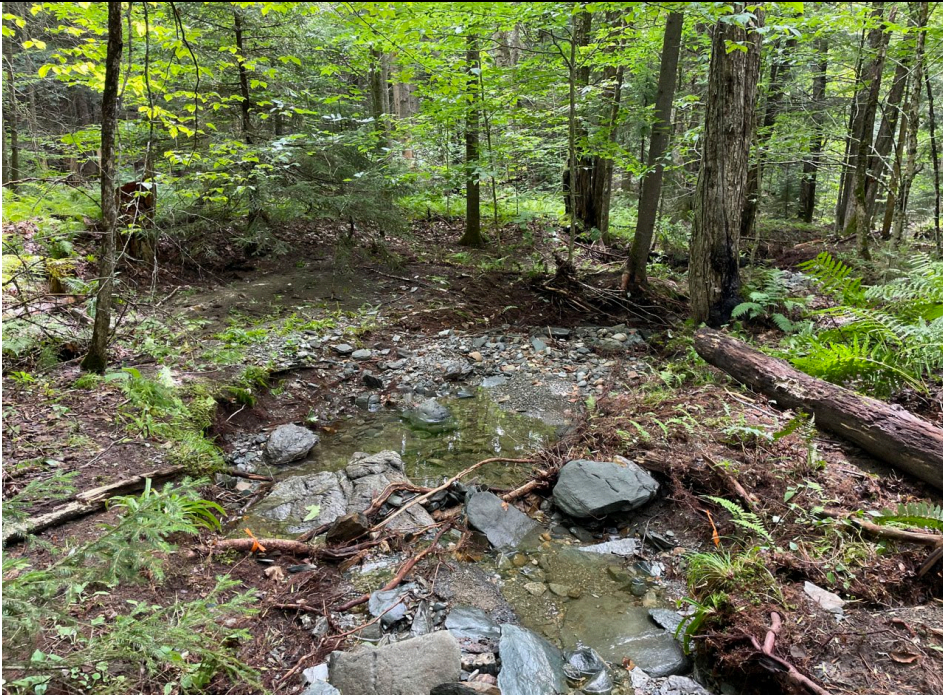
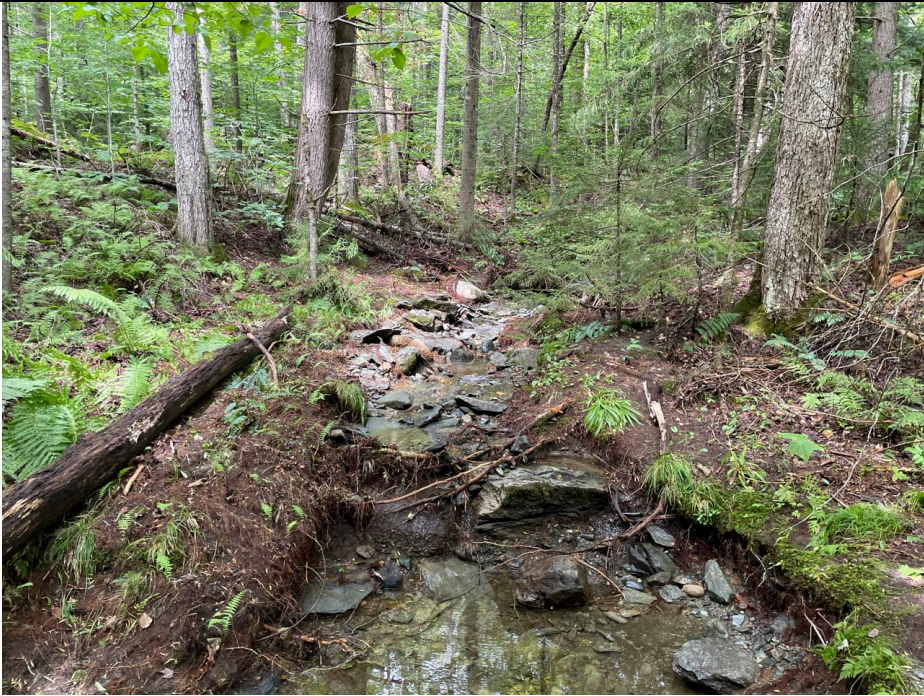
Stream Name: LMB Trib 1	FID(see map): 18	Coordinates: 44.334483, -72.549464	
Bank full width (ft): 6	Brook trout presence: Unknown	Avg.#CWM per 100 ft: 0	
Slope (looking upstream): 7%	Dominant substrate: Cobble	Riparian forest type: Mixed Woods	Avg. DBH of riparian trees: 10-12”
Corridor type: highgradefloodplain	Bank full height (ft): 0.8	Low floodplain Elevation (ft): 1.2	Incision Ratio: 1.5
Feasible floodplain reconnection: YBB	Predicted height of structure (ft): 1.5	Checkpoint log: no	
Surveyor: JK(8/6/2024)	Notes:

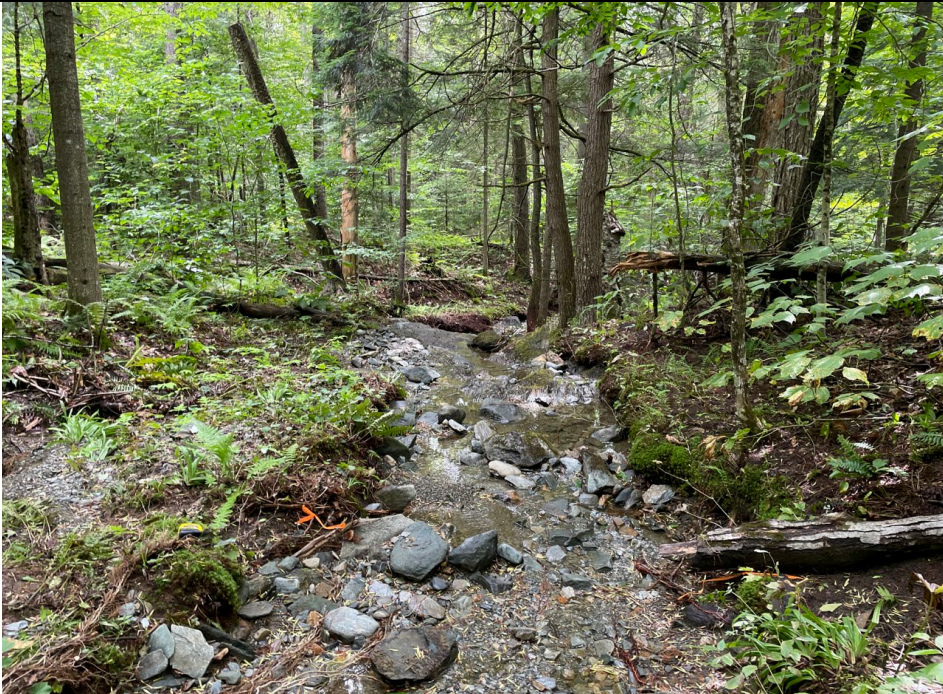
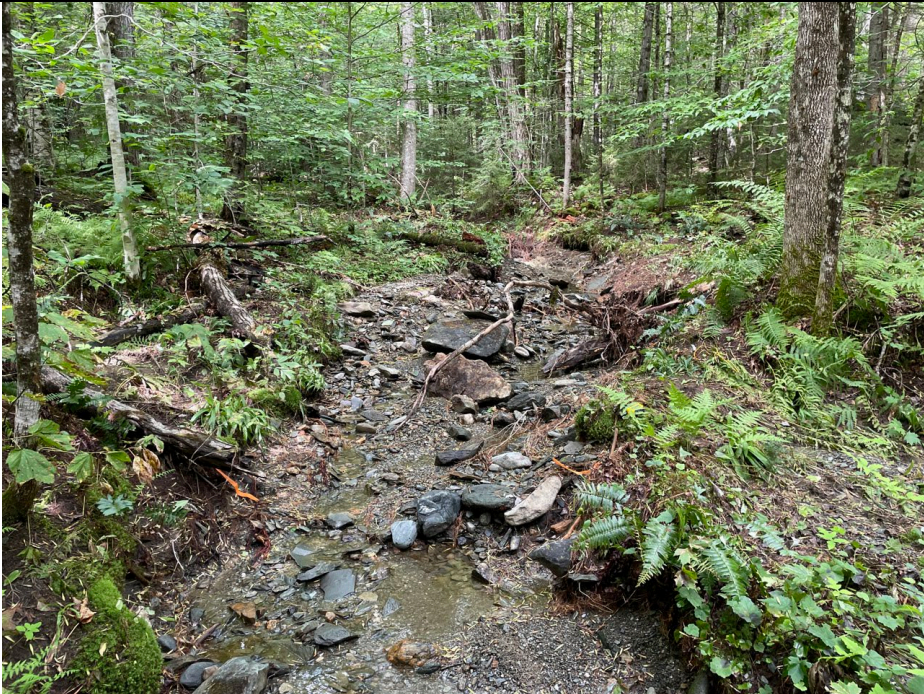
Stream Name: LMB Trib 1	FID(see map): 19	Coordinates: 44.334834, -72.54919	
Bank full width (ft): 6	Brook trout presence: Unknown	Avg.#CWM per 100 ft: 0	
Slope (looking upstream): 3%	Dominant substrate: Cobble	Riparian forest type: Mixed Woods	Avg. DBH of riparian trees: 12-18"
Corridor type: lowgradefloodplain	Bank full height (ft): 1	Low floodplain Elevation (ft): 1.2	Incision Ratio: 1.2
Feasible floodplain reconnection: YLB	Predicted height of structure (ft): 1.5	Checkpoint log: no	
Surveyor: JK(8/6/2024)	Notes: Typical point along reach

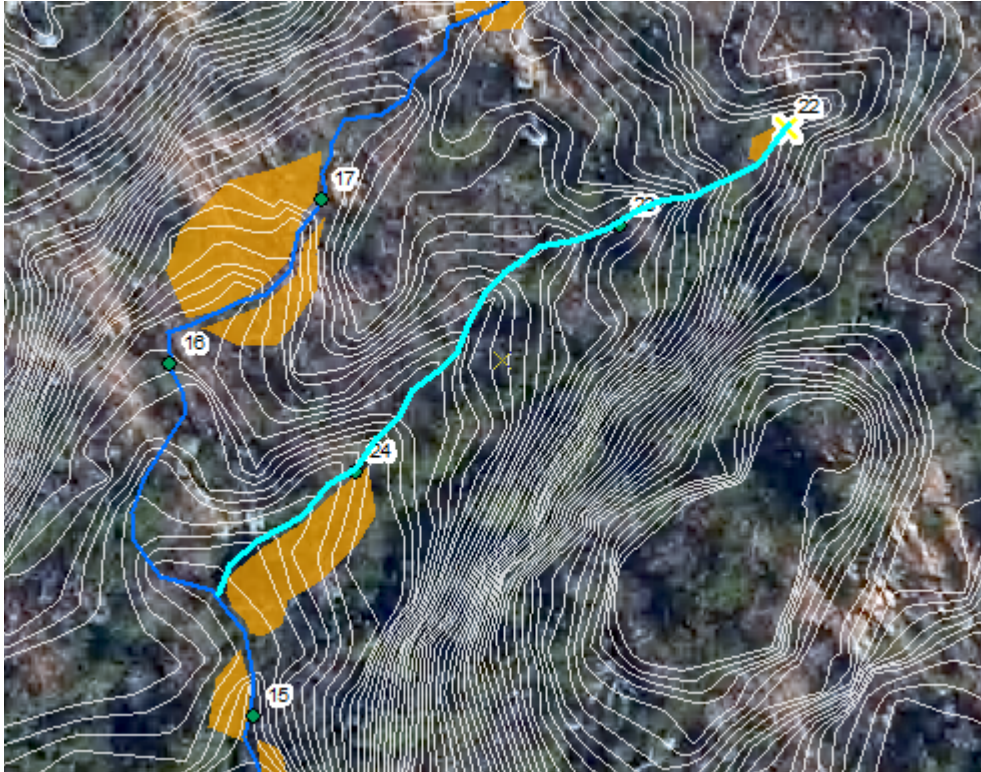
*This image shows LMB Trib 2 across 1' contour lines. The yellow X denotes where a representative cross section was taken, and the orange polygons denote potential areas for floodplain reconnection. The red lines show a 3x BFW setback from the stream, beyond which floodplain reconnection was not reported for p-crediting.*

Despite having a very small drainage area of 8 acres, this 1<sup>st</sup> order stream has undergone significant widening and deepening recently, and also clearly exported a log of sediments. This is likely to continue and worsen as it has become more incised.

Although it is not a long proposed area of stream restoration, there are some significant areas for floodplain restoration along the reach. Along the middle section of the reach where the stream is steepest and most incised, wood additions will not create floodplain access but will help to reduce peak velocities and prevent further erosion. See SWA inventory sheet for more details.

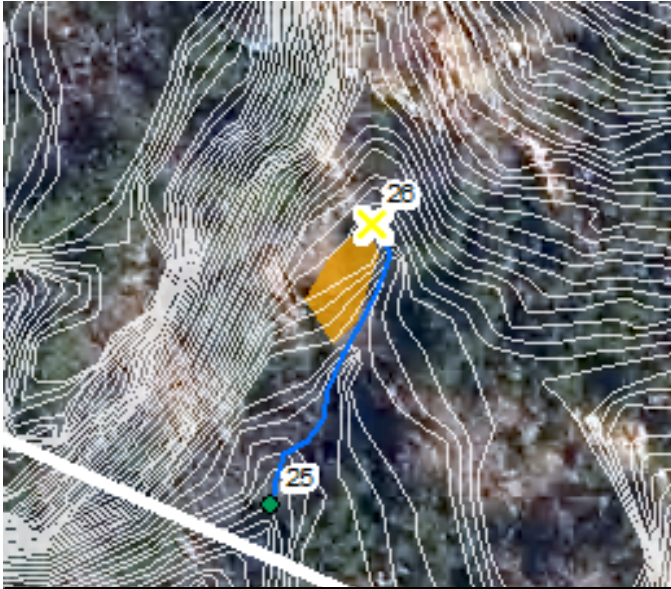
*This image shows LMB Trib 3 across 1' contour lines. The yellow X denotes where a representative cross section was taken, and the orange polygons denote potential areas for floodplain reconnection. The red line shows where a 3x BWF setback was applied to constrain crediting of floodplain reconnection.*

Similar to Trib 2, this small 1<sup>st</sup> order stream has a very small watershed that experienced severe flooding and storm flow in recent years. It has undergone worsening incision and bank erosion, which will likely worsen now that coarse wood material has been flushed away. This headcutting and bank erosion occurs mostly at and below point 26 where the planned work begins. Above this point the channel is lower slope and has adequate amounts of wood material in the channel.

SWA implementation will concentrate on floodplain engagement where it is feasible, but added wood will also benefit the stream by capturing sediment in-stream and by reducing peak velocities. See SWA inventory sheet for more details.
