Great Brook Watershed River Corridor Plan

Plainfield and Groton, Vermont
March 19, 2014

Prepared by:
Bear Creek Environmental, LLC
149 State Street, Suite 3
Montpelier, Vermont 05602

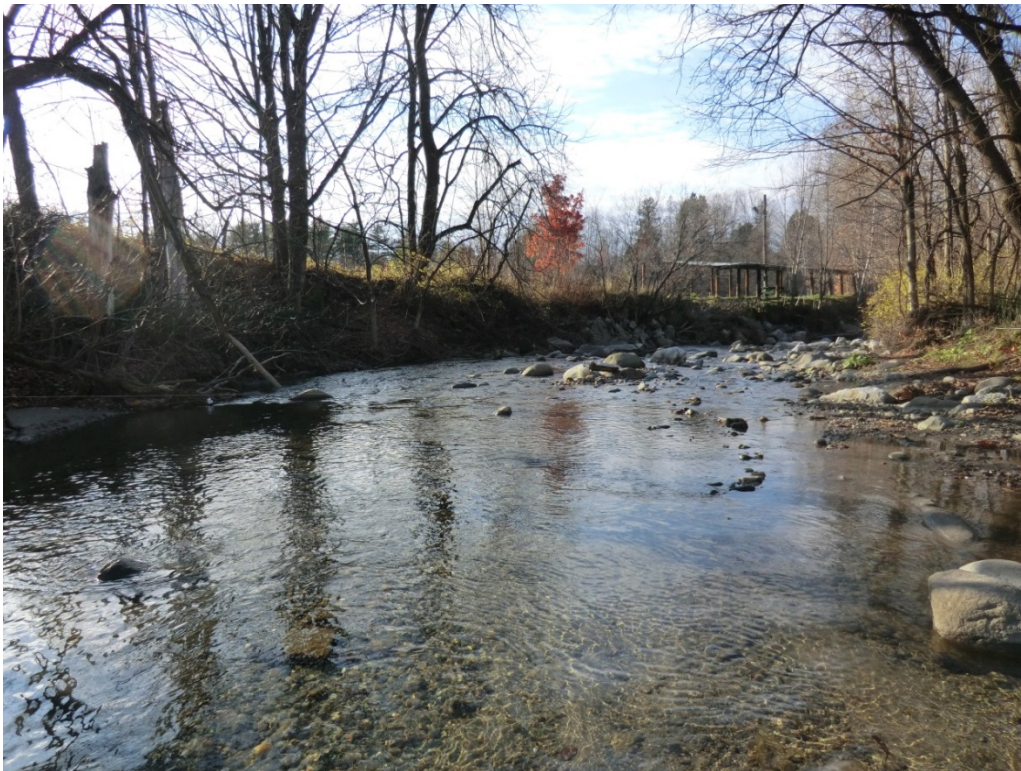
Figure 5.3. High western bank (left) in M301-A restricts floodplain access.

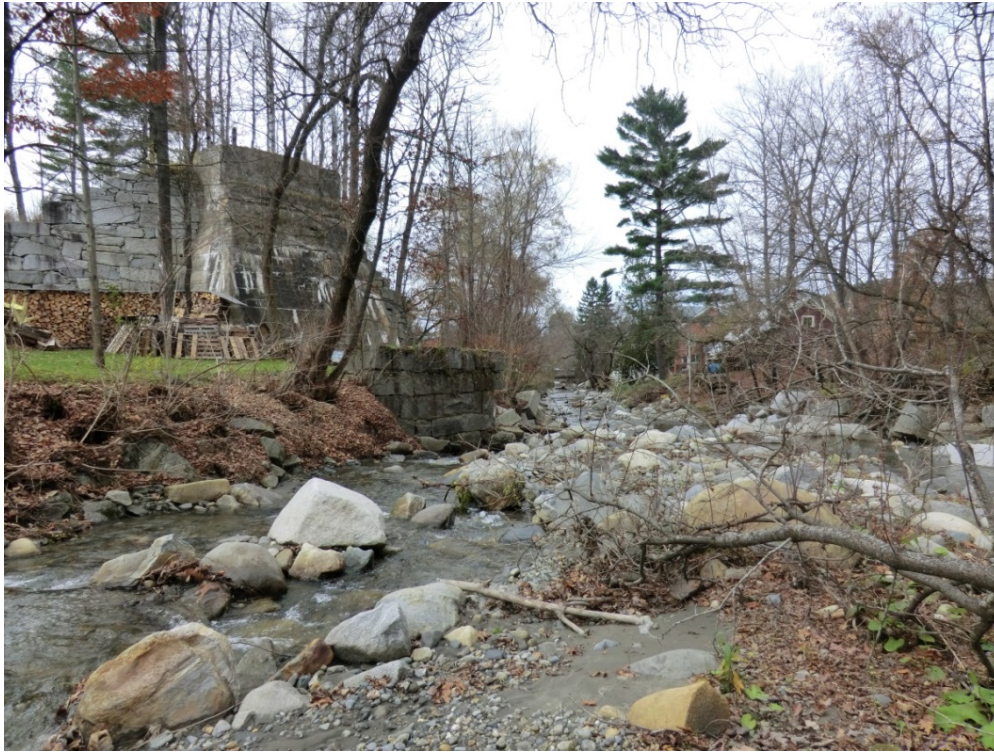
Figure 5.5. Old railroad abutment in M3.01-B may be contributing to geomorphic instability.

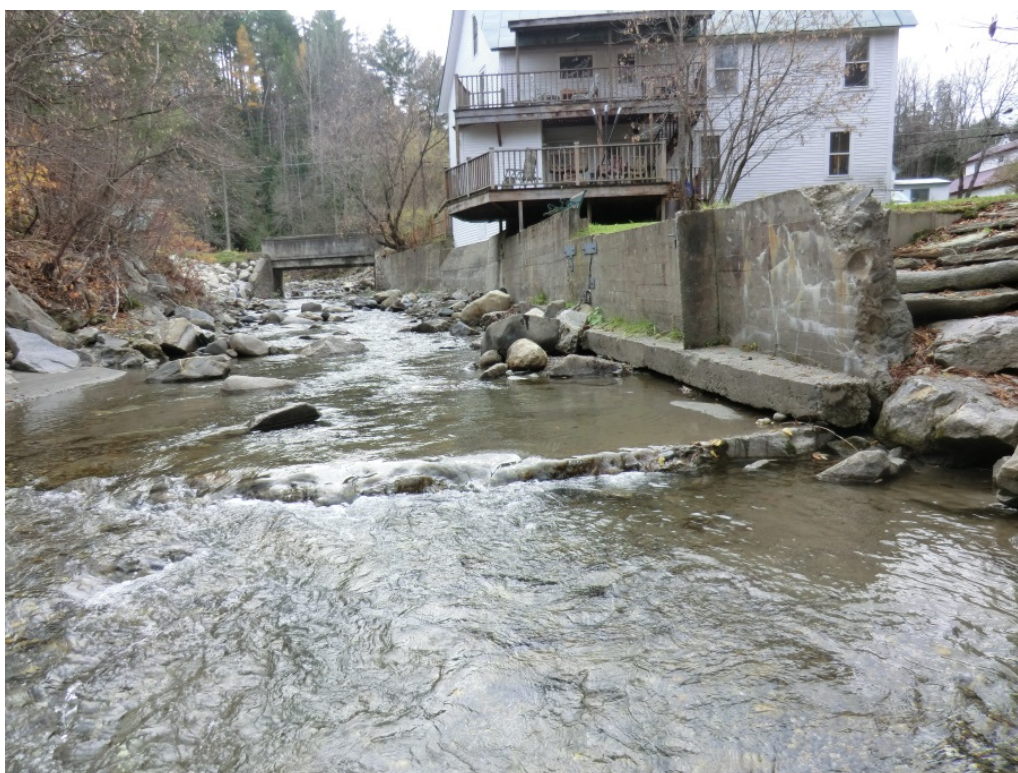
Figure 5.7. High banks and extensive armoring in M3.01-C restrict floodplain access.

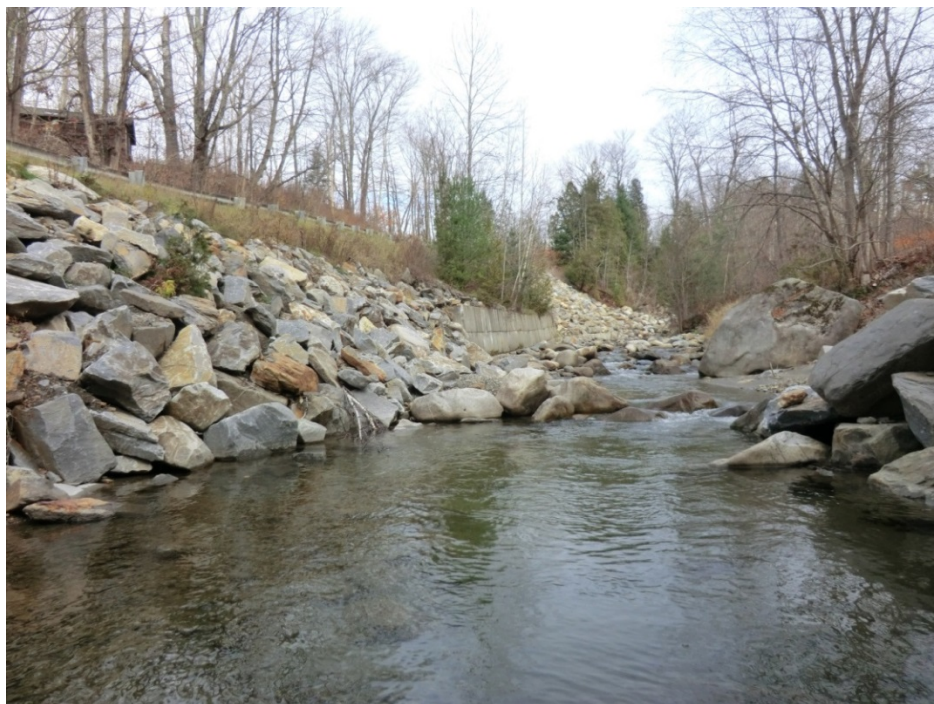
Segment M3.02-B begins about 100 feet downstream of the Brook Road crossing (near intersection with Cameron Road) and continues 1,200 feet upstream through a naturally semi-confined valley. The segment ends as the valley widens. At the downstream section of the segment, Brook Road and the Brook Road Bridge experienced damage during the May 2011, flood. This segment is in **fair** geomorphic condition and is currently undergoing major **incision**, **aggradation**, and **planform adjustment**. Widening is minor. The active incision is evident by a headcut (Figure 5.10) located mid-segment. At the downstream end of the segment, the northern valley wall is continuous with the bank, with Cameron Road running along the top of it. This area is heavily armored with either rip rap or cement blocks (Figure 5.11). M3.02-B is in

Figure 5.11. Rip rap and bank armoring along Cameron Road, looking upstream from the Brook Road Bridge.

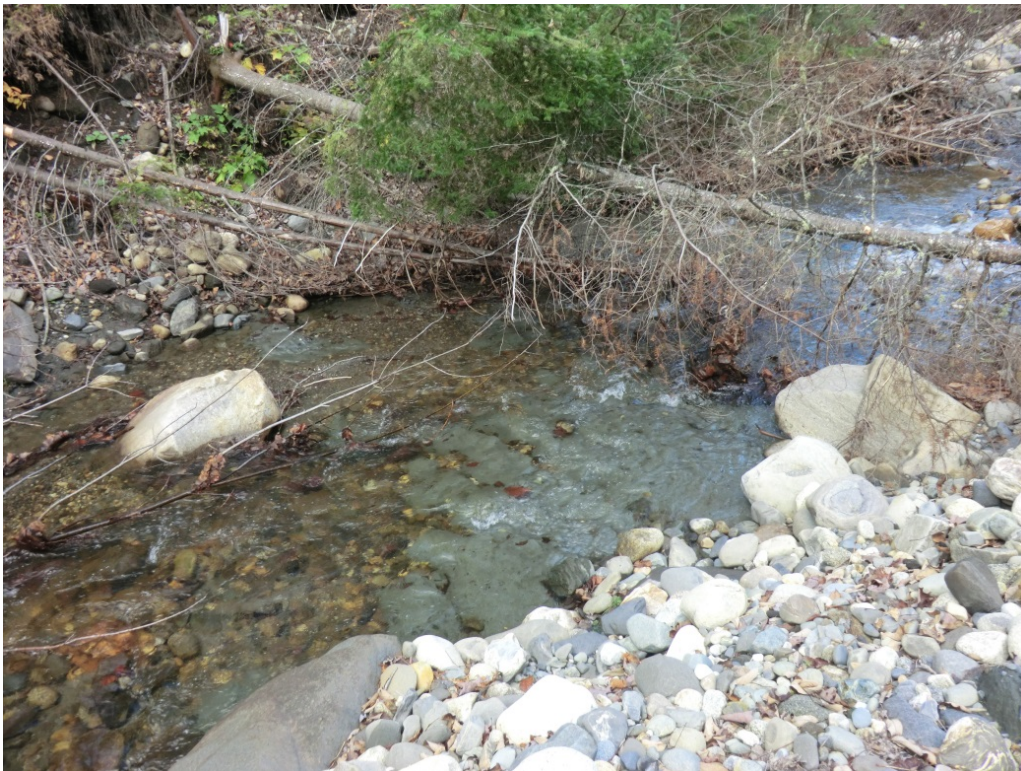
Figure 5.22. Glacial till is seen on the streambed in M3.05-A.

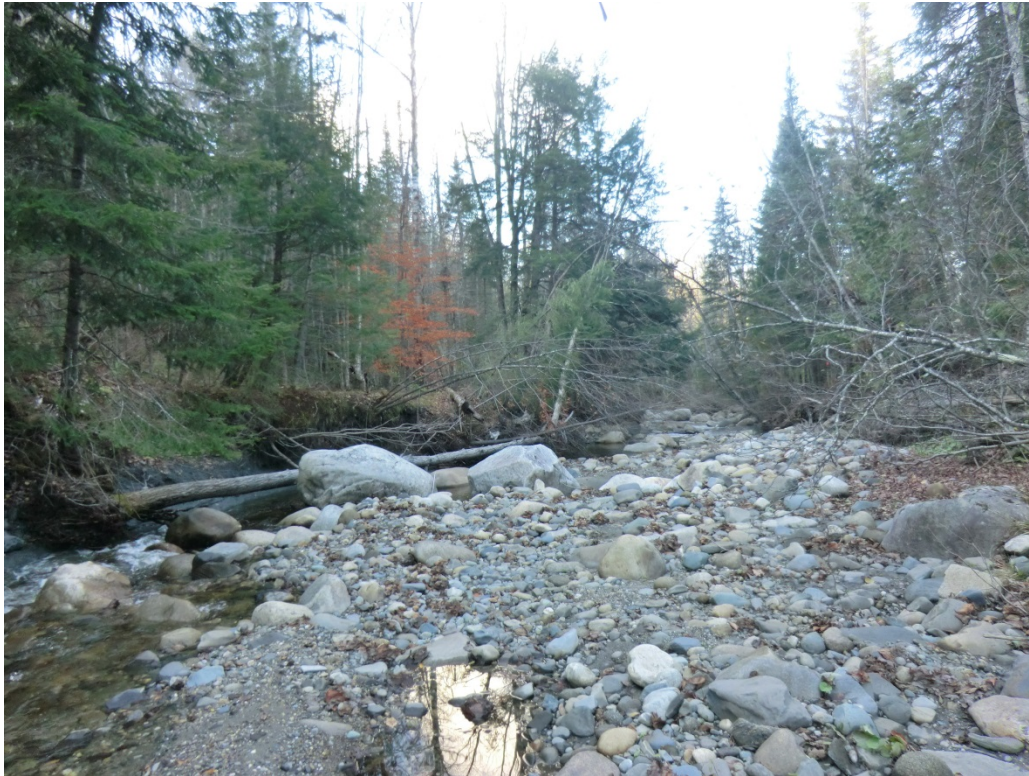
Figure 5.23. Typical view of M3.05-A shows major sediment build up.

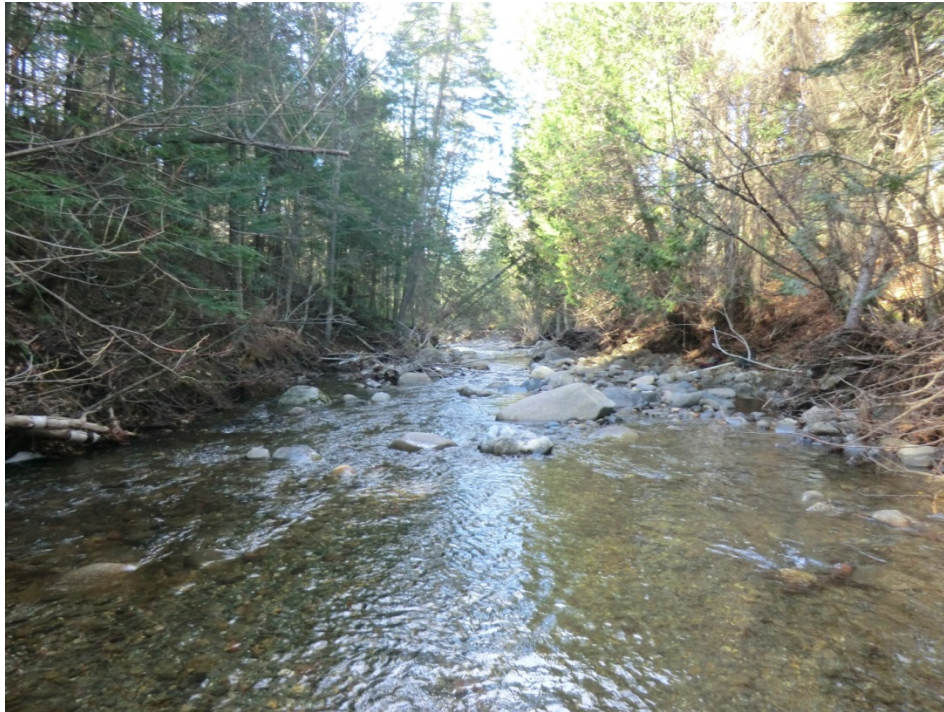
Figure 5.24. Typical channel is straight with little aggradation in M3.05-B.

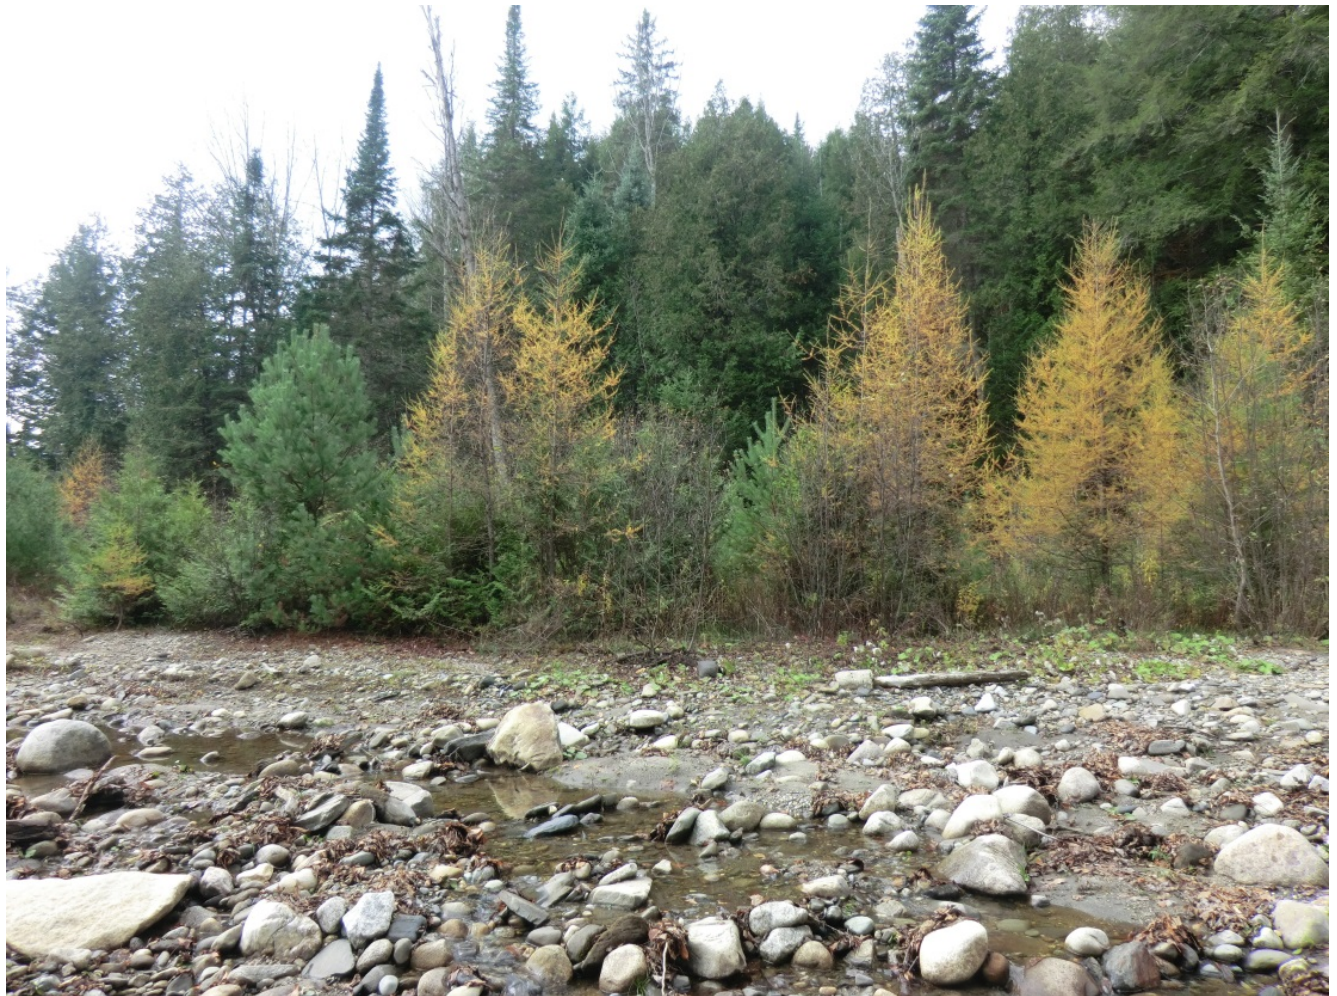
Figure 5.25. Area in M3.05-C with good floodplain access.

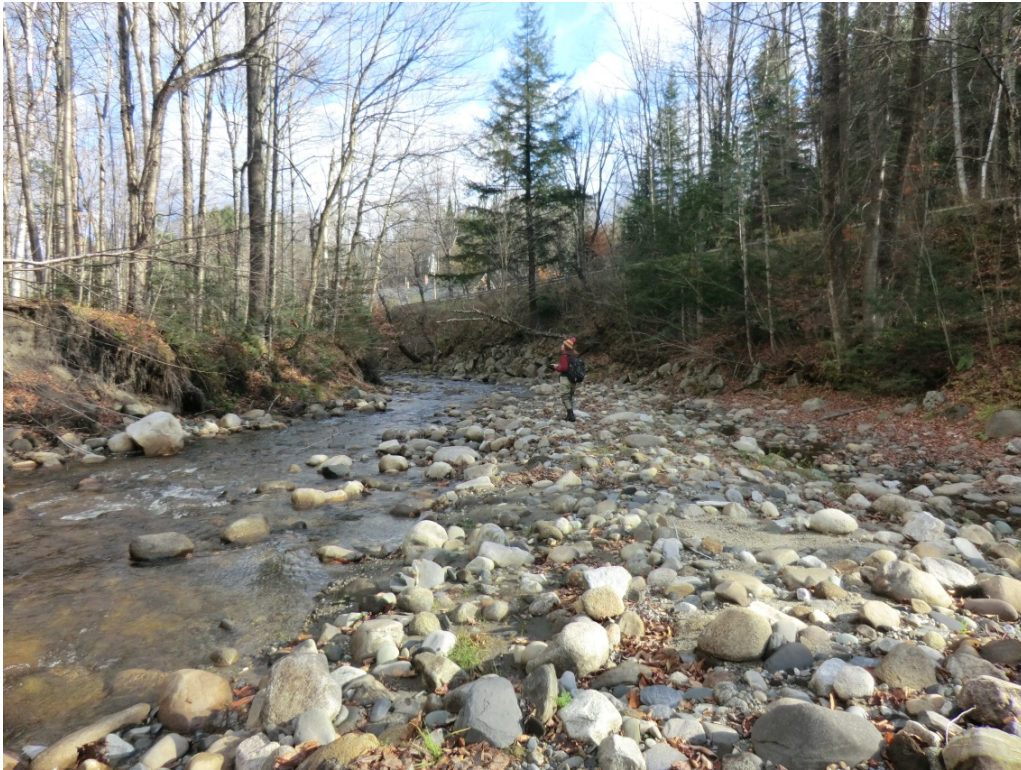
This segment begins as the Semi-Confined valley in M3.05-B opens up to a naturally Very Broad valley and continues 4,700 feet upstream to the reach break with M3.06. This is where the Very Broad valley transitions to Broad. M3.05-C could have been split into nine distinct segments; however, due to time constraints and short segment lengths the area was considered one segment. The segment displays varying degrees of departure from its reference stream type and geomorphic equilibrium. The reference stream type is a C. In general, the stream channel in this segment alternated several times between a C stream type with great floodplain access (Figure 5.25) and areas that exhibit a stream type departure to an F or B stream type with reduced floodplain access (Figure 5.26). The majority of the C stream type

Figure 5.26. Area in M3.05-C with limited floodplain access.

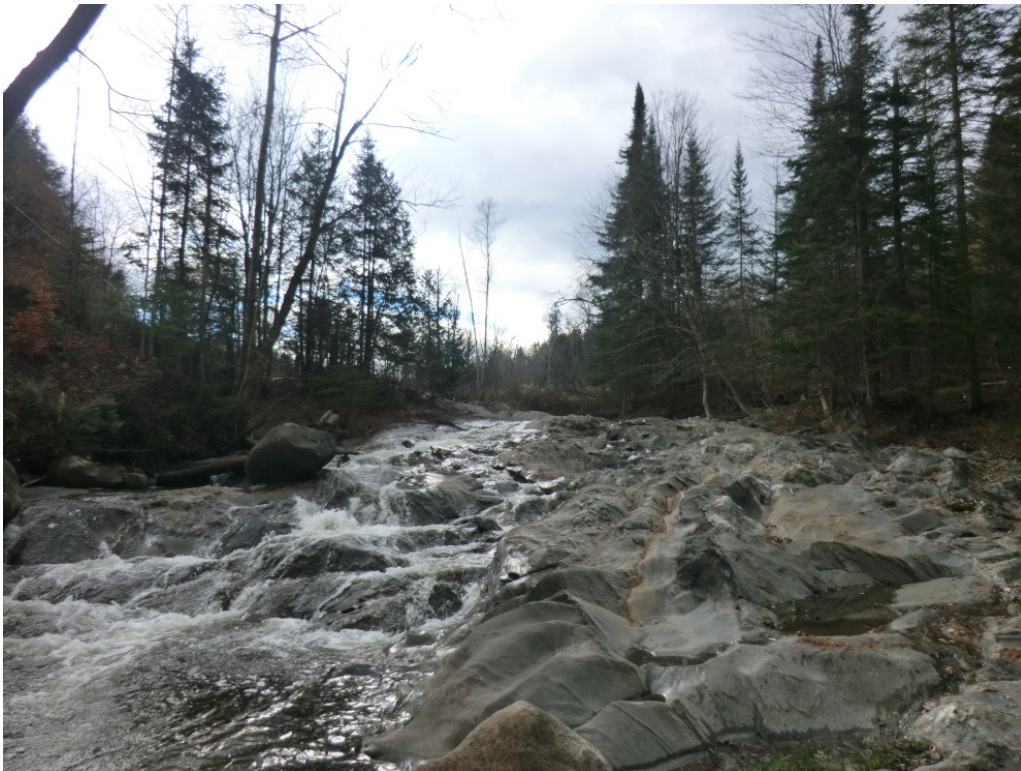
was in the downstream end of the segment. A 180-foot section of stream channel in the middle of the segment was dominated by a large grade control area just downstream of the Lee Road Bridge (Figure 5.27). The most upstream 300 feet of the reach was characterized by a step-pool dominated bedform. In general, M3.05-C is in **fair** geomorphic condition. Extreme **historic incision** has led to the stream type departure in many locations and **aggradation**, **widening**, and **planform adjustment** are major processes. Three box culverts and one bridge are all channel constrictions adding to geomorphic instability in M3.05-C. The segment is in **fair** habitat condition as a result of bank erosion contributing to large amounts of sediment in the channel.

Figure 5.27. Large grade control area downstream of Lee Road Bridge in M3.05-C.

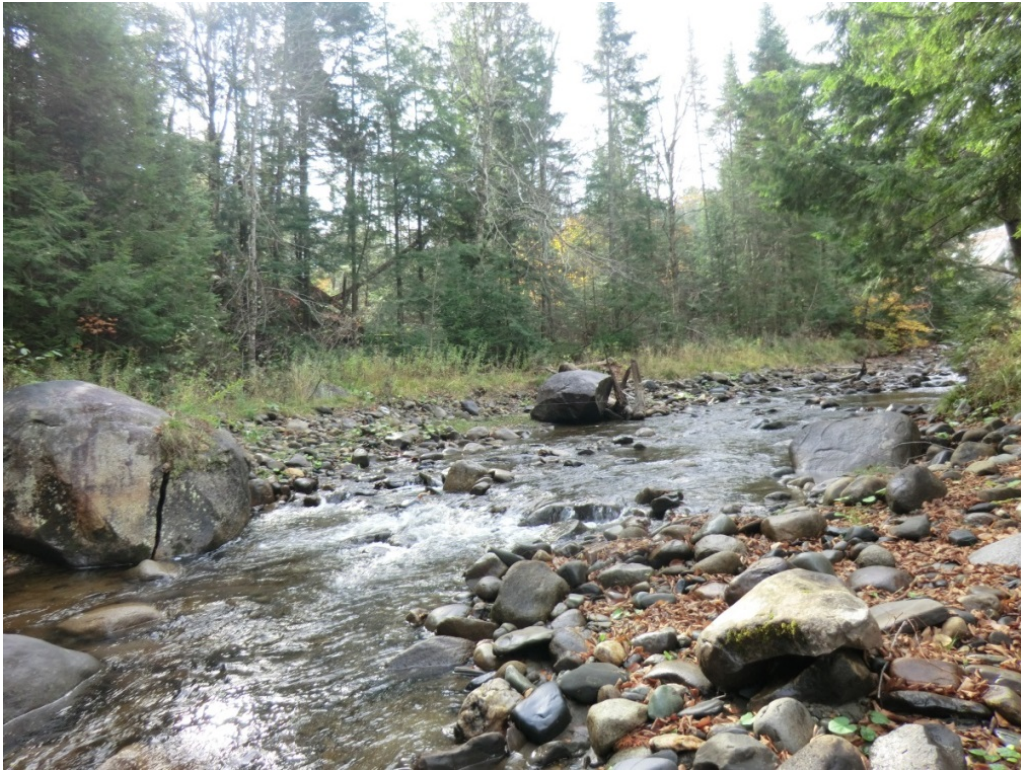
Figure 5.28. Typical channel in M3.06-A has good floodplain access and minor aggradation.

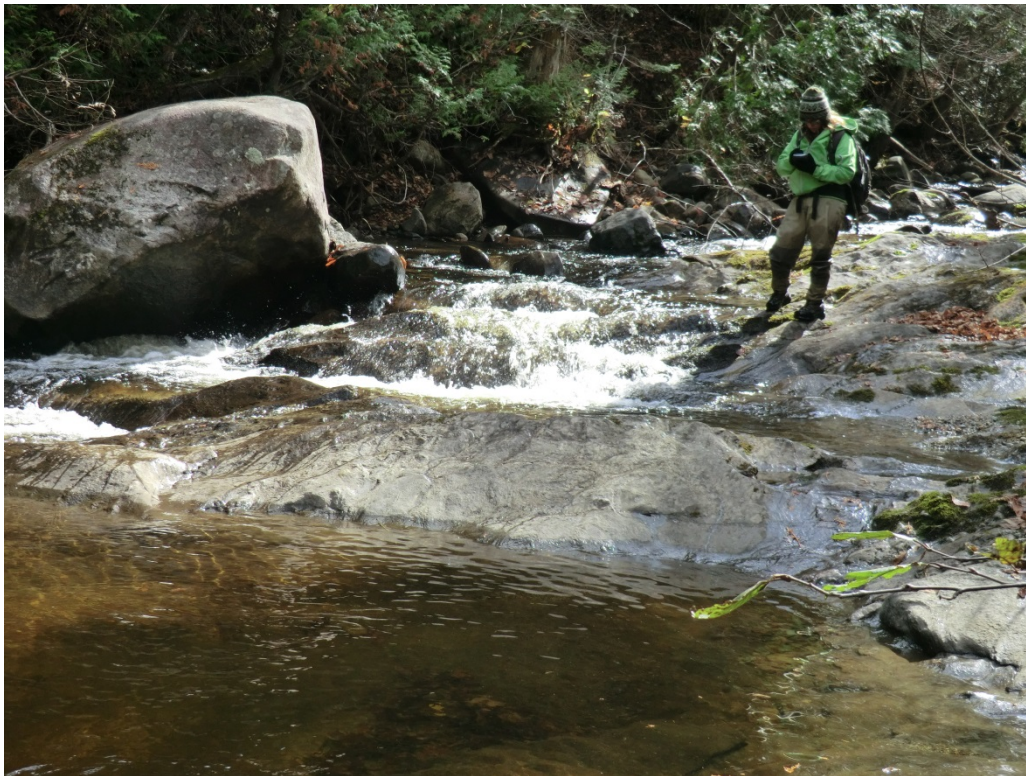
Figure 5.29. The grade control in M3.06-A is limiting vertical adjustment.

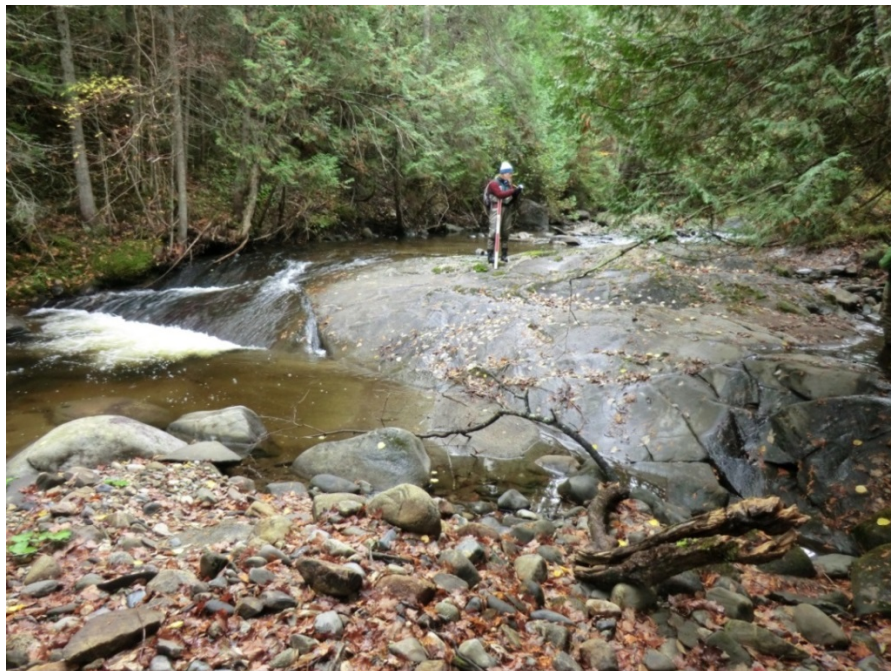
Figure 5.31. Several bedrock grade controls are limiting vertical adjustment in upstream section of M3.06-C.

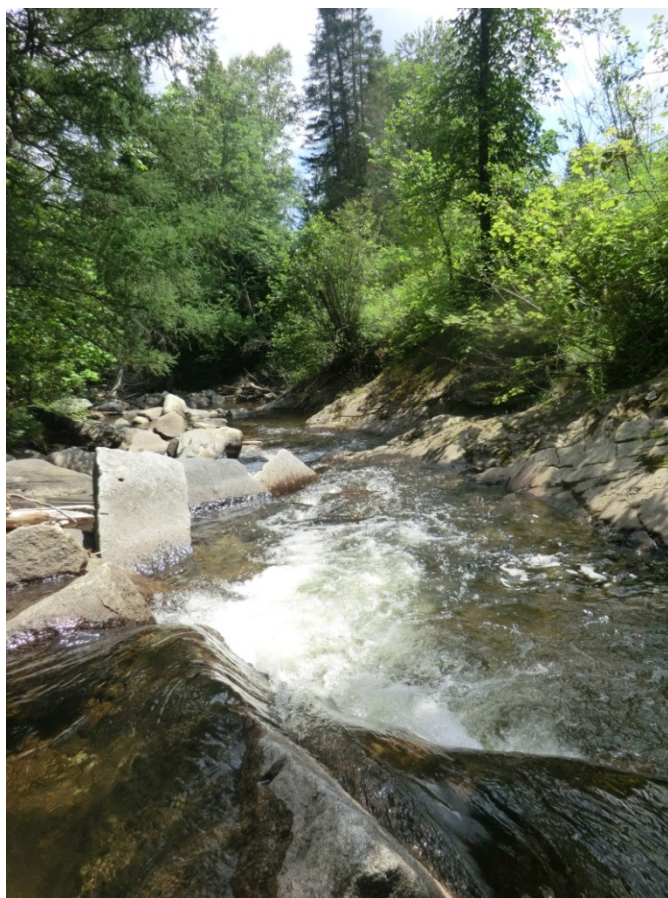
This segment begins approximately 560 feet below Maxfield Road and continues for approximately 200 feet. M3.07-A is in **fair** geomorphic condition and was very variable with an “F” or “B” stream type bedrock control section (Figure 5.32), an island area where the channel has experienced bifurcation, and a predominantly “C” stream type on the downstream end (Figure 5.33). Due to its short length of approximately 760 feet, it was not feasible to further segment based on these variations. The numerous bedrock grade controls in the upstream section are preventing incision. However, in the downstream portion where the cross section was done, the channel has undergone major **historic incision**. Aggradation and widening are minor, while **planform adjustment** is major due to the channel bifurcation around the island area. The streambanks of the segment have been impacted by exposed glacial till, mass failures (Figure 5.34), and revetments. A gully has developed along a field that is contributing sediment to the stream channel (Figure 5.35). The habitat condition in M3.07-A is **fair** due to the lack of refuge habitat and undercut banks, compromised bank vegetation from revetments, and limited large woody debris.

Figure 5.32. Bedrock grade control section in M3.07-A preventing further incision.

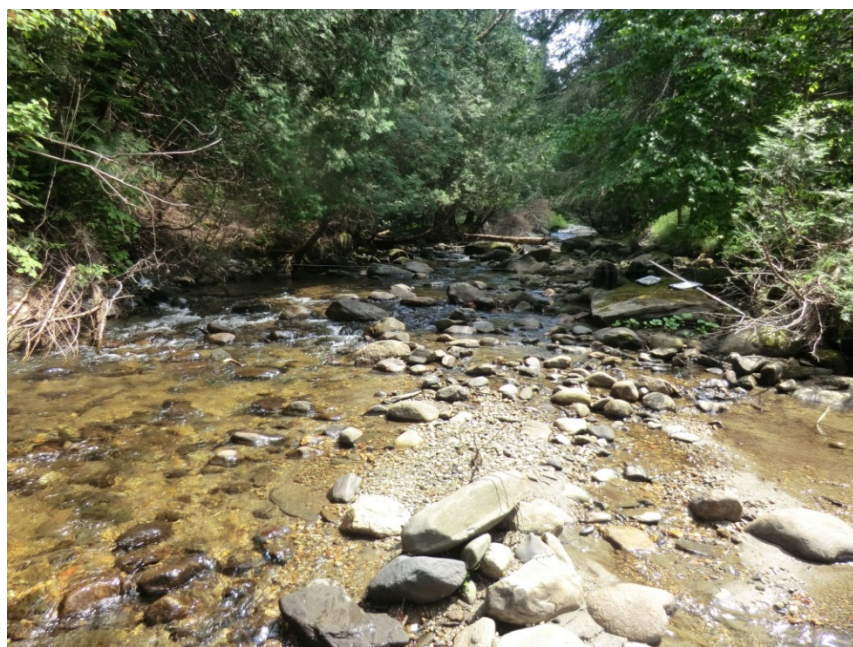
Figure 5.33. "C" stream type in M3.07-A is dominant stream type.

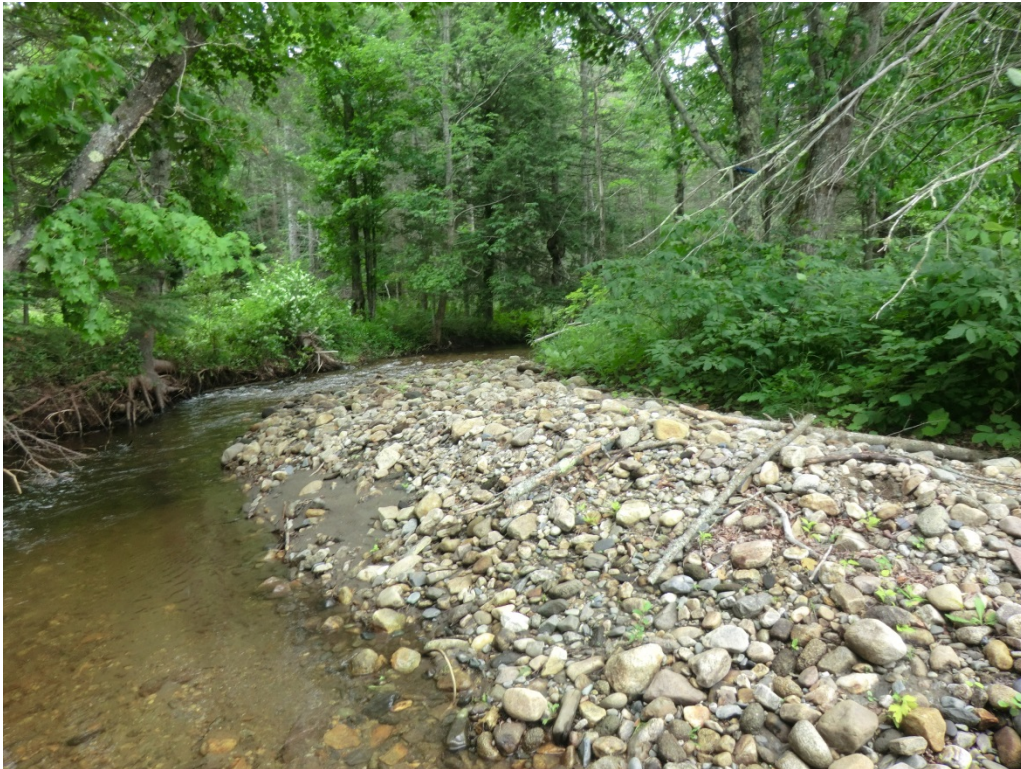
Segment M3.07-B begins 175 feet above the Maxfield Road crossing and continues until approximately 760 feet upstream of the Brook Road crossing. The majority of the segment has an eastern buffer that is inadequate due to the presence of agricultural fields. The channel has undergone major **historic degradation** as a result of channel straightening which had set off a series of events in the channel evolution process. The stream channel is experiencing major **widening**, which is exacerbated by the lack of bank and riparian buffer vegetation causing extensive bank erosion (Figure 5.36). The increase in sediment through erosion has resulted in major **aggradation** and **planform adjustment** as the channel develops flood chutes around large depositional features (Figure 5.37). Due to the extent of the processes in segment M3.07-B, it is in **fair** geomorphic condition.

Figure 5.37. Large point bar in M3.07-B leading to planform adjustment.

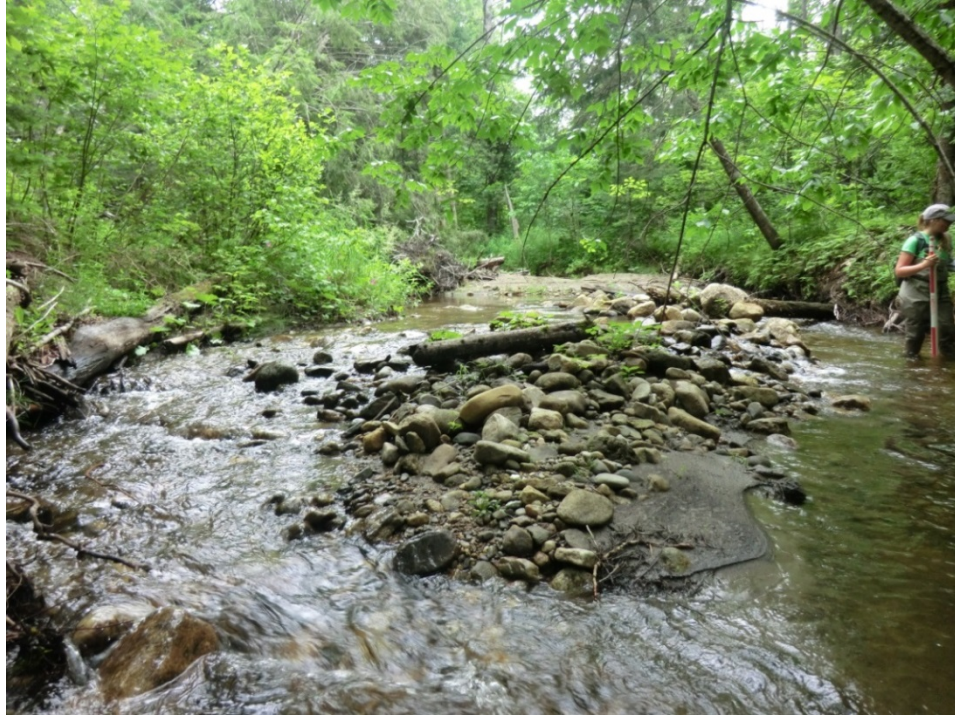
Figure 5.38. Diagonal bar in Segment M3.07-C.

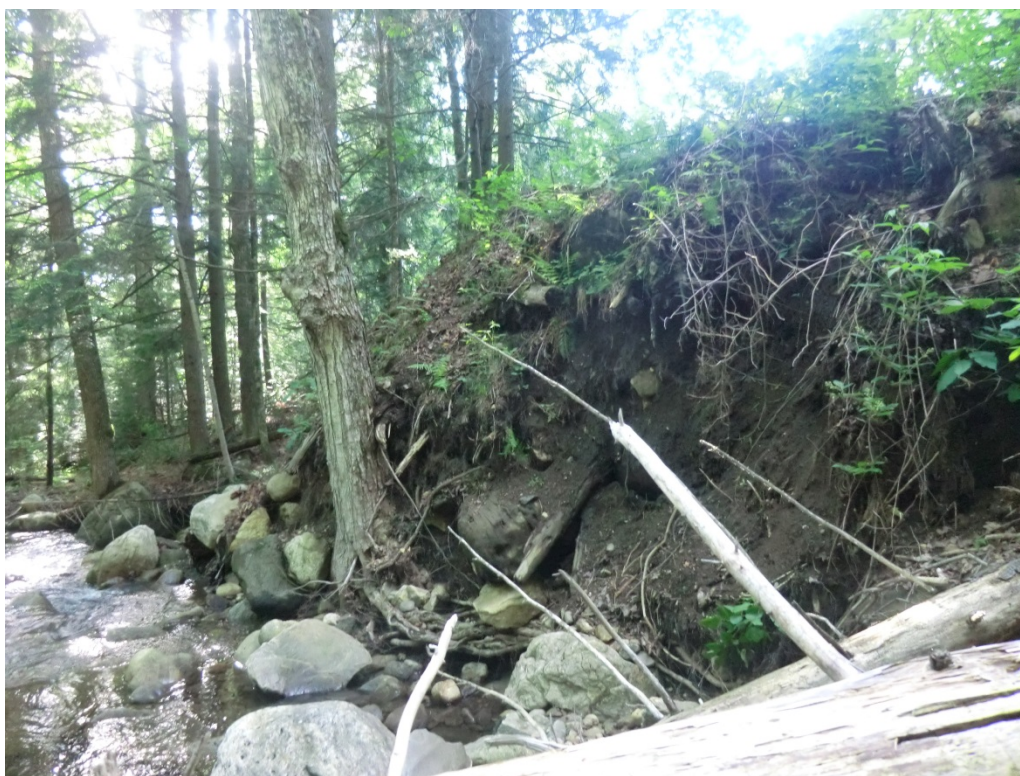
Figure 5.41. Localized bank erosion in M3.08-A contributing sediment to Great Brook.

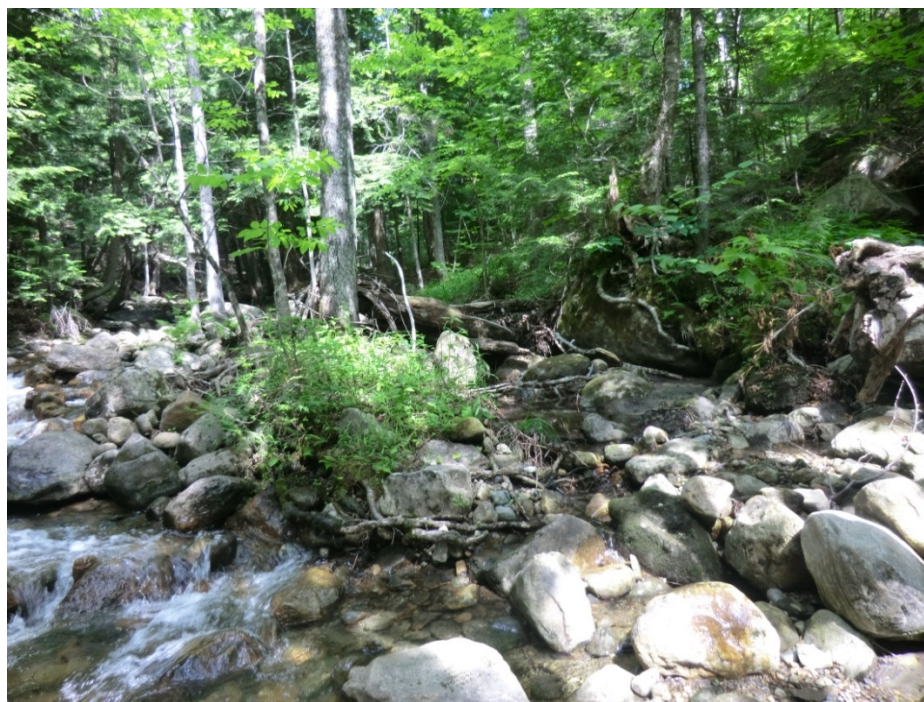
Figure 5.44. Streamflow around island in M3.08-B.

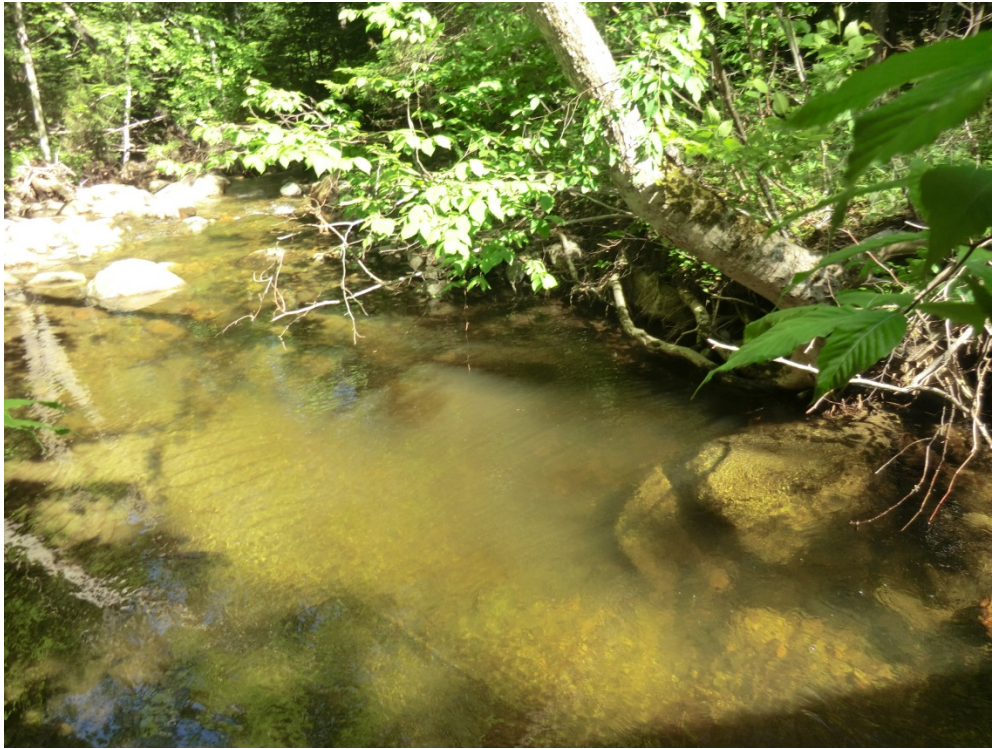
Figure 5.45. Pool habitat in M3.08-B.

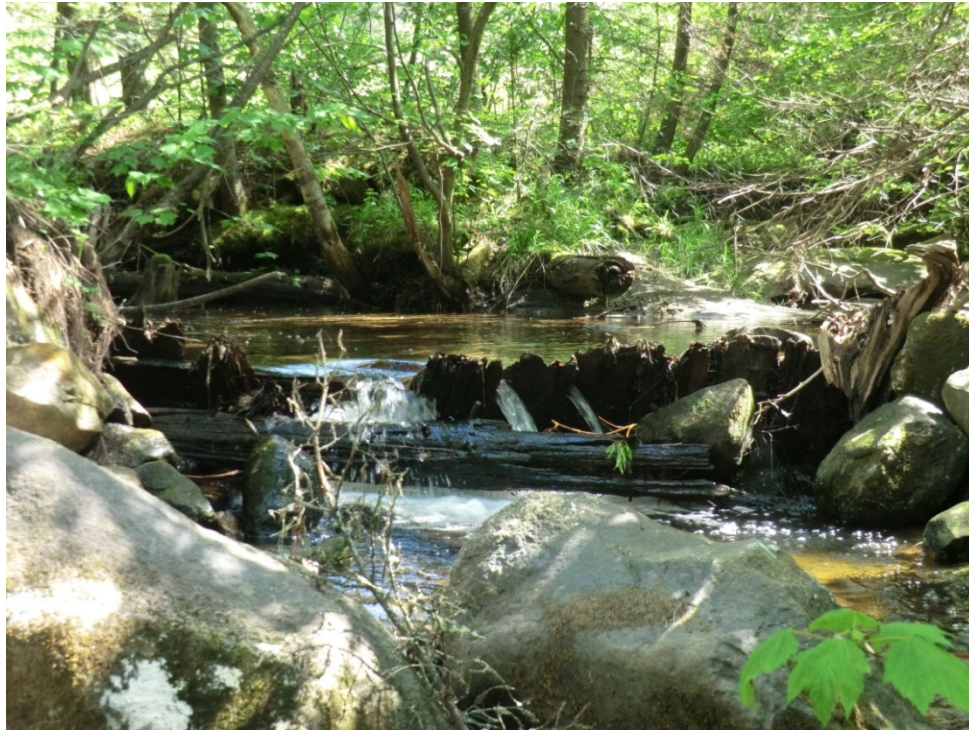
Figure 5.48. Collapsed bridge with old abutment causing channel constriction in M3.08-C.

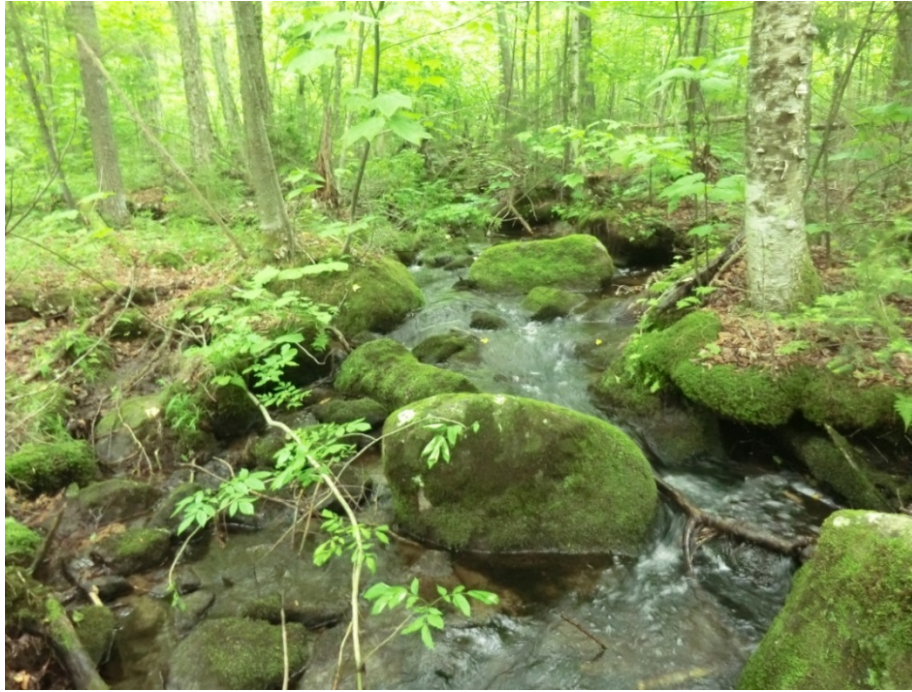
Figure 5.49. Reference condition stream in segment M3.08-D, with great floodplain access and mossy banks.

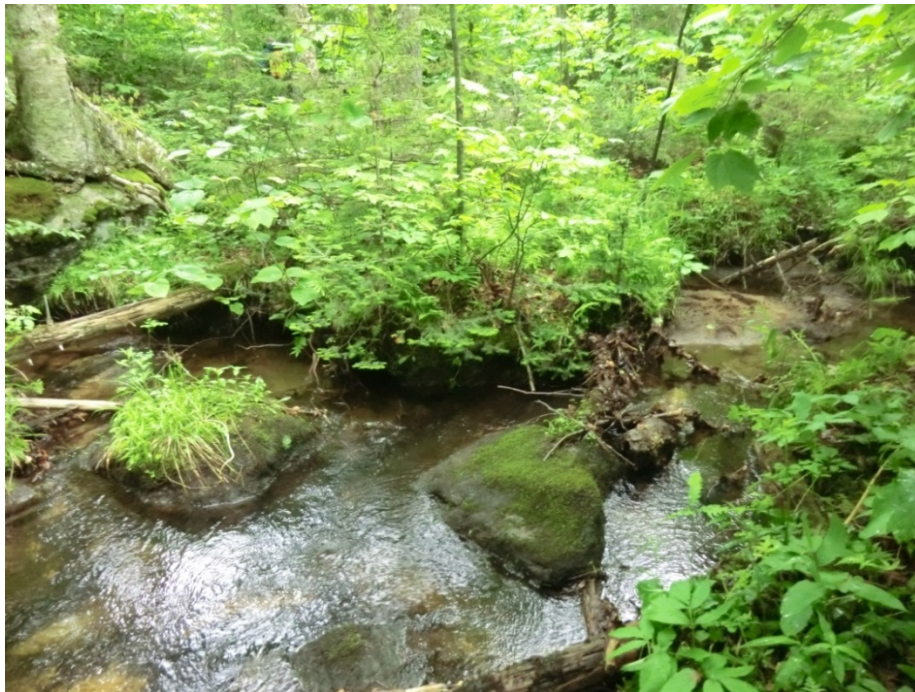
Figure 5.50. Channel bifurcation around island in M3.08-D.

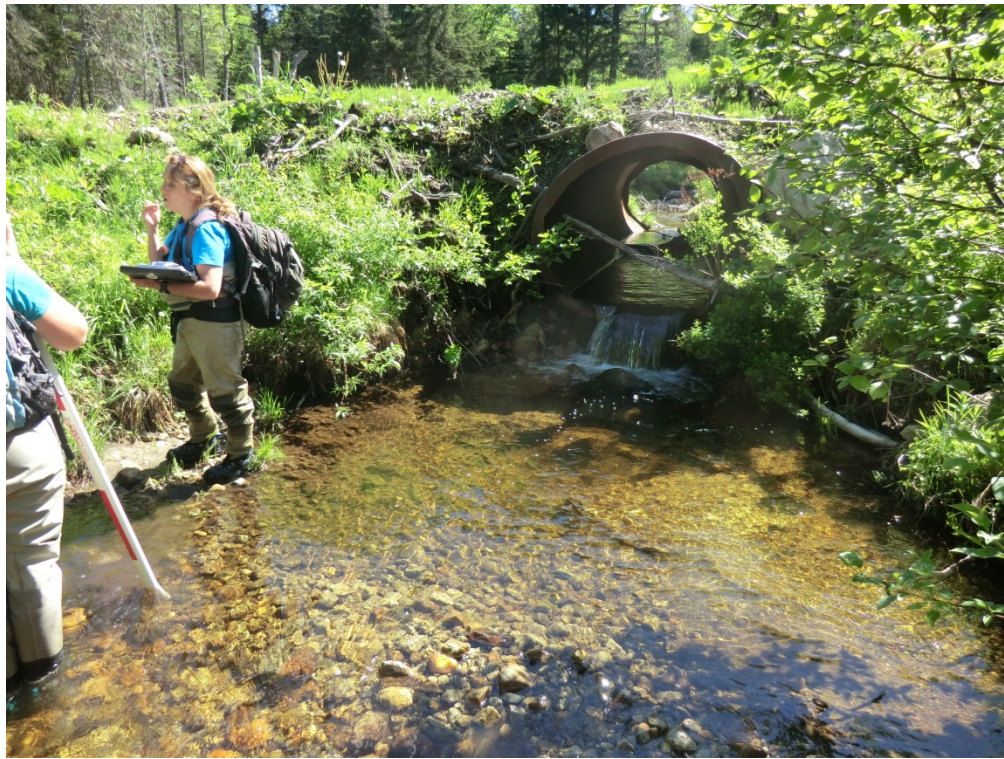
Figure 5.51. Tributary with perched culvert entering Great Brook in vicinity of lack of buffer from logging road in M3.08-D.

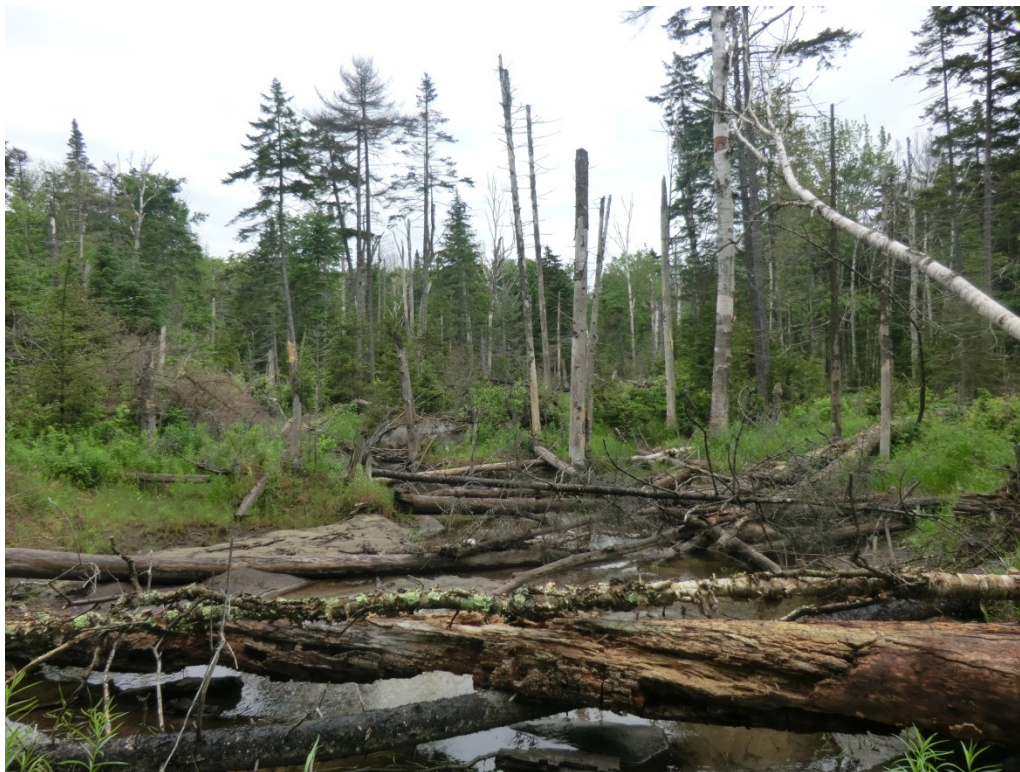
Figure 5.52. Palustrine wetland above Reach M3.08.

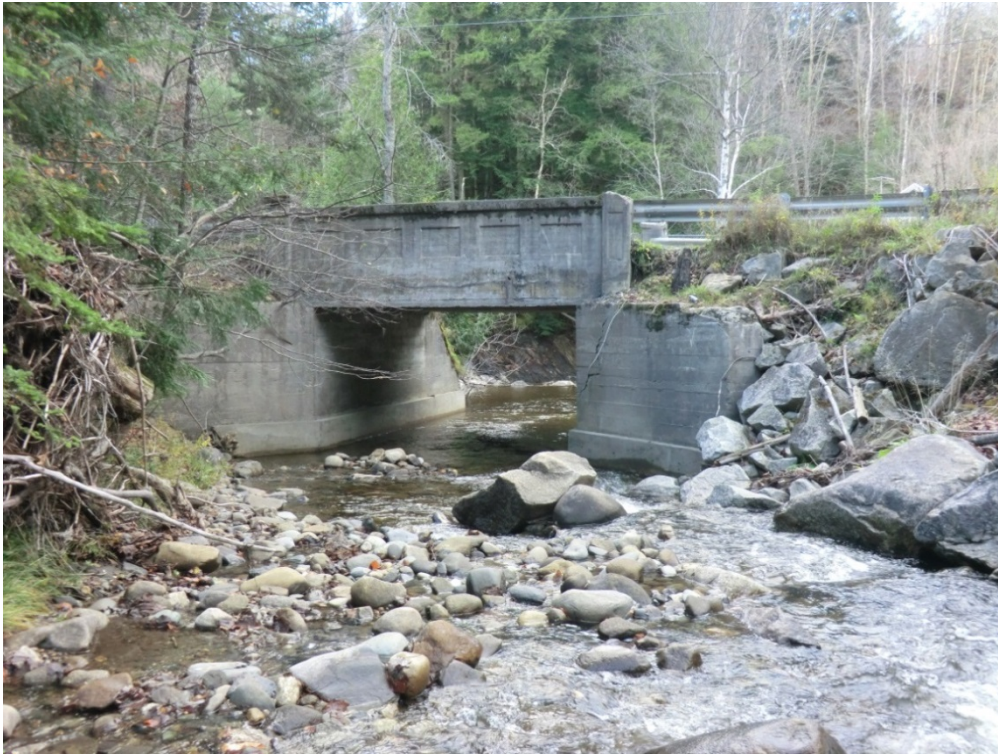
The three culverts in M3.05-C are recommended for replacement. Although it is in fairly good condition, the most downstream culvert is significantly undersized and fully incompatible with the stream geomorphology (Figure 5.55). There is a boulder weir at the downstream end that is controlling the tail water has improved fish passage. Another undersized culvert recommended for replacement is at the central Brook Road crossing is in M3.05-C. It is in poor condition and has a low clearance that has caused scour on the decking. It poses a greater risk for debris jams and fluvial erosion hazards (Figure 5.56). A boulder weir is also located at the downstream end of this structure that has improved fish passage. The most upstream crossing in segment M3.05-C is recommended for replacement due to its constrictive nature and its condition. There is significant scour on the wing walls with cracking and potential to fall down (Figure 5.57).

Figure 5.55. Box culvert at most downstream Brook Road crossing in segment M3.05-C.

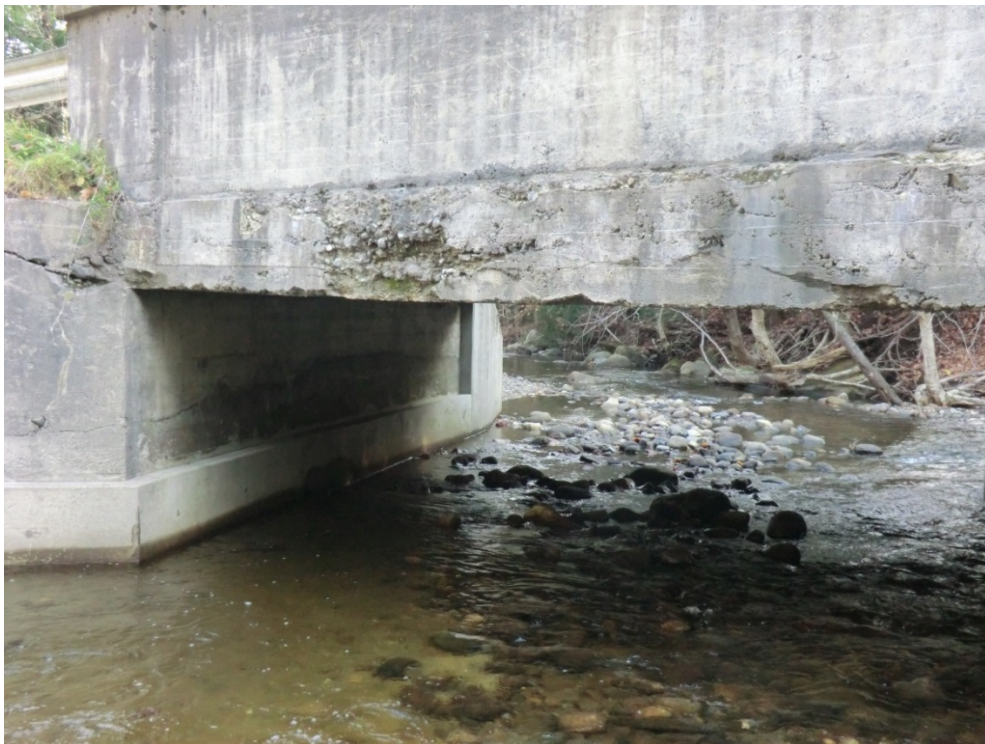
Figure 5.56. Box culvert at center Brook Road crossing in segment M3.05-C with low clearance.
