Great Brook Watershed River Corridor Plan

Plainfield and Groton, Vermont
March 19, 2014

Prepared by:
Bear Creek Environmental, LLC
149 State Street, Suite 3
Montpelier, Vermont 05602

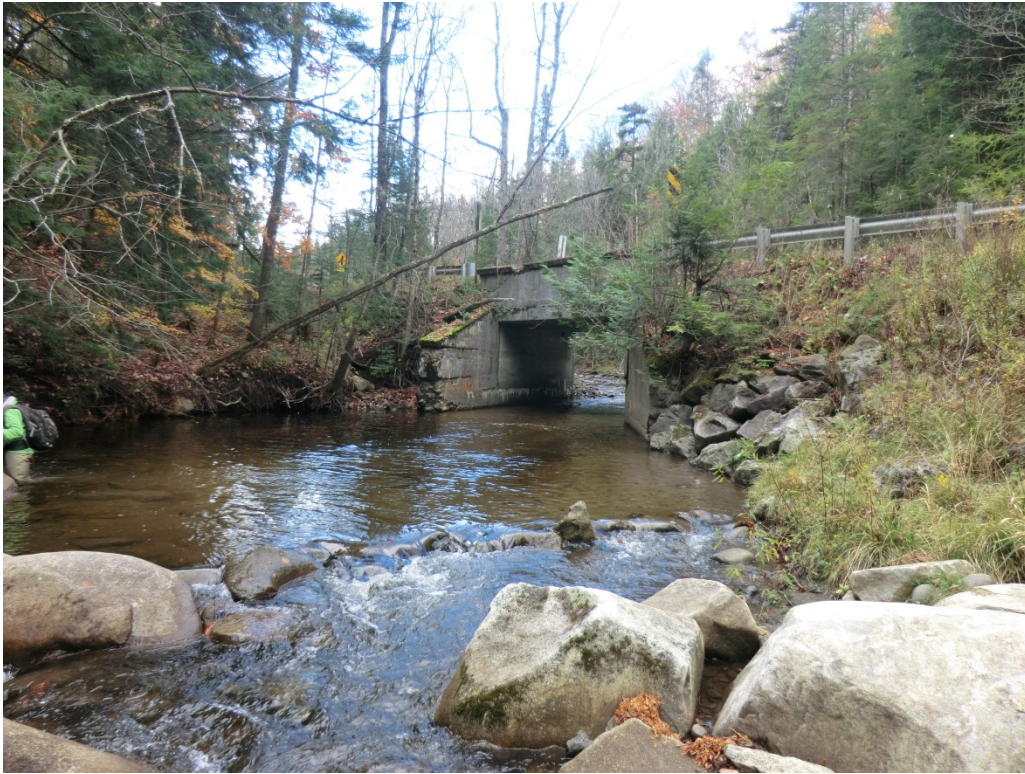
Great Brook crosses Brook Road again in segment M3.06-C where there is another undersized box culvert that is recommended for replacement. This culvert is in fair condition with failing hard bank armoring, especially at the base of the culvert and wing walls (Figure 5.58). A boulder weir has been placed at the downstream end of this structure and has improved fish passage. The final Brook Road crossing is located at a significantly undersized box culvert in segment M3.07-B. This culvert is recommended for replacement due its condition and constrictive nature (Figure 5.59), which has resulted in scour and deposition in the stream channel. The last culvert recommended for replacement is at the crossing on Gore Road in segment M3.08-A. This culvert has a poor alignment with the stream channel, no material throughout and has an outlet drop of approximately one foot that may be impeding fish passage (Figure 5.60). More details of recommendations on replacing the structures are included in the tables and maps in Appendix C.

Figure 5.58. Box culvert at Brook Road crossing in segment M3.06-C.

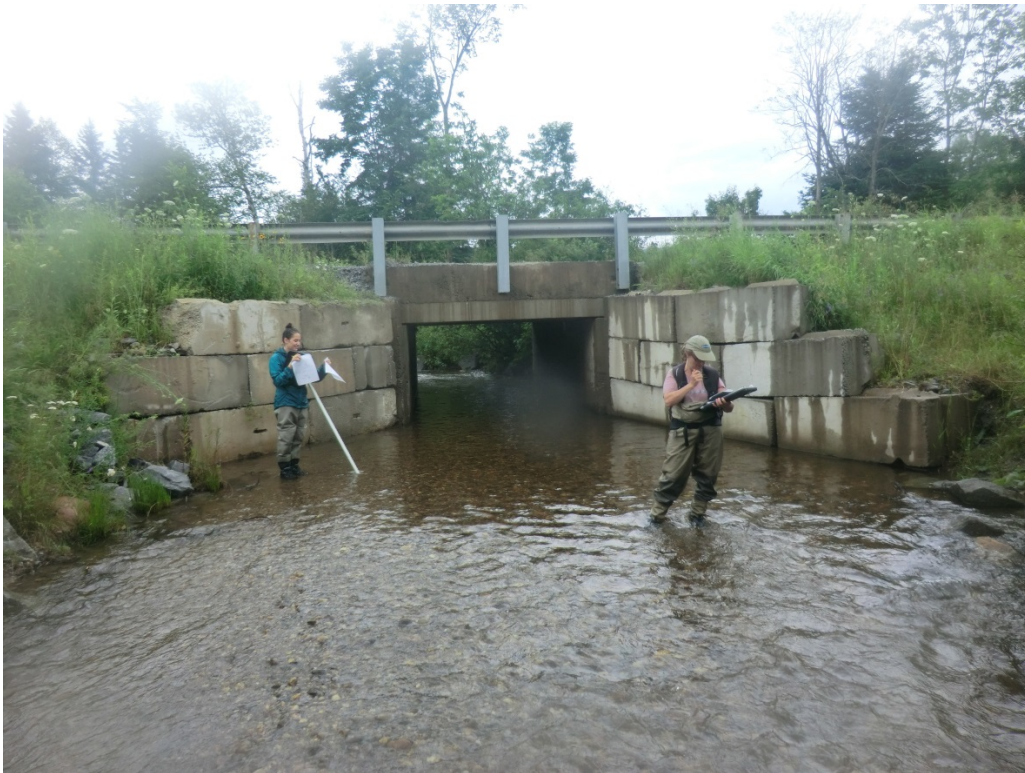
Figure 5.59. Box culvert at most upstream Brook Road crossing in segment M3.07-B.

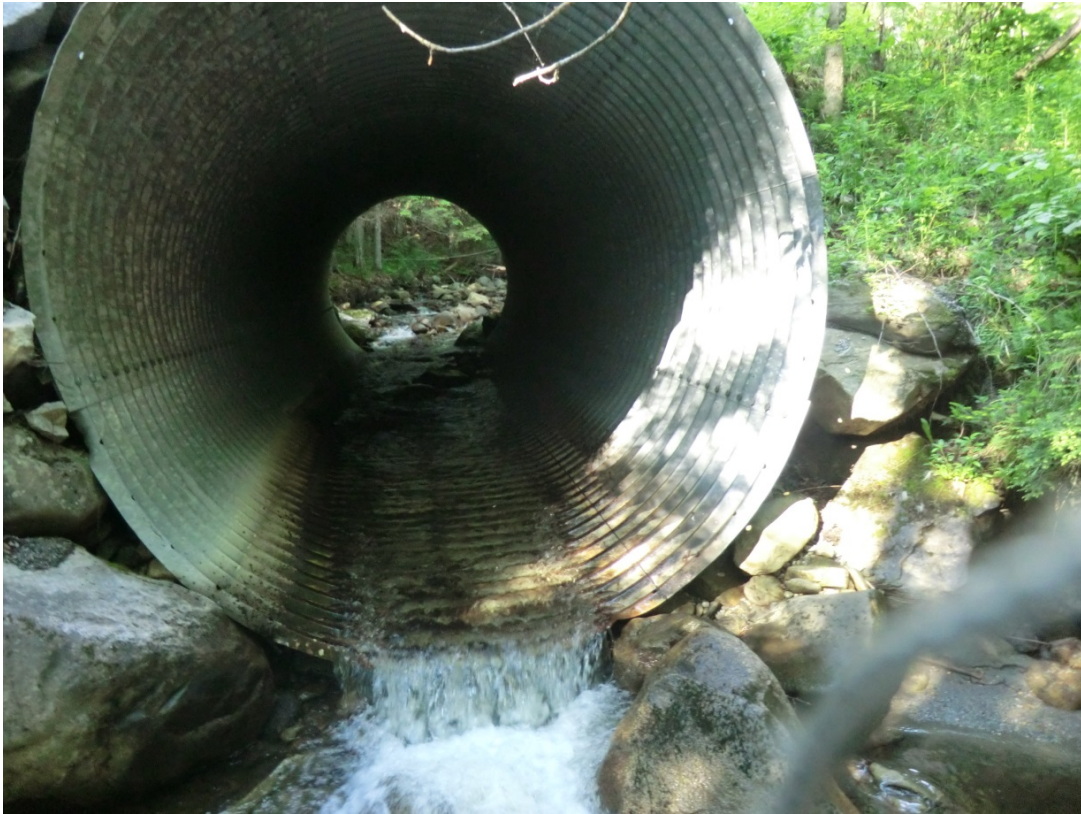
Figure 5.60. Culvert at Gore Road crossing in segment M3.08-A causing potential fish passage issue.

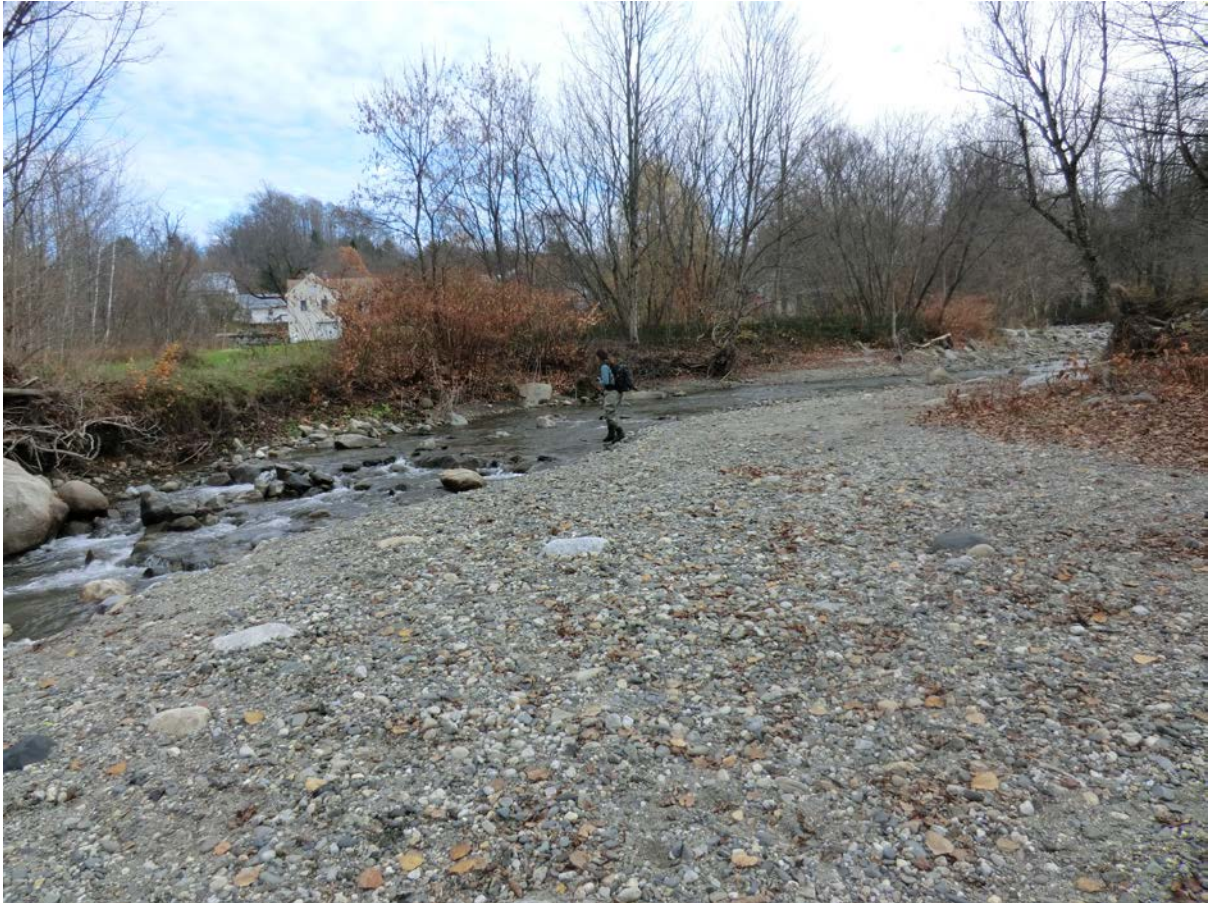
M3.01-A

Did you feel certain that the headcut noted near the mouth of the brook was indicative of a degradation process rather than an aggradation process? Did you happen to get a photo? **We did think this it was an aggradational feature, possibly a result of recent flooding. Both Mary and Sacha felt there was a head cut moving up through this aggraded feature (see photo below). We added an additional sentence to Step 5 in the DMS to describe this.**

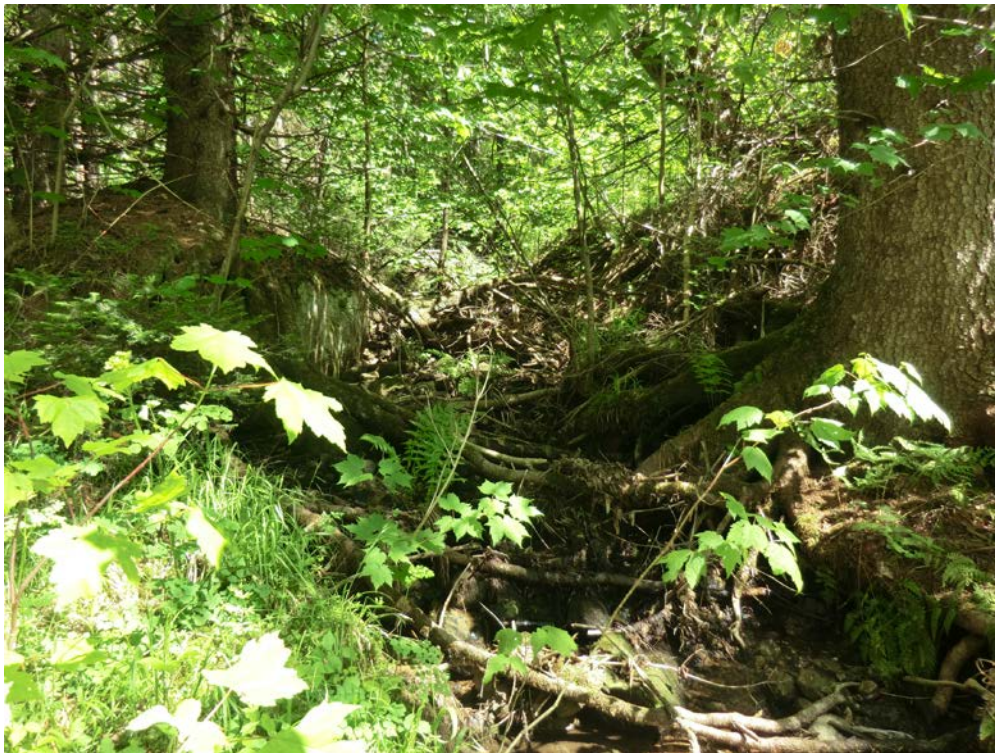
This channel really was not incised. There was ample floodplain access. There were many ephemeral tribs/gullies entering Great Brook in this part of the watershed and it was difficult to tell at times whether they were gullies or tributaries. The one that was marked as a rejuvenating trib in the photo log seemed somewhat perched (see photo below), which is why it was probably marked as being a rejuvenating trib in the photo log comments. After more review of the photo, we decided that it was not rejuvenating. We changed the comment in the photo to just say tributary so as not to be misleading that the segment is incised.
